**RE: Lehigh Southwest Cement Company—Permanente Quarry
Reclamation Plan, Conditions of Approval
Annual Compliance Report, 2016-2017**

Lehigh Permanente Quarry Reclamation Plan Amendment Conditions of Approval Compliance Annual Report 2016-2017 Information Package

REPRESENTATIVE STORMWATER AND EROSION CONTROL BMP PHOTOGRAPHS

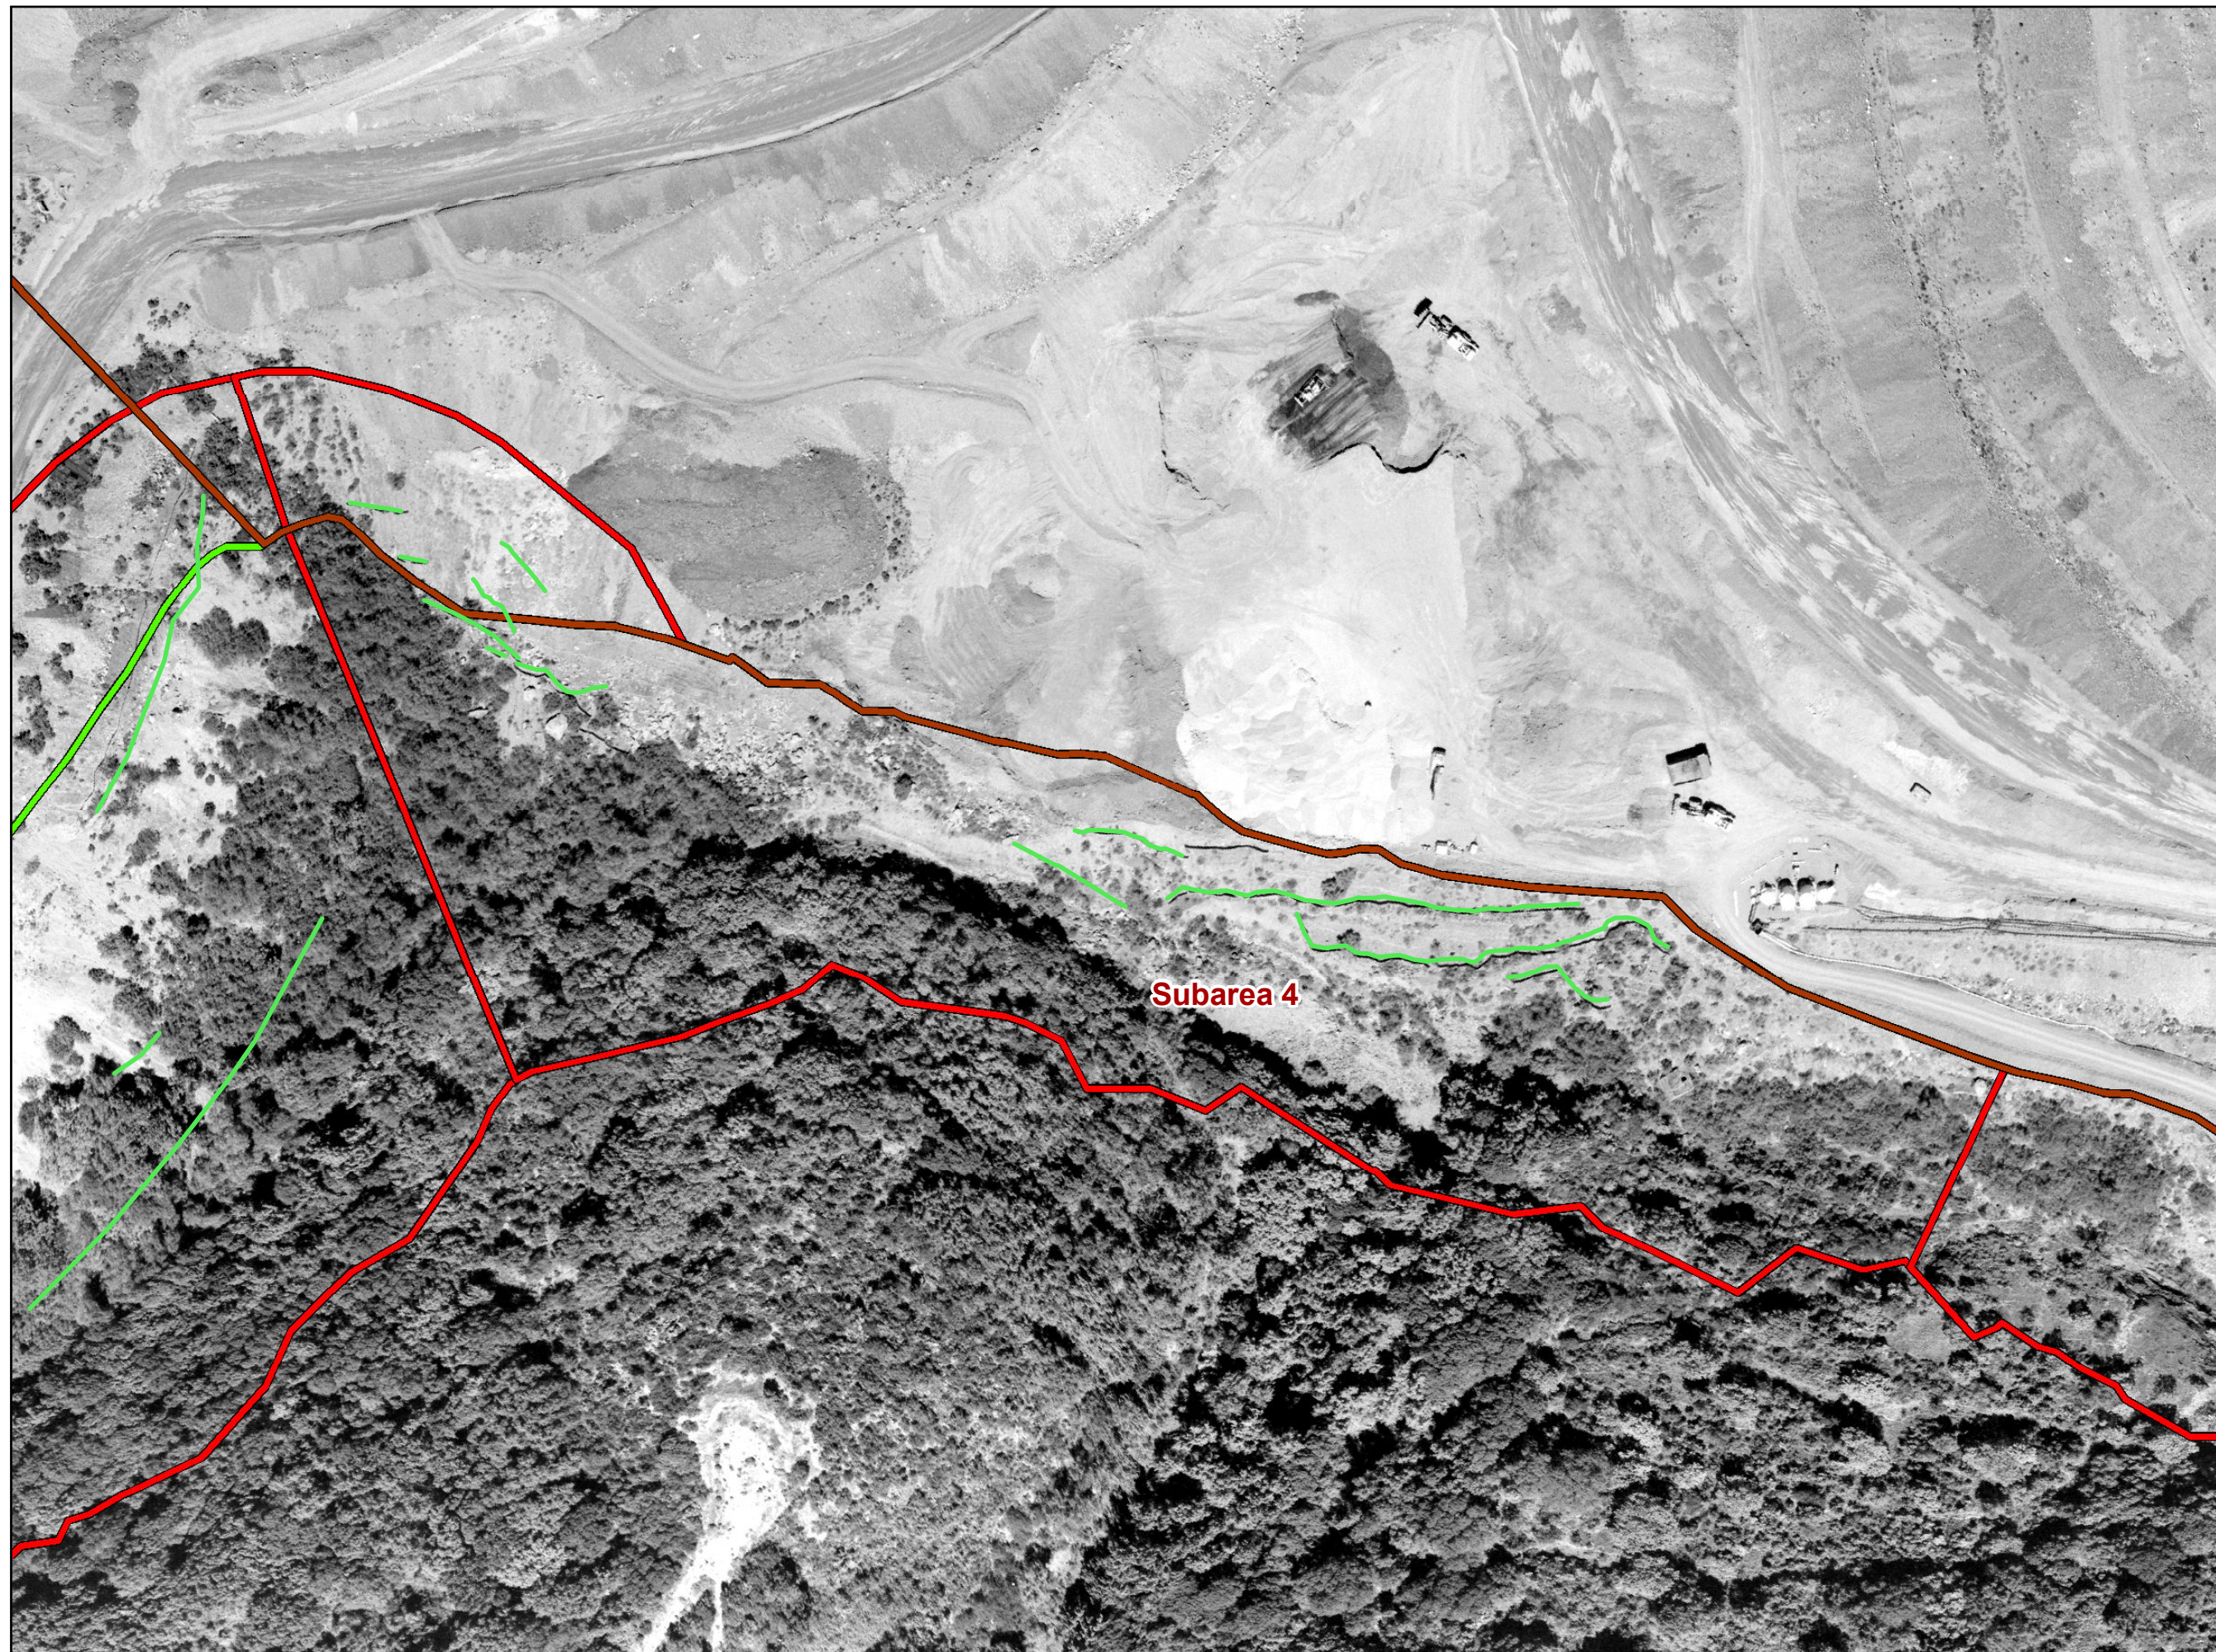
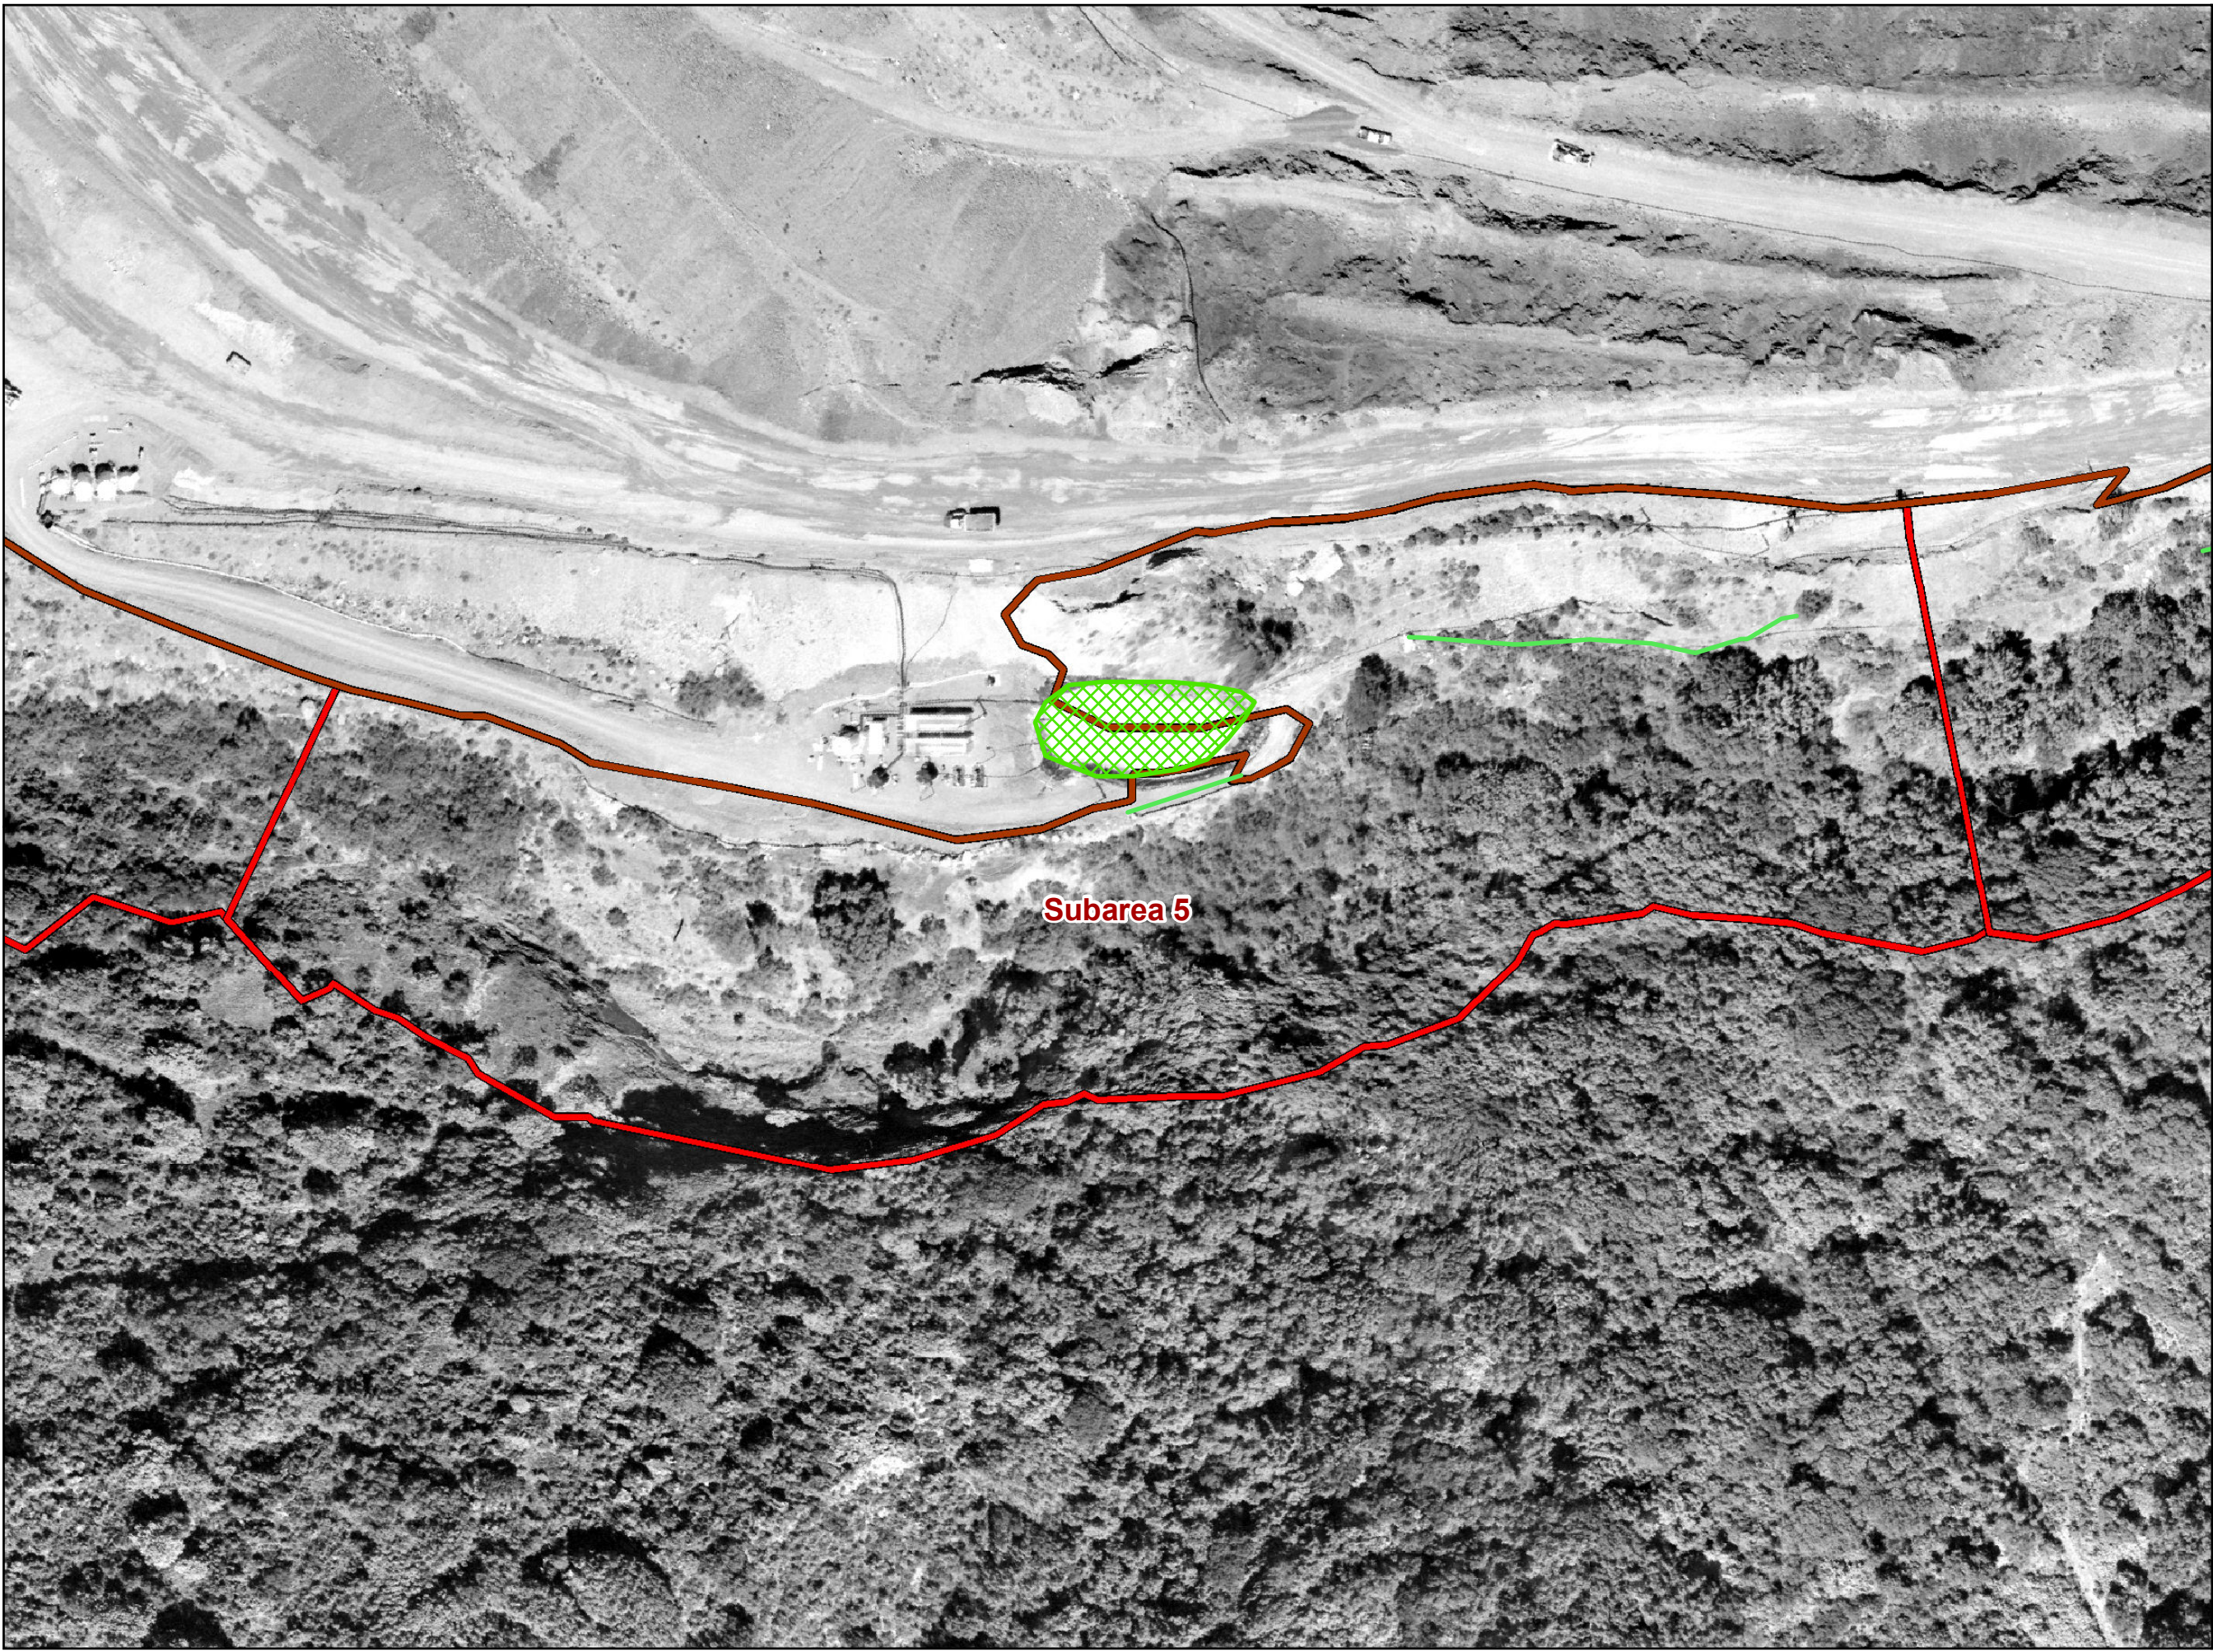
Subarea 5 is located at the southern border of the North Quarry, directly east of Subarea 4, south of Pond 4A and the Interim Treatment System (ITS), which treats stormwater and process water before discharging into Permanente Creek. The majority of Subarea 5 is extremely steep with limited access. No new erosion control measures were implemented in Subarea 5. All previously installed erosion control BMPs below the access road were routinely inspected and repaired as necessary. No substantial evidence of erosion has been observed over the 2016-2017 reporting period.

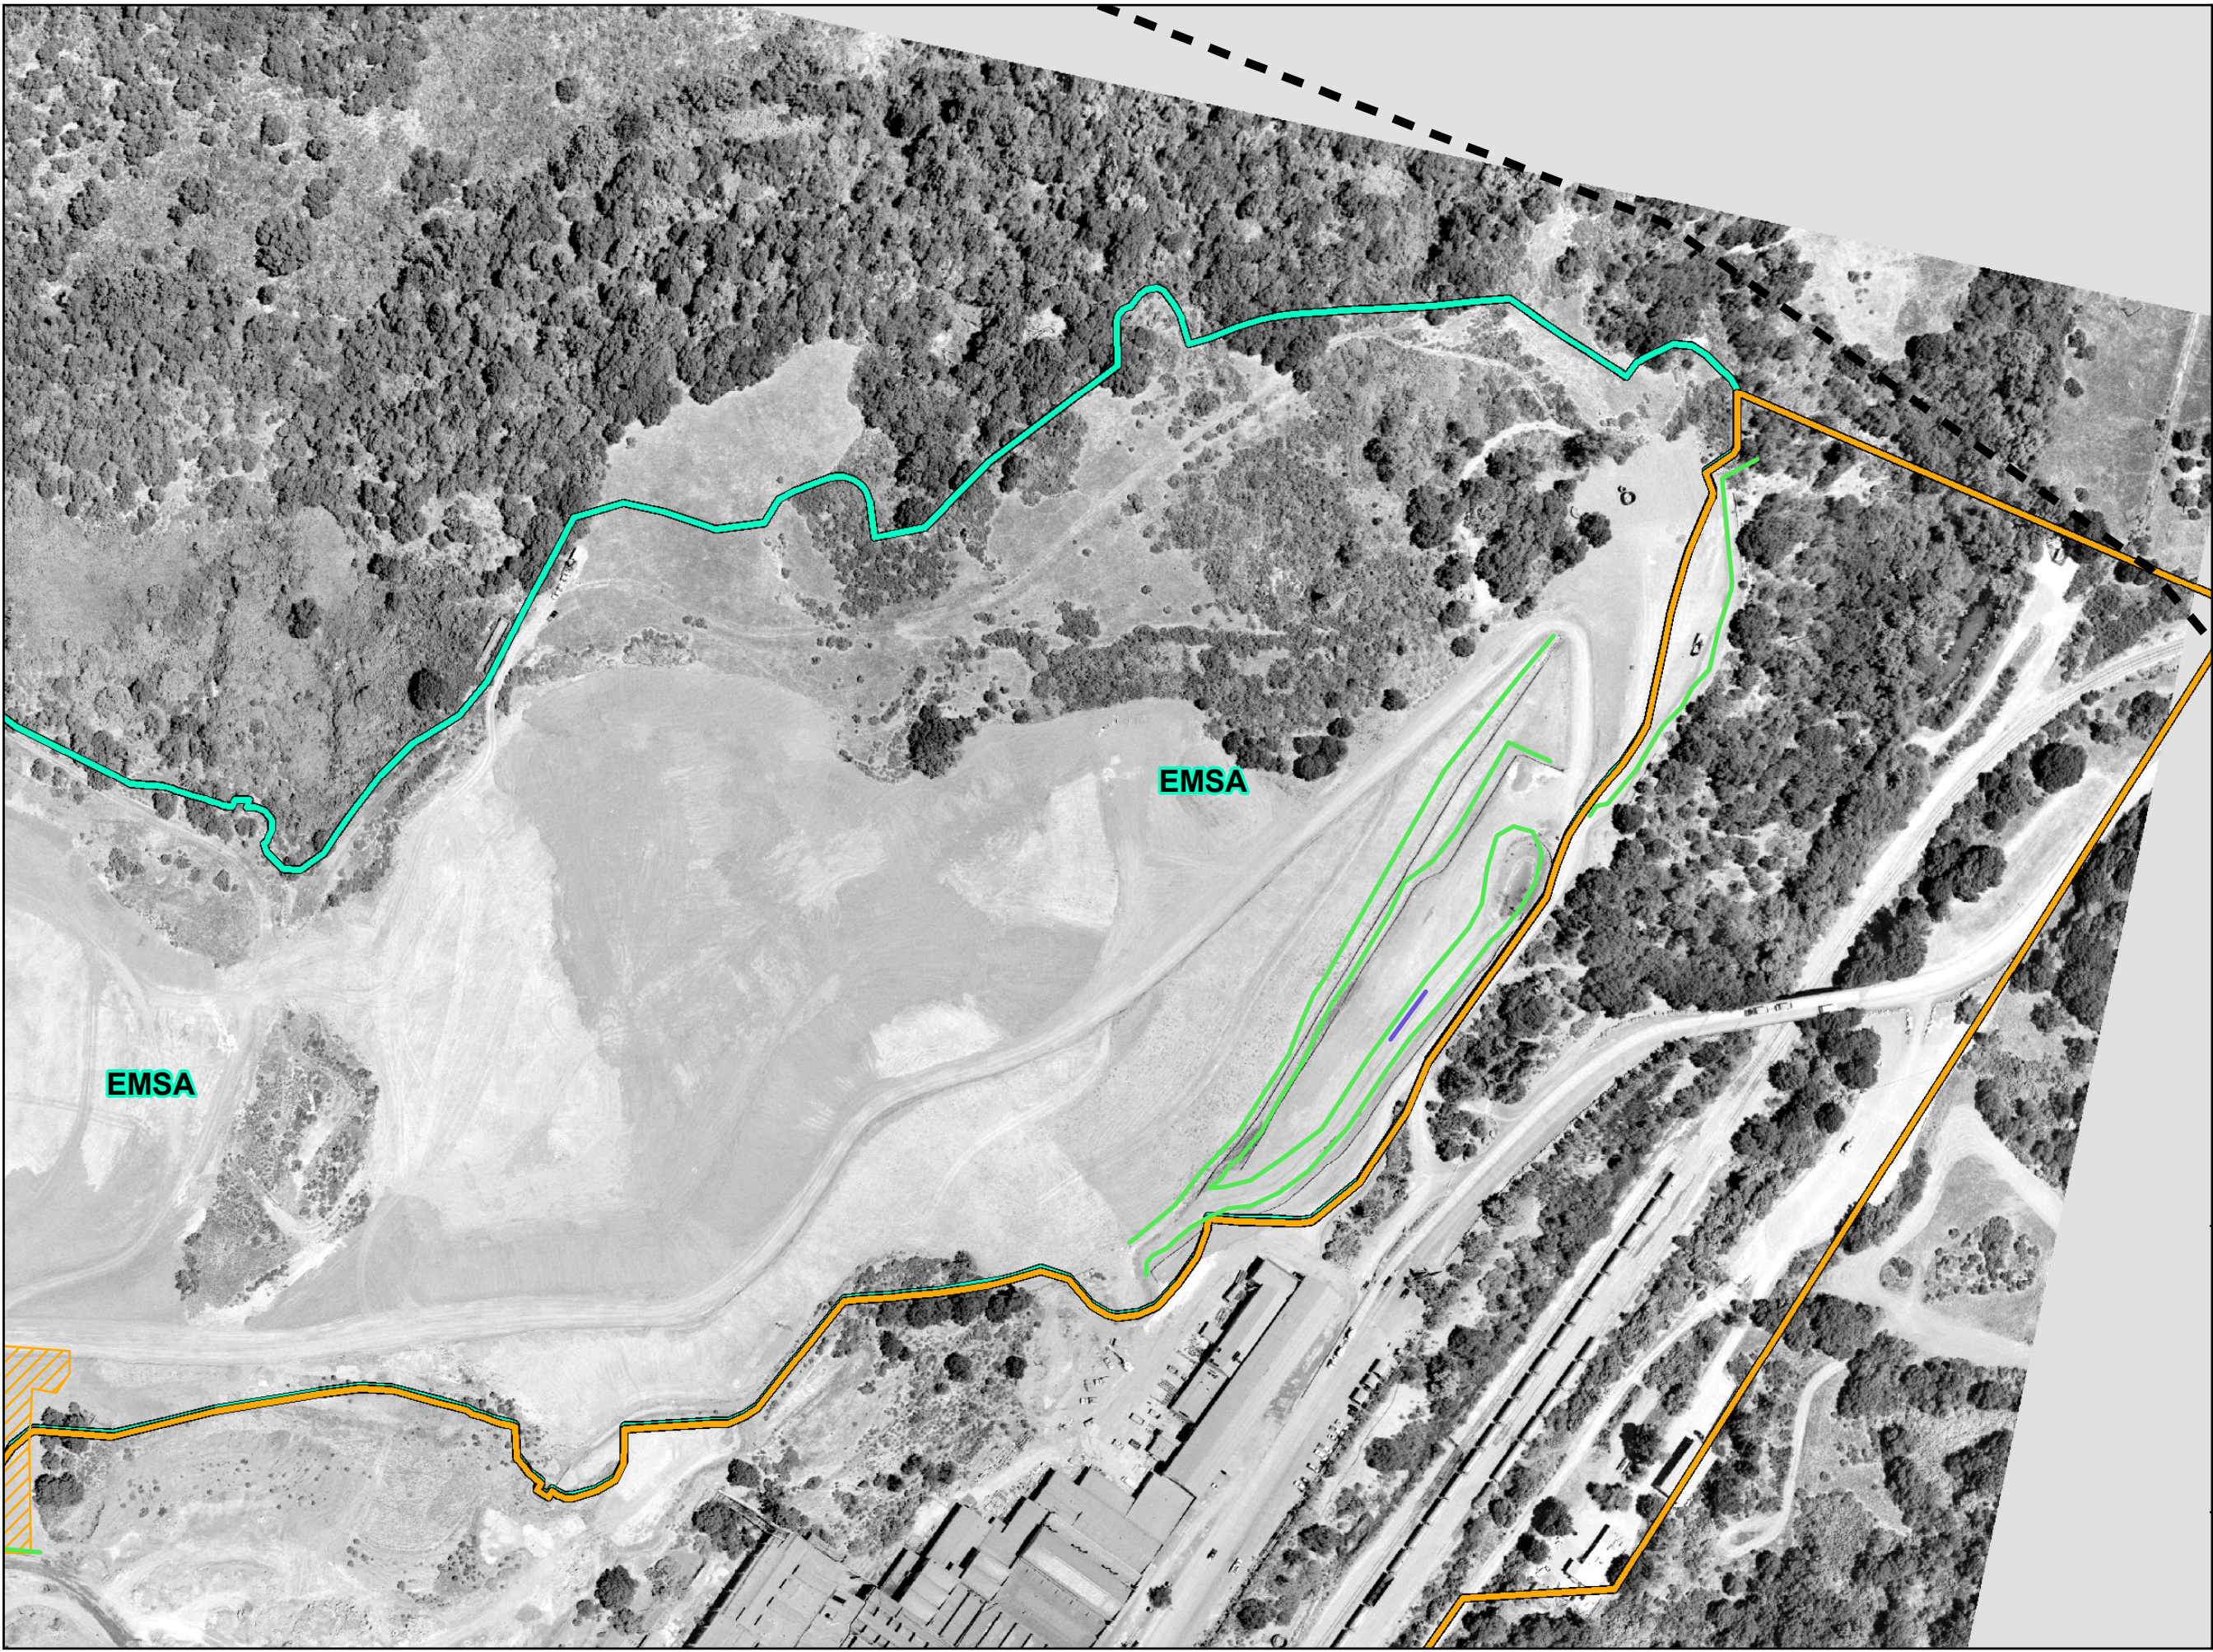
EMSA East

The EMSA is an overburden storage area located to the northeast of the Crusher/Support Area. All stormwater and erosion control BMPs previously installed within the EMSA were routinely inspected and repaired, replaced, or removed as needed throughout the 2016-2017 reporting year (see Appendix A - attached map book pages 10, 11, 13, and 14 and Appendix B photograph 1). No additional stormwater and erosion control BMPs were deemed necessary in the EMSA.

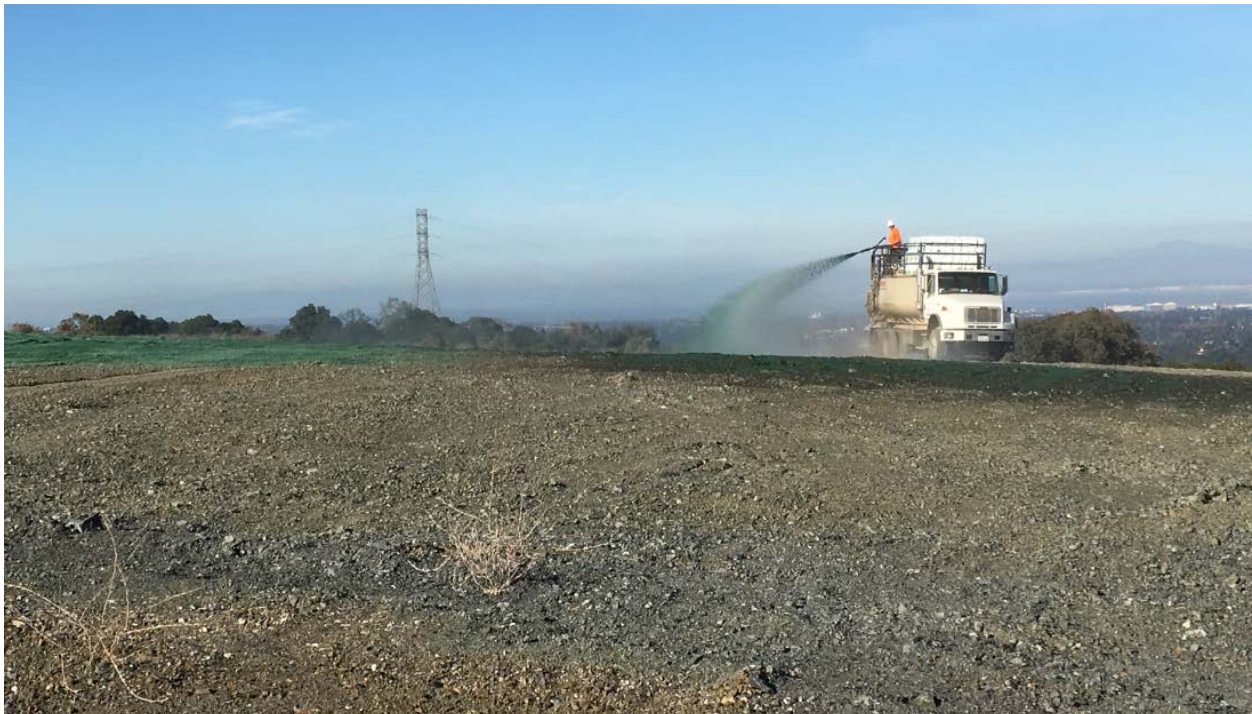
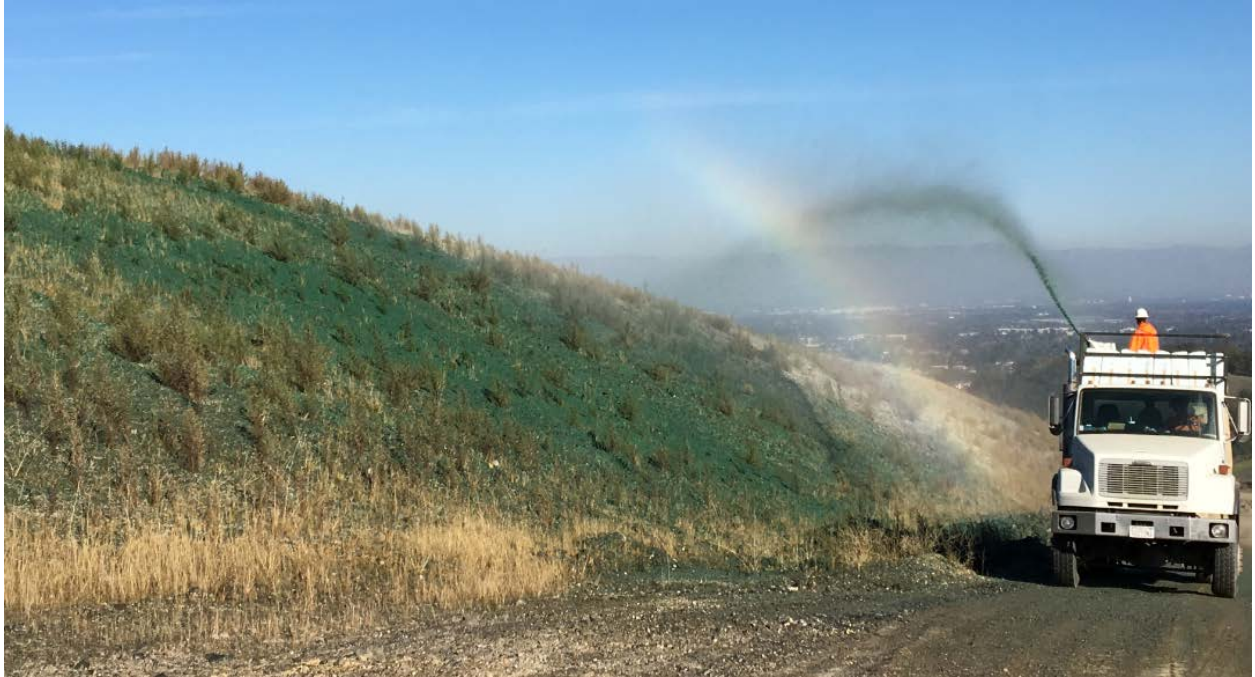
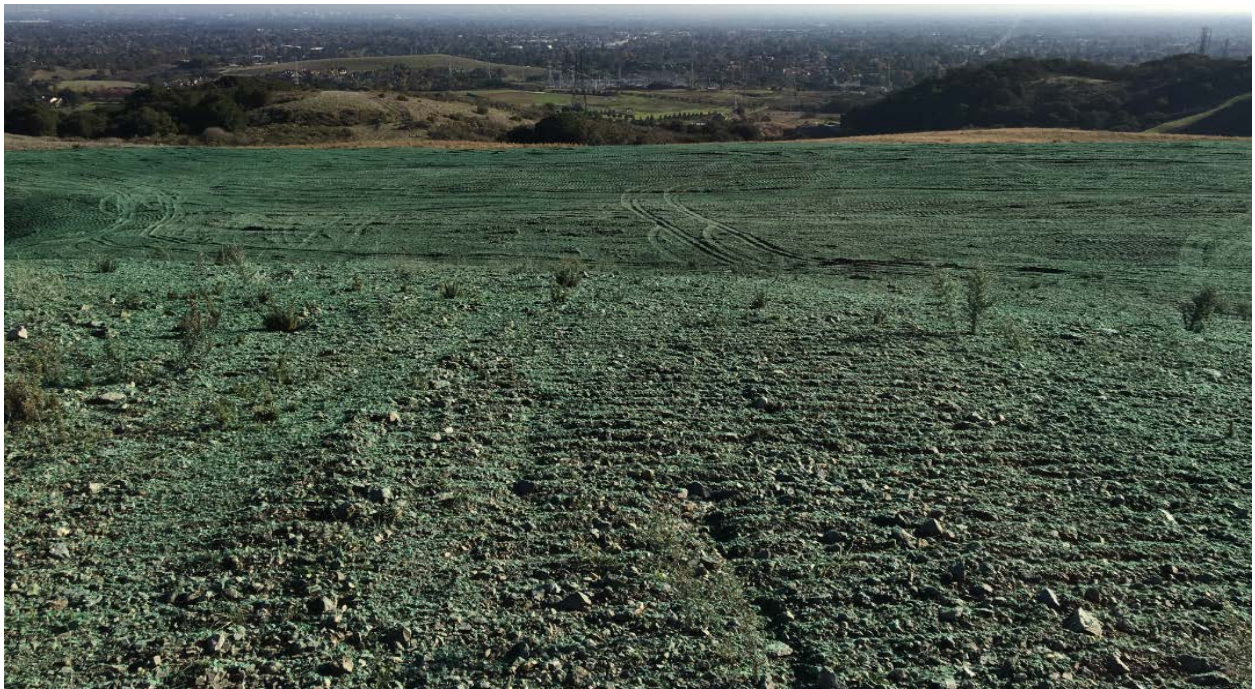
On November 8 & 9, 2016, approximately 6 acres of land in EMSA was hydro seeded using the erosion control mix. This inventory is pursuant to Conditions of Approval (COA) 27 of the 2012 Reclamation Plan Amendment.

Pacific Coast Seed supplied the erosion control mix and Freedlun Hydroseeding performed the hydroseeding activity.

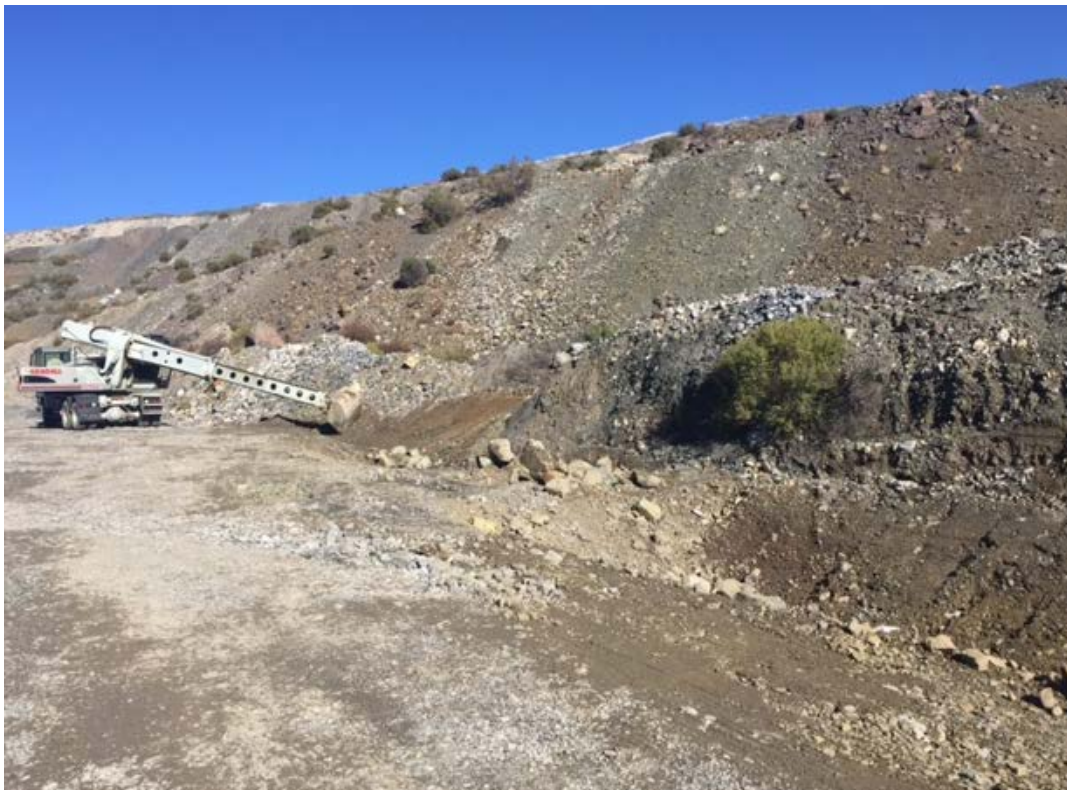
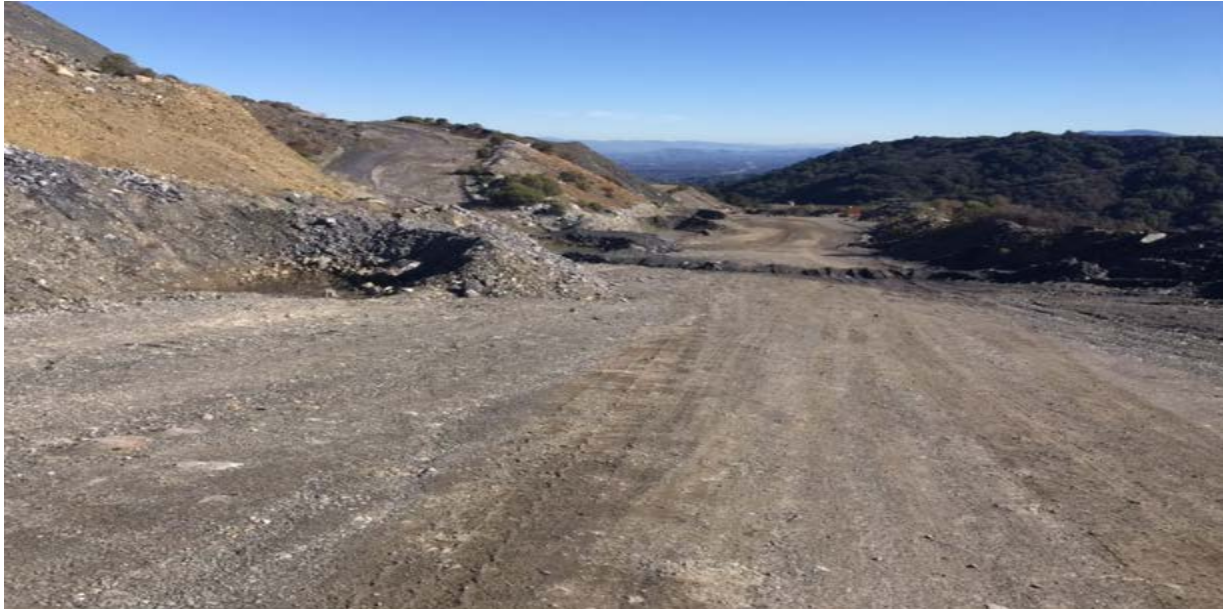
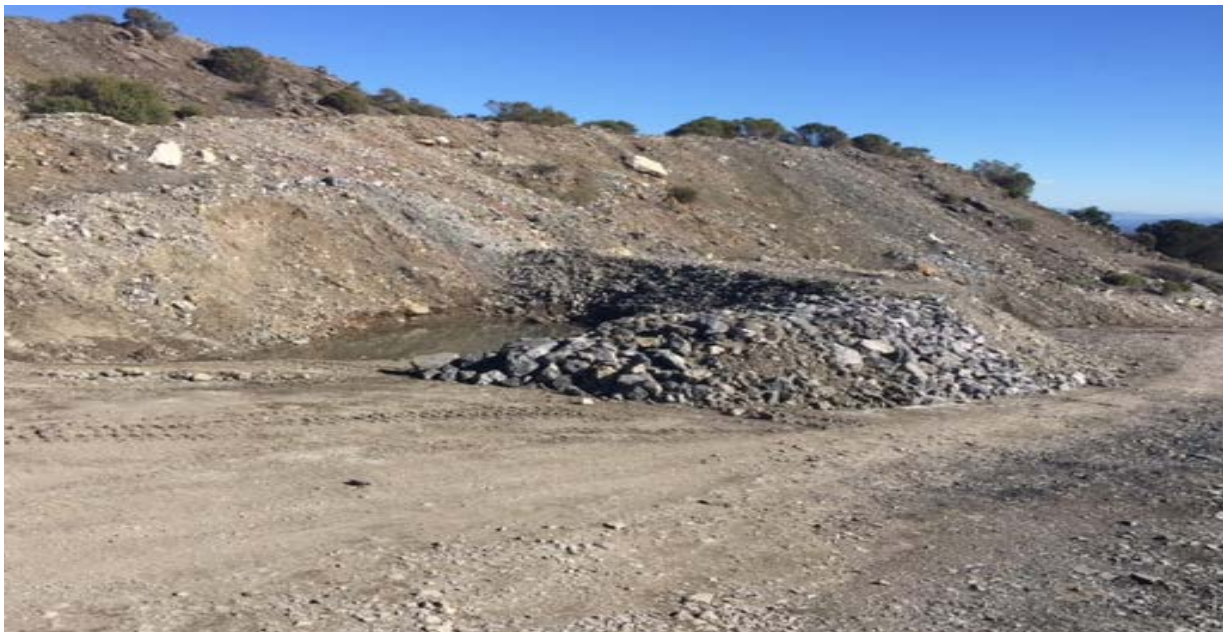
In December, 2016 and February 2017, approximately 1900 yards of silt was cleaned out from the silting basin in WMSA & Rock plant areas. The work was performed by Coulter Gradeall. The silt was deposited in WMSA.

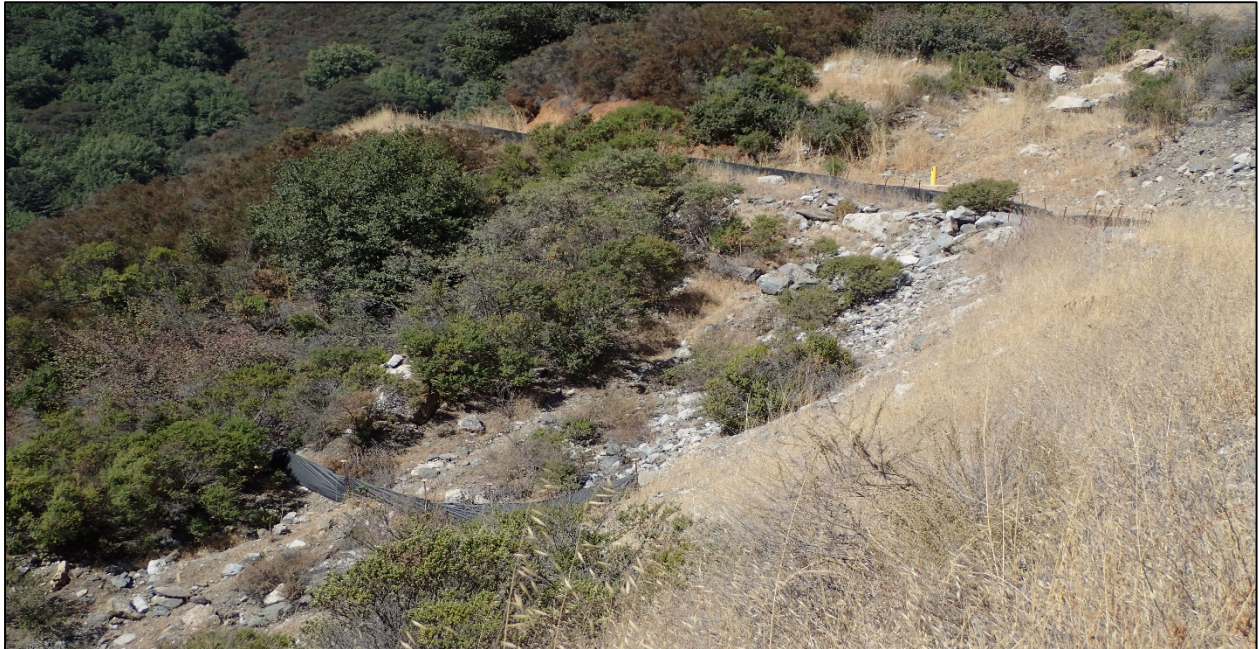
Photograph 1. Wire-backed erosion control silt fence installed on downhill side of access road in PCRA Subarea 1.

Photograph taken September 2, 2016.

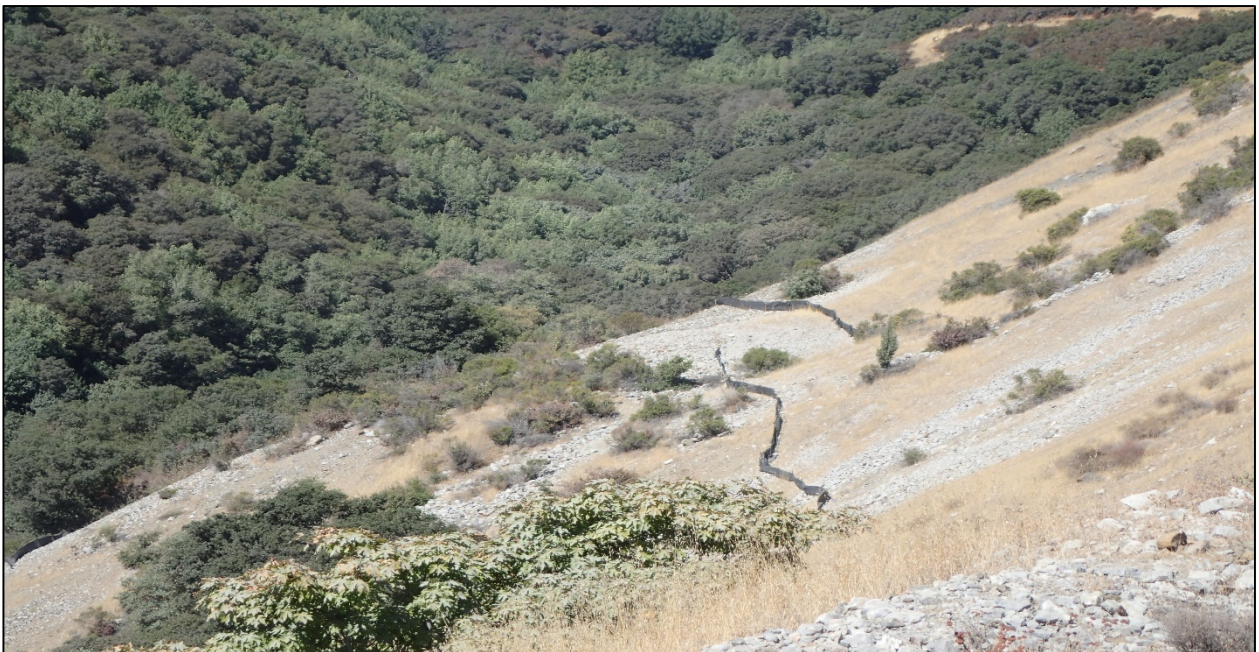
Photograph 2. Wire-backed erosion control silt fence installed below new mining activity in PCRA Subarea 2.

Photograph taken September 2, 2016.

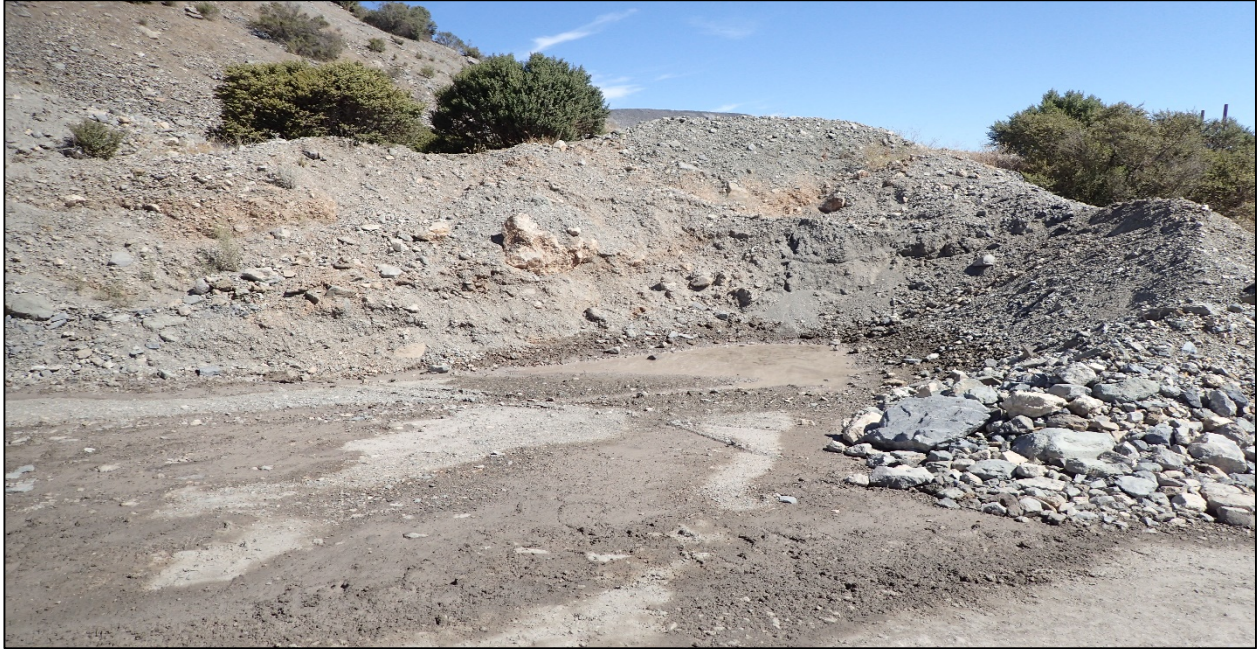
Photograph 3. Recently cleaned check dam along WMSA haul road,
Photograph taken January 5, 2015.

- Maintenance of the haul road and check dams (see Appendix B photographs 3 and 5)
- Repair and replacement of erosion control silt fences and fiber rolls securing the two topsoil stockpiles.

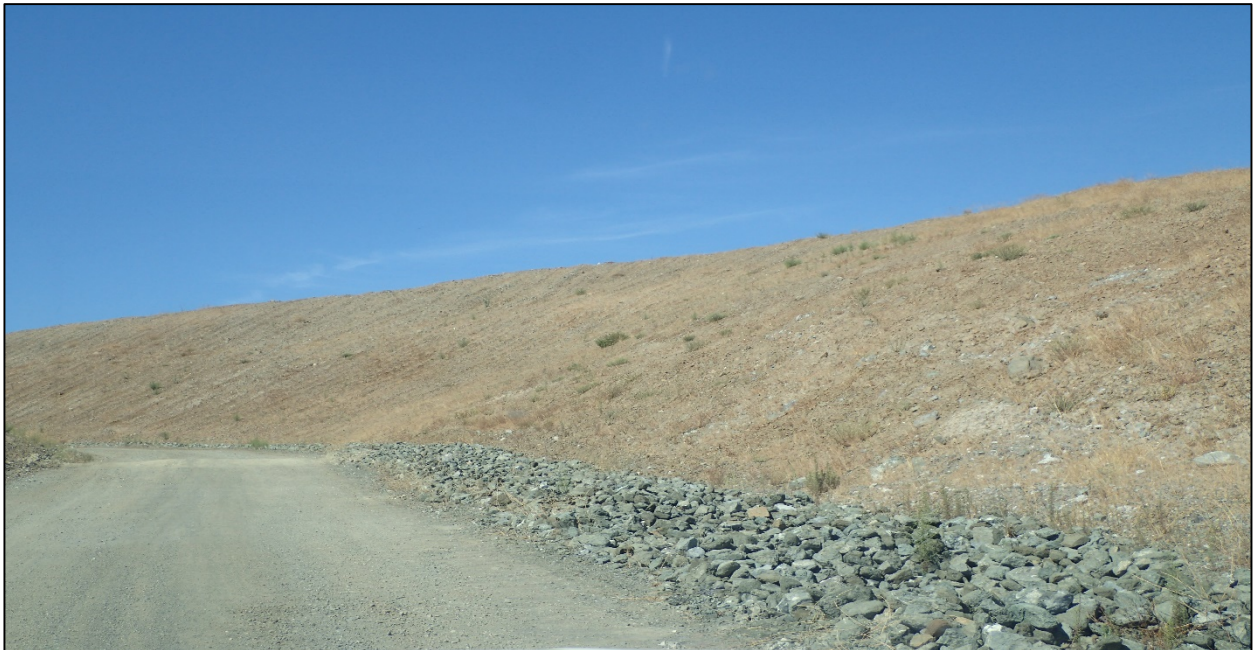
Photograph 4. Non-limestone lined stormwater ditch and previously hydroseeded slope along EMSA haul road.
Photograph taken September 2, 2016.

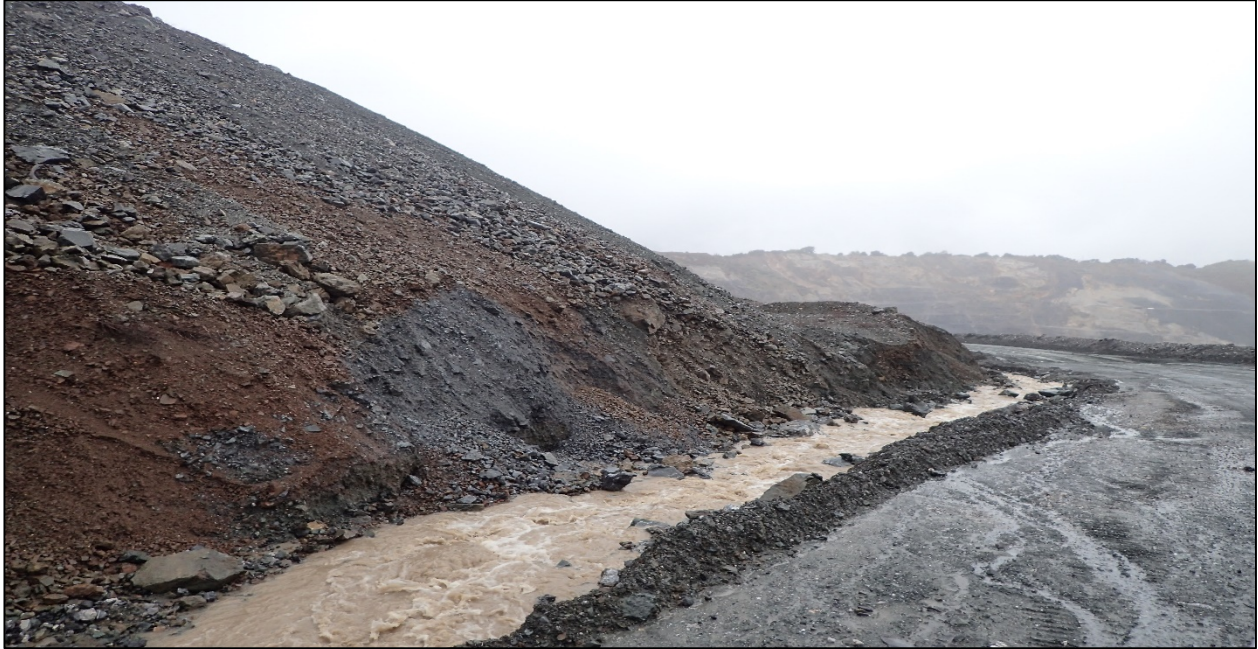
Photograph 5. Functioning stormwater ditch along the inside of the WMSA haul road.

Photograph taken February 7, 2017.

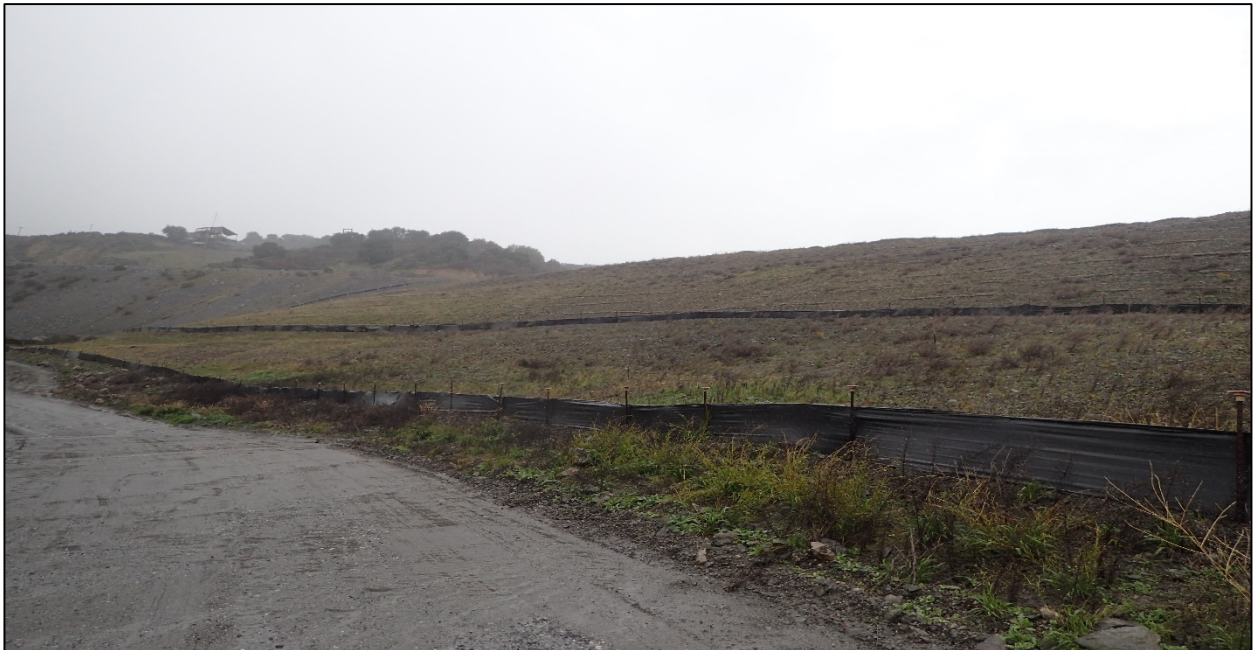
Photograph 6. Erosion control straw wattles and silt fences installed on interim reclaimed slopes in the EMSA.

Photograph taken February 7, 2017

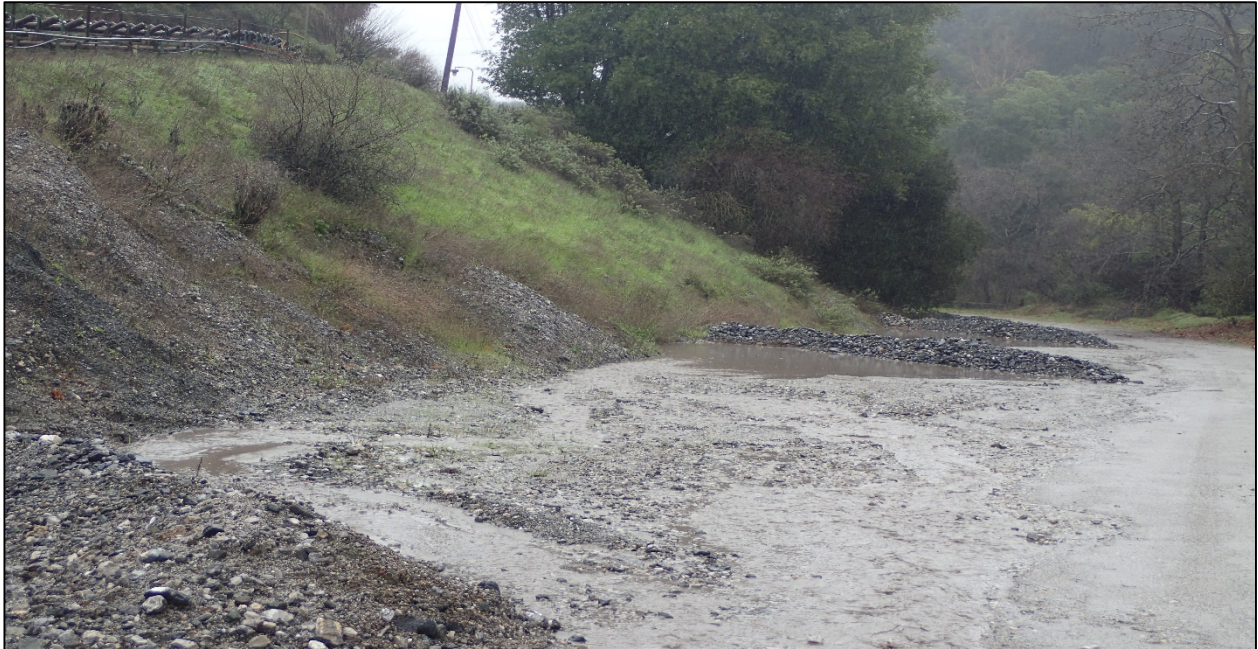
Photograph 7. Functioning check dams as see during a qualifying rain event

Photograph taken February 7, 2017.

stormwater and erosion control BMPs previously installed within the Surge Pile/Rock Plant area were routinely inspected and repaired as needed throughout the 2016-2017 reporting year (see Appendix A - attached map book pages 12, 13, and 14 and Appendix B photograph 7).
