**RE: Lehigh Southwest Cement Company—Permanente Quarry
Reclamation Plan, Conditions of Approval
Annual Compliance Report, 2016-2017**

Lehigh Permanente Quarry Reclamation Plan Amendment Conditions of Approval Compliance Annual Report 2016-2017 Information Package

REPRESENTATIVE STORMWATER AND EROSION CONTROL BMP PHOTOGRAPHS

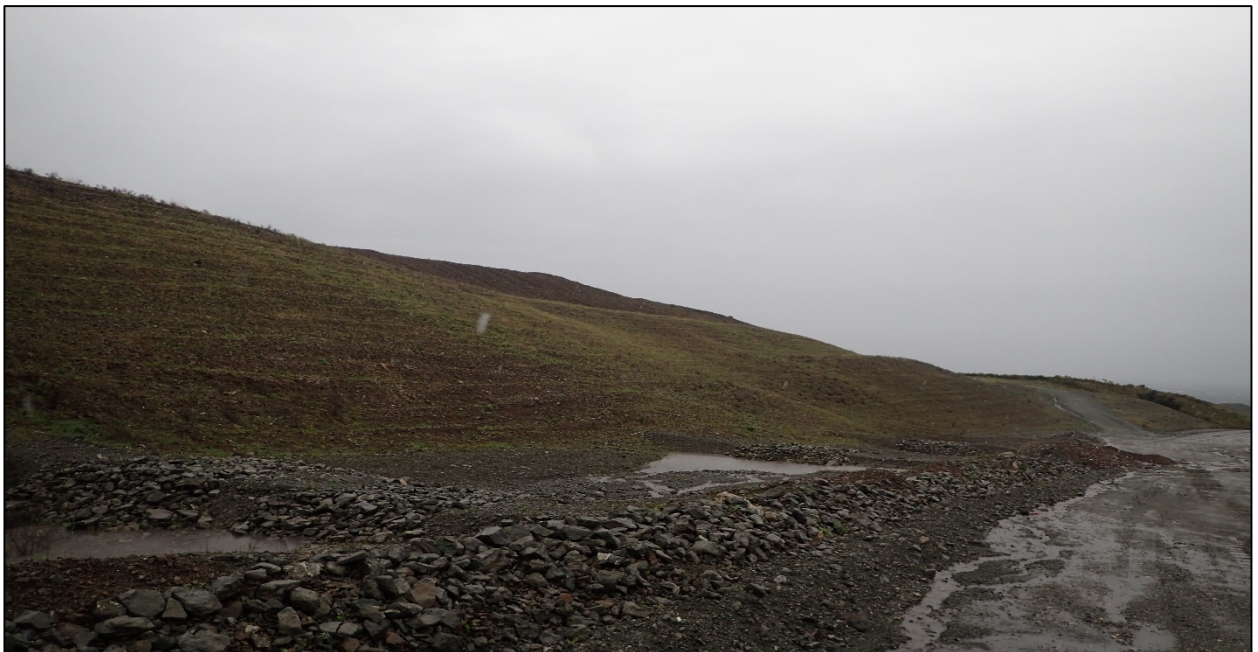
Photograph 8. Functioning check basins along EMSA haul road during a qualifying rain event.

Photograph taken February 7, 2017.

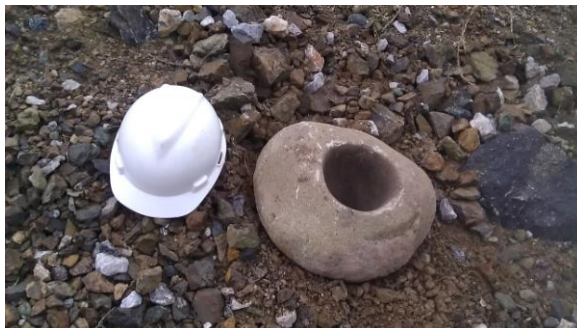
Figure 1. A grinding stone or ‘metate’ found on Permanente Quarry property.

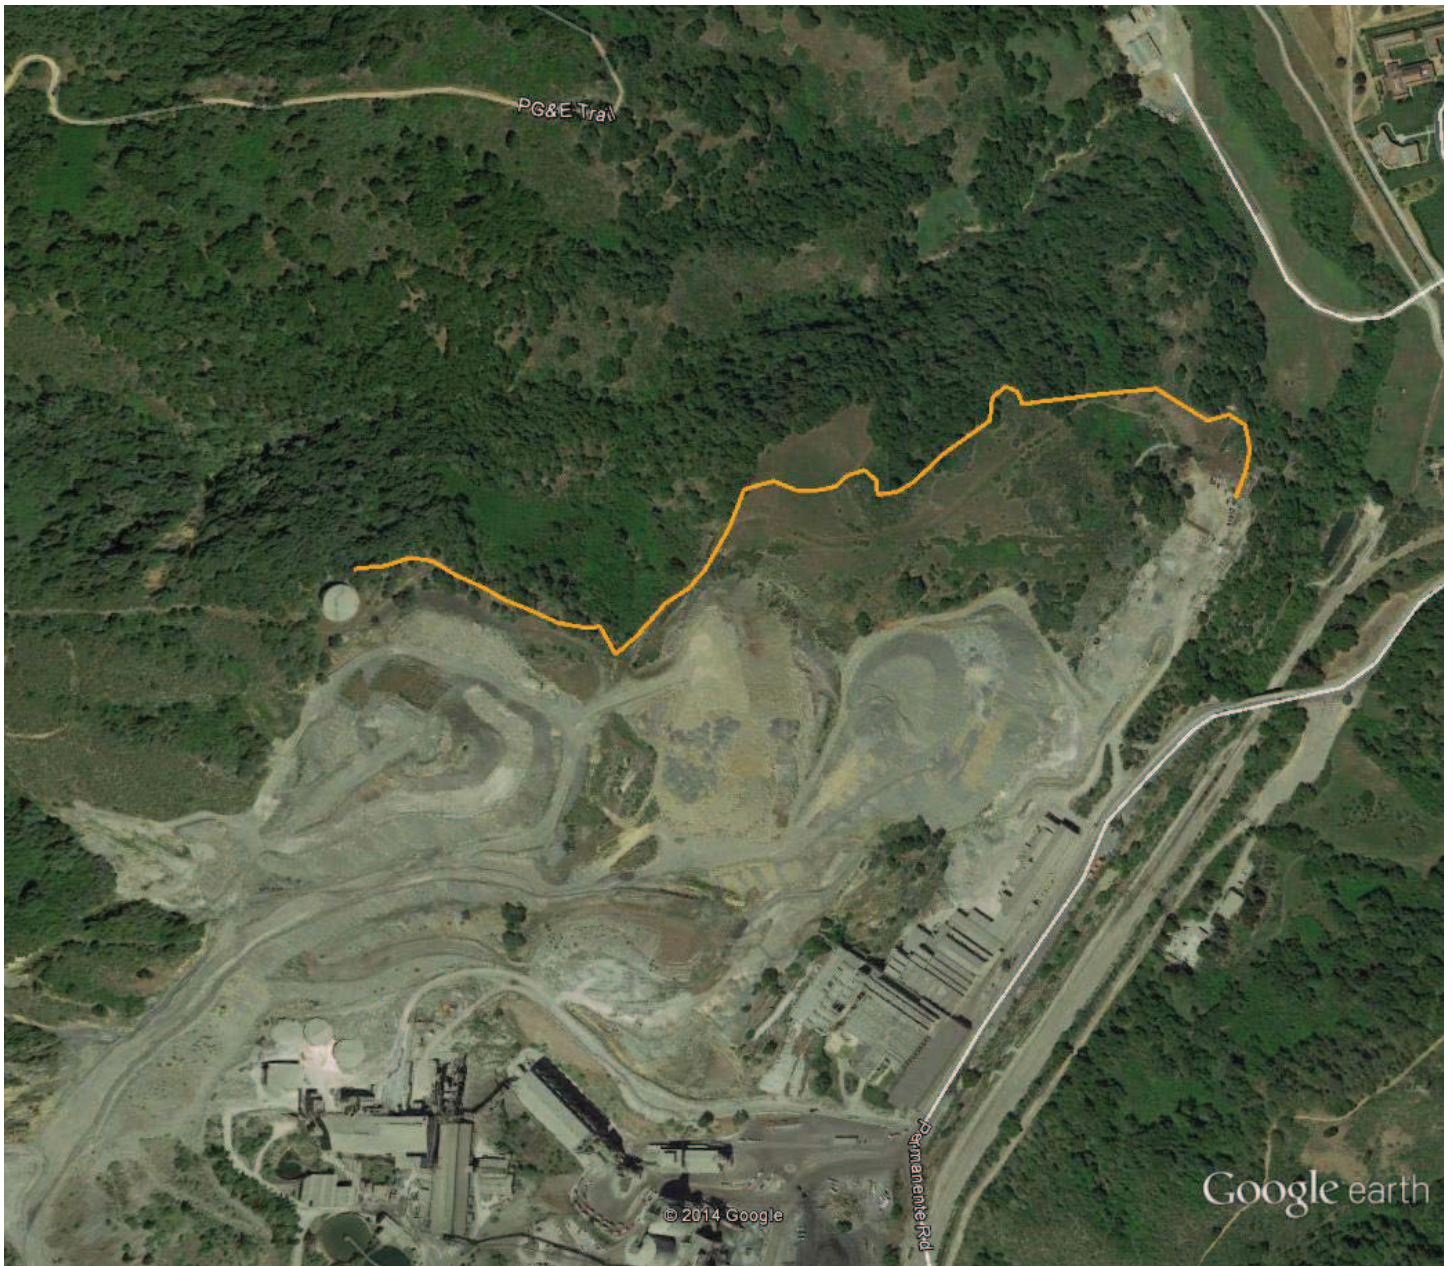
Figure 1. Location of RPA Boundary Demarcation in the EMSA.

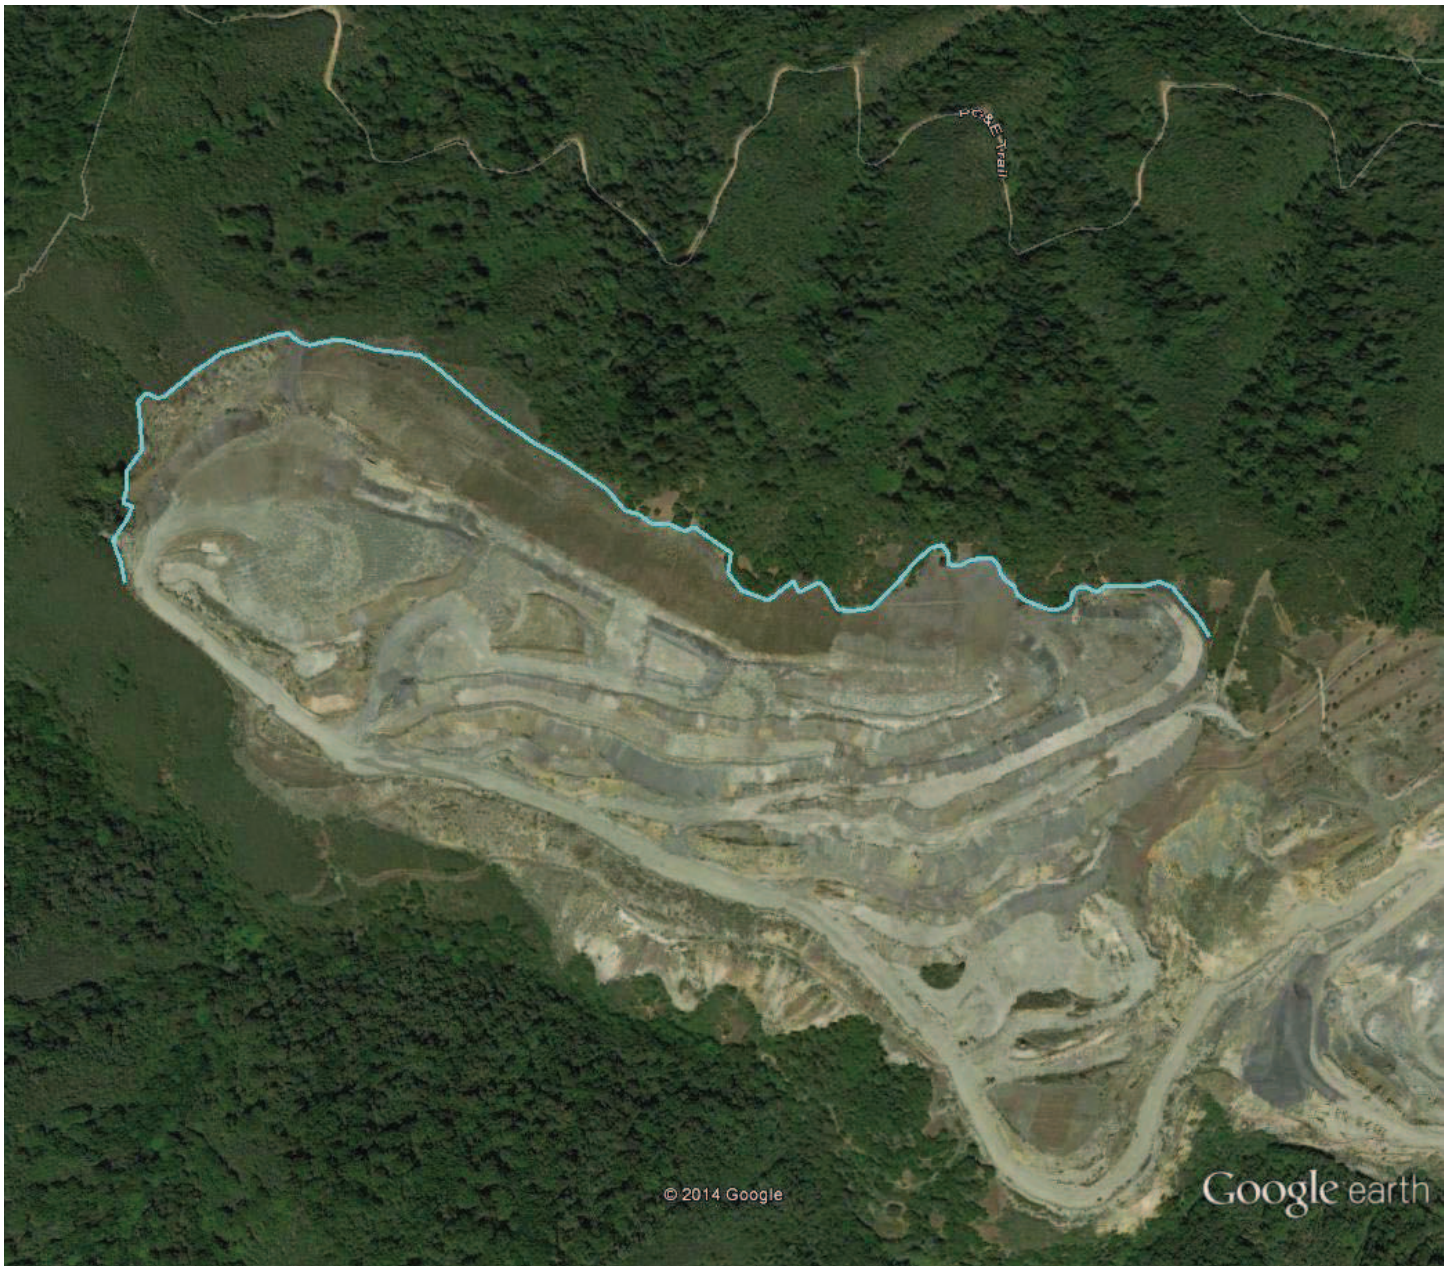
Figure 2. Location of RPA Boundary Demarcation in the WMSA.

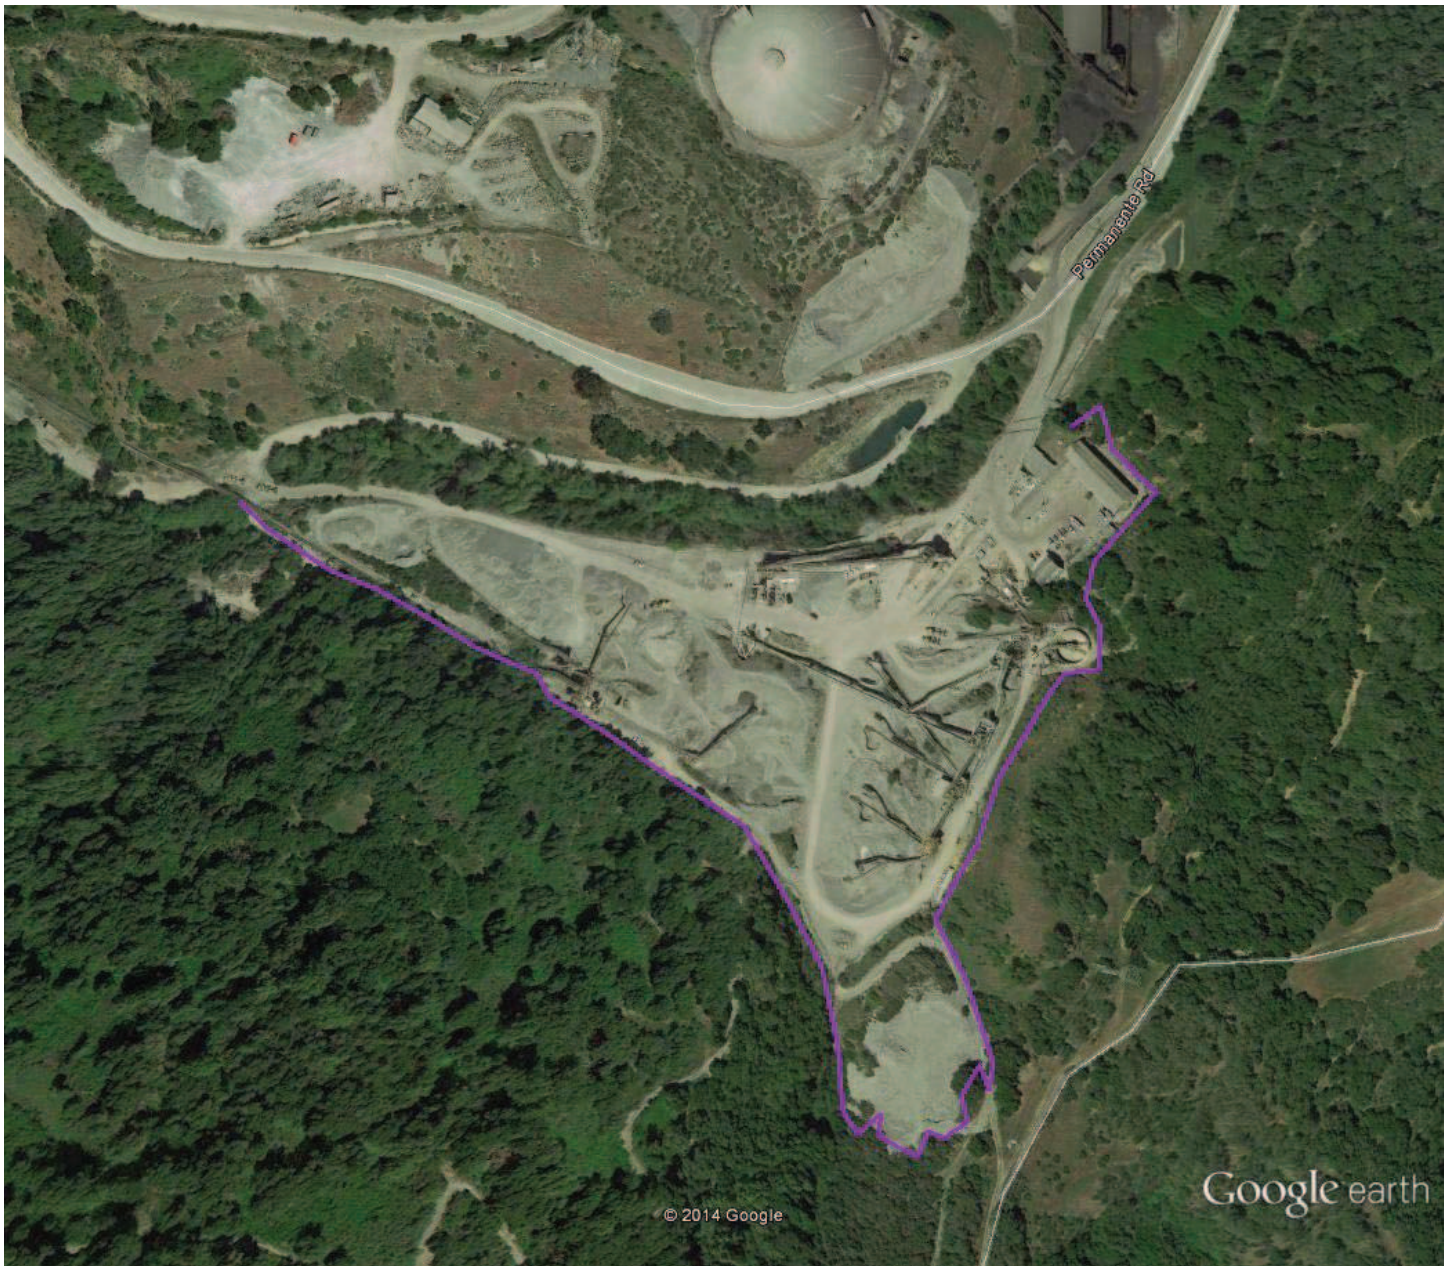
Figure 3. Location of RPA Boundary Demarcation in the Rock Plant.

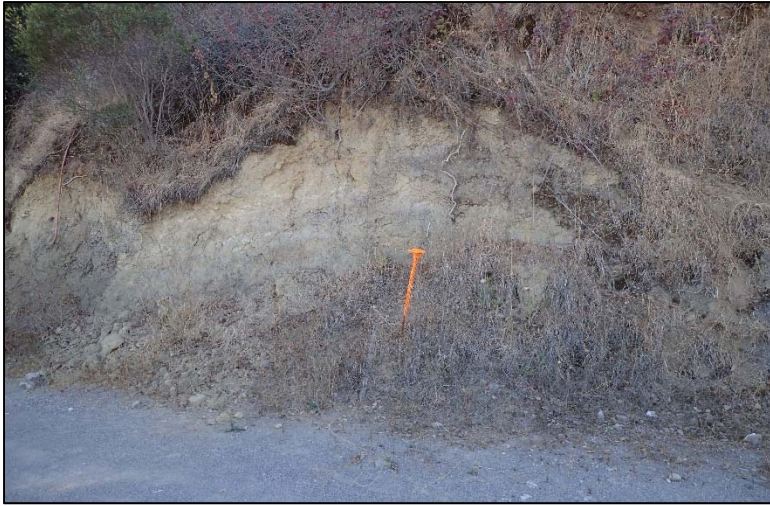
Photo 1. Repainted RPA Boundary demarcation T-post in the Rock Plant.

In order to maintain compliance with COA 22, improvements to the durability and visibility of the RPA Boundary were made by repainting the existing T-posts. All T-posts were observed to be standing in the exact locations as when they were placed. In addition during the Spring of 2017, ten T-posts were added to the WMSA RPA boundaries prior to vegetation removal and grading activities within this area.

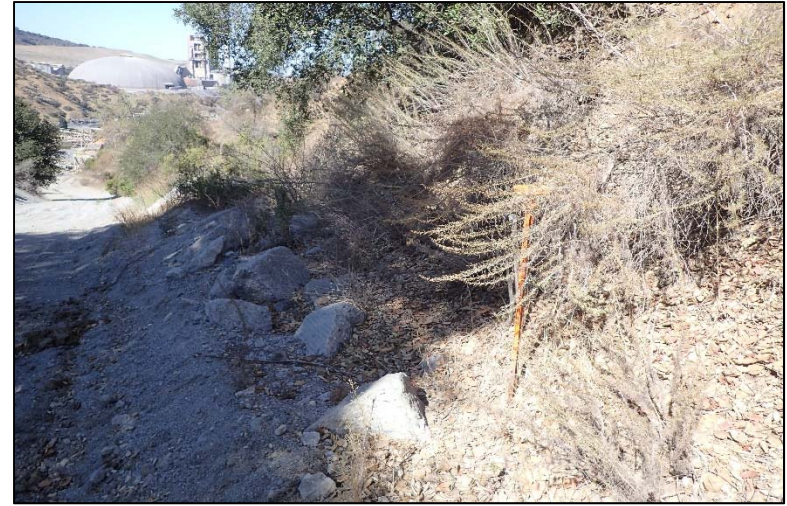
Photo 2. Repainted RPA Boundary demarcation T-post in the Rock Plant.

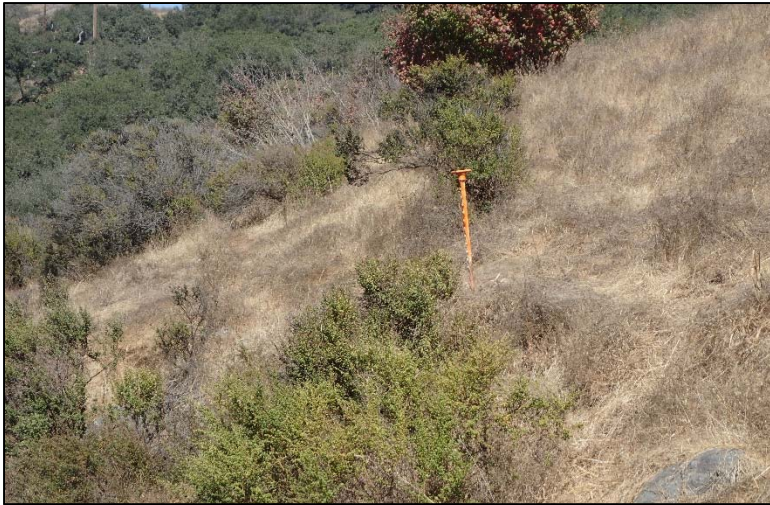
Photo 3. Repainted RPA Boundary demarcation T-posts near Rock Plant.

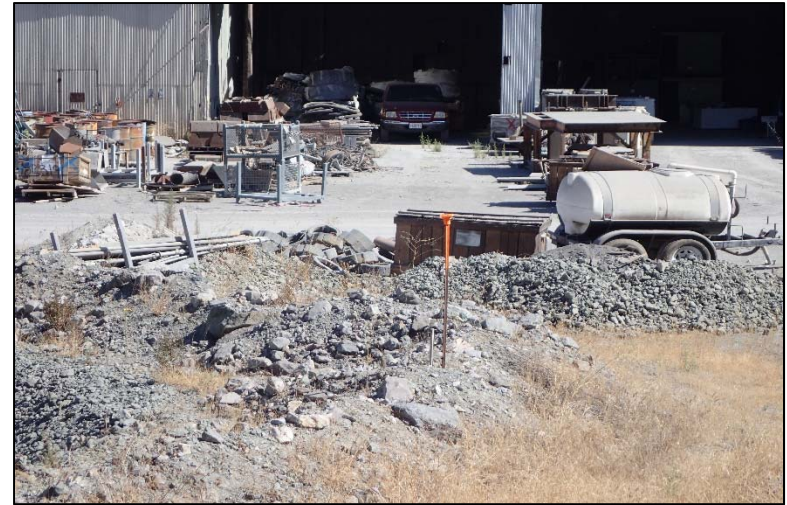
Photo 4. Repainted RPA Boundary demarcation T-posts in the lower EMSA near Pond 31a.
