Lehigh Permanente Quarry Reclamation Plan Amendment Conditions of Approval Compliance

2021-2022 Annual Report Information Package

SANTA CLARA COUNTY, CALIFORNIA

APPENDIX B - 2021-2022 EROSION CONTROL INSPECTION REPORTS

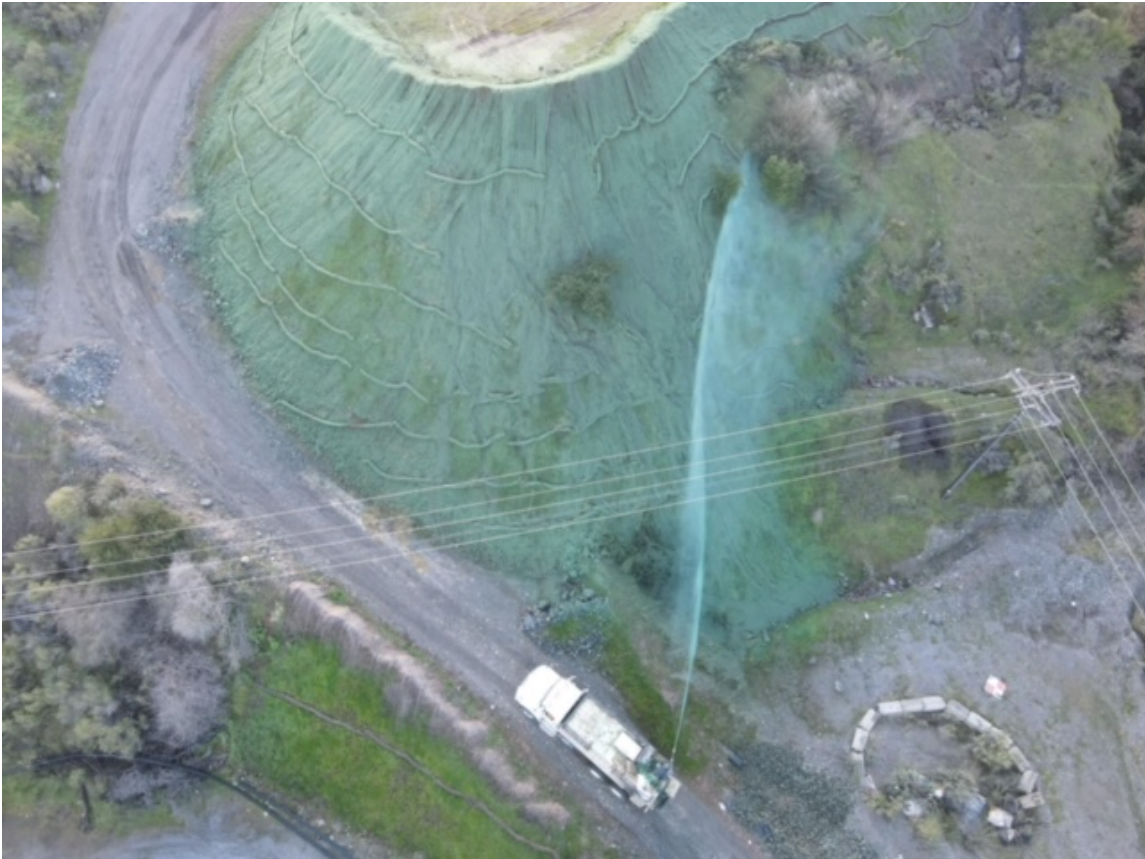
Rock Plant – Hydroseeding using erosion control seed Flexterra mix. Approximate hydroseeded area: 0.25 Acres

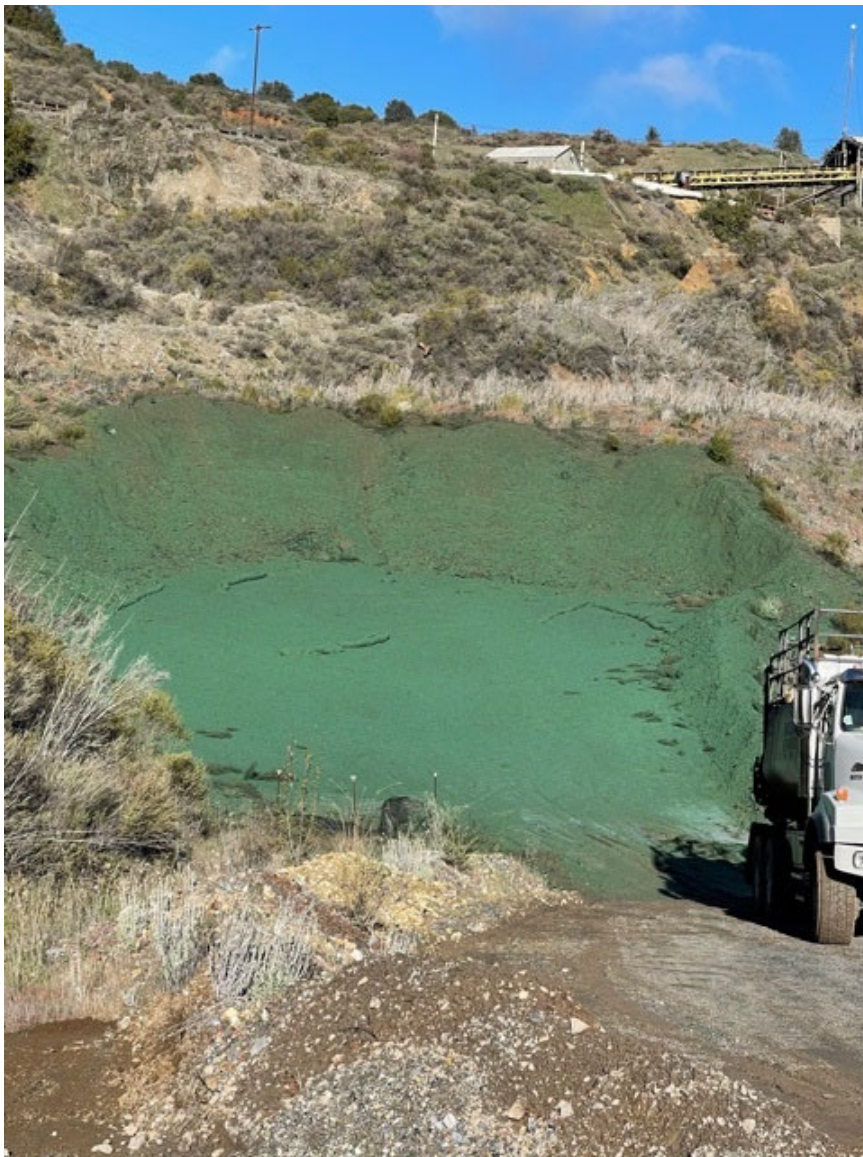
EMSA - Hydroseeding using erosion control seed Flexterra mix. Approximate hydroseeded area: 1.57 acres

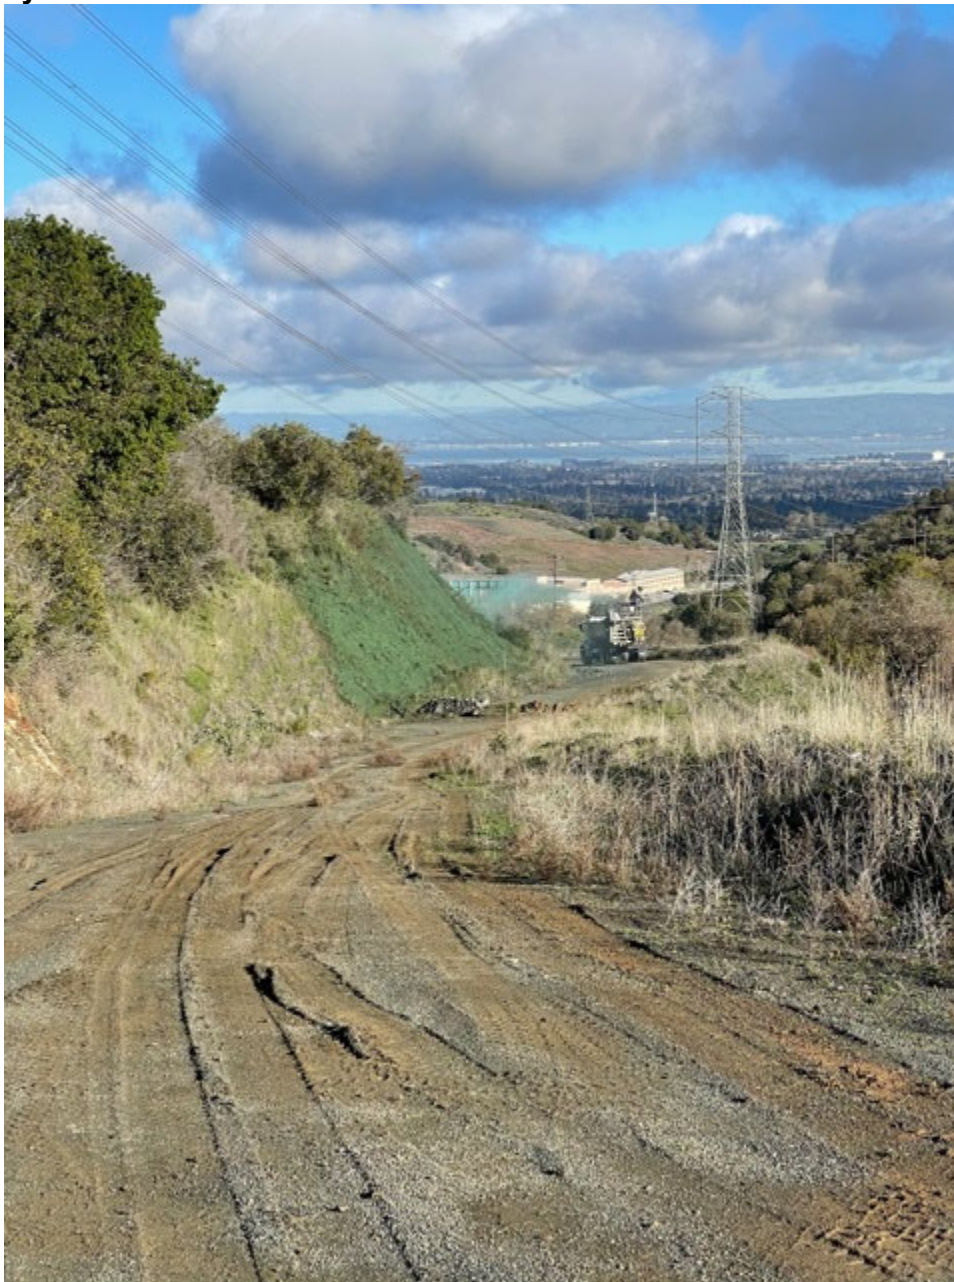
PG&E access road- Hydroseeding using erosion control seed Flexterra mix. Approximate hydroseeded area: 0.25 acres

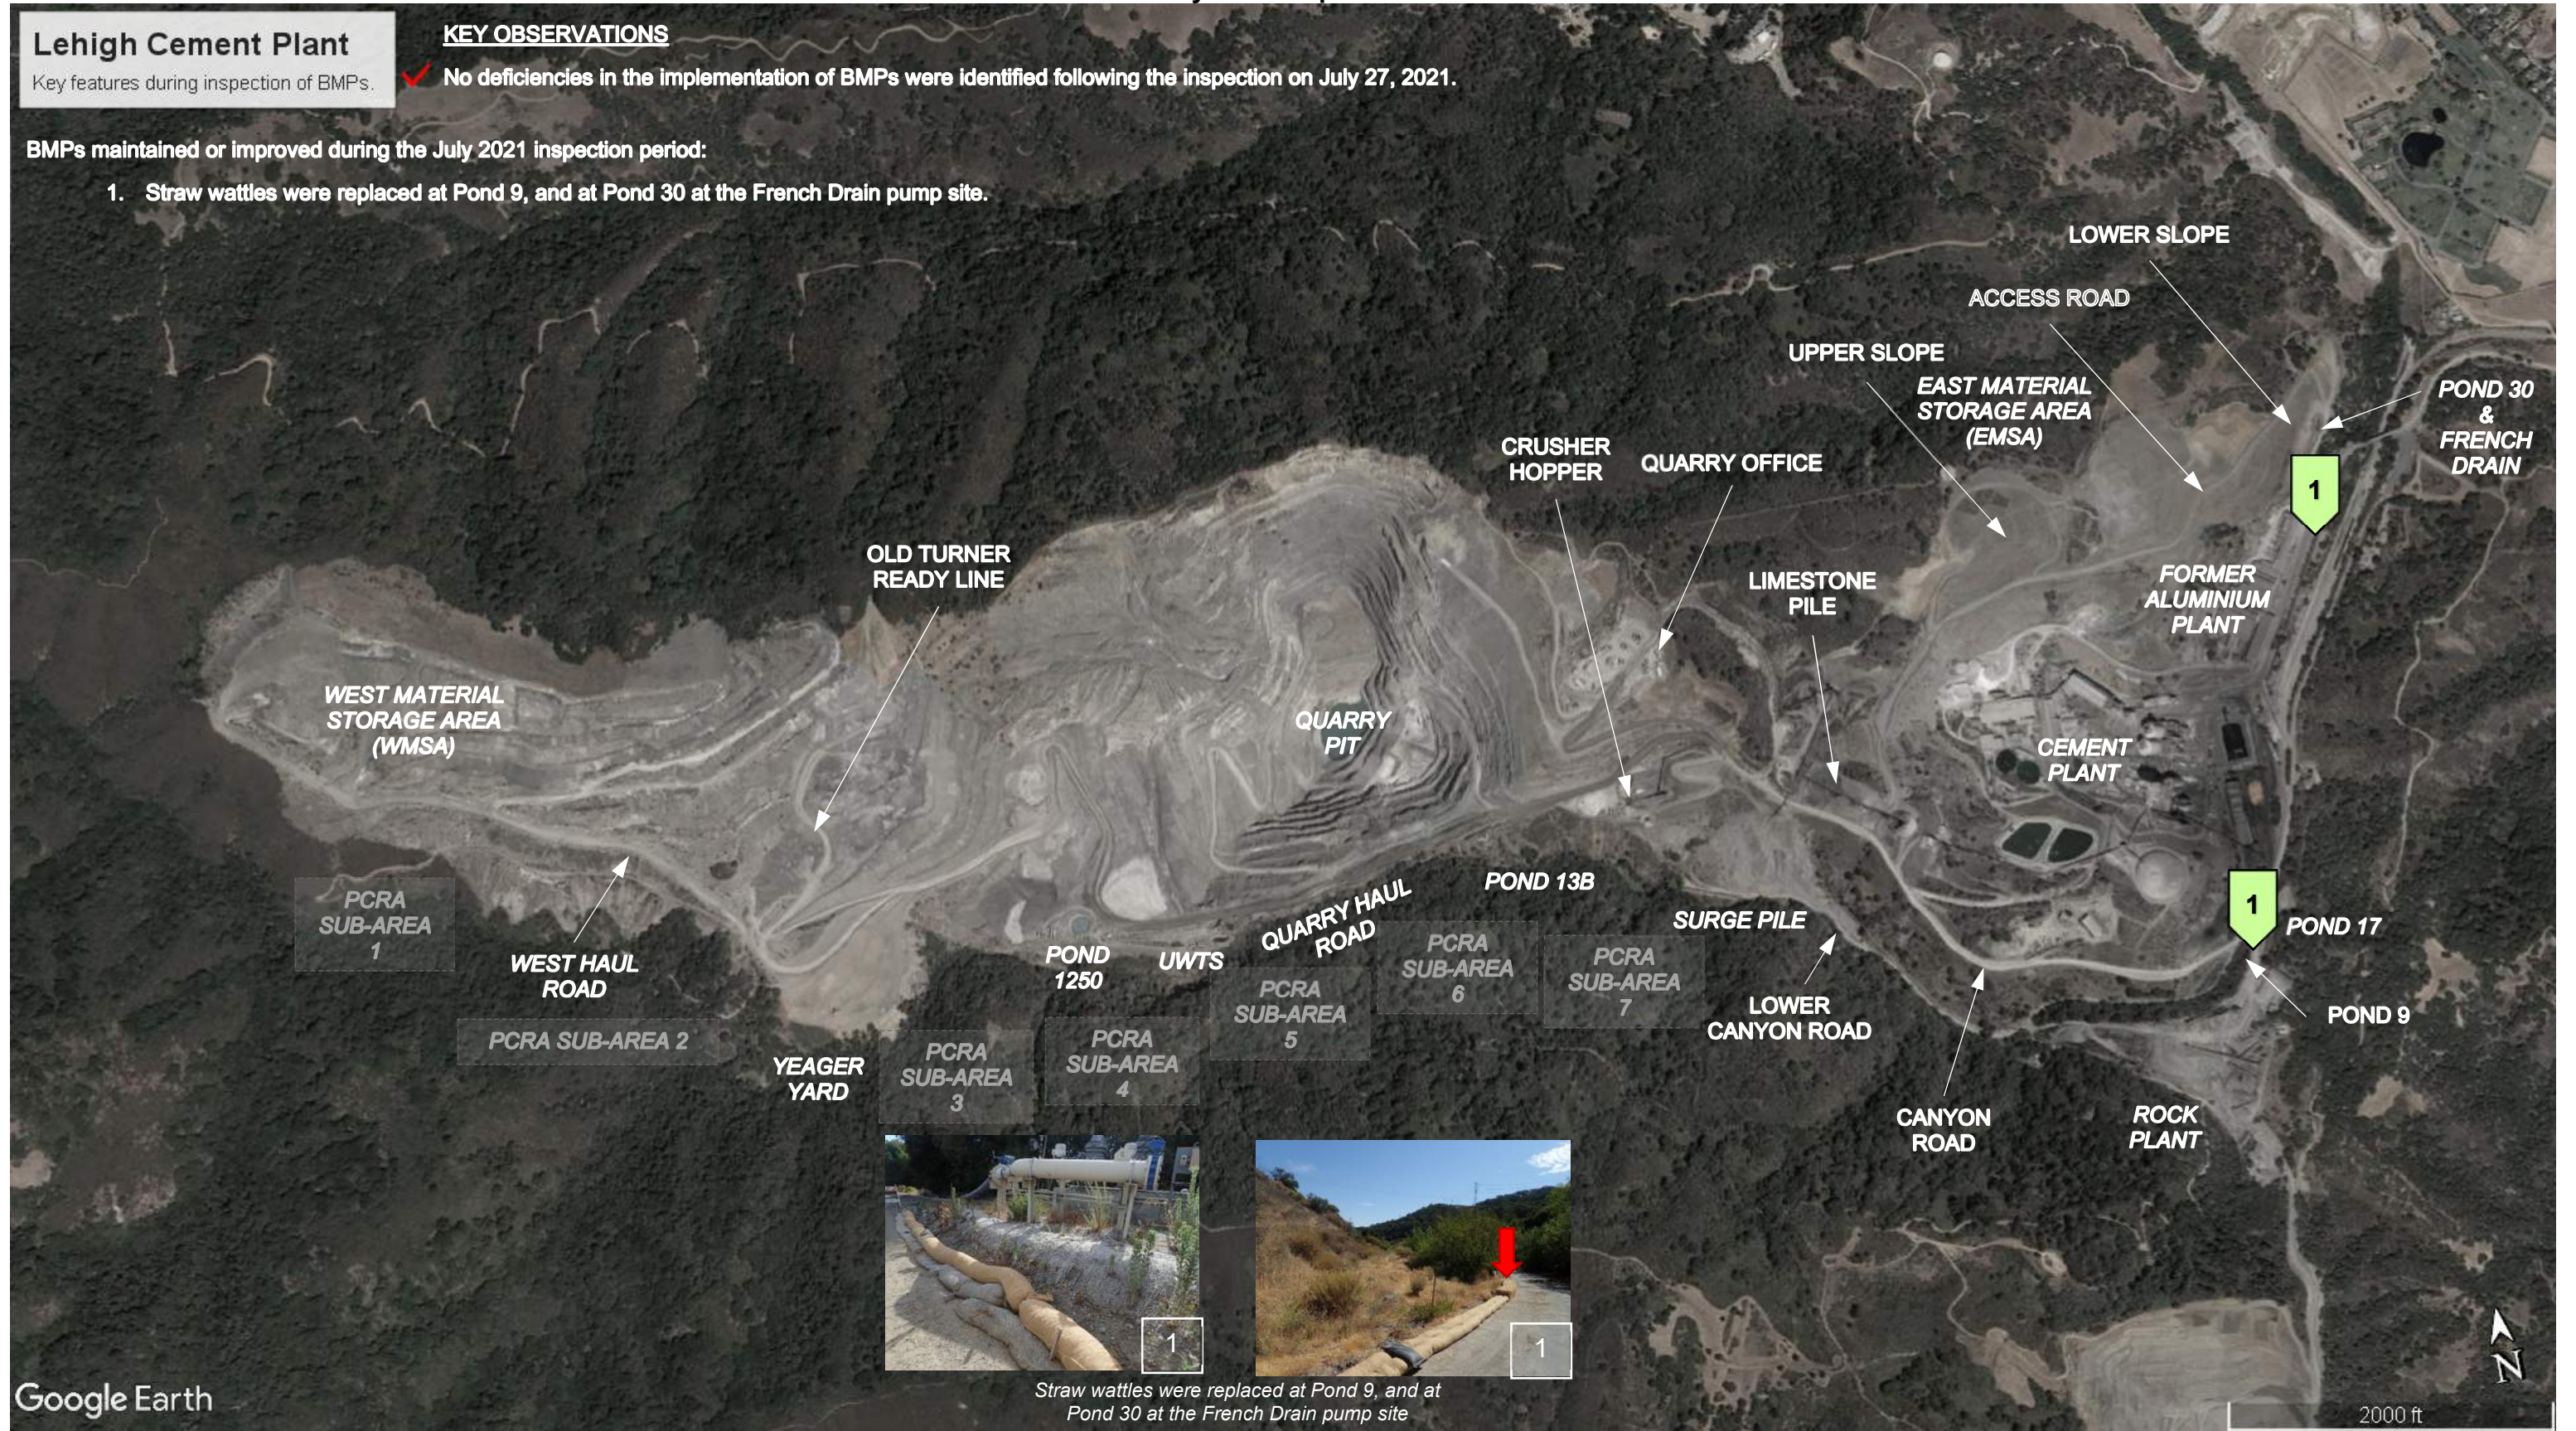
Straw wattles were replaced at Pond 9, and at Pond 30 at the French Drain pump site

1. Straw wattles were replaced at Pond 9, and at the Pond 30 and French drain pump site. See Photos 0727_01, 0727_09 in the appended DFR.

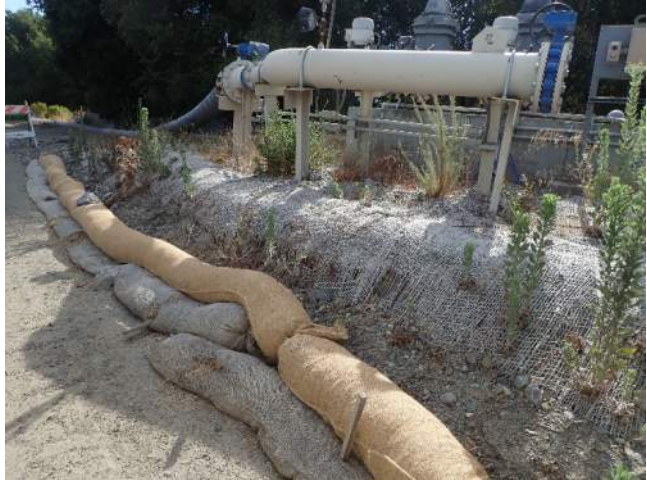
PHOTO ID	DESCRIPTION	PHOTO
0727_01	<p>Status: GOOD</p> <p>Location: EMSA – Pond 30 and French Drain</p> <p>Observations: Straw wattles were replaced around the pump station at Pond 30 and French Drain.</p> <p>Recommendations: Routine monitoring of the condition of the straw wattles, silt fences, and vegetative cover in this area.</p>

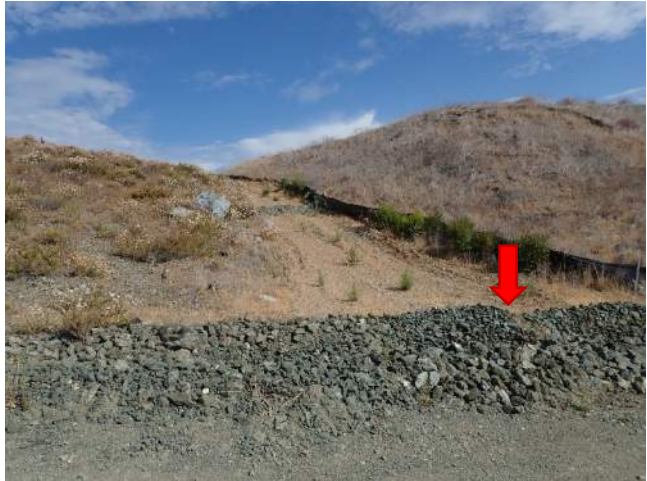
0727_02	<p>Status: GOOD</p> <p>Location: Lower EMSA by Access Road Non-limestone interim cover material storage area</p> <p>Observations: Roadside water bars and rock check-structures were re-established along and upslope from the EMSA access road.</p> <p>Recommendations: Routine monitoring of roadside check structures, sedimentation before and after rain events.</p>

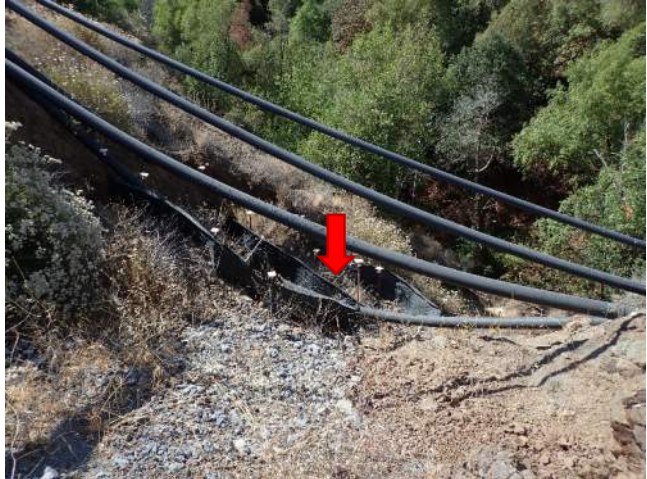
0727_03	<p>Status: MONITOR FOR CHANGES</p> <p>Location: Quarry Haul Road PCRA: 5 and 6</p> <p>Observations: Multiple lines of silt fencing remain in place and in good, functional condition. Debris is being retained behind fencing.</p> <p>Recommendations: Routine monitoring of sedimentation and debris accumulation behind silt fences.</p>

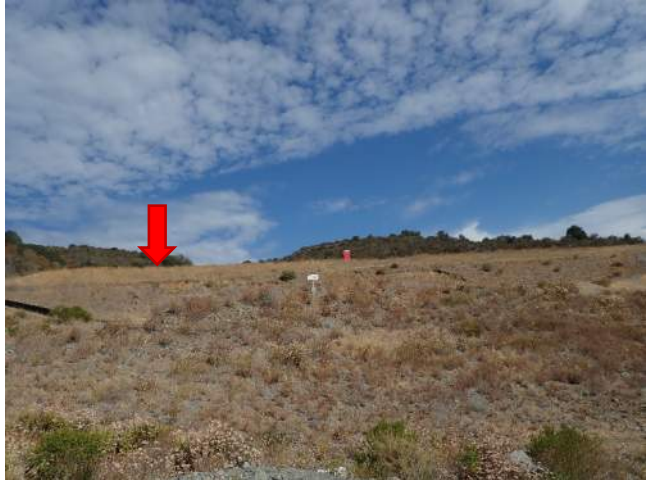
PHOTO ID	DESCRIPTION	PHOTO
0727_04	<p>Status: MONITOR FOR CHANGES Location: EMSA Upper Slopes Observations: Upper slopes of the East Material Storage Area (EMSA) remain vegetated. Recommendations: Routine monitoring of vegetative cover ahead of the rain season to begin as early as October.</p>

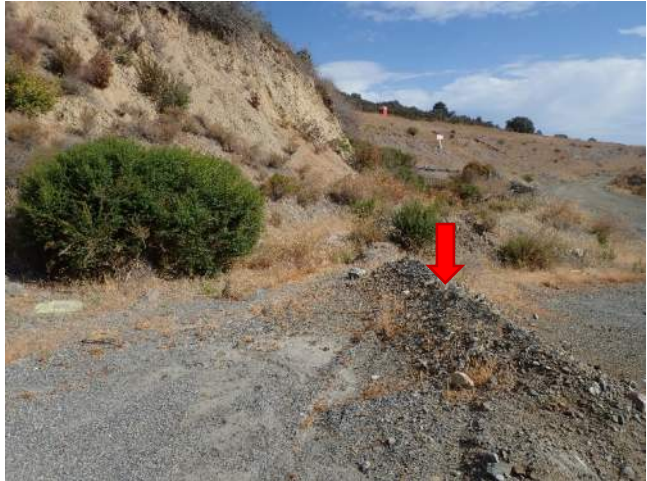
0727_05	<p>Status: MONITOR FOR CHANGES Location: EMSA – Access Road Observations: Check dams remain in functional condition. Water bars, cross-slope remain in place after the end of the rain season. Recommendations: Routine monitoring of the condition of check dams and sediment controls: hay bales, wattles. Replace bales and wattles ahead of the rain season to begin as early as October.</p>

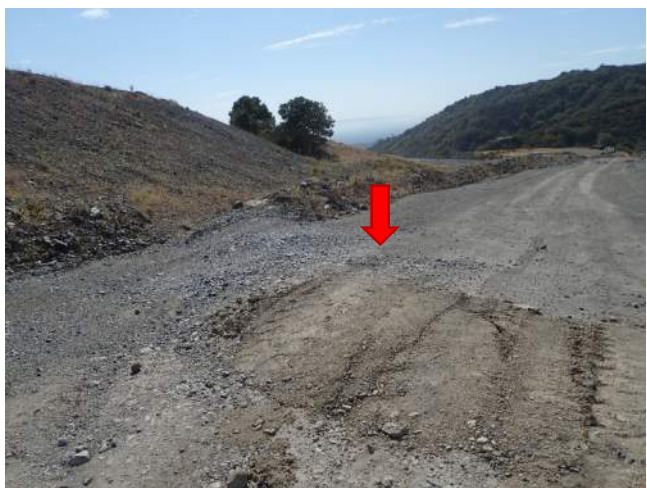
0727_06	<p>Status: MONITOR FOR CHANGES Location: WMSA – Haul Road Observations: Water bars remain in place draining to the drop inlet. Straw wattles and hay bales remain in place around the drop inlet next to the EMSA access road. Recommendations: Routine monitoring of the sedimentation behind water bars along the Quarry Haul Road to WMSA and re-establish water bars as needed ahead of the rain season to begin as early as October.</p>

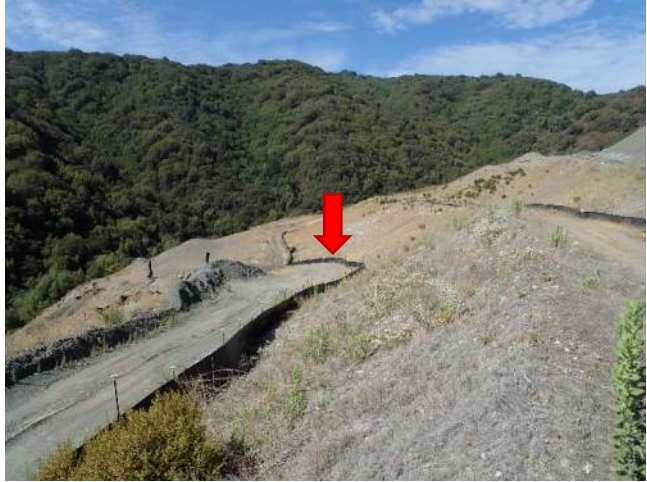
PHOTO ID	DESCRIPTION	PHOTO
0727_07	<p>Status: MONITOR FOR CHANGES</p> <p>Location: Yeager Yard – Upper Slopes PCRA: 2 and 3</p> <p>Observations: Silt fences are in good condition and remain functional. Vegetative cover has established over the upper slopes of the Yeager Yard.</p> <p>Recommendations: Routine monitoring of the vegetative cover on the slopes. Monitor the sediment accumulation on vegetated benches and silt fence condition routinely.</p>

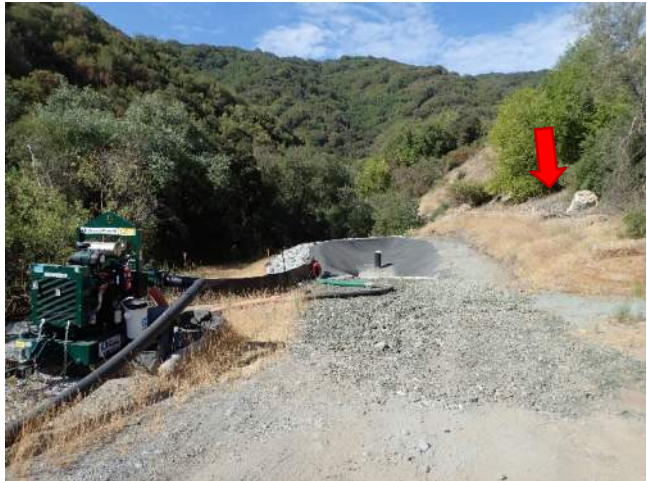
0727_08	<p>Status: MONITOR FOR CHANGES</p> <p>Location: Yeager Yard – Sediment Basin PCRA: 2 and 3</p> <p>Observations: Vegetation has developed around the hay bale check structures that were replaced upslope of the sediment capture basin for erosion and sediment control.</p> <p>Recommendations: Routine monitoring of the vegetative cover and hay bale conditions through establishment of hydroseed vegetation.</p>

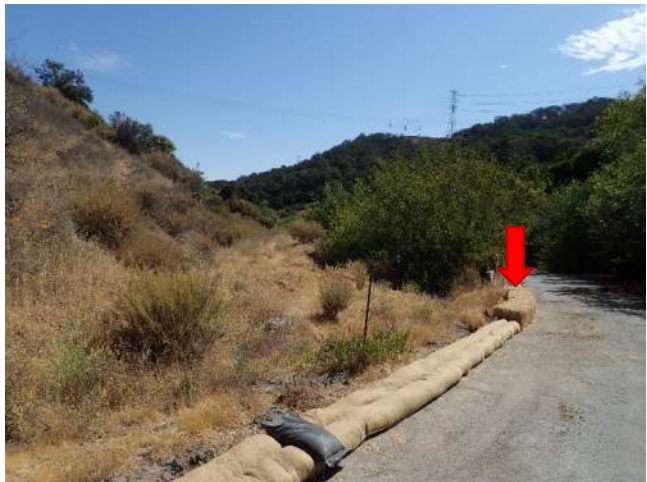
0727_09	<p>Status: GOOD</p> <p>Location: Pond 9 Access Corridor</p> <p>Observations: New straw wattles and hay bales were installed in a continuous arrangement along the Pond 9 access corridor.</p> <p>Recommendations: Monitor the condition of the wattles and bales for signs of degradation or gaps in the continuous erosion reduction and sediment retention feature.</p>

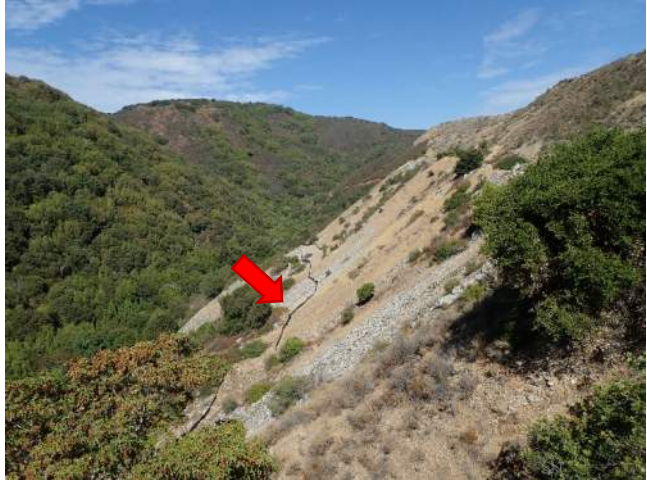
PHOTO ID	DESCRIPTION	PHOTO
0727_010	<p>Status: GOOD</p> <p>Location: PCRA 1</p> <p>PCRA: 1</p> <p>Observations: Slope below road remains vegetated. Silt fencing remains in place during the dry season.</p> <p>Recommendations: Routine monitoring of the silt fence condition and sedimentation behind lower line of silt fences.</p>

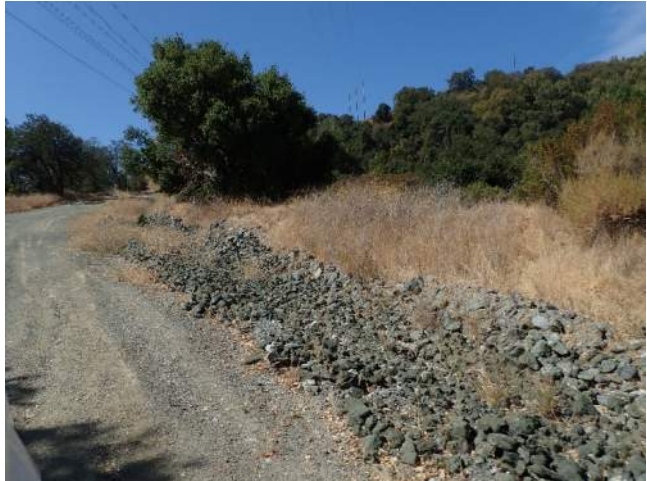
0727_11	<p>Status: MONITOR FOR CHANGES</p> <p>Location: Rock Plant – Improved Existing Access Road</p> <p>Observations: Water bars remain in place and vegetation has established beyond the rock-lined roadside ditch.</p> <p>Recommendations: Routine monitoring of the condition of the water bars and vegetative cover ahead of the rain season to begin as early as October.</p>

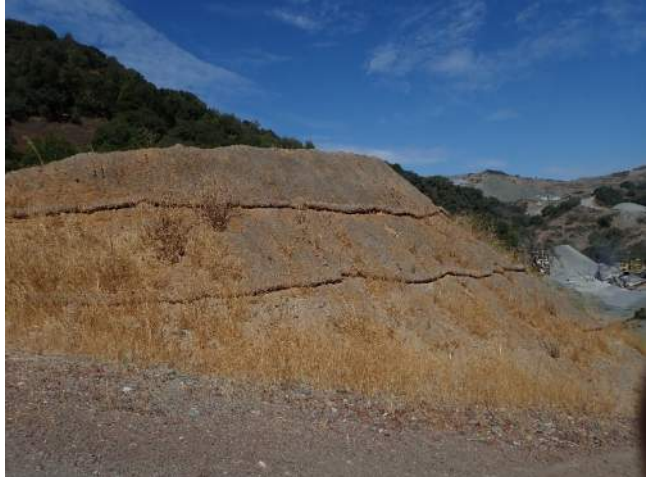
0727_12	<p>Status: GOOD</p> <p>Location: Rock Plant – Roadside Slope</p> <p>Observations: Jute matting and straw wattles remain in place, around the rounded slope at the Rock Plant. Hydroseeding vegetation is present, though dry in the summer.</p> <p>Recommendations: Routine monitoring of the condition of the jute matting and straw wattles. Adjust wattles as needed to achieve intended alignment and continuity.</p>

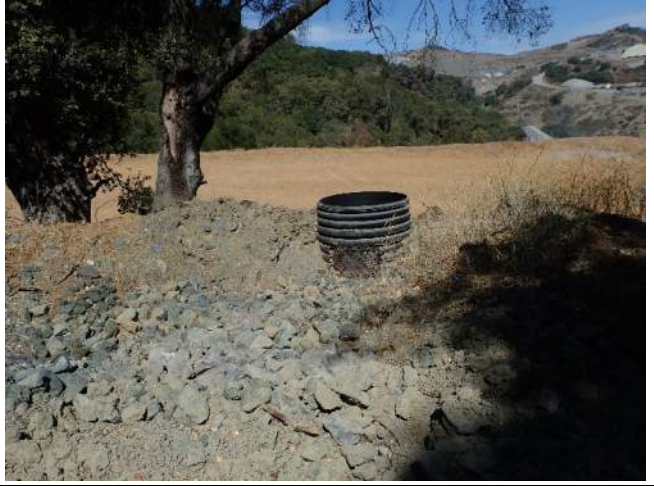
PHOTO ID	DESCRIPTION	PHOTO
0727_13	<p>Status: MONITOR FOR CHANGES</p> <p>Location: Rock Plant – Improved Existing Access Road</p> <p>Observations: Drop inlet and rock-lined apron are clear of significant debris and remain functional. The drop inlet pipe is clear of sediment ahead of the rain season.</p> <p>Recommendations: Routine monitoring of the sedimentation and debris accumulation inside the drop inlet pipe and stilling basin.</p>

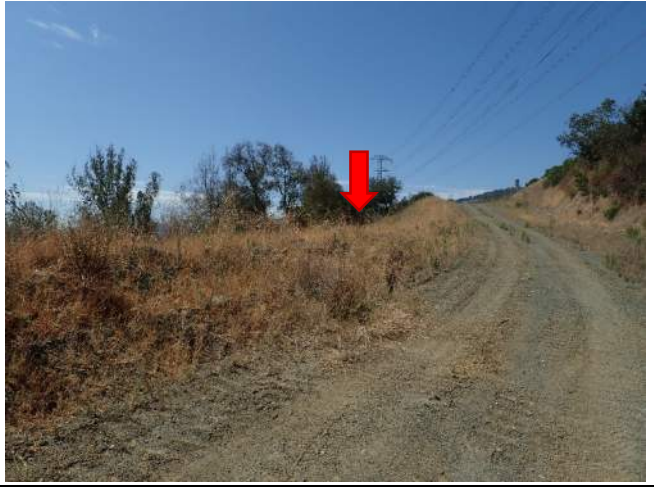
0727_14	<p>Status: MONITOR FOR CHANGES</p> <p>Location: Rock Plant – Improved Existing Access Road</p> <p>Observations: Roadside rock berm remains in place and vegetated. Vegetative cover is established over the slopes below the road and berm.</p> <p>Recommendations: Routine monitoring of rock-lined features, cross-slope ahead of the rain season to begin as early as October.</p>

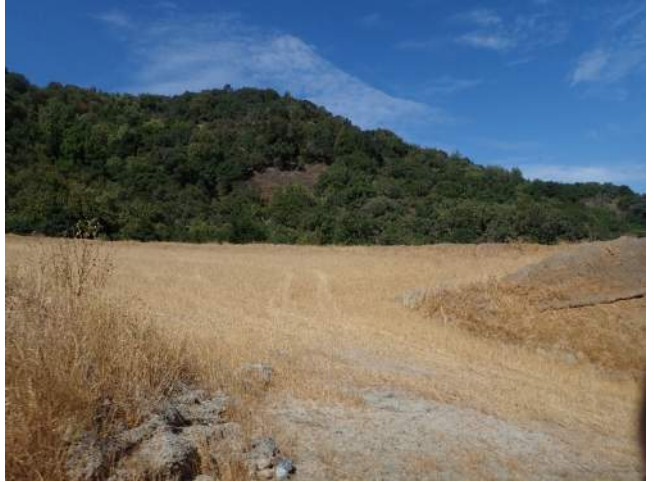
0727_15	<p>Status: GOOD</p> <p>Location: Rock Plant – Roadside Slope</p> <p>Observations: Hydroseed vegetative cover has established over the slopes and top bench at the Rock Plant.</p> <p>Recommendations: Routine monitoring of vegetative cover and roadside sediment accumulation.</p>

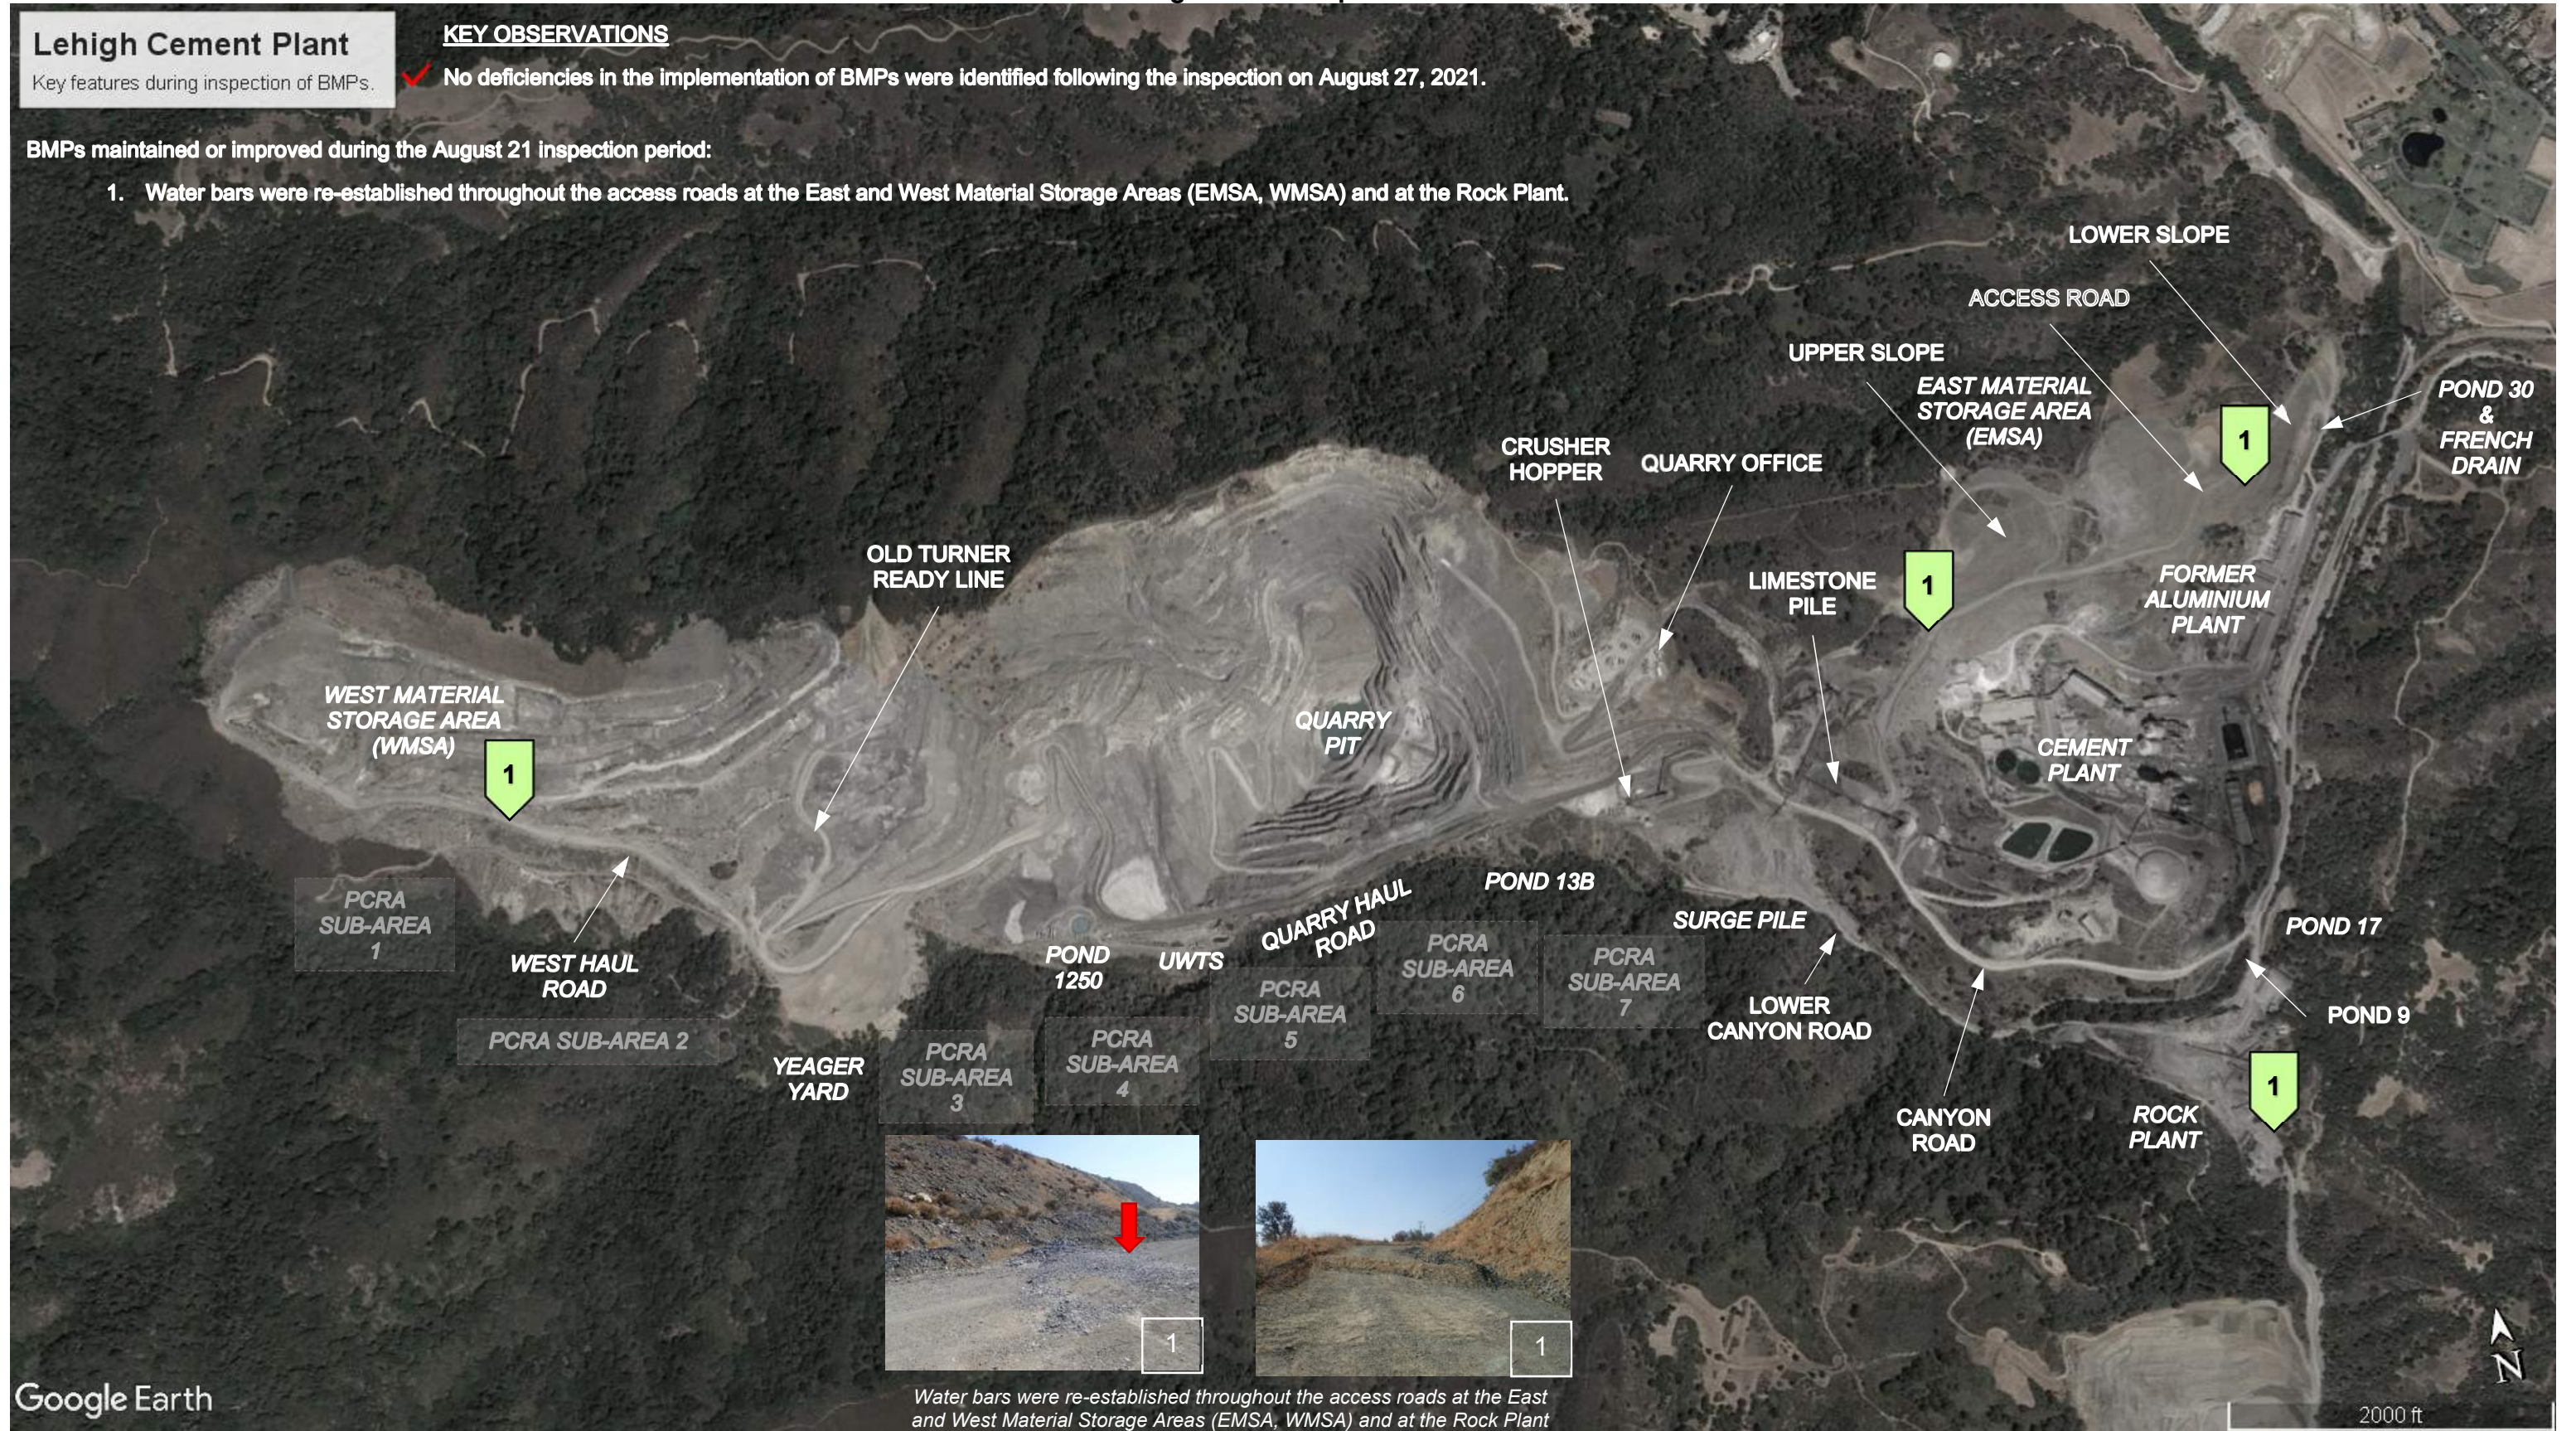
Water bars were re-established throughout the access roads at the East and West Material Storage Areas (EMSA, WMSA) and at the Rock Plant

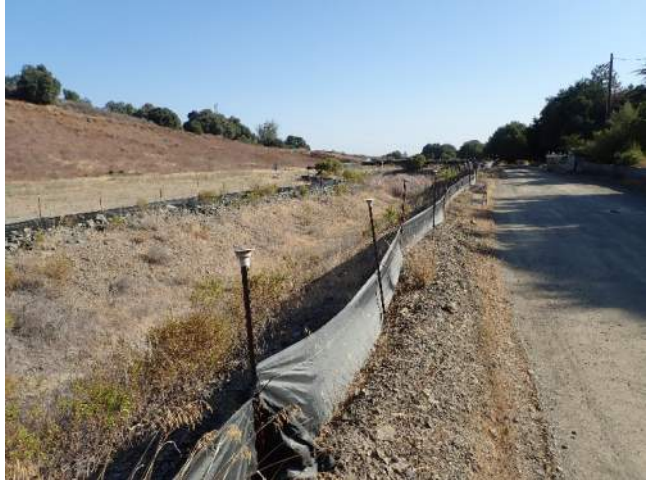
PHOTO ID	DESCRIPTION	PHOTO
0827_01	<p>Status: GOOD</p> <p>Location: EMSA – Pond 30 and French Drain</p> <p>Observations: Vegetation has established throughout the EMSA above the silt fences at Pond 30. Silt fences remain in good condition. Straw Wattles were recently replaced.</p> <p>Recommendations: Routine monitoring of the condition of the straw wattles, silt fences, and vegetative cover in this area.</p>

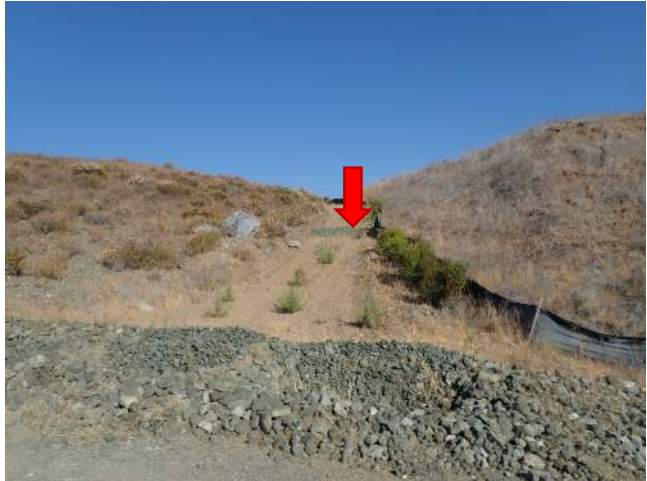
0827_02	<p>Status: GOOD</p> <p>Location: Lower EMSA by Access Road Non-limestone interim cover material storage area</p> <p>Observations: Roadside water bars and rock check-structures were re-established along and upslope from the EMSA access road.</p> <p>Recommendations: Routine monitoring of roadside check structures, sedimentation before and after rain events.</p>

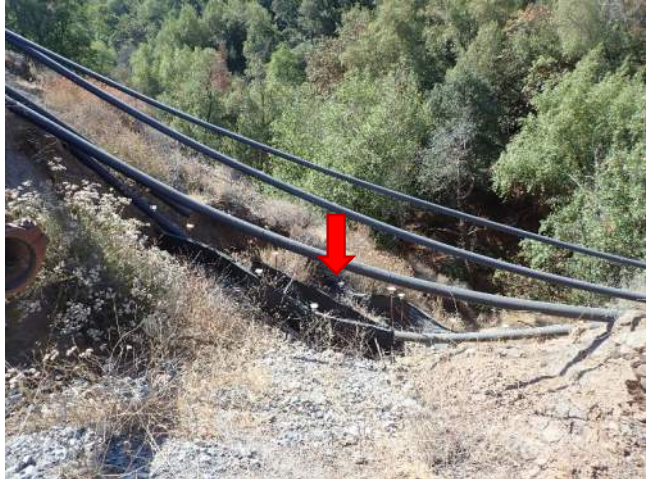
0827_03	<p>Status: MONITOR FOR CHANGES</p> <p>Location: Quarry Haul Road PCRA: 5 and 6</p> <p>Observations: Multiple lines of silt fencing remain in place and in good, functional condition. Debris is being retained behind fencing.</p> <p>Recommendations: Routine monitoring of sedimentation and debris accumulation behind silt fences.</p>

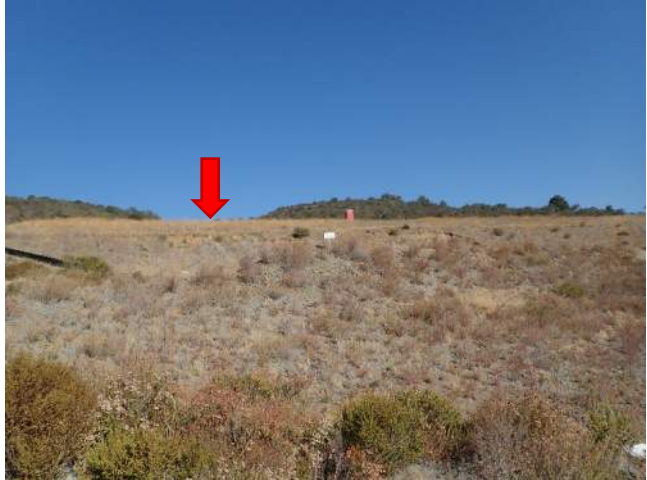
PHOTO ID	DESCRIPTION	PHOTO
0827_04	<p>Status: MONITOR FOR CHANGES</p> <p>Location: EMSA Upper Slopes</p> <p>Observations: Upper slopes of the East Material Storage Area (EMSA) remain vegetated. Hydroseeded vegetation has established over the interim cover material stockpile.</p> <p>Recommendations: Routine monitoring of vegetative cover ahead of the rain season to begin as early as October.</p>

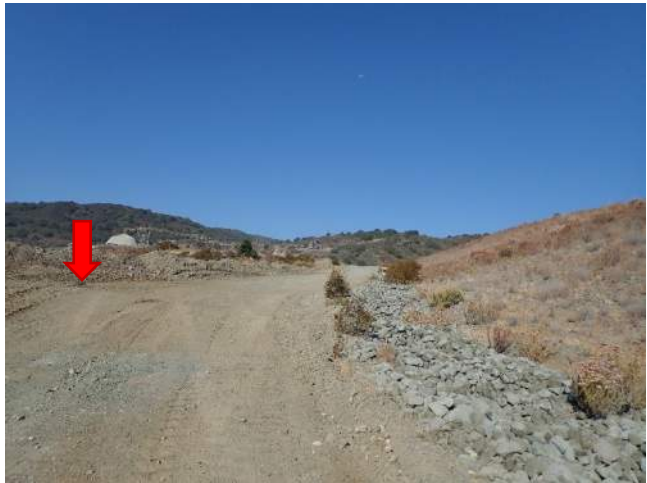
0827_05	<p>Status: MONITOR FOR CHANGES</p> <p>Location: EMSA – Access Road</p> <p>Observations: Water bars were re-established draining to the drop inlet. Straw wattles and hay bales remain in place around the drop inlet next to the EMSA access road.</p> <p>Recommendations: Routine monitoring of the condition of water bars and sediment controls: hay bales, wattles. Replace bales and wattles ahead of the rain season to begin as early as October.</p>

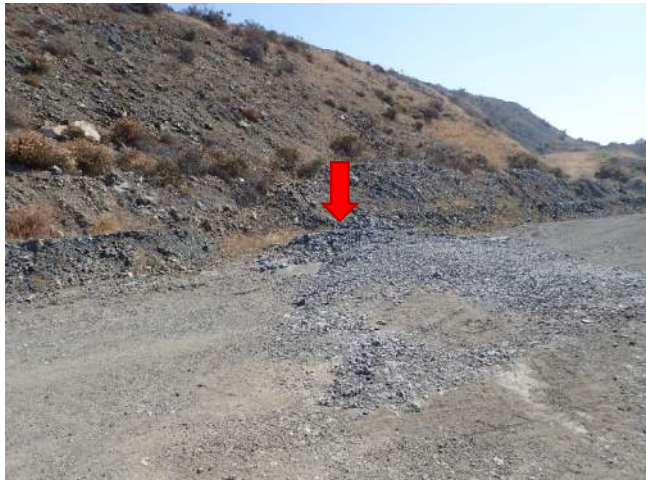
0827_06	<p>Status: MONITOR FOR CHANGES</p> <p>Location: WMSA – Haul Road</p> <p>Observations: Check dams remain in functional condition. Water bars, cross-slope remain in place after the end of the rain season.</p> <p>Recommendations: Routine monitoring of the sedimentation behind check dams along the Quarry Haul Road to WMSA and re-establish water bars as needed ahead of the rain season to begin as early as October.</p>

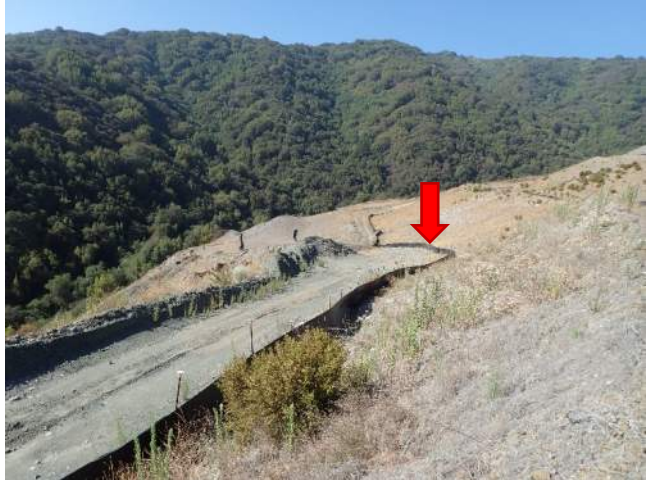
PHOTO ID	DESCRIPTION	PHOTO
0827_07	<p>Status: MONITOR FOR CHANGES</p> <p>Location: Yeager Yard – Upper Slopes PCRA: 2 and 3</p> <p>Observations: Silt fences are in good condition and remain functional. Vegetative cover has established over the upper slopes of the Yeager Yard.</p> <p>Recommendations: Routine monitoring of the vegetative cover on the slopes. Monitor the sediment accumulation on vegetated benches and silt fence condition routinely.</p>

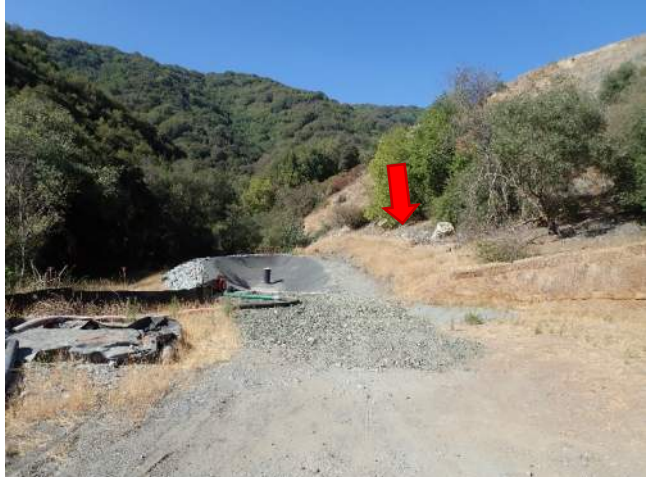
0827_08	<p>Status: MONITOR FOR CHANGES</p> <p>Location: Yeager Yard – Sediment Basin PCRA: 2 and 3</p> <p>Observations: Vegetation has developed around the hay bale check structures upslope of the sediment capture basin.</p> <p>Recommendations: Routine monitoring of the vegetative cover and hay bale conditions through establishment of hydroseed vegetation.</p>

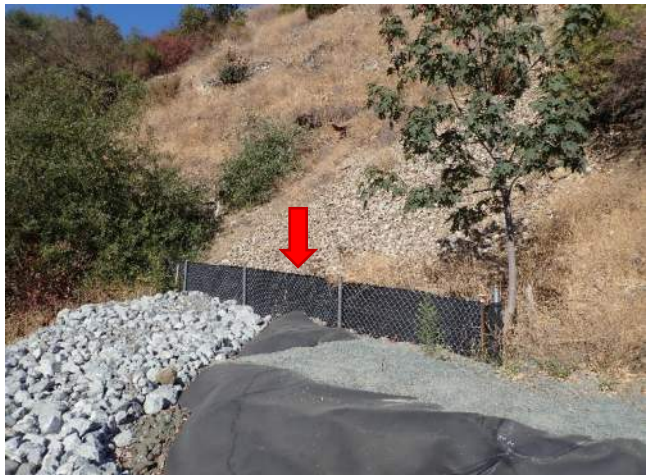
0827_09	<p>Status: GOOD</p> <p>Location: Yeager Yard – Sediment Basin PCRA: 2 and 3</p> <p>Observations: Super silt fence remains in place and in good condition with low levels of sedimentation and debris accumulation.</p> <p>Recommendations: Frequent monitoring of the sedimentation in the sediment capture basin and above the super silt fence; clear debris regularly.</p>

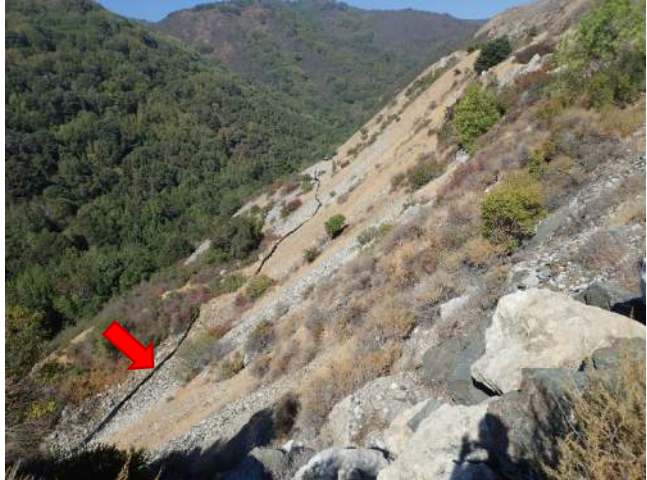
PHOTO ID	DESCRIPTION	PHOTO
0827_10	<p>Status: GOOD</p> <p>Location: PCRA 1 PCRA: 1</p> <p>Observations: Slope below road remains vegetated. Silt fencing was maintained in recent months.</p> <p>Recommendations: Routine monitoring of the silt fence condition and sedimentation behind lower line of silt fences.</p>

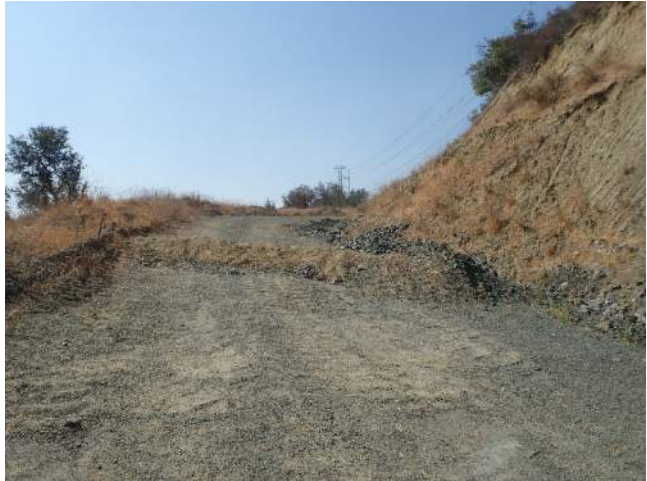
0827_11	<p>Status: MONITOR FOR CHANGES</p> <p>Location: Rock Plant – Improved Existing Access Road</p> <p>Observations: Water bars were re-established along the access road by the Rock Plant.</p> <p>Recommendations: Routine monitoring of the condition of the water bars and vegetative cover ahead of the rain season to begin as early as October.</p>

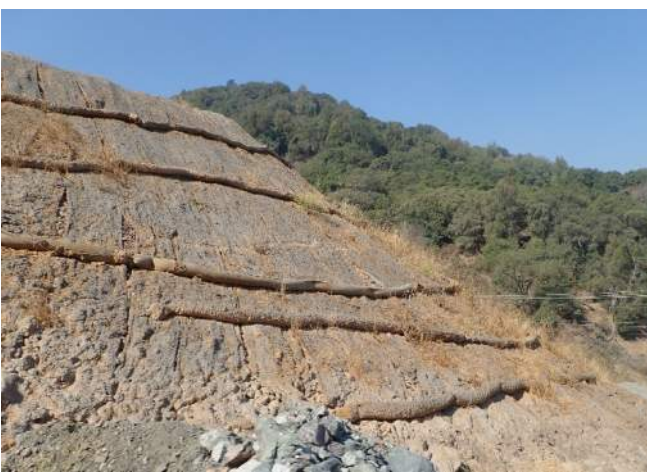
0827_12	<p>Status: GOOD</p> <p>Location: Rock Plant – Roadside Slope</p> <p>Observations: Jute matting and straw wattles remain in alignment and continuous around the hydroseeded slope at the Rock Plant.</p> <p>Recommendations: Routine monitoring of the sedimentation of the rock-lined features and the condition of the jute matting and straw wattles. Adjust wattles as needed to achieve intended alignment and continuity.</p>

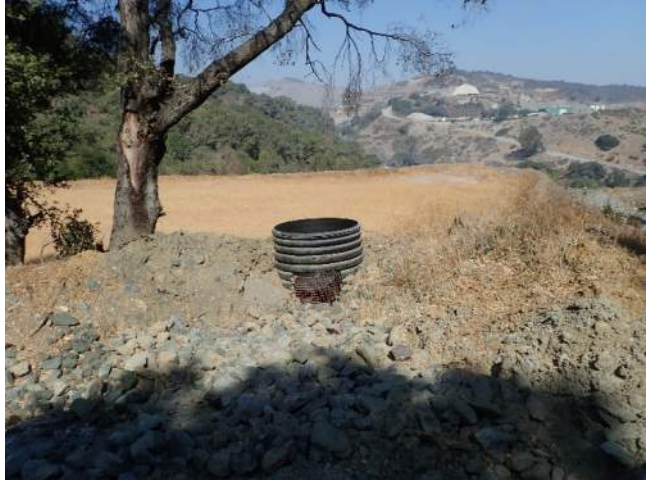
PHOTO ID	DESCRIPTION	PHOTO
0827_13	<p>Status: MONITOR FOR CHANGES</p> <p>Location: Rock Plant – Improved Existing Access Road</p> <p>Observations: Drop inlet and rock-lined apron are clear of significant debris and remain functional. The drop inlet pipe is clear of sediment at the end of the rain season.</p> <p>Recommendations: Routine monitoring of the sedimentation and debris accumulation inside the drop inlet pipe and stilling basin.</p>

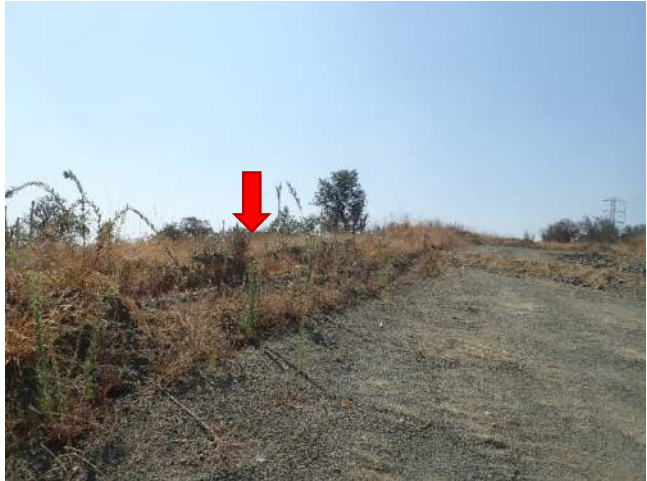
0827_14	<p>Status: MONITOR FOR CHANGES</p> <p>Location: Rock Plant – Improved Existing Access Road</p> <p>Observations: Roadside rock berm remains in place and vegetated. Vegetative cover is established over the slopes below the road and berm.</p> <p>Recommendations: Routine monitoring of rock-lined features, cross-slope ahead of the rain season to begin as early as October.</p>
