Lehigh Permanente Quarry Reclamation Plan Amendment Conditions of Approval Compliance

2021-2022 Annual Report Information Package

SANTA CLARA COUNTY, CALIFORNIA

APPENDIX B - 2021-2022 EROSION CONTROL INSPECTION REPORTS

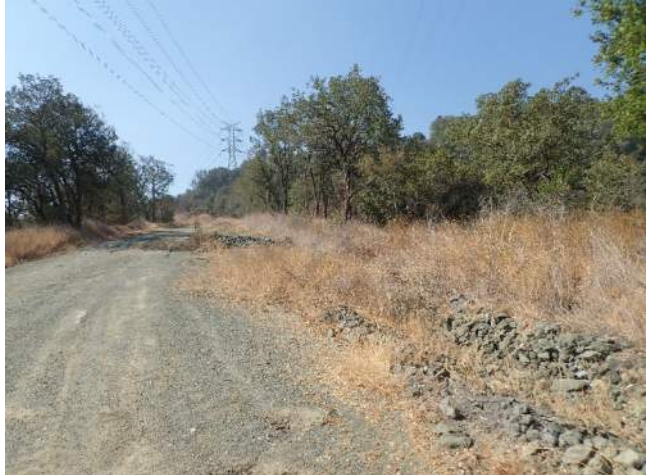
0827_15	<p>Status: GOOD</p> <p>Location: Rock Plant – Roadside ditch and Slope</p> <p>Observations: Roadside rock-lined ditches remain in place and maintain positive drainage. Vegetation has established in the adjacent slopes, although dry during the summer</p> <p>Recommendations: Routine monitoring of vegetative cover and roadside sediment accumulation.</p>

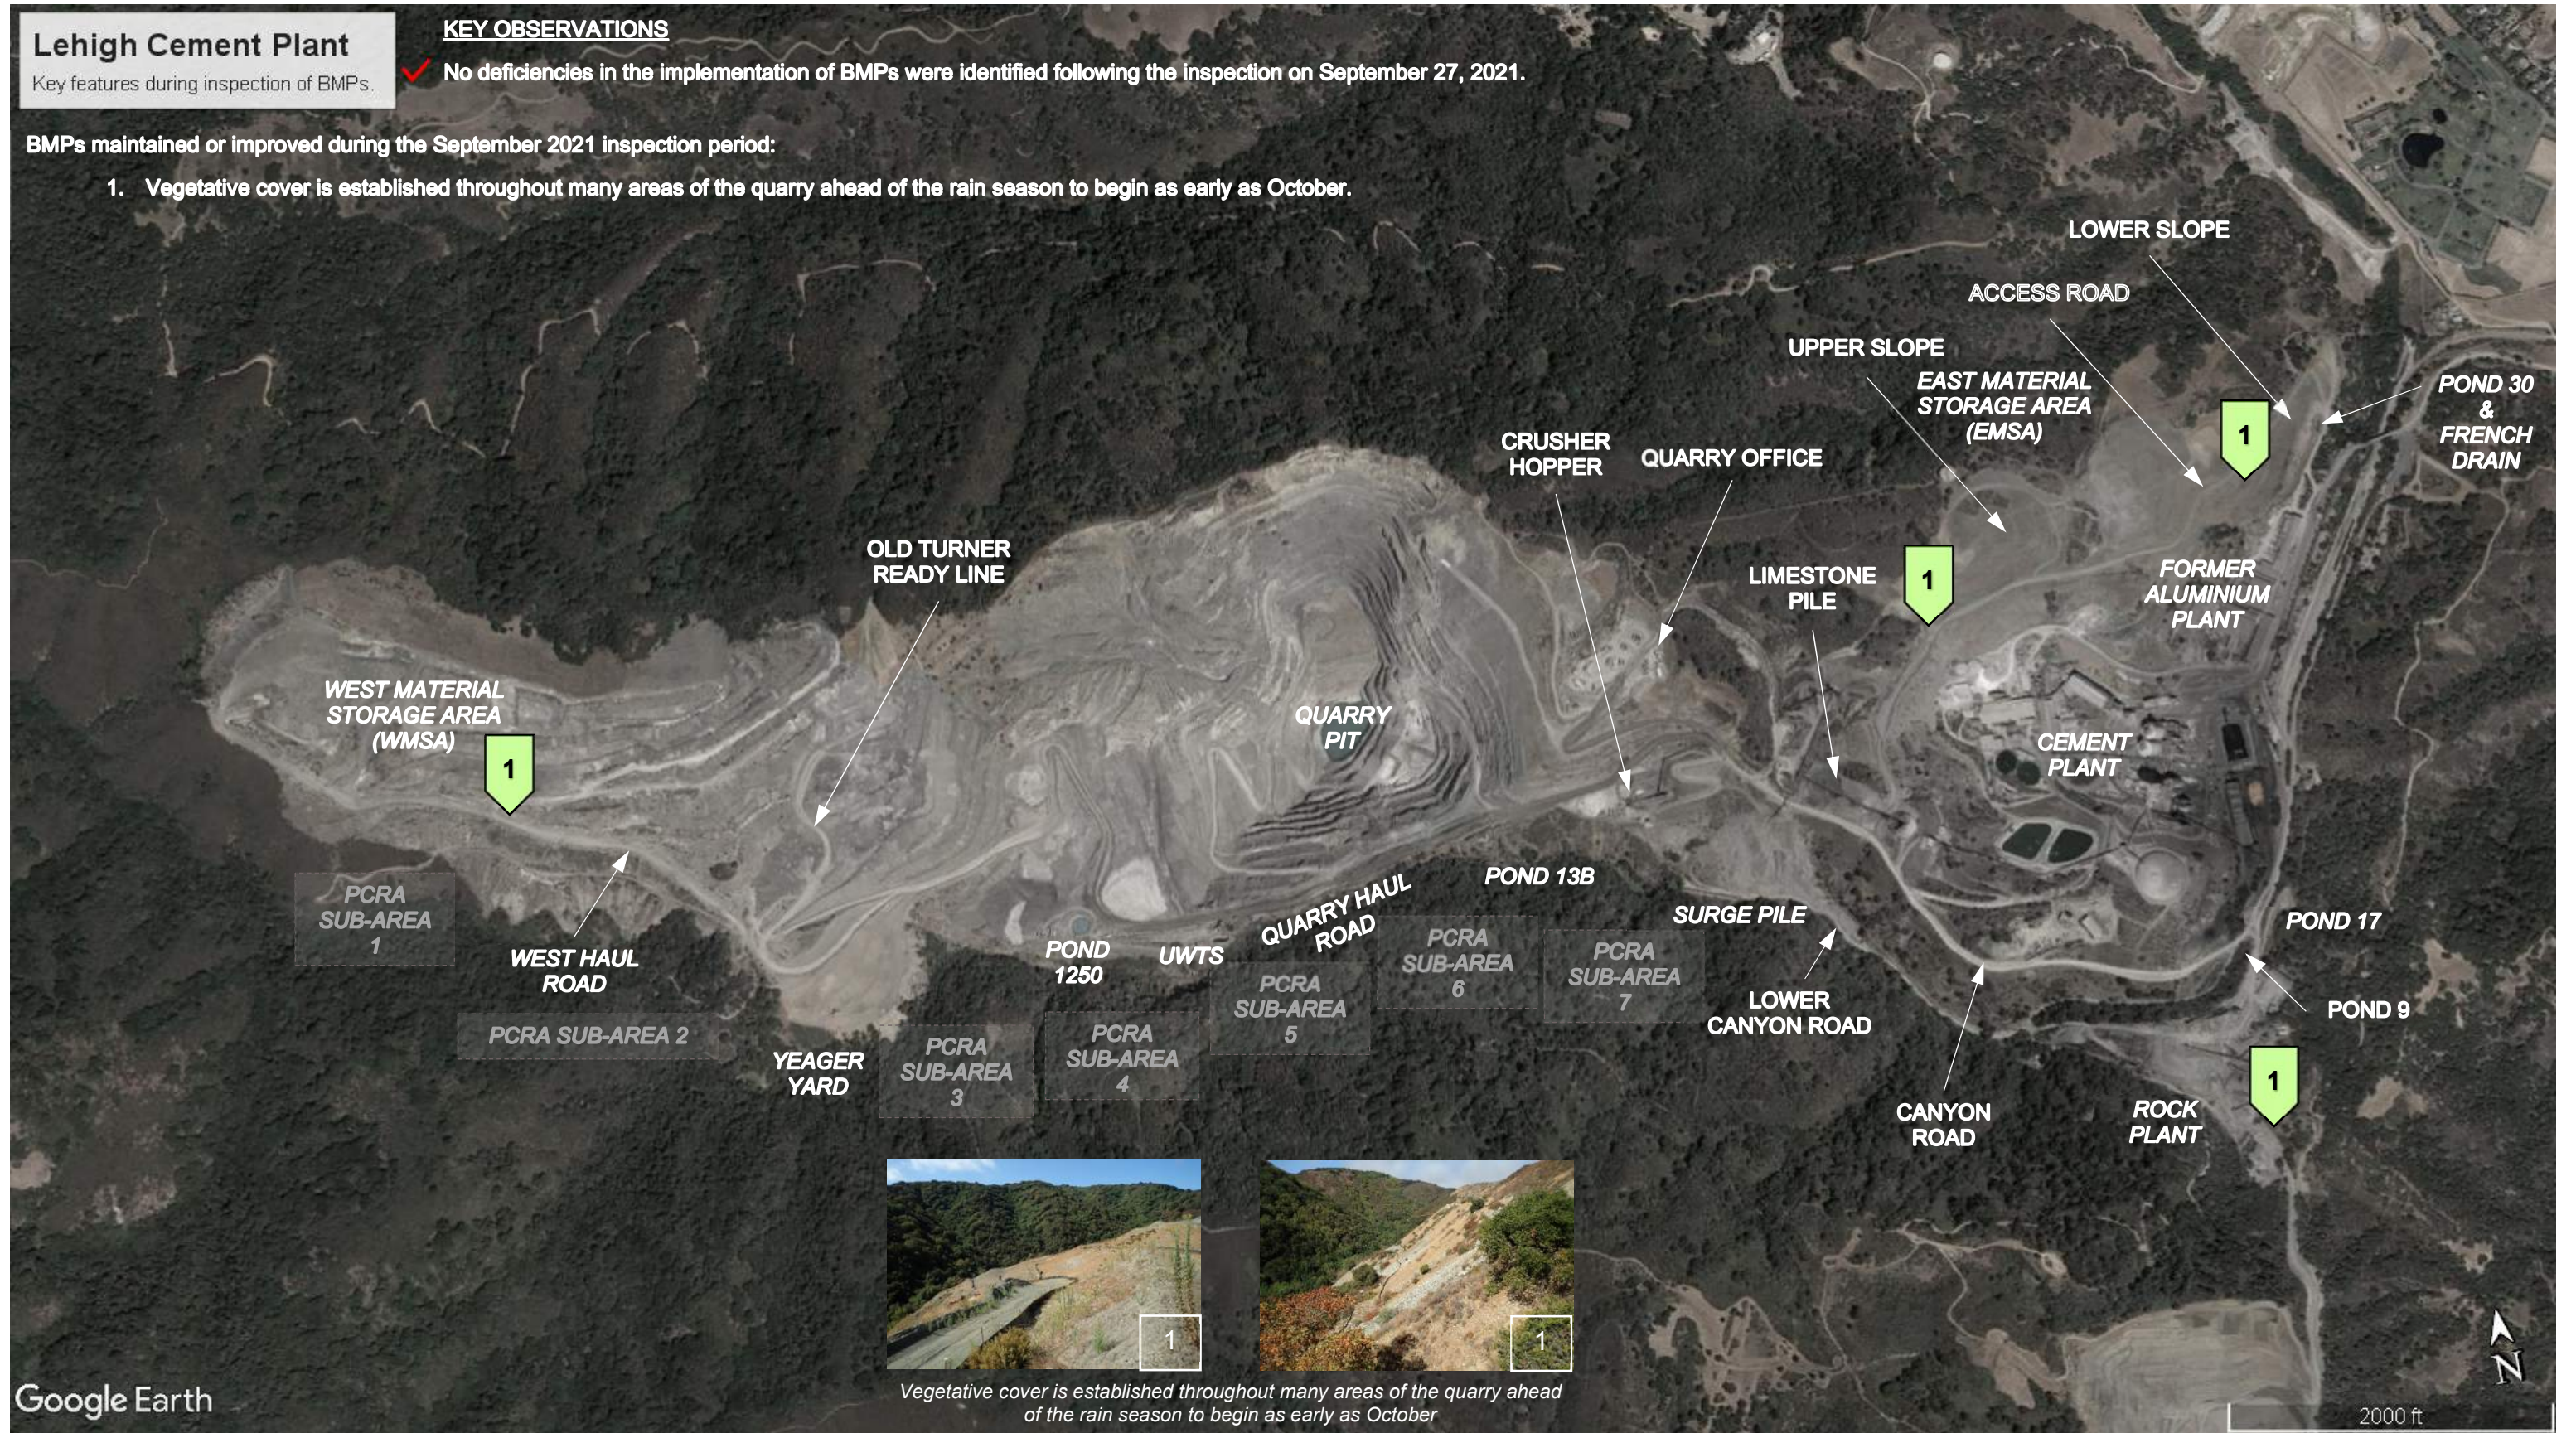
Vegetative cover is established throughout many areas of the quarry ahead of the rain season to begin as early as October

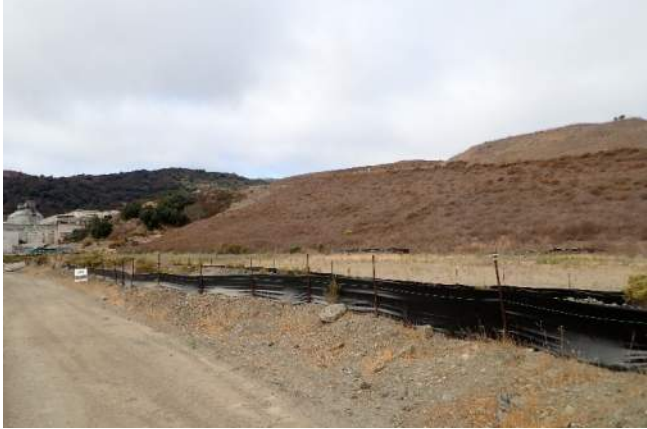
PHOTO ID	DESCRIPTION	PHOTO
0927_01	<p>Status: GOOD</p> <p>Location: EMSA – Pond 30 and French Drain</p> <p>Observations: Vegetation has established throughout the EMSA above the silt fences at Pond 30. Silt fences remain in good condition. Straw Wattles were recently replaced.</p> <p>Recommendations: Routine monitoring of the condition of the straw wattles, silt fences, and vegetative cover in this area.</p>

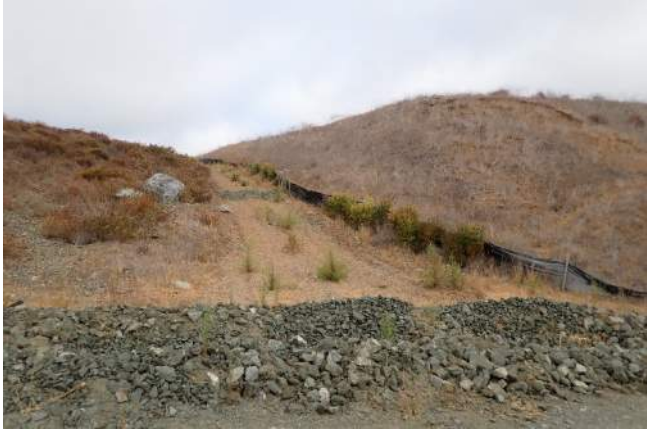
0927_02	<p>Status: GOOD</p> <p>Location: Lower EMSA by Access Road Non-limestone interim cover material storage area</p> <p>Observations: Roadside water bars and rock check structures were re-established along and upslope from the EMSA access road.</p> <p>Recommendations: Routine monitoring of roadside check structures and sedimentation before and after rain events.</p>

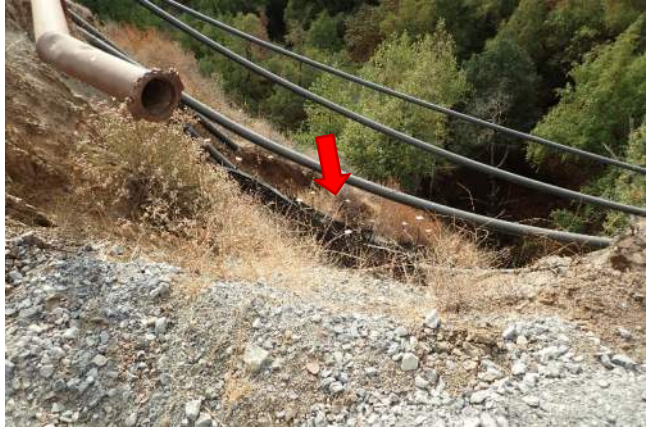
0927_03	<p>Status: MONITOR FOR CHANGES</p> <p>Location: Quarry Haul Road PCRA: 5 and 6</p> <p>Observations: Multiple lines of silt fencing remain in place and in good, functional condition. Debris is being retained behind fencing.</p> <p>Recommendations: Routine monitoring of sedimentation and debris accumulation behind silt fences.</p>

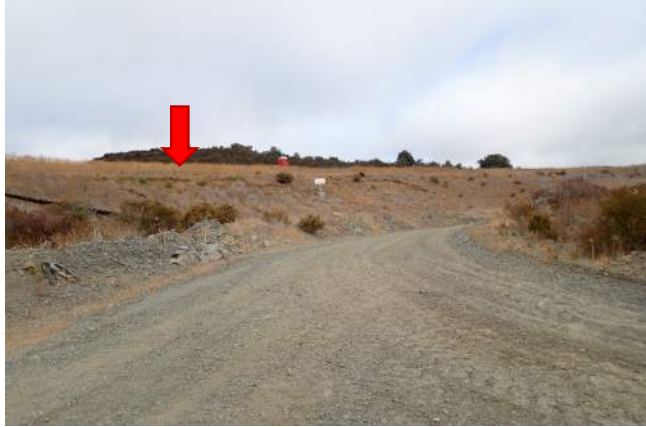
PHOTO ID	DESCRIPTION	PHOTO
0927_04	<p>Status: MONITOR FOR CHANGES</p> <p>Location: EMSA Upper Slopes</p> <p>Observations: Upper slopes of the East Material Storage Area (EMSA) remain vegetated. Hydroseeded vegetation has established over the interim cover material stockpile.</p> <p>Recommendations: Routine monitoring of vegetative cover ahead of the rain season to begin as early as October.</p>

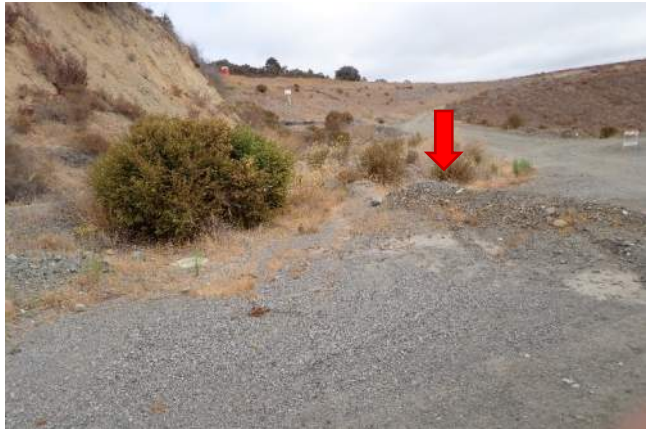
0927_05	<p>Status: MONITOR FOR CHANGES</p> <p>Location: EMSA – Access Road</p> <p>Observations: Water bars were re-established draining into the drop inlet. Straw wattles and hay bales remain in place around the drop inlet next to the EMSA access road.</p> <p>Recommendations: Routine monitoring of the condition of water bars and sediment controls (hay bales, wattles). Replace bales and wattles ahead of the rain season to begin as early as October.</p>

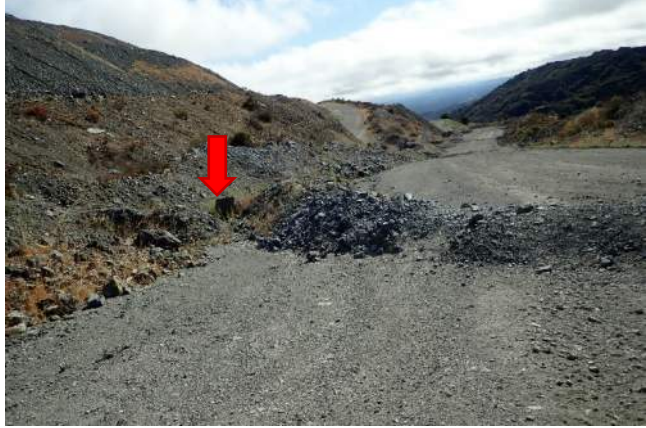
0927_06	<p>Status: MONITOR FOR CHANGES</p> <p>Location: WMSA – Haul Road</p> <p>Observations: Check dams remain in functional condition. Water bars, cross-slope remain in place after the end of the rain season.</p> <p>Recommendations: Routine monitoring of the sedimentation behind check dams along the Quarry Haul Road to WMSA and re-establish water bars as needed ahead of the rain season to begin as early as October.</p>

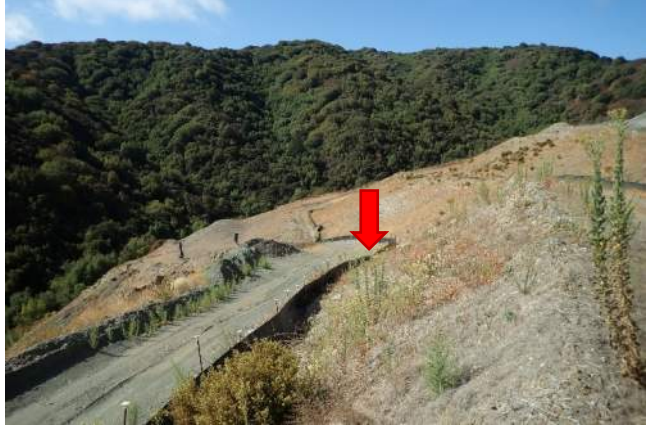
PHOTO ID	DESCRIPTION	PHOTO
0927_07	<p>Status: MONITOR FOR CHANGES</p> <p>Location: Yeager Yard – Upper Slopes PCRA: 2 and 3</p> <p>Observations: Silt fences are in good condition and remain functional. Vegetative cover has established over the upper slopes of the Yeager Yard.</p> <p>Recommendations: Routine monitoring of the vegetative cover on the slopes. Monitor the sediment accumulation on vegetated benches and silt fence condition routinely.</p>

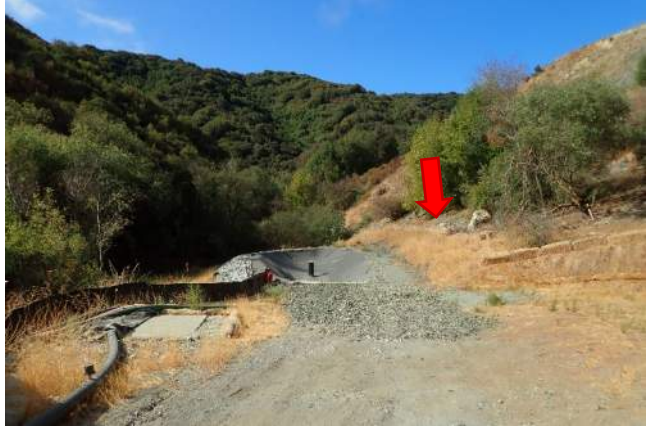
0927_08	<p>Status: MONITOR FOR CHANGES</p> <p>Location: Yeager Yard – Sediment Basin PCRA: 2 and 3</p> <p>Observations: Vegetation has developed around the hay bale check structures upslope of the sediment capture basin.</p> <p>Recommendations: Routine monitoring of the vegetative cover and hay bale conditions through establishment of hydroseed vegetation.</p>

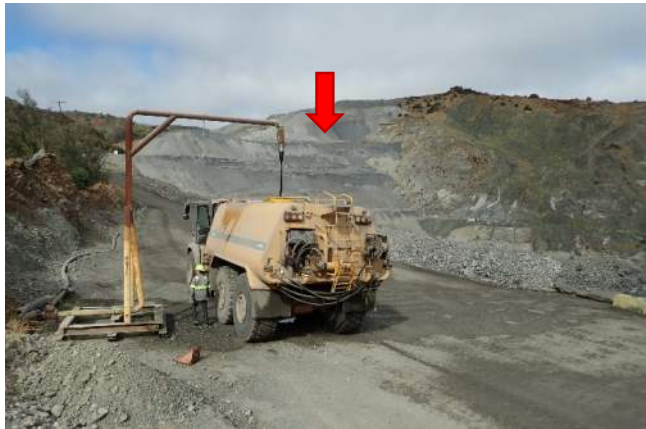
0927_09	<p>Status: GOOD</p> <p>Location: Quarry Haul Road PCRA: 2 and 3</p> <p>Observations: Water truck fills water tank to continue dust-suppression watering on the Quarry Haul Road.</p> <p>Recommendations: Routine monitoring of dust conditions on unpaved roads. Maintain required watering efforts; adjust road watering frequency based on observed conditions.</p>

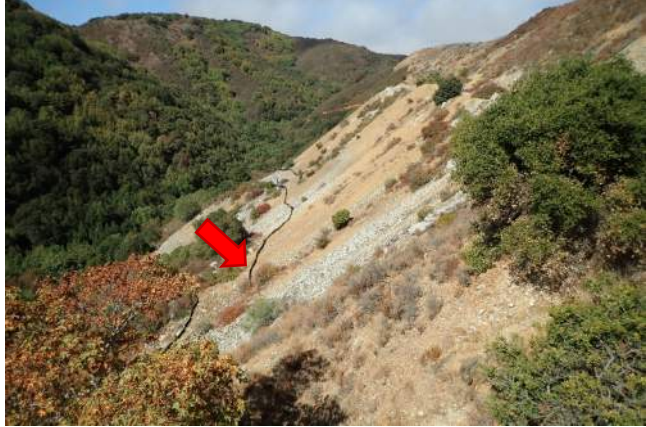
PHOTO ID	DESCRIPTION	PHOTO
0927_10	<p>Status: GOOD</p> <p>Location: PCRA 1 PCRA: 1</p> <p>Observations: Slope below road remains vegetated. Silt fencing was maintained in recent months.</p> <p>Recommendations: Routine monitoring of the silt fence condition and sedimentation behind lower line of silt fences.</p>

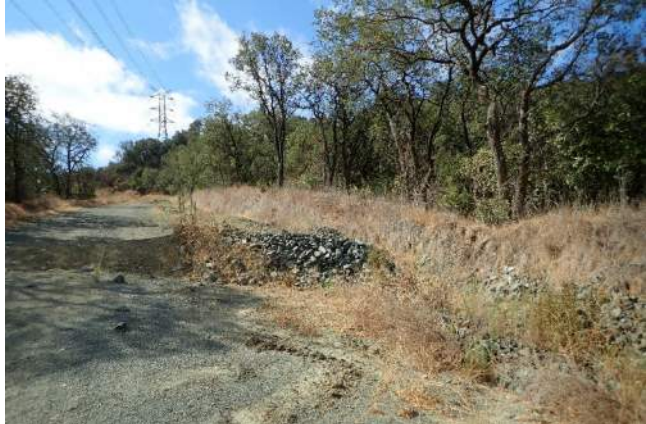
0927_11	<p>Status: MONITOR FOR CHANGES</p> <p>Location: Rock Plant – Improved Existing Access Road</p> <p>Observations: Water bars were re-established along the access road by the Rock Plant.</p> <p>Recommendations: Routine monitoring of the condition of the water bars and vegetative cover ahead of the rain season to begin as early as October.</p>

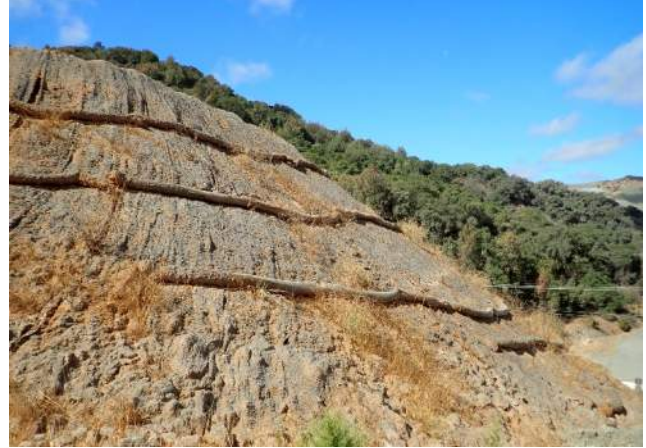
0927_12	<p>Status: GOOD</p> <p>Location: Rock Plant – Roadside Slope</p> <p>Observations: Jute matting and straw wattles remain in alignment and continuous around the hydroseeded slope at the Rock Plant.</p> <p>Recommendations: Routine monitoring of the sedimentation of the rock-lined features and the condition of the jute matting and straw wattles. Adjust wattles as needed to achieve intended alignment and continuity.</p>

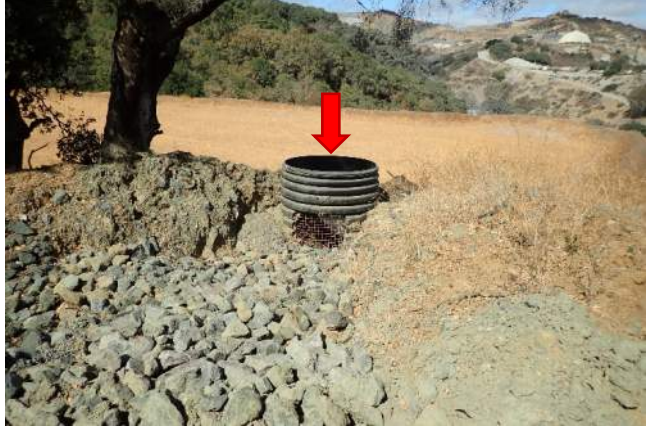
PHOTO ID	DESCRIPTION	PHOTO
0927_13	<p>Status: MONITOR FOR CHANGES</p> <p>Location: Rock Plant – Improved Existing Access Road</p> <p>Observations: Drop inlet and rock-lined apron are clear of significant debris and remain functional. The drop inlet pipe is clear of sediment at the end of the dry season.</p> <p>Recommendations: Routine monitoring of the sedimentation and debris accumulation inside the drop inlet pipe and stilling basin.</p>

1. Vegetative cover is established throughout many areas of the quarry ahead of the rain season to begin as early as October. See Photos 0927_01, 0927_02, 0927_04, 0927_07, 0927_08, 0927_10, 0927_13, and 0927_14 in the appended DFR.

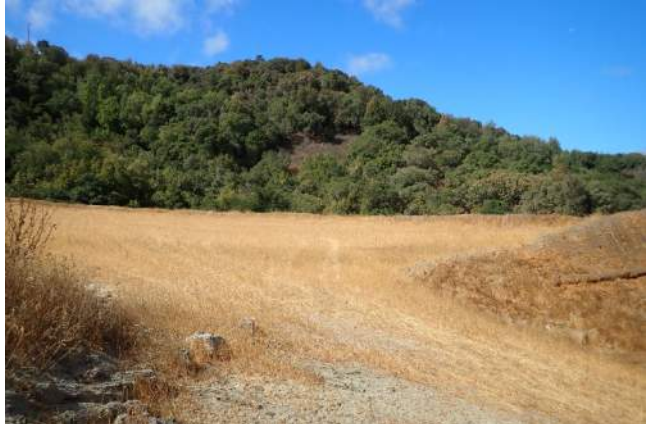
0927_14	<p>Status: GOOD</p> <p>Location: Rock Plant – Roadside Slope</p> <p>Observations: Roadside slope and top bench remain vegetated. Vegetative cover is established over the top bench and main slope at Rock Plant.</p> <p>Recommendations: Routine monitoring of vegetative cover during the rain season.</p>

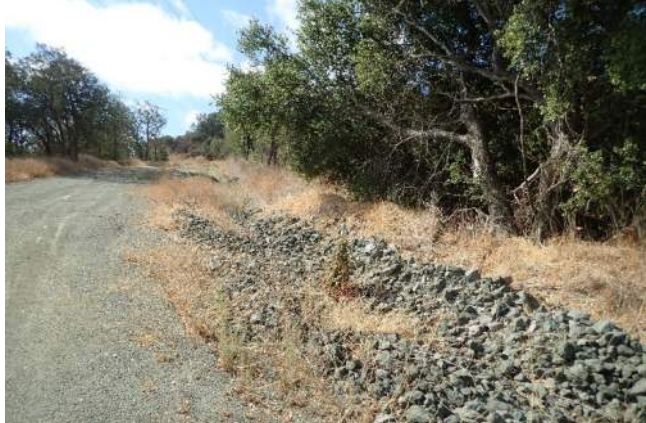
0927_15	<p>Status: GOOD</p> <p>Location: Rock Plant – Roadside ditch and Slope</p> <p>Observations: Roadside rock-lined ditches remain in place and maintain positive drainage. Vegetation has established in the adjacent slopes, although dry during the summer</p> <p>Recommendations: Routine monitoring of vegetative cover and roadside sediment accumulation.</p>

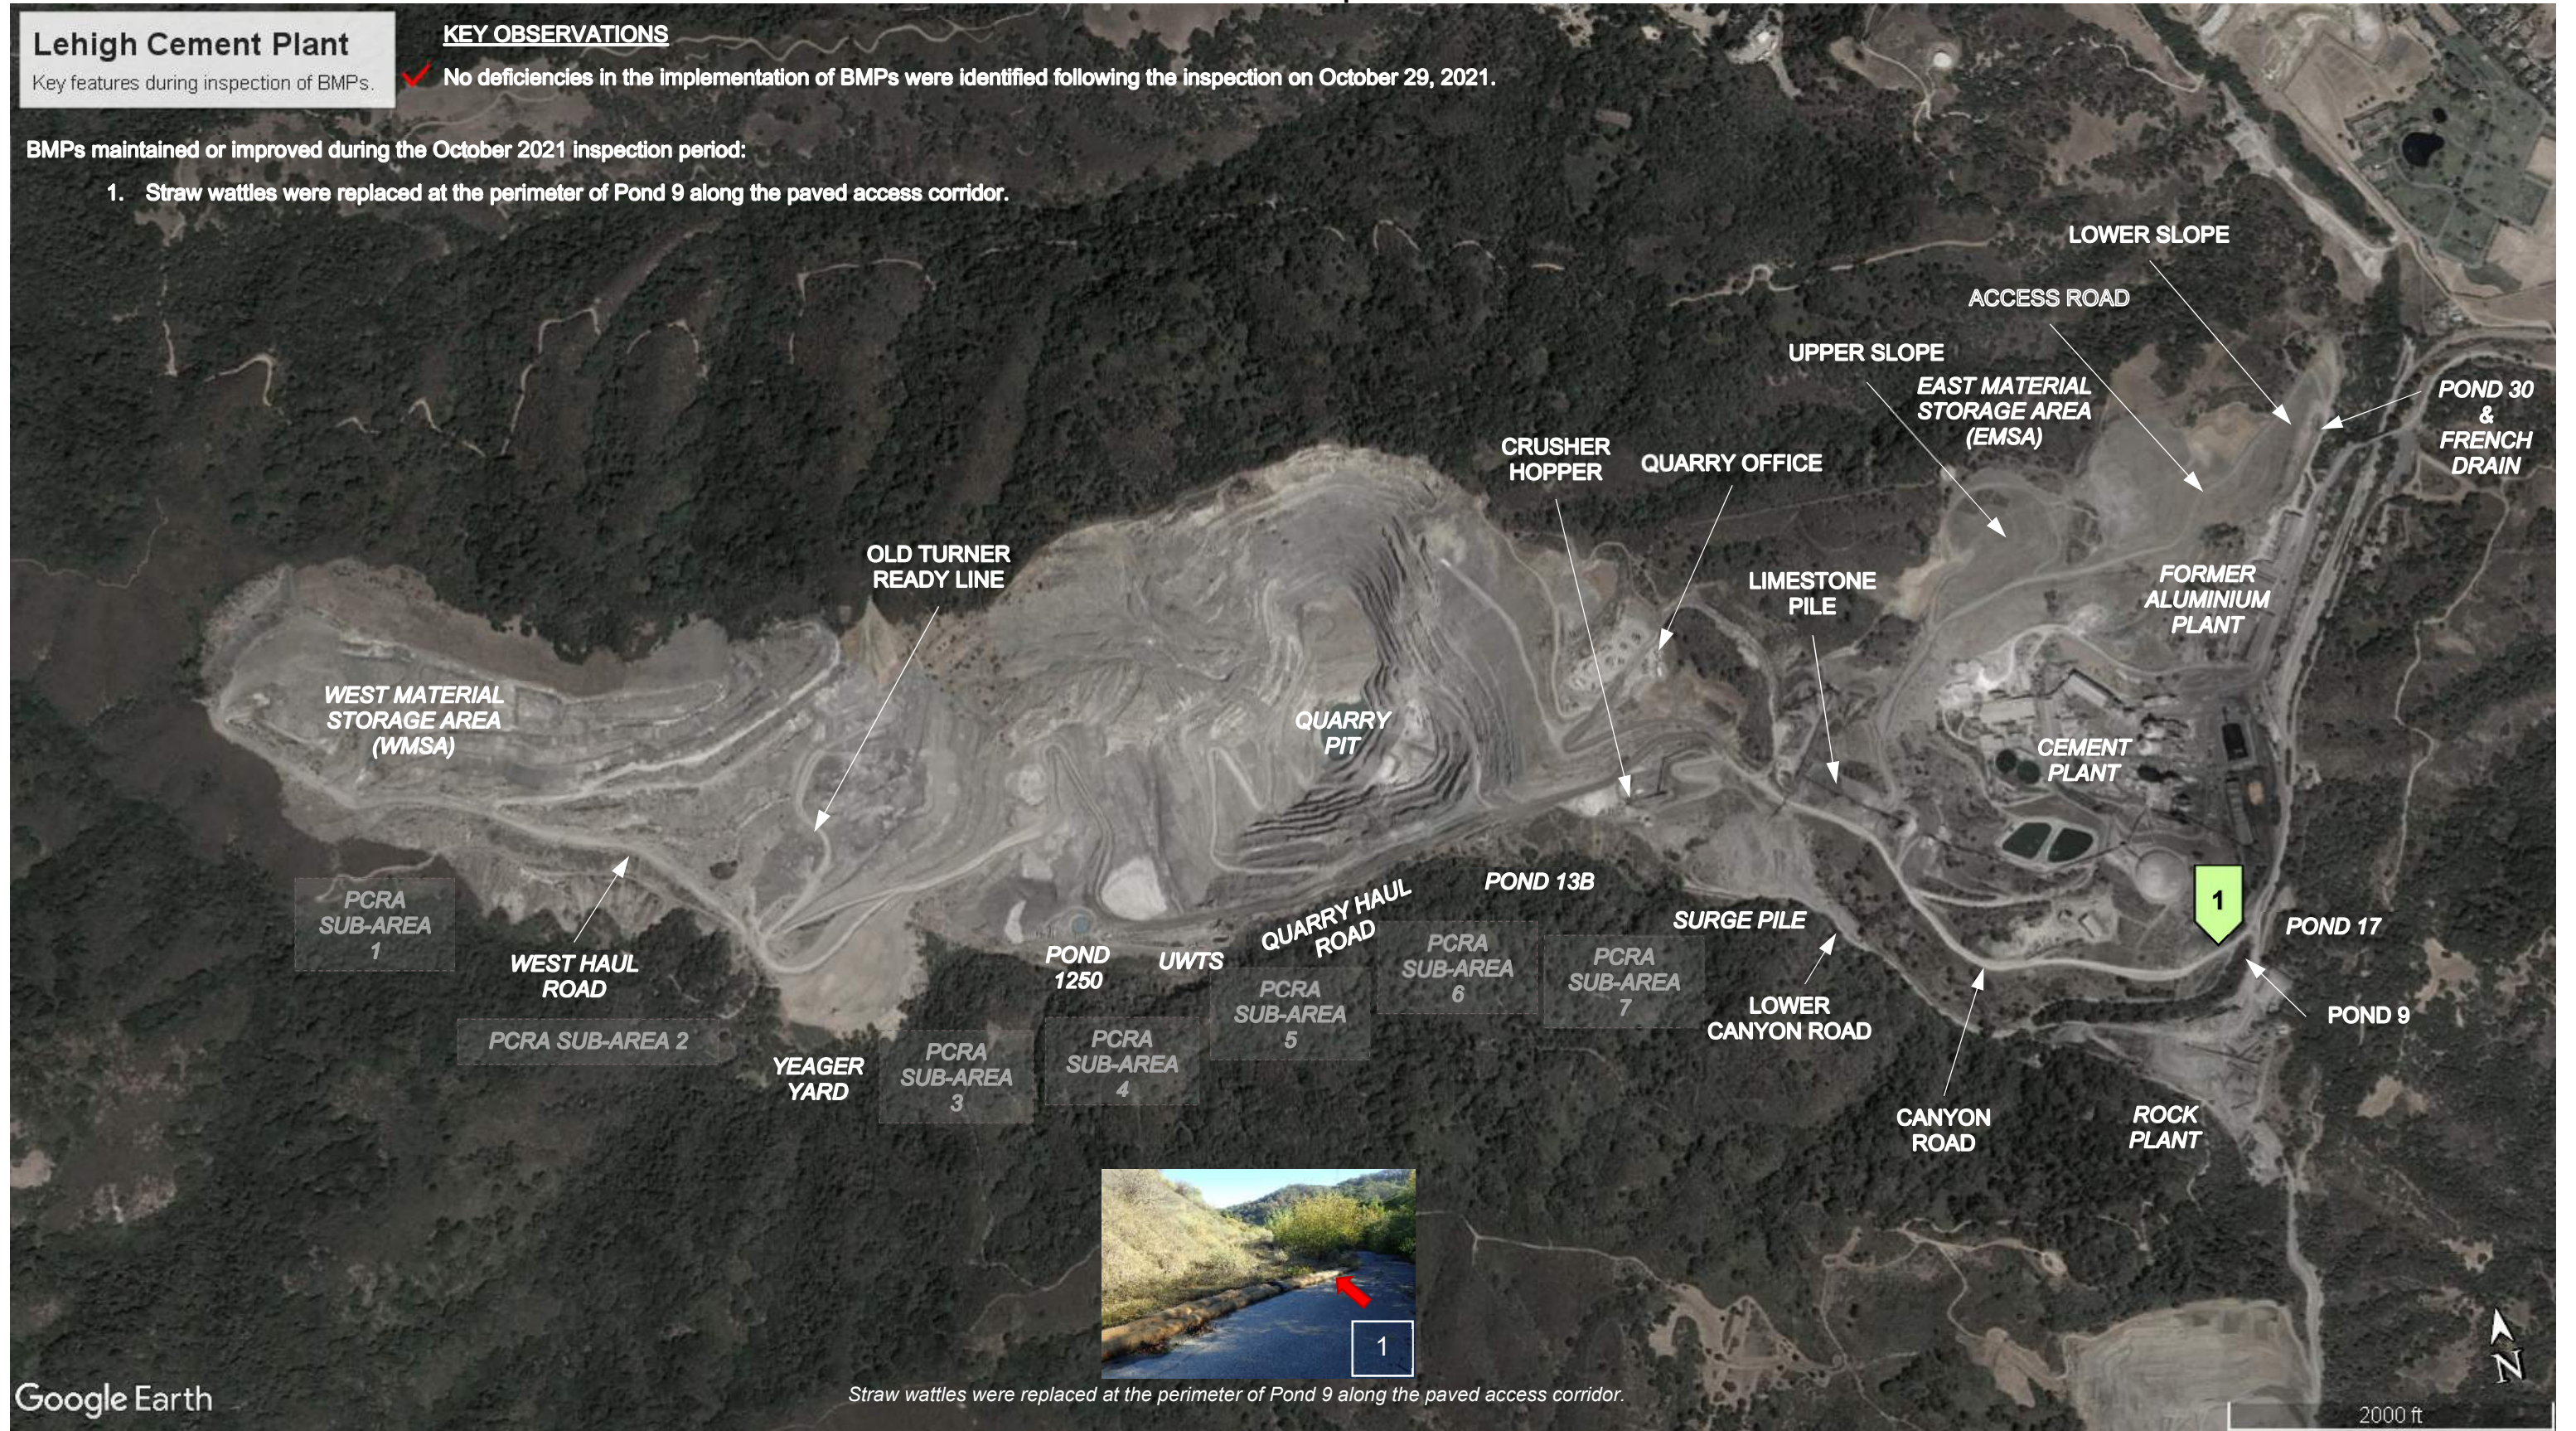
Straw wattles were replaced at the perimeter of Pond 9 along the paved access corridor.

1. Straw wattles were replaced at the perimeter of Pond 9 along the paved access corridor.

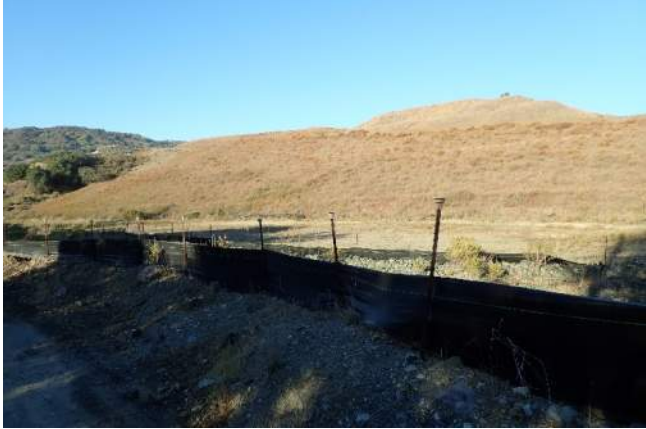
PHOTO ID	DESCRIPTION	PHOTO
1029_01	<p>Status: GOOD</p> <p>Location: EMSA – Pond 30 and French Drain</p> <p>Observations: Vegetation has established throughout the EMSA above the silt fences at Pond 30. Silt fences remain in good condition.</p> <p>Recommendations: Routine monitoring of the condition of the straw wattles, silt fences, and vegetative cover in this area.</p>

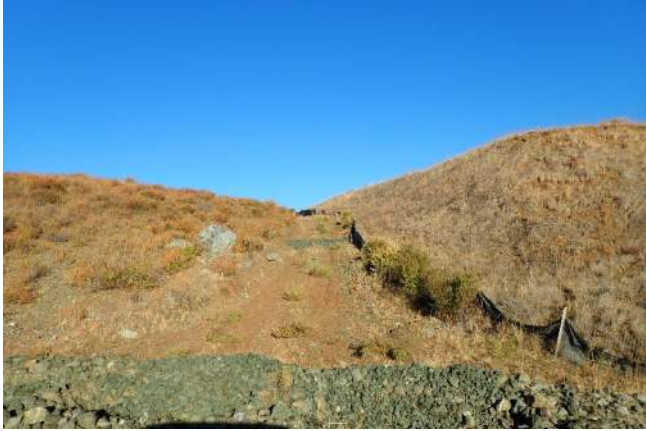
1029_02	<p>Status: GOOD</p> <p>Location: Lower EMSA by Access Road Non-limestone interim cover material storage area</p> <p>Observations: Roadside water bars and rock check-structures are re-established along and upslope from the EMSA access road.</p> <p>Recommendations: Routine monitoring of roadside check structures, sedimentation before and after rain events.</p>

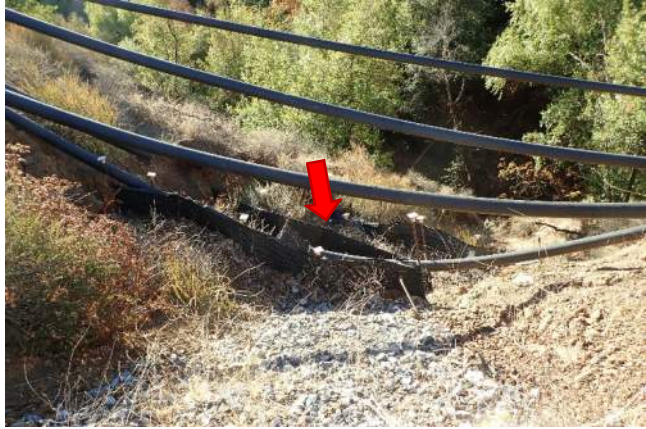
1029_03	<p>Status: MONITOR FOR CHANGES</p> <p>Location: Quarry Haul Road PCRA: 5 and 6</p> <p>Observations: Multiple lines of silt fencing remain in place and in good, functional condition. Debris is being retained behind fencing.</p> <p>Recommendations: Routine monitoring of sedimentation and debris accumulation behind silt fences.</p>

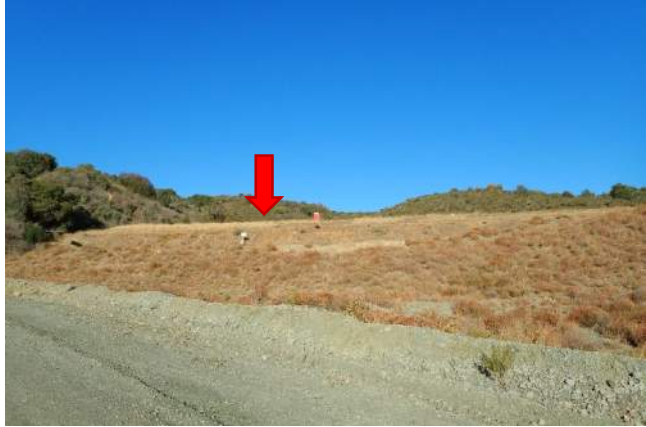
PHOTO ID	DESCRIPTION	PHOTO
1029_04	<p>Status: MONITOR FOR CHANGES</p> <p>Location: EMSA Upper Slopes</p> <p>Observations: Upper slopes of the East Material Storage Area (EMSA) remain vegetated. Hydroseeded vegetation has established over the interim cover material stockpile.</p> <p>Recommendations: Routine monitoring of vegetative cover ahead of the rain season to begin as early as October.</p>

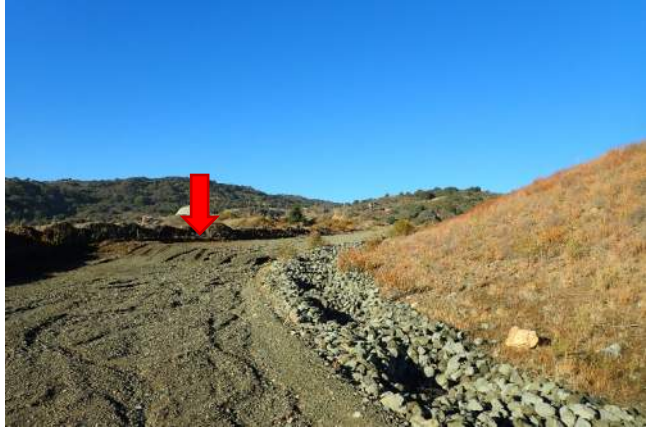
1029_05	<p>Status: MONITOR FOR CHANGES</p> <p>Location: EMSA – Access Road</p> <p>Observations: Water bars are established and draining to the drop inlet. Straw wattles and hay bales remain in place around the drop inlet next to the EMSA access road.</p> <p>Recommendations: Routine monitoring of the condition of water bars and sediment controls: hay bales, wattles.</p>

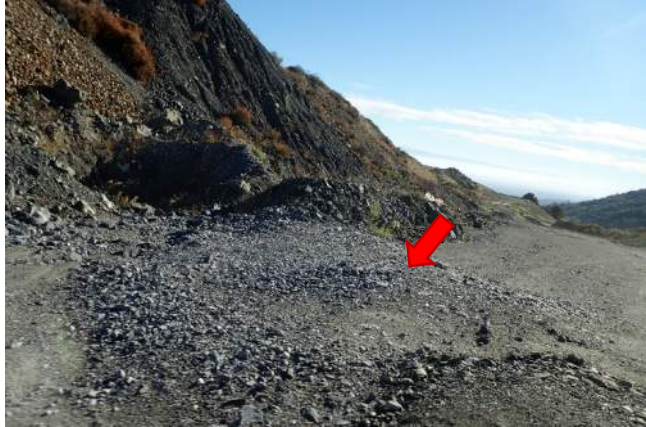
1029_06	<p>Status: MONITOR FOR CHANGES</p> <p>Location: WMSA – Haul Road</p> <p>Observations: Check dams remain in functional condition. Water bars, cross-slope remain in place after the end of the dry season.</p> <p>Recommendations: Routine monitoring of the sedimentation behind check dams along the Quarry Haul Road to WMSA and re-establish water bars as needed.</p>

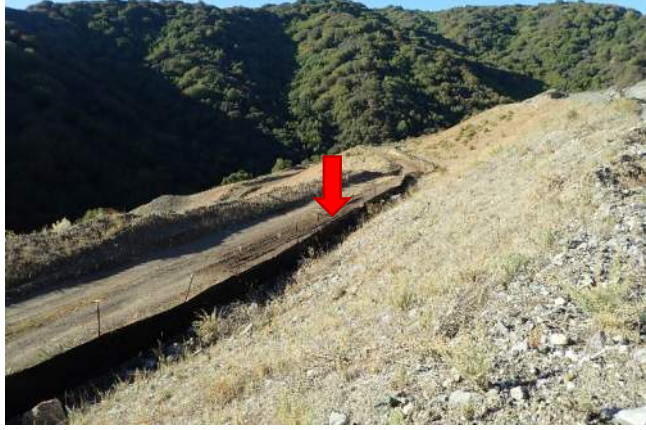
PHOTO ID	DESCRIPTION	PHOTO
1029_07	<p>Status: MONITOR FOR CHANGES</p> <p>Location: Yeager Yard – Upper Slopes PCRA: 2 and 3</p> <p>Observations: Silt fences are in good condition and remain functional. Vegetative cover has established over the upper slopes of the Yeager Yard.</p> <p>Recommendations: Routine monitoring of the vegetative cover on the slopes. Monitor the sediment accumulation on vegetated benches and silt fence condition routinely.</p>

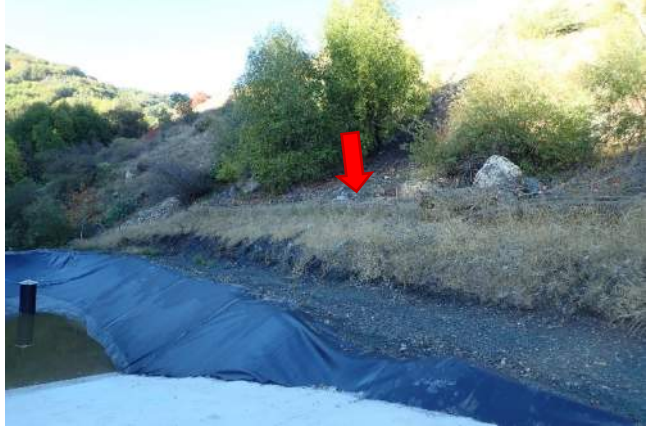
1029_08	<p>Status: MONITOR FOR CHANGES</p> <p>Location: Yeager Yard – Sediment Basin PCRA: 2 and 3</p> <p>Observations: Vegetation has developed around the hay bale check structures upslope of the sediment capture basin.</p> <p>Recommendations: Routine monitoring of the vegetative cover and hay bale conditions through establishment of hydroseed vegetation.</p>

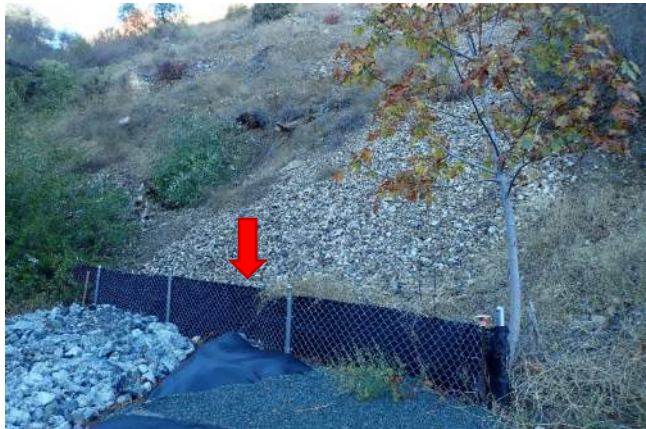
1029_09	<p>Status: GOOD</p> <p>Location: Yeager Yard – Sediment Basin PCRA: 2 and 3</p> <p>Observations: Super silt fence remains in place and in good condition with low levels of sedimentation and debris accumulation.</p> <p>Recommendations: Frequent monitoring of the sedimentation in the sediment capture basin and above the super silt fence; clear debris regularly.</p>

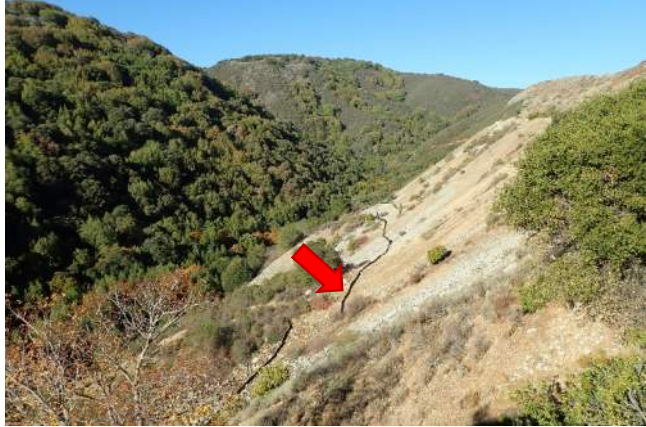
PHOTO ID	DESCRIPTION	PHOTO
1029_10	<p>Status: GOOD</p> <p>Location: PCRA 1 PCRA: 1</p> <p>Observations: Slope below road remains vegetated. Silt fencing continues in good condition.</p> <p>Recommendations: Routine monitoring of the silt fence condition and sedimentation behind lower line of silt fences.</p>

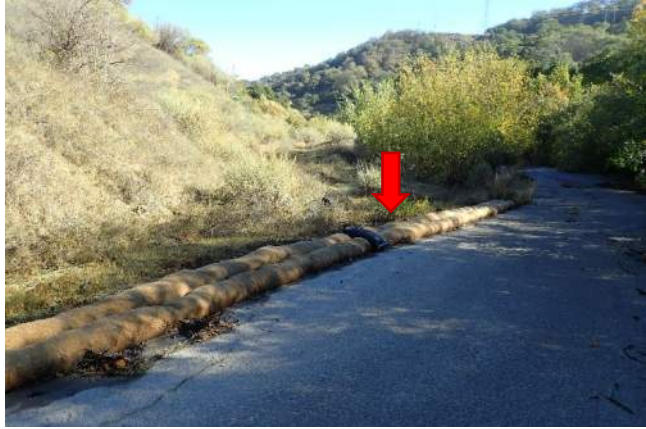
1029_11	<p>Status: GOOD</p> <p>Location: Pond 9</p> <p>Observations: Straw wattles were replaced at the perimeter of Pond 9 along the paved access corridor. Hay bales adjacent to straw wattles remain in good condition.</p> <p>Recommendations: Routine monitoring of the condition of the straw wattles and hay bales at Pond 9 throughout the rain season.</p>

1. Straw wattles were replaced at the perimeter of Pond 9 along the paved access corridor. See photo 1029_11 in the appended DFR.

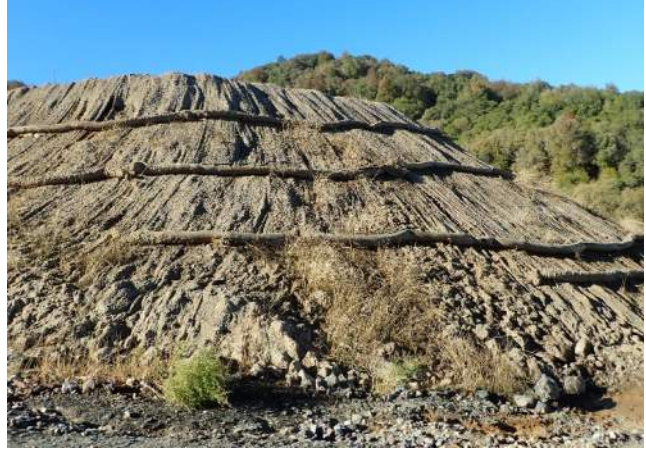
1029_12	<p>Status: GOOD</p> <p>Location: Rock Plant – Roadside Slope</p> <p>Observations: Jute matting and straw wattles remain in alignment and continuous around the hydroseeded slope at the Rock Plant.</p> <p>Recommendations: Routine monitoring of the sedimentation of the rock-lined features and the condition of the jute matting and straw wattles. Adjust wattles as needed to achieve intended alignment and continuity.</p>

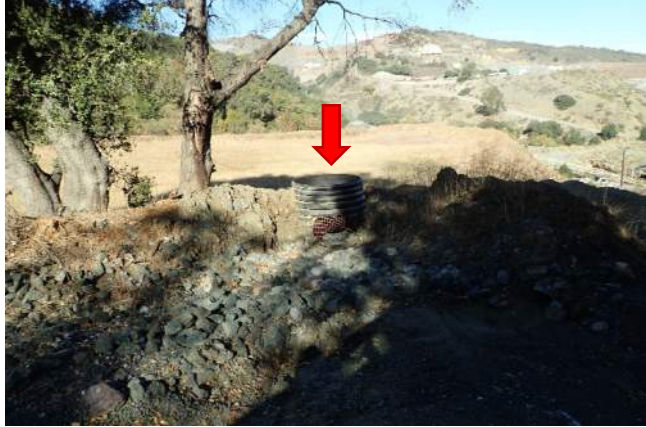
PHOTO ID	DESCRIPTION	PHOTO
1029_13	<p>Status: MONITOR FOR CHANGES</p> <p>Location: Rock Plant – Improved Existing Access Road</p> <p>Observations: Drop inlet and rock-lined apron are clear of significant debris and remain functional. The drop inlet pipe is clear of sediment at the end of the dry season.</p> <p>Recommendations: Routine monitoring of the sedimentation and debris accumulation inside the drop inlet pipe and stilling basin.</p>

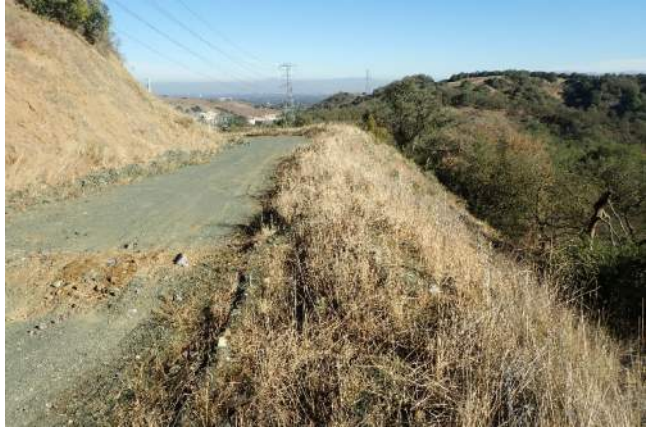
1029_14	<p>Status: MONITOR FOR CHANGES</p> <p>Location: Rock Plant – Improved Existing Access Road</p> <p>Observations: Roadside rock berm remains in place and vegetated. Vegetative cover is established over the slopes below the road and berm.</p> <p>Recommendations: Routine monitoring of rock-lined features, cross-slope in the rain season that began in October.</p>

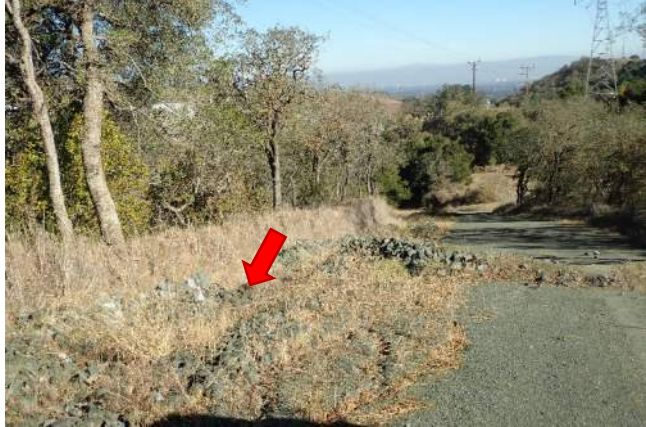
1029_15	<p>Status: GOOD</p> <p>Location: Rock Plant – Roadside ditch and Slope</p> <p>Observations: Roadside rock-lined ditches remain in place and maintain positive drainage. Vegetation has established in the adjacent slopes, although dry during the summer</p> <p>Recommendations: Routine monitoring of vegetative cover and roadside sediment accumulation.</p>
