Lehigh Permanente Quarry Reclamation Plan Amendment Conditions of Approval Compliance

2021-2022 Annual Report Information Package

SANTA CLARA COUNTY, CALIFORNIA

APPENDIX B - 2021-2022 EROSION CONTROL INSPECTION REPORTS

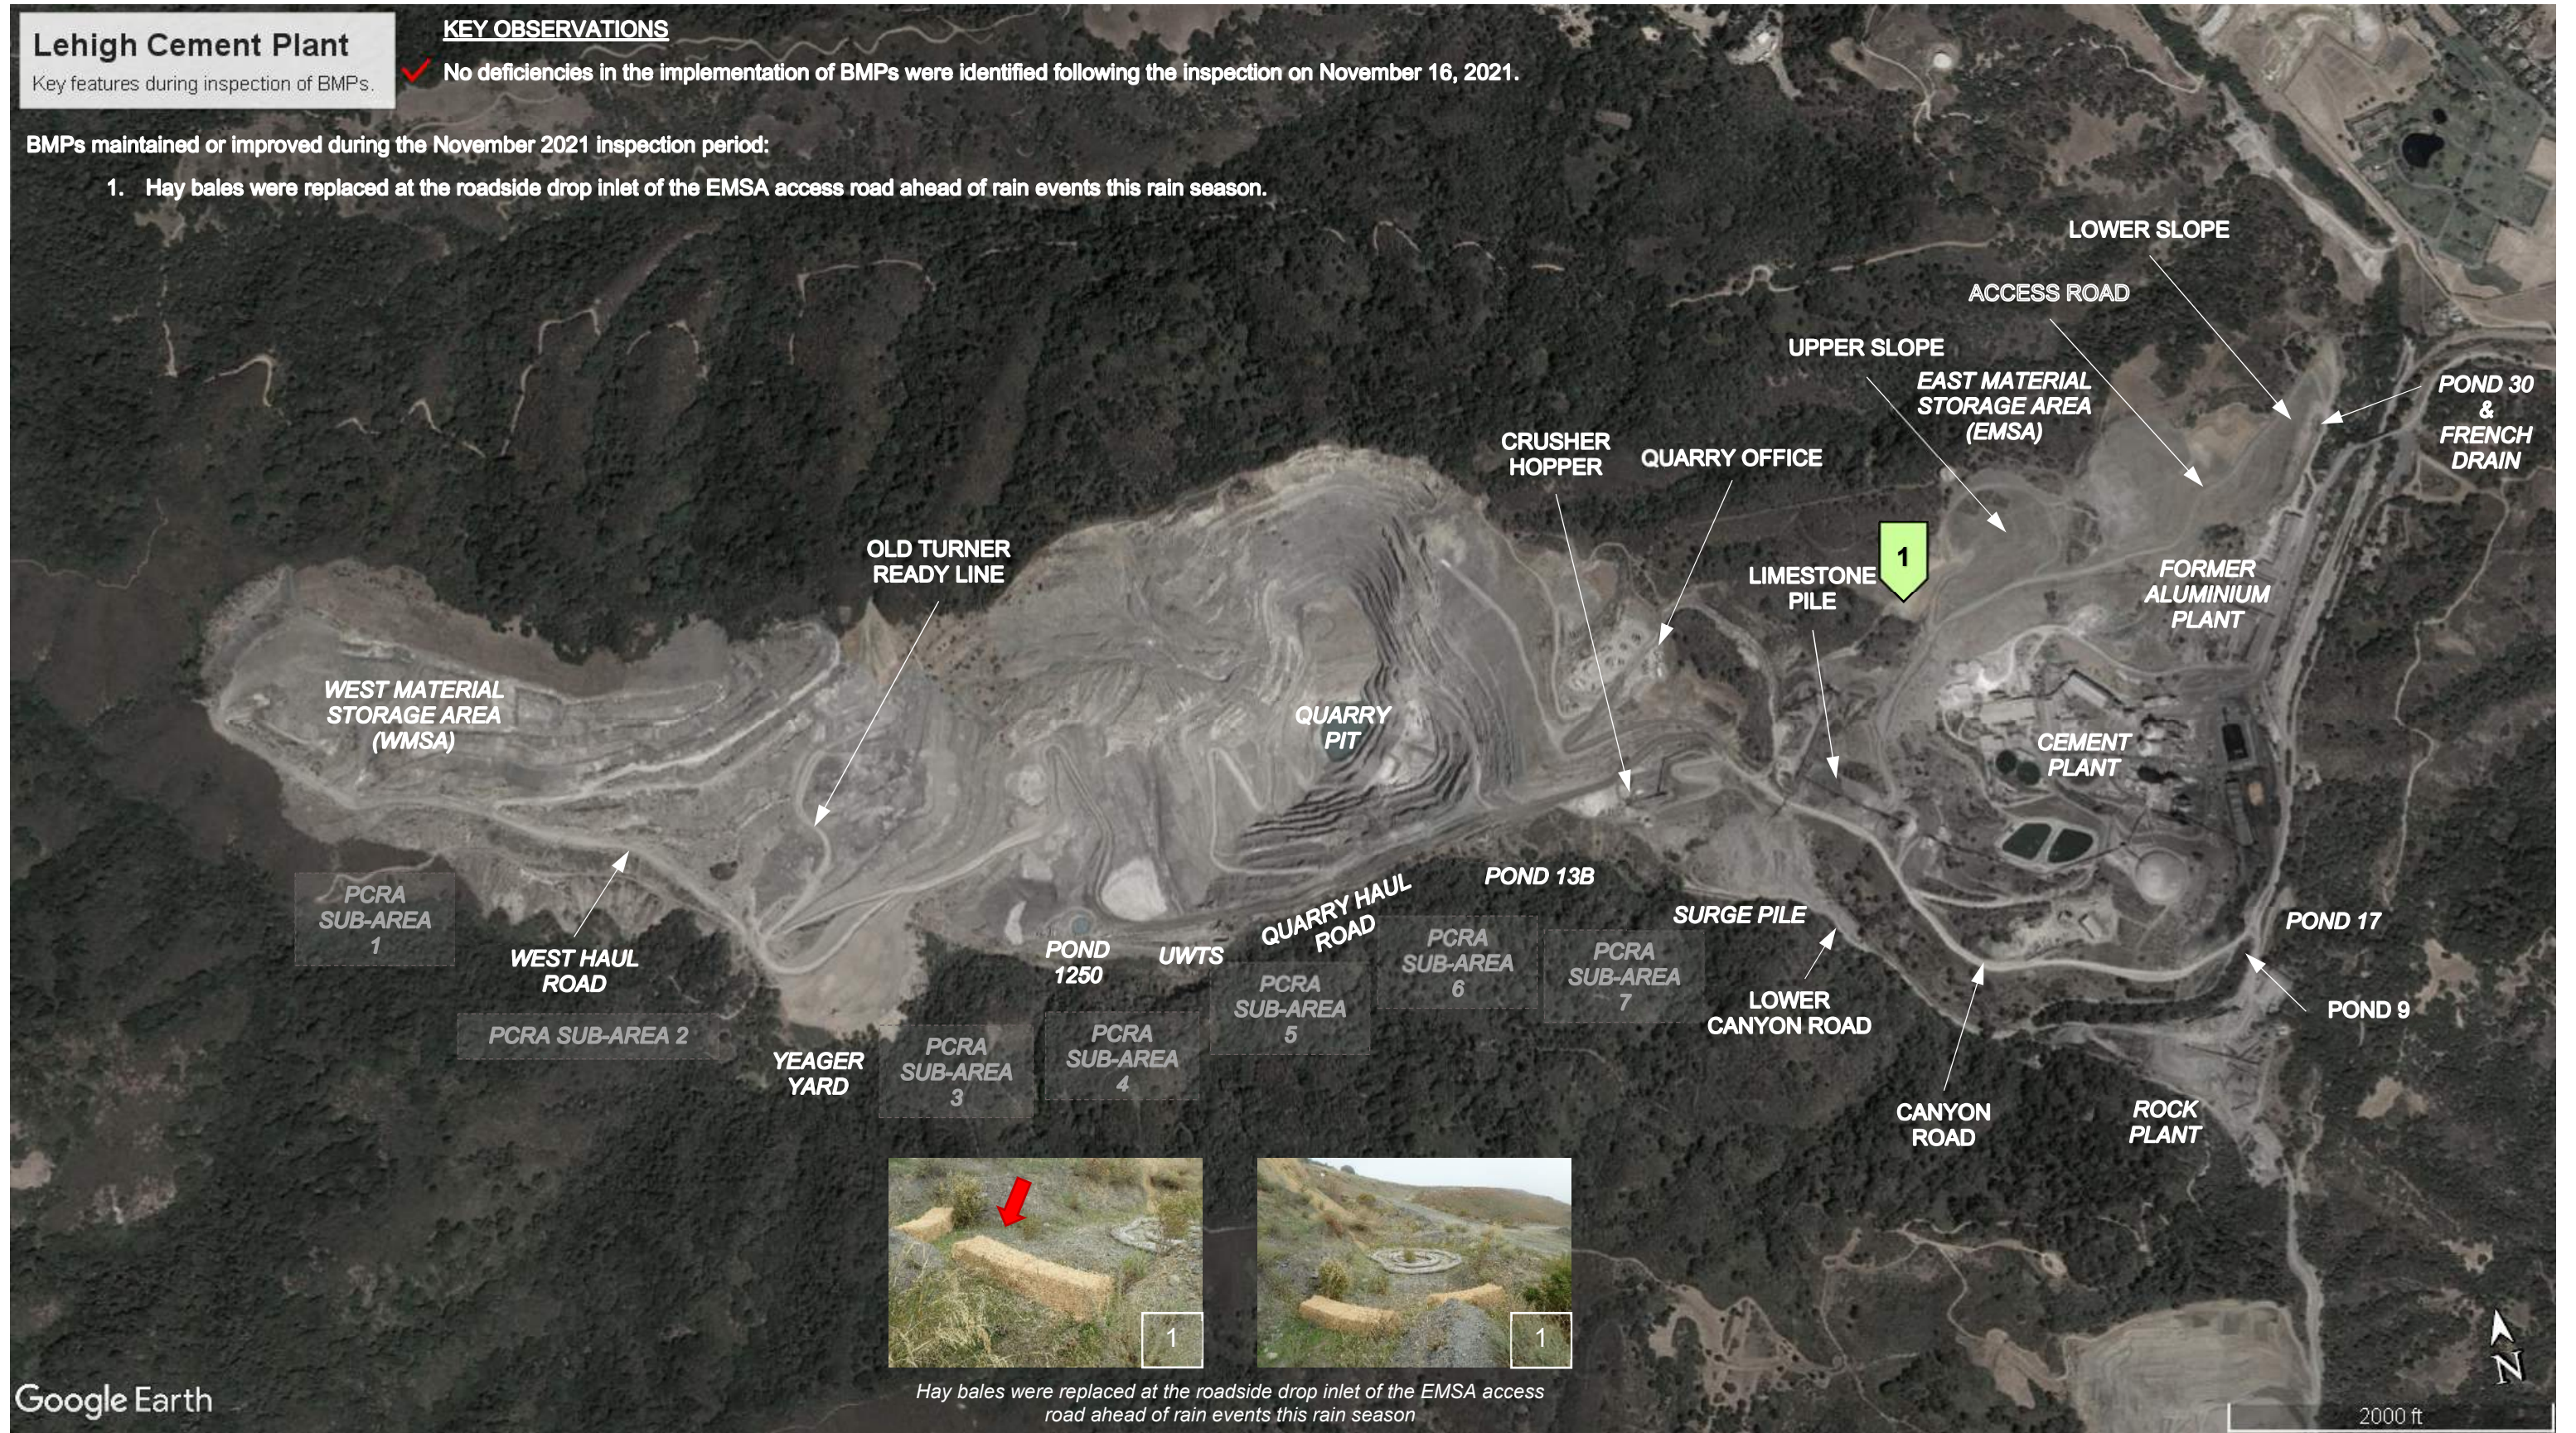
Hay bales were replaced at the roadside drop inlet of the EMSA access road ahead of rain events this rain season

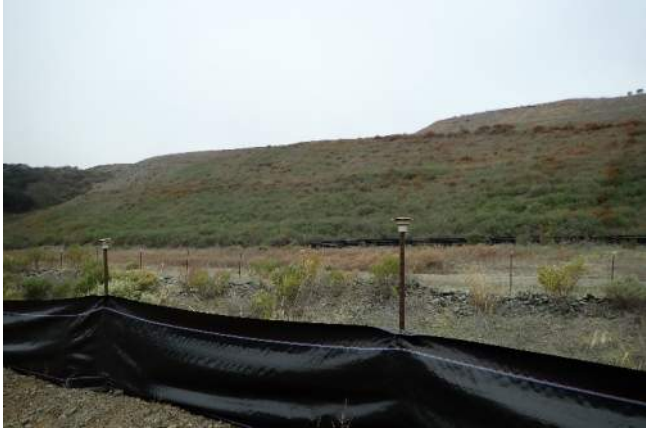
PHOTO ID	DESCRIPTION	PHOTO
1116_01	<p>Status: GOOD</p> <p>Location: EMSA – Pond 30 and French Drain</p> <p>Observations: Vegetation has established throughout the EMSA above the silt fences at Pond 30. Silt fences remain in good condition.</p> <p>Recommendations: Routine monitoring of the condition of the straw wattles, silt fences, and vegetative cover in this area.</p>

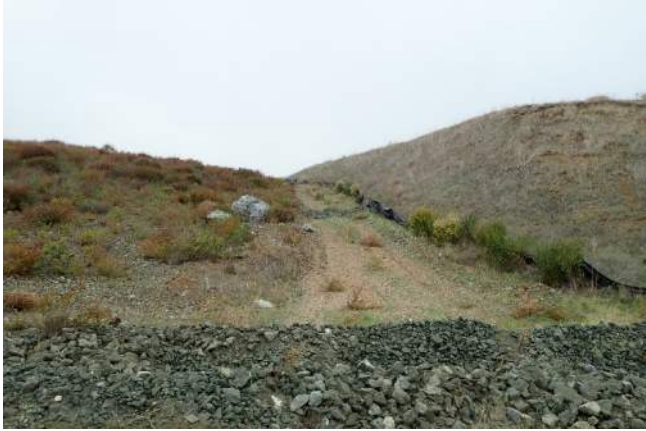
1116_02	<p>Status: GOOD</p> <p>Location: Lower EMSA by Access Road Non-limestone interim cover material storage area</p> <p>Observations: Roadside water bars and rock check-structures are re-established along and upslope from the EMSA access road.</p> <p>Recommendations: Routine monitoring of roadside check structures, sedimentation before and after rain events.</p>

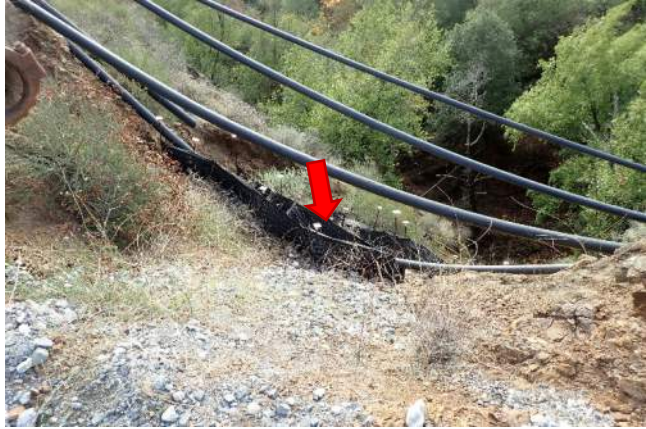
1116_03	<p>Status: MONITOR FOR CHANGES</p> <p>Location: Quarry Haul Road PCRA: 5 and 6</p> <p>Observations: Multiple lines of silt fencing remain in place and in good, functional condition. Debris is being retained behind fencing.</p> <p>Recommendations: Routine monitoring of sedimentation and debris accumulation behind silt fences.</p>

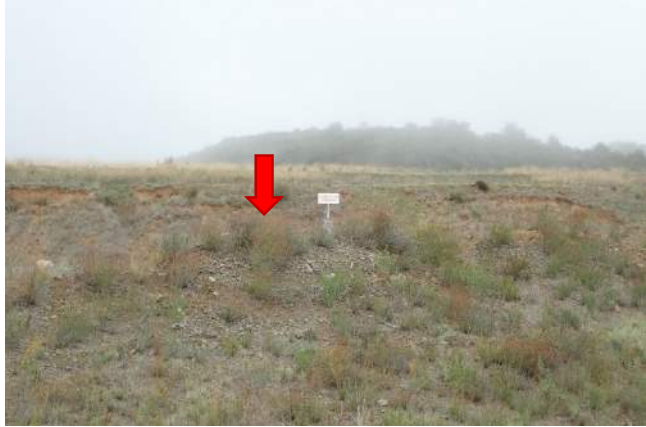
PHOTO ID	DESCRIPTION	PHOTO
1116_04	<p>Status: MONITOR FOR CHANGES</p> <p>Location: EMSA Upper Slopes</p> <p>Observations: Upper slopes of the East Material Storage Area (EMSA) remain vegetated. Hydroseeded vegetation has established over the interim cover material stockpile.</p> <p>Recommendations: Routine monitoring of vegetative cover throughout the rain season that began in October.</p>

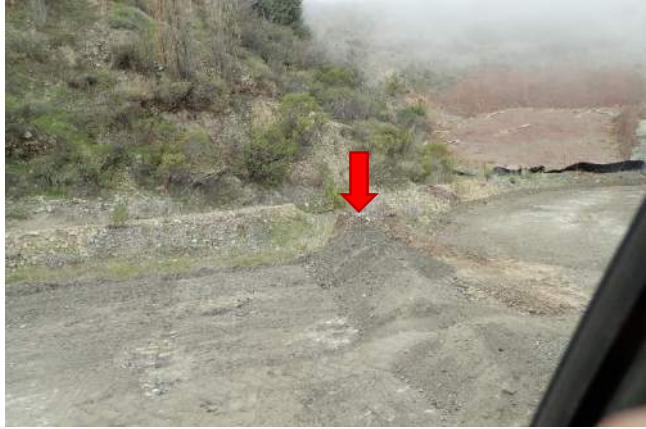
1116_05	<p>Status: MONITOR FOR CHANGES</p> <p>Location: EMSA – Access Road</p> <p>Observations: Water bars are established and draining to roadside ditch. Straw wattles and hay bales remain in place around the drop inlet next to the EMSA access road.</p> <p>Recommendations: Routine monitoring of the condition of water bars and sediment controls: hay bales, wattles.</p>

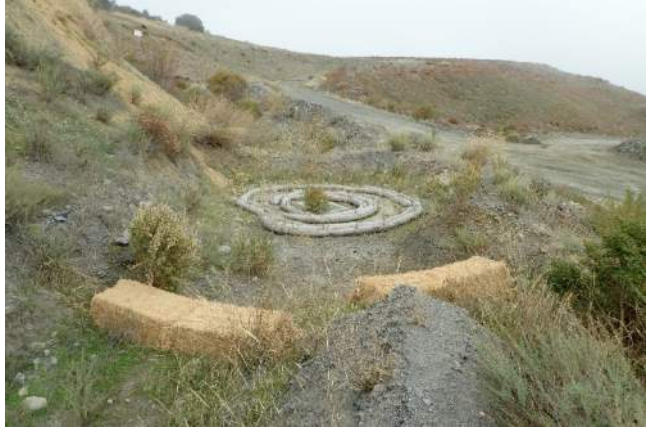
1116_06	<p>Status: GOOD</p> <p>Location: EMSA – Access Road, Inlet</p> <p>Observations: Hay bales were replaced at the roadside drop inlet ahead of rain events this rain season. Straw wattles remain in place and in good condition ahead of the rain season.</p> <p>Recommendations: Routine monitoring of the sedimentation, and deterioration of the hay bales along throughout the rain season.</p>

1. Hay bales were replaced at the roadside drop inlet of the EMSA access road ahead of rain events this rain season. See photos 1116_06 in the appended DFR.

1. Hay bales were replaced at the roadside drop inlet of the EMSA access road ahead of rain events this rain season.

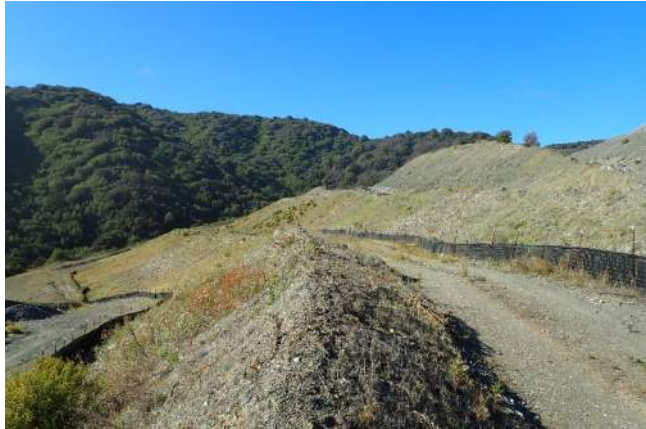
PHOTO ID	DESCRIPTION	PHOTO
1116_07	<p>Status: MONITOR FOR CHANGES</p> <p>Location: Yeager Yard – Upper Slopes PCRA: 2 and 3</p> <p>Observations: Silt fences are in good condition and remain functional. Vegetative cover has established over the upper slopes of the Yeager Yard.</p> <p>Recommendations: Routine monitoring of the vegetative cover on the slopes. Monitor the sediment accumulation on vegetated benches and silt fence condition routinely.</p>

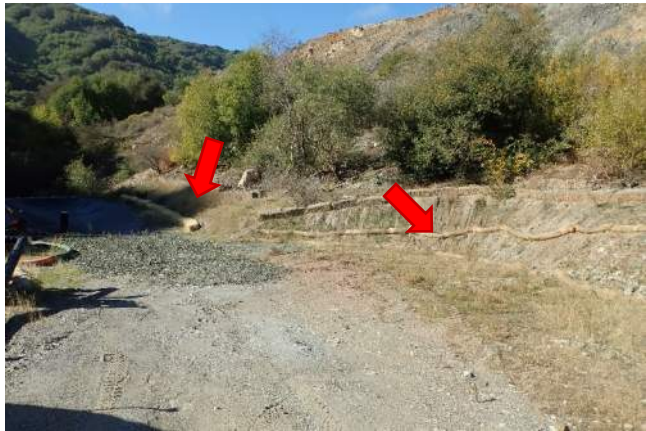
1116_08	<p>Status: MONITOR FOR CHANGES</p> <p>Location: Yeager Yard – Sediment Basin PCRA: 2 and 3</p> <p>Observations: New hay bales were installed upslope of the sediment capture basin. Jute matting and straw wattles remain in alignment and continuous on the hydroseeded slope</p> <p>Recommendations: Routine monitoring of the vegetative cover and BMPs conditions through establishment of hydroseed vegetation.</p>

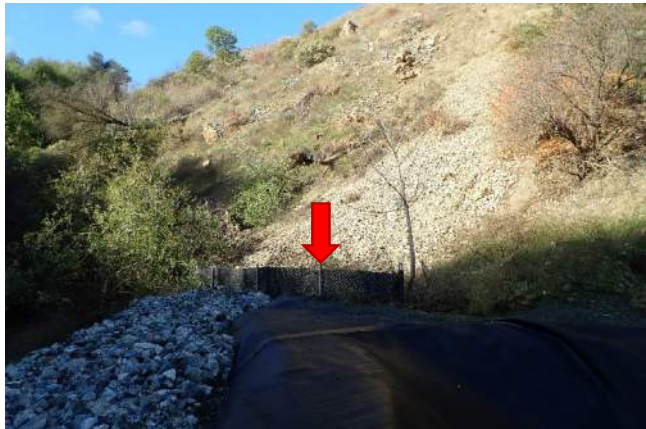
1116_09	<p>Status: GOOD</p> <p>Location: Yeager Yard – Sediment Basin PCRA: 2 and 3</p> <p>Observations: Super silt fence remains in place and in good condition with low levels of sedimentation and debris accumulation.</p> <p>Recommendations: Frequent monitoring of the sedimentation in the sediment capture basin and above the super silt fence; clear debris regularly.</p>

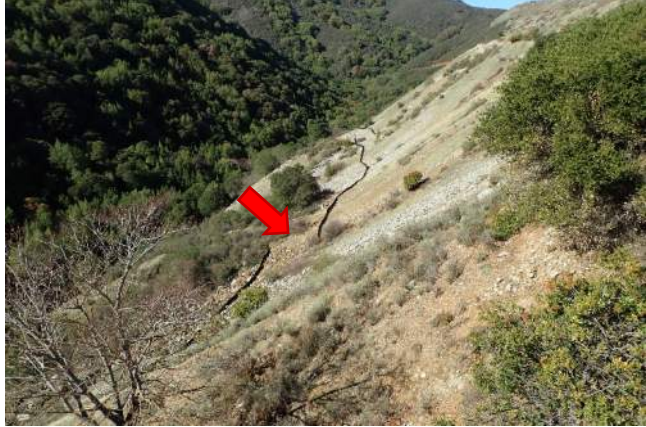
PHOTO ID	DESCRIPTION	PHOTO
1116_10	<p>Status: GOOD</p> <p>Location: PCRA 1 PCRA: 1</p> <p>Observations: Slope below road remains vegetated. Silt fencing continues in good condition.</p> <p>Recommendations: Routine monitoring of the silt fence condition and sedimentation behind lower line of silt fences.</p>

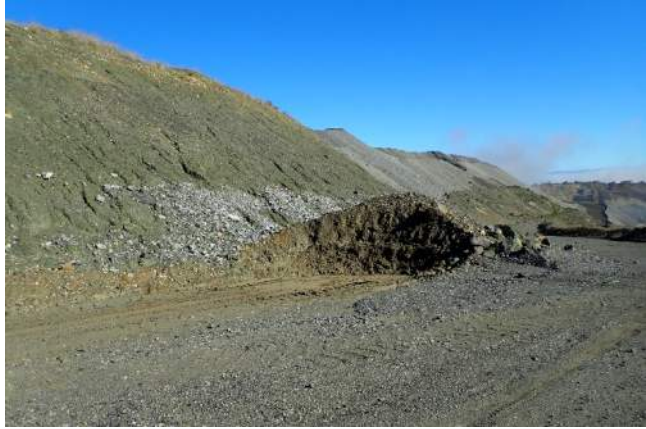
1116_11	<p>Status: GOOD</p> <p>Location: WMSA – West Haul Road</p> <p>Observations: Roadside check dams were cleared of sediment ahead of the rain season.</p> <p>Recommendations: Routine monitoring of roadside check dams for sediment accumulation, condition, and adequacy throughout the rain season that began in October.</p>

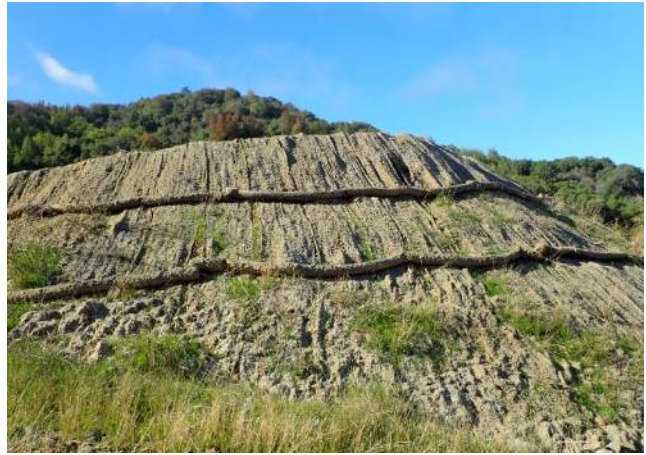
1116_12	<p>Status: GOOD</p> <p>Location: Rock Plant – Roadside Slope</p> <p>Observations: Jute matting and straw wattles remain in alignment and continuous around the hydroseeded slope at the Rock Plant.</p> <p>Recommendations: Routine monitoring of the sedimentation of the rock-lined features and the condition of the jute matting and straw wattles. Adjust wattles as needed to achieve intended alignment and continuity.</p>

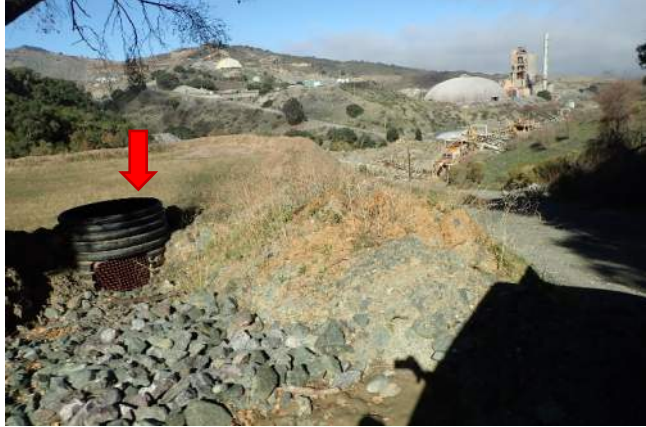
PHOTO ID	DESCRIPTION	PHOTO
1116_13	<p>Status: MONITOR FOR CHANGES</p> <p>Location: Rock Plant – Improved Existing Access Road</p> <p>Observations: Drop inlet and rock-lined apron are clear of significant debris and remain functional. The drop inlet pipe is clear of sediment at the end of the dry season.</p> <p>Recommendations: Routine monitoring of the sedimentation and debris accumulation inside the drop inlet pipe and stilling basin.</p>

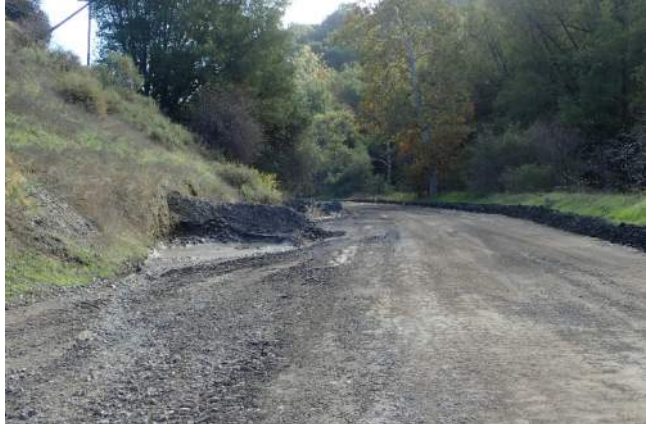
1116_14	<p>Status: MONITOR FOR CHANGES</p> <p>Location: Rock Plant – Improved Existing Access Road</p> <p>Observations: Check dams were re-established along the access road by the Rock Plant.</p> <p>Recommendations: Routine monitoring of the condition of the check dams and vegetative cover throughout the rain season.</p>

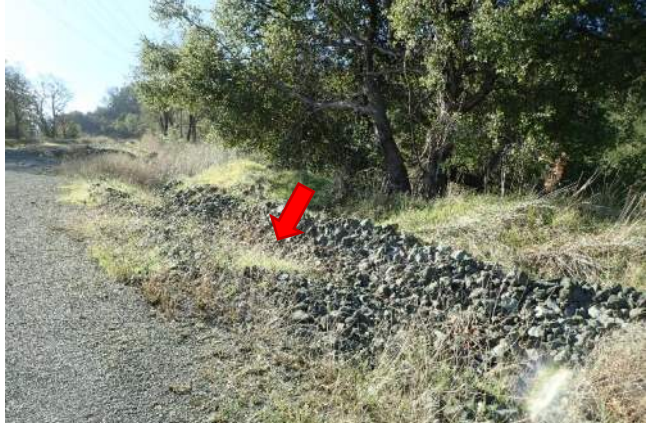
1116_15	<p>Status: GOOD</p> <p>Location: Rock Plant – Roadside ditch and Slope</p> <p>Observations: Roadside rock-lined ditches remain in place and maintain positive drainage. Vegetation has established in the adjacent slopes.</p> <p>Recommendations: Routine monitoring of vegetative cover and roadside sediment accumulation.</p>

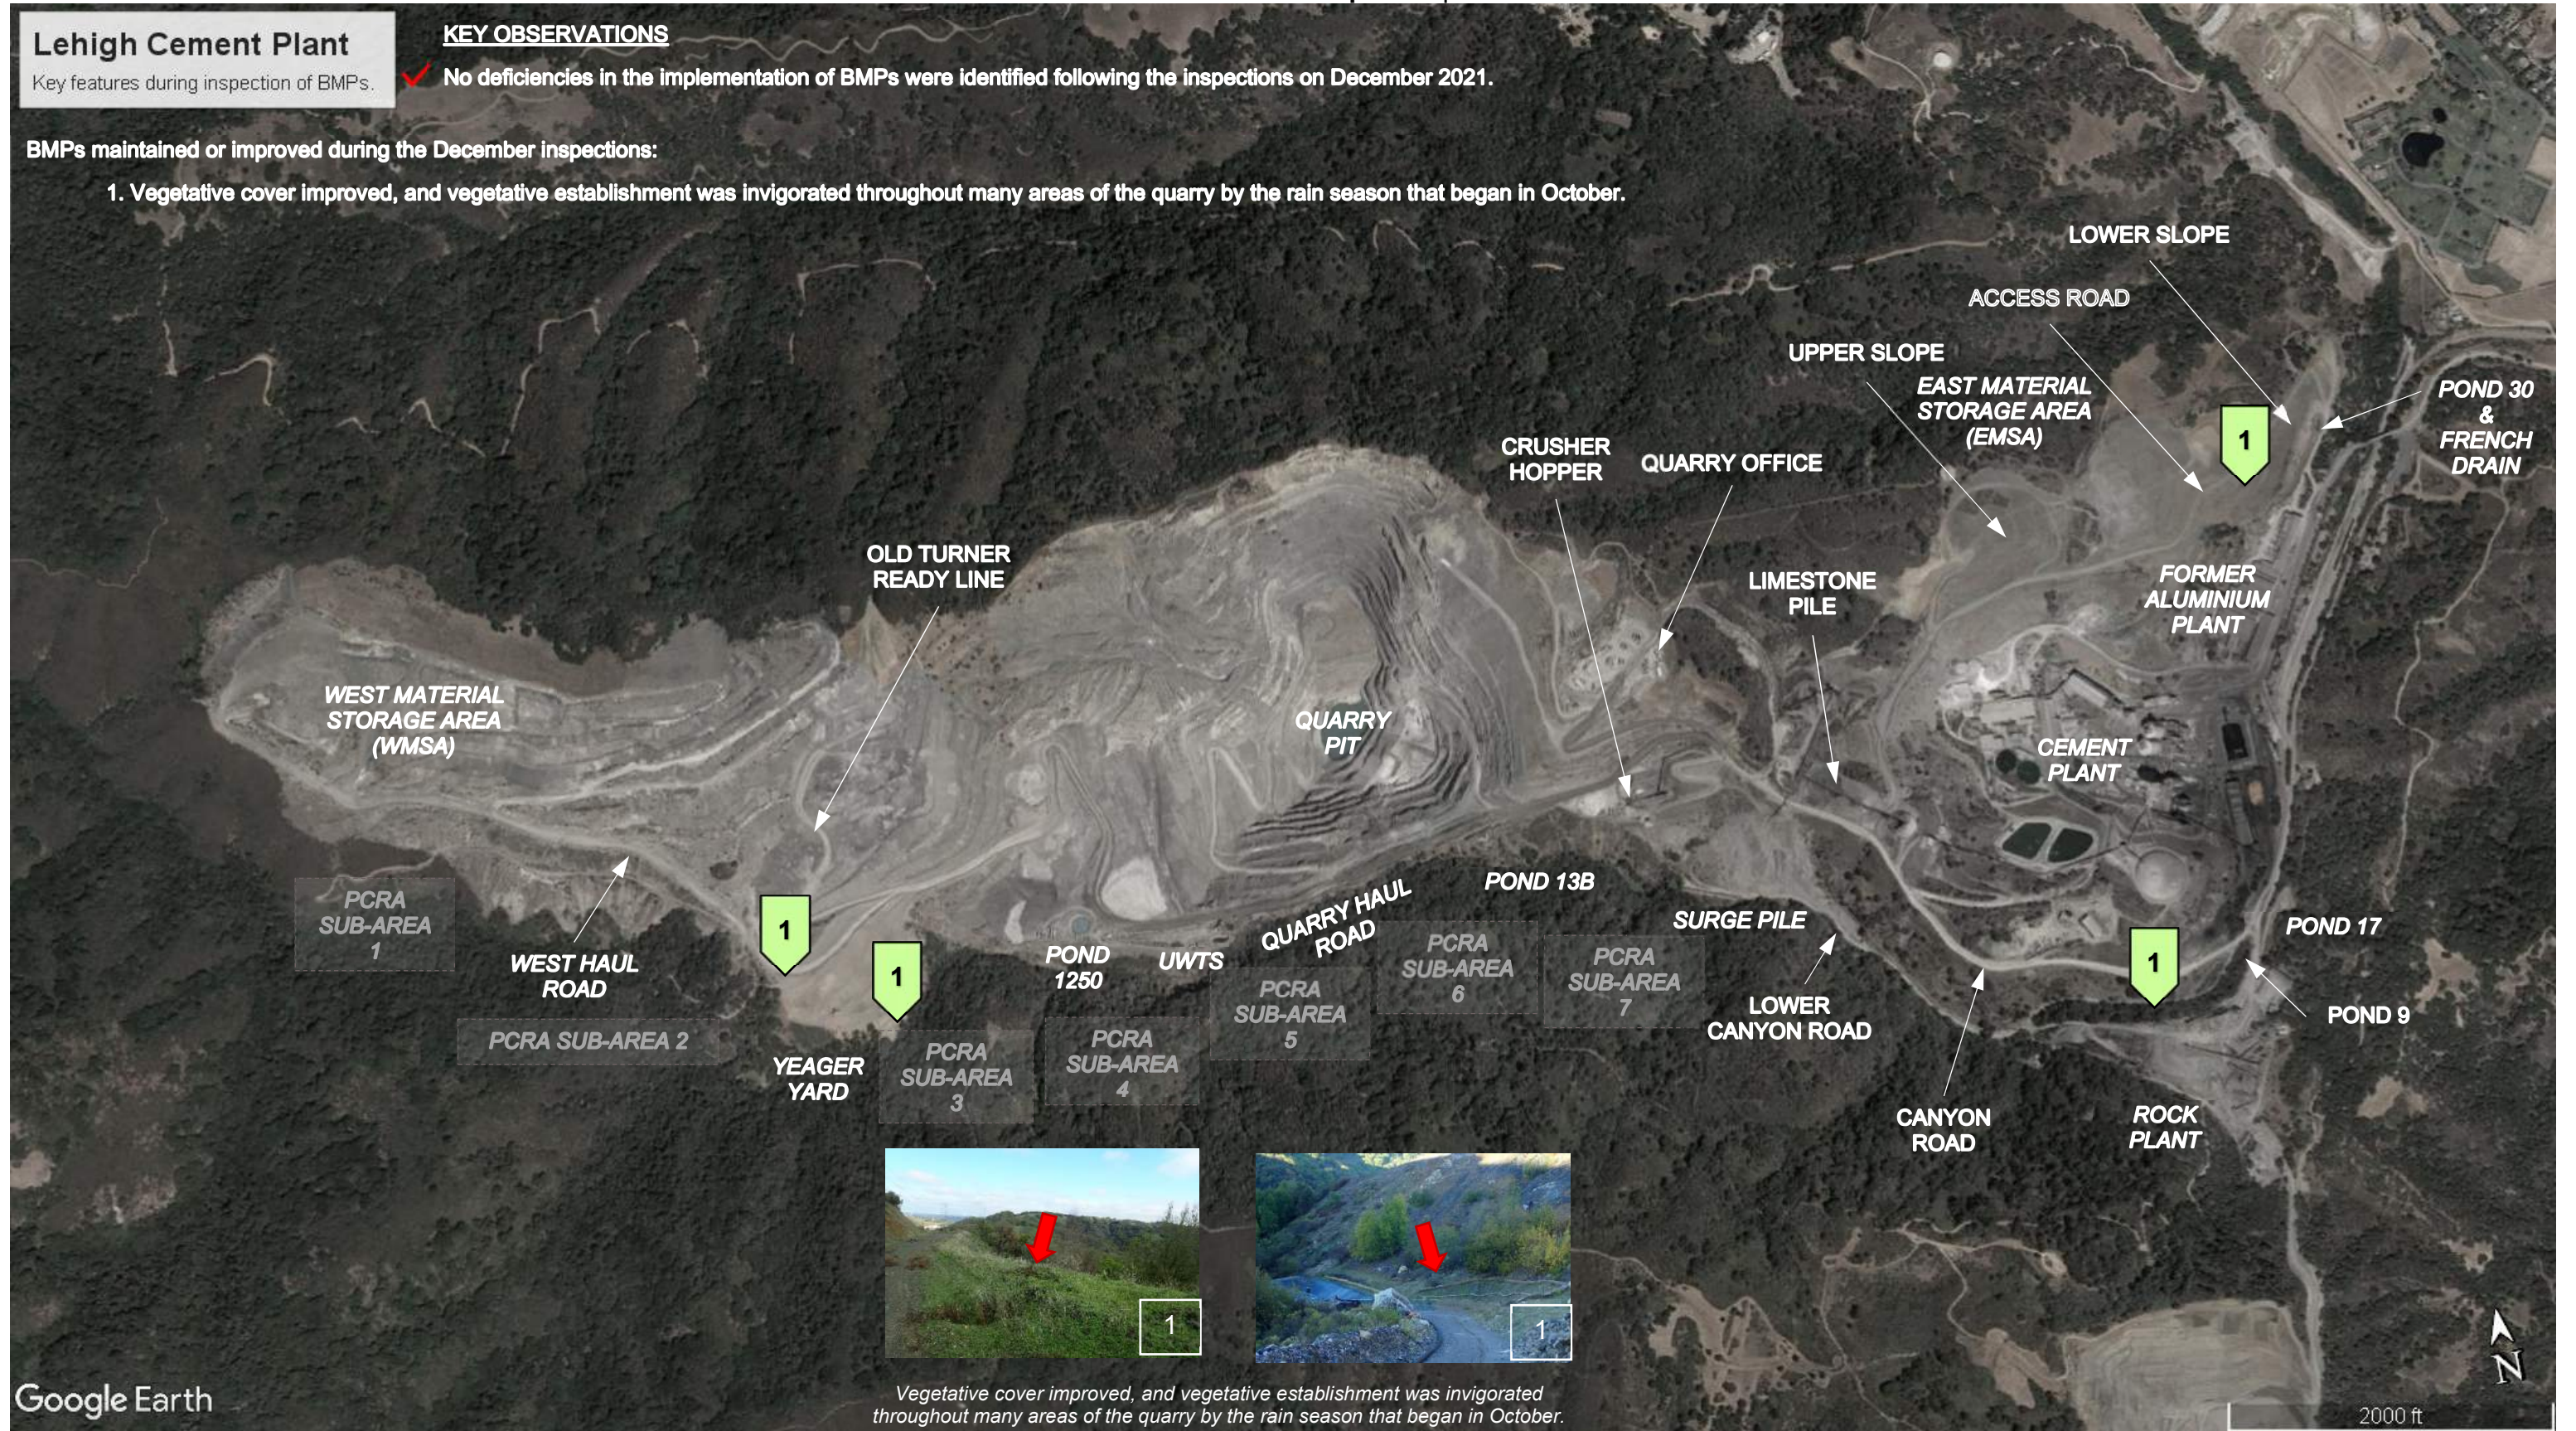
Vegetative cover improved, and vegetative establishment was invigorated throughout many areas of the quarry by the rain season that began in October.

1. Vegetative cover improved, and vegetative establishment was invigorated throughout many areas of the quarry by the rain season that began in October. See Photos 1217_04, 1217_09, 1217_15, 1230_01, 1230_04, 1230_07, 1230_08, 1230_14, and 1230_15 in the appended DFR.

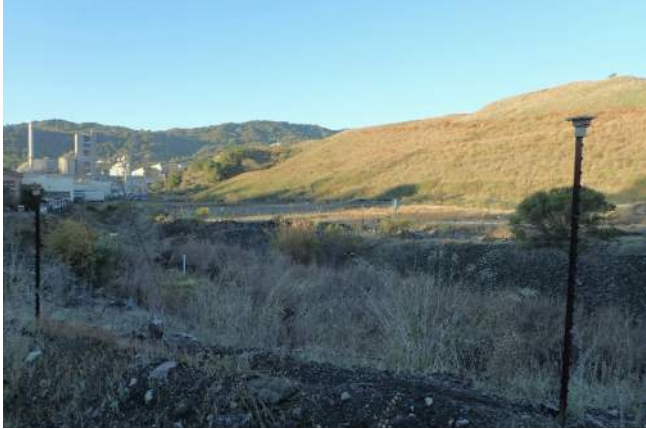
PHOTO ID	DESCRIPTION	PHOTO
1217_01	<p>Status: GOOD</p> <p>Location: EMSA – Pond 30 and French Drain</p> <p>Observations: Vegetation has established throughout the EMSA above the silt fences at Pond 30. Silt fences remain in good condition.</p> <p>Recommendations: Routine monitoring of the condition of the straw wattles, silt fences, and vegetative cover in this area.</p>

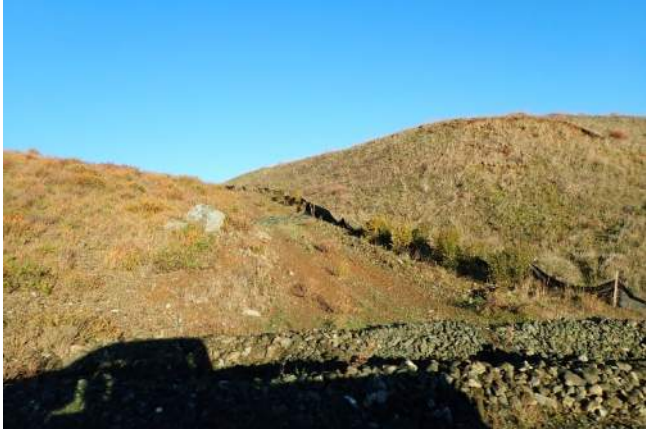
1217_02	<p>Status: GOOD</p> <p>Location: Lower EMSA by Access Road Non-limestone interim cover material storage area</p> <p>Observations: Roadside rock check-structures are re-established along and upslope from the EMSA access road.</p> <p>Recommendations: Routine monitoring of roadside check structures, sedimentation before and after rain events.</p>

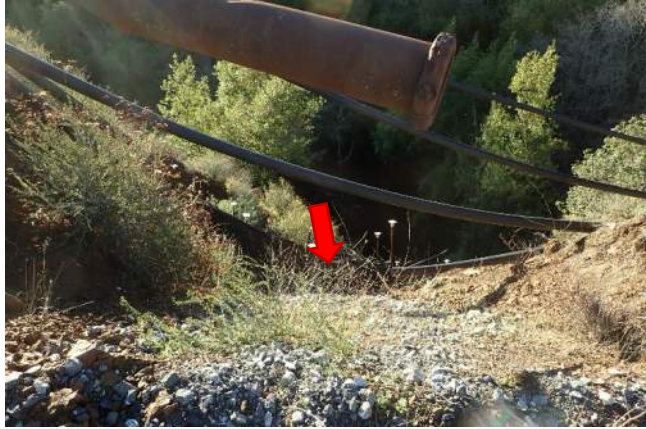
1217_03	<p>Status: MONITOR FOR CHANGES</p> <p>Location: Quarry Haul Road PCRA: 5 and 6</p> <p>Observations: Multiple lines of silt fencing remain in place and in good, functional condition. Debris is being retained behind fencing.</p> <p>Recommendations: Routine monitoring of sedimentation and debris accumulation behind silt fences.</p>

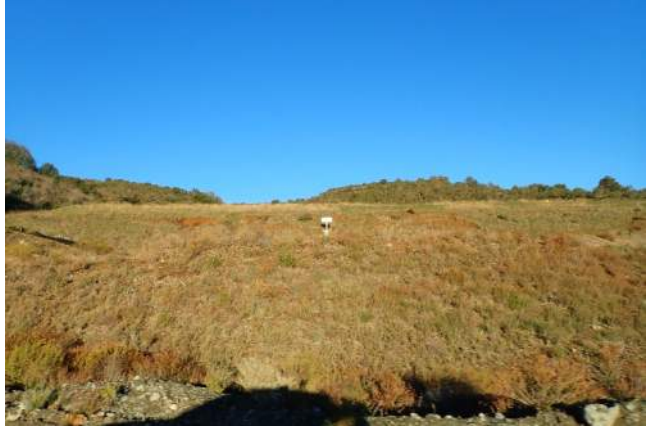
PHOTO ID	DESCRIPTION	PHOTO
1217_04	<p>Status: MONITOR FOR CHANGES Location: EMSA Upper Slopes Observations: Upper slopes of the East Material Storage Area (EMSA) remain vegetated. Hydroseeded vegetation has established over the interim cover material stockpile. Recommendations: Routine monitoring of vegetative cover throughout the rain season.</p>

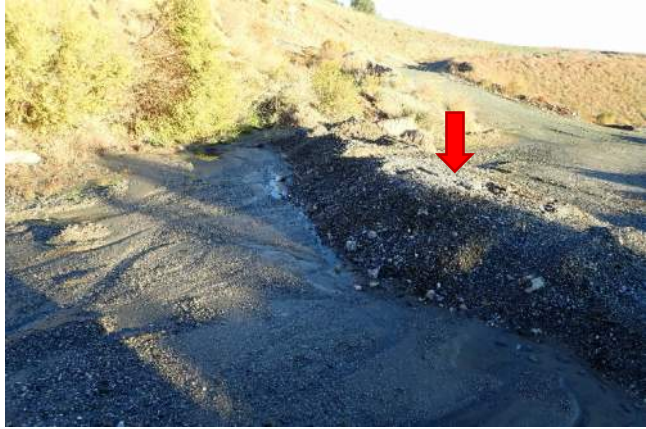
1217_05	<p>Status: MONITOR FOR CHANGES Location: EMSA – Access Road Observations: Water bars are established and draining to the drop inlet. Recommendations: Routine monitoring of the condition of water bars and sediment controls: hay bales, wattles.</p>

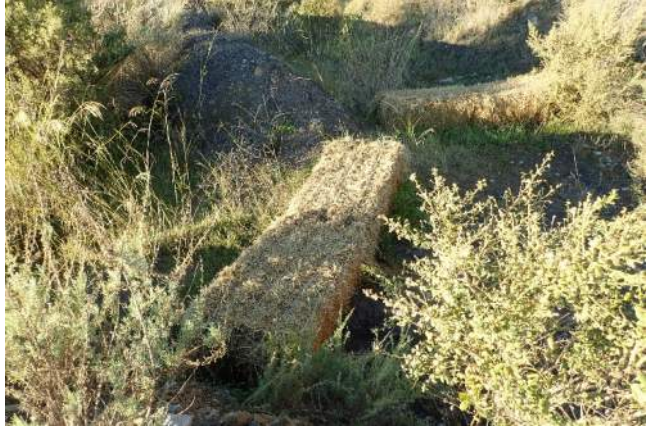
1217_06	<p>Status: MONITOR FOR CHANGES Location: EMSA – Access Road Observations: Straw wattles and hay bales remain in place around the drop inlet next to the EMSA access road. Recommendations: Routine monitoring of the condition of water bars and sediment controls: hay bales, wattles.</p>

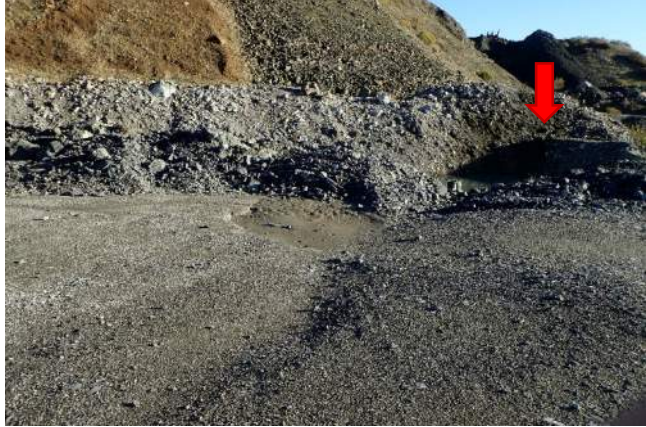
PHOTO ID	DESCRIPTION	PHOTO
1217_07	<p>Status: MONITOR FOR CHANGES</p> <p>Location: WMSA – Haul Road</p> <p>Observations: Check dams remain in functional condition. Water bars, cross-slope remain in place after the end of the dry season.</p> <p>Recommendations: Routine monitoring of the sedimentation behind check dams along the Quarry Haul Road to WMSA and re-establish water bars as needed.</p>

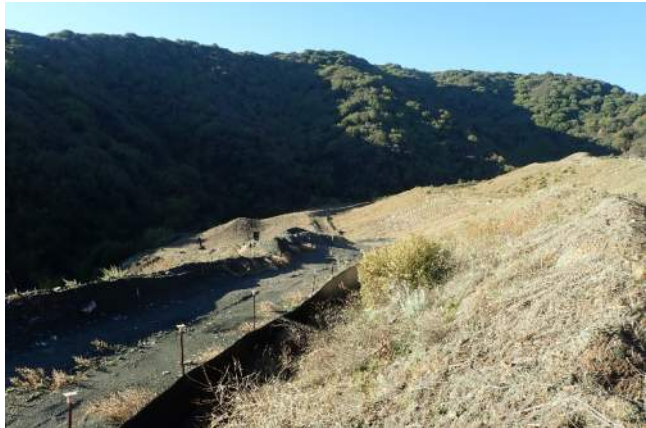
1217_08	<p>Status: MONITOR FOR CHANGES</p> <p>Location: Yeager Yard – Upper Slopes</p> <p>PCRA: 2 and 3</p> <p>Observations: Silt fences are in good condition and remain functional. Vegetative cover has established over the upper slopes of the Yeager Yard.</p> <p>Recommendations: Routine monitoring of the vegetative cover on the slopes. Monitor the sediment accumulation on vegetated benches and silt fence condition routinely.</p>

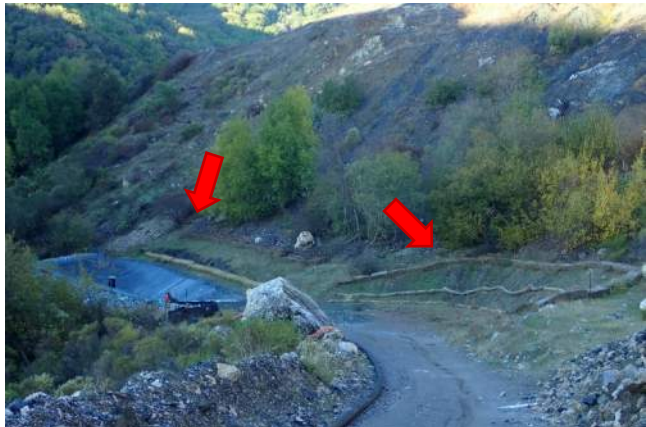
1217_09	<p>Status: MONITOR FOR CHANGES</p> <p>Location: Yeager Yard – Sediment Basin</p> <p>PCRA: 2 and 3</p> <p>Observations: Vegetation has established on the hydroseeded slope. Hay bales and straw wattles remain in place.</p> <p>Recommendations: Routine monitoring of the vegetative cover and BMPs conditions through establishment of hydroseed vegetation.</p>

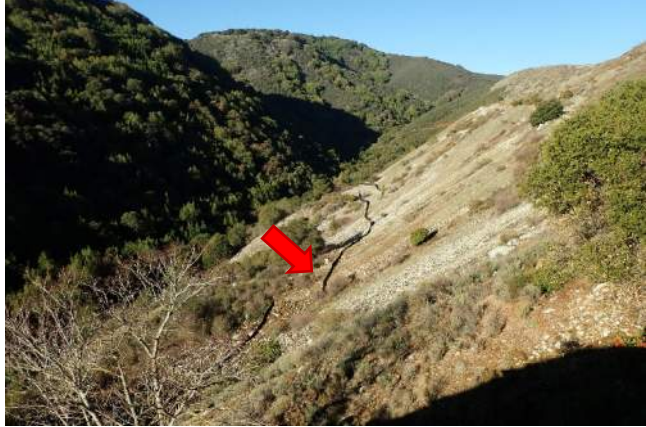
PHOTO ID	DESCRIPTION	PHOTO
1217_6	<p>Status: GOOD</p> <p>Location: PCRA 1 PCRA: 1</p> <p>Observations: Slope below road remains vegetated. Silt fencing continues in good condition.</p> <p>Recommendations: Routine monitoring of the silt fence condition and sedimentation behind lower line of silt fences.</p>

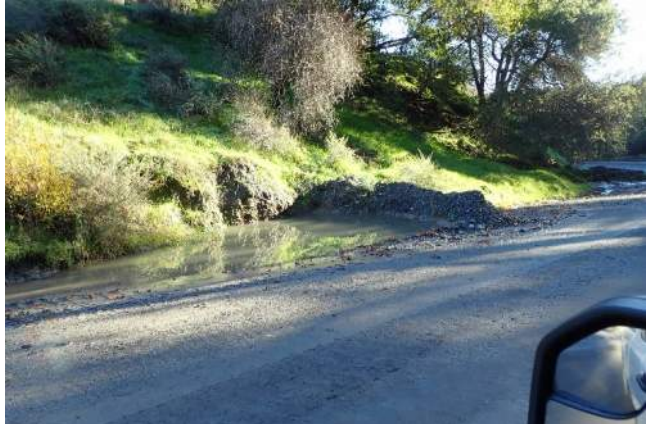
1217_7	<p>Status: MONITOR FOR CHANGES</p> <p>Location: Rock Plant – Lower Canyon Road</p> <p>Observations: Roadside check dams were re-established and remain functional along the Lower Canyon Road to the Rock Plant.</p> <p>Recommendations: Routine monitoring of the condition of the water bars and check dams and vegetative cover throughout the rain season.</p>

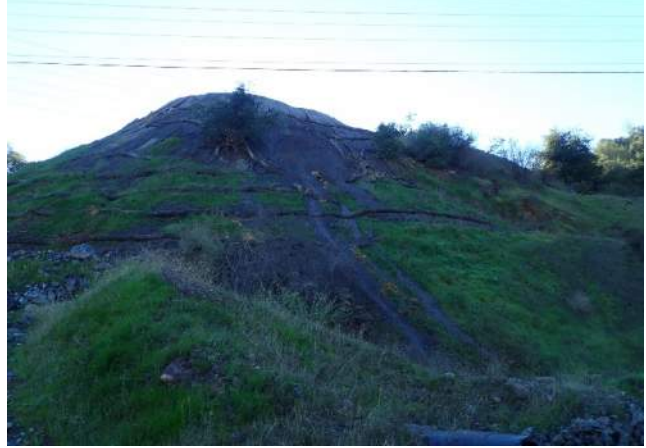
1217_8	<p>Status: MONITOR FOR CHANGES</p> <p>Location: Rock Plant – Roadside Slope</p> <p>Observations: Jute matting and straw wattles remain in alignment and continuous around the hydroseeded slope at the Rock Plant.</p> <p>Recommendations: Routine monitoring of the sedimentation of the rock-lined features and the condition of the jute matting and straw wattles. Adjust wattles as needed to achieve intended alignment and continuity.</p>

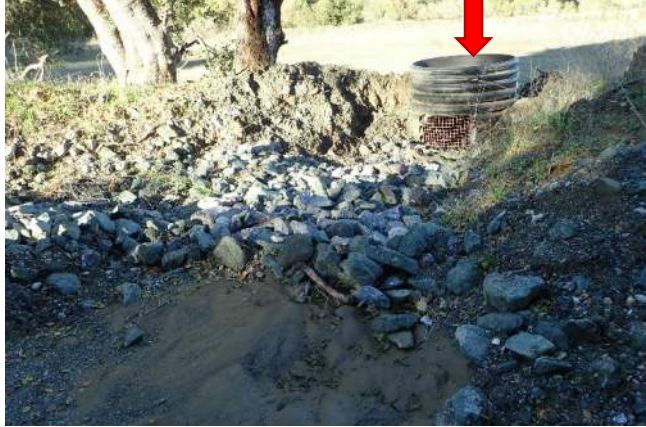
PHOTO ID	DESCRIPTION	PHOTO
1217_9	<p>Status: MONITOR FOR CHANGES</p> <p>Location: Rock Plant – Improved Existing Access Road</p> <p>Observations: Drop inlet and rock-lined apron are clear of significant debris and remain functional. The drop inlet pipe is clear of sediment at the beginning of wet season.</p> <p>Recommendations: Routine monitoring of the sedimentation and debris accumulation inside the drop inlet pipe and stilling basin.</p>

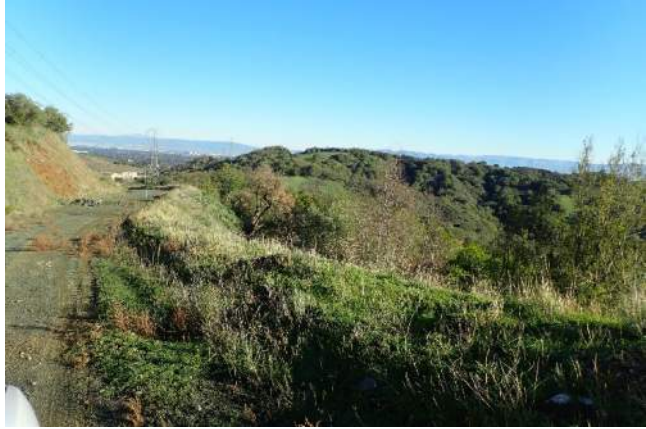
1217_10	<p>Status: MONITOR FOR CHANGES</p> <p>Location: Rock Plant – Improved Existing Access Road</p> <p>Observations: Roadside rock berm remains in place and vegetated. Vegetative cover is established over the slopes below the road and berm.</p> <p>Recommendations: Routine monitoring of rock-lined features, cross-slope in the rain season that began in October.</p>

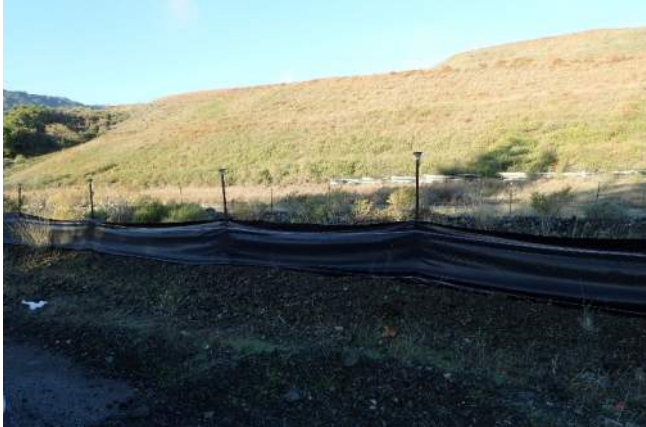
PHOTO ID	DESCRIPTION	PHOTO
1230_01	<p>Status: GOOD</p> <p>Location: EMSA – Pond 30 and French Drain</p> <p>Observations: Vegetation has established throughout the EMSA above the silt fences at Pond 30. Silt fences remain in good condition.</p> <p>Recommendations: Routine monitoring of the condition of the straw wattles, silt fences, and vegetative cover in this area.</p>

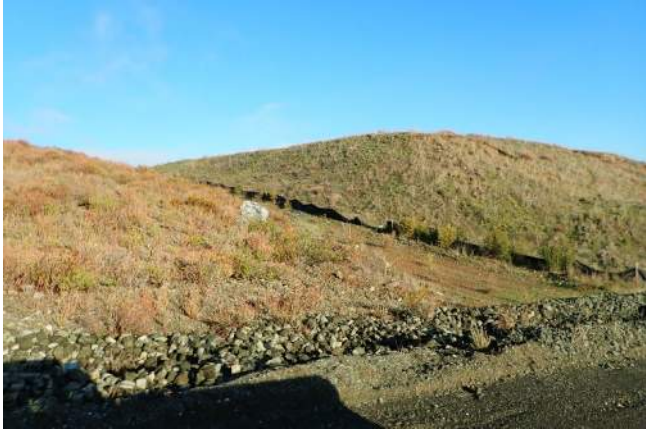
1230_02	<p>Status: GOOD</p> <p>Location: Lower EMSA by Access Road Non-limestone interim cover material storage area</p> <p>Observations: Roadside water bars and rock check-structures are re-established along and upslope from the EMSA access road.</p> <p>Recommendations: Routine monitoring of roadside check structures, sedimentation before and after rain events.</p>

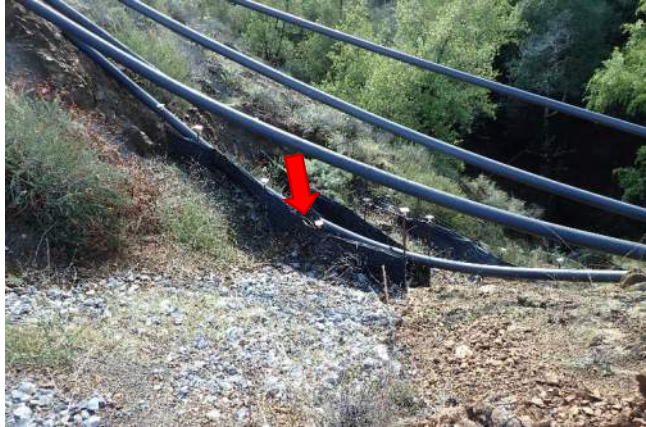
1230_03	<p>Status: MONITOR FOR CHANGES</p> <p>Location: Quarry Haul Road PCRA: 5 and 6</p> <p>Observations: Multiple lines of silt fencing remain in place and in good, functional condition. Debris is being retained behind fencing.</p> <p>Recommendations: Routine monitoring of sedimentation and debris accumulation behind silt fences.</p>

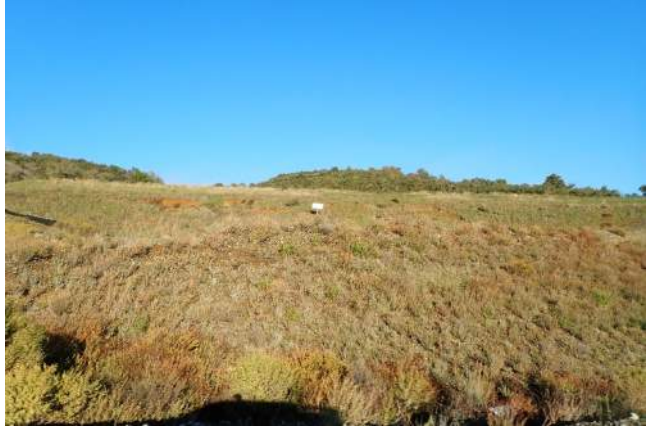
PHOTO ID	DESCRIPTION	PHOTO
1230_04	<p>Status: MONITOR FOR CHANGES Location: EMSA Upper Slopes Observations: Upper slopes of the East Material Storage Area (EMSA) remain vegetated. Hydroseeded vegetation has established over the interim cover material stockpile. Recommendations: Routine monitoring of vegetative cover throughout the rain season.</p>

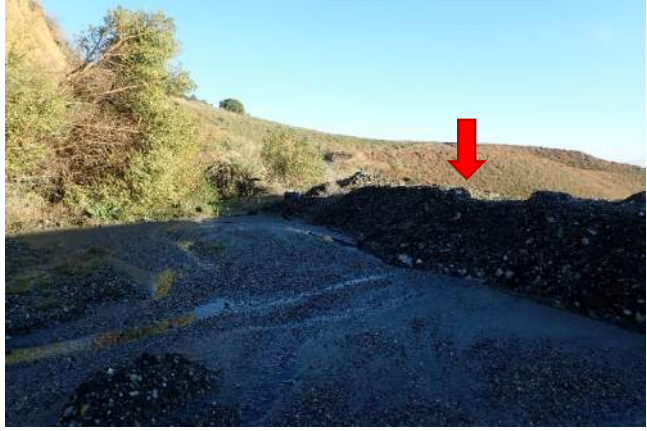
1230_05	<p>Status: MONITOR FOR CHANGES Location: EMSA – Access Road Observations: Water bars are established and draining to the drop inlet. Straw wattles and hay bales remain in place around the drop inlet next to the EMSA access road. Recommendations: Routine monitoring of the condition of water bars and sediment controls: hay bales, wattles.</p>

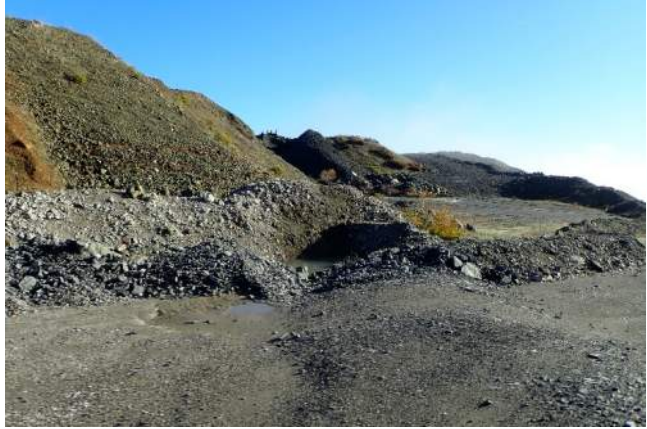
1230_06	<p>Status: MONITOR FOR CHANGES Location: WMSA – Haul Road Observations: Check dams remain in functional condition. Water bars, cross-slope remain in place. Recommendations: Routine monitoring of the sedimentation behind check dams along the Quarry Haul Road to WMSA and re-establish water bars as needed.</p>

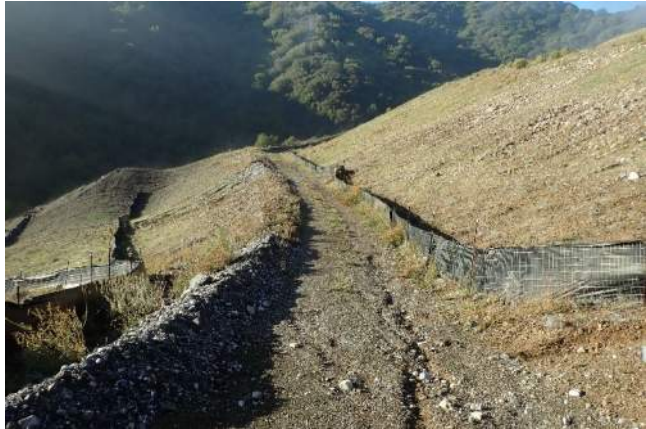
PHOTO ID	DESCRIPTION	PHOTO
1230_07	<p>Status: MONITOR FOR CHANGES</p> <p>Location: Yeager Yard – Upper Slopes PCRA: 2 and 3</p> <p>Observations: Silt fences are in good condition and remain functional. Vegetative cover has established over the upper slopes of the Yeager Yard.</p> <p>Recommendations: Routine monitoring of the vegetative cover on the slopes. Monitor the sediment accumulation on vegetated benches and silt fence condition routinely.</p>

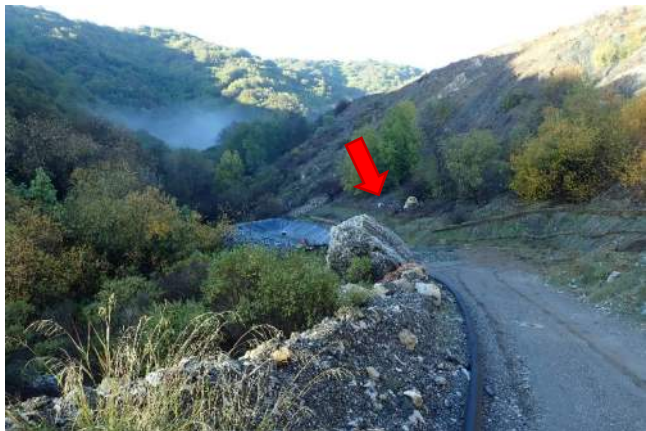
1230_08	<p>Status: MONITOR FOR CHANGES</p> <p>Location: Yeager Yard – Sediment Basin PCRA: 2 and 3</p> <p>Observations: Vegetation has established on the hydroseeded slope. Hay bales and straw wattles remain in place.</p> <p>Recommendations: Routine monitoring of the vegetative cover and BMPs conditions through establishment of hydroseed vegetation.</p>

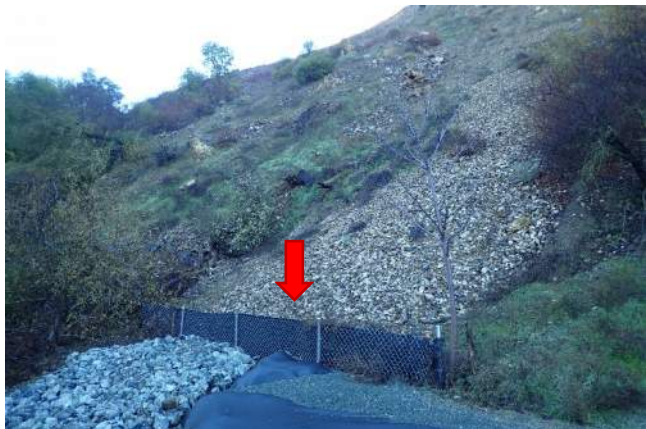
1230_09	<p>Status: GOOD</p> <p>Location: Yeager Yard – Sediment Basin PCRA: 2 and 3</p> <p>Observations: Super silt fence remains in place and in good condition with low levels of sedimentation and debris accumulation.</p> <p>Recommendations: Frequent monitoring of the sedimentation in the sediment capture basin and above the super silt fence; clear debris regularly.</p>

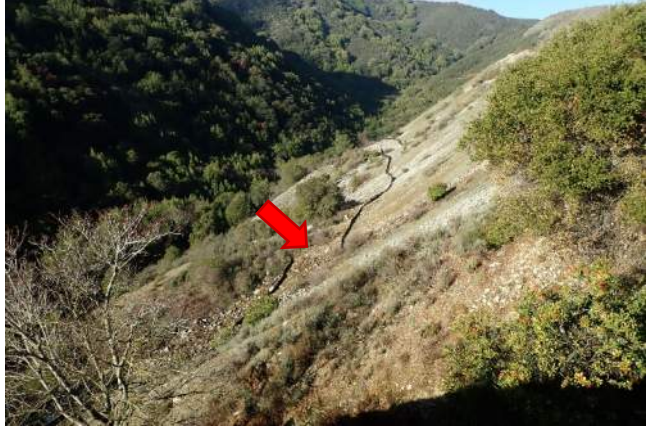
PHOTO ID	DESCRIPTION	PHOTO
1230_10	<p>Status: GOOD</p> <p>Location: PCRA 1 PCRA: 1</p> <p>Observations: Slope below road remains vegetated. Silt fencing continues in good condition.</p> <p>Recommendations: Routine monitoring of the silt fence condition and sedimentation behind lower line of silt fences.</p>

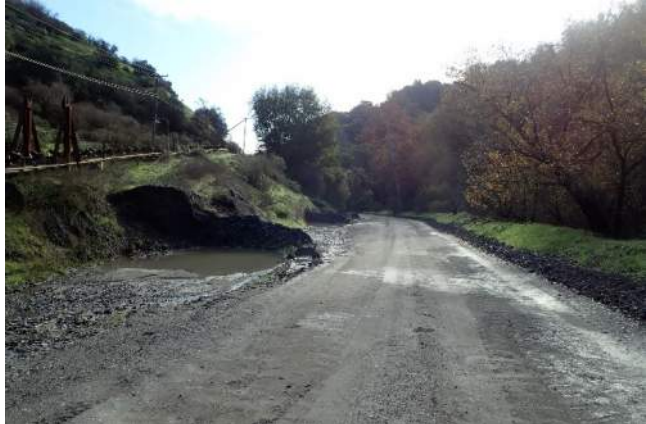
1230_11	<p>Status: MONITOR FOR CHANGES</p> <p>Location: Rock Plant – Lower Canyon Road</p> <p>Observations: Roadside check dams remain functional along the Lower Canyon Road to the Rock Plant.</p> <p>Recommendations: Routine monitoring of the condition and sedimentation of the check dams and nearby vegetative cover throughout the rain season.</p>
