Lehigh Permanente Quarry Reclamation Plan Amendment Conditions of Approval Compliance

2021-2022 Annual Report Information Package

SANTA CLARA COUNTY, CALIFORNIA

APPENDIX B - 2021-2022 EROSION CONTROL INSPECTION REPORTS

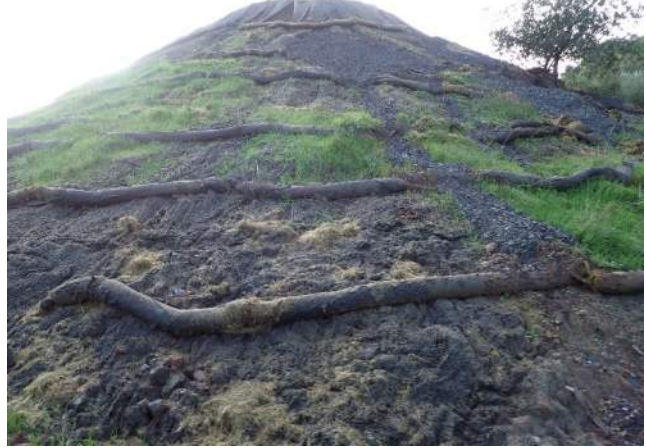
1230_12	<p>Status: MONITOR FOR CHANGES</p> <p>Location: Rock Plant – Roadside Slope</p> <p>Observations: Jute matting and straw wattles remain in alignment and continuous around the hydroseeded slope at the Rock Plant.</p> <p>Recommendations: Routine monitoring of the sedimentation of the rock-lined features and the condition of the jute matting and straw wattles. Adjust wattles as needed to achieve intended alignment and continuity.</p>

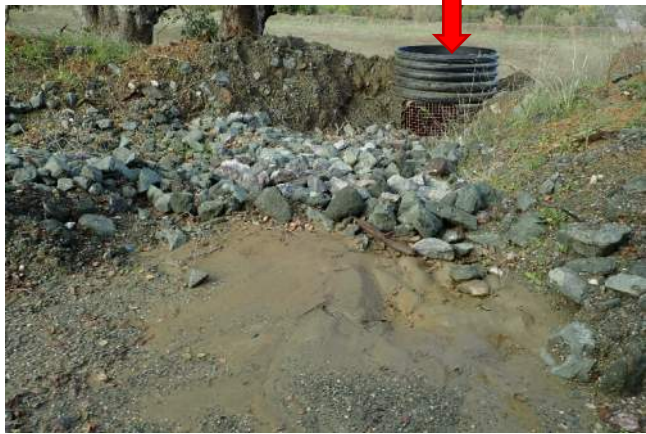
PHOTO ID	DESCRIPTION	PHOTO
1230_13	<p>Status: MONITOR FOR CHANGES</p> <p>Location: Rock Plant – Improved Existing Access Road</p> <p>Observations: Drop inlet and rock-lined apron are clear of significant debris and remain functional. The drop inlet pipe is clear of sediment..</p> <p>Recommendations: Routine monitoring of the sedimentation and debris accumulation inside the drop inlet pipe and stilling basin.</p>

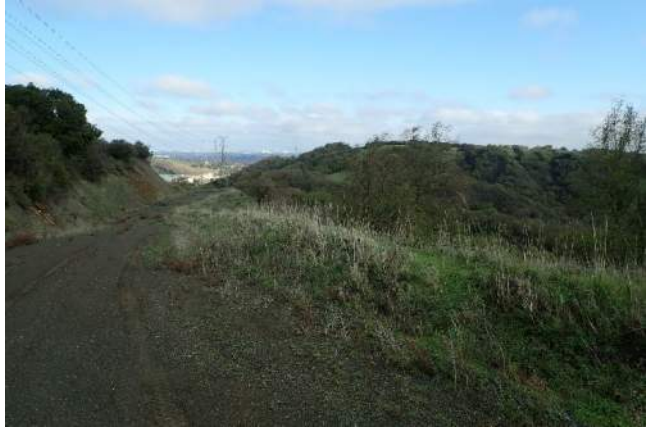
1230_14	<p>Status: MONITOR FOR CHANGES</p> <p>Location: Rock Plant – Improved Existing Access Road</p> <p>Observations: Roadside rock berm remains in place and vegetated. Vegetative cover is established over the slopes below the road and berm.</p> <p>Recommendations: Routine monitoring of rock-lined features, cross-slope in the rain season that began in October.</p>

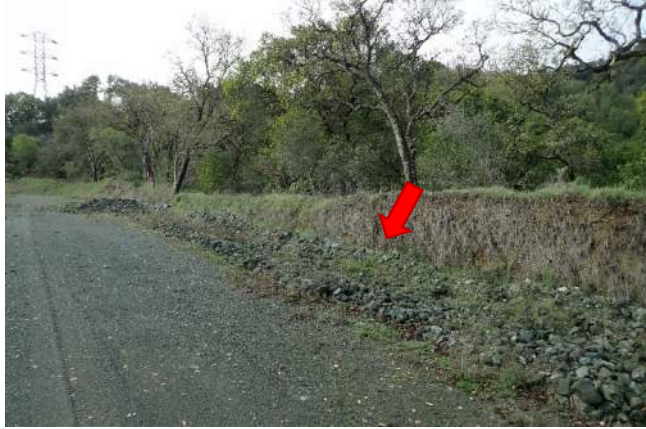
1230_15	<p>Status: GOOD</p> <p>Location: Rock Plant – Roadside ditch and Slope</p> <p>Observations: Roadside rock-lined ditches remain in place and maintain positive drainage. Vegetation has established in the adjacent slopes.</p> <p>Recommendations: Routine monitoring of vegetative cover and roadside sediment accumulation.</p>

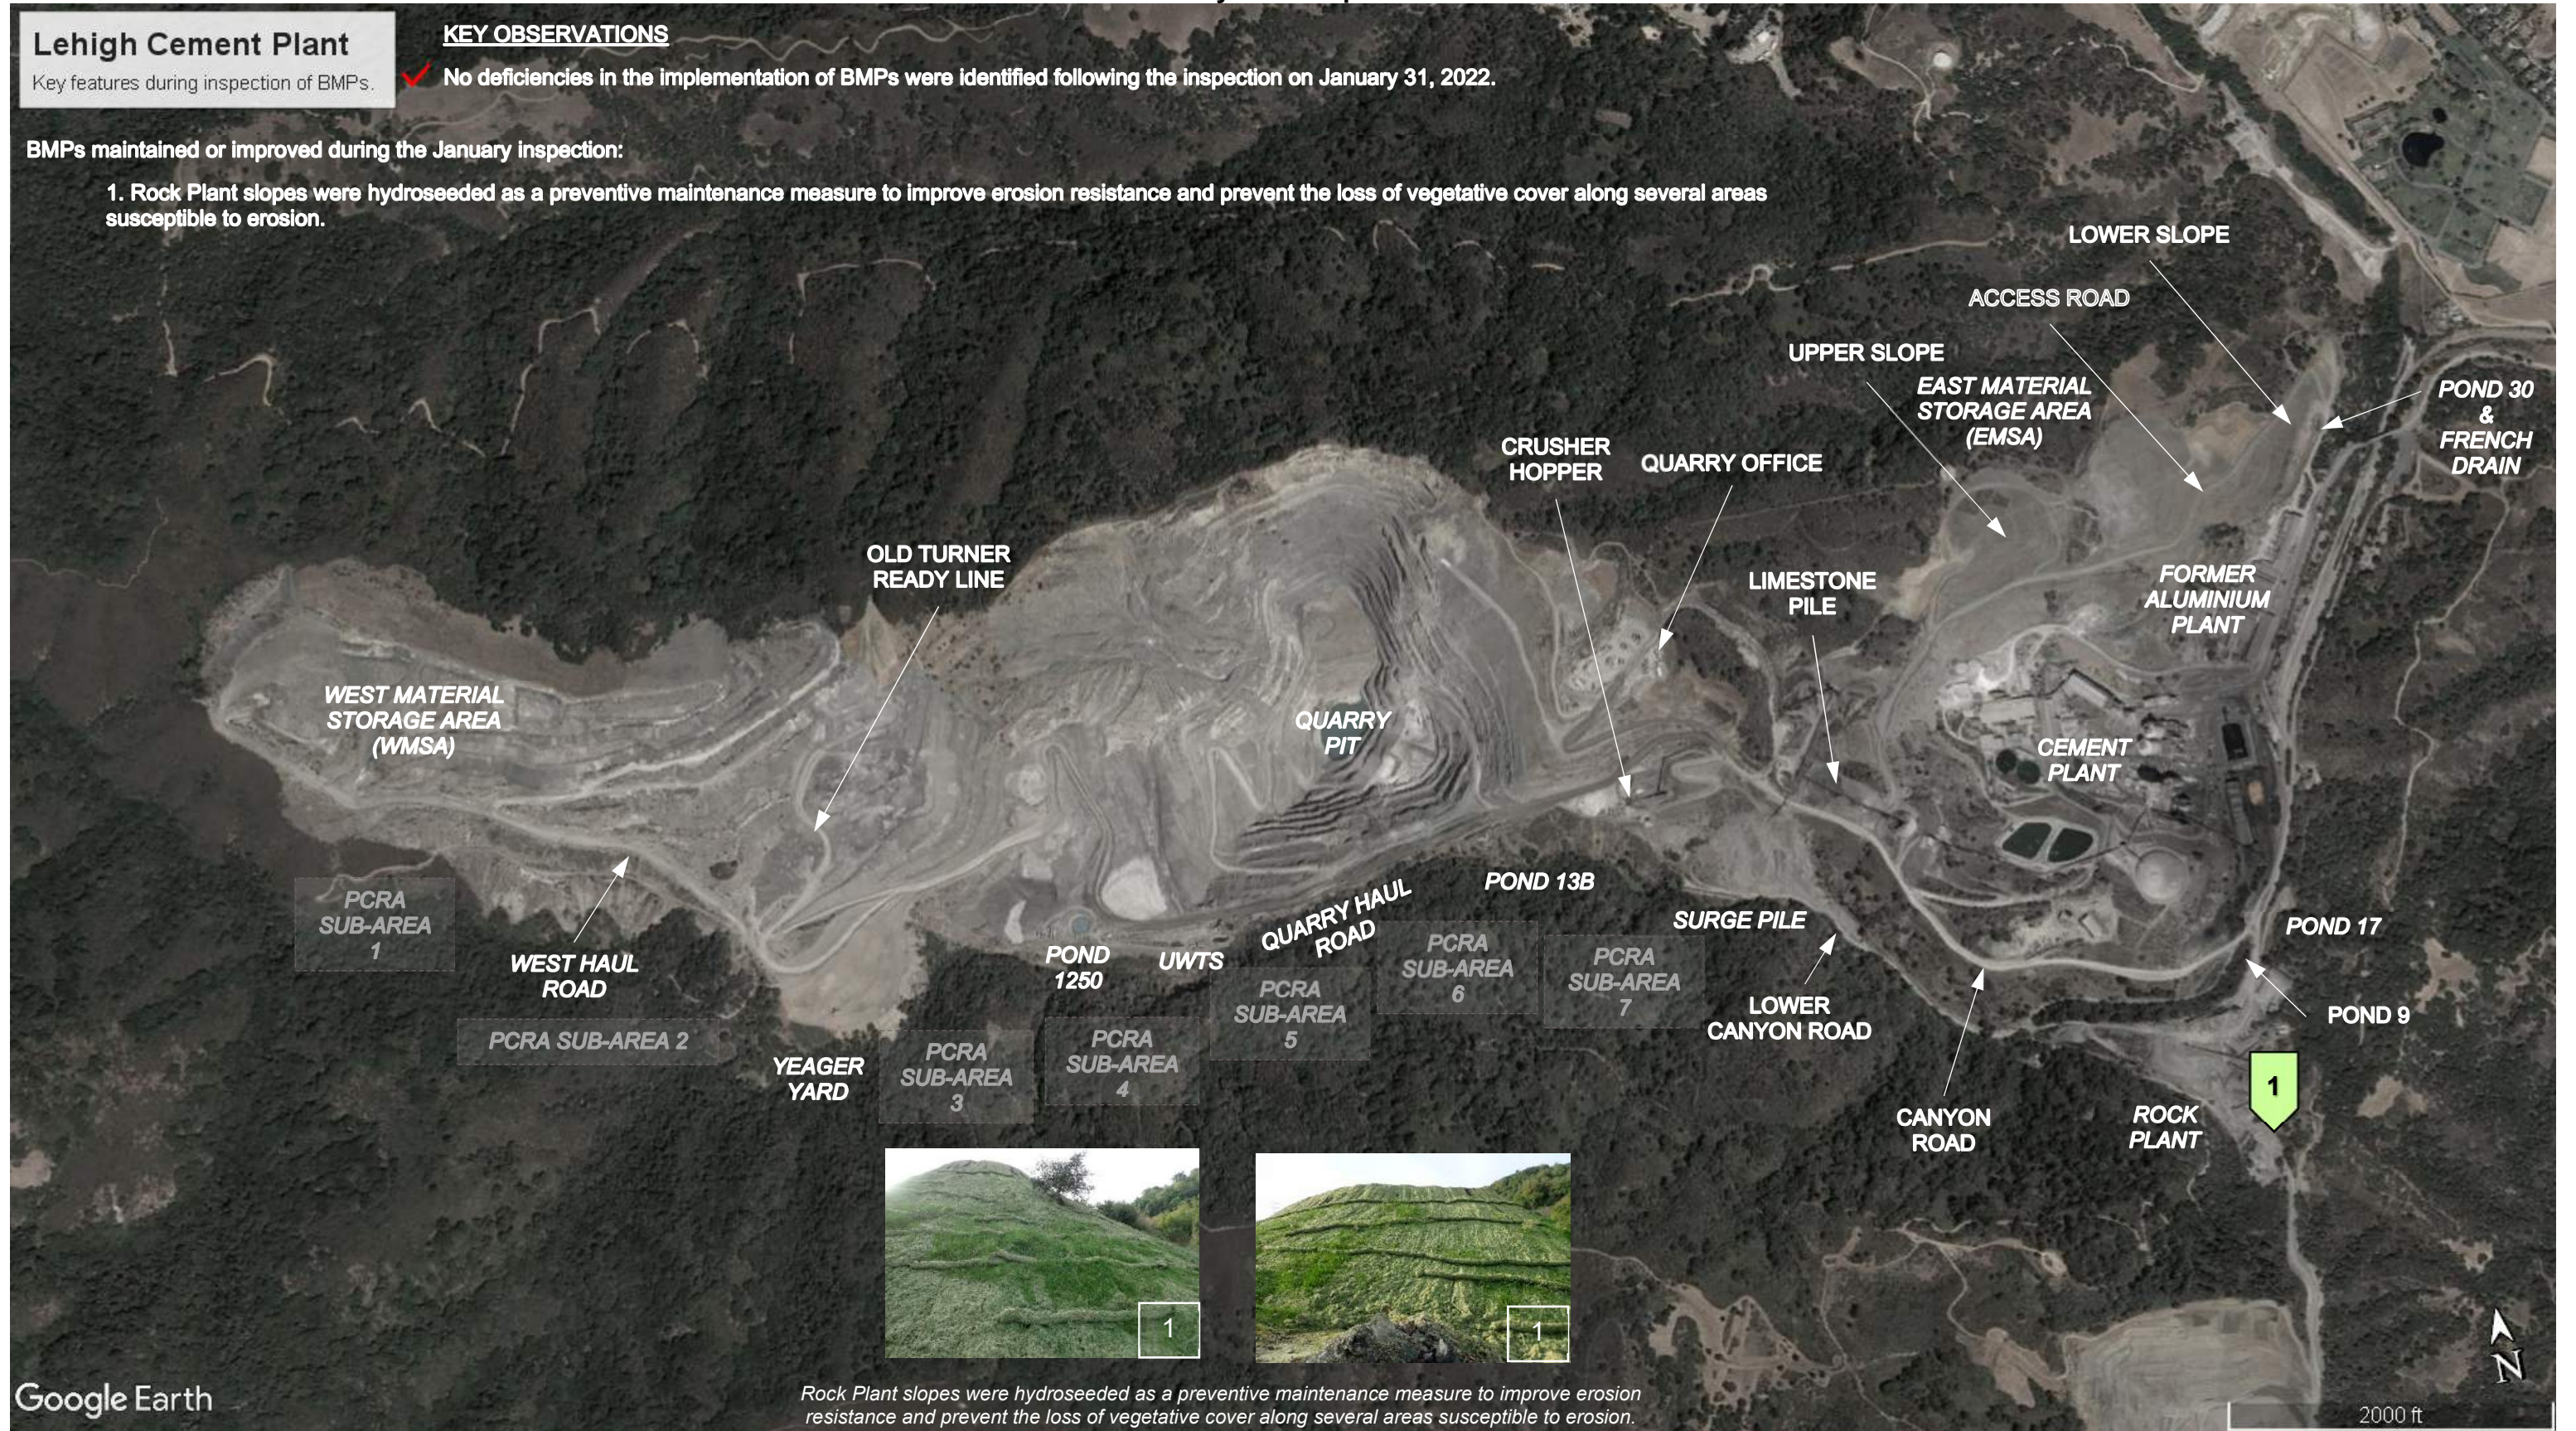
Rock Plant slopes were hydroseeded as a preventive maintenance measure to improve erosion resistance and prevent the loss of vegetative cover along several areas susceptible to erosion.

1. Rock Plant slopes were hydroseeded as a preventive maintenance measure to improve erosion resistance and prevent the loss of vegetative cover along several areas susceptible to erosion. See photo 0131_12 in the attached DFR.

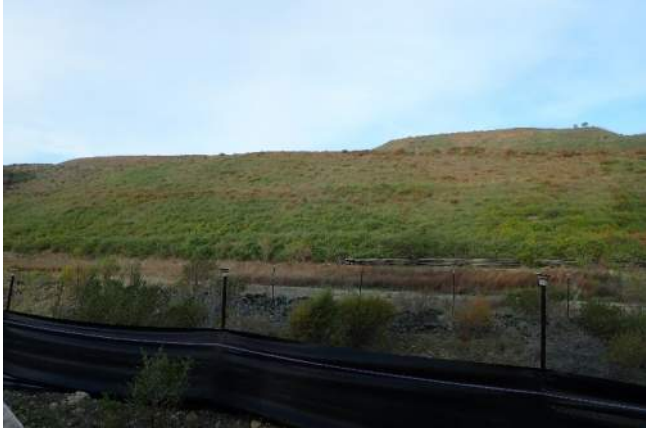
PHOTO ID	DESCRIPTION	PHOTO
0131_01	<p>Status: GOOD</p> <p>Location: EMSA – Pond 30 and French Drain</p> <p>Observations: Vegetation has established throughout the EMSA above the silt fences at Pond 30. Silt fences remain in good condition.</p> <p>Recommendations: Routine monitoring of the condition of the straw wattles, silt fences, and vegetative cover in this area.</p>

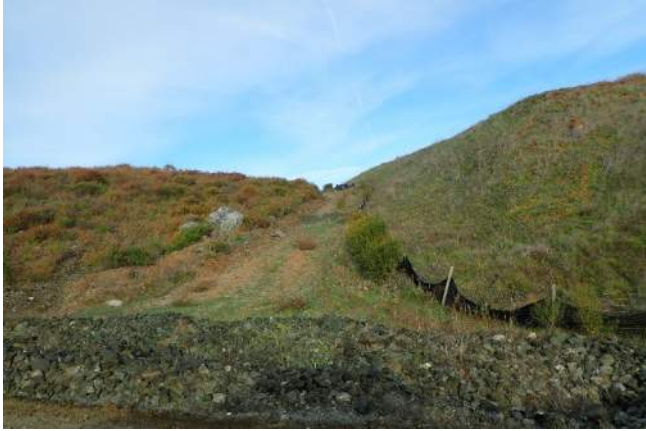
0131_02	<p>Status: GOOD</p> <p>Location: Lower EMSA by Access Road Non-limestone interim cover material storage area</p> <p>Observations: Roadside water bars and rock check-structures are re-established along and upslope from the EMSA access road.</p> <p>Recommendations: Routine monitoring of roadside check structures, sedimentation before and after rain events.</p>

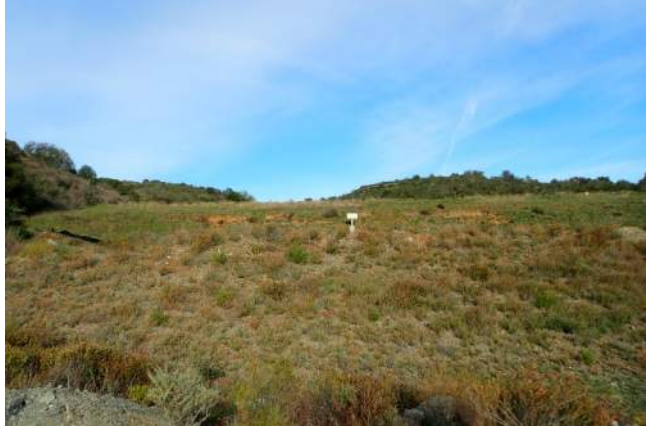
PHOTO ID	DESCRIPTION	PHOTO
0131_04	<p>Status: MONITOR FOR CHANGES Location: EMSA Upper Slopes Observations: Upper slopes of the East Material Storage Area (EMSA) remain vegetated. Hydroseeded vegetation has established over the interim cover material stockpile. Recommendations: Routine monitoring of vegetative cover throughout the rain season.</p>

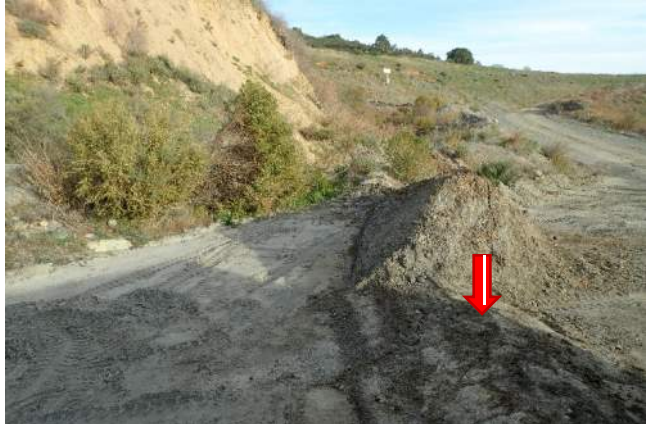
0131_05	<p>Status: MONITOR FOR CHANGES Location: EMSA – Access Road Observations: Water bars are established and draining to the drop inlet. Straw wattles and hay bales remain in place around the drop inlet next to the EMSA access road. Recommendations: Routine monitoring of the condition of water bars and sediment controls: hay bales, wattles.</p>

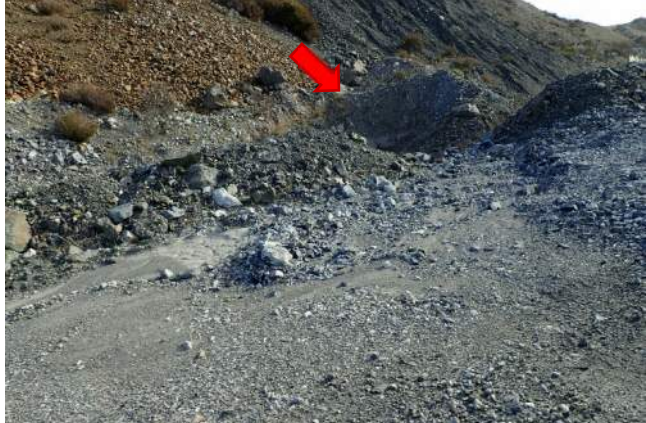
0131_06	<p>Status: MONITOR FOR CHANGES Location: WMSA – Haul Road Observations: Check dams remain in functional condition. Water bars, cross-slope remain in place. Recommendations: Routine monitoring of the sedimentation behind check dams along the Quarry Haul Road to WMSA and re-establish water bars as needed.</p>

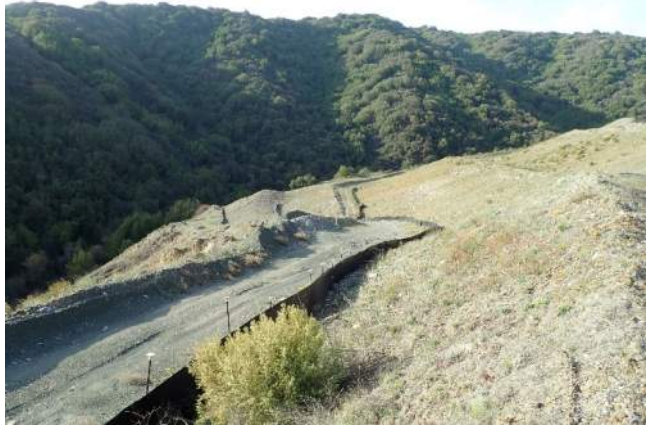
PHOTO ID	DESCRIPTION	PHOTO
0131_07	<p>Status: MONITOR FOR CHANGES</p> <p>Location: Yeager Yard – Upper Slopes PCRA: 2 and 3</p> <p>Observations: Silt fences are in good condition and remain functional. Vegetative cover has established over the upper slopes of the Yeager Yard.</p> <p>Recommendations: Routine monitoring of the vegetative cover on the slopes. Monitor the sediment accumulation on vegetated benches and silt fence condition routinely.</p>

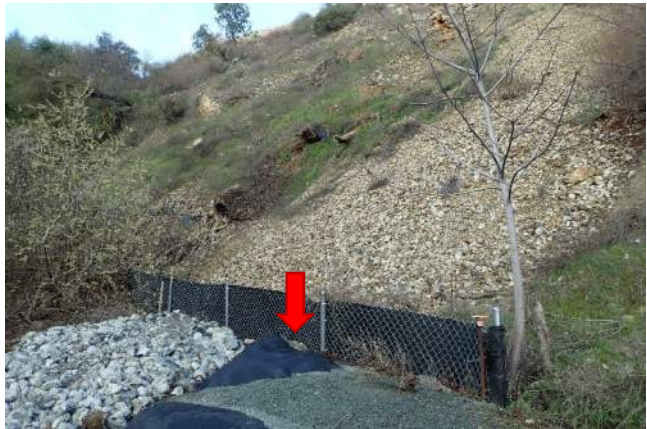
0131_09	<p>Status: GOOD</p> <p>Location: Yeager Yard – Sediment Basin PCRA: 2 and 3</p> <p>Observations: Super silt fence remains in place and in good condition with low levels of sedimentation and debris accumulation.</p> <p>Recommendations: Frequent monitoring of the sedimentation in the sediment capture basin and above the super silt fence; clear debris regularly.</p>

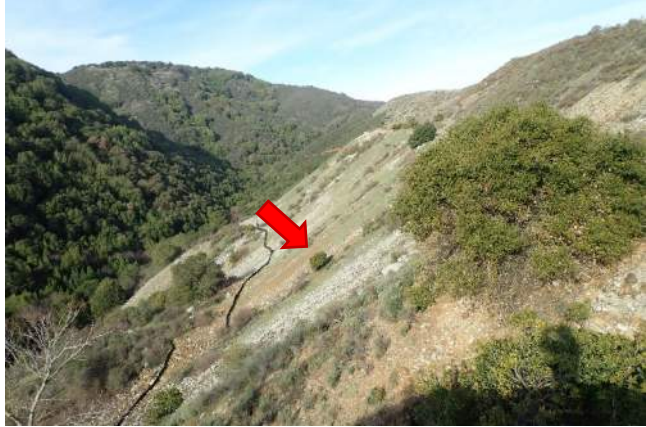
PHOTO ID	DESCRIPTION	PHOTO
0131_10	<p>Status: GOOD</p> <p>Location: PCRA 1 PCRA: 1</p> <p>Observations: Slope below road remains vegetated. Silt fencing continues in good condition.</p> <p>Recommendations: Routine monitoring of the silt fence condition and sedimentation behind lower line of silt fences.</p>

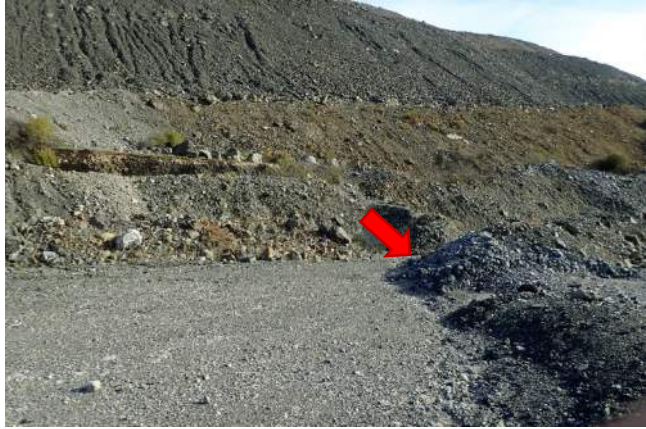
0131_11	<p>Status: MONITOR FOR CHANGES</p> <p>Location: Rock Plant – Improved Existing Access Road</p> <p>Observations: Water bars were re-established along the access road by the Rock Plant.</p> <p>Recommendations: Routine monitoring of the condition of the water bars and check dams and vegetative cover throughout the rain season.</p>

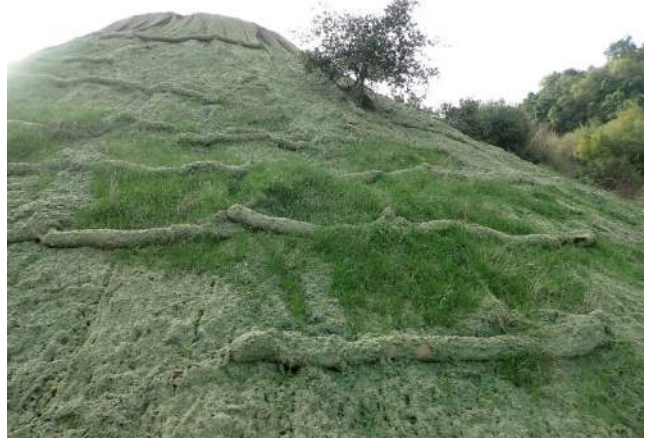
0131_12	<p>Status: GOOD</p> <p>Location: Rock Plant – Roadside Slope</p> <p>Observations: Slope was hydroseeded at the Rock Plant. Jute matting and straw wattles were realigned.</p> <p>Recommendations: Routine monitoring of the sedimentation of the rock-lined features and the condition of the jute matting and straw wattles. Adjust wattles as needed to achieve intended alignment and continuity.</p>

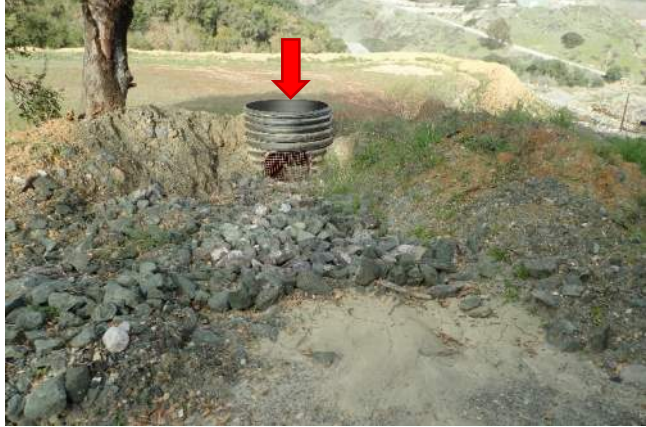
PHOTO ID	DESCRIPTION	PHOTO
0131_13	<p>Status: MONITOR FOR CHANGES</p> <p>Location: Rock Plant – Improved Existing Access Road</p> <p>Observations: Drop inlet and rock-lined apron are clear of significant debris and remain functional. The drop inlet pipe is clear of sediment..</p> <p>Recommendations: Routine monitoring of the sedimentation and debris accumulation inside the drop inlet pipe and stilling basin.</p>

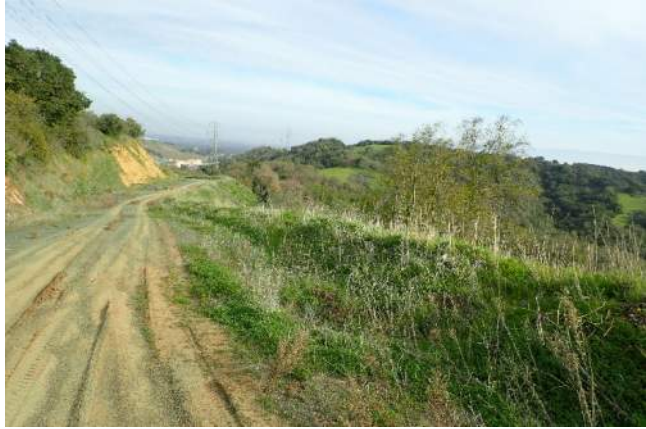
0131_14	<p>Status: MONITOR FOR CHANGES</p> <p>Location: Rock Plant – Improved Existing Access Road</p> <p>Observations: Roadside rock berm remains in place and vegetated. Vegetative cover is established over the slopes below the road and berm.</p> <p>Recommendations: Routine monitoring of rock-lined features, cross-slope in the rain season that began in October.</p>

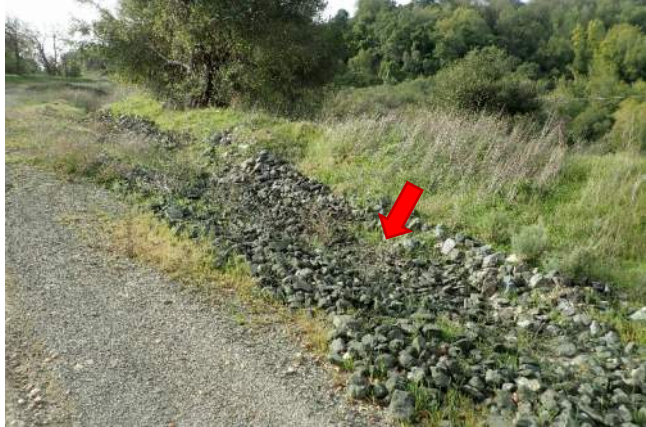
0131_15	<p>Status: GOOD</p> <p>Location: Rock Plant – Roadside ditch and Slope</p> <p>Observations: Roadside rock-lined ditches remain in place and maintain positive drainage. Vegetation has established in the adjacent slopes.</p> <p>Recommendations: Routine monitoring of vegetative cover and roadside sediment accumulation.</p>

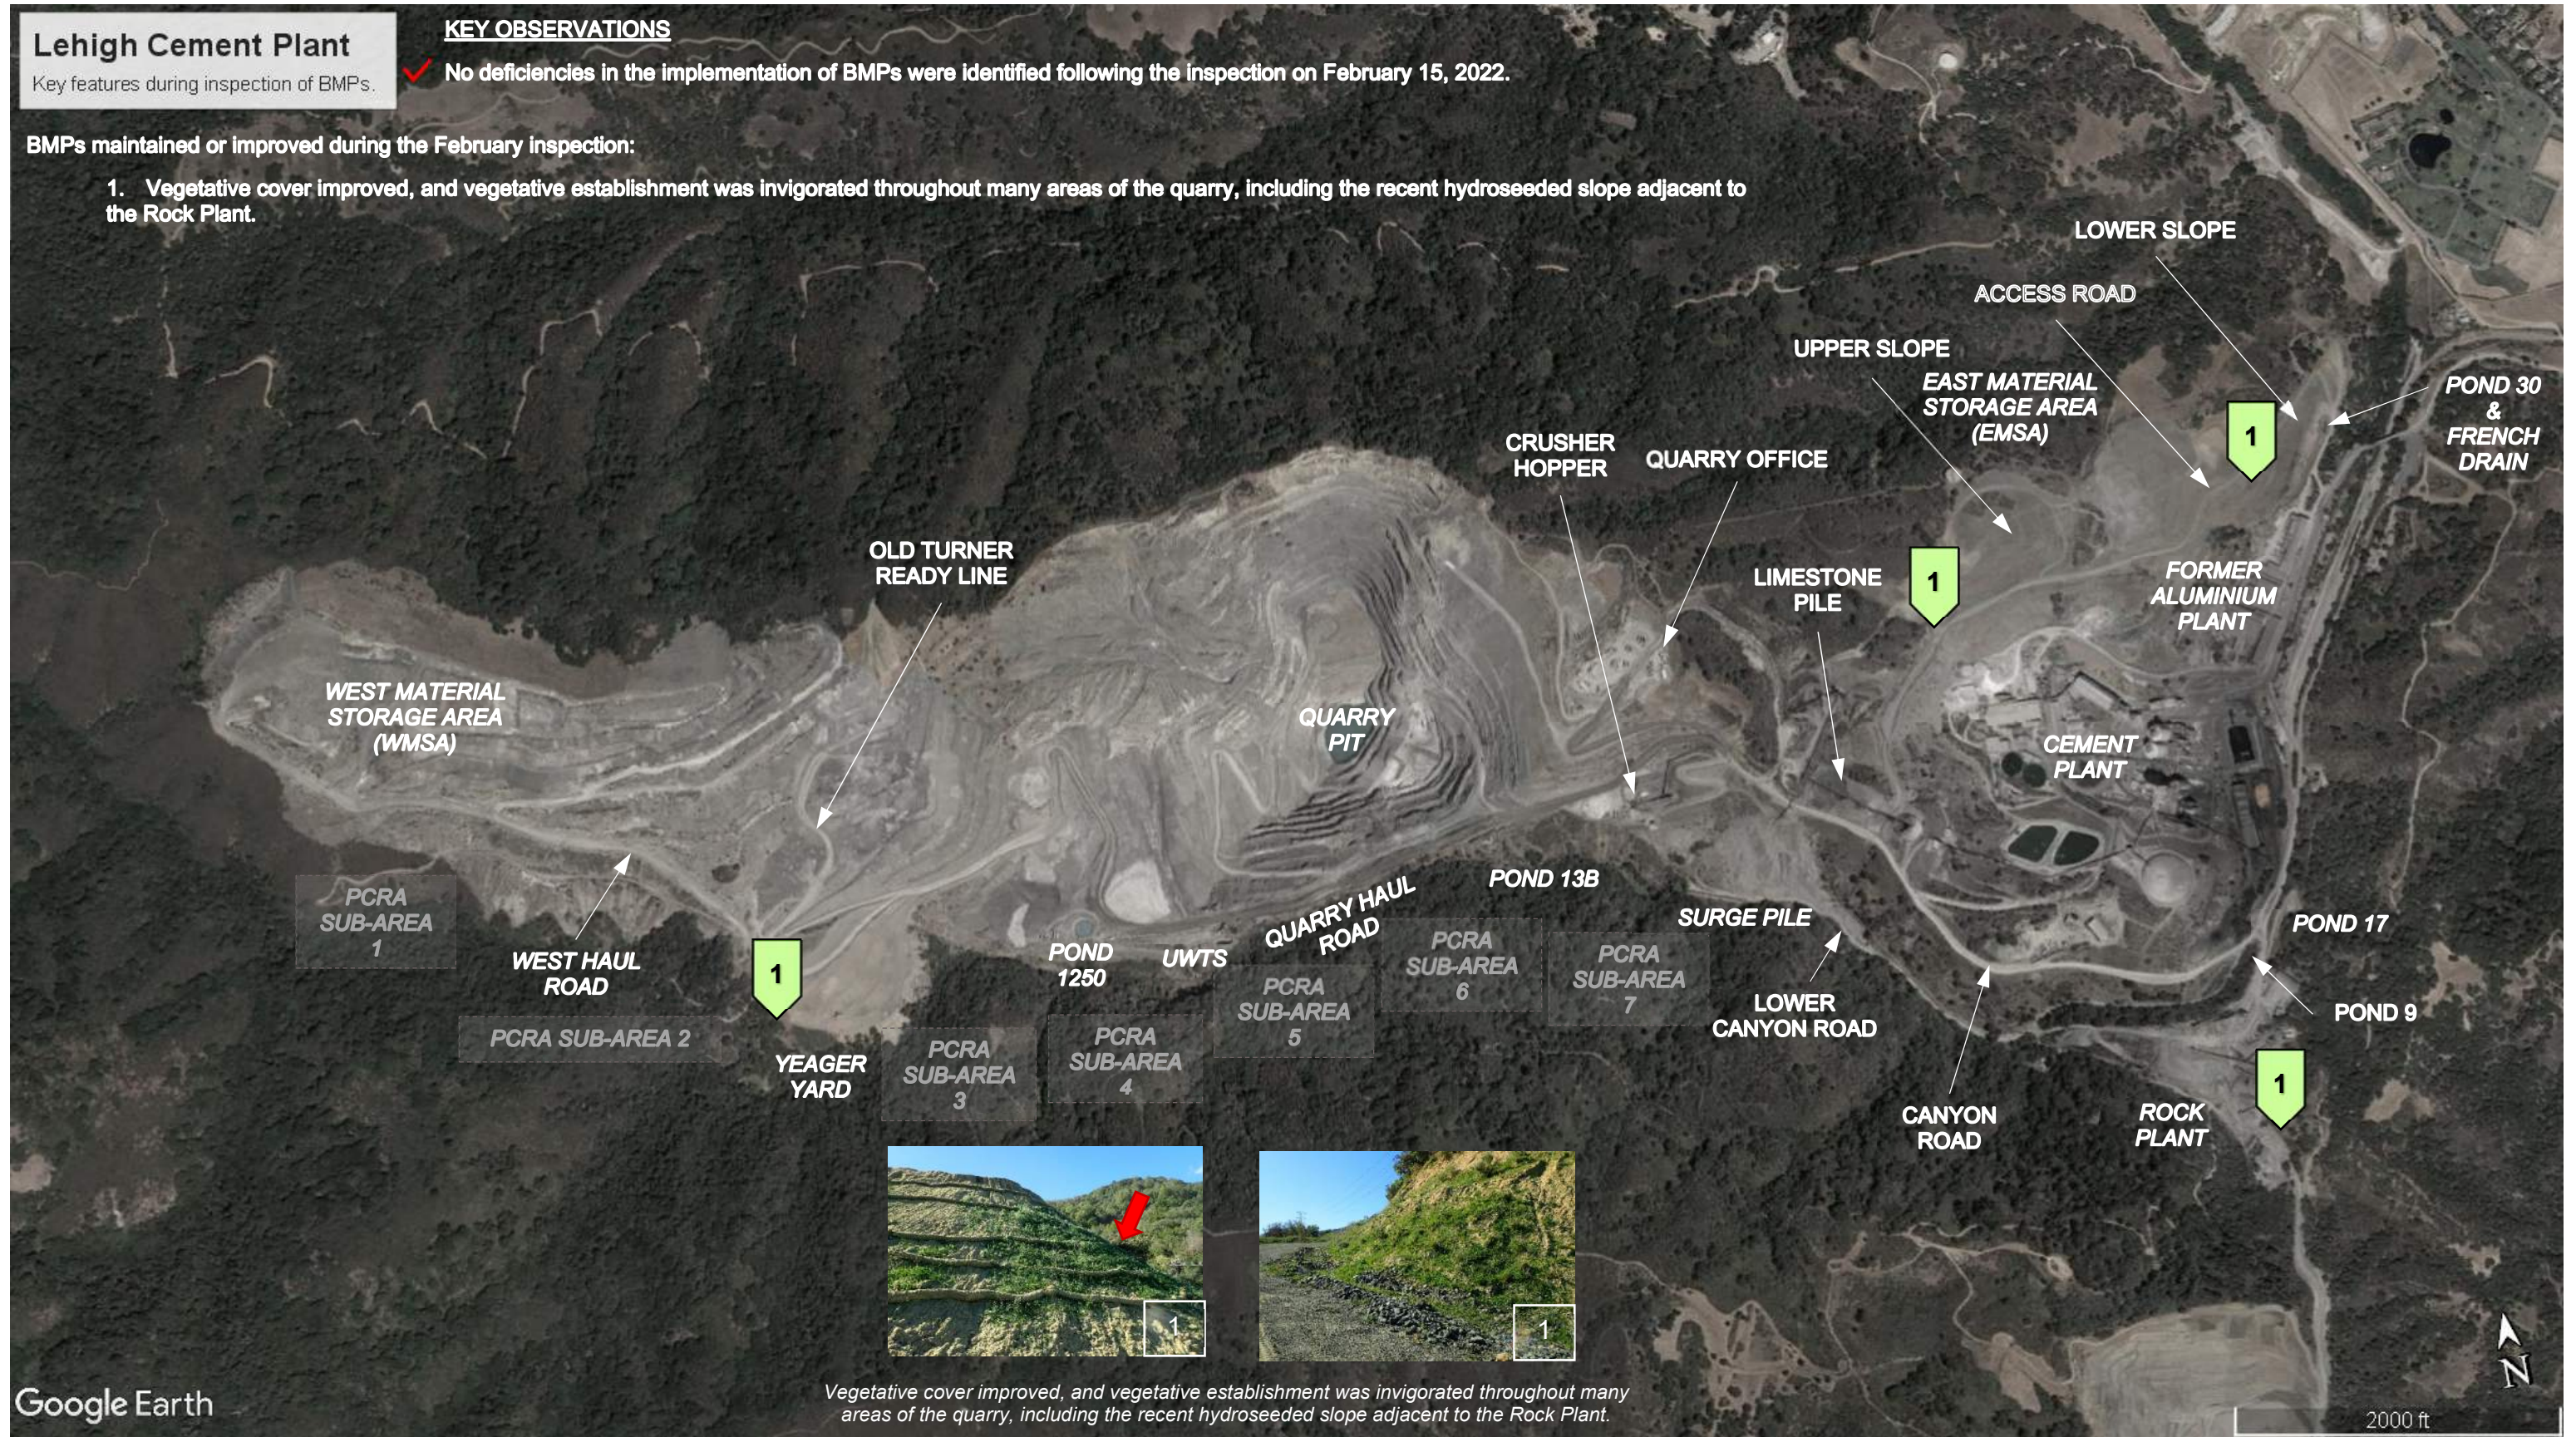
Vegetative cover improved, and vegetative establishment was invigorated throughout many areas of the quarry, including the recent hydroseeded slope adjacent to the Rock Plant.

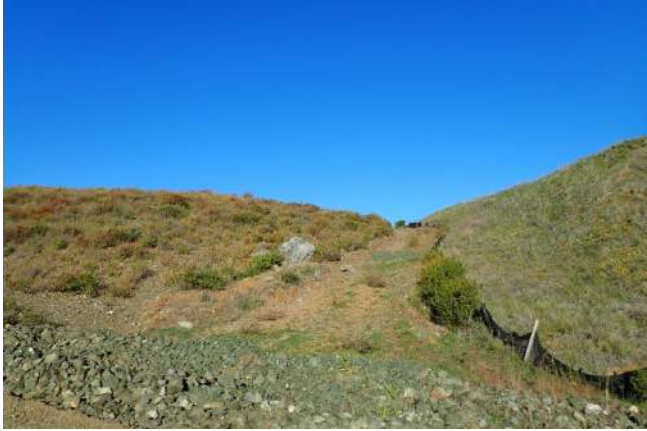
0215_02	<p>Status: GOOD</p> <p>Location: Lower EMSA by Access Road Non-limestone interim cover material storage area</p> <p>Observations: Roadside water bars and rock check-structures are re-established along and upslope from the EMSA access road.</p> <p>Recommendations: Routine monitoring of roadside check structures, sedimentation before and after rain events.</p>

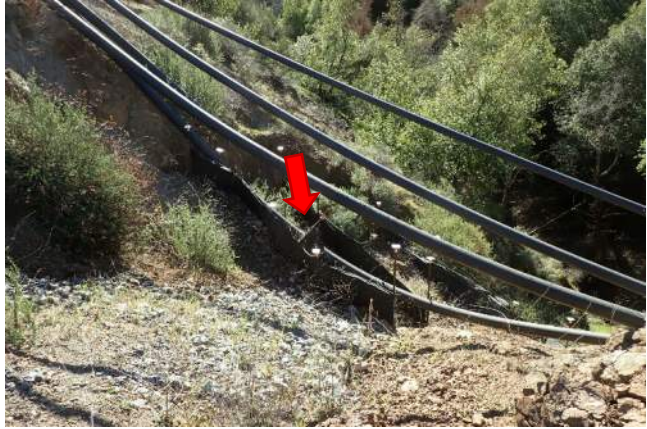
0215_03	<p>Status: MONITOR FOR CHANGES</p> <p>Location: Quarry Haul Road PCRA: 5 and 6</p> <p>Observations: Multiple lines of silt fencing remain in place and in good, functional condition. Debris is being retained behind fencing.</p> <p>Recommendations: Routine monitoring of sedimentation and debris accumulation behind silt fences.</p>

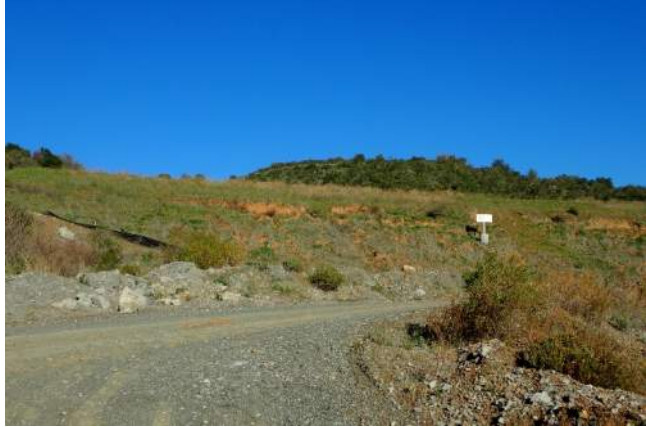
1. Vegetative cover improved, and vegetative establishment was invigorated throughout many areas of the quarry, including the recent hydroseeded slope adjacent to the Rock Plant. See Photos 0215_01, 0215_04, 0215_12, 0215_14 and 0215_15 in the appended DFR.

PHOTO ID	DESCRIPTION	PHOTO
0215_04	<p>Status: MONITOR FOR CHANGES Location: EMSA Upper Slopes Observations: Upper slopes of the East Material Storage Area (EMSA) remain vegetated. Hydroseeded vegetation has established over the interim cover material stockpile. Recommendations: Routine monitoring of vegetative cover throughout the rain season.</p>

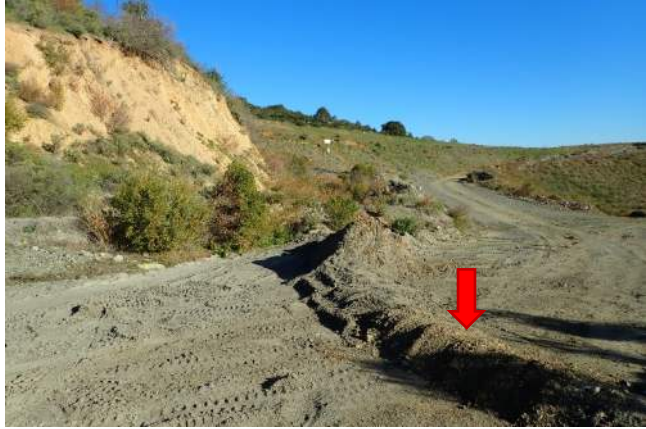
0215_05	<p>Status: MONITOR FOR CHANGES Location: EMSA – Access Road Observations: Water bars are established and draining to the drop inlet. Straw wattles and hay bales remain in place around the drop inlet next to the EMSA access road. Recommendations: Routine monitoring of the condition of water bars and sediment controls: hay bales, wattles.</p>

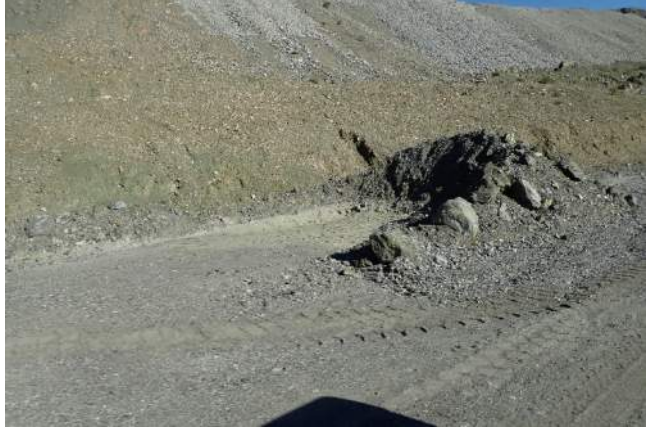
0215_06	<p>Status: MONITOR FOR CHANGES Location: WMSA – Haul Road Observations: Check dams remain in functional condition. Water bars, cross-slope remain in place. Recommendations: Routine monitoring of the sedimentation behind check dams along the Quarry Haul Road to WMSA and re-establish water bars as needed.</p>

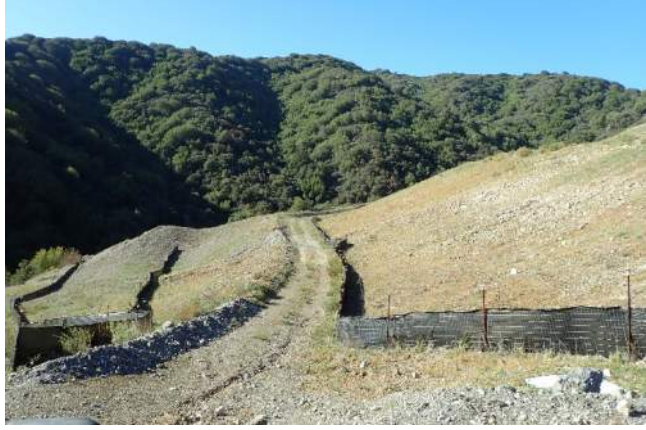
PHOTO ID	DESCRIPTION	PHOTO
0215_07	<p>Status: MONITOR FOR CHANGES</p> <p>Location: Yeager Yard – Upper Slopes PCRA: 2 and 3</p> <p>Observations: Silt fences are in good condition and remain functional. Vegetative cover has established over the upper slopes of the Yeager Yard.</p> <p>Recommendations: Routine monitoring of the vegetative cover on the slopes. Monitor the sediment accumulation on vegetated benches and silt fence condition routinely.</p>

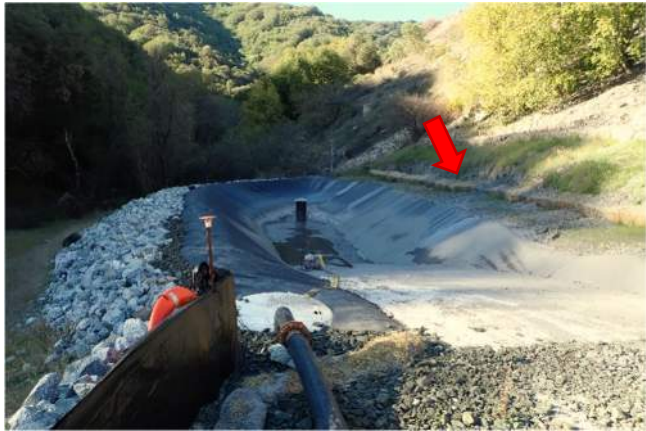
0215_08	<p>Status: MONITOR FOR CHANGES</p> <p>Location: Yeager Yard – Sediment Basin PCRA: 2 and 3</p> <p>Observations: Vegetation has established on the hydroseeded slope. Hay bales and straw wattles remain in place.</p> <p>Recommendations: Routine monitoring of the vegetative cover and BMPs conditions through establishment of hydroseed vegetation.</p>

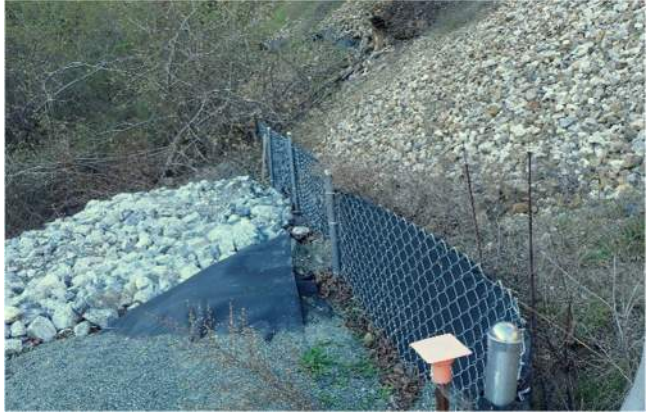
0215_09	<p>Status: GOOD</p> <p>Location: Yeager Yard – Sediment Basin PCRA: 2 and 3</p> <p>Observations: Super silt fence remains in place and in good condition with low levels of sedimentation and debris accumulation.</p> <p>Recommendations: Frequent monitoring of the sedimentation in the sediment capture basin and above the super silt fence; clear debris regularly.</p>

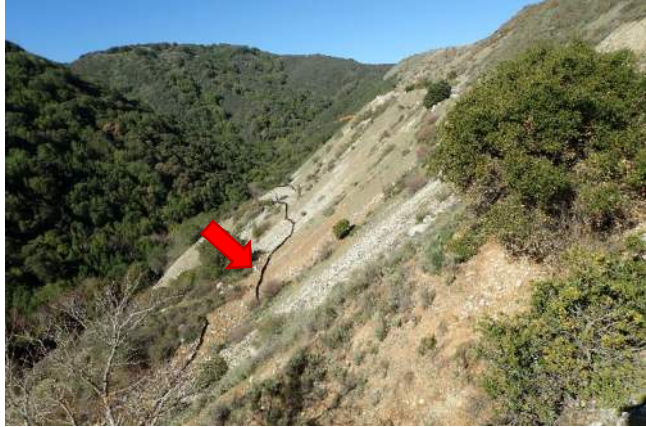
PHOTO ID	DESCRIPTION	PHOTO
0215_10	<p>Status: GOOD</p> <p>Location: PCRA 1 PCRA: 1</p> <p>Observations: Slope below road remains vegetated. Silt fencing continues in good condition.</p> <p>Recommendations: Routine monitoring of the silt fence condition and sedimentation behind lower line of silt fences.</p>

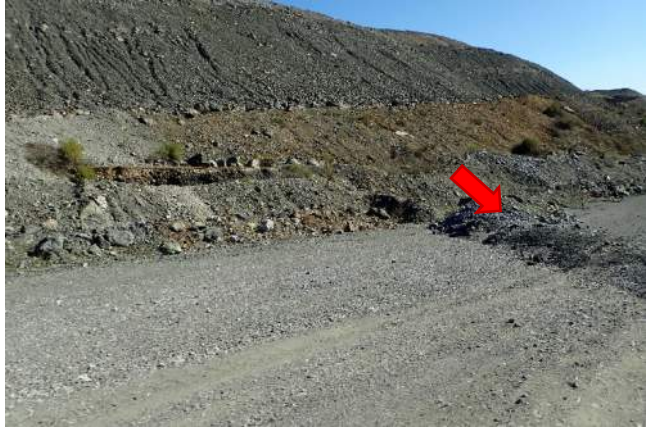
0215_11	<p>Status: MONITOR FOR CHANGES</p> <p>Location: Rock Plant – Improved Existing Access Road</p> <p>Observations: Water bars were re-established along the access road by the Rock Plant.</p> <p>Recommendations: Routine monitoring of the condition of the water bars and check dams and vegetative cover throughout the rain season.</p>

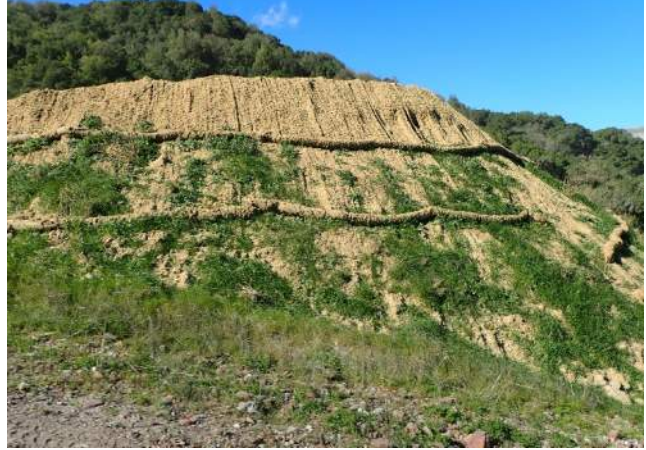
0215_12	<p>Status: GOOD</p> <p>Location: Rock Plant – Roadside Slope</p> <p>Observations: Jute matting and straw wattles remain in alignment and continuous around the hydroseeded slope at the Rock Plant.</p> <p>Recommendations: Routine monitoring of the sedimentation of the rock-lined features and the condition of the jute matting and straw wattles. Adjust wattles as needed to achieve intended alignment and continuity.</p>

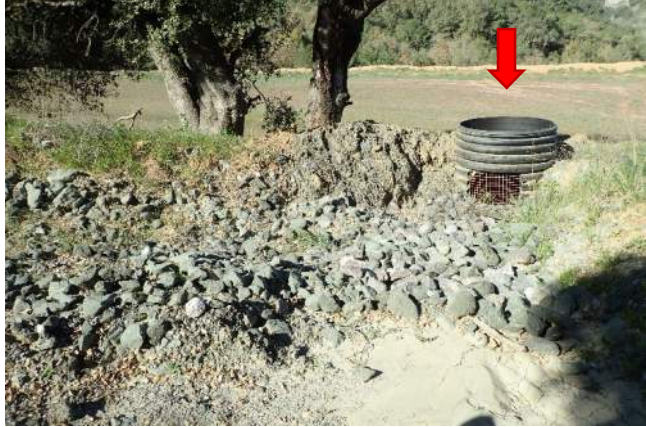
PHOTO ID	DESCRIPTION	PHOTO
0215_13	<p>Status: MONITOR FOR CHANGES</p> <p>Location: Rock Plant – Improved Existing Access Road</p> <p>Observations: Drop inlet and rock-lined apron are clear of significant debris and remain functional. The drop inlet pipe is clear of sediment..</p> <p>Recommendations: Routine monitoring of the sedimentation and debris accumulation inside the drop inlet pipe and stilling basin.</p>

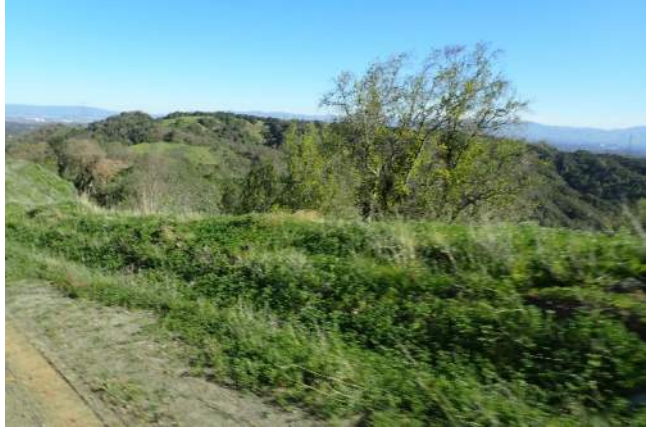
0215_14	<p>Status: MONITOR FOR CHANGES</p> <p>Location: Rock Plant – Improved Existing Access Road</p> <p>Observations: Roadside rock berm remains in place and vegetated. Vegetative cover is established over the slopes below the road and berm.</p> <p>Recommendations: Routine monitoring of rock-lined features, cross-slope in the rain season that began in October.</p>

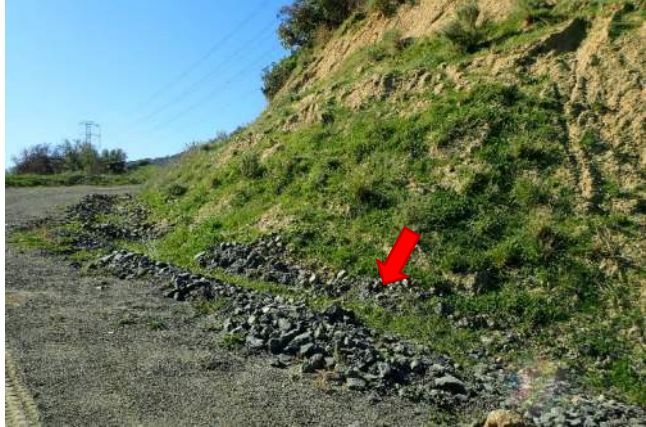
0215_15	<p>Status: GOOD</p> <p>Location: Rock Plant – Roadside ditch and Slope</p> <p>Observations: Roadside rock-lined ditches remain in place and maintain positive drainage. Vegetation has established in the adjacent slopes.</p> <p>Recommendations: Routine monitoring of vegetative cover and roadside sediment accumulation.</p>
