Lehigh Permanente Quarry Reclamation Plan Amendment Conditions of Approval Compliance

2021-2022 Annual Report Information Package

SANTA CLARA COUNTY, CALIFORNIA

APPENDIX B - 2021-2022 EROSION CONTROL INSPECTION REPORTS

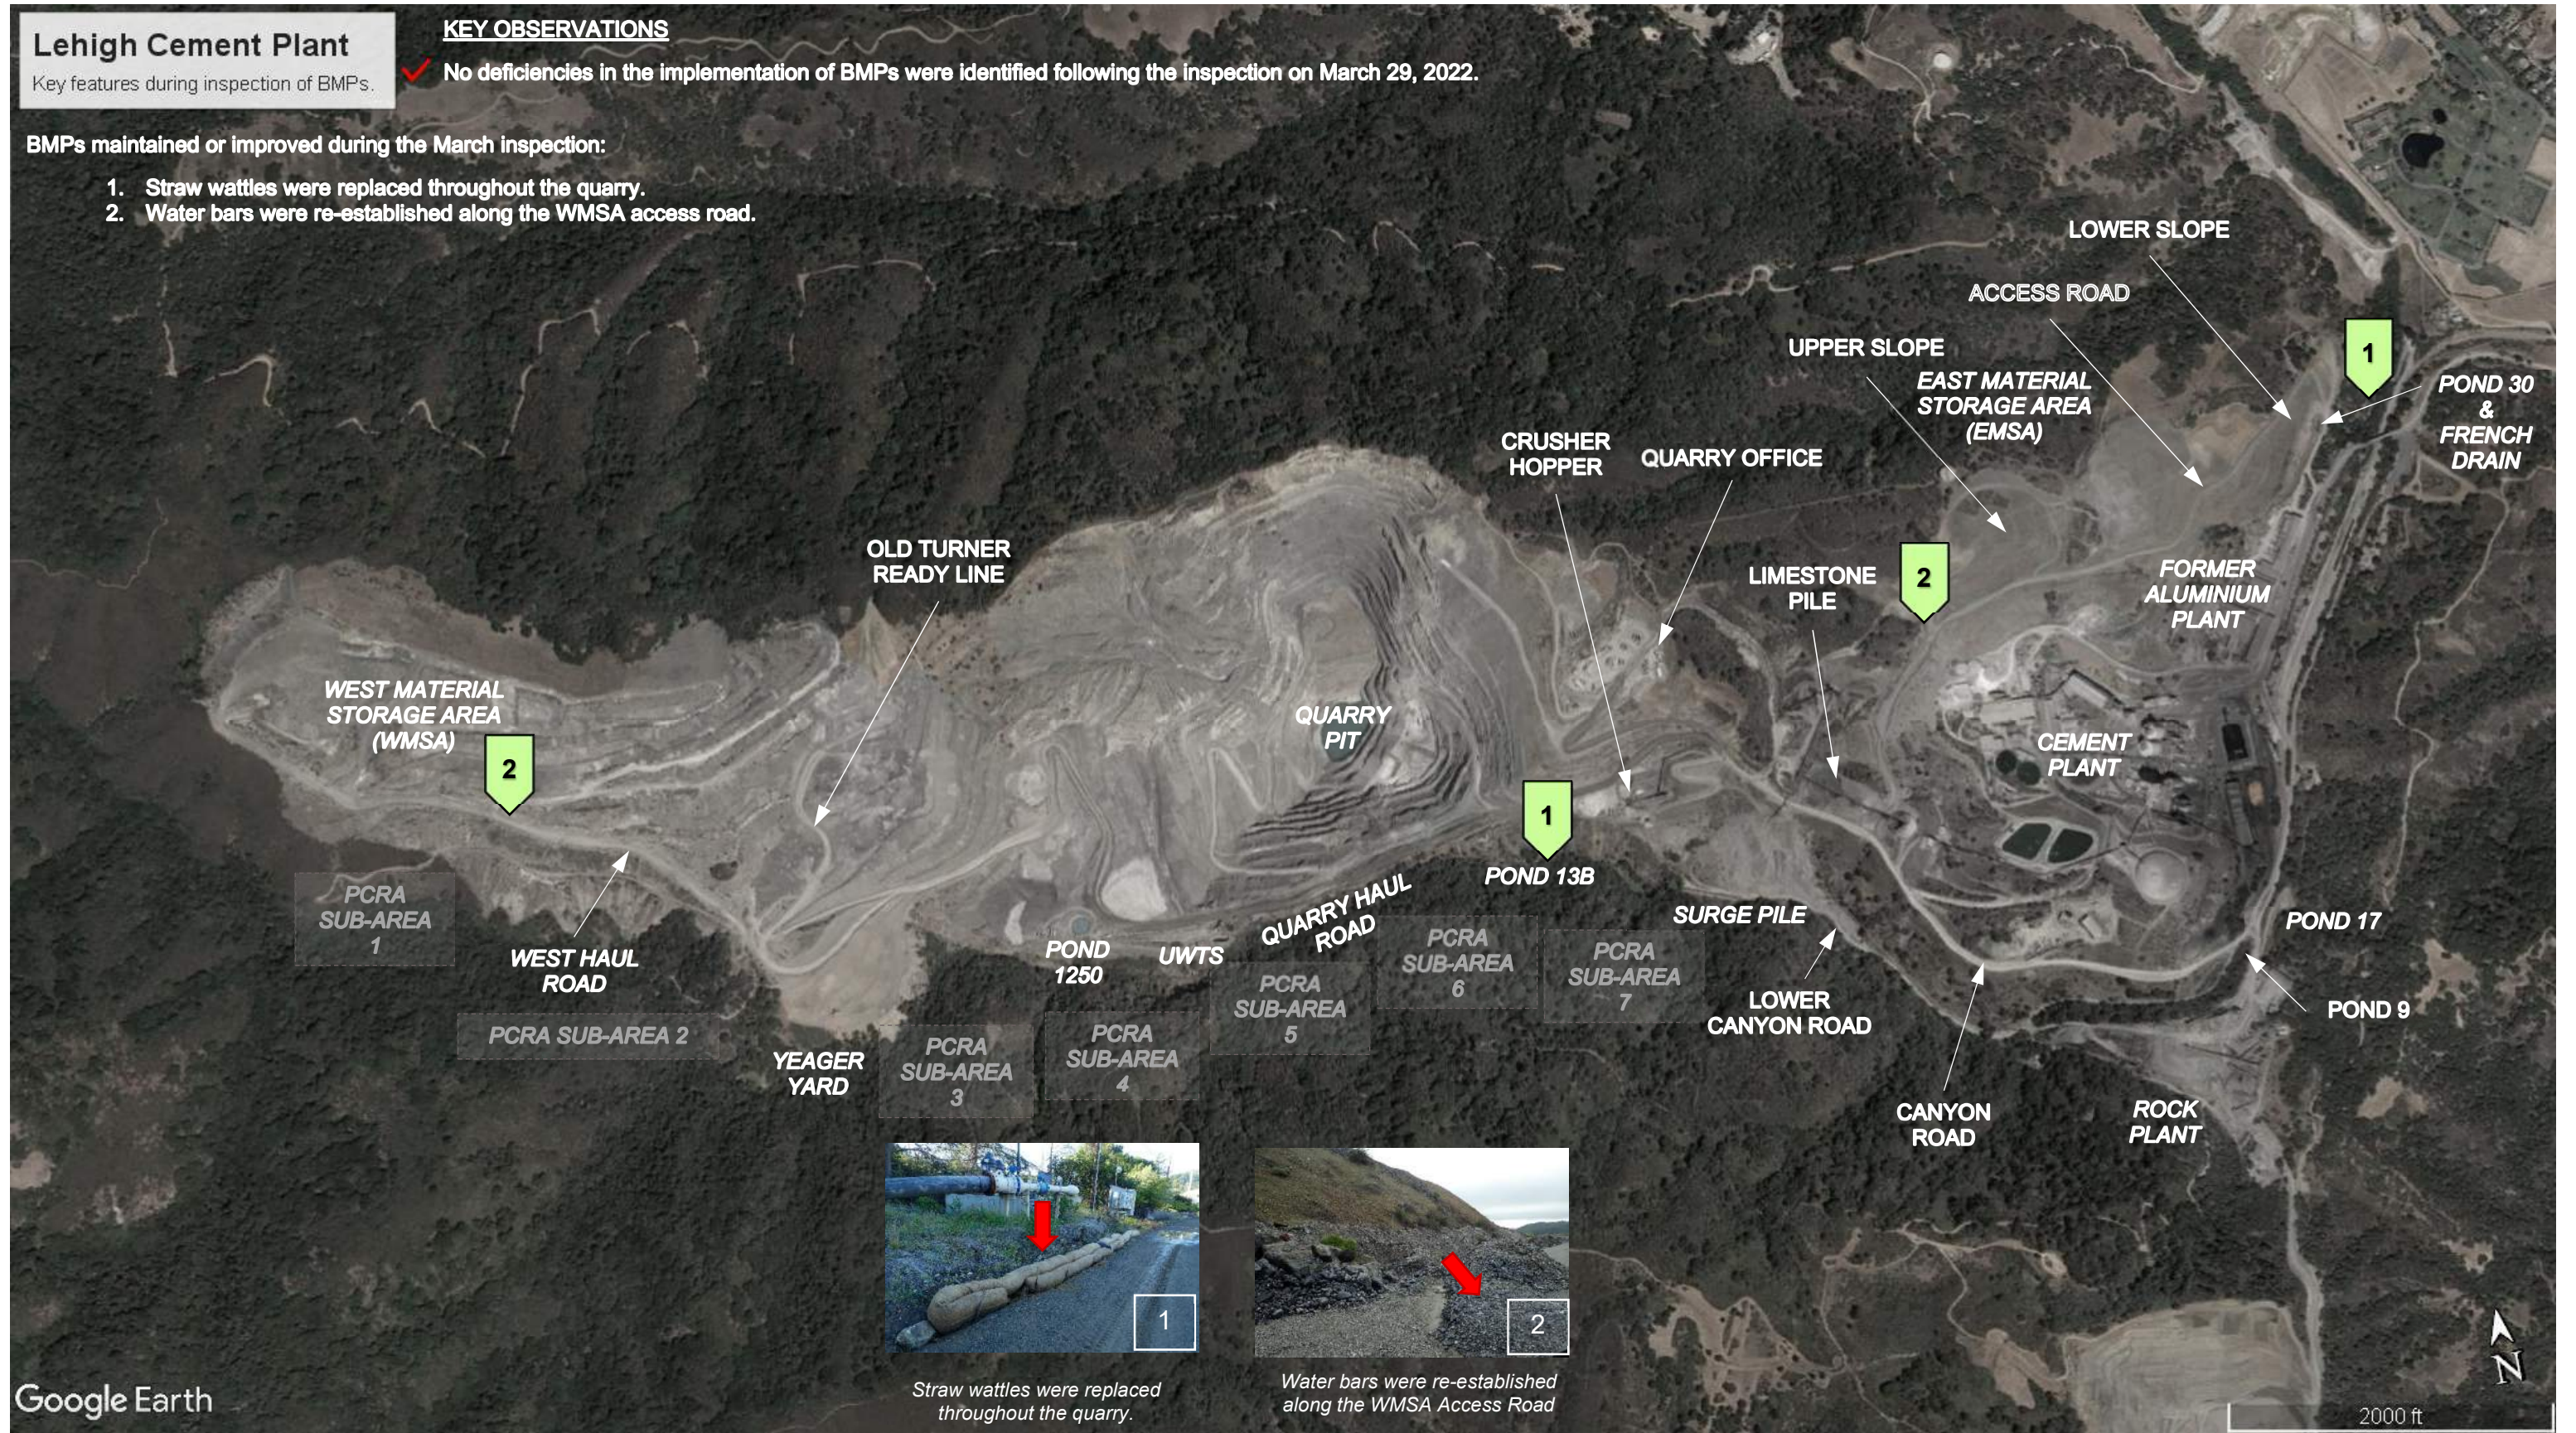
1. Straw wattles were replaced throughout the quarry.
2. Water bars were re-established along the WMSA access road.

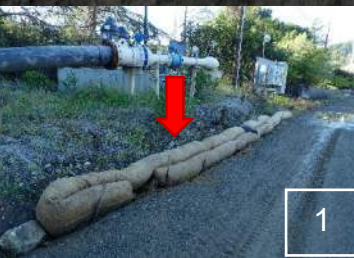
Straw wattles were replaced throughout the quarry.

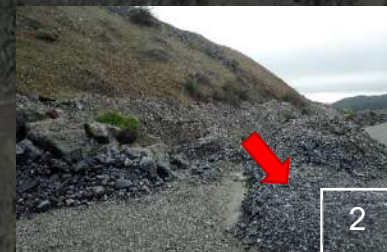
Water bars were re-established along the WMSA Access Road

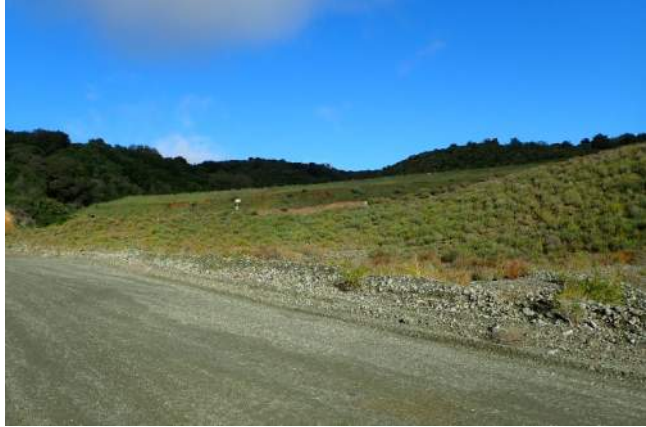
PHOTO ID	DESCRIPTION	PHOTO
0329_04	<p>Status: MONITOR FOR CHANGES Location: EMSA Upper Slopes Observations: Upper slopes of the East Material Storage Area (EMSA) remain vegetated. Hydroseeded vegetation has established over the interim cover material stockpile. Recommendations: Routine monitoring of vegetative cover throughout the rain season.</p>

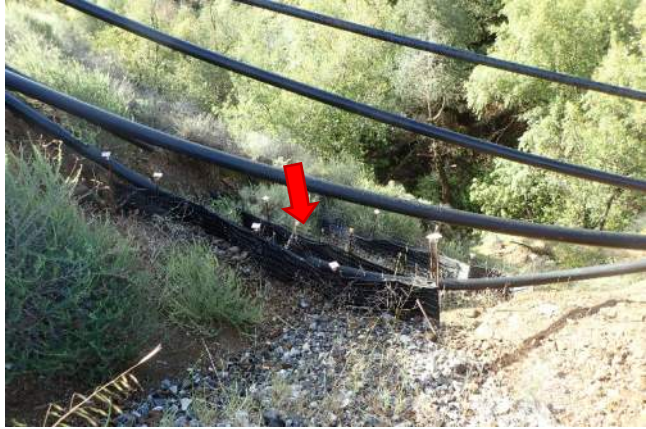
0329_05	<p>Status: MONITOR FOR CHANGES Location: Quarry Haul Road PCRA: 5 and 6 Observations: Multiple lines of silt fencing remain in place and in good, functional condition. Debris is being retained behind fencing. Recommendations: Routine monitoring of sedimentation and debris accumulation behind silt fences.</p>

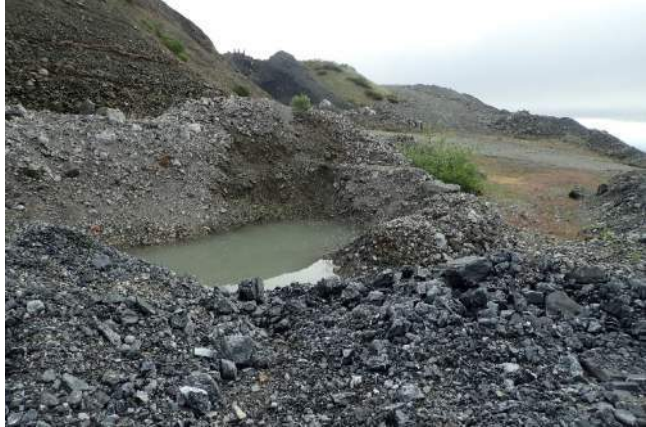
0329_06	<p>Status: MONITOR FOR CHANGES Location: WMSA – Haul Road Observations: Check dams remain in functional condition. Water bars were re-established and are in good condition Recommendations: Routine monitoring of the sedimentation behind check dams along the Quarry Haul Road to WMSA and re-establish water bars as needed.</p>

1. Straw wattles were replaced throughout the quarry. See Photos 0329_01, 0329_11 in the appended DFR.
2. Water bars were re-established along the WMSA access road. See Photos 0329_02, 0329_03, 0329_06 in the appended DFR.

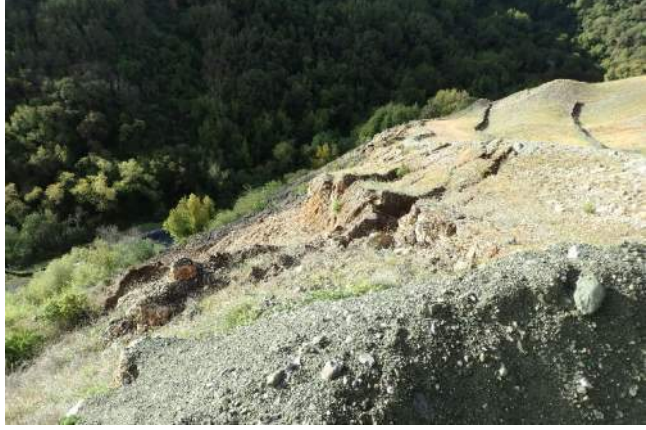
PHOTO ID	DESCRIPTION	PHOTO
0329_07	<p>Status: MONITOR FOR CHANGES</p> <p>Location: Yeager Yard – Upper Slopes PCRA: 2 and 3</p> <p>Observations: Silt fences are in good condition and remain functional. Vegetative cover has established over the upper slopes of the Yeager Yard.</p> <p>Recommendations: Routine monitoring of the vegetative cover on the slopes. Monitor the sediment accumulation on vegetated benches and silt fence condition routinely.</p>

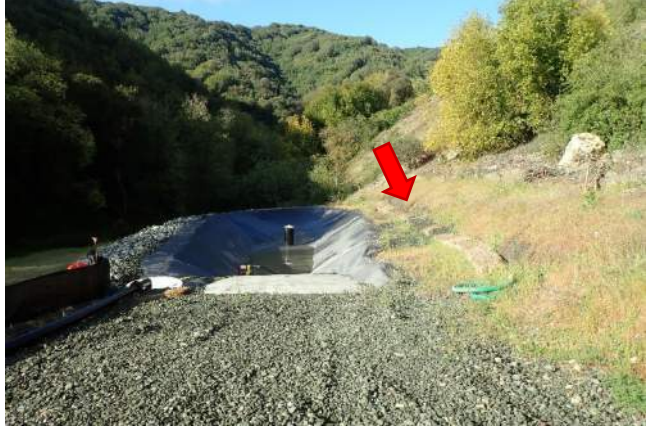
0329_08	<p>Status: MONITOR FOR CHANGES</p> <p>Location: Yeager Yard – Sediment Basin PCRA: 2 and 3</p> <p>Observations: Vegetation has established on the hydroseeded slope. Hay bales and straw wattles remain in place.</p> <p>Recommendations: Routine monitoring of the vegetative cover and BMPs conditions through establishment of hydroseed vegetation.</p>

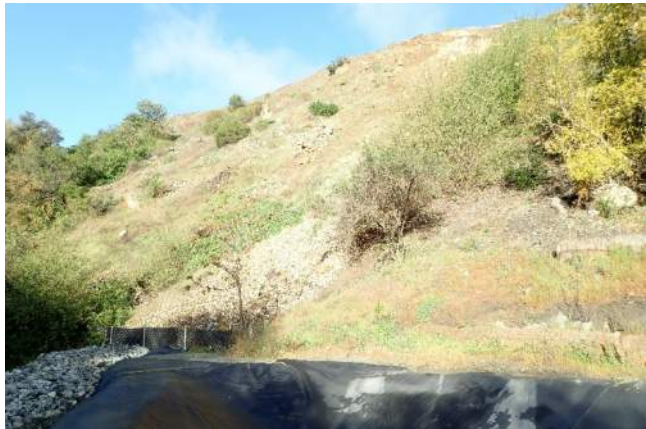
0329_09	<p>Status: GOOD</p> <p>Location: Yeager Yard – Sediment Basin PCRA: 2 and 3</p> <p>Observations: Super silt fence remains in place and in good condition with low levels of sedimentation and debris accumulation.</p> <p>Recommendations: Frequent monitoring of the sedimentation in the sediment capture basin and above the super silt fence; clear debris regularly.</p>

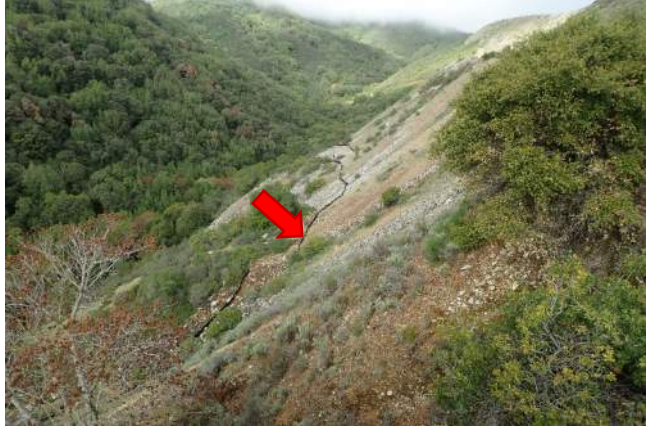
PHOTO ID	DESCRIPTION	PHOTO
0329_10	<p>Status: GOOD</p> <p>Location: PCRA 1 PCRA: 1</p> <p>Observations: Slope below road remains vegetated. Silt fencing continues in good condition.</p> <p>Recommendations: Routine monitoring of the silt fence condition and sedimentation behind lower line of silt fences.</p>

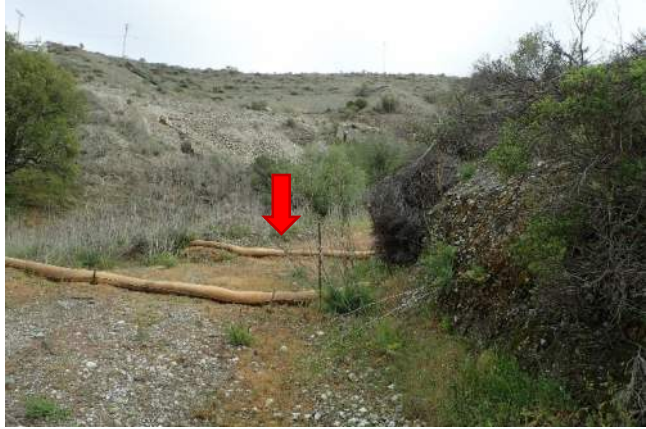
0329_11	<p>Status: GOOD</p> <p>Location: Pond 13B</p> <p>Observations: Straw wattles were replaced and appear in good condition.</p> <p>Recommendations: Routine monitoring of the condition of the straw wattles and vegetative cover throughout the rain season.</p>

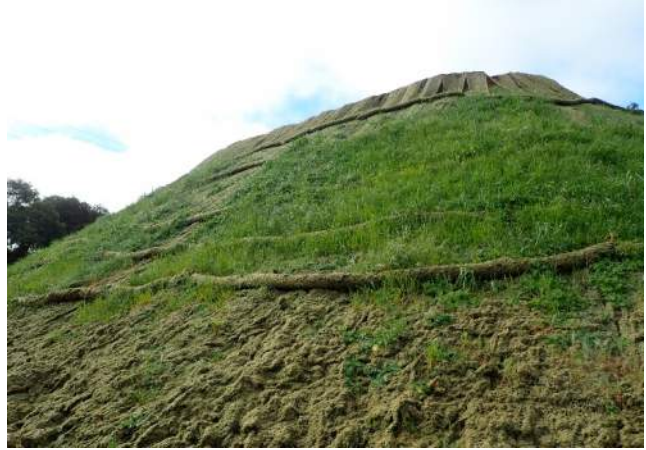
0329_12	<p>Status: GOOD</p> <p>Location: Rock Plant – Roadside Slope</p> <p>Observations: Jute matting and straw wattles remain in alignment and continuous around the hydroseeded slope at the Rock Plant.</p> <p>Recommendations: Routine monitoring of the sedimentation of the rock-lined features and the condition of the jute matting and straw wattles. Adjust wattles as needed to achieve intended alignment and continuity.</p>

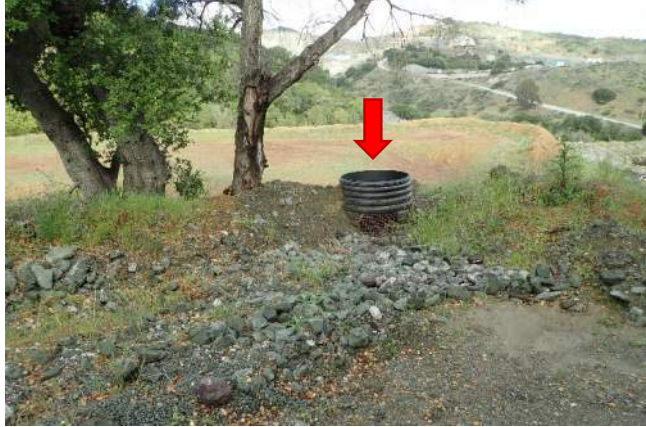
PHOTO ID	DESCRIPTION	PHOTO
0329_13	<p>Status: MONITOR FOR CHANGES</p> <p>Location: Rock Plant – Improved Existing Access Road</p> <p>Observations: Drop inlet and rock-lined apron are clear of significant debris and remain functional. The drop inlet pipe is clear of sediment..</p> <p>Recommendations: Routine monitoring of the sedimentation and debris accumulation inside the drop inlet pipe and stilling basin.</p>

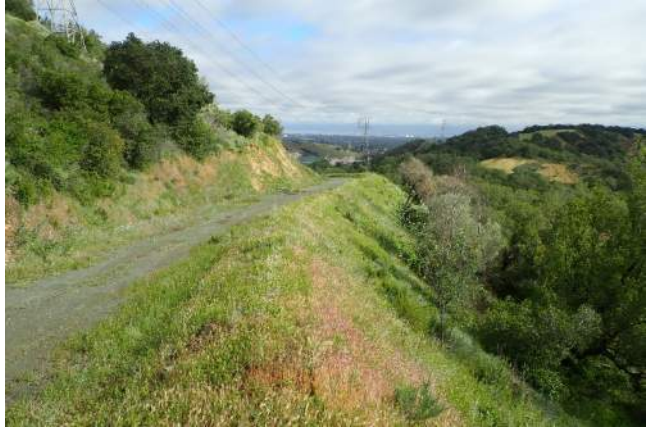
0329_14	<p>Status: MONITOR FOR CHANGES</p> <p>Location: Rock Plant – Improved Existing Access Road</p> <p>Observations: Roadside rock berm remains in place and vegetated. Vegetative cover is established over the slopes below the road and berm.</p> <p>Recommendations: Routine monitoring of rock-lined features, cross-slope in the rain season that began in October.</p>

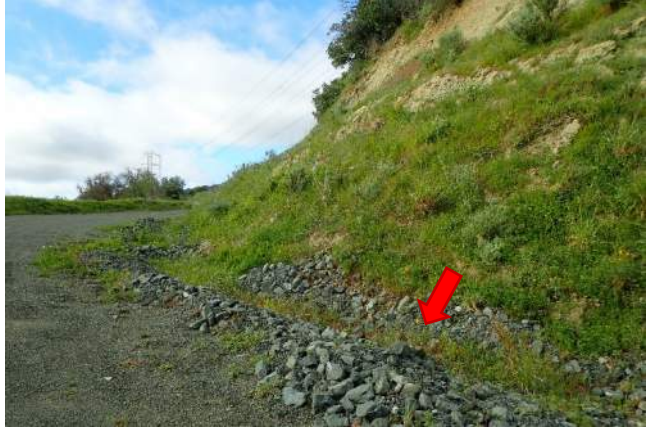
0329_15	<p>Status: GOOD</p> <p>Location: Rock Plant – Roadside ditch and Slope</p> <p>Observations: Roadside rock-lined ditches remain in place and maintain positive drainage. Vegetation has established in the adjacent slopes.</p> <p>Recommendations: Routine monitoring of vegetative cover and roadside sediment accumulation.</p>

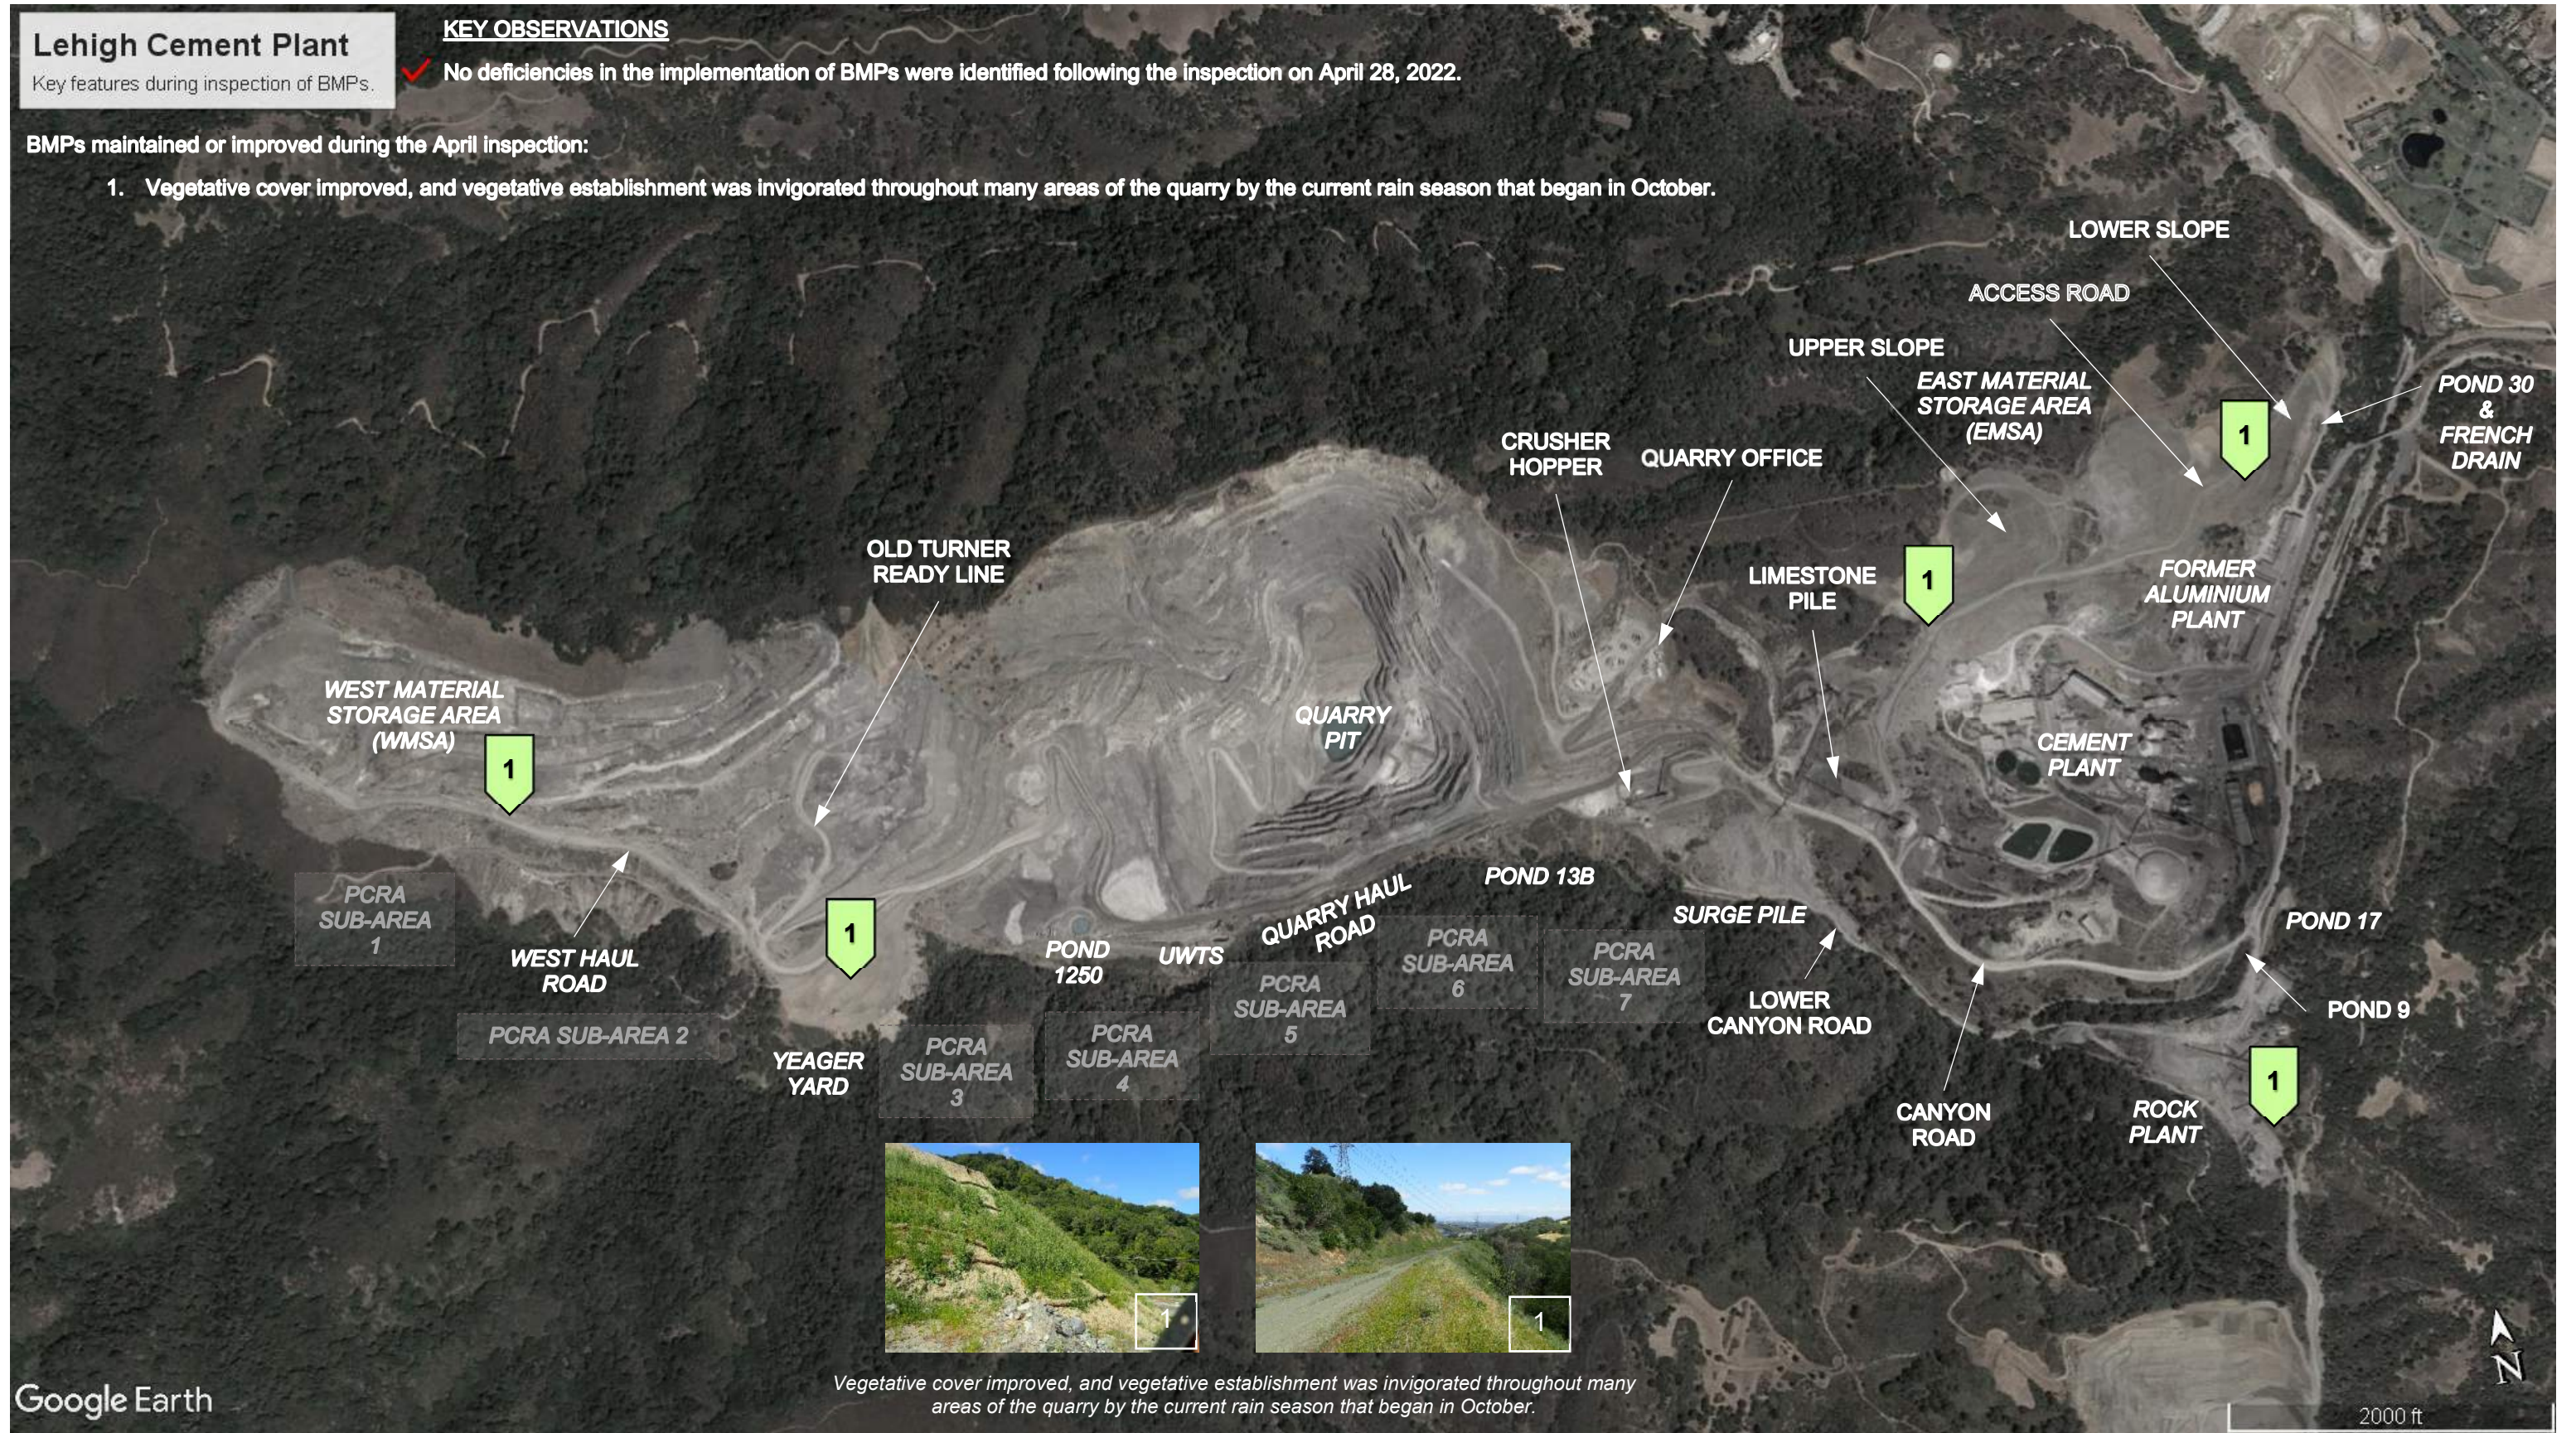
Vegetative cover improved, and vegetative establishment was invigorated throughout many areas of the quarry by the current rain season that began in October.

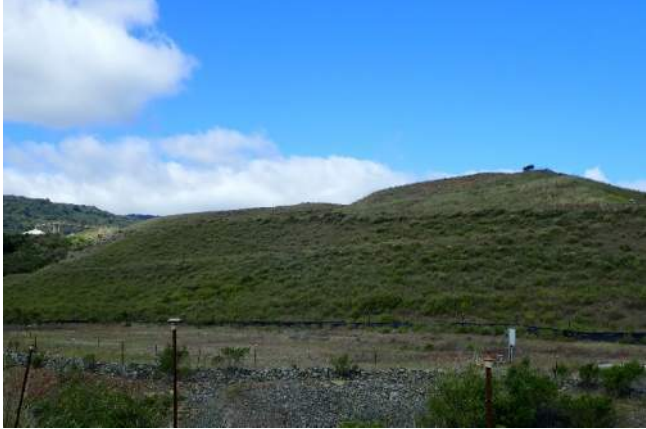
1. Vegetative cover improved, and vegetative establishment was invigorated throughout many areas of the quarry by the current rain season that began in October. See Photos 0428_01, 0428_04, 0428_07, 0428_08, 0428_10, 0428_11, 0428_14, and 0428_15 in the appended DFR.

PHOTO ID	DESCRIPTION	PHOTO
0428_01	<p>Status: GOOD</p> <p>Location: EMSA – Pond 30 and French Drain</p> <p>Observations: Vegetation has established throughout the EMSA above the silt fences at Pond 30. Silt fences remain in good condition.</p> <p>Recommendations: Routine monitoring of the condition of the straw wattles, silt fences, and vegetative cover in this area.</p>

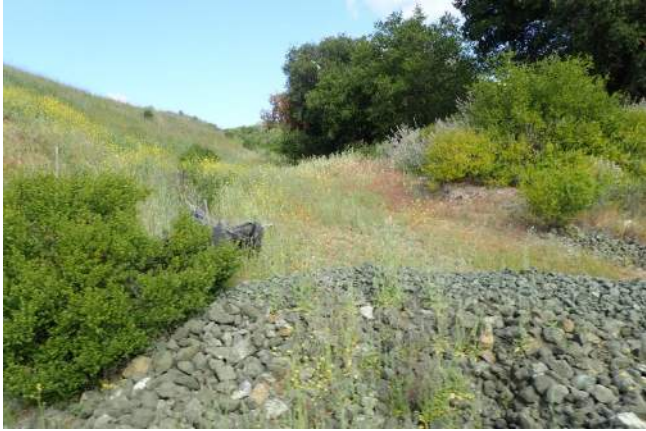
0428_02	<p>Status: GOOD</p> <p>Location: Lower EMSA by Access Road Non-limestone interim cover material storage area</p> <p>Observations: Water bars and rock check-structures are re-established along and upslope from the EMSA access road.</p> <p>Recommendations: Routine monitoring of roadside check structures, sedimentation before and after rain events.</p>

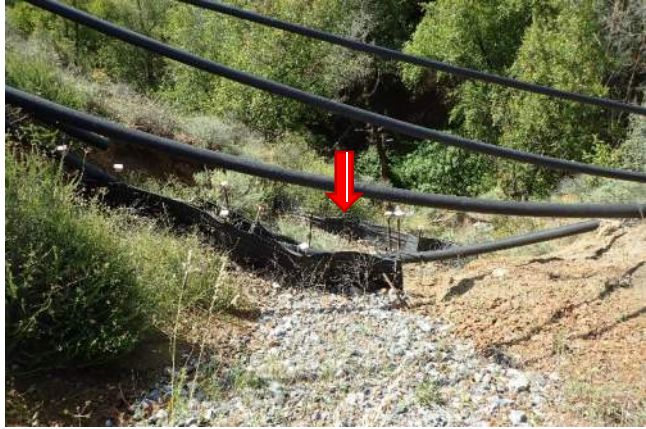
0428_03	<p>Status: MONITOR FOR CHANGES</p> <p>Location: Quarry Haul Road PCRA: 5 and 6</p> <p>Observations: Multiple lines of silt fencing remain in place and in good, functional condition. Debris is being retained behind fencing.</p> <p>Recommendations: Routine monitoring of sedimentation and debris accumulation behind silt fences.</p>

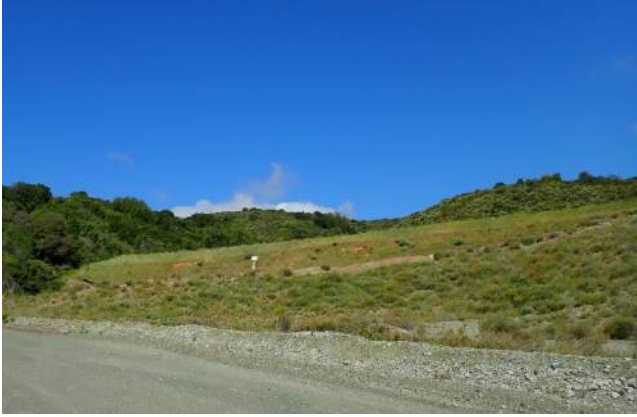
PHOTO ID	DESCRIPTION	PHOTO
0428_04	<p>Status: MONITOR FOR CHANGES Location: EMSA Upper Slopes Observations: Upper slopes of the East Material Storage Area (EMSA) remain vegetated. Hydroseeded vegetation has established over the interim cover material stockpile. Recommendations: Routine monitoring of vegetative cover throughout the rain season.</p>

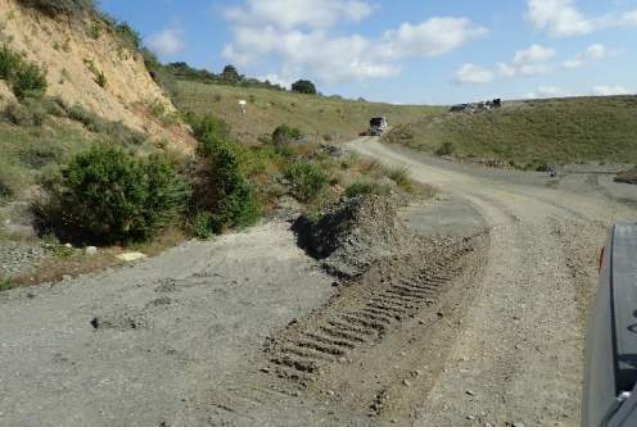
0428_05	<p>Status: MONITOR FOR CHANGES Location: EMSA – Access Road Observations: Water bars are established and draining to the drop inlet. Straw wattles and hay bales remain in place around the drop inlet next to the EMSA access road. Recommendations: Routine monitoring of the condition of water bars and sediment controls: hay bales, wattles.</p>

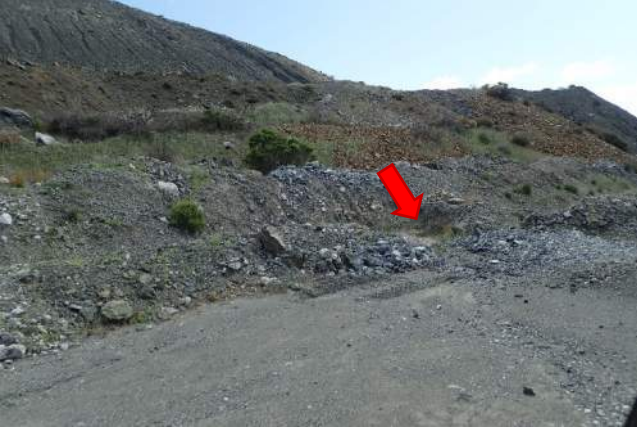
0428_06	<p>Status: MONITOR FOR CHANGES Location: WMSA – Haul Road Observations: Check dams remain in functional condition. Water bars, cross-slope remain in place. Recommendations: Routine monitoring of the sedimentation behind check dams along the Quarry Haul Road to WMSA and re-establish water bars as needed.</p>

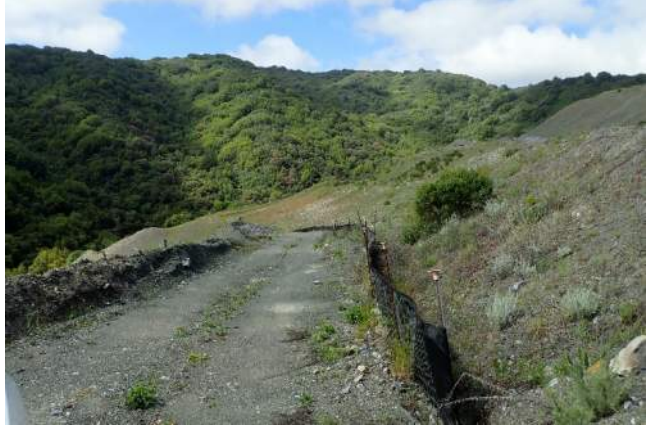
PHOTO ID	DESCRIPTION	PHOTO
0428_07	<p>Status: MONITOR FOR CHANGES Location: Yeager Yard – Upper Slopes PCRA: 2 and 3 Observations: Silt fences are in good condition and remain functional. Vegetative cover has established over the upper slopes of the Yeager Yard. Recommendations: Routine monitoring of the vegetative cover on the slopes. Monitor the sediment accumulation on vegetated benches and silt fence condition routinely.</p>

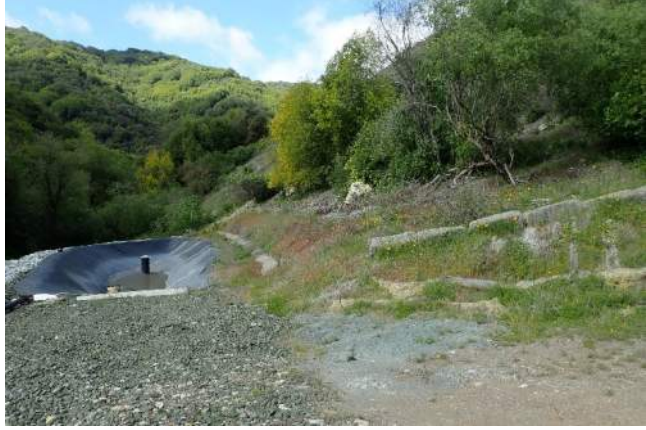
0428_08	<p>Status: MONITOR FOR CHANGES Location: Yeager Yard – Sediment Basin PCRA: 2 and 3 Observations: Vegetation has established on the hydroseeded slope above sediment capture basin. Recommendations: Routine monitoring of the vegetative cover and BMPs conditions through establishment of hydroseed vegetation.</p>

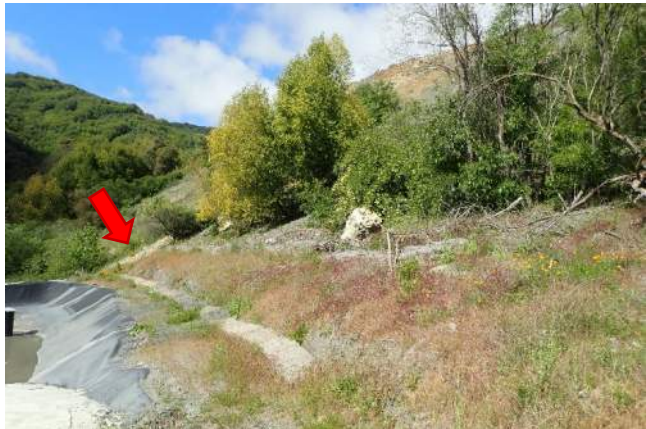
0428_09	<p>Status: MONITOR FOR CHANGES Location: Yeager Yard – Sediment Basin PCRA: 2 and 3 Observations: Hay bales and straw wattles remain in place and in working condition. Supersilt fence shows low levels of sedimentation and debris accumulation. Recommendations: Frequent monitoring of the sedimentation in the sediment capture basin and above the super silt fence; clear debris regularly.</p>

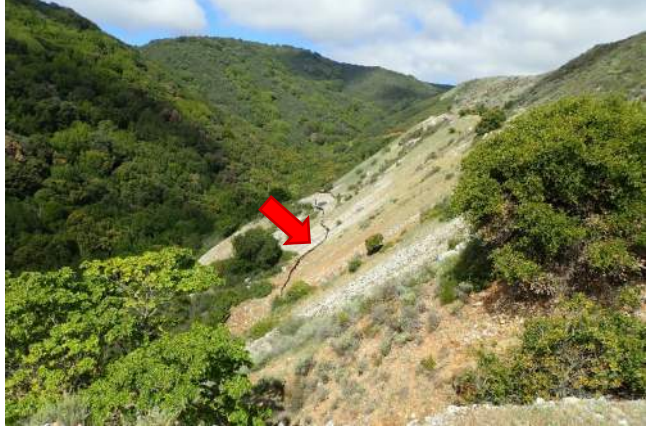
PHOTO ID	DESCRIPTION	PHOTO
0428_10	<p>Status: GOOD</p> <p>Location: PCRA 1 PCRA: 1</p> <p>Observations: Slope below road remains vegetated. Silt fencing continues in good condition.</p> <p>Recommendations: Routine monitoring of the silt fence condition and sedimentation behind lower line of silt fences.</p>

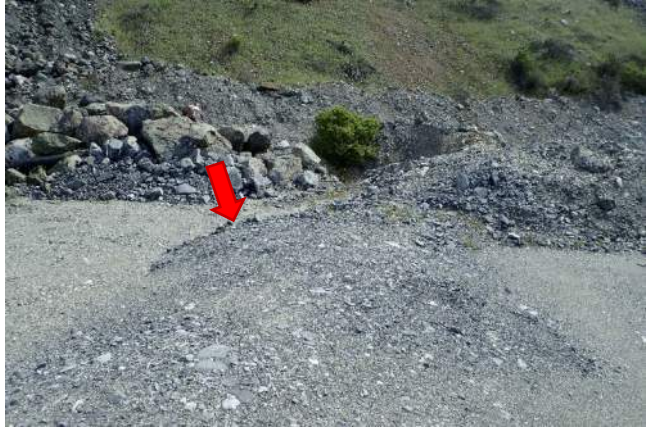
0428_11	<p>Status: MONITOR FOR CHANGES</p> <p>Location: Rock Plant – Improved Existing Access Road</p> <p>Observations: Water bars were re-established along the access road by the Rock Plant.</p> <p>Recommendations: Routine monitoring of the condition of the water bars and check dams and vegetative cover throughout the rain season.</p>

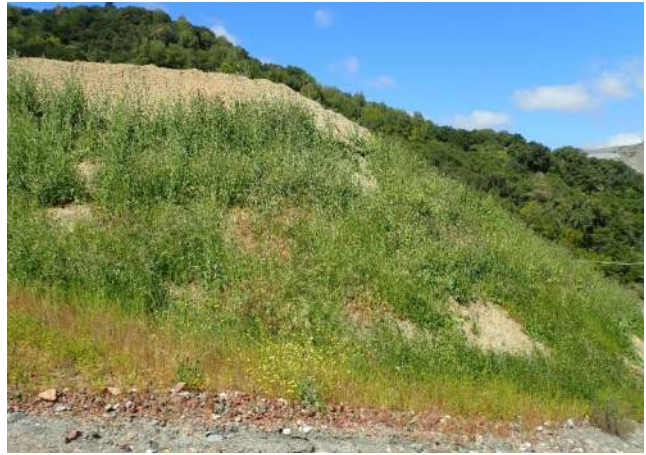
0428_12	<p>Status: GOOD</p> <p>Location: Rock Plant – Roadside Slope</p> <p>Observations: Jute matting and straw wattles remain in alignment and continuous around the hydroseeded slope at the Rock Plant.</p> <p>Recommendations: Routine monitoring of the sedimentation of the rock-lined features and the condition of the jute matting and straw wattles. Adjust wattles as needed to achieve intended alignment and continuity.</p>

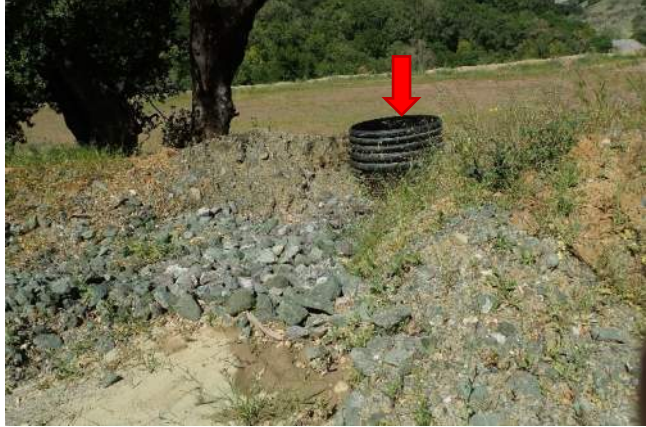
PHOTO ID	DESCRIPTION	PHOTO
0428_13	<p>Status: MONITOR FOR CHANGES</p> <p>Location: Rock Plant – Improved Existing Access Road</p> <p>Observations: Drop inlet and rock-lined apron are clear of significant debris and remain functional. The drop inlet pipe is clear of sediment..</p> <p>Recommendations: Routine monitoring of the sedimentation and debris accumulation inside the drop inlet pipe and stilling basin.</p>

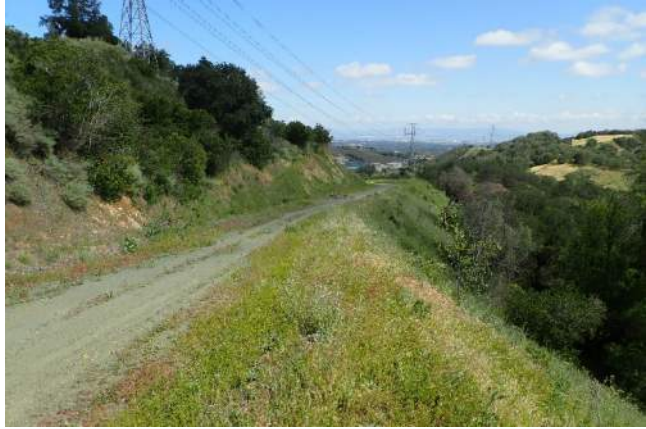
0428_14	<p>Status: MONITOR FOR CHANGES</p> <p>Location: Rock Plant – Improved Existing Access Road</p> <p>Observations: Roadside rock berm remains in place and vegetated. Vegetative cover is established over the slopes below the road and berm.</p> <p>Recommendations: Routine monitoring of rock-lined features, cross-slope in the rain season that began in October.</p>

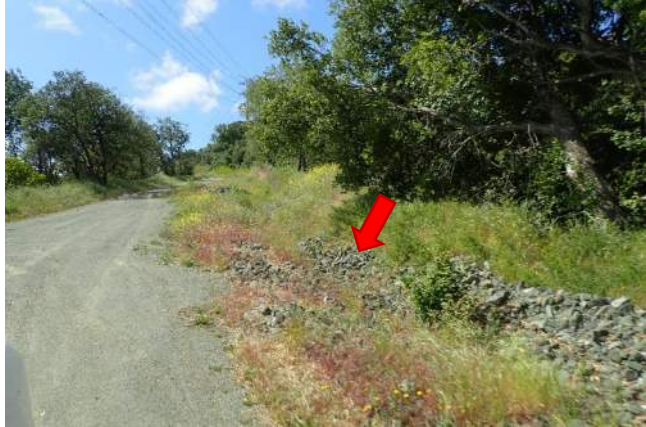
0428_15	<p>Status: GOOD</p> <p>Location: Rock Plant – Roadside ditch and Slope</p> <p>Observations: Roadside rock-lined ditches remain in place and maintain positive drainage. Vegetation has established in the adjacent slopes.</p> <p>Recommendations: Routine monitoring of vegetative cover and roadside sediment accumulation.</p>

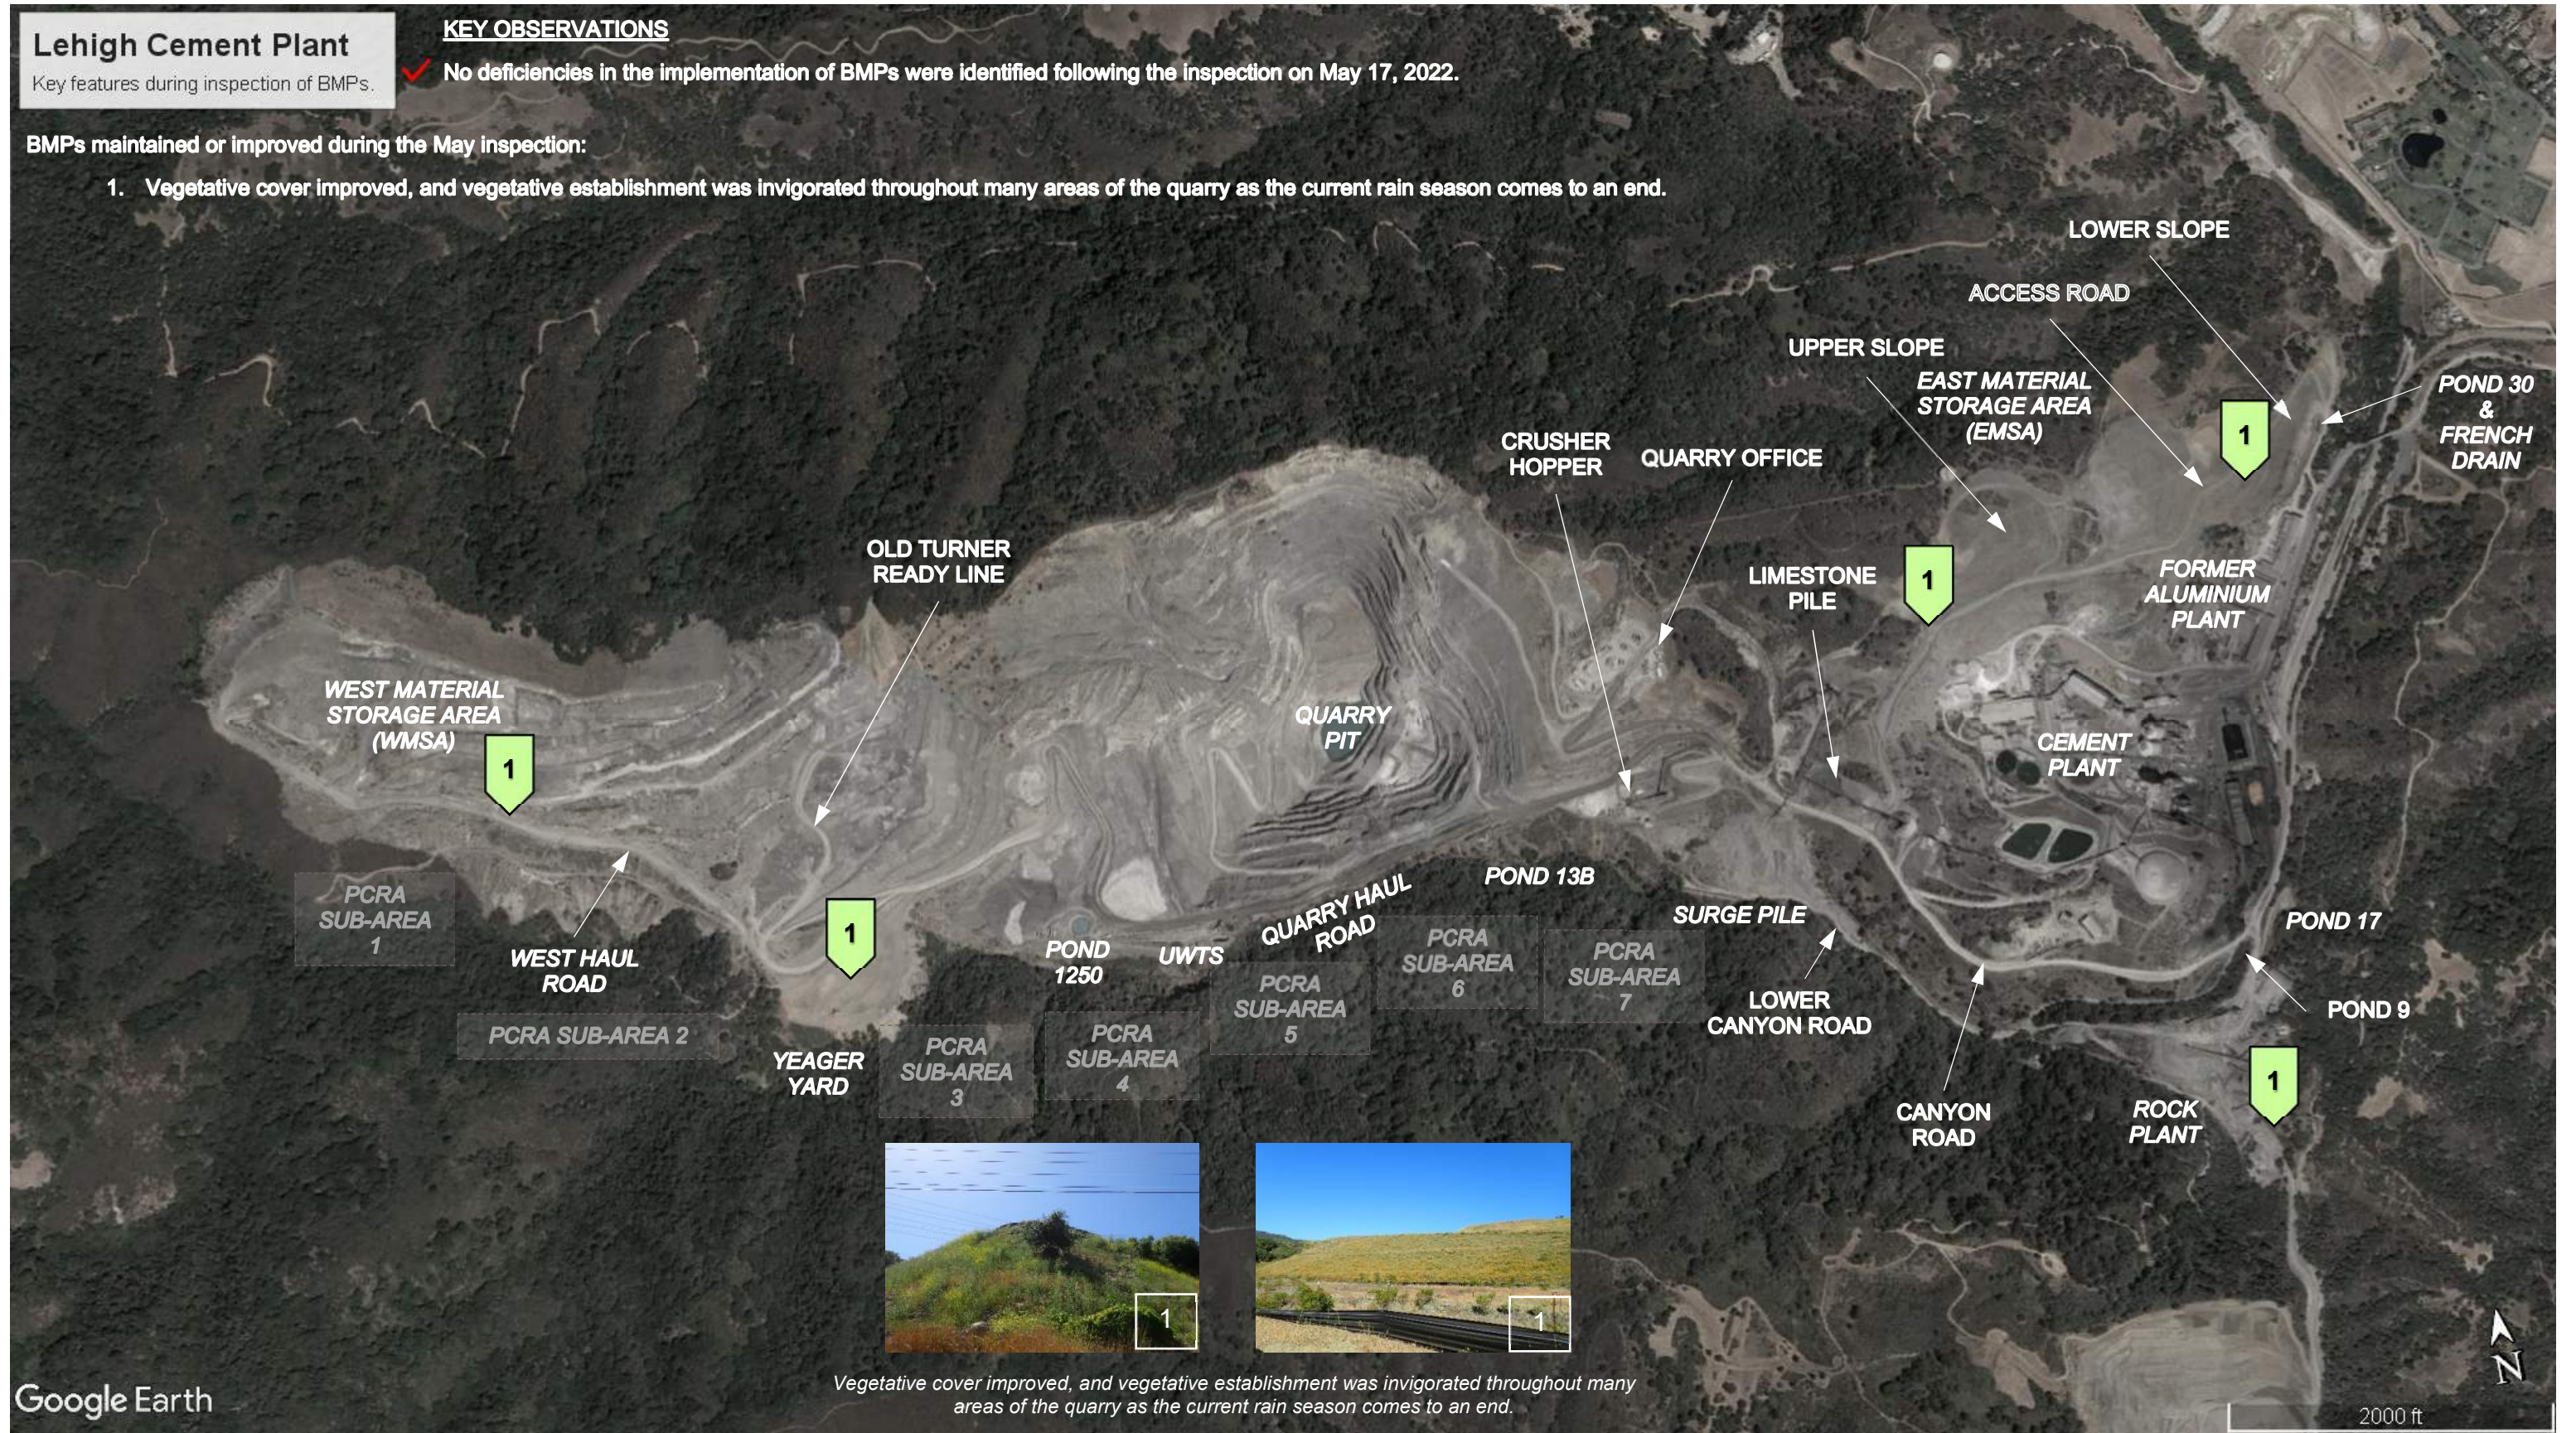
Vegetative cover improved, and vegetative establishment was invigorated throughout many areas of the quarry as the current rain season comes to an end.

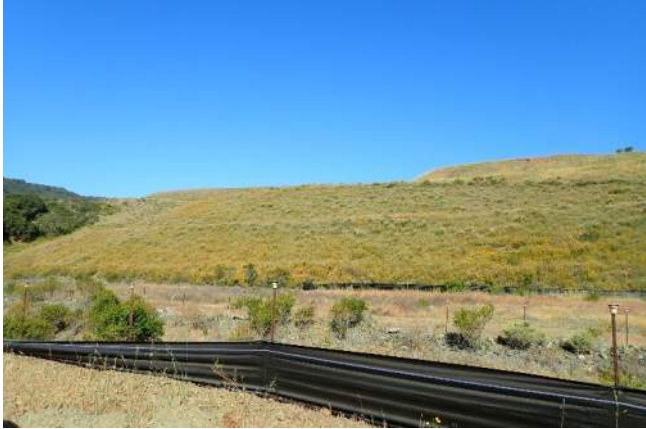
1. Vegetative cover improved, and vegetative establishment was invigorated throughout many areas of the quarry as the current rain season comes to an end. See Photos 0517_01, 0517_04, 0517_07, 0517_08, 0517_10, 0517_12, 0517_14, and 0517_15 in the appended DFR.

PHOTO ID	DESCRIPTION	PHOTO
0517_01	<p>Status: GOOD</p> <p>Location: EMSA – Pond 30 and French Drain</p> <p>Observations: Vegetation has established throughout the EMSA above the silt fences at Pond 30. Silt fences remain in good condition.</p> <p>Recommendations: Routine monitoring of the condition of the straw wattles, silt fences, and vegetative cover in this area.</p>

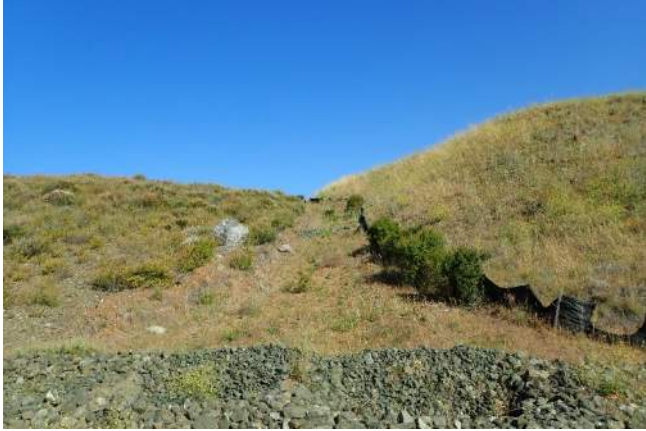
0517_02	<p>Status: GOOD</p> <p>Location: Lower EMSA by Access Road Non-limestone interim cover material storage area</p> <p>Observations: Water bars and rock check-structures are re-established along and upslope from the EMSA access road.</p> <p>Recommendations: Routine monitoring of roadside check structures sedimentation before and after rain events.</p>

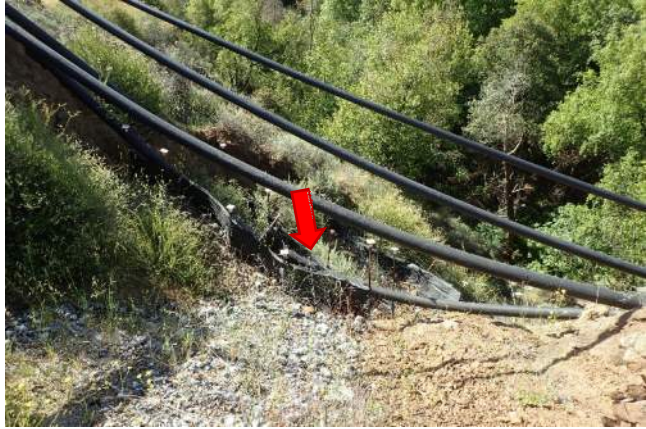
0517_03	<p>Status: MONITOR FOR CHANGES</p> <p>Location: Quarry Haul Road PCRA: 5 and 6</p> <p>Observations: Multiple lines of silt fencing remain in place and in good, functional condition. Debris is being retained behind fencing.</p> <p>Recommendations: Routine monitoring of sedimentation and debris accumulation behind silt fences.</p>
