Lehigh Permanente Quarry Reclamation Plan Amendment Conditions of Approval Compliance

2021-2022 Annual Report Information Package

SANTA CLARA COUNTY, CALIFORNIA

APPENDIX B - 2021-2022 EROSION CONTROL INSPECTION REPORTS

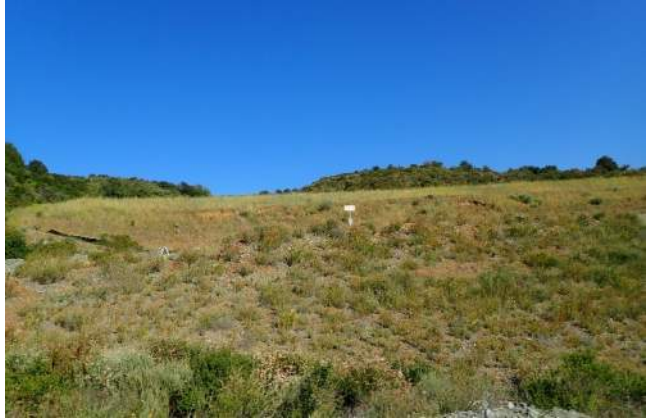
1. Vegetative cover improved, and vegetative establishment was invigorated throughout many areas of the quarry as the current rain season comes to an end. See Photos 0517_01, 0517_04, 0517_07, 0517_08, 0517_10, 0517_12, 0517_14, and 0517_15 in the appended DFR.

PHOTO ID	DESCRIPTION	PHOTO
0517_04	<p>Status: MONITOR FOR CHANGES Location: EMSA Upper Slopes Observations: Upper slopes of the East Material Storage Area (EMSA) remain vegetated. Hydroseeded vegetation has established over the interim cover material stockpile. Recommendations: Routine monitoring of vegetative cover throughout the rain season.</p>

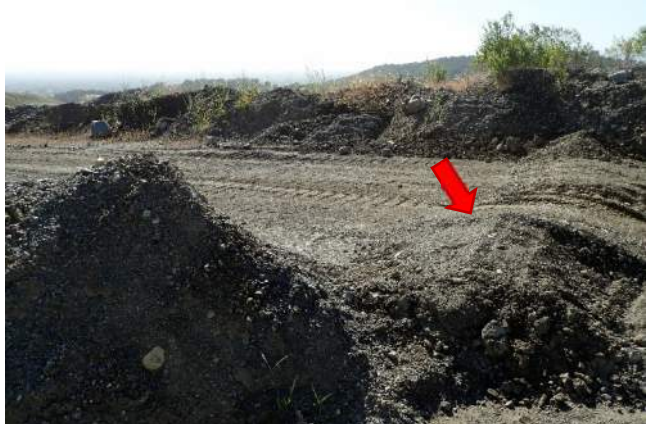
0517_05	<p>Status: MONITOR FOR CHANGES Location: EMSA – Access Road Observations: Water bars are established and draining to the drop inlet. Straw wattles and hay bales remain in place around the drop inlet next to the EMSA access road. Recommendations: Routine monitoring of the condition of water bars and sediment controls: hay bales, wattles.</p>

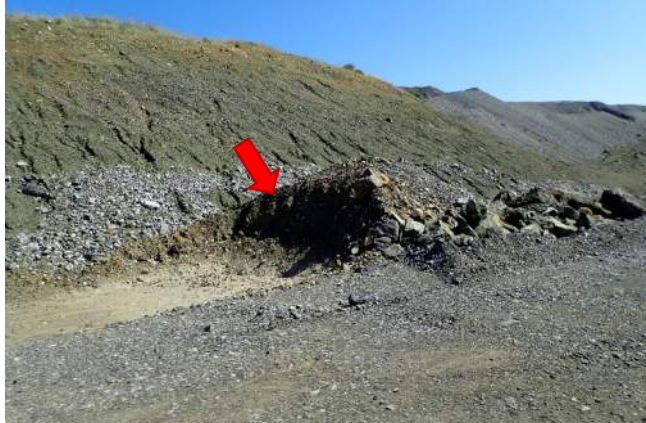
0517_06	<p>Status: MONITOR FOR CHANGES Location: WMSA – Haul Road Observations: Check dams remain in functional condition. Water bars, cross-slope remain in place. Recommendations: Routine monitoring of the sedimentation behind check dams along the Quarry Haul Road to WMSA and re-establish water bars as needed.</p>

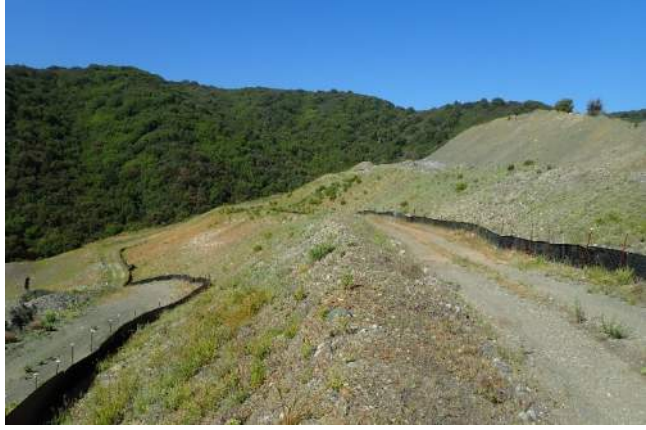
PHOTO ID	DESCRIPTION	PHOTO
0517_07	<p>Status: MONITOR FOR CHANGES</p> <p>Location: Yeager Yard – Upper Slopes PCRA: 2 and 3</p> <p>Observations: Silt fences are in good condition and remain functional. Vegetative cover has established over the upper slopes of the Yeager Yard.</p> <p>Recommendations: Routine monitoring of the vegetative cover on the slopes. Monitor the sediment accumulation on vegetated benches and silt fence condition routinely.</p>

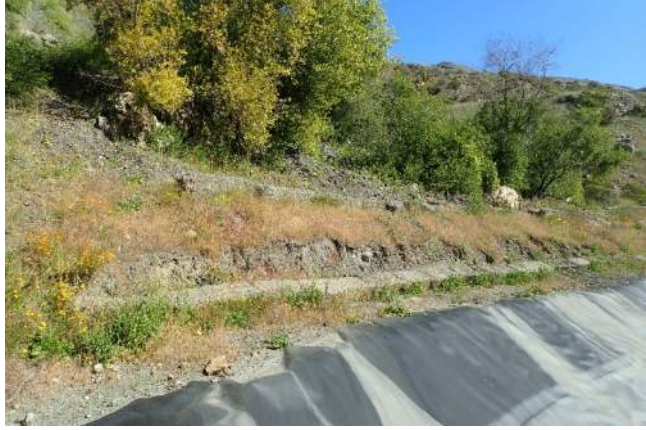
0517_08	<p>Status: MONITOR FOR CHANGES</p> <p>Location: Yeager Yard – Sediment Basin PCRA: 2 and 3</p> <p>Observations: Vegetation has established on the hydroseeded slope. Hay bales and straw wattles remain in place.</p> <p>Recommendations: Routine monitoring of the vegetative cover and BMPs conditions through establishment of hydroseed vegetation.</p>

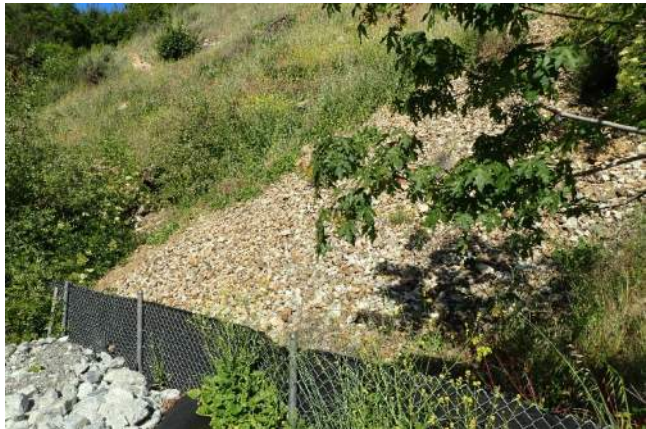
0517_09	<p>Status: GOOD</p> <p>Location: Yeager Yard – Sediment Basin PCRA: 2 and 3</p> <p>Observations: Super silt fence remains in place and in good condition with low levels of sedimentation and debris accumulation.</p> <p>Recommendations: Frequent monitoring of the sedimentation in the sediment capture basin and above the super silt fence; clear debris regularly.</p>

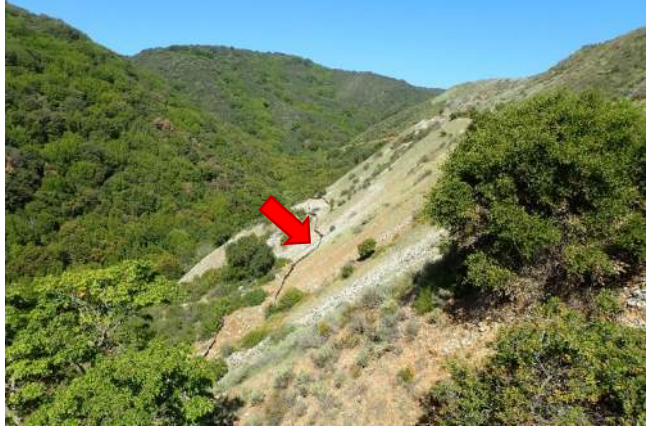
PHOTO ID	DESCRIPTION	PHOTO
0517_10	<p>Status: GOOD</p> <p>Location: PCRA 1 PCRA: 1</p> <p>Observations: Slope below road remains vegetated. Silt fencing continues in good condition.</p> <p>Recommendations: Routine monitoring of the silt fence condition and sedimentation behind lower line of silt fences.</p>

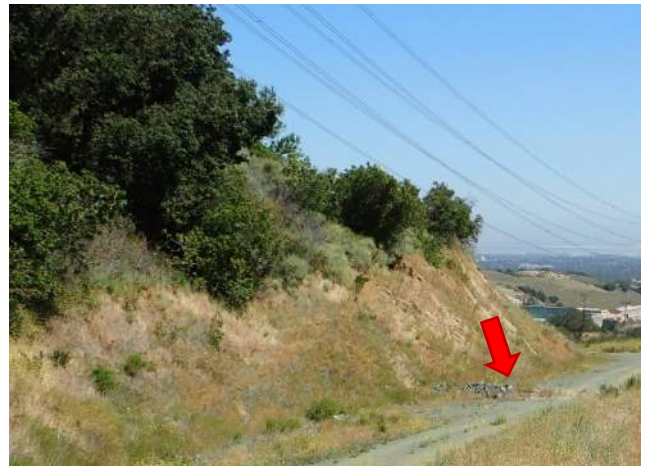
0517_11	<p>Status: MONITOR FOR CHANGES</p> <p>Location: Rock Plant – Improved Existing Access Road</p> <p>Observations: Water bars were re-established along the access road by the Rock Plant.</p> <p>Recommendations: Routine monitoring of the condition of the water bars and check dams and vegetative cover throughout the rain season.</p>

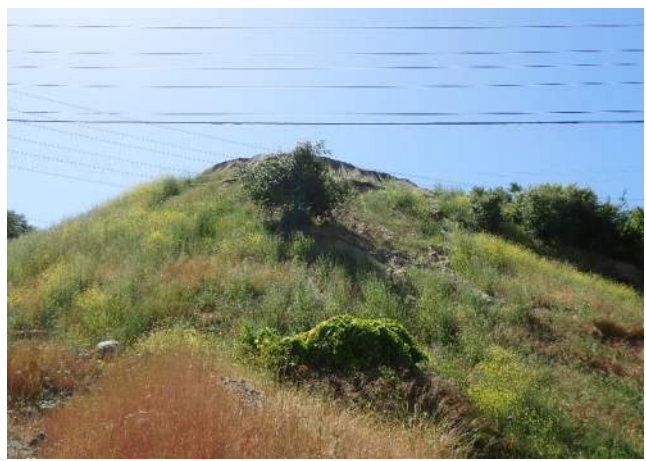
0517_12	<p>Status: GOOD</p> <p>Location: Rock Plant – Roadside Slope</p> <p>Observations: Jute matting and straw wattles remain in alignment and continuous around the hydroseeded slope at the Rock Plant.</p> <p>Recommendations: Routine monitoring of the sedimentation of the rock-lined features and the condition of the jute matting and straw wattles. Adjust wattles as needed to achieve intended alignment and continuity.</p>

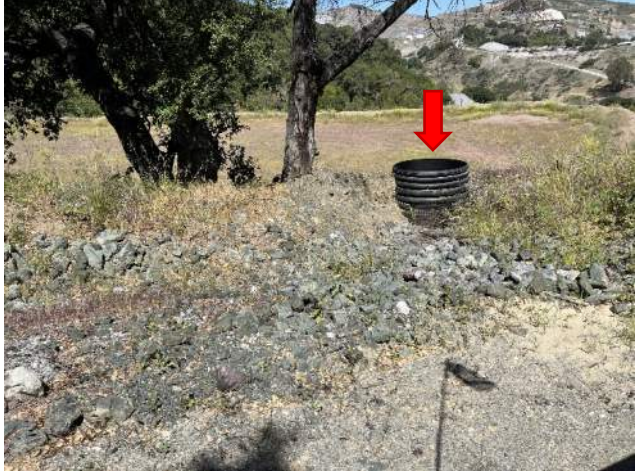
PHOTO ID	DESCRIPTION	PHOTO
0517_13	<p>Status: MONITOR FOR CHANGES</p> <p>Location: Rock Plant – Improved Existing Access Road</p> <p>Observations: Drop inlet and rock-lined apron are clear of significant debris and remain functional. The drop inlet pipe is clear of sediment.</p> <p>Recommendations: Routine monitoring of the sedimentation and debris accumulation inside the drop inlet pipe and stilling basin.</p>

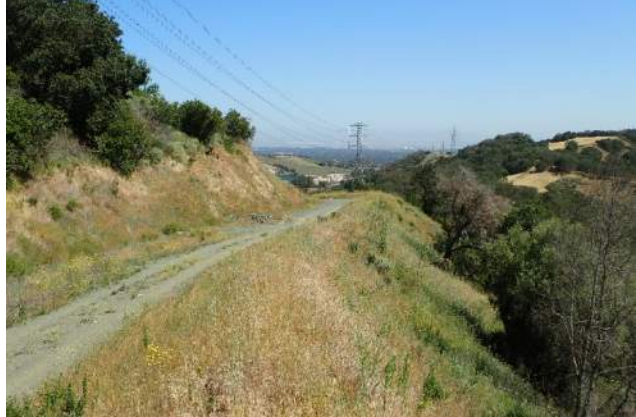
0517_14	<p>Status: MONITOR FOR CHANGES</p> <p>Location: Rock Plant – Improved Existing Access Road</p> <p>Observations: Roadside rock berm remains in place and vegetated. Vegetative cover is established over the slopes below the road and berm.</p> <p>Recommendations: Routine monitoring of rock-lined features, cross-slope throughout the rain season.</p>

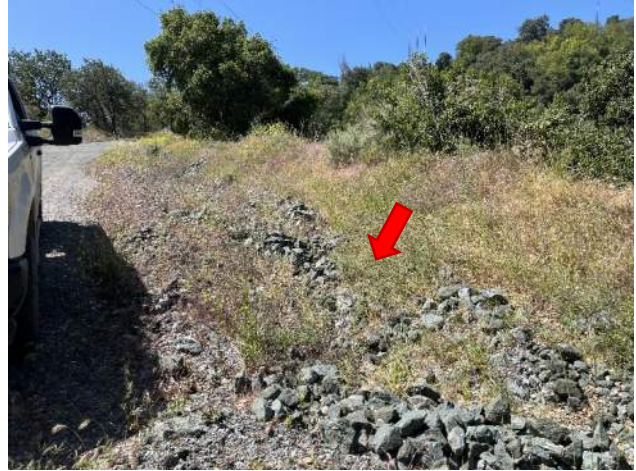
0517_15	<p>Status: GOOD</p> <p>Location: Rock Plant – Roadside ditch and Slope</p> <p>Observations: Roadside rock-lined ditches remain in place and maintain positive drainage. Vegetation has established in the adjacent slopes.</p> <p>Recommendations: Routine monitoring of vegetative cover and roadside sediment accumulation.</p>

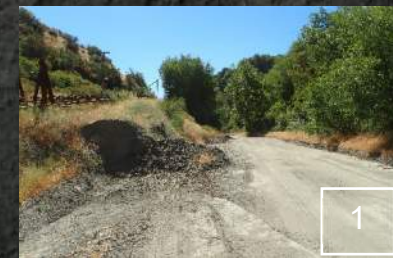
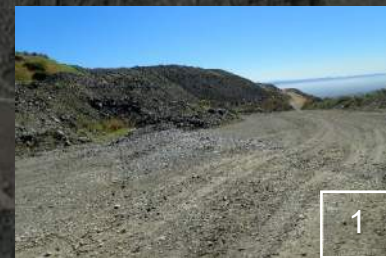
Check dams and water bars remain functional along the EMSA access road, West Haul Road towards the WMSA, and the Rock Plant access road.

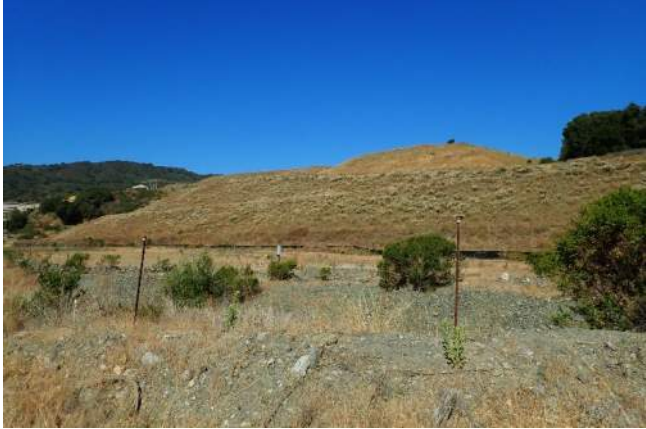
PHOTO ID	DESCRIPTION	PHOTO
0628_01	<p>Status: GOOD</p> <p>Location: EMSA – Pond 30 and French Drain</p> <p>Observations: Vegetation has established throughout the EMSA above the silt fences at Pond 30. Silt fences remain in good condition.</p> <p>Recommendations: Routine monitoring of the condition of the straw wattles, silt fences, and vegetative cover in this area.</p>

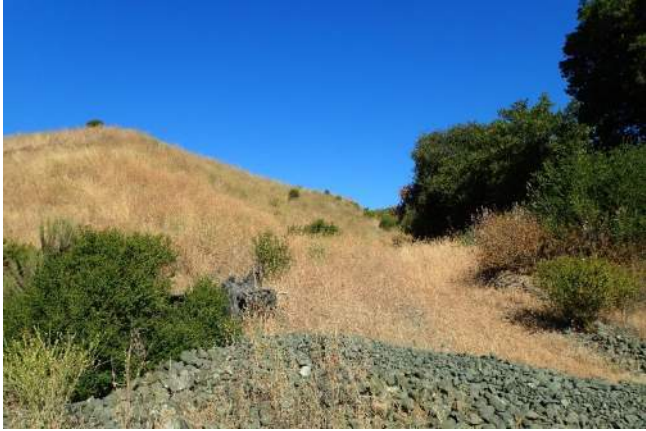
0628_02	<p>Status: GOOD</p> <p>Location: Lower EMSA by Access Road Non-limestone interim cover material storage area</p> <p>Observations: Water bars and rock check-structures are re-established along and upslope from the EMSA access road.</p> <p>Recommendations: Routine monitoring of roadside check structures sedimentation throughout the dry season.</p>

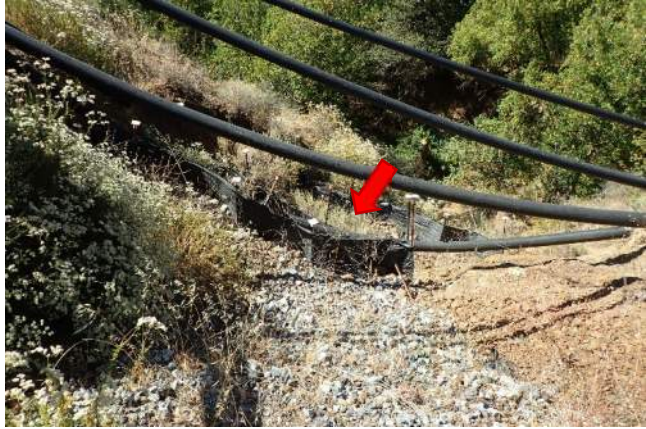
0628_03	<p>Status: MONITOR FOR CHANGES</p> <p>Location: Quarry Haul Road PCRA: 5 and 6</p> <p>Observations: Multiple lines of silt fencing remain in place and in good, functional condition. Debris is being retained behind fencing.</p> <p>Recommendations: Routine monitoring of sedimentation and debris accumulation behind silt fences.</p>

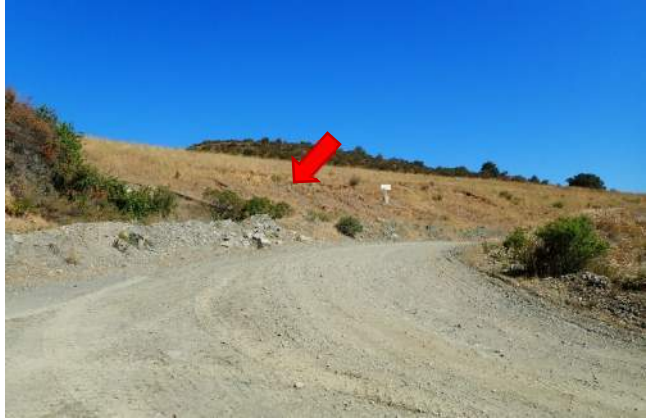
PHOTO ID	DESCRIPTION	PHOTO
0628_04	<p>Status: MONITOR FOR CHANGES Location: EMSA Upper Slopes Observations: Upper slopes of the East Material Storage Area (EMSA) remain vegetated. Hydroseeded vegetation has established over the interim cover material stockpile. Recommendations: Routine monitoring of vegetative cover throughout the dry season.</p>

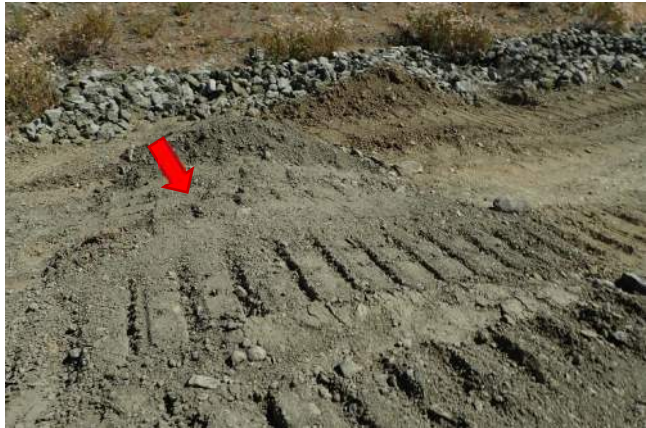
0628_05	<p>Status: MONITOR FOR CHANGES Location: EMSA – Access Road Observations: Water bars are established and draining to the drop inlet. Straw wattles and hay bales remain in place around the drop inlet next to the EMSA access road. Recommendations: Routine monitoring of the condition of water bars and sediment controls: hay bales, wattles.</p>

1. Water bars remain functional along the access roads at the East and West Material Storage Areas (EMSA, WMSA) and at the Rock Plant. See Photos 0628_05, 0628_06, 0628_11, and 0628_14 in the appended DFR.
2. Straw wattles were replaced at Pond 13B. Vegetative cover remains established in the vicinity of the new straw wattles. See Photo 0628_12 in the appended DFR.

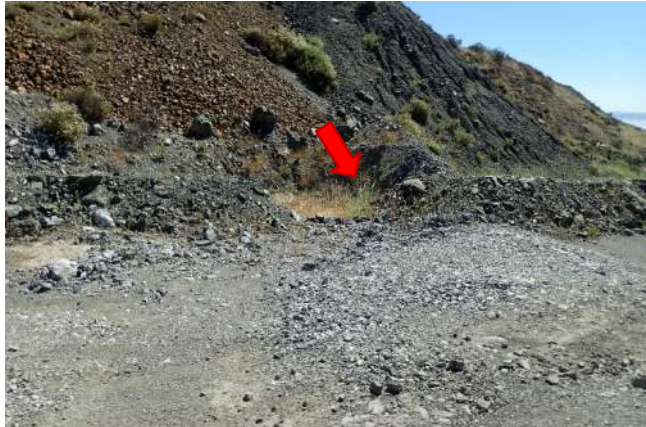
0628_06	<p>Status: MONITOR FOR CHANGES Location: WMSA – Haul Road Observations: Check dams remain in functional condition. Water bars, cross-slope remain in place. Recommendations: Routine monitoring of the sedimentation behind check dams along the Quarry Haul Road to WMSA and re-establish water bars as needed.</p>

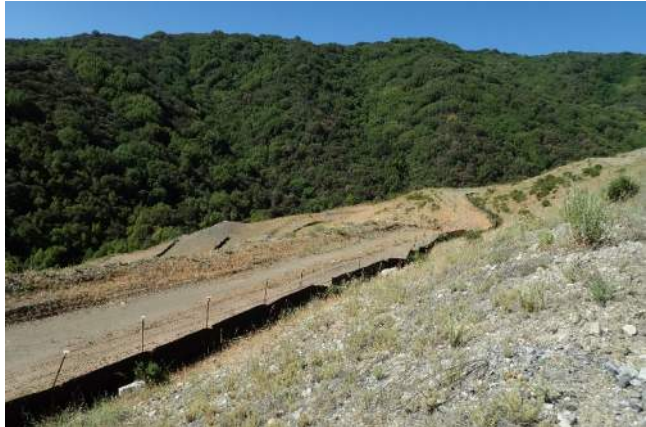
PHOTO ID	DESCRIPTION	PHOTO
0628_07	<p>Status: MONITOR FOR CHANGES</p> <p>Location: Yeager Yard – Upper Slopes PCRA: 2 and 3</p> <p>Observations: Silt fences are in good condition and remain functional. Vegetative cover has established over the upper slopes of the Yeager Yard.</p> <p>Recommendations: Routine monitoring of the vegetative cover on the slopes. Monitor the sediment accumulation on vegetated benches and silt fence condition routinely.</p>

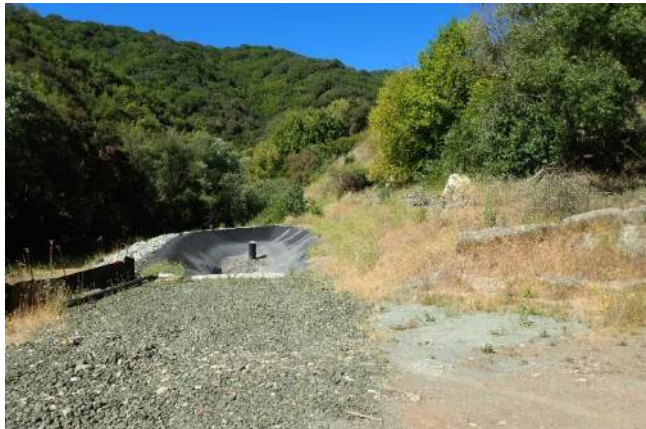
0628_08	<p>Status: MONITOR FOR CHANGES</p> <p>Location: Yeager Yard – Sediment Basin PCRA: 2 and 3</p> <p>Observations: Vegetation has established on the hydroseeded slope. Hay bales and straw wattles remain in place.</p> <p>Recommendations: Routine monitoring of the vegetative cover and BMPs conditions through establishment of hydroseed vegetation.</p>

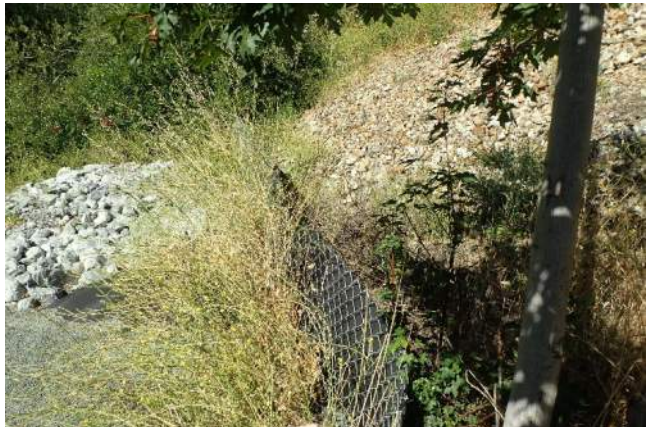
0628_09	<p>Status: GOOD</p> <p>Location: Yeager Yard – Sediment Basin PCRA: 2 and 3</p> <p>Observations: Super silt fence remains in place and in good condition with low levels of sedimentation and debris accumulation.</p> <p>Recommendations: Frequent monitoring of the sedimentation in the sediment capture basin and above the super silt fence; clear debris regularly.</p>

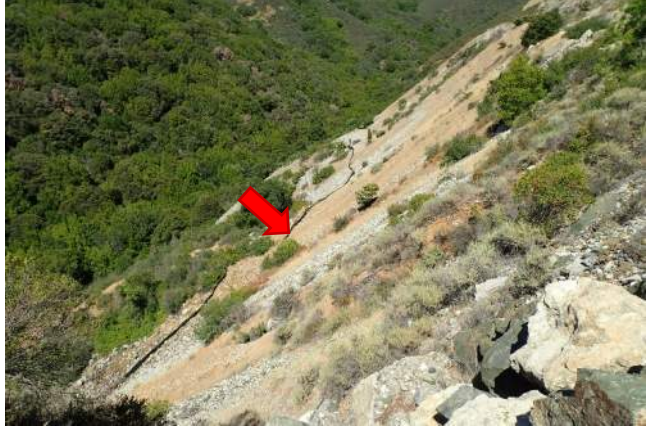
PHOTO ID	DESCRIPTION	PHOTO
0628_10	<p>Status: GOOD</p> <p>Location: PCRA 1 PCRA: 1</p> <p>Observations: Slope below road remains vegetated. Silt fencing continues in good condition.</p> <p>Recommendations: Routine monitoring of the silt fence condition and sedimentation behind lower line of silt fences.</p>

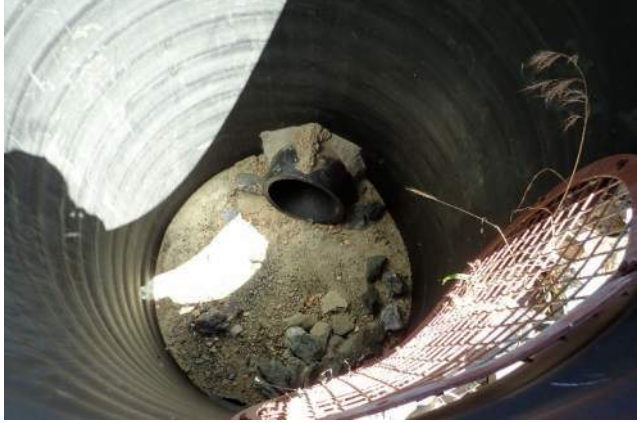
PHOTO ID	DESCRIPTION	PHOTO
0628_13	<p>Status: MONITOR FOR CHANGES</p> <p>Location: Rock Plant – Improved Existing Access Road</p> <p>Observations: Drop inlet and rock-lined apron are clear of significant debris and remain functional. The drop inlet pipe is clear of sediment.</p> <p>Recommendations: Routine monitoring of the sedimentation and debris accumulation inside the drop inlet pipe and stilling basin.</p>

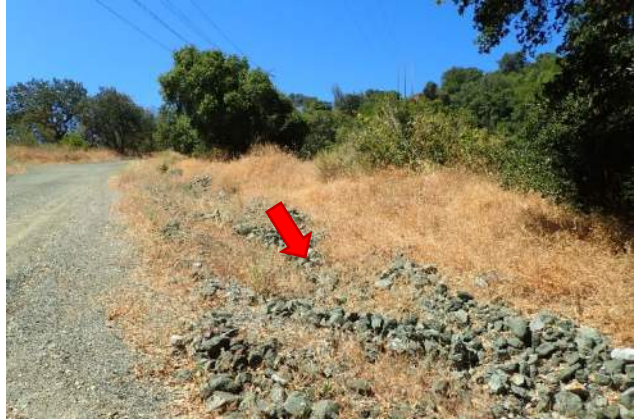
0628_14	<p>Status: GOOD</p> <p>Location: Rock Plant – Roadside ditch and Slope</p> <p>Observations: Roadside rock-lined ditches remain in place and maintain positive drainage. Vegetation has established in the adjacent slopes.</p> <p>Recommendations: Routine monitoring of vegetative cover and roadside sediment accumulation.</p>

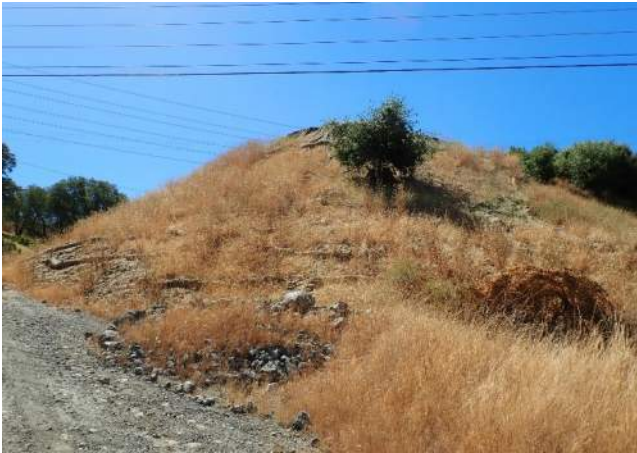
0628_15	<p>Status: GOOD</p> <p>Location: Rock Plant – Roadside Slope</p> <p>Observations: Jute matting and straw wattles remain in alignment and continuous around the hydroseeded slope at the Rock Plant.</p> <p>Recommendations: Routine monitoring of the sedimentation of the rock-lined features and the condition of the jute matting and straw wattles. Adjust wattles as needed to achieve intended alignment and continuity.</p>

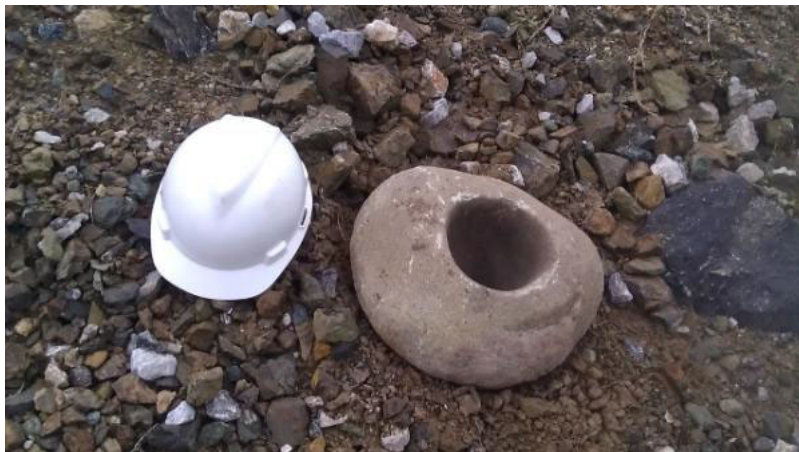
Figure 1. A grinding stone or 'metate' found on Permanente Quarry property.

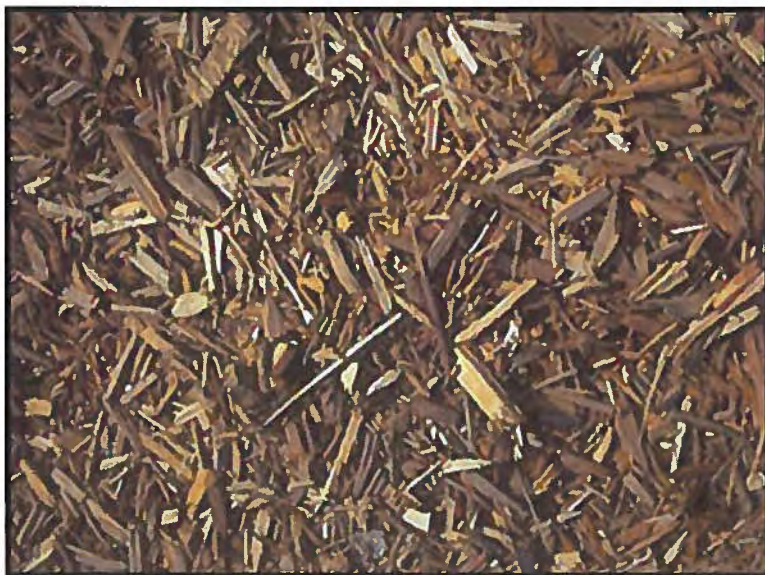
Description and Purpose

Non-vegetative stabilization methods are used for temporary or permanent stabilization of areas prone to erosion and should be used only where vegetative options are not feasible; examples include:

There are several non-vegetative stabilization methods and selection should be based on site-specific conditions.

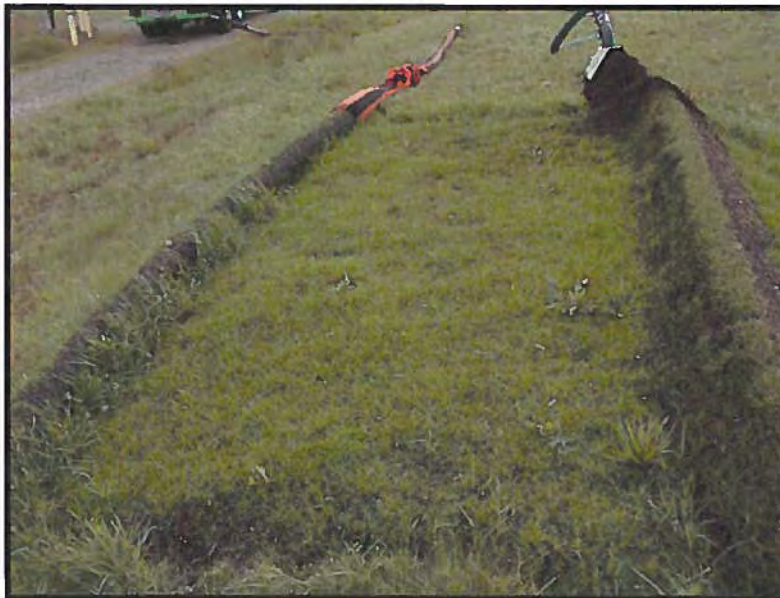
Description and Purpose

Compost socks and berms act as three-dimensional biodegradable filtering structures to intercept runoff where sheet flow occurs and are generally placed at the site perimeter or at intervals on sloped areas. Compost socks are generally a mesh sock containing compost and a compost berm is a dike of compost, trapezoidal in cross section. When employed to intercept sheet flow, both BMPs are placed perpendicular to the flow of runoff, allowing filtered runoff to pass through the compost and retaining sediment (and potentially other pollutants). A compost sock can be assembled on site by filling a mesh sock (e.g. with a pneumatic blower). The compost berm should be constructed using a backhoe or equivalent and/or a pneumatic delivery (blower) system and should be properly compacted. Compost socks and berms act as filters, reduce runoff velocities, and in some cases, aid in establishing vegetation.

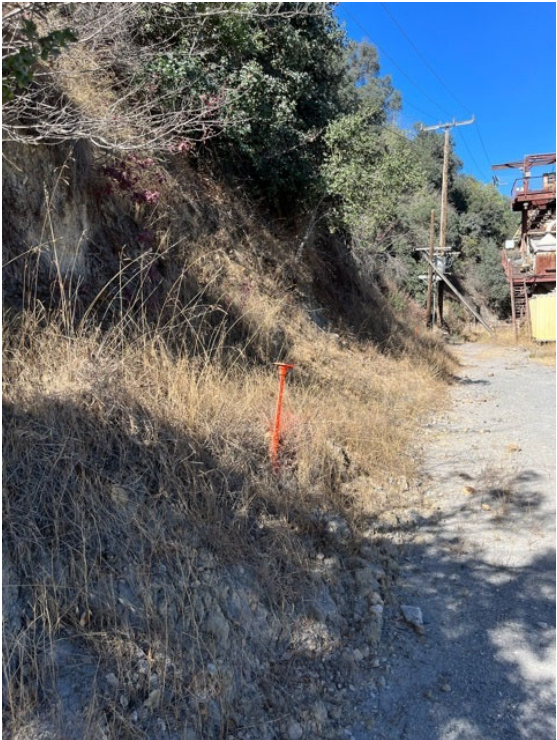
Rock Plant

Pictures of RPA Boundary Demarcation in the Rock Plant, EMSA and WMSA.
