**Re: Observations from Inspection of Silt Fences at the Yeager Yard
Lehigh Southwest Cement Company–Permanente Plant
Cupertino, California**

Photo Log

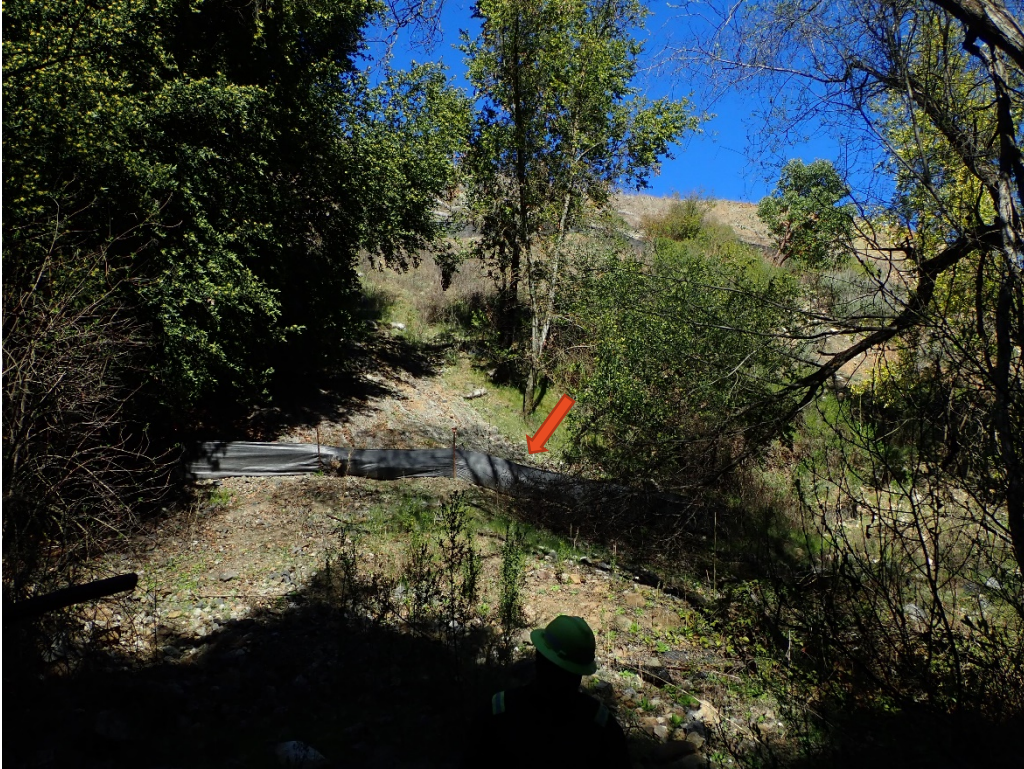
Photo 1. Silt fence above Permanente Creek on the lower slopes west of sediment capture basin.

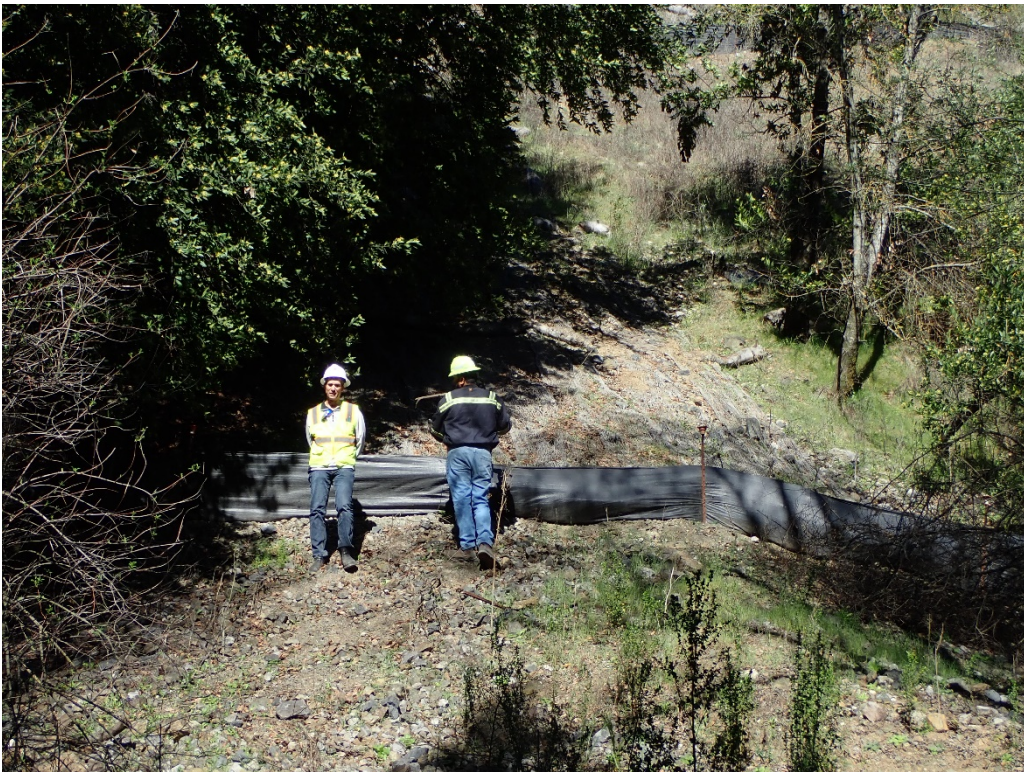
Photo 2. Detail of silt fence above Permanente Creek on the lower slopes west of sediment capture basin.

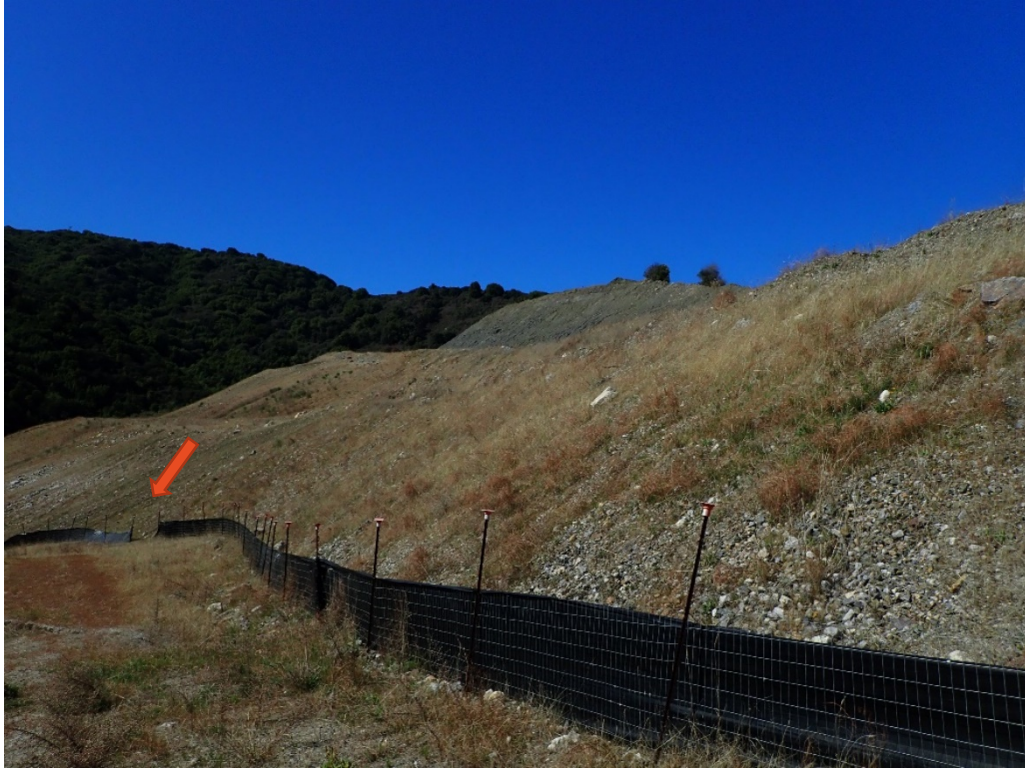
On March 3, 2020, GEI conducted a site walk to observe the condition of the existing silt fences throughout the Yeager Yard. GEI and Lehigh representatives identified silt fences to be repaired, removed, or replaced over the upper slopes of the Yeager Yard as well as along Permanente Creek at the toe of the Yeager Yard slopes. GEI noted that hydroseeded vegetation has established over the upper slopes of the Yeager Yard and this vegetation prevents erosion and reduces sedimentation by providing ground cover and reducing surface flow velocities over the slopes; see photos 1 and 2 of the Photo Log for reference. GEI also observed that the silt fence fabric had fallen off the wire backing on a few short segments of fencing on the upper slopes of the Yeager Yard, and that certain segments of silt fencing installed over the upper slopes of the Yeager Yard were downed or otherwise not performing as initially intended; see photos 3 and 4 of the Photo Log for reference.

Photo 3. Silt fence on upper slopes of the Yeager Yard. Short segment of silt fence fabric is down below hydroseeded slopes with established vegetation.

1. Where silt fence fabric has fallen off of the wire mesh backing, the operator should re-tie the silt fencing to the support wire and make any needed repairs to prevent runoff from breaching these sediment control structures.
2. The silt fencing BMPs that are no longer performing as intended should be removed because the wire fencing and poles could become a hazard, but care must be taken to not

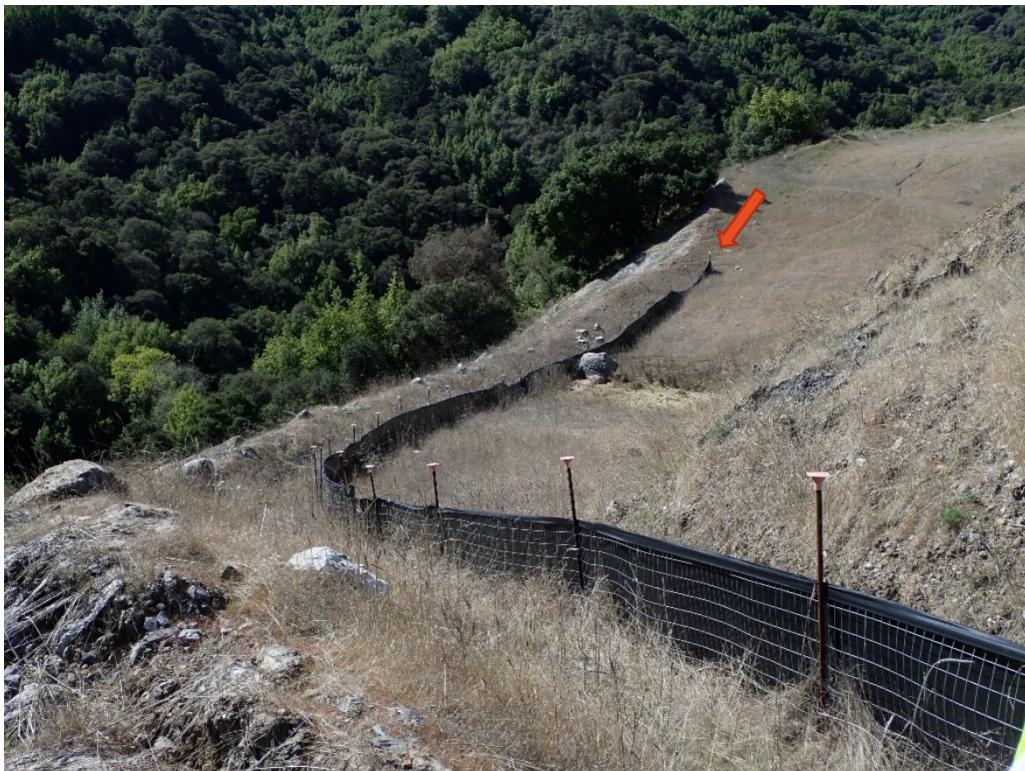
Photo 4. Silt fence on upper slopes of the Yeager Yard. Short segment of silt fence is down below hydroseeded slopes with established vegetation.

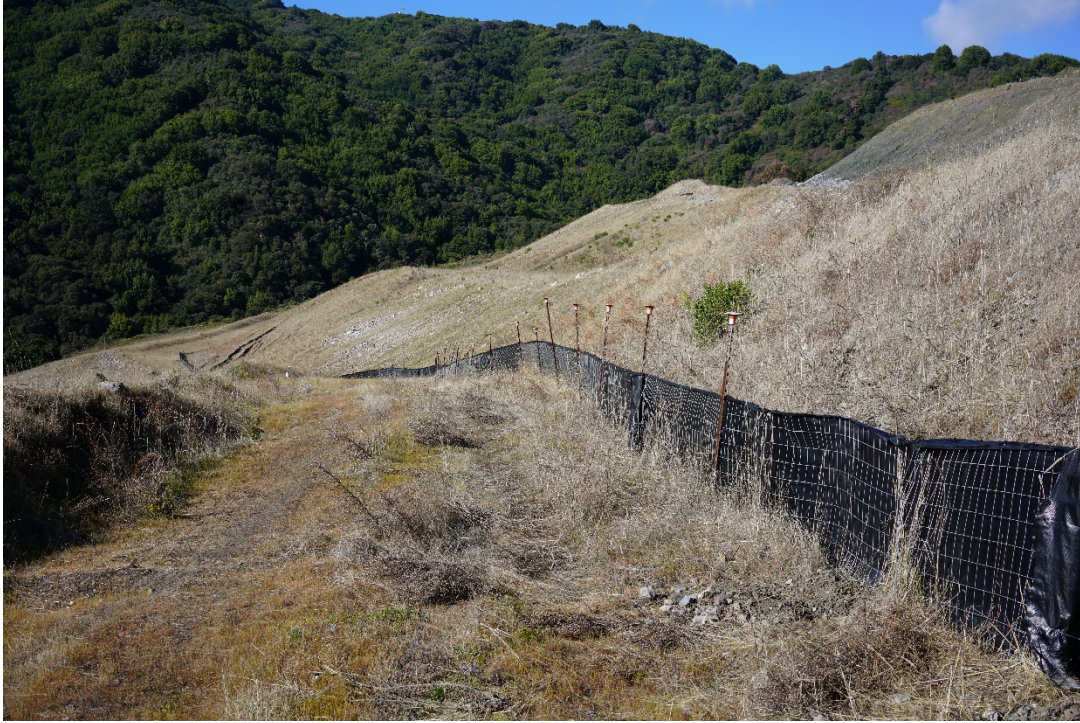
Photo 5. Silt fence on upper slopes of the Yeager Yard. Short segment of silt fence fabric is down below hydroseeded slopes with established vegetation.

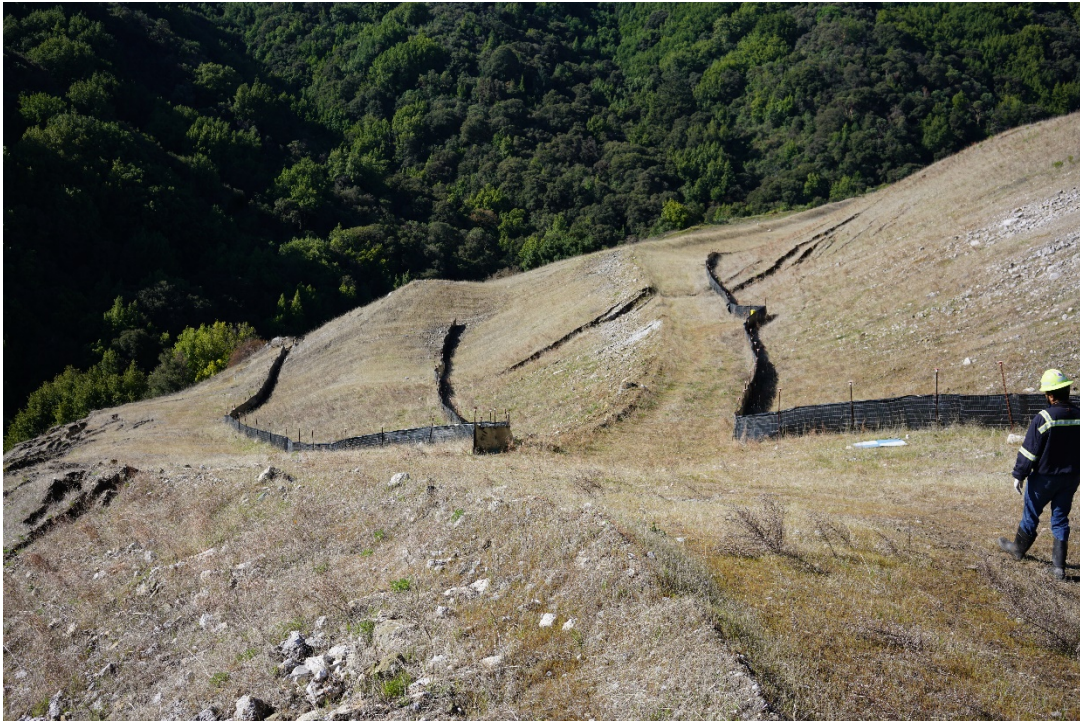
Photo 6. Silt fences on upper slopes of the Yeager Yard. All silt fences on the upper slopes of the Yeager Yard were repaired, or removed where no longer functional.

1. A couple lines of silt fencing and T-posts that were no longer performing as intended were removed from the vegetated upper slopes of the Yeager Yard. See photo 6 in the photo log.
2. All lines of silt fencing that remained over the upper benches of the Yeager Yard were maintained, re-tied to the wire backing and replaced where necessary. See photos 5 and 6 in the photo log.
3. GEI and Lehigh identified the segments of silt fencing along and above Permanente Creek to be replaced and repaired. See photos 7 and 8 in the photo log.

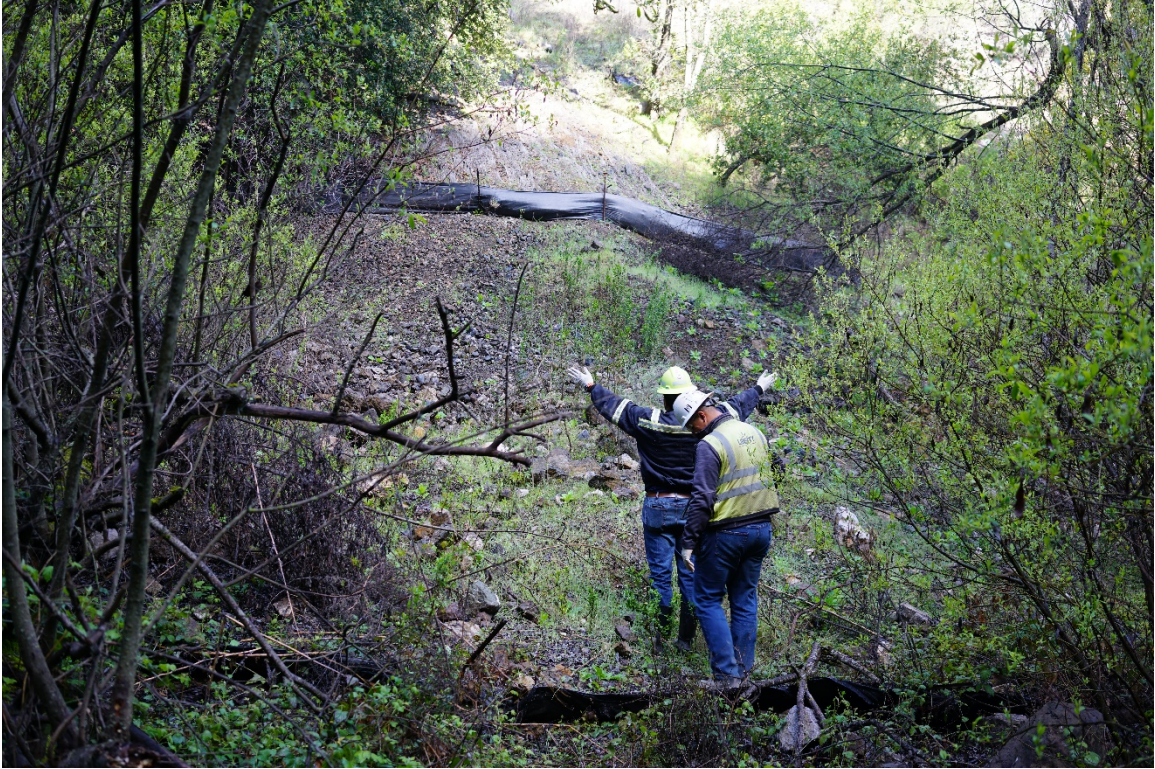
Photo 7. Detail of silt fence above Permanente Creek on the lower slopes west of sediment capture basin.

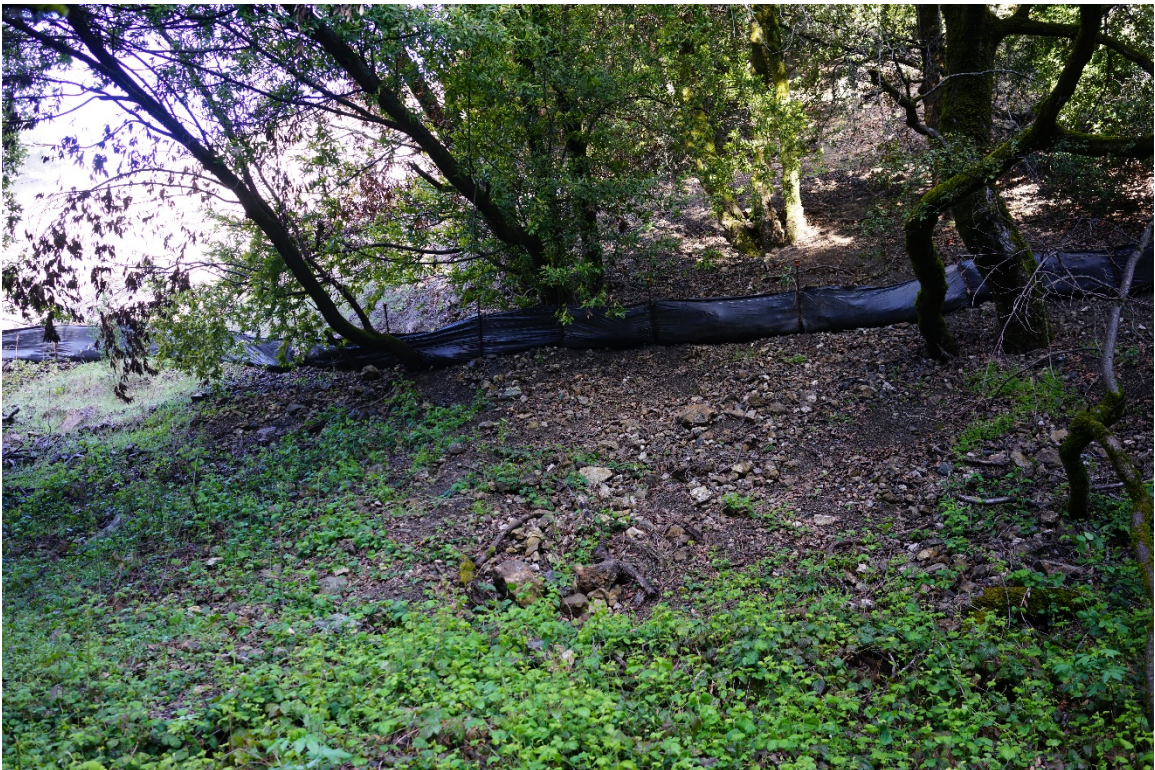
Photo 8. Silt fence above Permanente Creek on the lower slopes west of sediment capture basin.

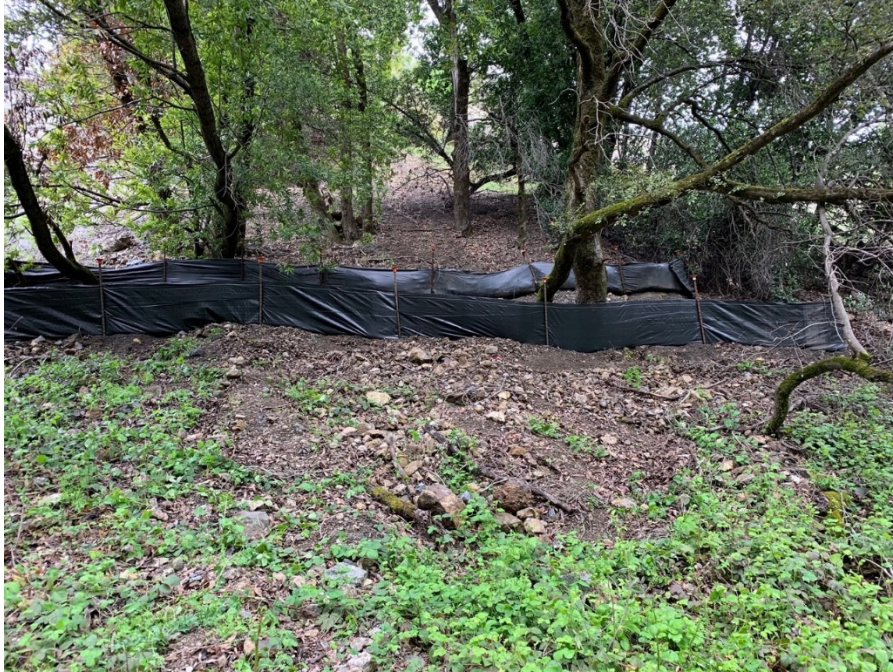
Photo 9. Additional line of silt fencing installed downslope from the existing silt fence above Permanente Creek on the lower slopes west of sediment capture basin.

1. Additional lines of silt fencing and T-posts were installed adjacent to existing silt fencing as a second line of defense in the lower slopes of the Yeager Yard above Permanente Creek to the west of the sediment capture basin in case of future toppling or failure of the existing silt fencing. See photos 9 through 11 on the photo log.

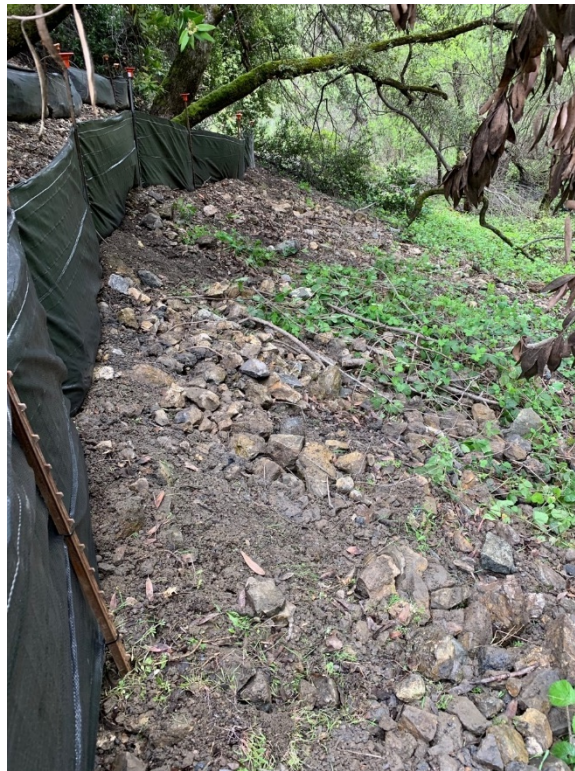
Photo 10. Detail of additional line of silt fencing installed downslope from the existing silt fence above Permanente Creek on the lower slopes west of sediment capture basin.

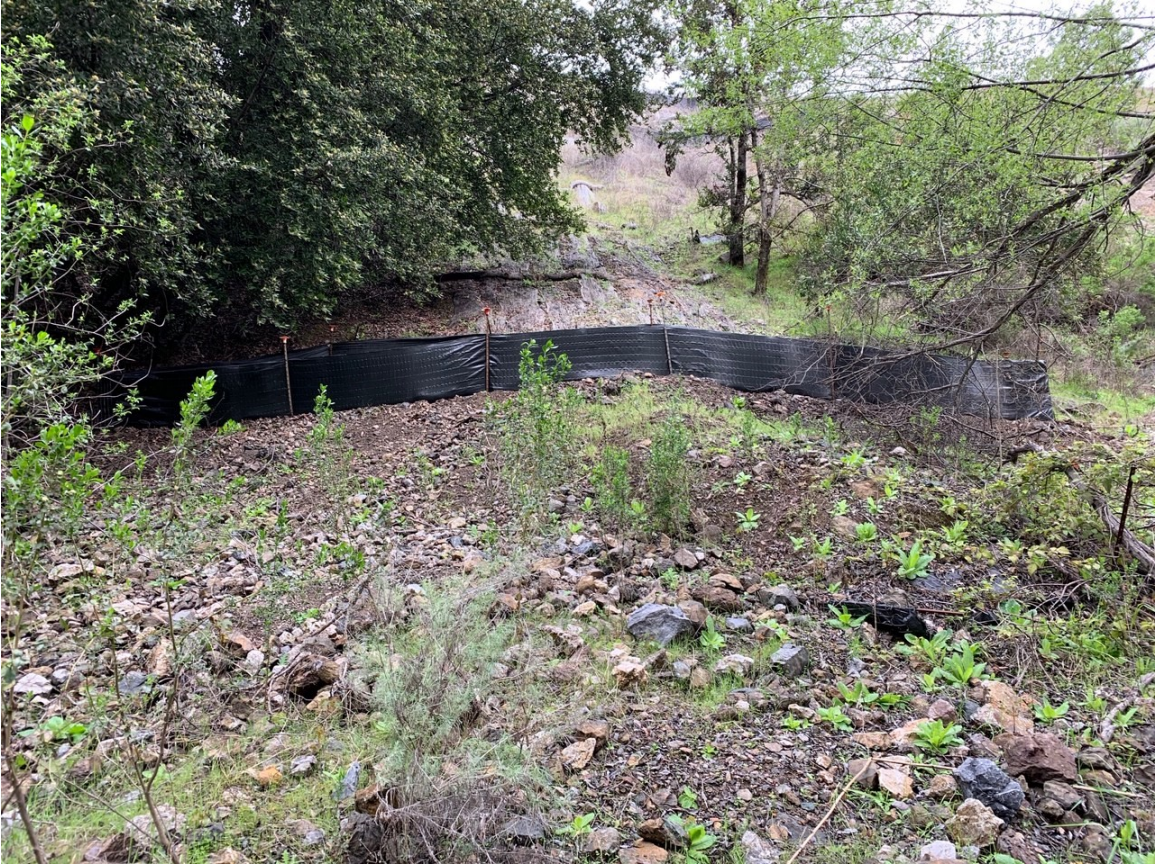
Photo 11. Detail of additional line of silt fencing installed upslope from the existing silt fence above Permanente Creek on the lower slopes west of sediment capture basin.
