SURFACE MINING INSPECTION REPORT

| I. Mine Name (As Shown on Approved Reclamation Plan) Permanente Quarry | Inspection Date: 9/26 & 9/27, 2013 | CA MINE ID# 91- 43-0004 |

This letter report summarizes the findings of PMC's annual Surface Mining and Reclamation Act (SMARA) site inspection of the Permanente Quarry in Cupertino, CA (Mine ID #91-43-0004) conducted on September 26 and 27, 2013. PMC was retained by Santa Clara County to assist County staff with the annual SMARA mine inspection and to provide written documentation of our observations, issues of concern and recommendations.

2013 SMARA INSPECTION PHOTOS

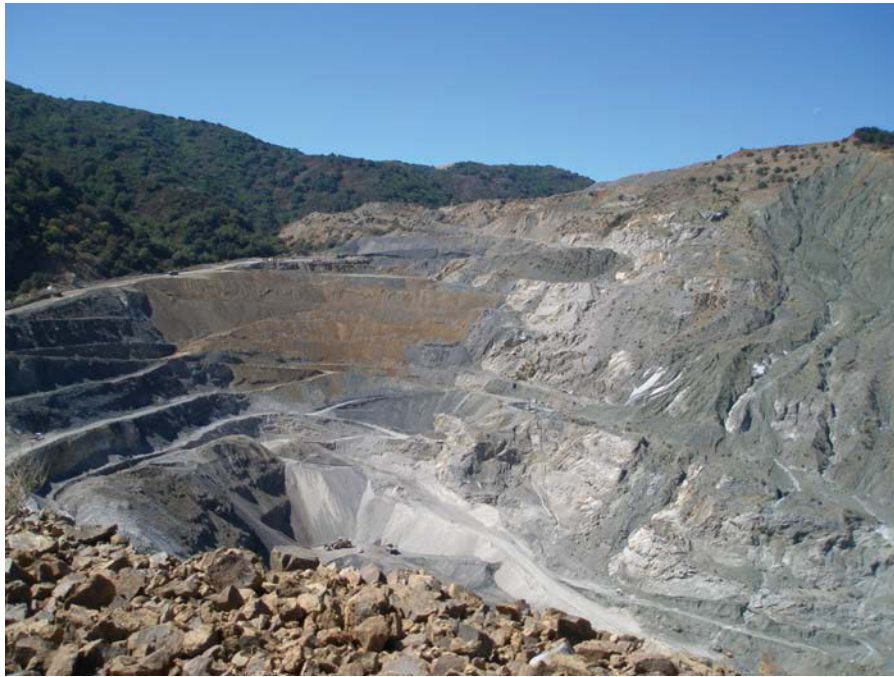
Photo 1: North Quarry, southwest portion. Waste rock material being placed at toe of western slope. Potential “Haul Road Slide” in eastern slope of WMSA, right of image. Floor elevation of quarry at approximately 725 feet msl. Dated September 26, 2013.

A fourth apparent landslide occurs on the western side of the pit. This area of movement was noted by Golder and Associates in their November 2007 Slope Stability Evaluation report and may extend westward below the toe of the eastern slope of the WMSA overburden stockpile (right center of Photo 1). The County's Geologist, Mr. James Baker, referred to this western landslide as the "Haul Road Slide." The placement of overburden backfill against the western toe of the North Quarry is intended to stabilize this slide.

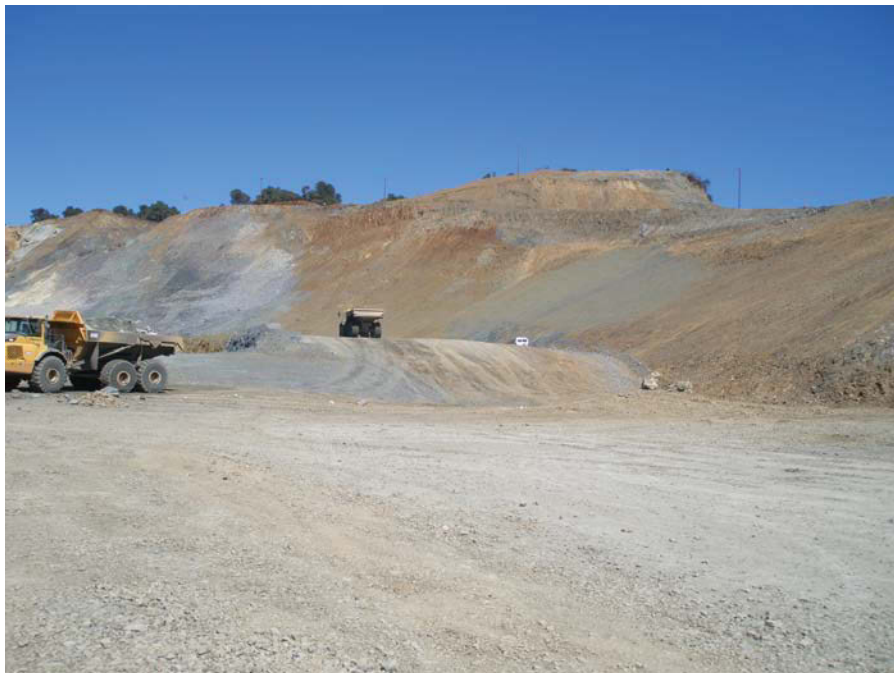
Photo 2: Upper portion of eastern highwall of North Quarry with slopes at final grade. First bench being cut to elevation at right side of photo. Dated September 26, 2013.

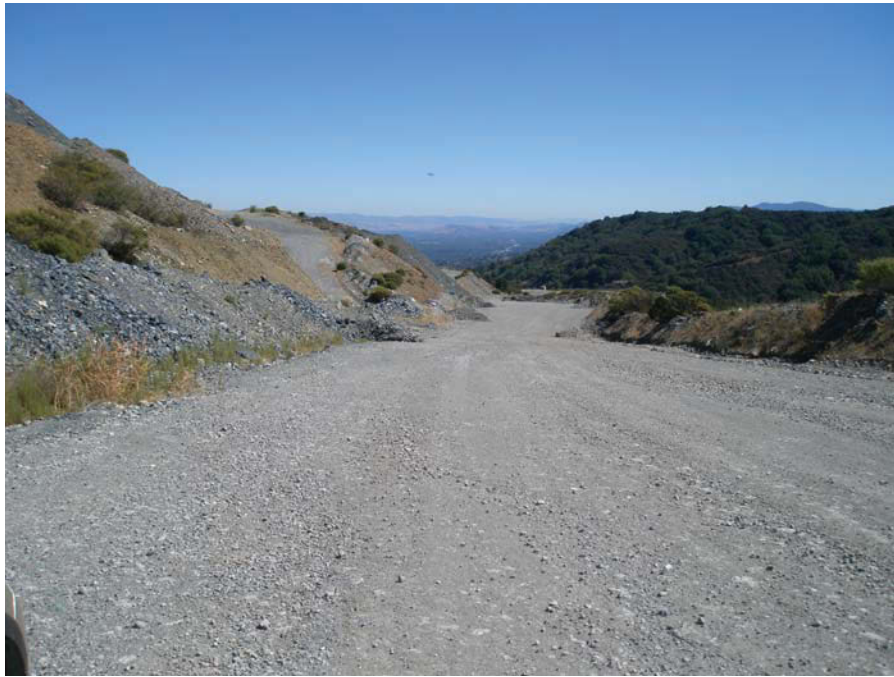
Photo 3: Check dams on WMSA haul road that were replaced with non-limestone materials, looking eastward. Dated September 26, 2013.

As part of the site's stormwater management, numerous rock checkdams have been placed along the haul roads. However, the rock material initially used for these checkdams was limestone. To mitigate the potential for selenium to leach, the operator replaced the limestone check dams with greenstone or other non-limestone rock (Photo 3).

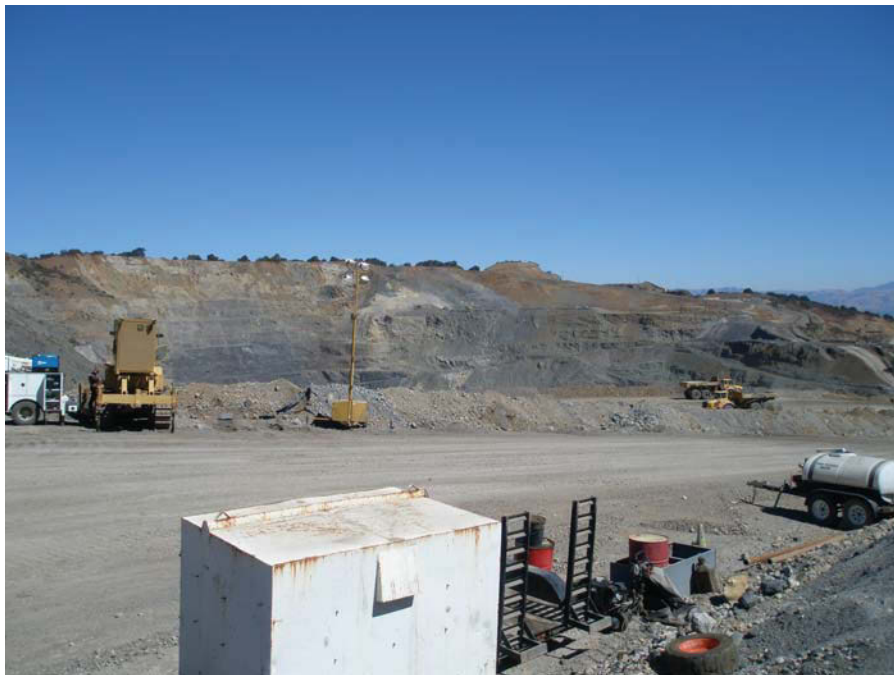
Photo 4: Looking northeast at the North Quarry. Mid-Pen Rockslide area at in center of image being removed by recent mining. Dated September 26, 2013

The northern highwall of the North Quarry has had three large rockslides, which are described in the RPA. No major new movement on these rockslides was observed during the 2013 inspection. The Mid-Pen Rockslide that extended approximately halfway down the eastern highwall is being graded out as part of the mining (Photo 4). The Scenic Easement Rockslide has a slope failure that extends down slope approximately as far as the Mid-Pen Rockslide (Photo 5). This rockslide lowered the ridgeline contrary to the 1972 Ridgeline Protection Easement requirement. The largest slide, the Main Rockslide, appears to extend across most of the current height of the northwestern highwall (Photo 6).

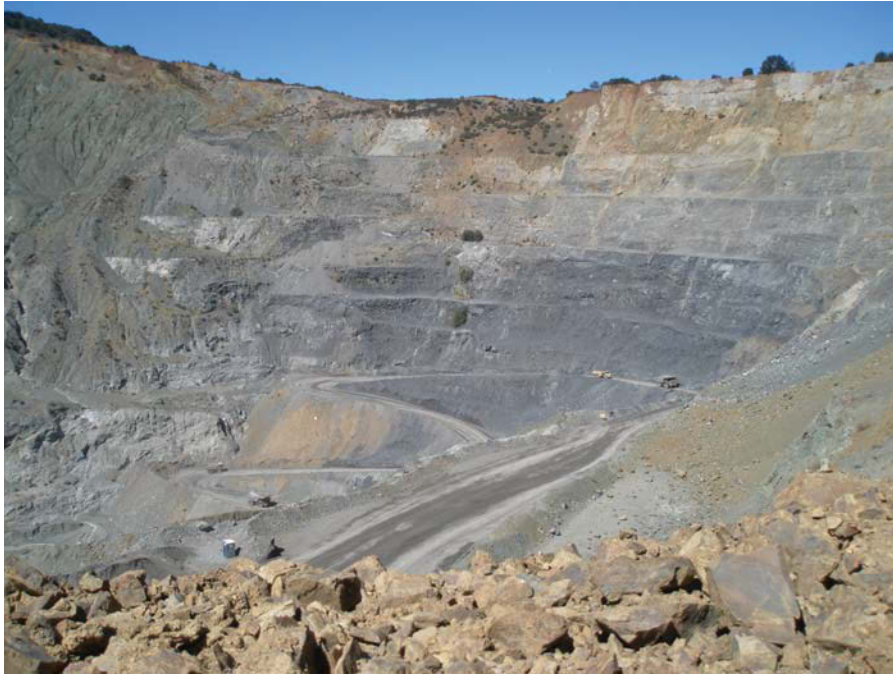
Photo 5: Looking northwest at Scenic Easement Rockslide in center of image. Dated September 26, 2013.

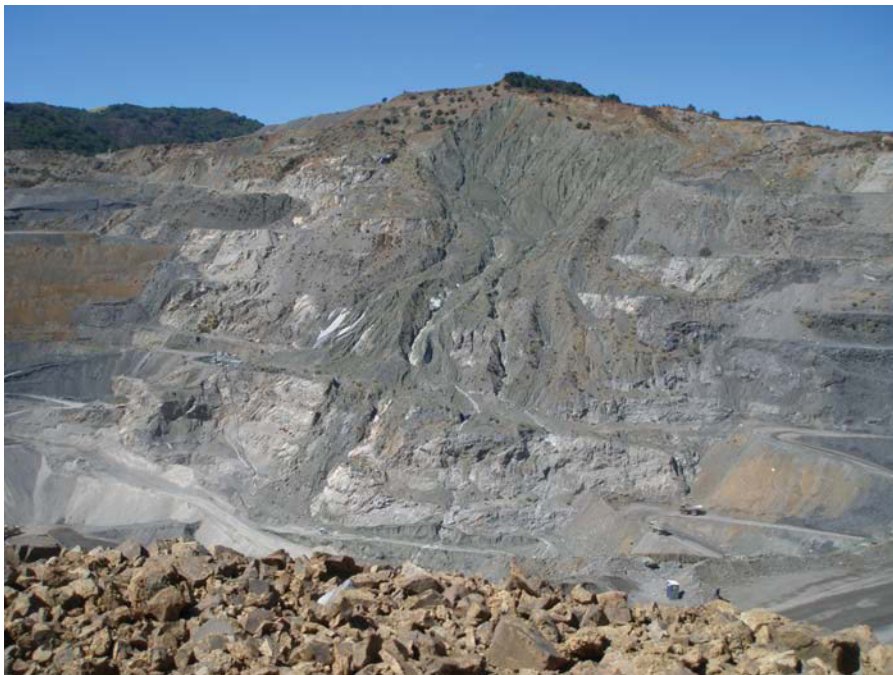
Photo 6: Looking west at Main Rockslide and WMSA. Dated September 26, 2013.

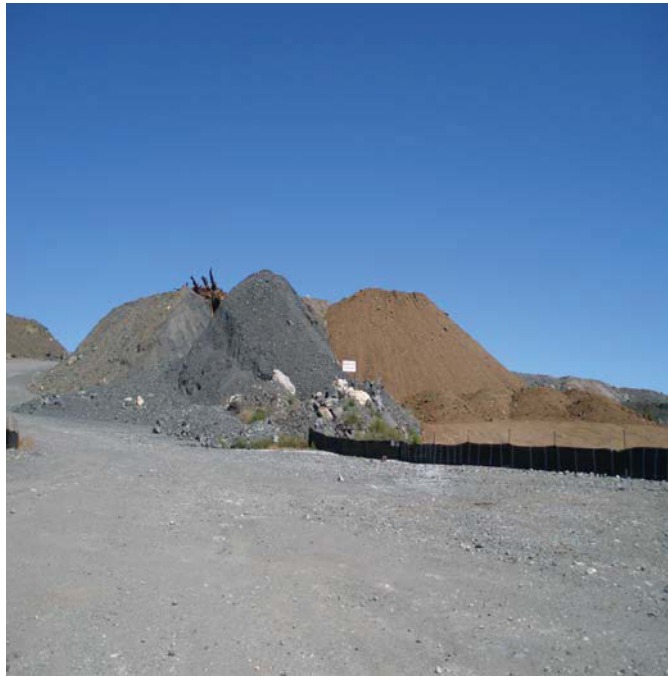
Photo 7: New topsoil storage area in WMSA, looking north. Sign and silt fence in foreground. Dated September 26, 2013.

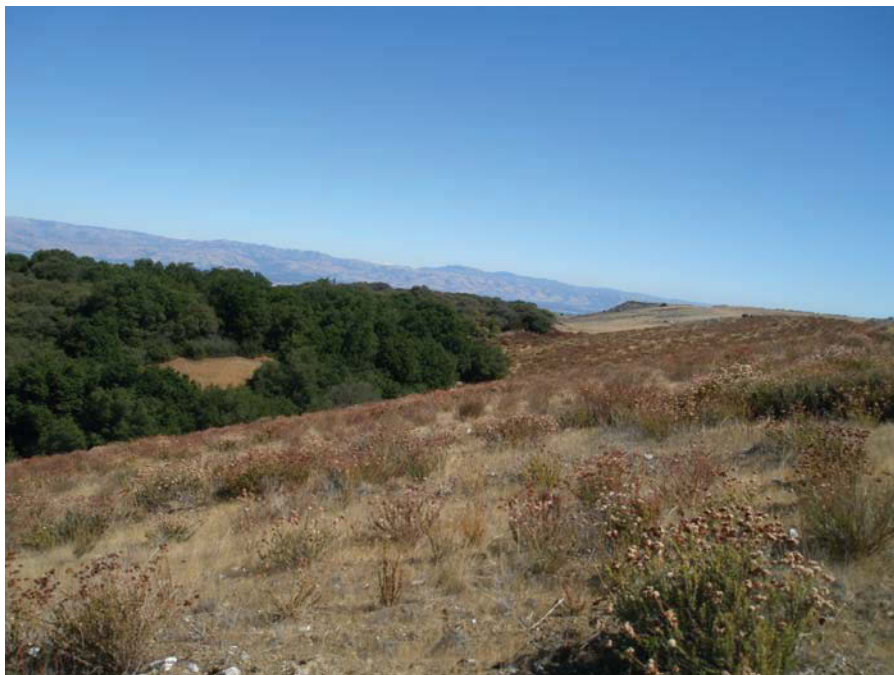
Photo 8: Portion of re-vegetated north-facing slope of WMSA, looking east. A portion of this slope will be removed in Phase 2 to backfill of North Quarry. Dated September 26, 2013.

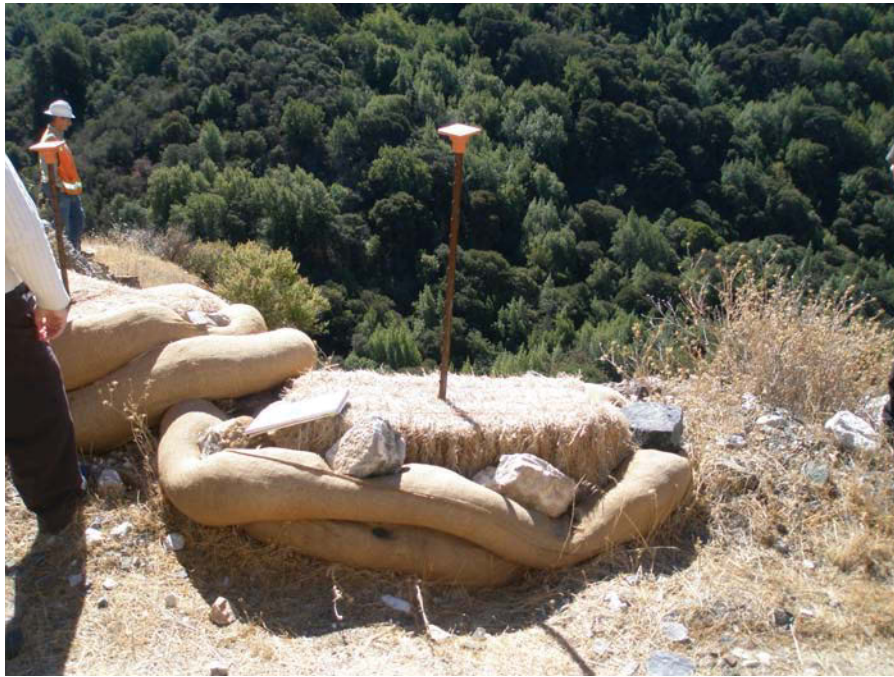
Photo 9: Rocked outfall in mid-slope bench on southern WMSA slope with straw waddles and bales, looking southwest into Permanente Creek. Dated September 26, 2013.

Running across the pre-SMARA slopes south of the WMSA is an old unpaved mid-slope road that is not used in the current mining operations and functions like a drainage bench. A low point in this road causes concentrated runoff to discharge over the slope and appears to create a sedimentation problem at Permanente Creek. This condition was noted in the 2008 annual SMARA report, and during the 2009 SMARA inspection a number of large rocks were observed being placed in this outfall with the intention of mitigating the potential erosion and instability. In 2013 straw waddles and bales were added to this drainage outfall and it appears to be performing as intended (Photo 9). In 2012 and 2013 straw waddles and straw bales have been placed along the outer edge of several low points in this mid-slope road to capture potential sedimentation (Photo 10). During the 2013 inspection, deposition of fines on top of rock talus that were continued to be observed as in the 2012 inspection west of the drainage outfall approximately one-third of the way down the slope (Photo 11), suggests that a small surficial slide. The headscarp of this slope failure hasn't extended into the mid-slope road/bench. A series of silt fences has been placed along the toe of the southern WMSA pre-SMARA slope as part of stormwater management (Photos 11 and 12). Hydroseeding of the upper portions of the pre-SMARA slope above the mid-slope road were done in late 2012 (right side of Photo 12). The drainage outfalls along this roadway should continue to be monitored as part of the site's stormwater management. County staff should continue to observe the roadway before the end of November as part of the pre-winter inspection.

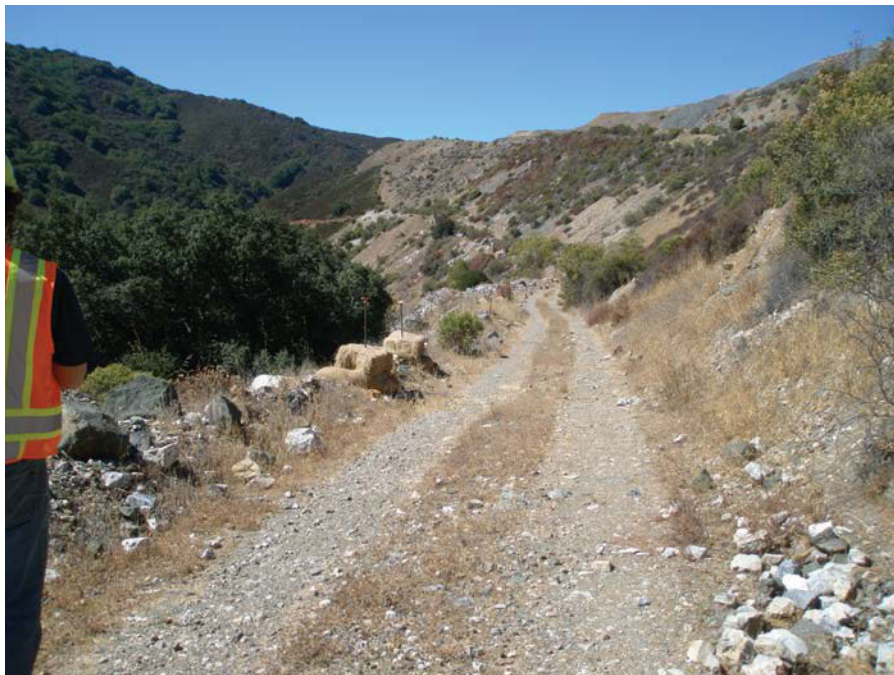
Photo 10: Straw waddles and bales at outfalls of mid-slope bench on southern slope of WMSA, looking looking west. Dated September 26, 2013.

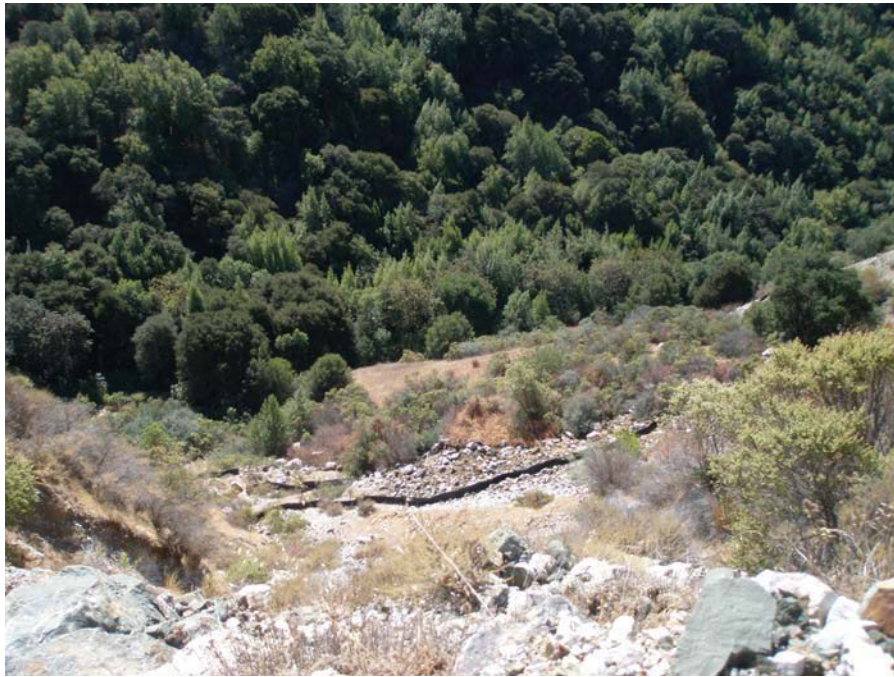
Photo 11: Silt fencing on southern slope of WMSA below outfall in Photo 9. Note soil mixed with talus adjacent to silt fence may be result of past slide. Dated September 26, 2013.

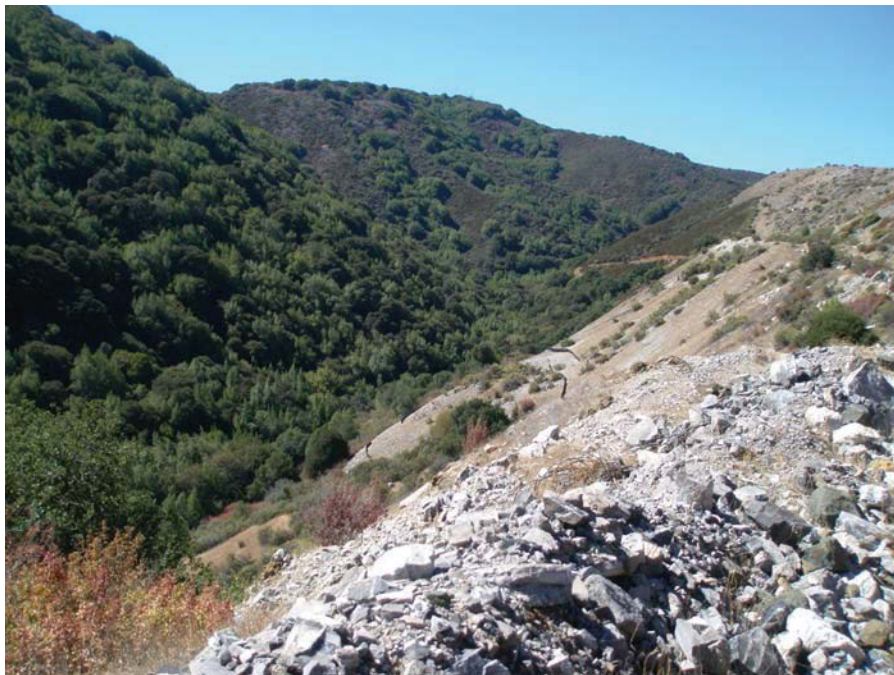
Photo 12: Southern slope of WMSA with silt fencing, looking west up Permanente Creek. Dated September 26, 2013.

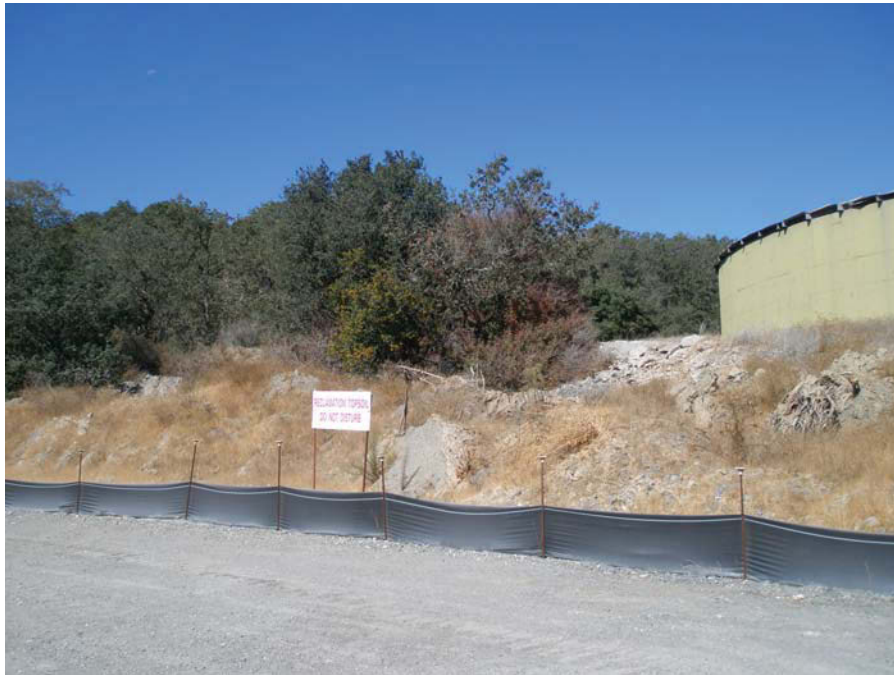
Photo 13: Topsoil storage area EMSA with sign and silt fence, looking west. Abandoned water tank at right side of image. Dated September 26, 2013.

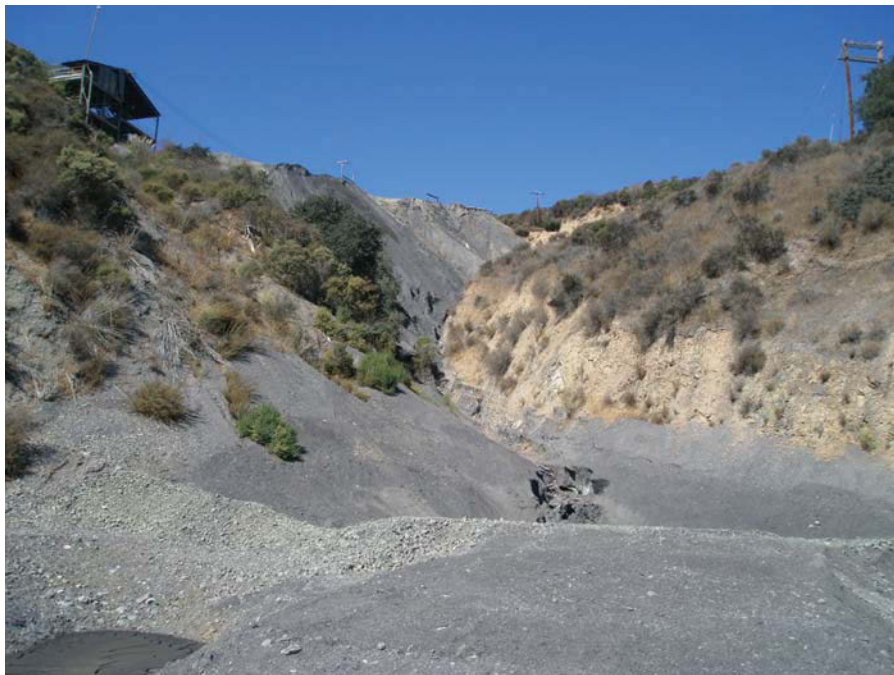
Photo 14: Slope failure north of eastern end of 500-foot long conveyor tunnel in Crusher/Support Area, looking west. Sediment catch basins constructed above western perimeter drainage ditch in foreground. Dated September 26, 2013.

The operator has created a network of lined and unlined drainage ditches to convey stormwater runoff from the EMSA into holding ponds. During the 2012-13 rainy season a slope failure occurred in a slope adjacent to the eastern end of the conveyor tunnel that deposited limestone rock in the upper portions of the drainage ditch that runs along the western edge of the EMSA (Photo 14). This material was removed, a series of sediment catch basins were created and the ditch cleaned out and relined with greenstone (Photos 15 and 16). Continued failure of the slope is anticipated, therefore periodic cleanout of the sediment catch basins is now part of the stormwater management plan. The EMSA drainage ditches were all relined with greenstone, a non-limestone rock, and they appeared to be capable of functioning as intended. The lowermost stormwater pond is called Pond 30 (Photo 17), which discharges runoff through a culvert into Permanent Creek. Rock armoring with greenstone was done to mitigate this erosion at the outfall of Pond 30 (Photo 18). County staff should inspect the channels, ponds and culvert outfall as part of the pre-winter site inspection to document that the structures will function properly.

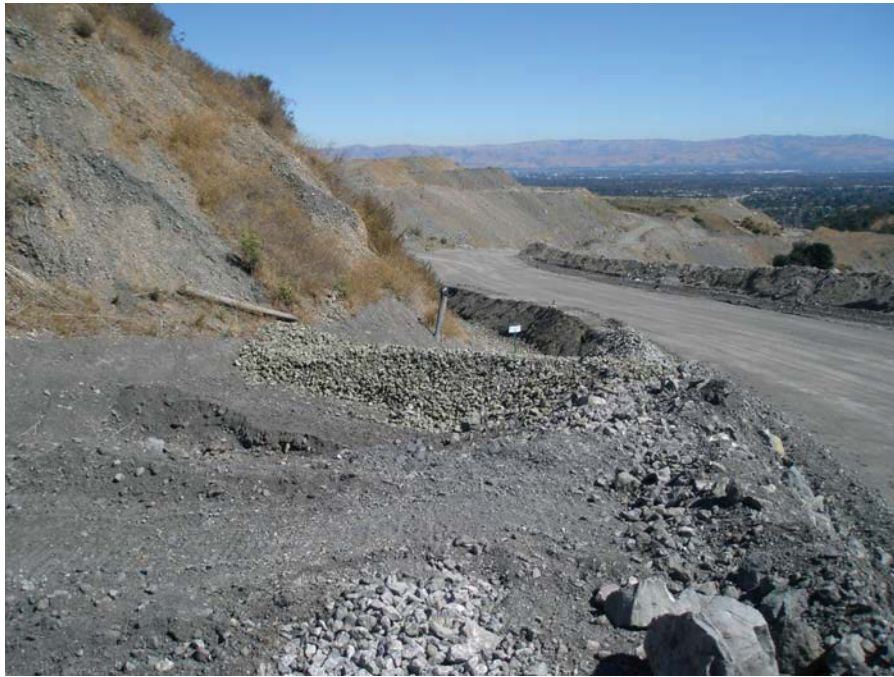
Photo 15: Sediment catch basin, greenstone rock weir and western perimeter drainage ditch in EMSA, looking northeast. Dated September 26, 2013.

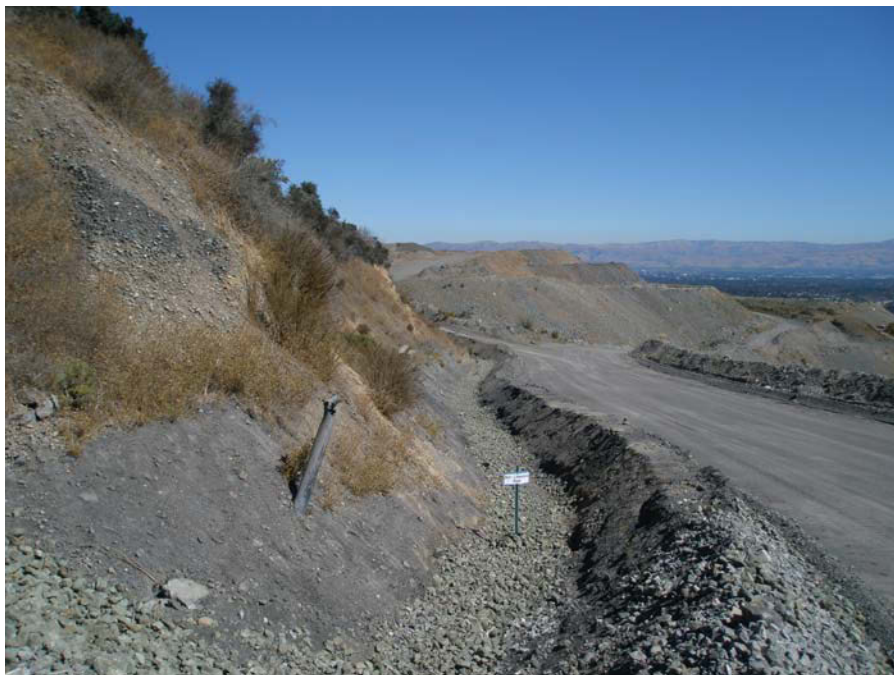
Photo 16: Western perimeter drainage ditch in EMSA. Ditch cleaned out and greenstone rock placed in bottom, looking northeast. Dated September 26, 2013.

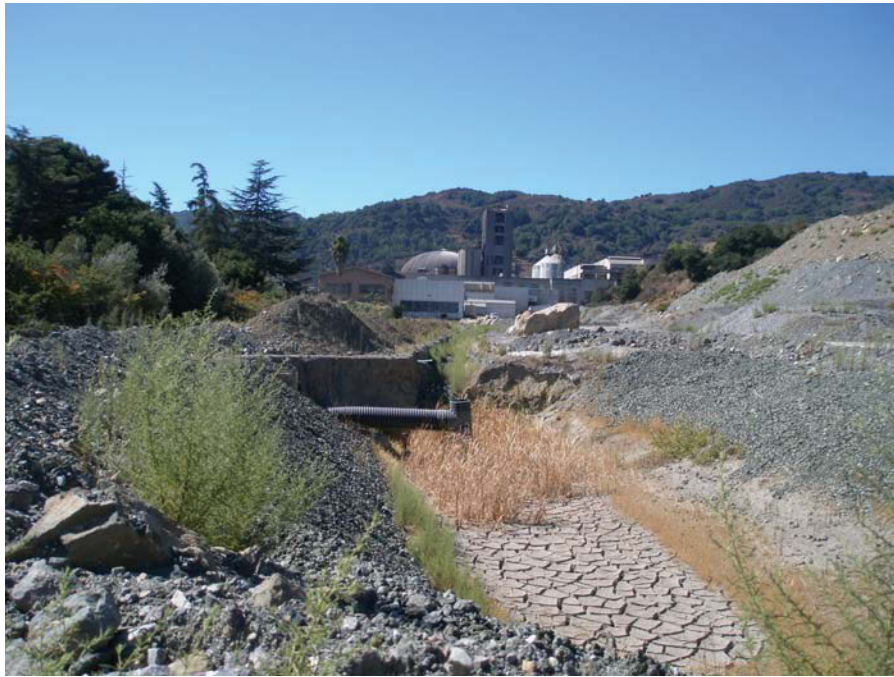
Photo 17: Pond 30 lowest pond in EMSA and drains into Permanente Creek, looking south at cement plant. Walls of pond and drainage ditch relined with greenstone. Dated September 26, 2013.

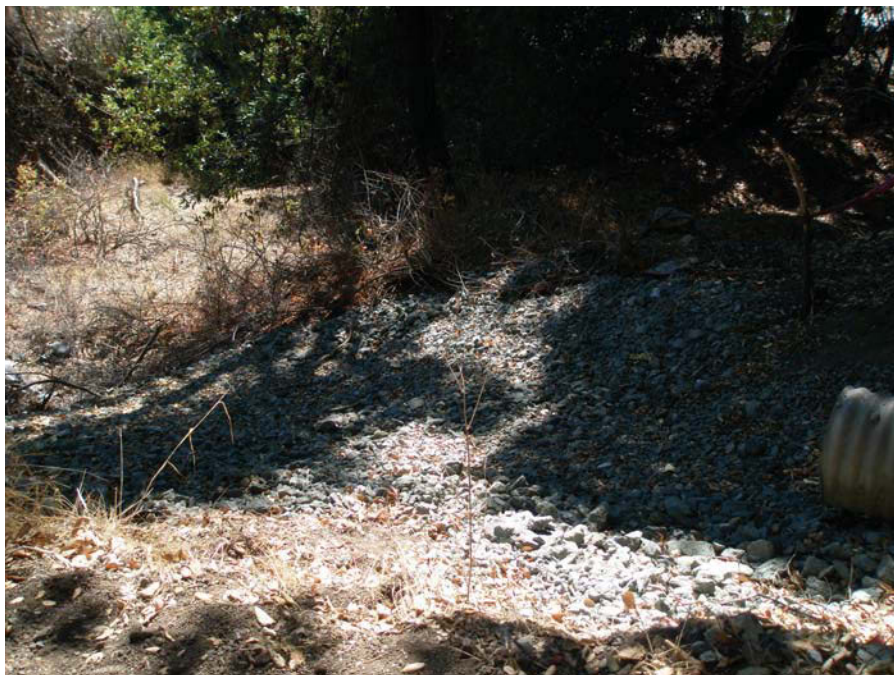
Photo 18: Pond 30 outfall to Permanente Creek, relined with greenstone. Dated September 26, 2013.

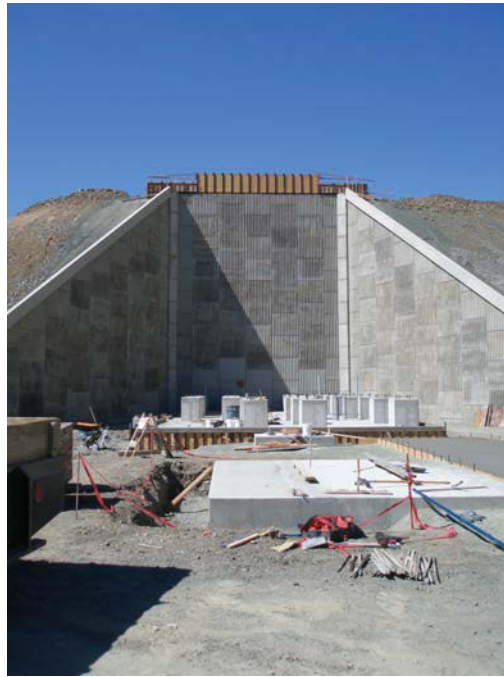
Photo 19: New primary crusher structure, looking west. Drainage from area will be collected and pumped into North Quarry for treatment before discharge. Dated September 26, 2013.

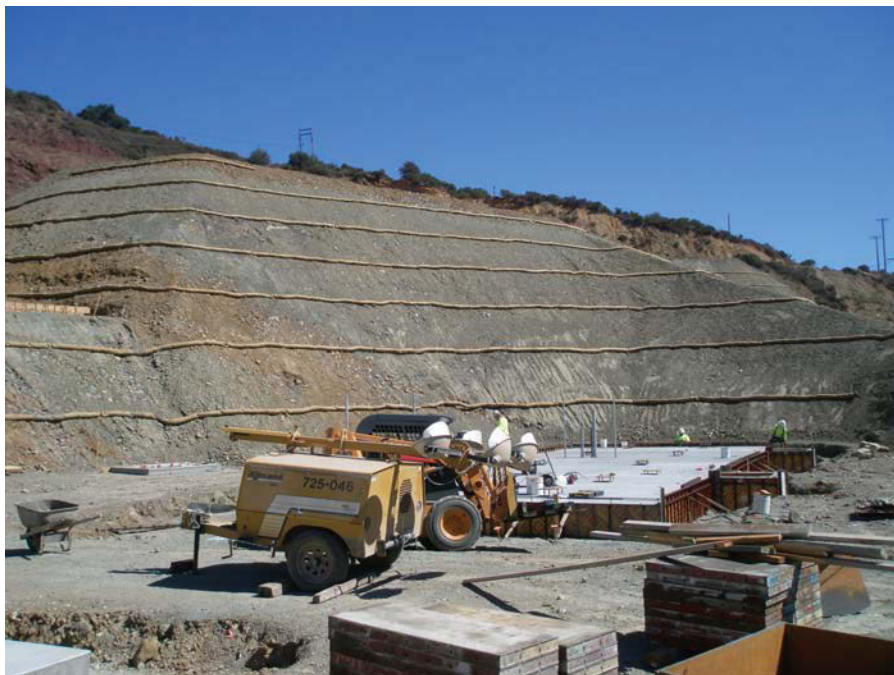
Photo 20: New secondary crusher pad area, looking northeast. Note straw waddles on slope. Slope will be hydroseeded before this winter. Dated September 26, 2013.

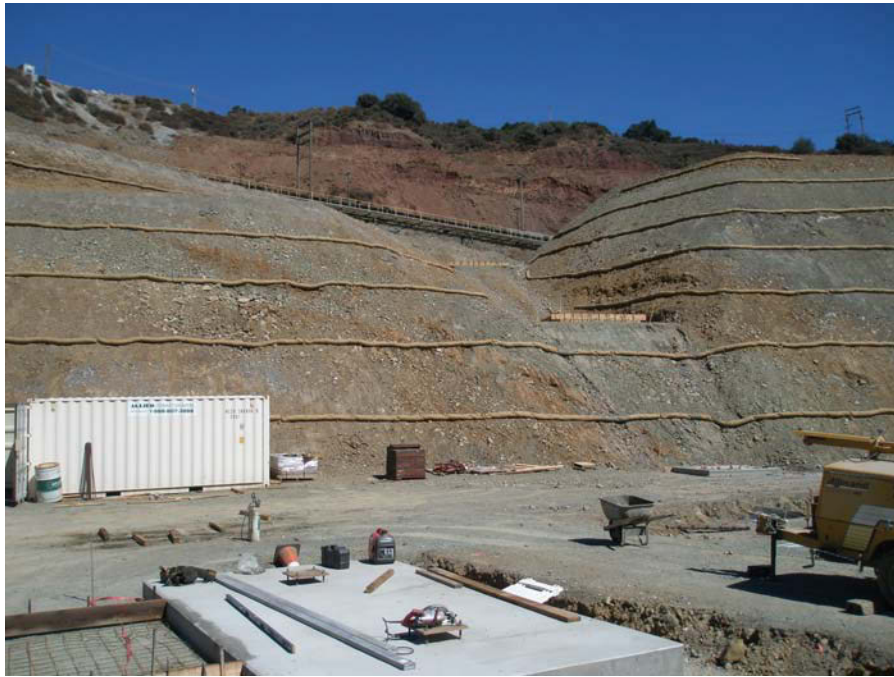
Photo 21: New primary and secondary crusher area, looking northeast. Looking at location where new crushers will tie into existing conveyor. Portion of convey to left of notch will be removed. Dated September 26, 2013.

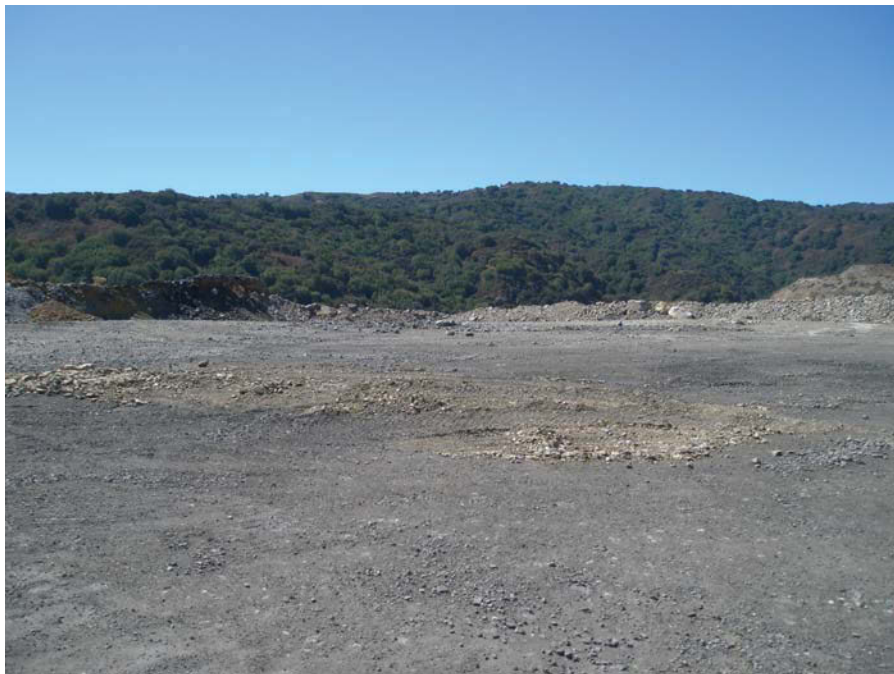
Photo 22: Previous temporary limestone stockpile area at eastern edge of North Quarry and north of mine office area. Limestone material has been removed, looking southwest. Dated September 26, 2013.

An upper bench area located north of the mine office had a stockpile of limestone rock that was sufficiently high as to be visible from the Town of Cupertino. County staff noted this material during the 2012 pre-winter site inspections and removal was required. During the 2013 inspection, the area of this limestone stockpile and found that it had been removed (Photo 22).

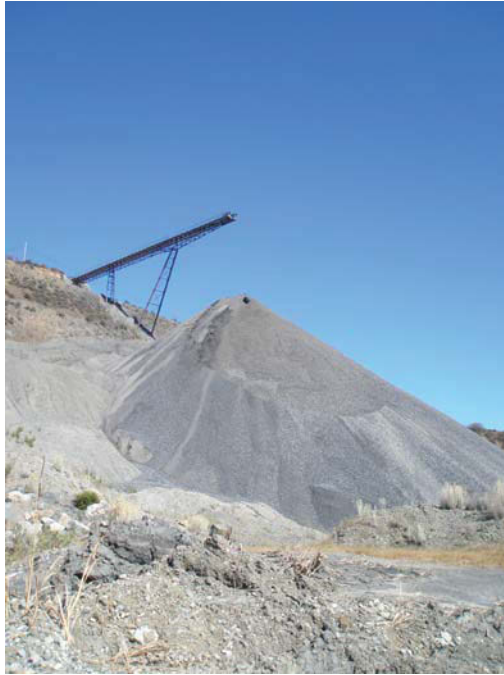
Photo 23: Surge pile, looking northeast from area of Pond 13B. Dated September 26, 2013.

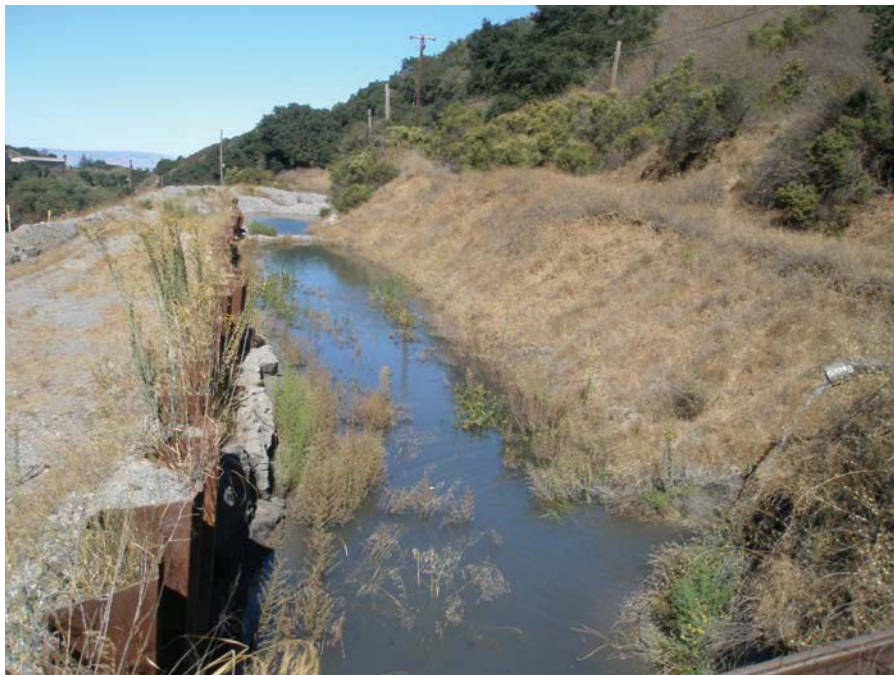
Photo 24: Pond 17 collects runoff from Rock Plant, looking north. Dated September 26, 2013.

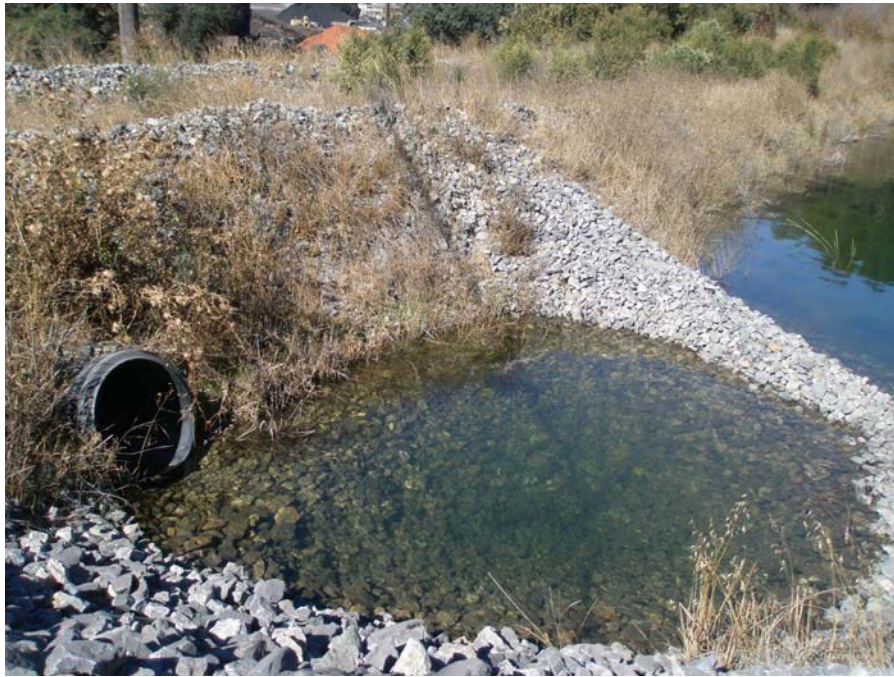
Photo 25: Pond 17 outfall to Permanente Creek, looking north. Dated September 26, 2013.

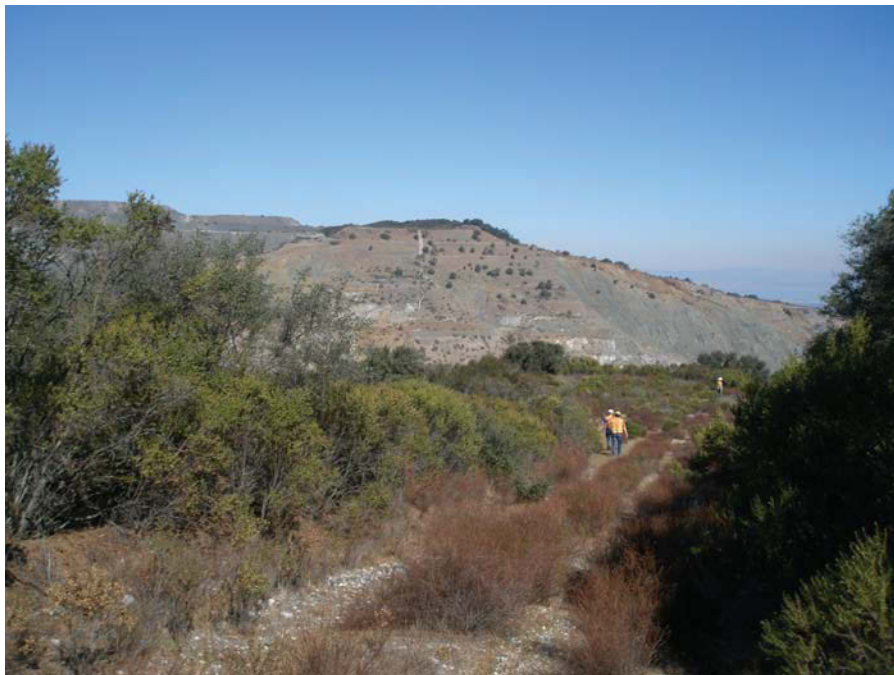
Photo 26: Re-vegetated drill roadway and pad in South Quarry Exploration near N37° 18.898', W122° 06.843', looking north at west side of quarry. Dated September 27 2013.

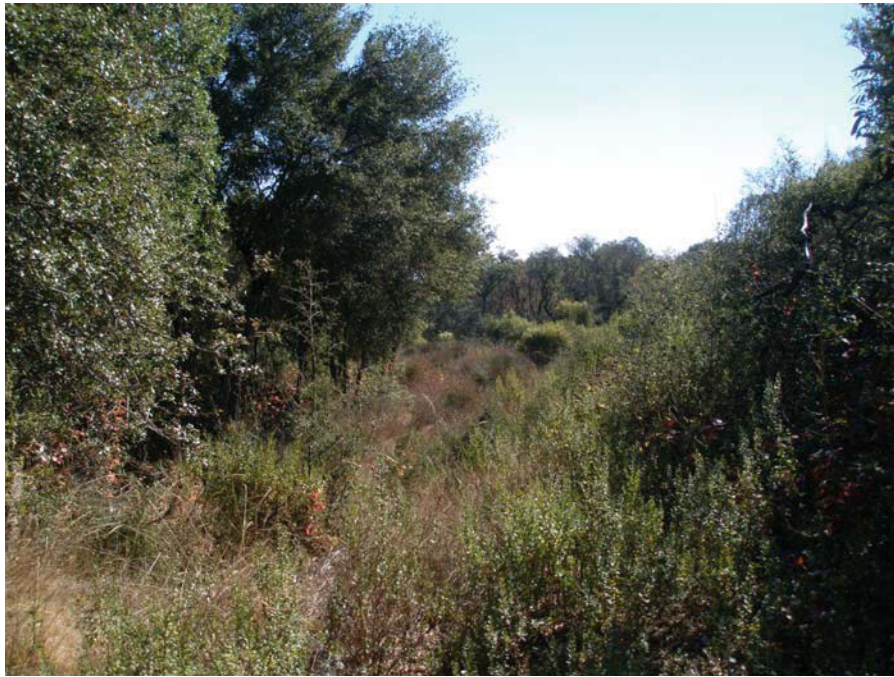
Photo 27: Re-vegetated drill roadway in South Quarry Exploration area near N37° 18.707', W122° 06.448', looking east. Dated September 27, 2013.

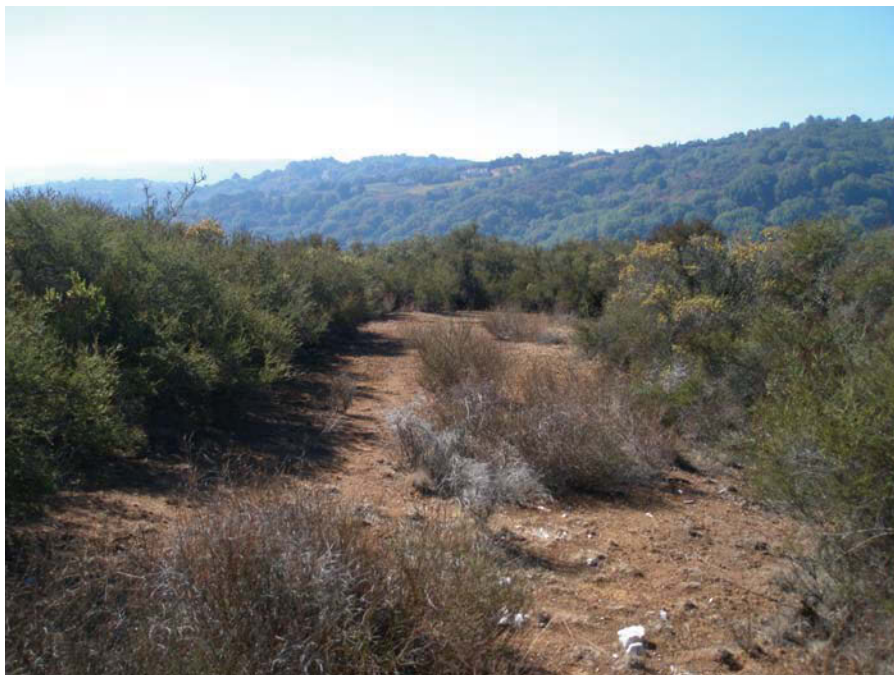
Photo 28: Re-vegetated drill pad in South Quarry Exploration area near N37° 18.670', W122° 06.457', looking south. Dated September 27, 2013.

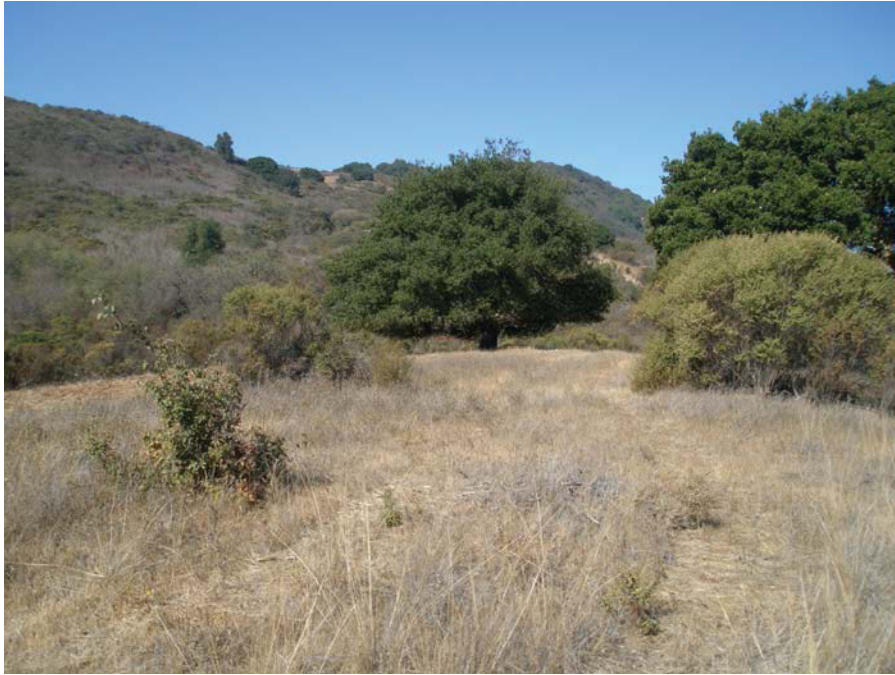
Photo 29: Re-vegetated drill pad in South Quarry Exploration area near N37° 18.555', W122° 05.731', looking west. Dated September 27, 2013.
