County of Santa Clara

Date: January 26, 2011

Subject: Analysis of Limestone Mapping and Historic Air-photos (taken in 1939, 1948, 1955 and 1960) of the Permanente Quarry, Santa Clara County Planning Office File# 2250-13-66-09P-10P

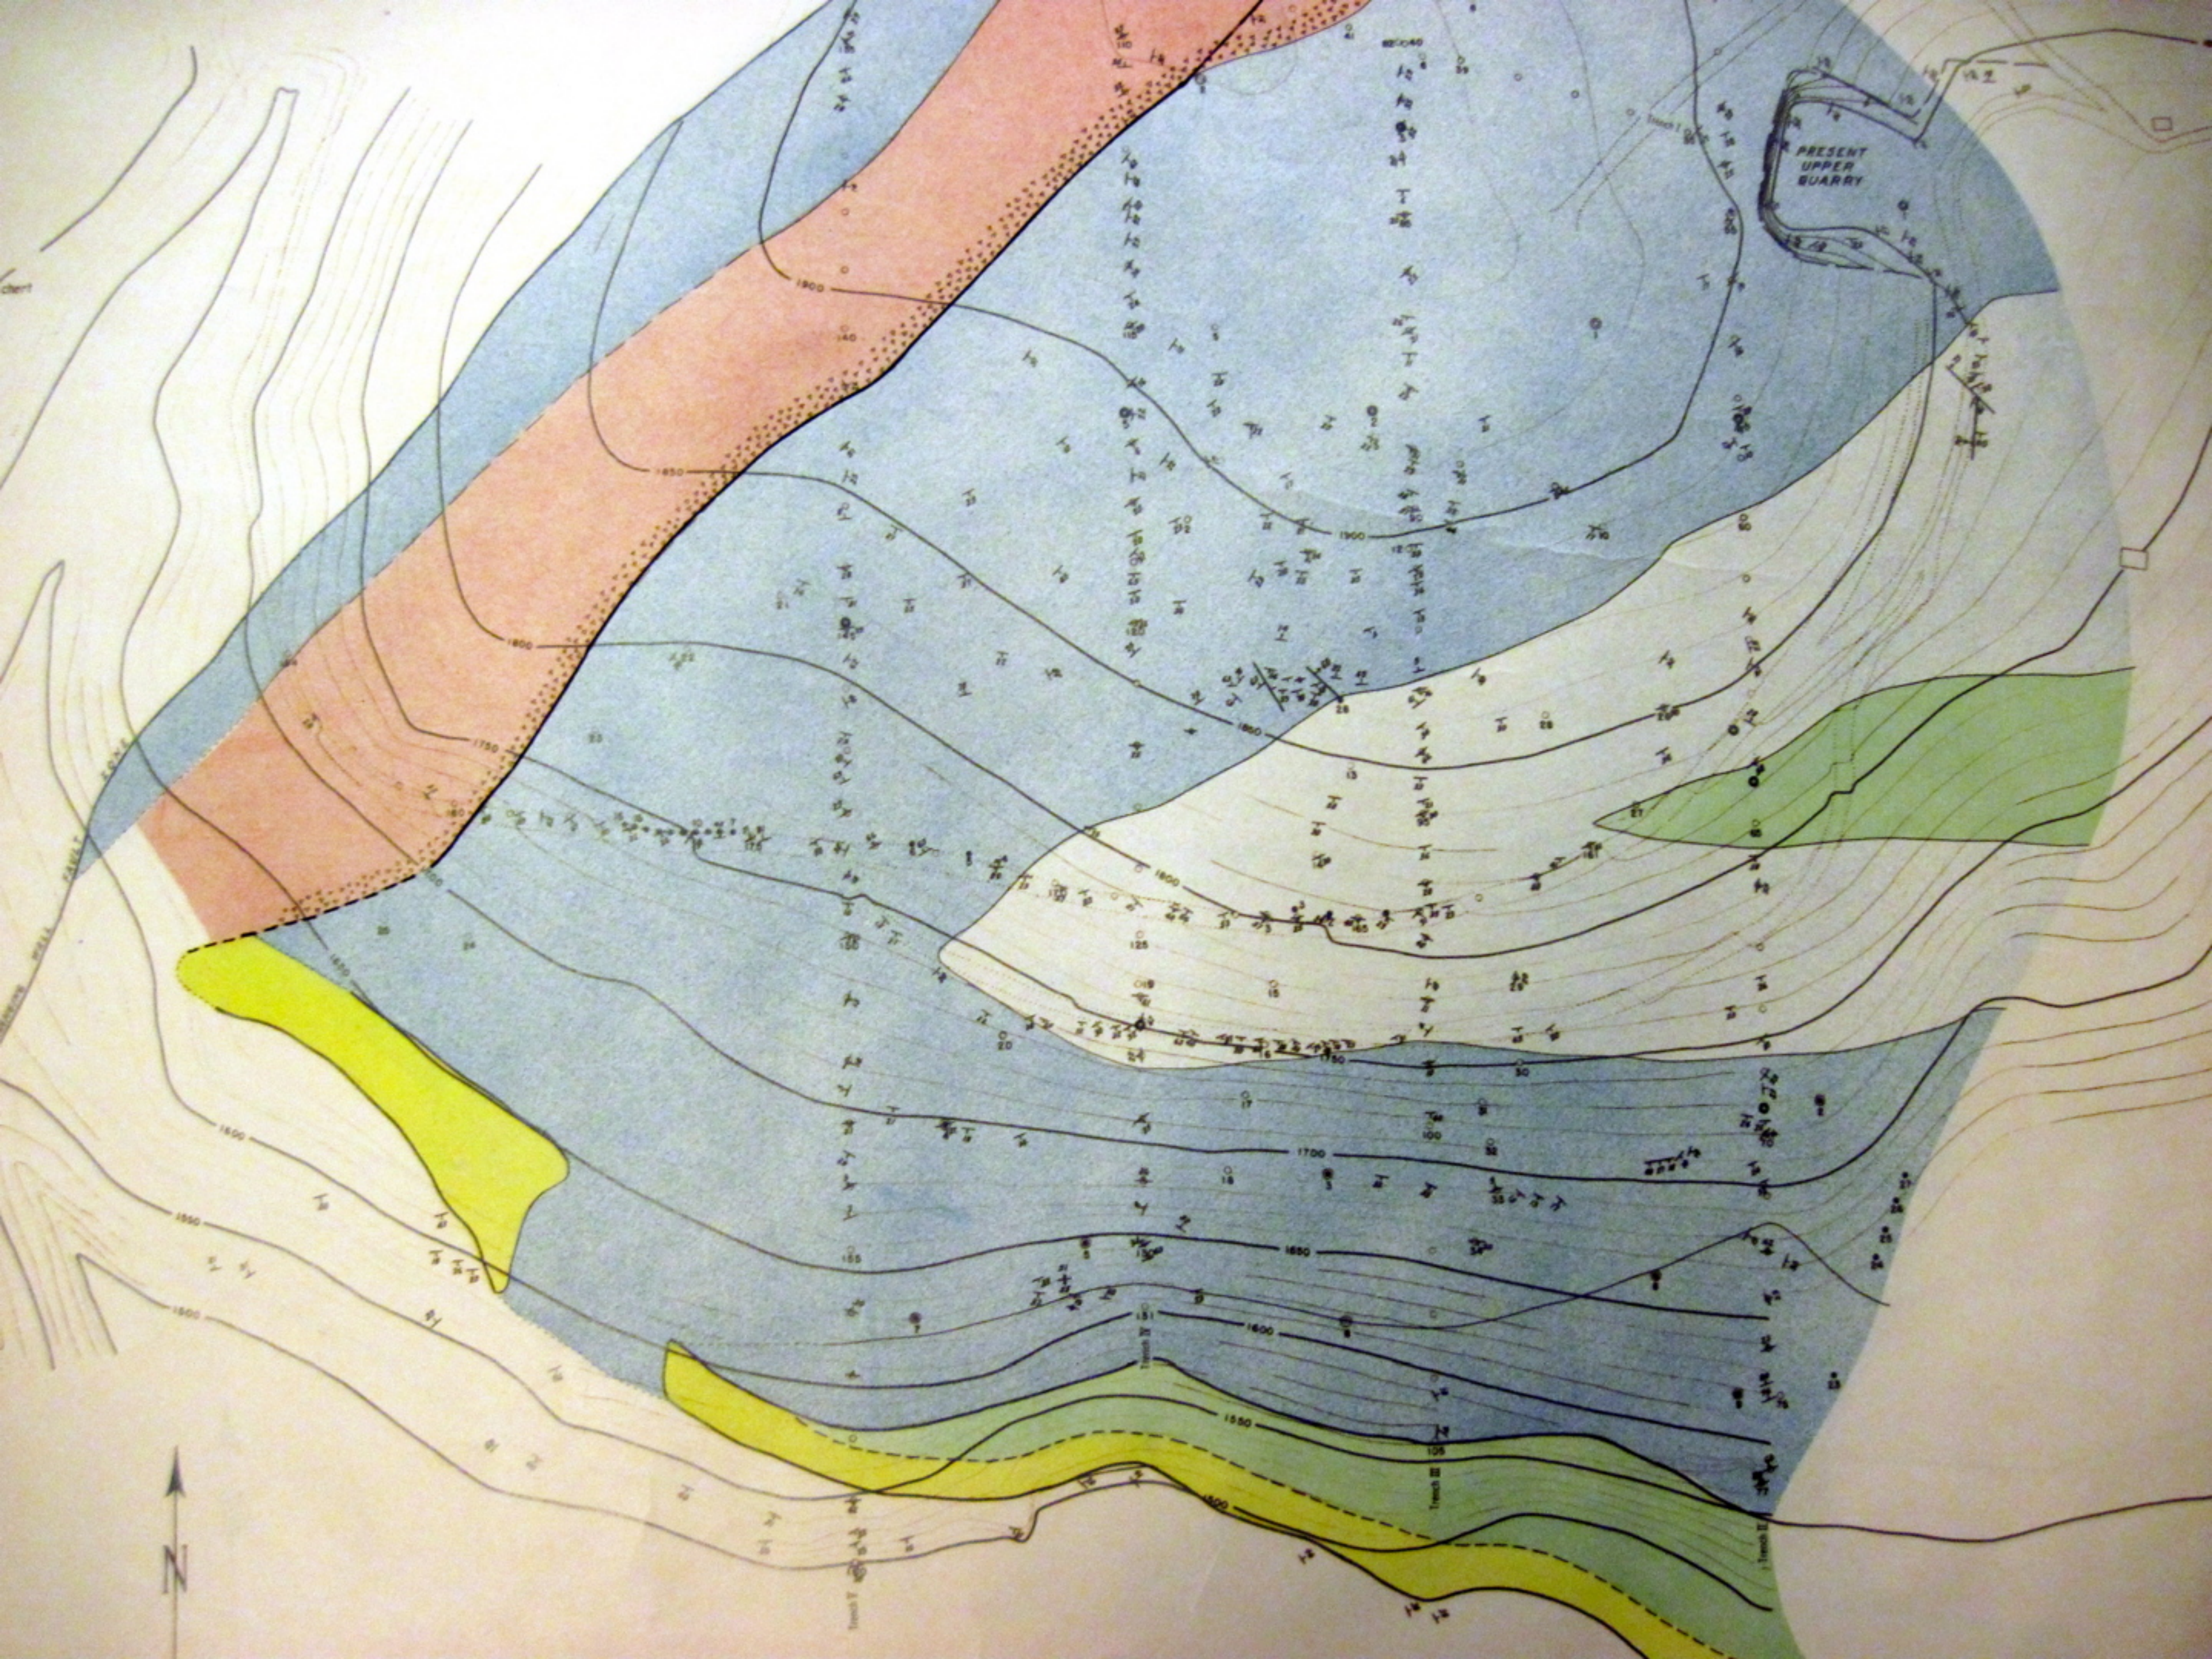
GEOLOGIC MAP OF PROPOSED QUARRIES A AND B PERMANENTE CORPORATION SANTA CLARA COUNTY, CALIFORNIA

Showing area trenched and sampled in detail
by Jackhammer holes, Diamond Drill holes,
Churn Drill holes, and outcrop samples.

Quarry A from 1700 contour to 1930 contour
Quarry B from 1500 contour to 1700 contour
