Re: Permanente Quarry, Mine ID # 91-43-0004 Response to April 29, 2019, Incompleteness Letter and Resubmittal of Utility Road Reclamation Plan Amendment

PROJECT DESCRIPTION

BACKGROUND

VISIBILITY ASSESSMENT

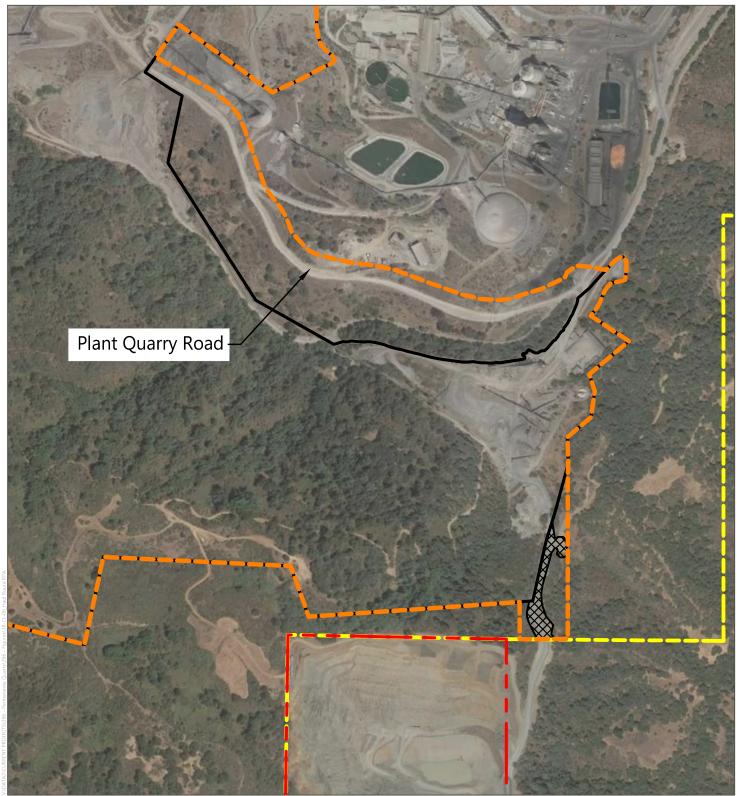
PERMANENTE QUARRY UTILITY ROAD RECLAMATION PLAN AMENDMENT Figure 2

SOURCES: AERIAL: Towill, Inc. flown (8-1-2018); SITE BOUNDARY & RECLAMATION BOUNDARIES: Lehigh Southwest Cement Company, generated Nov. 2018; compiled by Benchmark Resources in 2019

Property Boundary Vested Rights Boundary Existing Reclamation Boundary

Based on geographic information system (GIS), the disturbance associated with the new haul road occurs on lands within unincorporated Santa Clara County (APN: 351-10-033) and within the City of Cupertino (APN 351-10-017) (**Figure 2**). The length of disturbance on property within unincorporated Santa Clara County is approximately 352 linear feet, totaling approximately 0.45 acre. The length of disturbance on property within the City of Cupertino is approximately 536 linear feet, totaling approximately 0.92 acre.

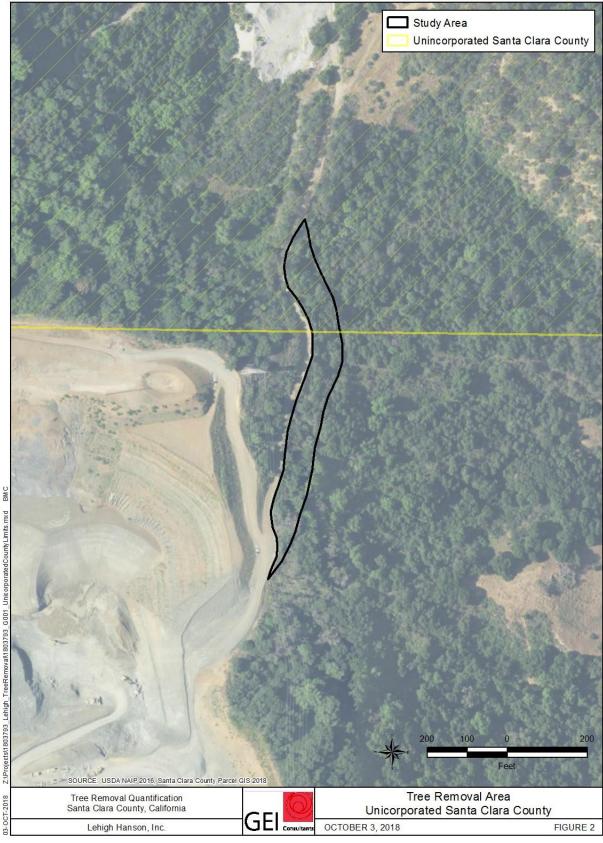
Figure 2. Unincorporated Santa Clara County Jurisdiction

Source: GEI Consultants, Inc., 2018

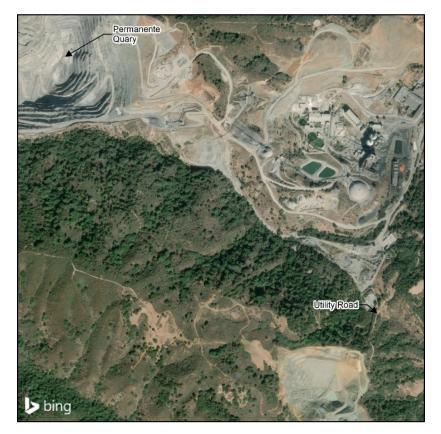
Figure 1 Utility Road Location

Lehigh Hanson (Lehigh) improved an approximately 800-foot long portion of an existing utility road that climbs southerly from the Permanente aggregate plant and continues along a ridge toward the neighboring quarry site (**Figure 1**). The alignment has been in use for 50 plus years and does not represent an engineered design. This roadway began as a narrow, bulldozed exploration and utility access road. It was subsequently used as a maintenance road to access this portion of the property, and by Pacific Gas and Electric Company (PG&E) to access power lines in the area. The road was improved in 2018 to allow for off-site materials transport. Lehigh plans to grade the utility road to decrease slope gradients while continuing to allow access by site personnel for maintenance and exploration purposes, PG&E maintenance vehicles, and potentially emergency response vehicles. No further hauling is planned for the road.

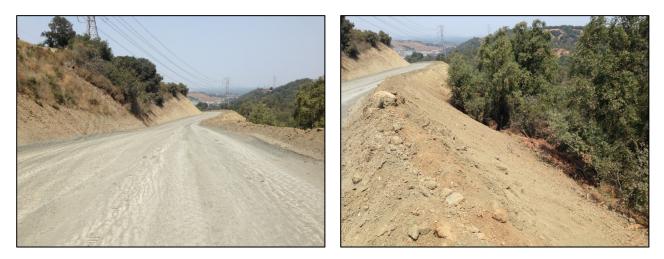
Figure 2 Utility Road Cross-Section

The utility road was improved along its preexisting alignment. While the road contains steep slopes and grades, it is within typical mining industry standards for grading, slopes, and drainage controls. A key consideration of this road is that it is an internal road that cannot be accessed by the public. It must remain serviceable as it serves the primary access to the southern property and as an easement for PG&E utility lines. Roads such as this are typically constructed following existing site practices that have been proven to work at the site. Photographs of the improved road are included below. **Figure 2** shows the road cross-section and presents the range of excavation heights. **Figure 3** shows the fill profile. It should be noted that the slopes pictured have been revegetated since these photographs were taken.

The utility road was constructed by placing a key at the toe of the fill slope. The key included excavating material from the toe of the fill area and backfilling it with compacted fill. Water was added to the fill to achieve optimal moisture content, and it was compacted with a vibratory sheep's foot roller. Once the key was constructed, the utility road was improved by cutting material from the uphill slope and placing compacted fill on the downhill slope above the key. The fill slope was cleared and grubbed, but the surface soil was not removed, except where the key was placed. The cut slopes vary, but they are generally steep at approximately 1:1 (45°), with cut heights are up to 30 feet. The fill slopes are also steep at approximately 1.2:1 (39°), with fill slopes up to 50 feet high. Internal mine roads are often constructed with cut and fill slopes in this range, and any erosion that occurs is managed by the site maintenance crews. A safety berm was

Stantec recommends grading the road to reduce fill slope gradients to comply with local rules and regulations. City and County grading regulations require slope gradients be 2h:1v, or the design be certified by a Certified Engineering Geologist. The grading design is based on a minimum 20-foot road width, which includes sufficient space for one-way travel, a ditch, and a berm. Road widths for retained roads, in the currently approved Reclamation Plan Amendment for the Permanente Quarry, vary and are as narrow as 12 feet. Wherever practical, the road will be wider than 20 feet to provide turn-off locations. The grading plan has an overall road gradient of approximately 12%, with short sections that exceed 20% gradient. These grades are consistent with the original utility road and other roads that will be retained during reclamation per the currently approved Reclamation Plan Amendment for the Permanente Quarry.

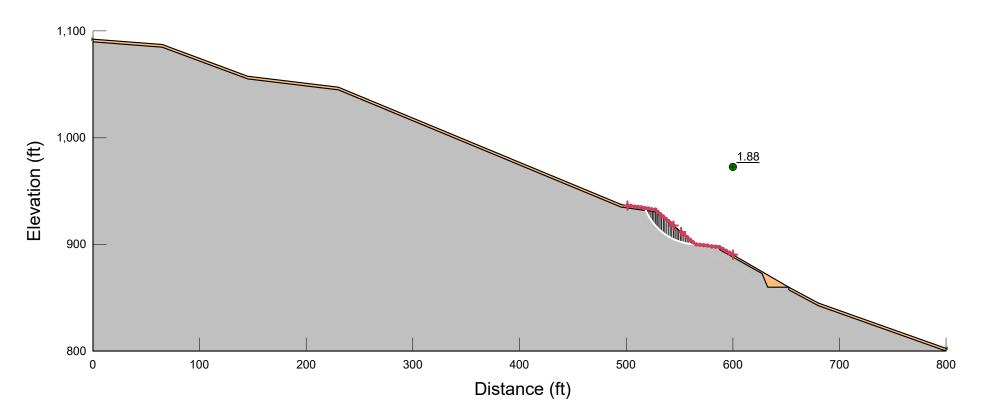
Parent: 1. Cut Slope (Local) Name: 1a. Static Analysis

Color	Name	Model	Unit Weight (pcf)	Cohesion' (psf)	Phi' (°)
	Residual Soil	Mohr-Coulomb	120	200	30
	Santa Clara	Mohr-Coulomb	165	550	33

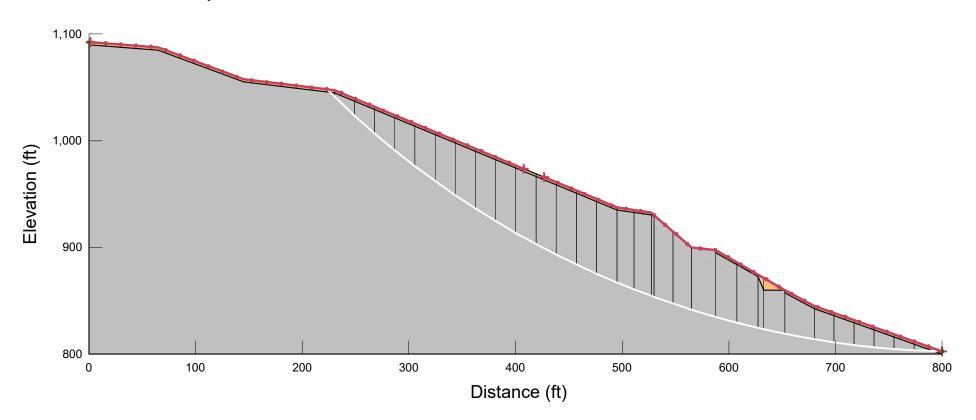
Parent: 2. Cut Slope (Global) Name: 2a. Static Analysis

Factor of Safety: 1.78

Colo	r	Name	Model	Unit Weight (pcf)	Cohesion' (psf)	Phi' (°)
		Residual Soil	Mohr-Coulomb	120	200	30
		Santa Clara	Mohr-Coulomb	165	550	33

●<u>1.78</u>

The slope stability results identify the minimum factors of safety for each analysis, and these results are summarized in **Table 2** below and the model reports are included in **Attachment 1**. The results indicate that the cut and fill slopes are stable (FOS>1.0) during both the static and pseudo-static conditions. There is no infrastructure or any sort of facility below the road that can be impacted by potential slope movements. Stantec recognizes that the location of the pre-construction topography is approximate, and a sensitivity analysis was performed to assess the fill slope stability if the entire road bench is fill material. This sensitivity demonstrates that the slope is stable in this unlikely scenario. Stantec also recognizes that the strength of the Santa Clara Formation may not be uniform along the road cut, and a sensitivity analysis was performed using published strengths for fine-grained sections of the formation with "adverse bedding conditions" (CGS 2002). The sensitivity also demonstrates that the slope is stable if there is fine-grained Santa Clara Formation present; see **Attachment 1**.

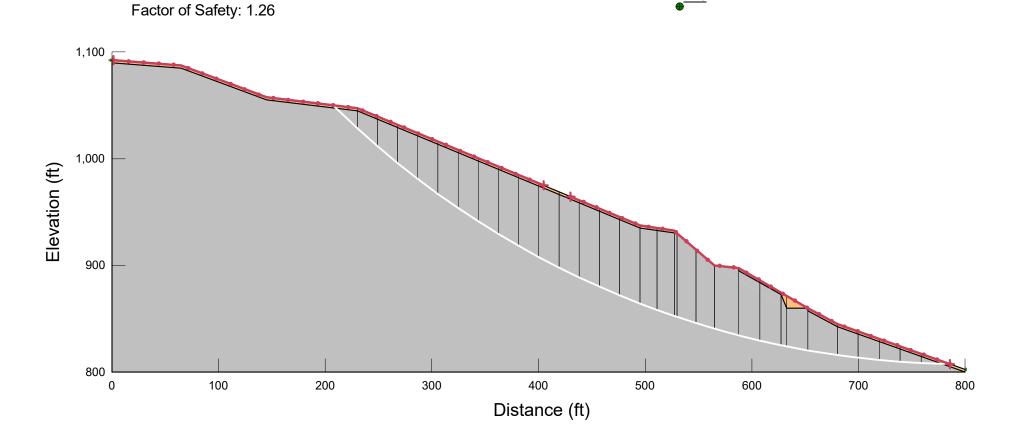
Parent: 2. Cut Slope (Global) Name: 2b. Pseudostatic Analysis Color Name Model Unit Cohesion' Phi' (°) Weight (psf) (pcf) Residual Soil Mohr-Coulomb 120 200 30 Santa Clara Mohr-Coulomb 165 550 33

<u>1.26</u>

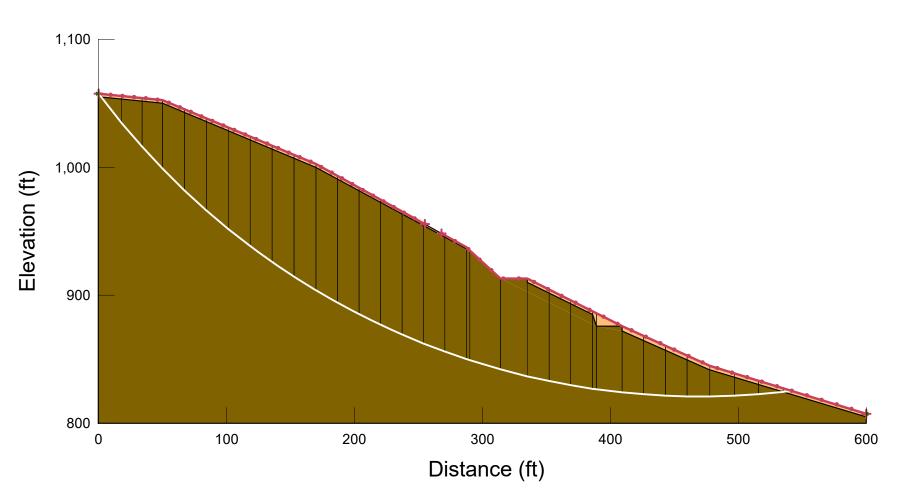
Parent: 2. Cut Slope (Global) Name: 2b. Pseudostatic Analysis

Color	Name	Model	Unit Weight (pcf)	Cohesion' (psf)	Phi' (°)
	Greenstone	Mohr-Coulomb	165	1,400	23
	Residual Soil	Mohr-Coulomb	120	200	30

<u>1.02</u>

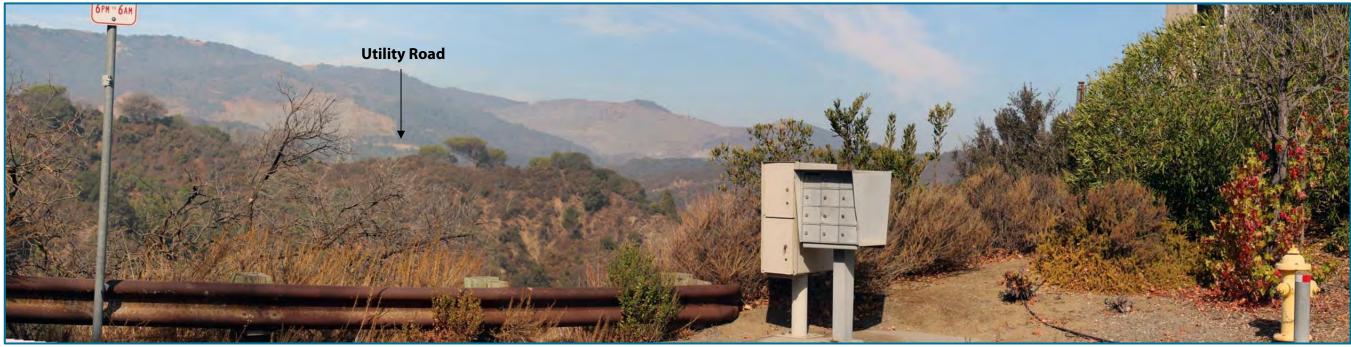
VIEWPOINT 3: CANYON VIEW CIRCLE LOOKING NORTHWEST

Existing Conditions Viewpoints PERMANENTE QUARRY UTILITY ROAD VISIBILITY ASSESSMENT **Figure 4** (page 1 of 3)

Five viewpoint locations were photographed that represent the areas with the highest potential for viewing the utility road from public roadways in the local community. See Figure 4 to view panoramic photographs of Viewpoints 1–5, which include labels on the photographs to show the location of the utility road. The following subsections provide a brief description of each viewpoint followed by an assessment of the visibility of the utility road from each viewpoint.

A portion of the utility road can be seen just below the Stevens Creek Quarry mined area, as labeled on the Viewpoint 3 photograph in Figure 4. This portion of the road is visible, but does not stand out as noteworthy in relation to the surrounding surface disturbance. After the slope above the road is vegetated to control erosion, the portion of the road visible from this viewpoint would not contrast with the surroundings. Reclamation would further reduce visibility of the road from this viewpoint.
