**Re: Permanente Quarry, Mine ID # 91-43-0004**  
*Application for Reclamation Plan Amendment (PLN 19-0106)*  
*Response to July 22, 2019 Incompleteness Determination*

On behalf of Lehigh Southwest Cement Company (“Lehigh”), this letter responds to Santa Clara County’s July 22, 2019 letter which informed Lehigh that its May 2019 Application for a Reclamation Plan Amendment (“Application”) is incomplete.

**Reclamation Plan**

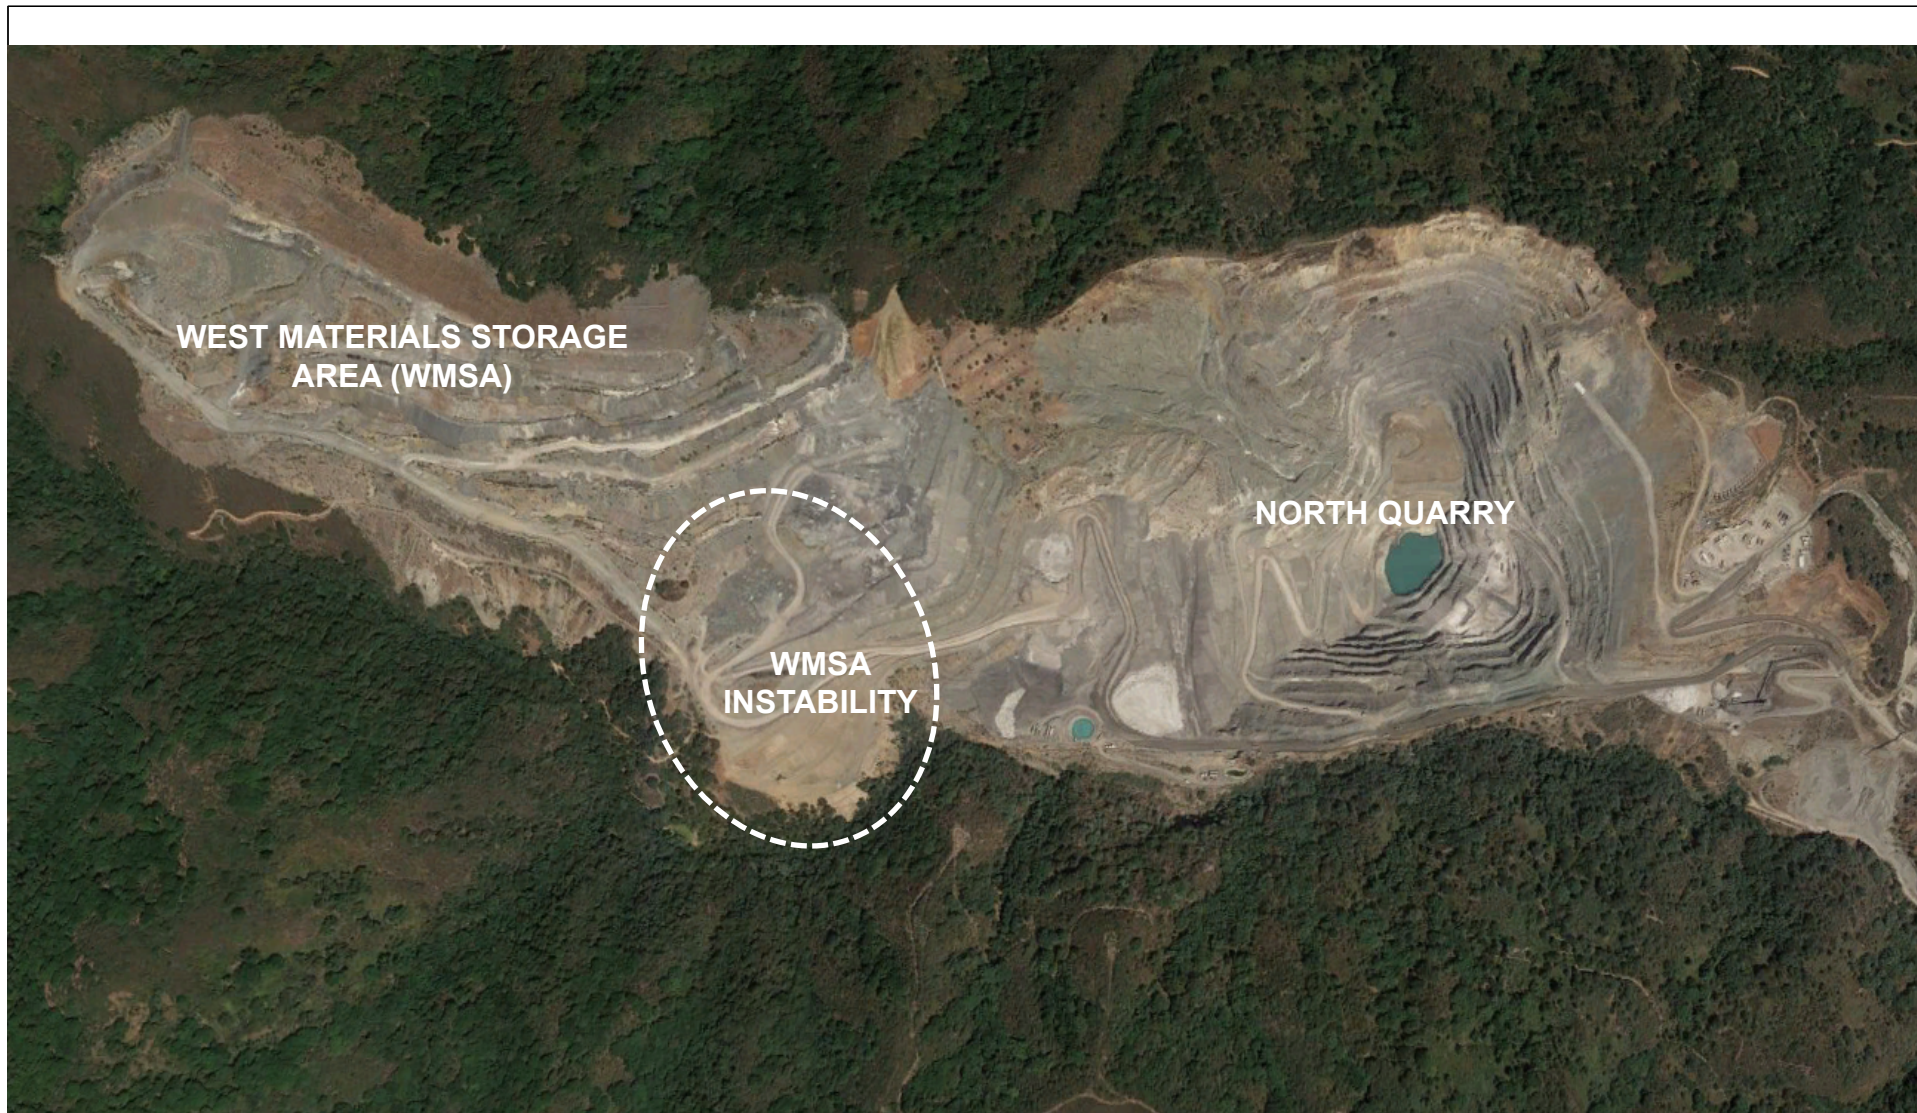
Title  
Site Map

The WMSA instability is located on the north side of Permanente Creek, as shown on Figure 1. This area is suspected to be part of an ancient landslide considering the notable deflection of the creek in this area. This area was previously quarried and backfilled with greenstone overburden. Surface cracking has been noted in this area for several years; however, recent grading and heavy rains caused increased movements in the WMSA instability area (Golder 2019). Additional cracks formed at the crest, lateral extents, and toe of the movement area, and the cracks and movement areas were mapped, as shown on Figure 2. Lehigh has and continues to monitor the movements, which have significantly reduced due to additional grading, surface water controls, and decreased precipitation during the summer.

The area of WMSA instability is shown on Figure 1 (Site Map). The overall slopes in this area are relatively shallow at approximately 3H:1V. This indicates that the instability occurs in a weak layer of rock or sediments beneath the slope. The presence of seeps along the toe of the instability suggest elevated pore water pressures along the slide plane. Aerial photographs from the 1960’s show quarrying of limestone near the toe of the instability and the presence of rock outcrops in the area. These rock outcrops remained after mining, and this competent material causes the WMSA instability movements to shift towards the southeast on the lower part of the instability and cause the toe of the WMSA instability to daylight above Permanente Creek. Movements are towards the south on the upper part of the instability.

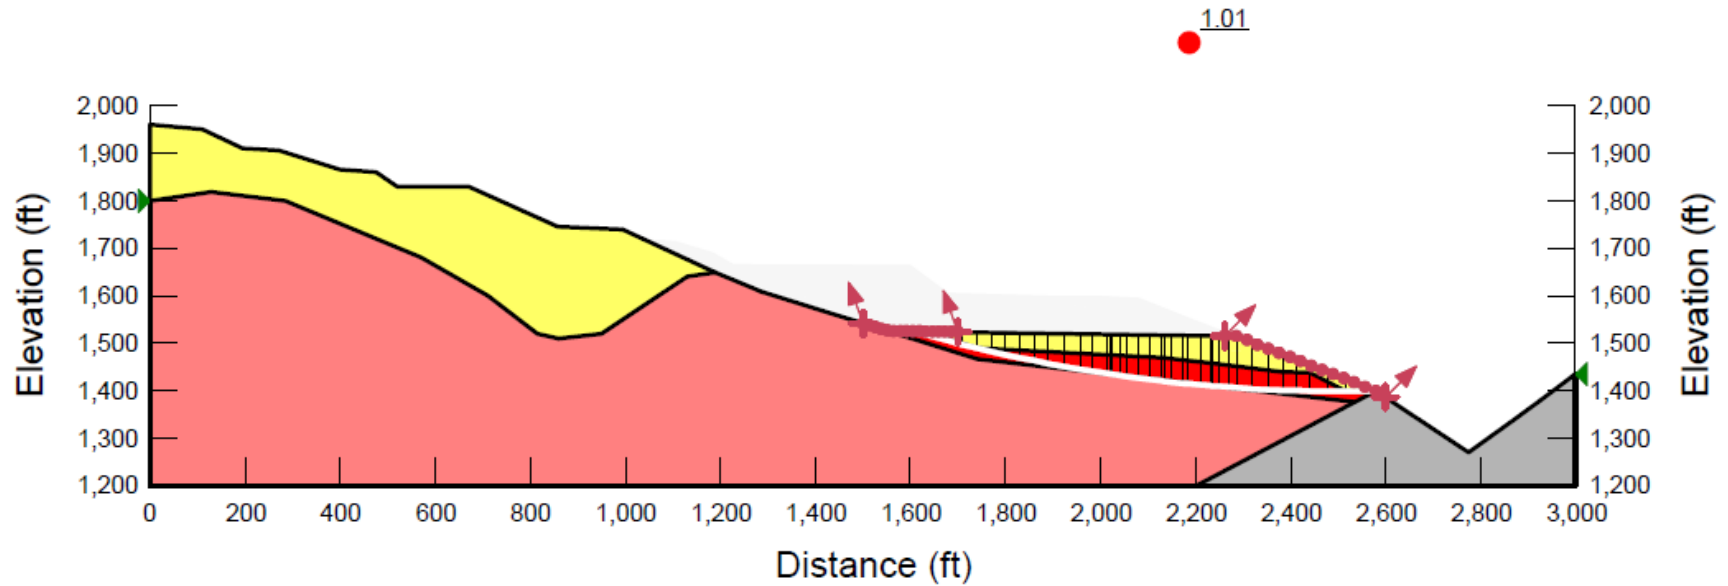
## Static Analysis of Proposed Reclamation Plan Grading

Title: Yeager Yard Slide - Section C  
 Parent: 01. Ru = 0.1 with Defined Failure Plane  
 Name: 01I. Pseudostatic with 2.5:1 Butress, -80 feet bench  
 Method: Spencer  
 Factor of Safety: 1.01  
 Horz Seismic Coef.: 0.15

| Color | Name | Model | Unit Weight (pcf) | C-Horizontal (pcf) | C-Vertical (pcf) | Phi-Horizontal (°) | Phi-Vertical (°) | Cohesion (pcf) | Phi (°) | Ru |
|---|---|---|---|---|---|---|---|---|---|---|
| Grey | Limestone (or competent Greenstone) | Mohr-Coulomb | 165 | | | | | 12,500 | 30 | 0 |
| Yellow | Waste Rock | Mohr-Coulomb | 155 | | | | | 0 | 35 | 0 |

The models were evaluated under static and pseudo-static conditions, with horizontal ground acceleration, for the closure configurations of the WMSA area using the Spencer method. The two types of analysis are summarized in Table 1. The target FOS for the analyses are 1.3 for static conditions, and 1.0 for pseudo-static conditions based on mining industry standards for lands to be reclaimed to open space end uses, consistent with prior geotechnical analyses. For the pseudo-static model conditions, a horizontal seismic coefficient of 0.15g was applied to the static condition models to be consistent with associated geotechnical studies (Stantec 2019) and to follow recommendations for earthquakes with magnitudes up to 8.25 (Seed 1982).
