BAGG Job No: STEVE-18-03

Engineering Geologic and  
Geotechnical Investigation

New Settling Pond

Stevens Creek Quarry

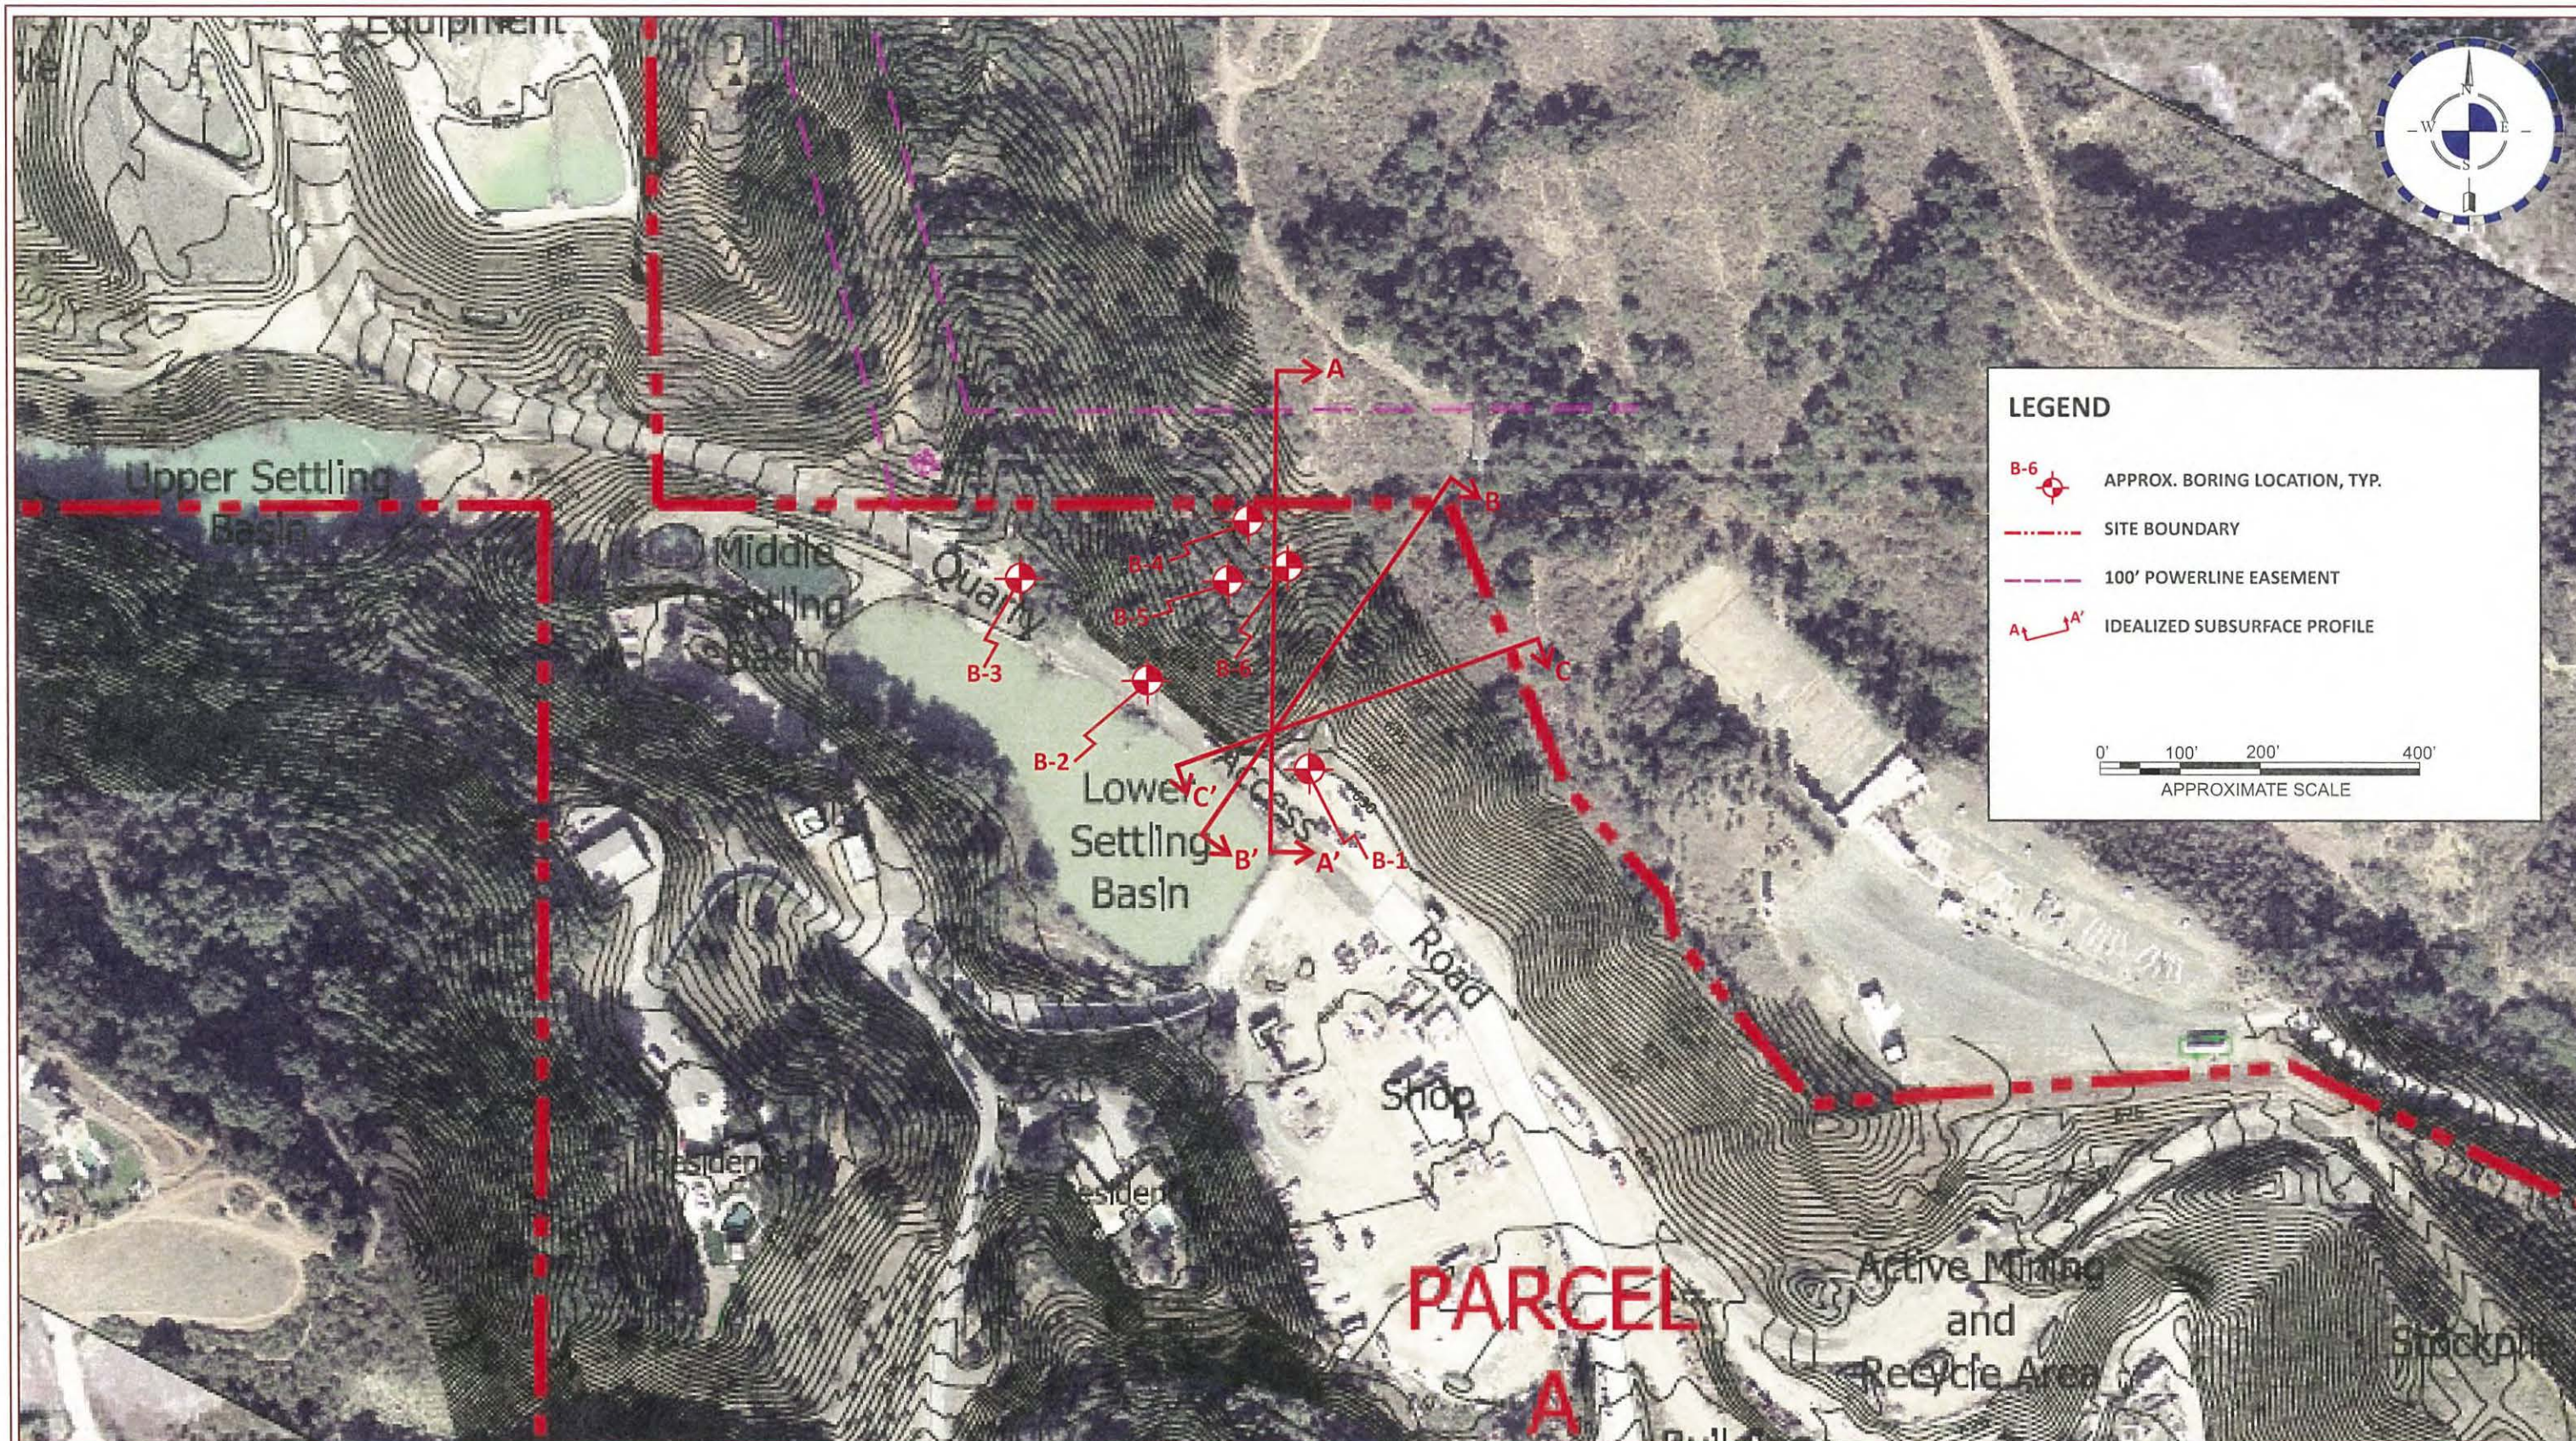
PLATE:  
2

Base: "Sheet 1, Existing Conditions Aerial Photograph, Stevens Creek Quarry", prepared by Resource Design Technology, Inc., dated January, 2008.

The topographic knob will be cut starting at near the prominent bend in the property line and carried downslope towards the southwest to create south- and southwest-facing slopes to permit the construction of the NSP as depicted on Plate 3. The NSP slope cuts were initially proposed at an approximate gradient of 1.5H:1V. However, our stability analyses results indicated that the noted 1.5H:1V NSP cut slope gradient was not considered stable under seismic loading. We understand that the portion of the DAR to abut the planned NSP along its western side will be raised about 10 feet in height to help achieve a desirable pond capacity, which will not reach or exceed the 15-acre-foot jurisdictional threshold capacity. It is important to note that the level area traversed by the DAR used to be occupied by a tributary creek channel to the main Stevens Creek channel, which has been infilled and dammed in few places to create the Upper, Middle and Lower Settling Basins and extend the DAR shown on Plates 2 and 3.

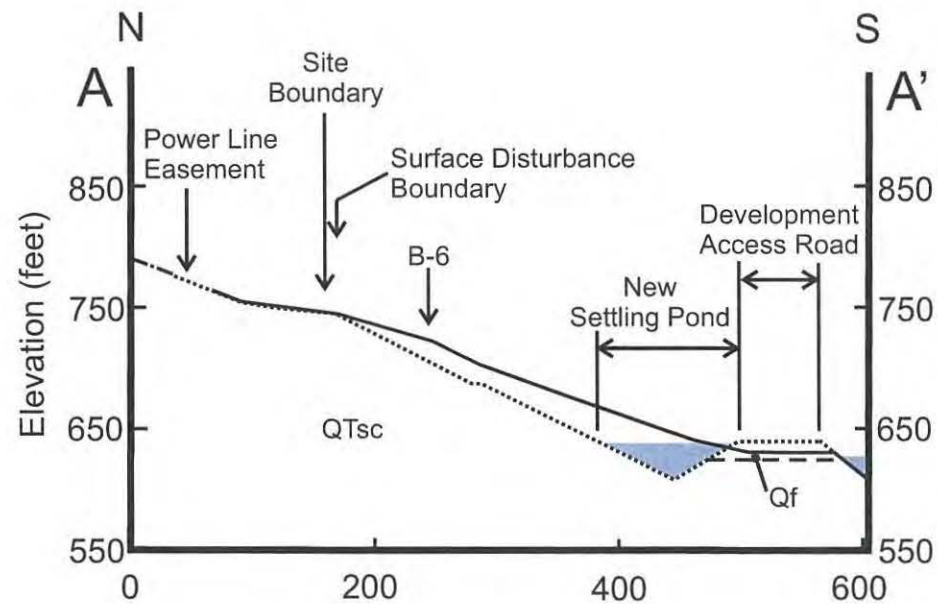
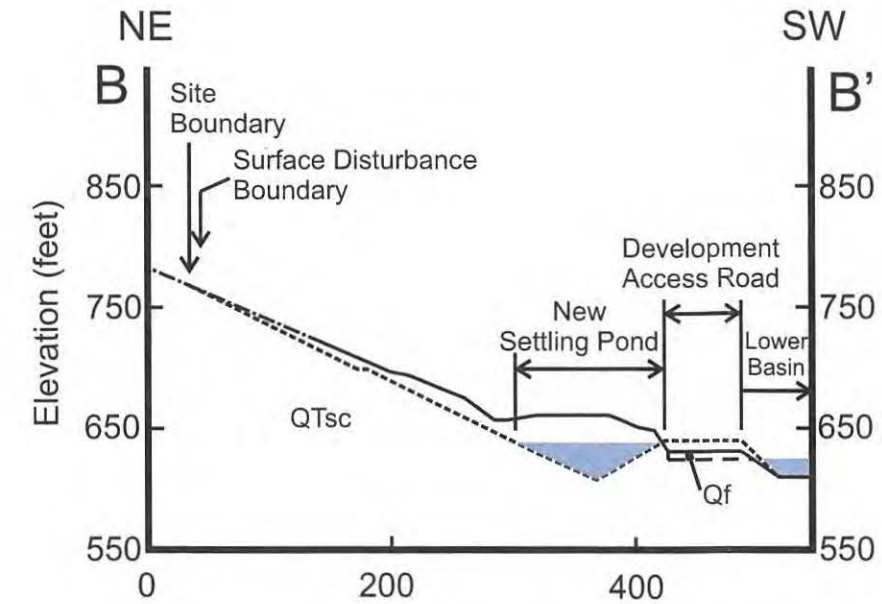
- EXISTING GROUND SURFACE, APPROXIMATE.
- - - PROPOSED GROUND SURFACE AT 2:1 SLOPE W/ 8 FEET BENCH, APPROXIMATE.
- · - · - INFERRED GROUND SURFACE
- - - GEOLOGIC CONTACT, APPROXIMATE
- B-6 ↓ APPROX. BORING LOCATION, TYP.
- QTsc SANTA CLARA FORMATION
- Qf EXISTING FILL

Our interpretations of the subsurface conditions as extrapolated from the information obtained during our site reconnaissance, subsurface exploration and published geologic literature, are presented on Cross Sections A-A', B-B' and C-C' presented as Plate 5, Geologic Cross Sections. More detail pertaining to the subsurface conditions is presented of the boring logs

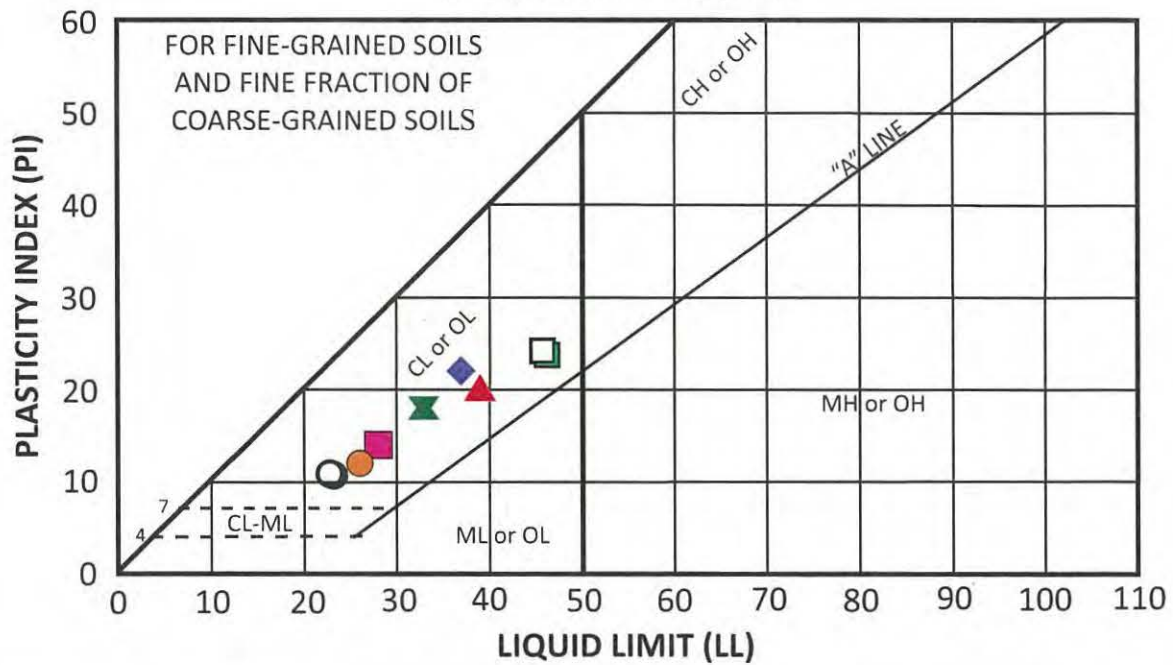
## PLASTICITY CHART

SYMBOL	SAMPLE SOURCE	DEPTH (FEET)	NATURAL WATER CONTENT (%)	LIQUID LIMIT	PLASTIC LIMIT	PLASTICITY INDEX	SOIL DESCRIPTION
▲	Boring B-3	9½	33.4	39	19	20	Sandy lean clay (CL)
■	Boring B-3	29	—	28	14	14	Yellow brown clayey sand (SC)
●	Boring B-4	8½	—	26	14	12	Yellow brown clayey sand (SC)
✕	Boring B-4	34¼	9.5	33	15	18	Orange brown lean clay with sand (CL)
◆	Boring B-5	13¾	—	37	15	22	Yellow brown lean clay with sand (CL)
◻	Boring B-5	44	23.2	46	22	24	Yellow brown lean clay (CL)
○	Boring B-5	58½	8.5	23	12	11	Blue gray clayey sand (SC)

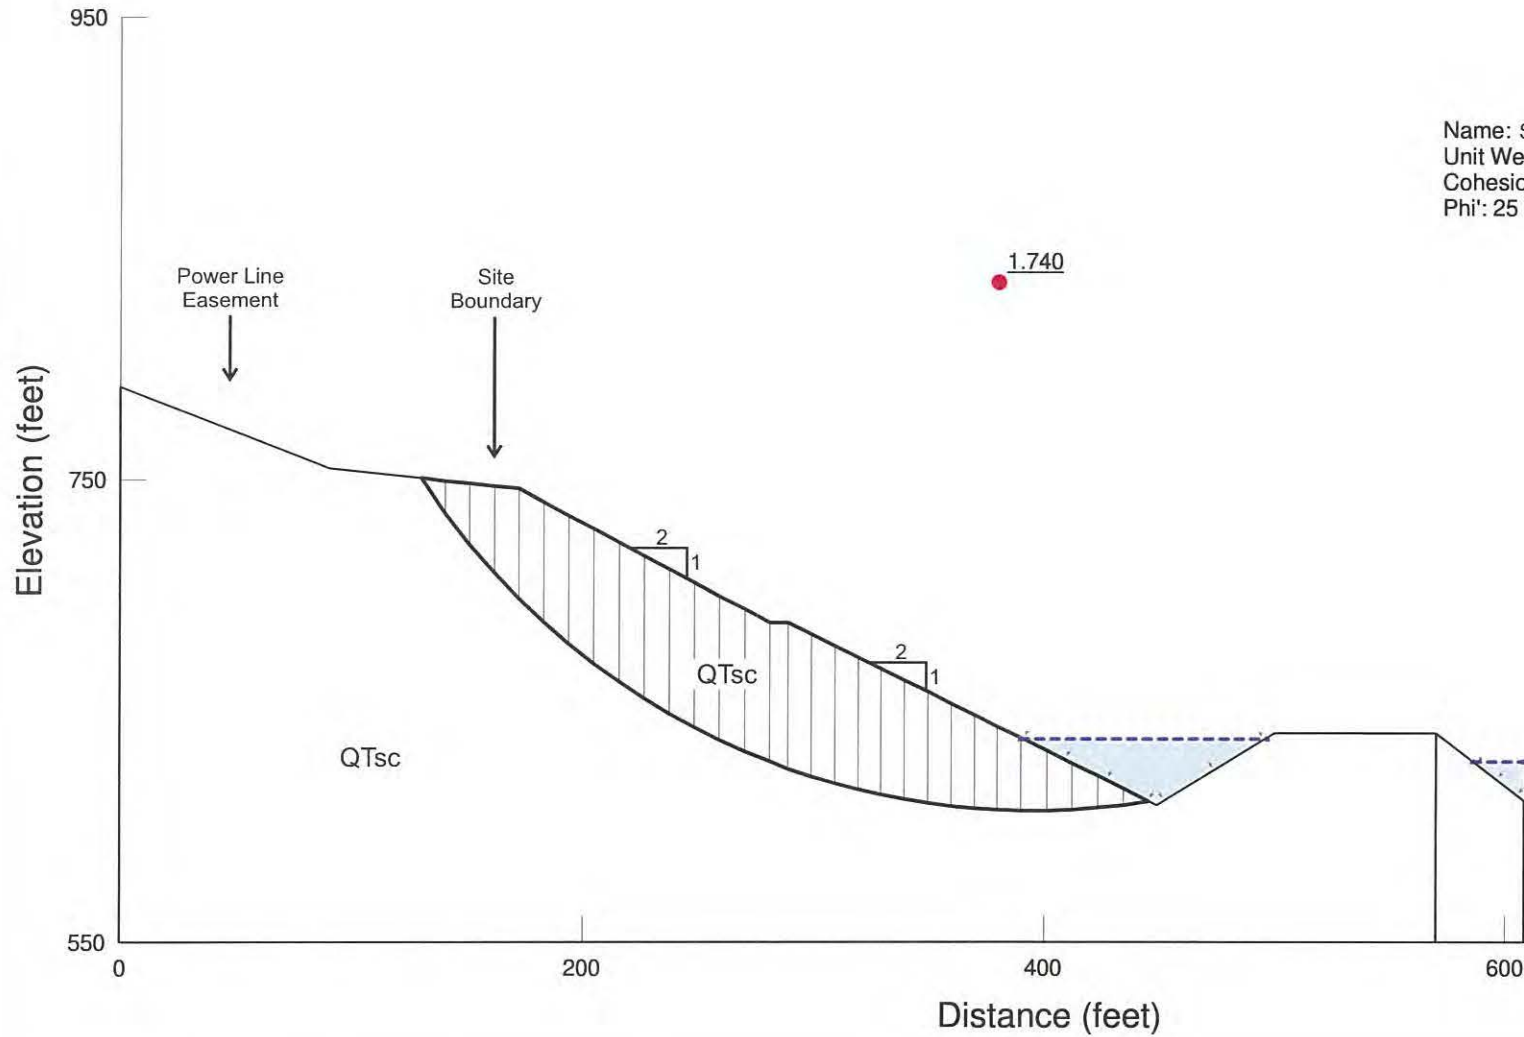
PLATE  
 19

Name: Santa Clara Formation (QTsc)  
 Unit Weight: 130 pcf  
 Cohesion: 1,000 psf  
 Phi: 25 °

Based on the noted strength parameters and the geometry of Cross Sections A-A' through C-C', the results of our slope stability analyses yielded static FOS ranging from about 1.66 to 1.74 for global conditions. We note that these analyses were based on slope configurations with 2H:1V gradients for the cut slopes coupled with an 8-foot wide drainage terrace/bench to be installed at near mid-slope height, and 1.5H:1V for the raised DAR northeast-facing eastern side slope.

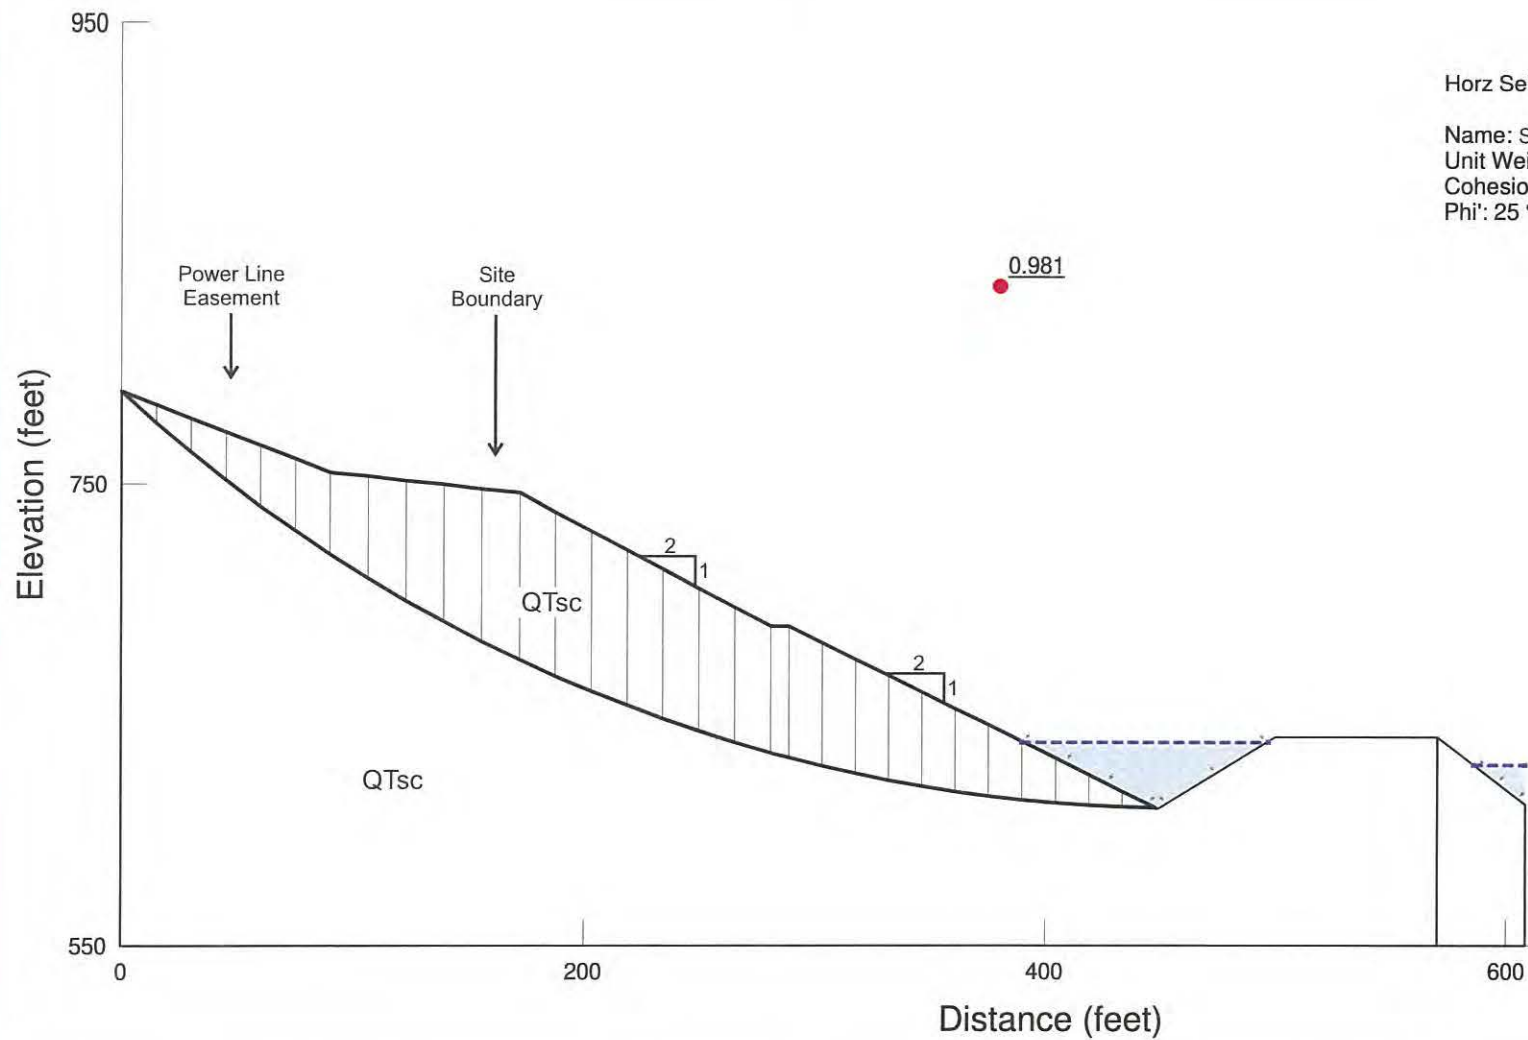
Horz Seismic Coef.: 0.29g

Name: Santa Clara Formation (QTsc)  
 Unit Weight: 130 pcf  
 Cohesion': 1,000 psf  
 Phi': 25 °

The seismic stability of the slopes was analyzed using a pseudo-static approach per the general guidelines included in CGS Special Publication 117A (2008) and the Southern California Earthquake Center (2002). Earthquake Engineering Research Institute has published a screening analysis procedure for seismic slope stability (Stewart et al., 2003), which takes into account local variations in the seismicity as presented by the earthquake magnitude, as well as the distance from the fault that most significantly contributes to the ground motion hazard at the site. The screening procedure is based on a statistical relationship previously developed by Bray et al. (1998) between seismic slope displacement ( $u$ ), peak amplitude of shaking in the underlying bedrock ( $k_{max}$ ), significant duration of shaking ( $D5-95$ ), and the ratio of slope resistance to peak demand ( $k_y/k_{max}$ ), where  $k_y$  is the yield acceleration, or the horizontal acceleration required to reduce the safety factor to unity. A tolerable seismic slope displacement ( $u$ ) for residential range from 5 cm to 15 cm. A safety factor of 1 is the minimum required for passing the screening procedure.
