Re: Statement of Justification for Grading Abatement  
Pacheco Pass  
APN 898-19-003,-005,-029,-033.-036,-037

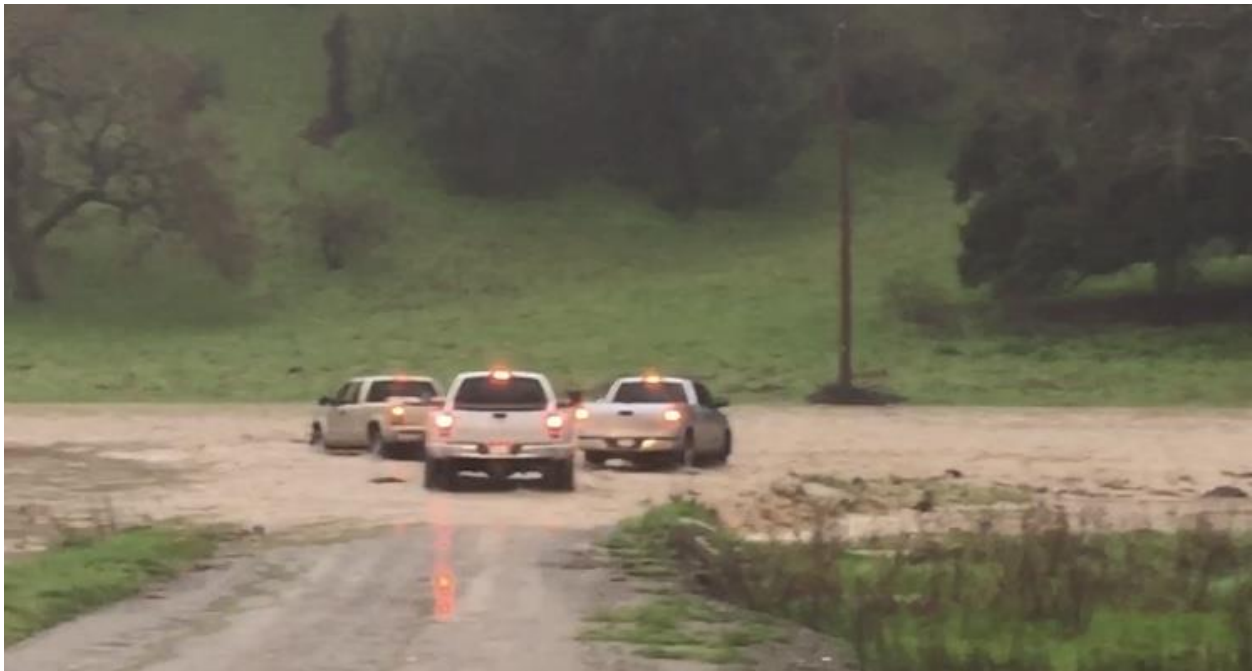
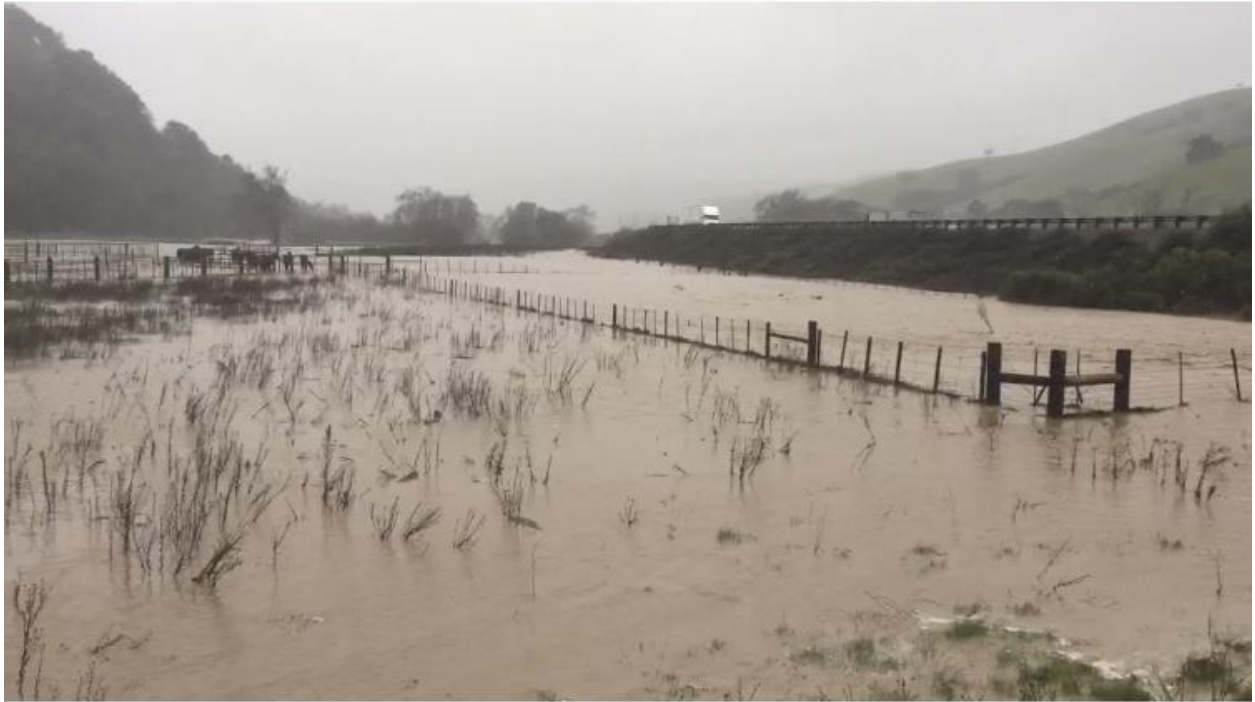
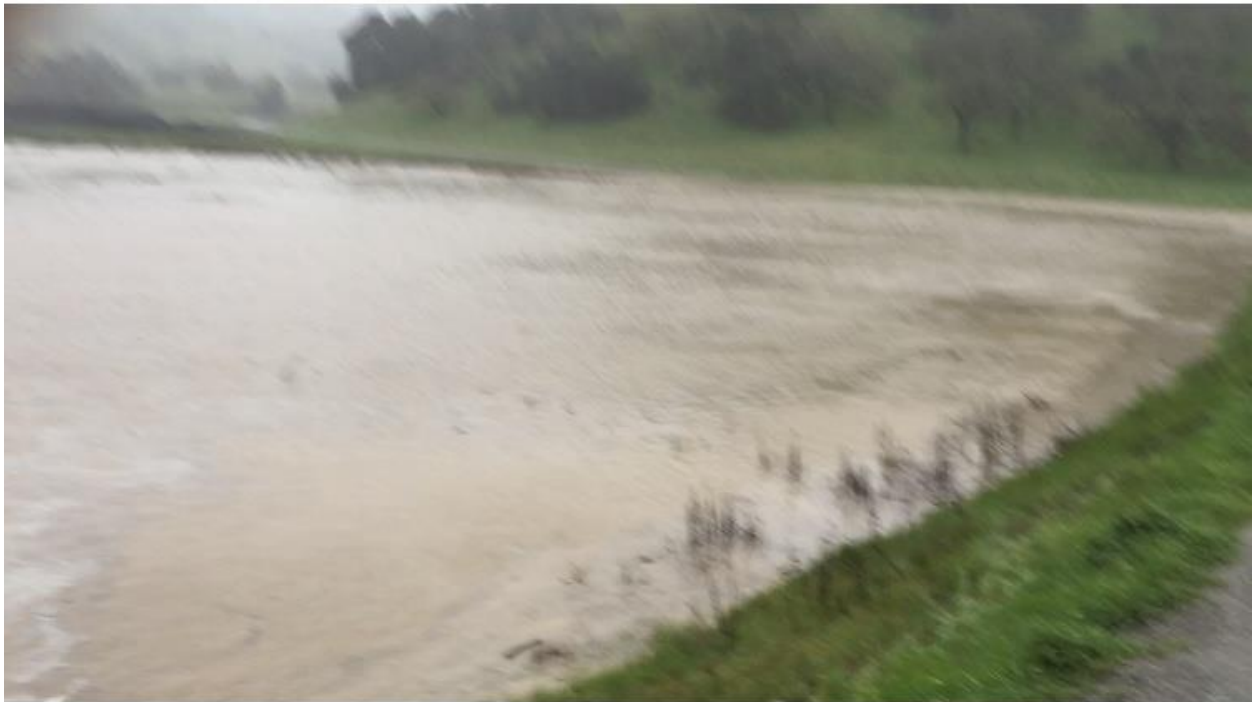
The flattest portion of the 3,000+ acre ranch is along Highway 152. This area is the main hub of the cattle ranching operation shipping and receiving, it is also subject to noise from the adjacent highway, and subject to flooding. All of these reasons makes this location not suitable for a house location. See photos below:
