**Bourdet Ranch**  
**Notice of Violation Abatement Project**  
**Santa Clara County, California**  
**Biological Resources Report**

**August 2022**

Sequoia Ecological Consulting, Inc.  
1342 Creekside Drive  
Walnut Creek, CA 94596  
(925) 855-5500

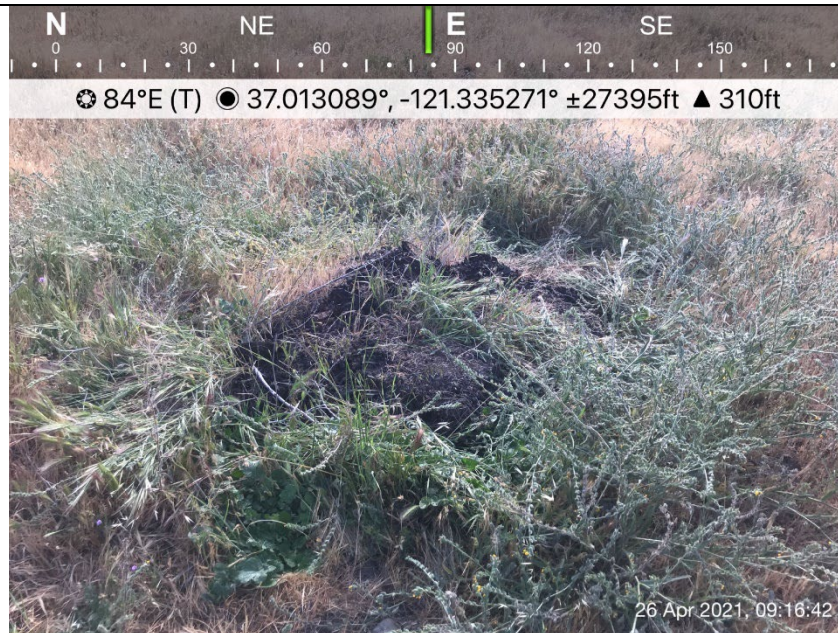
**Photo 2:** Example of tree stumps that were found onsite.

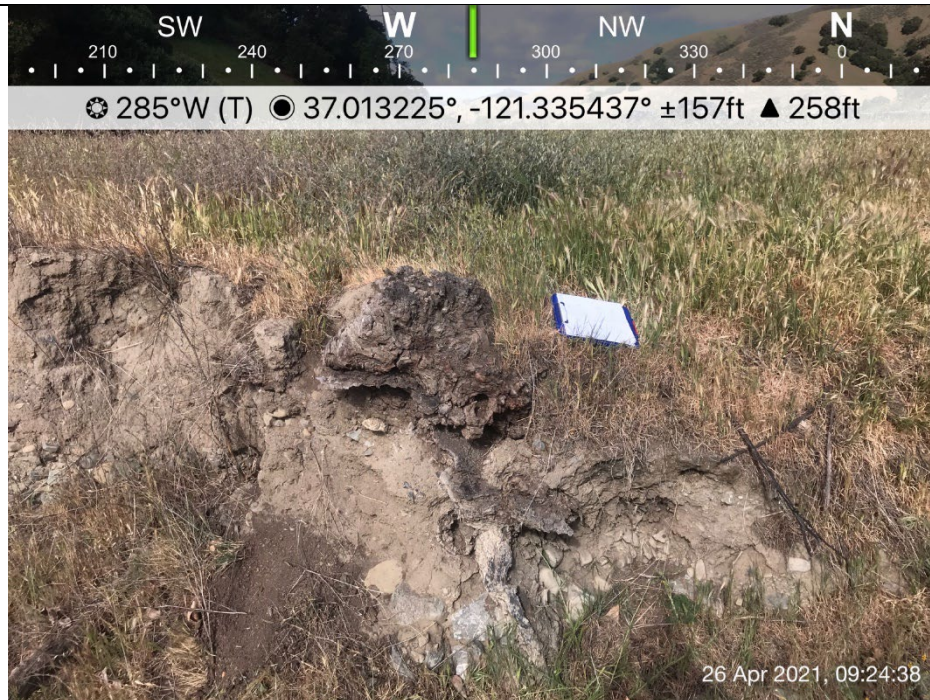
Photo 3. Stump location of Tree 12 showing the partial stump in the creek bank.

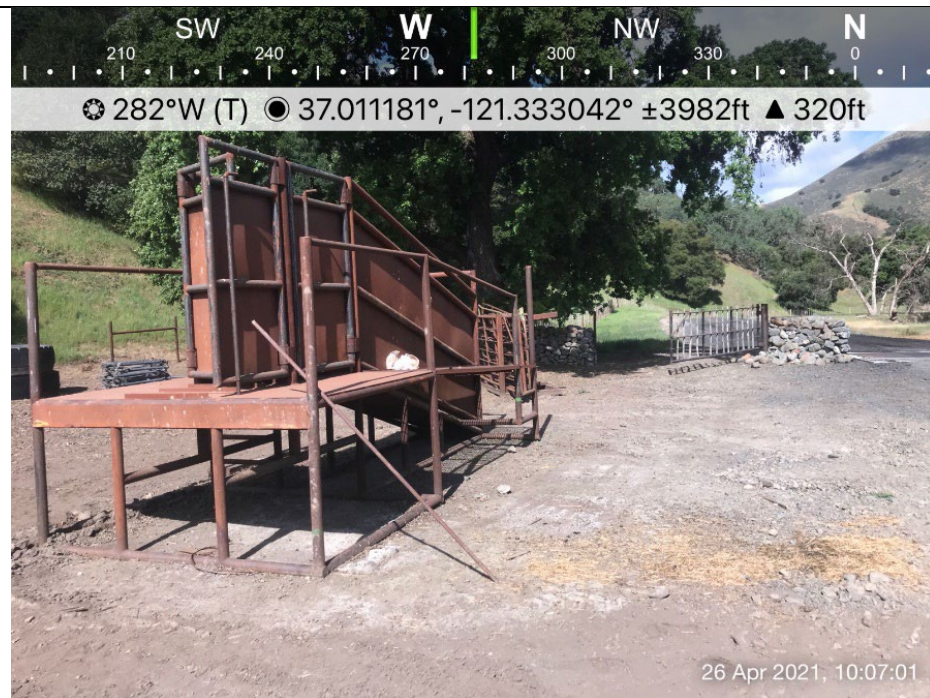
Photo 4: Photo showing a portion of the violation area where a tree was removed.

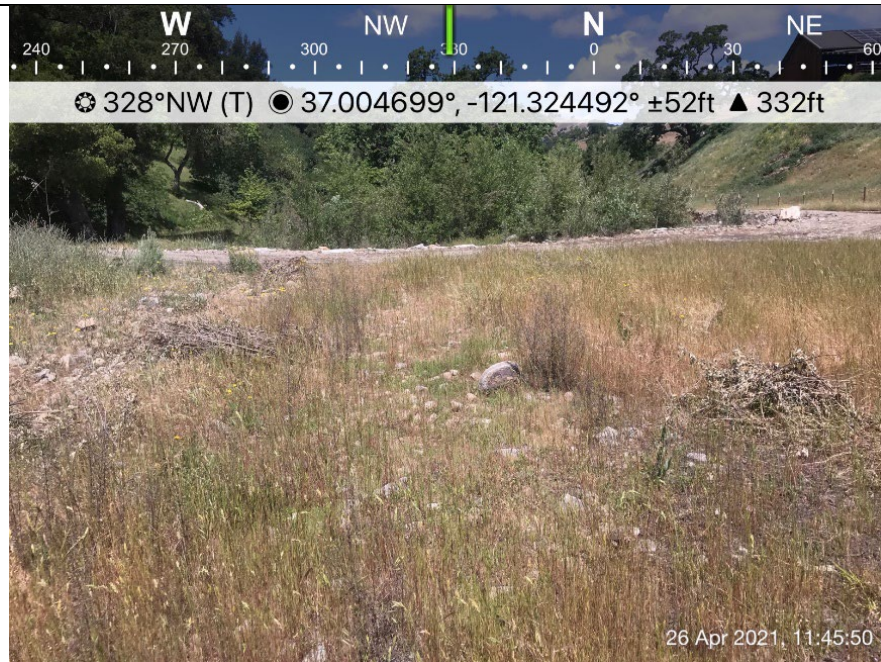
**Photo 5:** Locations of Tree 1 and 2 along Harper Canyon Creek along the boundary of the riparian zone.
