Bourdet Ranch Notice of Violation Abatement Project Santa Clara County, California

Biological Resources Report

August 2021

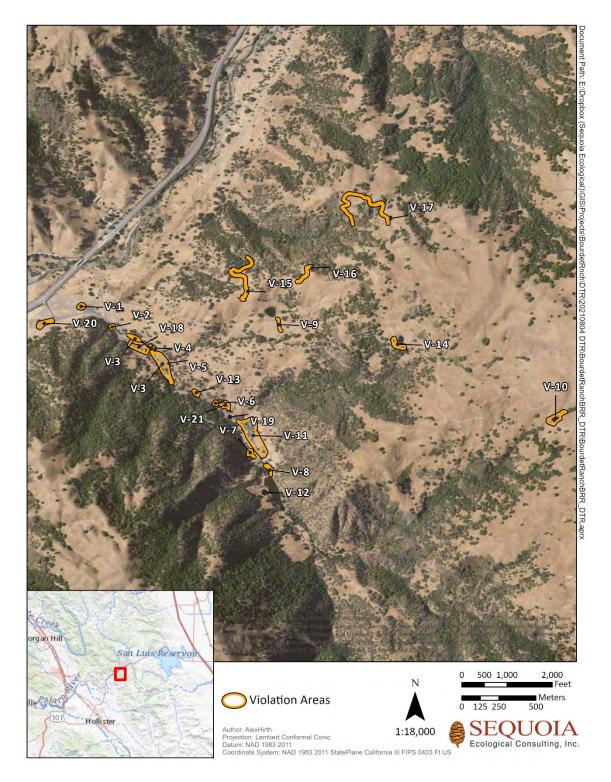
Figure 2. Project Area Map Showing Named Violation Areas. Violation Area Names Correspond with Locations and Descriptions in Table 1.

Sequoia reviewed the preliminary design plans provided in Appendices I and J and created a combined project area that covered all project activities. Sequoia then assigned each discrete work area a unique identifier for uniform tracking, identified the nature and description of the violation, classified the disturbance type in accordance with the Santa Clara Valley Habitat Plan and proposed abatement (temporary/permanent), and quantified impact areas based on maximum grading extents. A summary of the violations is provided in Table 1. Narrative and key design features for each group of proposed abatements are provided in Sections 3.1.1 -3.1.4.

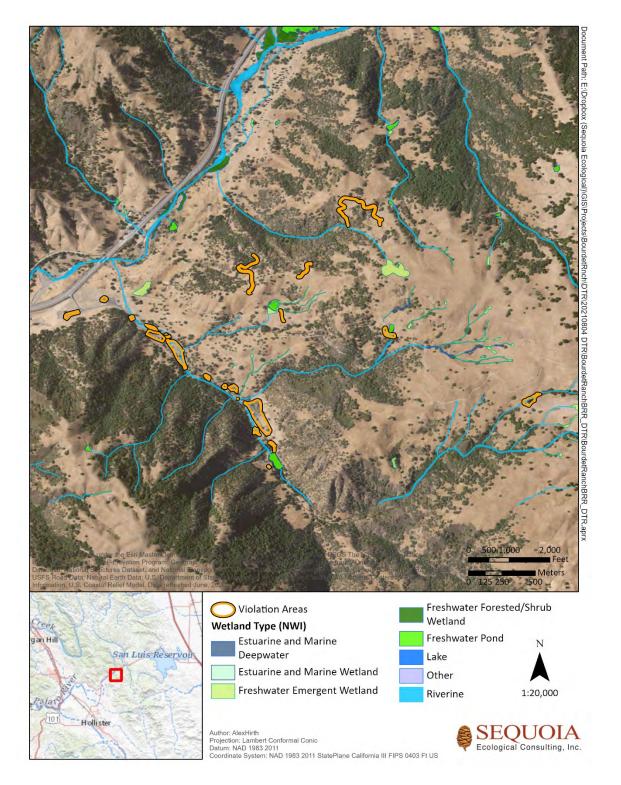
Figure 3. Occurrences of NWI Wetland Types and Waterways within the Project Area.

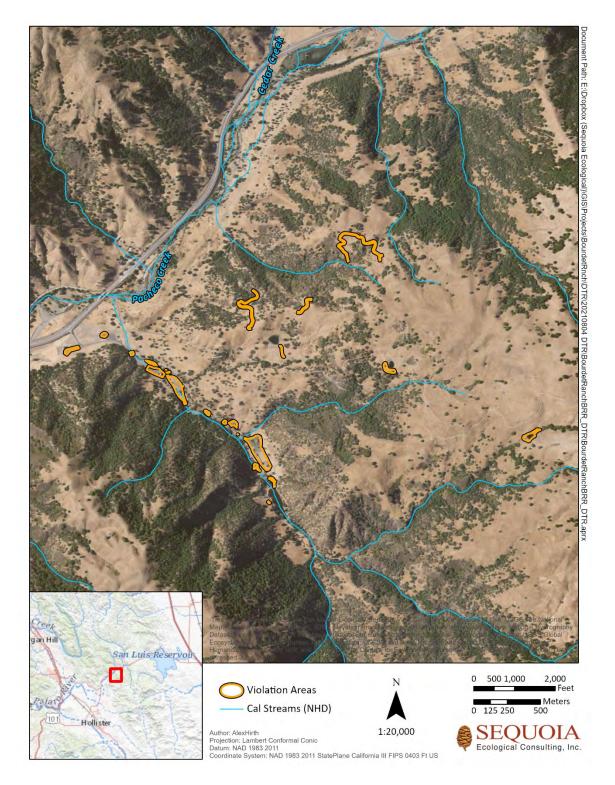
Figure 4. National Hydrography Dataset Map of the Project Area.

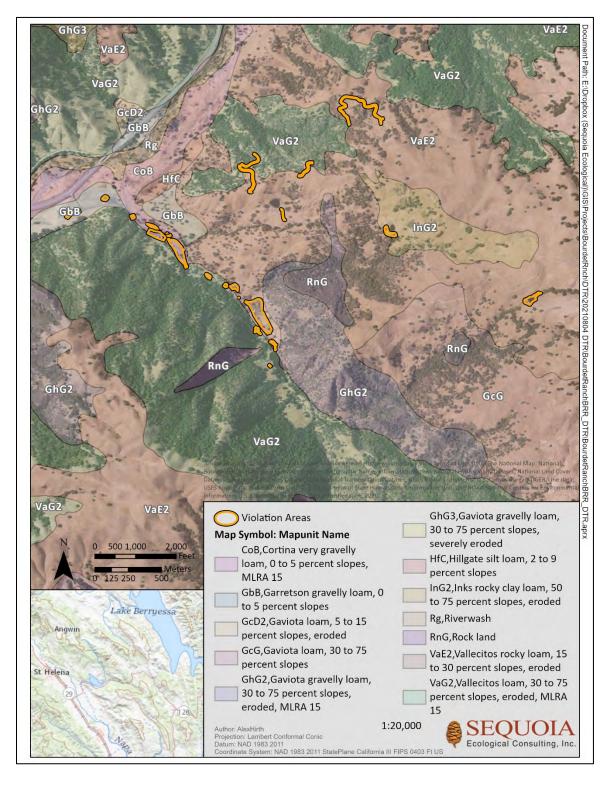
Figure 5. NRCS Soil Map of the Project Area.

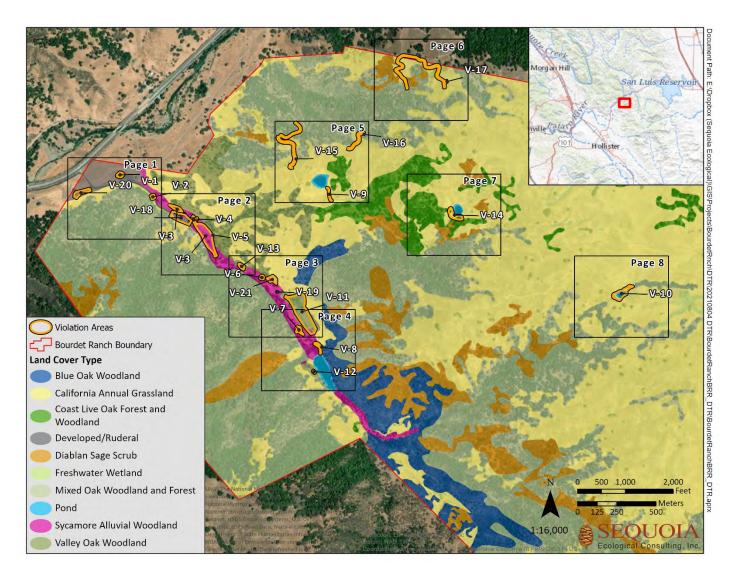
Figure 6. Valley Habitat Plan Land Cover Types Found on Bourdet Ranch and in Violation Areas.

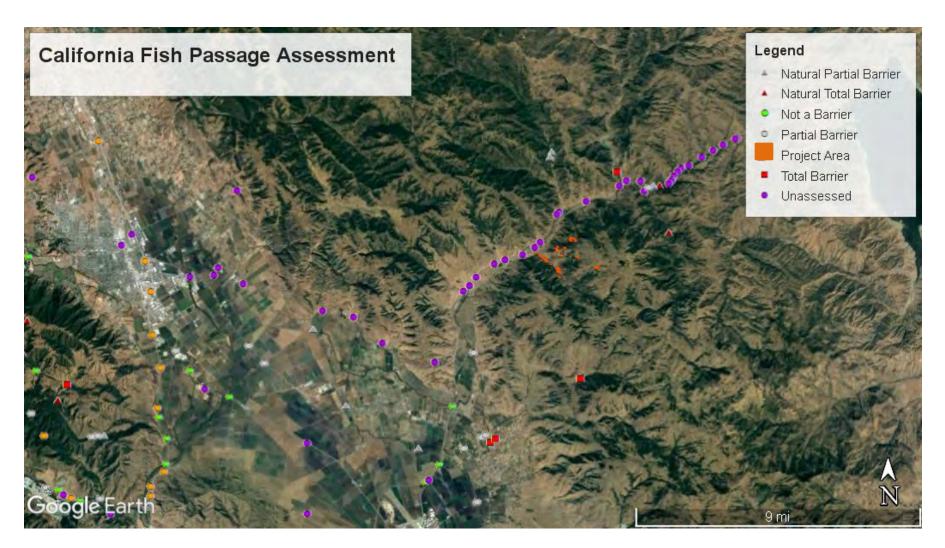
Figure 10. California Fish Passage Assessment Database Results.

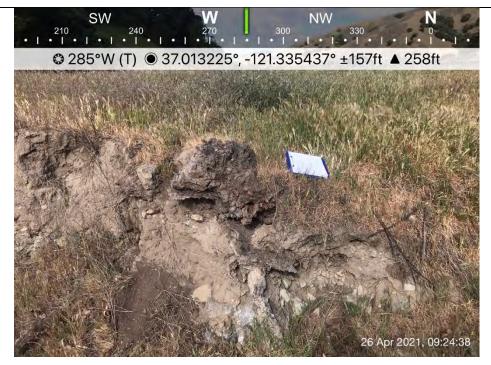
Photo 3. Stump location of Tree 12 showing the partial stump in the creek bank.

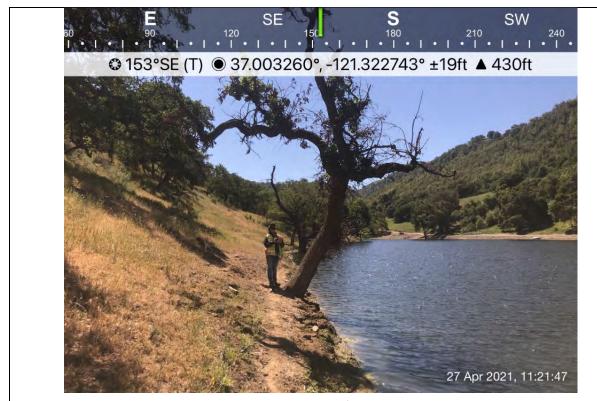
Photo 9: Tree 39 shown to still be alive along the lake formed by the Impoundment at Harper Creek.

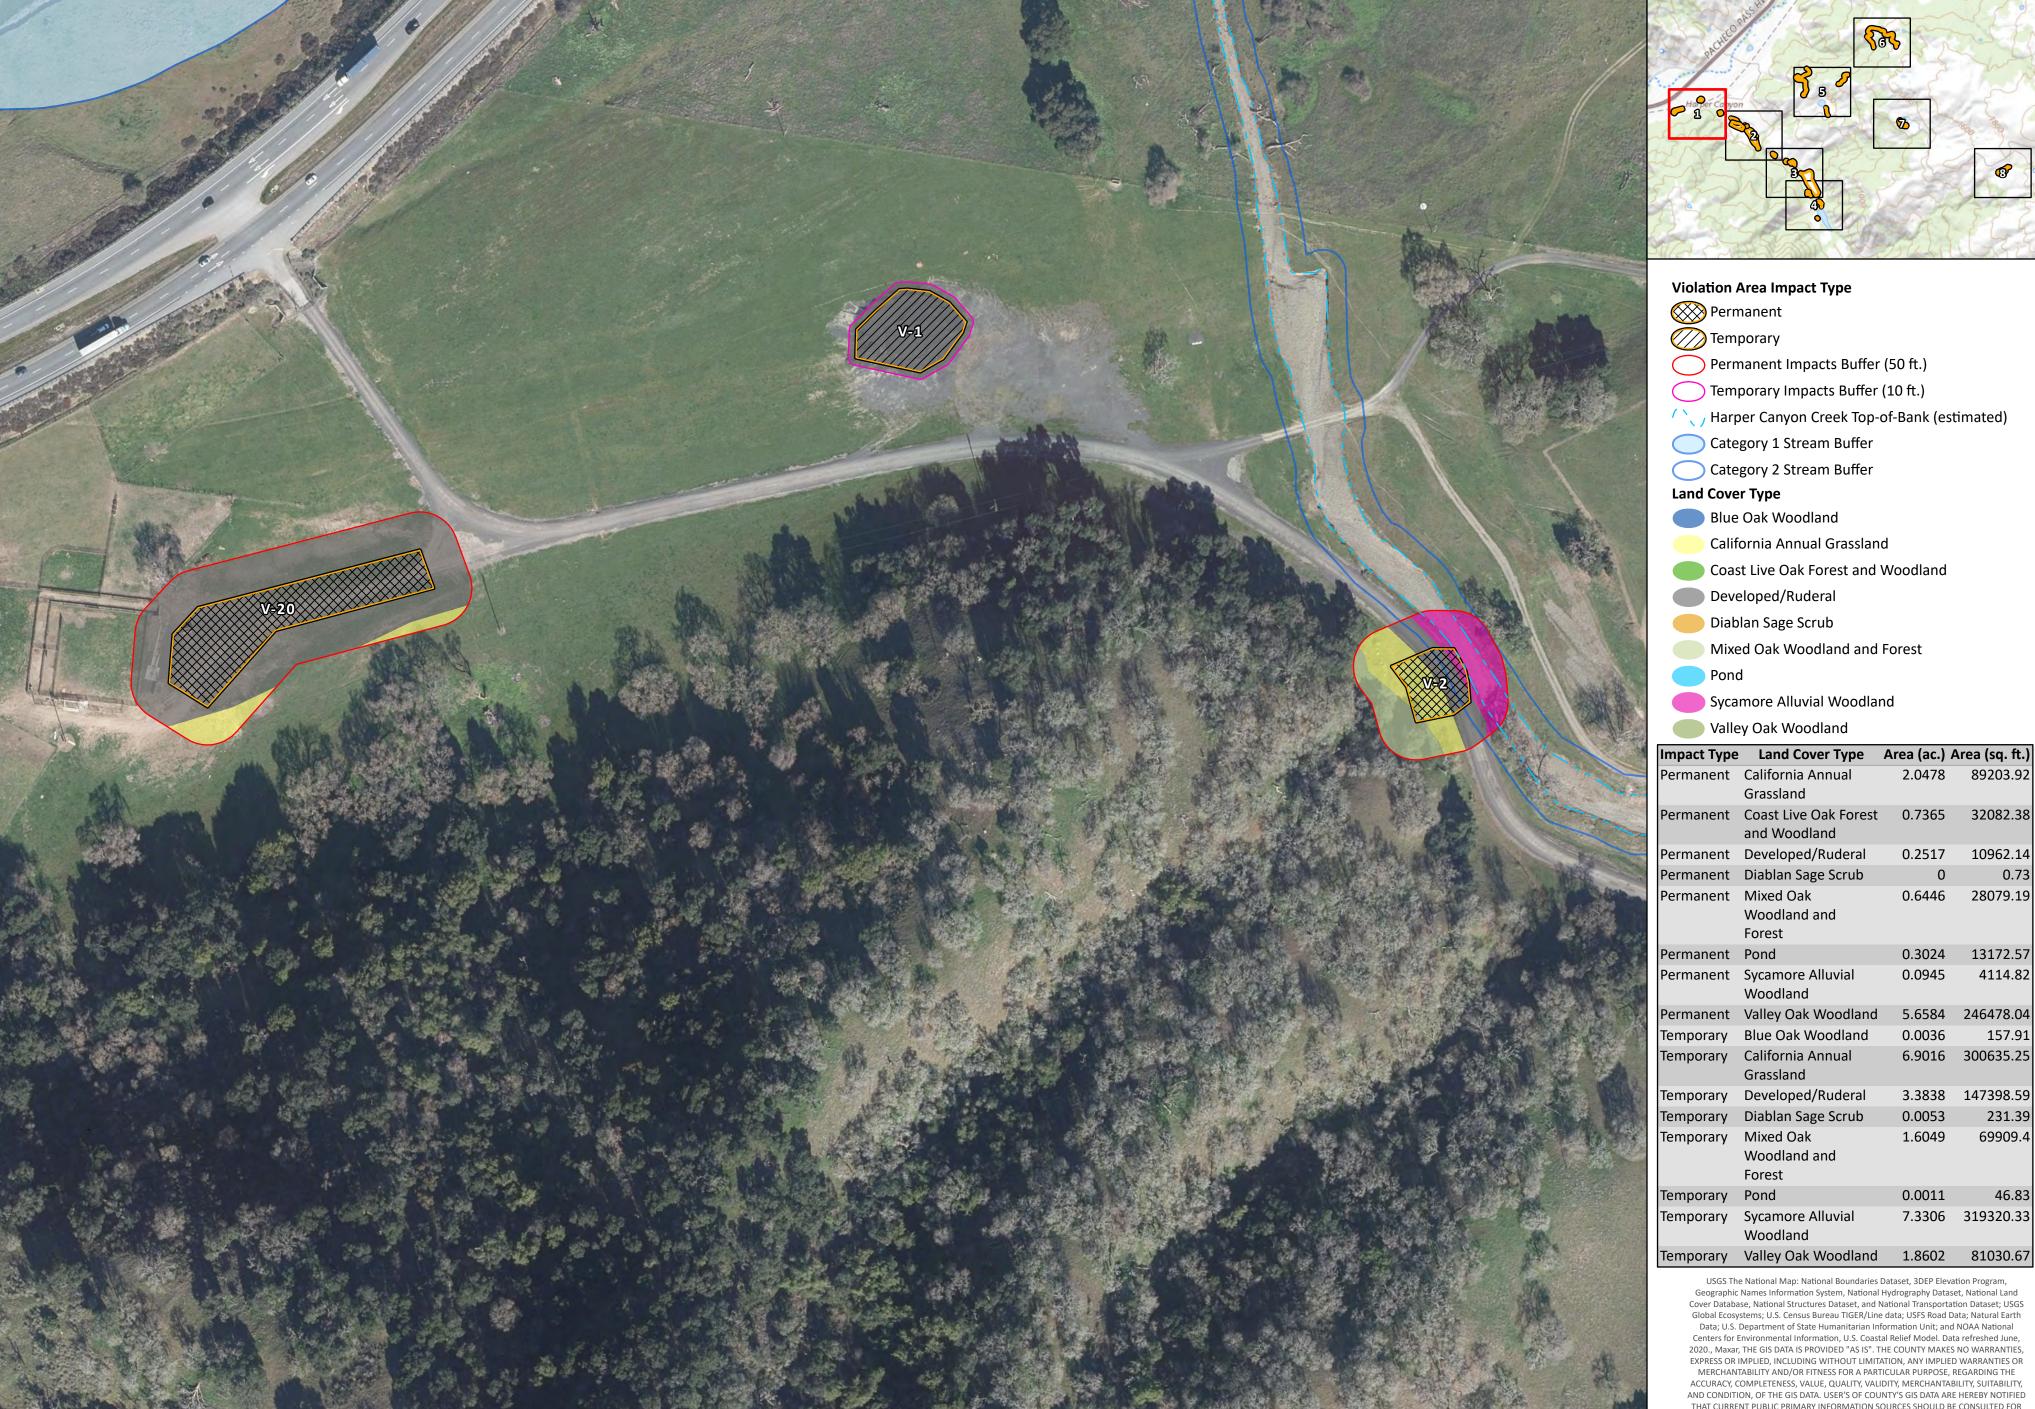
UniqueID	Name	Description	Area (ac.) A	Area (sq. ft.) Lii	near Feet
V-1	Stockpile Area	A large stockpile of material near the entrance to the property. Adjacent to Harper Canyon Creek.	0.2452	10679.63	110
V-2	Double Culvert Crossing	Erosion of crossing fill above culverts due to improperly placed concrete slope protection.	0.1489	6486.27	88
V-20	Fill Area	Unpermitted fill area to be legalized	0.5449	23737.8	373

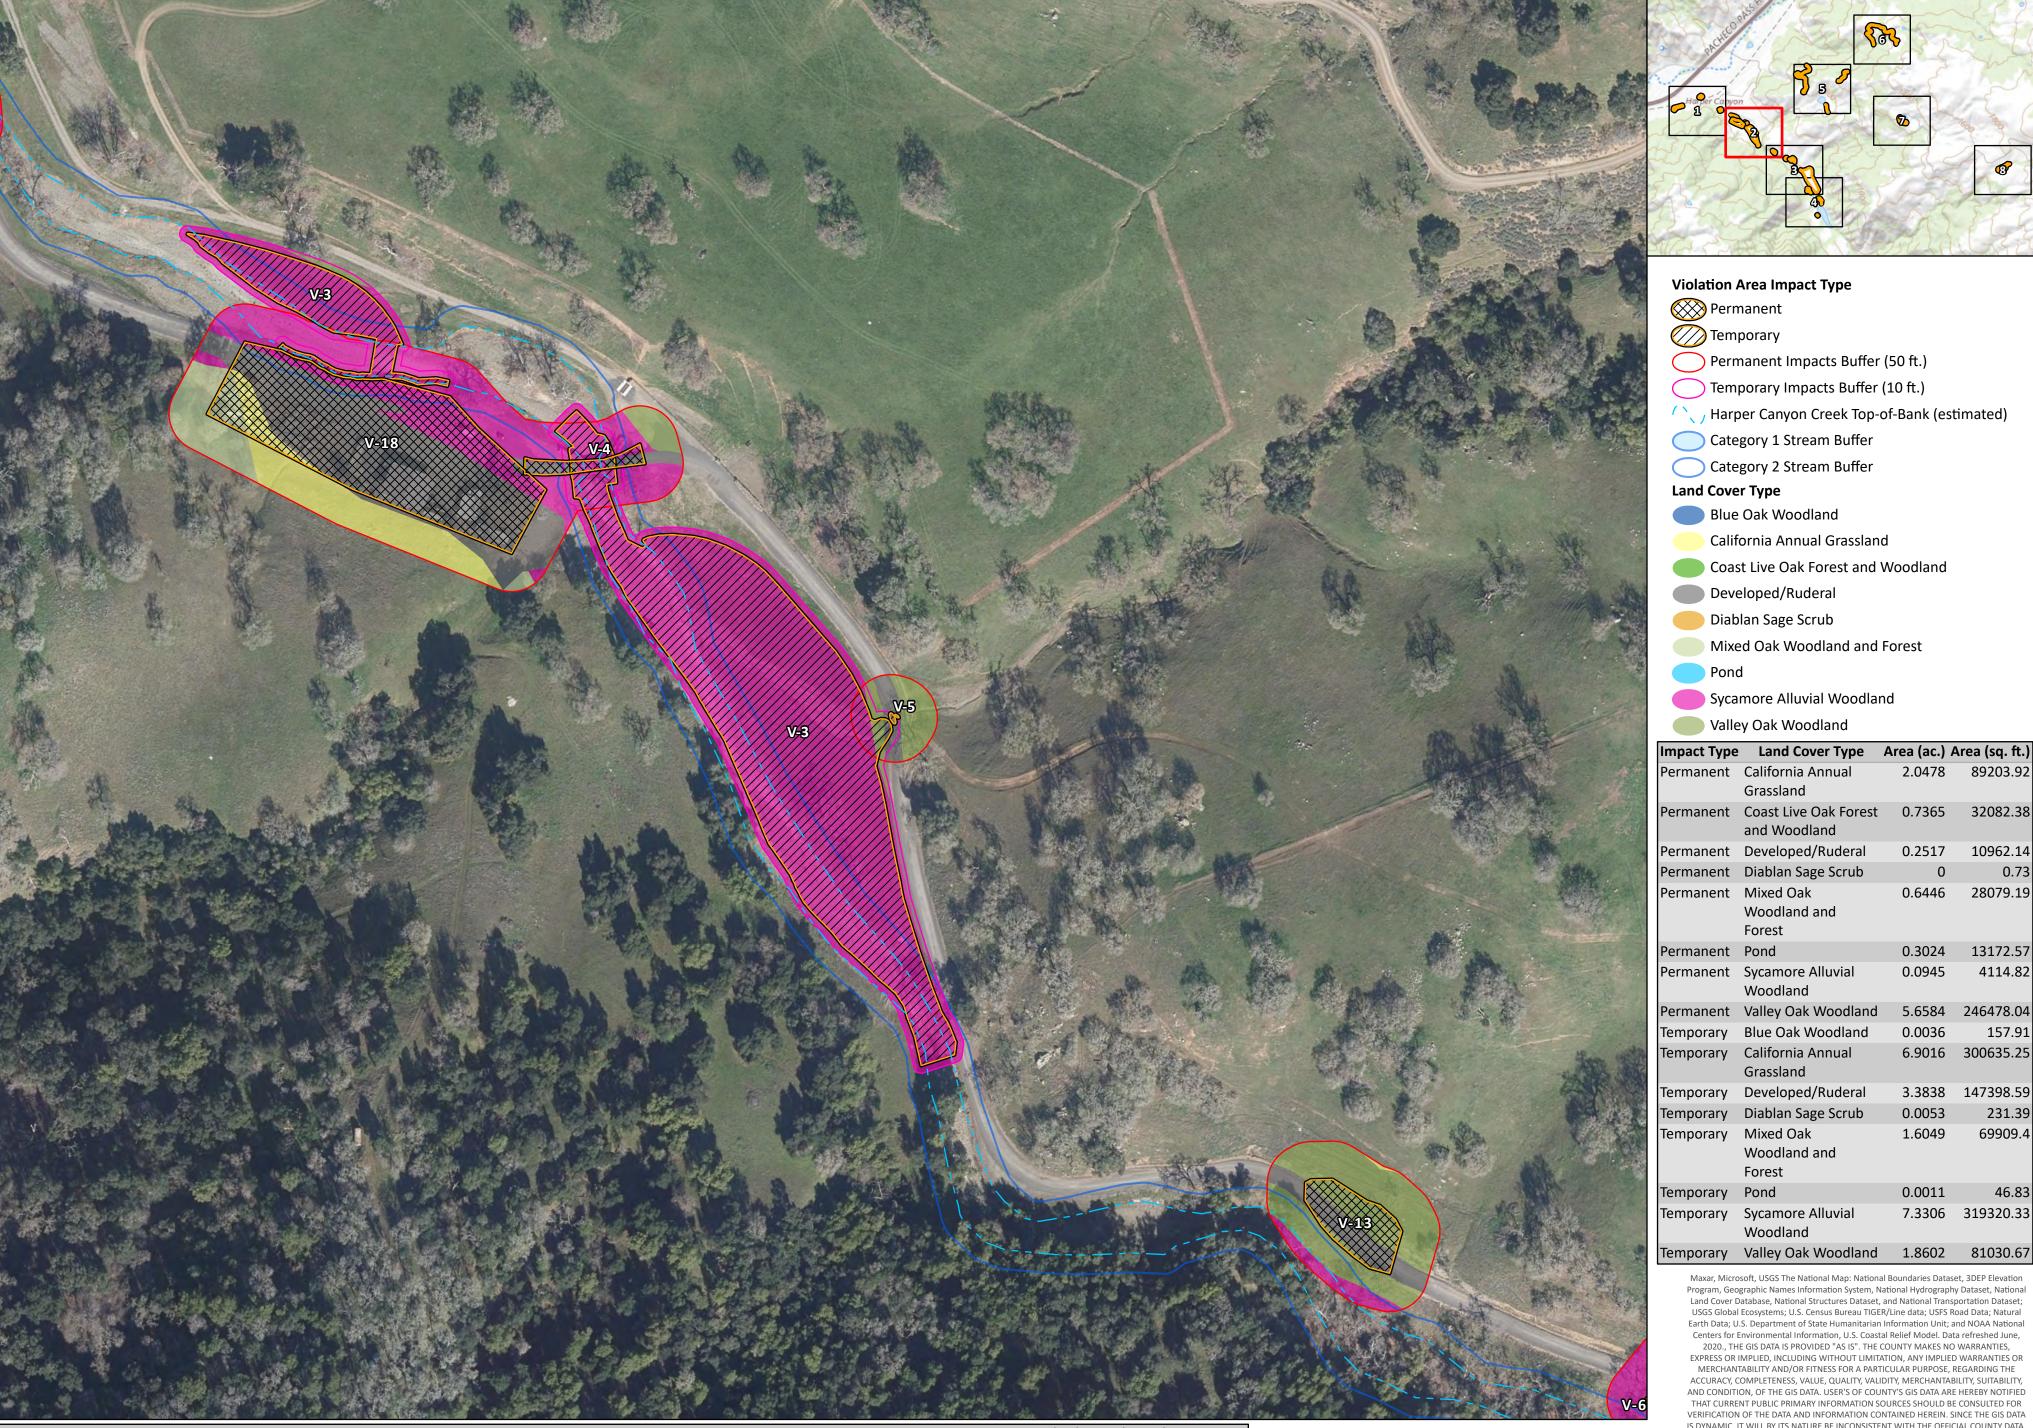
UniqueID	Name	Description	Area (ac.)	Area (sq. ft.)	Linear Feet
V-13	Harper Canyon Creek Road Grading	Unpermitted road grading along Harper Canyon Creek.	0.1964	8555.54	150
V-18	Bridge Area Construction	Building pad adjacent to the bridge and the building footprints of several unpermitted structures.	1.2904	56209.98	435
V-3	Grading in Harper Canyon Creek	Approximate graded area of impacts along lower Harper Canyon Creek.	2.9545	128699.51	1300
V-4	Bridge over Harper Canyon Creek	Bridge construction in Harper Canyon Creek Channel.	0.058	2527.17	155
V-5	Double Culvert Crossing 1	Erosion of crossing and fill above double culvert.	0.0019	83.13	15

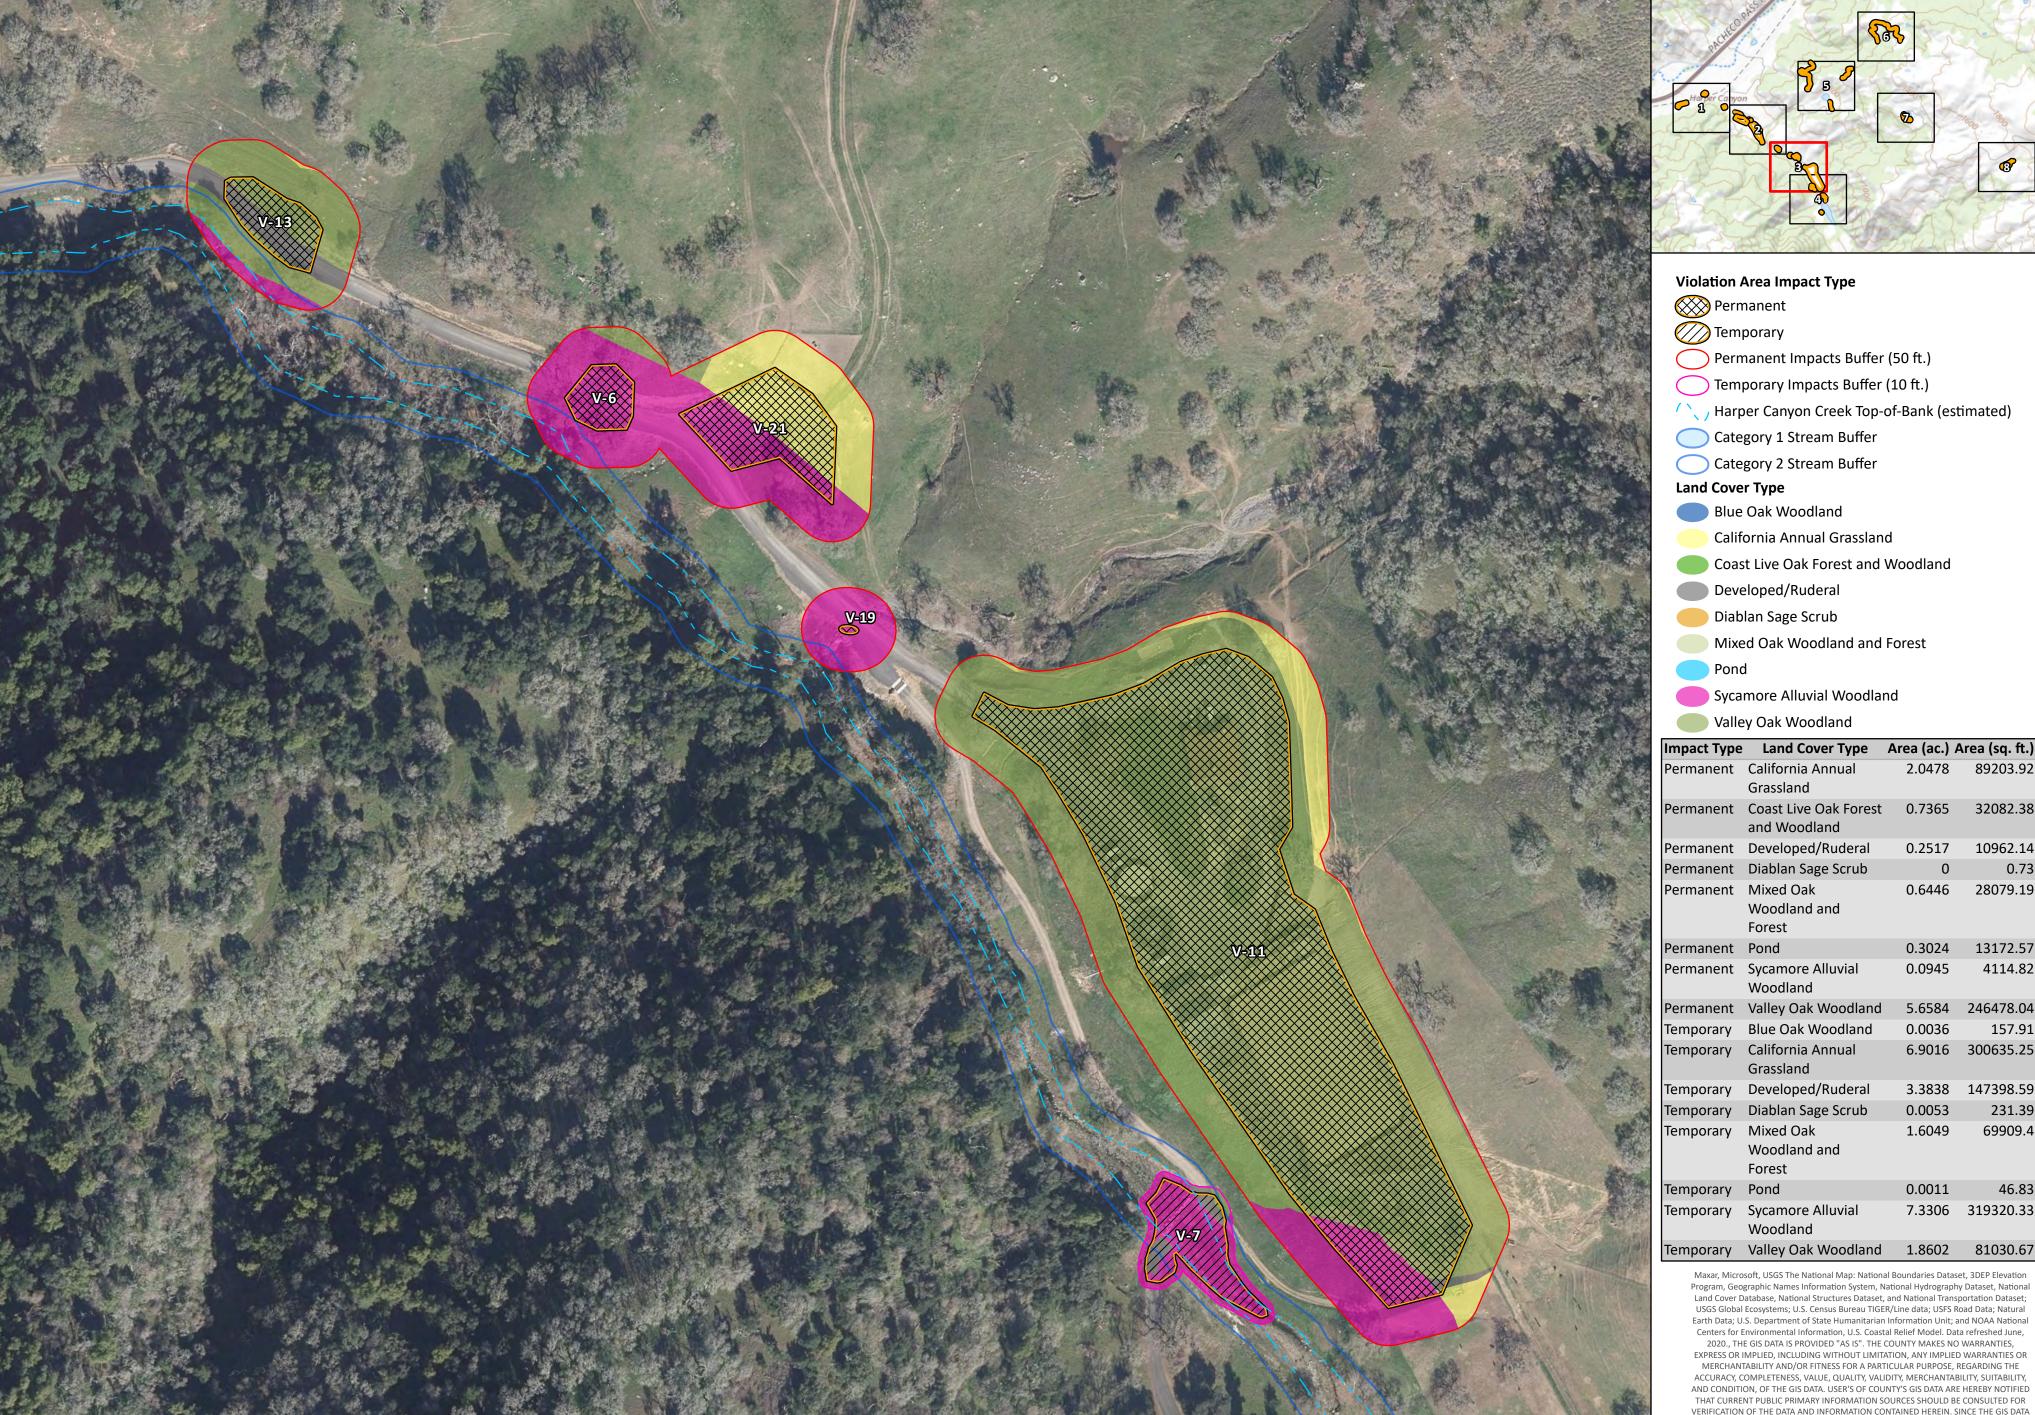
UniqueID Name Description Area (ac.) Area (sq. ft.) Linear Feet V-11 House, Horse Arena Area Unpermitted grading to construct house, horse arena, and other structures. 4.6531 202687.02 900 150 V-13 Harper Canyon Creek Road Grading Unpermitted road grading along Harper Canyon Creek. 0.1964 8555.54 Plastic double culvert of 30-inch diameter installed with cast-in-place concrete. V-19 171.47 23 Double Culvert Crossing on a Tributary 0.0039 V-21 18443.47 200 Turn Around Grading Unpermitted turn around grading 0.4234 V-6 Double Culvert Crossing 2 Culvert crossing for drainage into Harper Canyon Creek. 5659.13 90 0.1299 Creek Crossing Downstream of Impoundment Realignment of middle Harper Canyon Creek. 12261.12 210 0.2815

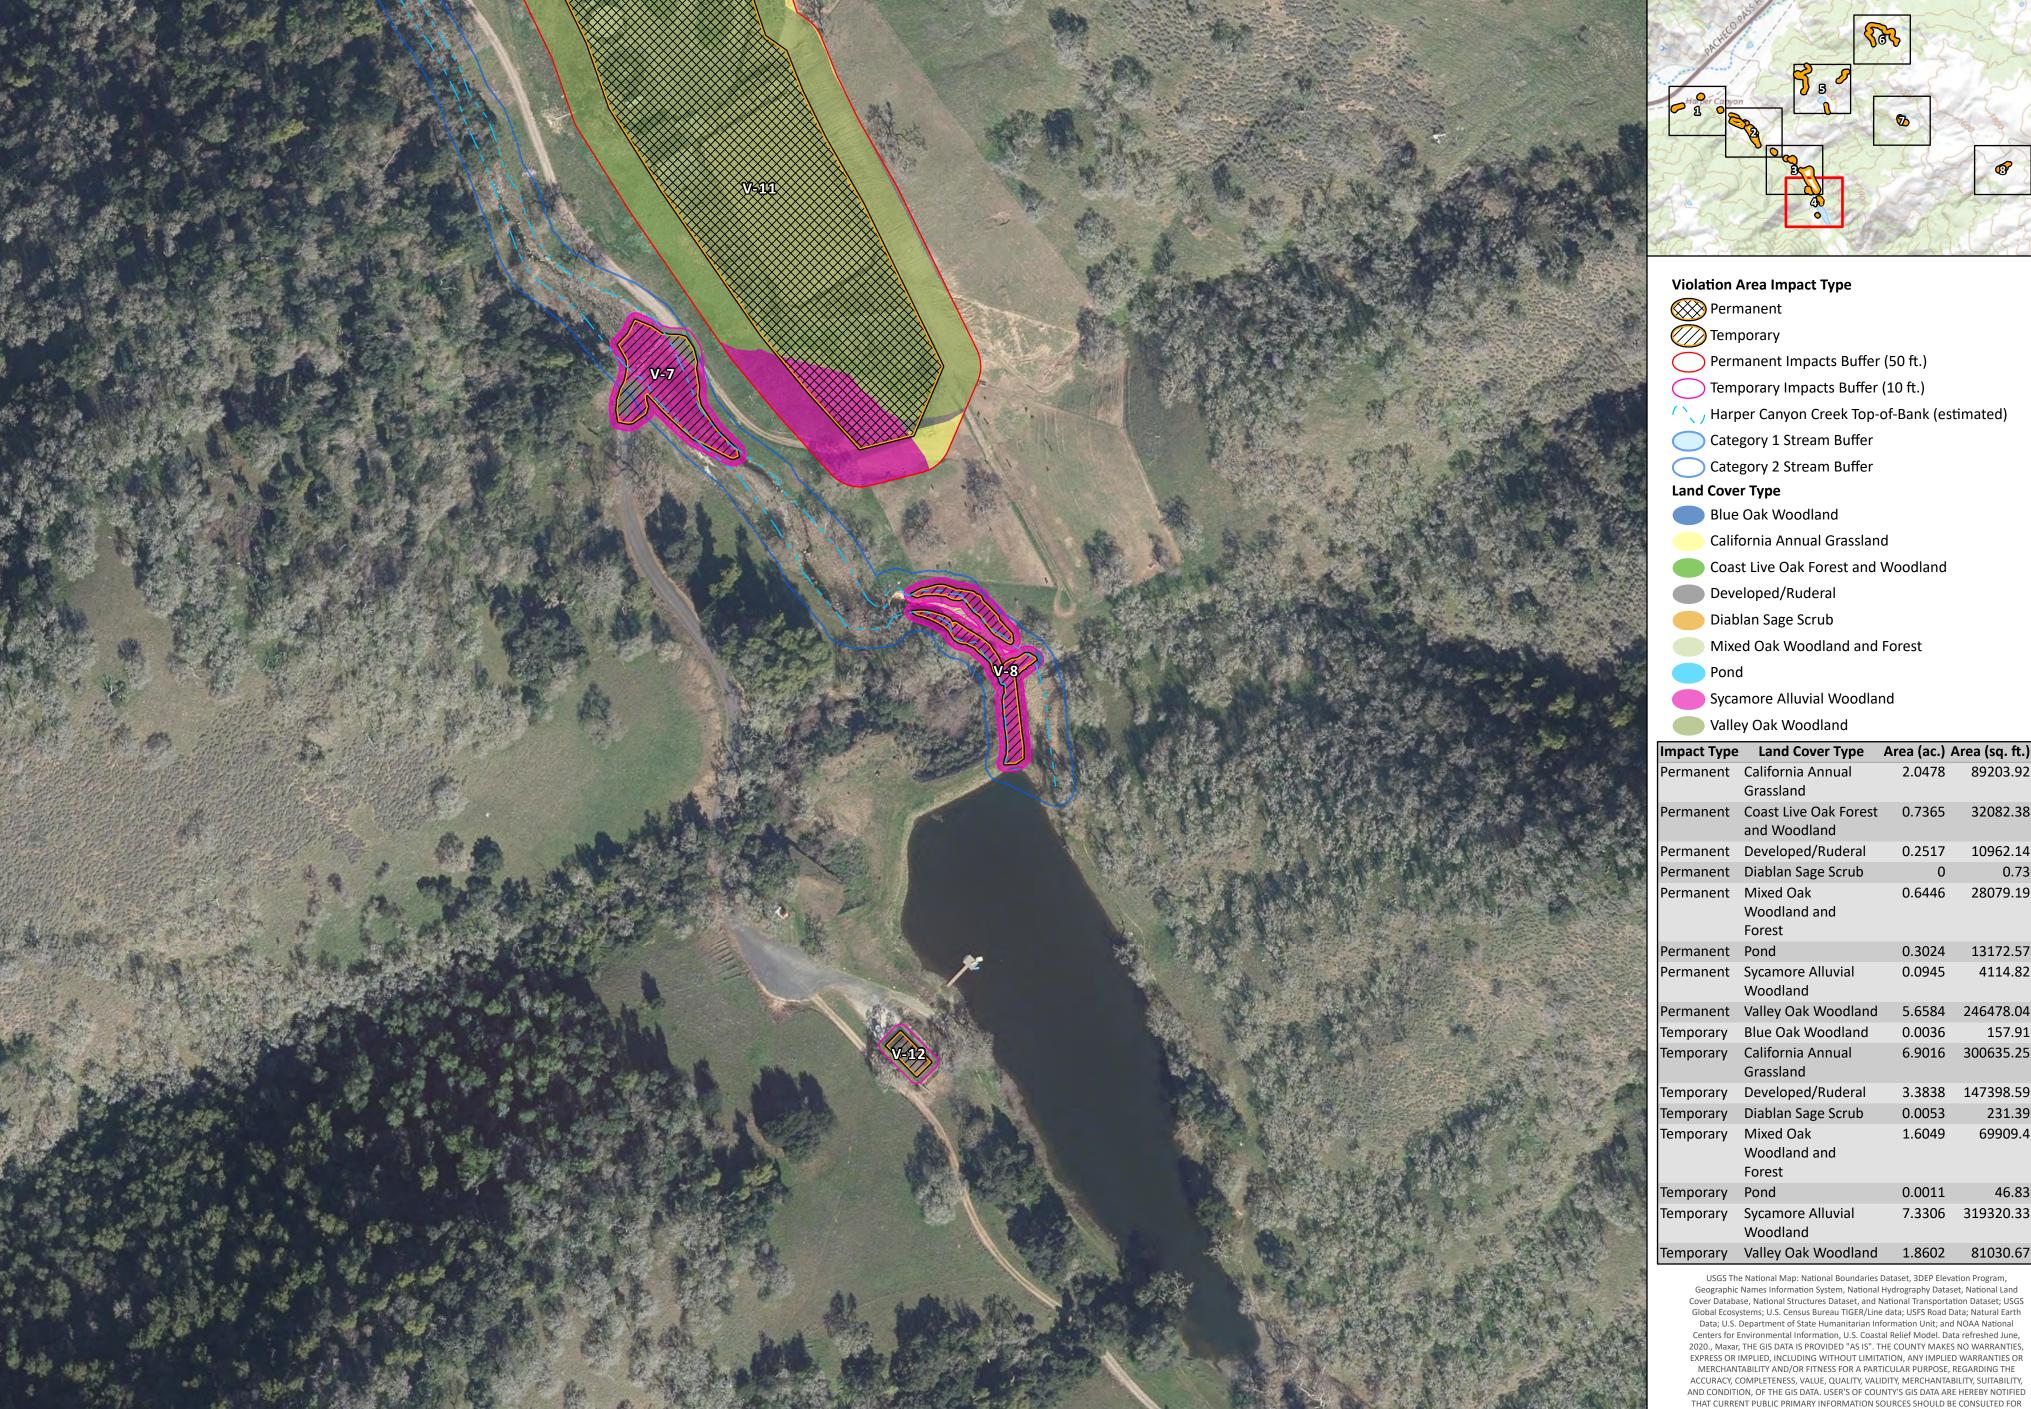
UniqueID	Name	Description	Area (ac.)	Area (sq. ft.) L	inear Feet
V-11	House, Horse Arena Area	Unpermitted grading to construct house, horse arena, and other structures.	4.6531	202687.02	900
V-12	ADU Area	Unpermitted grading to construct secondary residence.	0.0319	1388.5	55
V-7	Creek Crossing Downstream of Impoundment	Realignment of middle Harper Canyon Creek.	0.2815	12261.12	210
V-8	Impoundment on Harper Canyon Creek	Eroded eastern drainage and concrete blocks placed across eastern drainage.	0.1481	6450.33	255

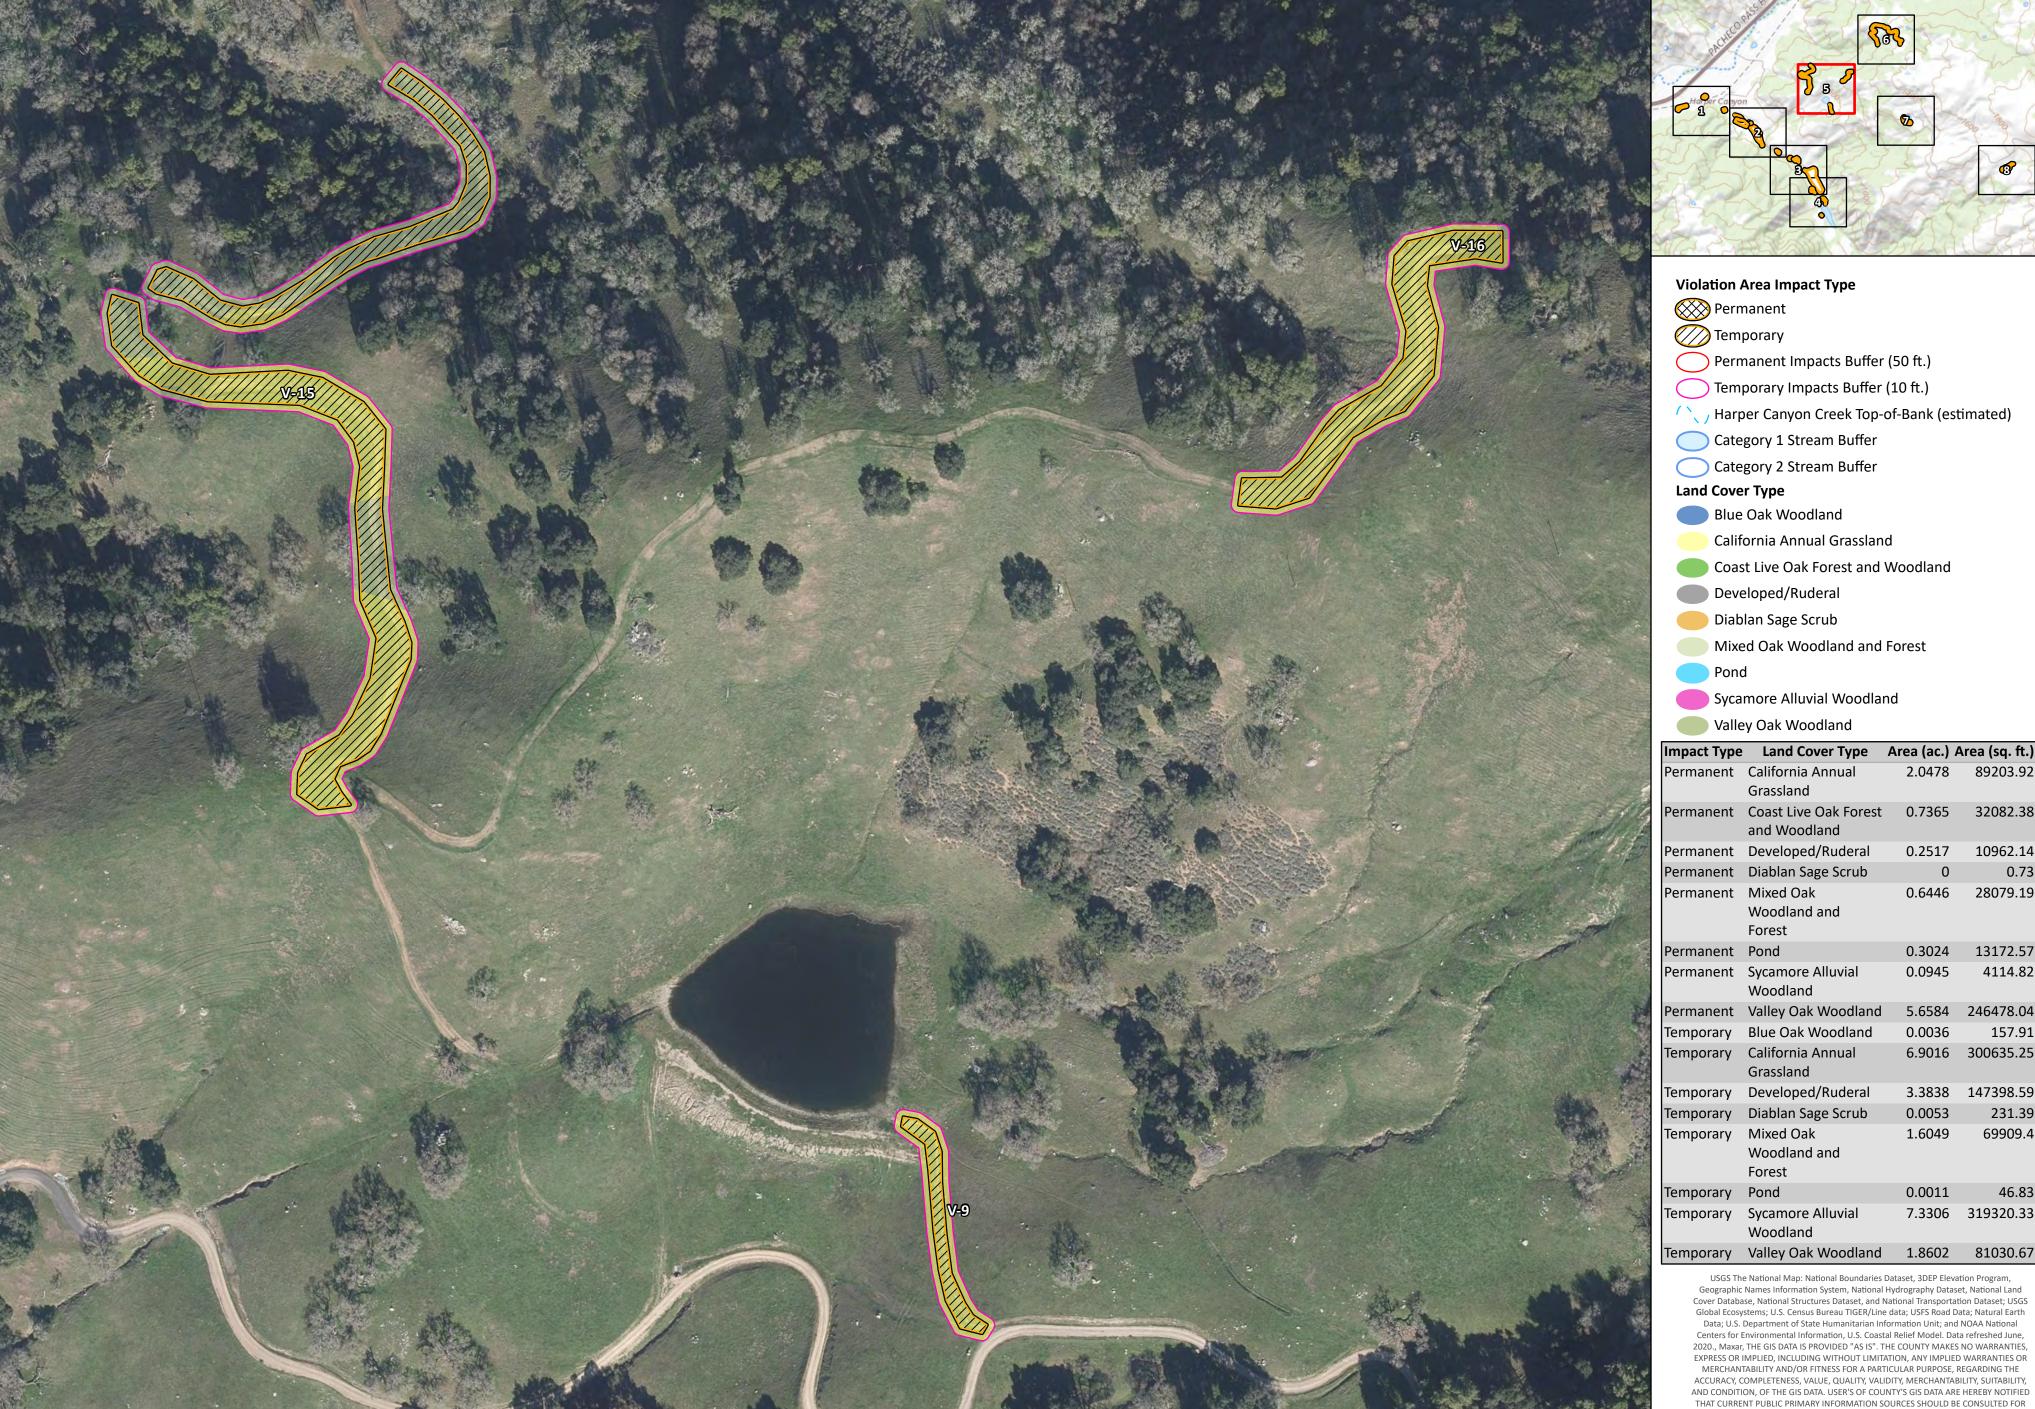
UniqueID	Name	Description	Area (ac.) Area (sq. ft.) Linear Feet
V-15	Upland Road Grading 1	Unpermitted road grading	1.1866 51687.54 1490
V-16	Upland Road Grading 2	Unpermitted road grading	0.4886 21282.31 550
V-9	West Cattle Stock Pond Impoundment	Dam modification and expansion.	0.1155 5032.75 270

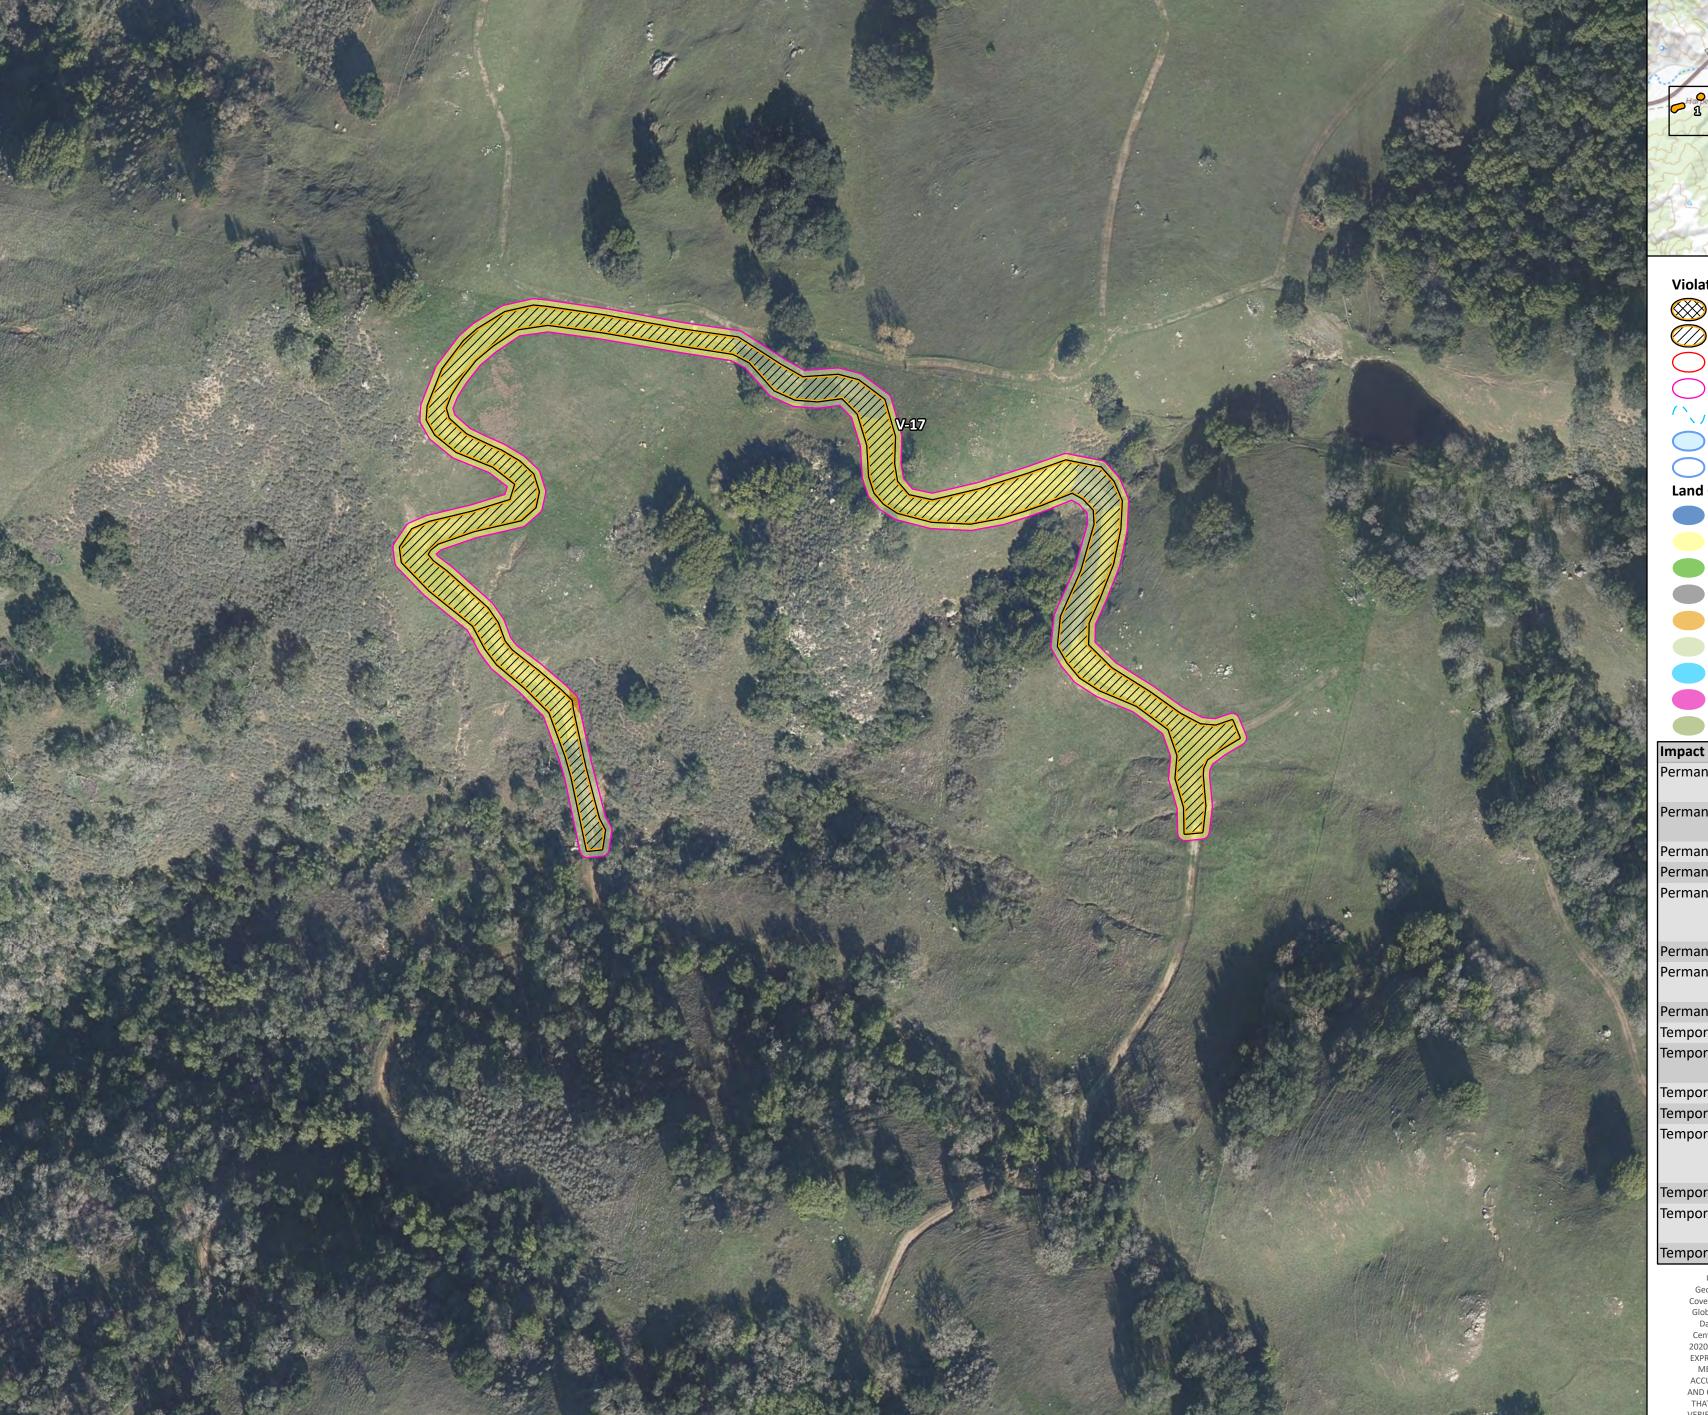
UniqueID	Name	Description	Area (ac.) A	rea (sq. ft.) Lin	ear I
V-17	Upland Road Grading 3	Unpermitted road grading	1.5837	68987.7	2
