Bourdet Ranch Notice of Violation Abatement Project Santa Clara County, California

Biological Resources Report

August 2021

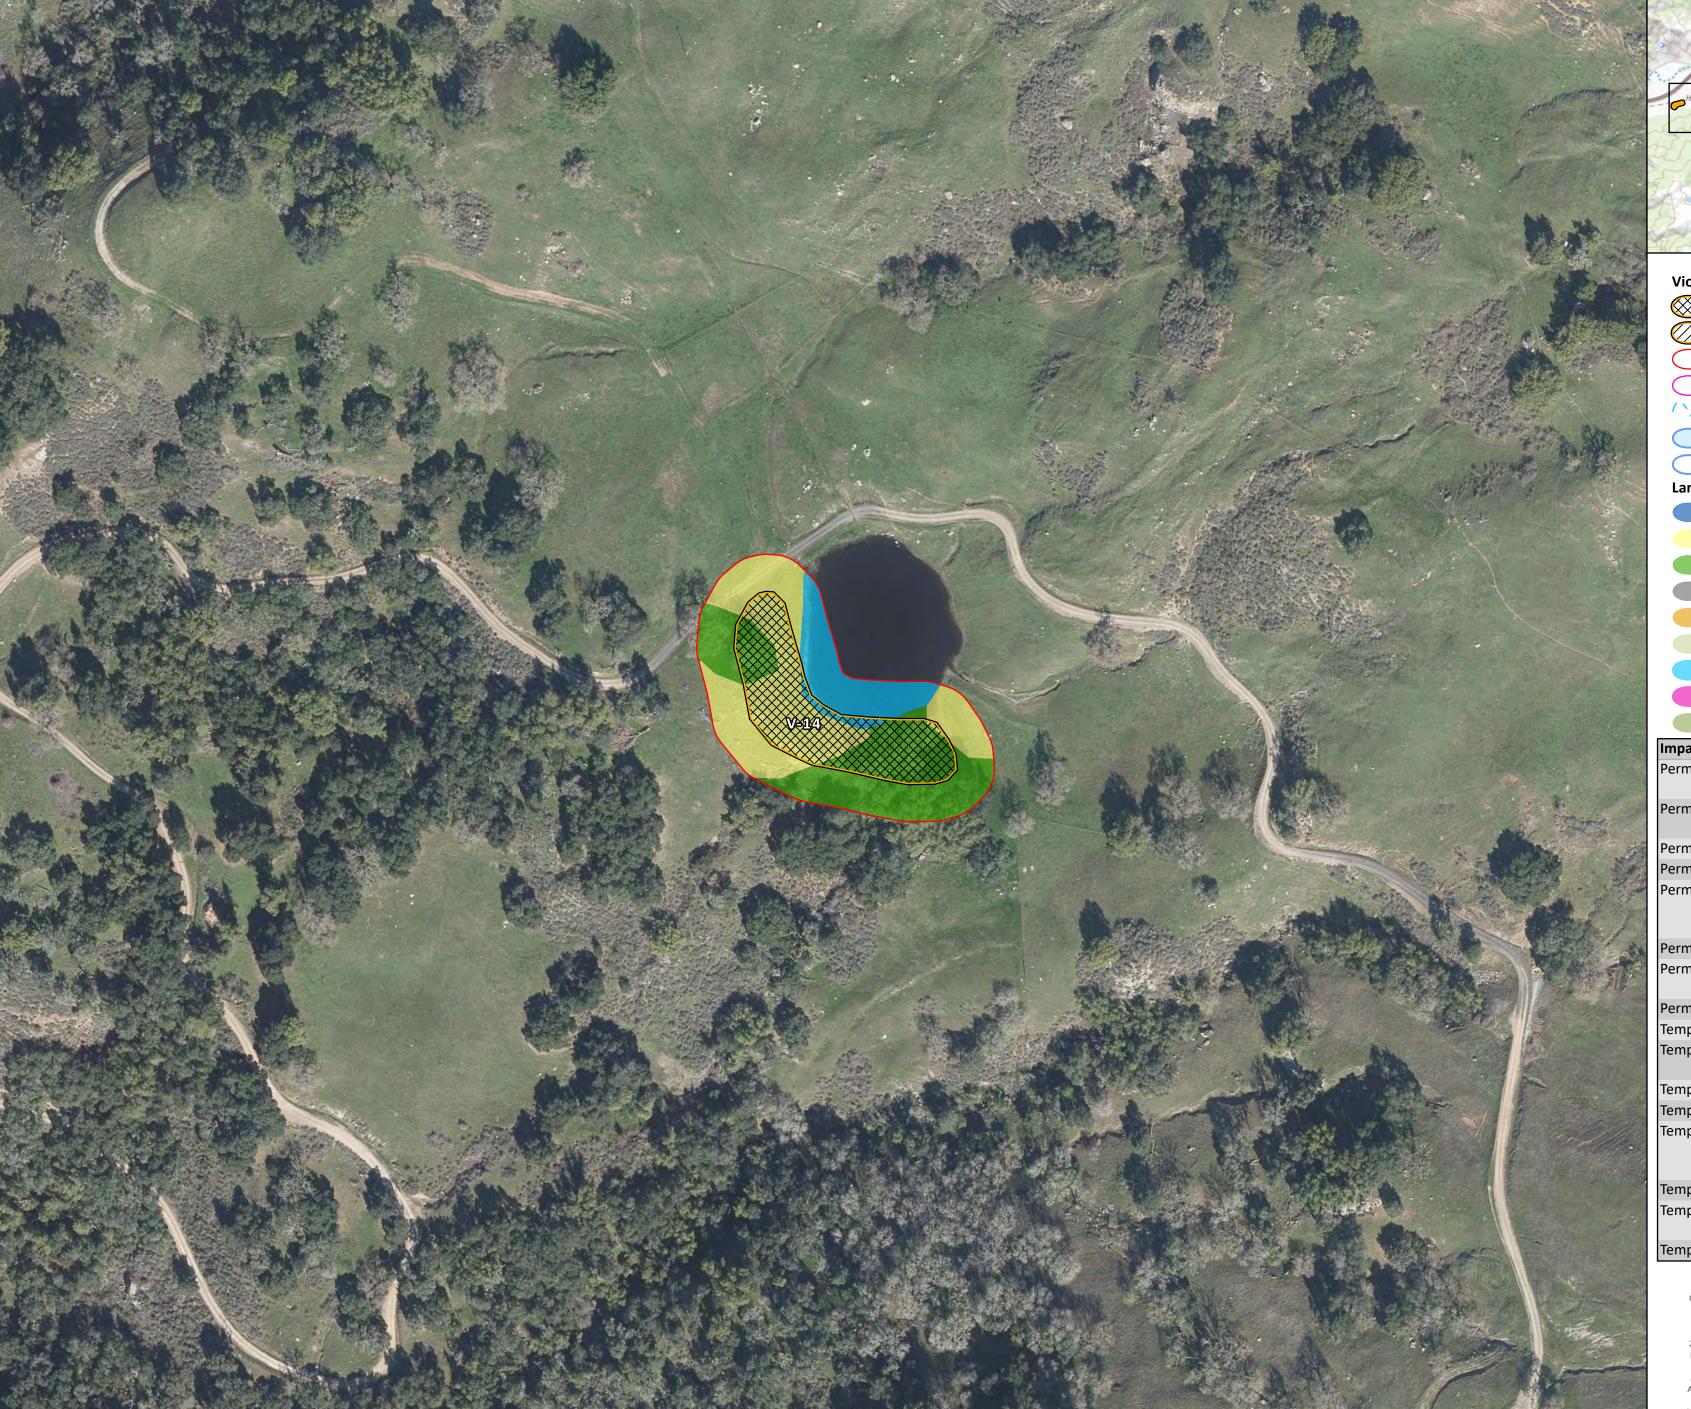
UniqueID	Name	Description	Area (ac.) Area (sq. ft.) Linear Fee
•	Middle Cattle Stock Pond Impoundment	Impoundment, grading of banks, dam, and drainage.	0.6505 28337.38 400

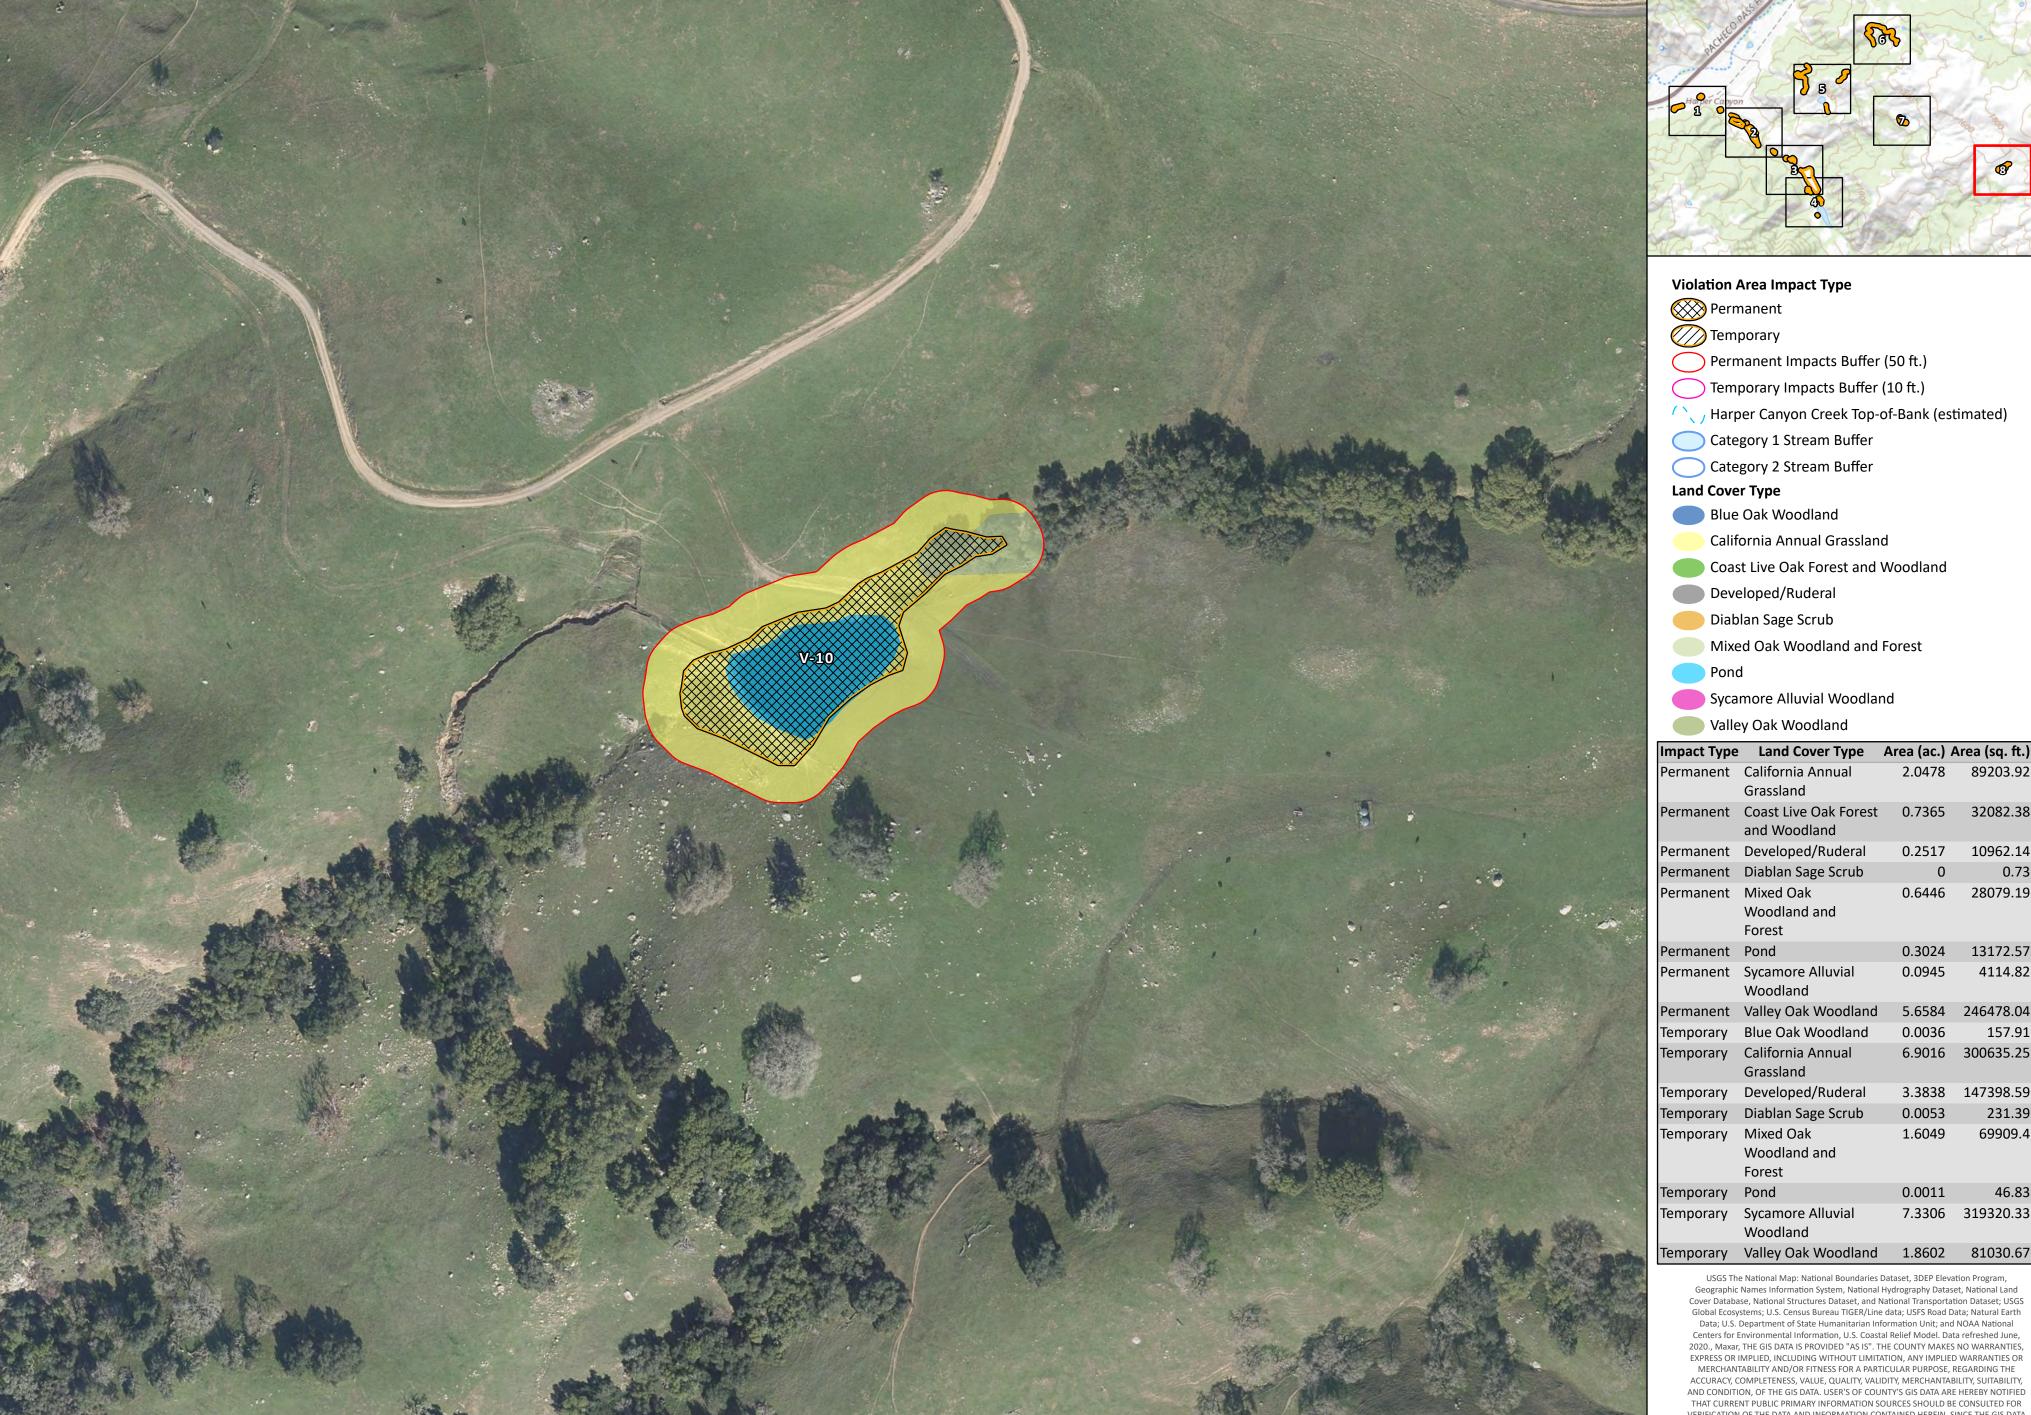
UniqueID	Name Name	Description	Area (ac.) A	Area (sq. ft.) Lir	near Fee
V-10	East Cattle Stock Pond Impoundment	Channelized outflow eroded grasslands, connecting to a tributary downstream of the dam.	1.0492	45705.18	47
