## **Design Basis Report – Preliminary Design Level**

Bourdet Ranch Grading Violation Abatement Project

Santa Clara County PLN20-139

August 2021

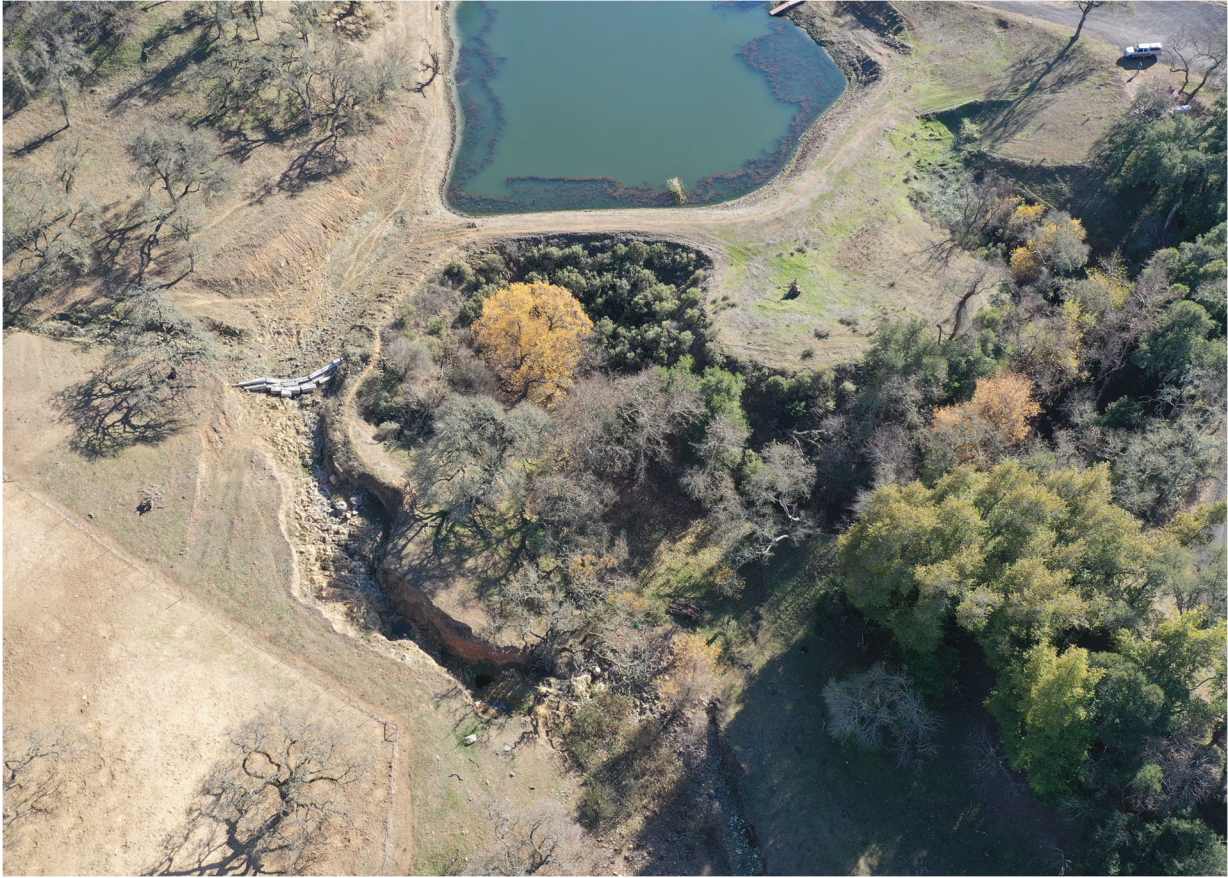
**Photo 1.** Drone photo looking upstream at spillway channel site and reservoir (January 14, 2021)

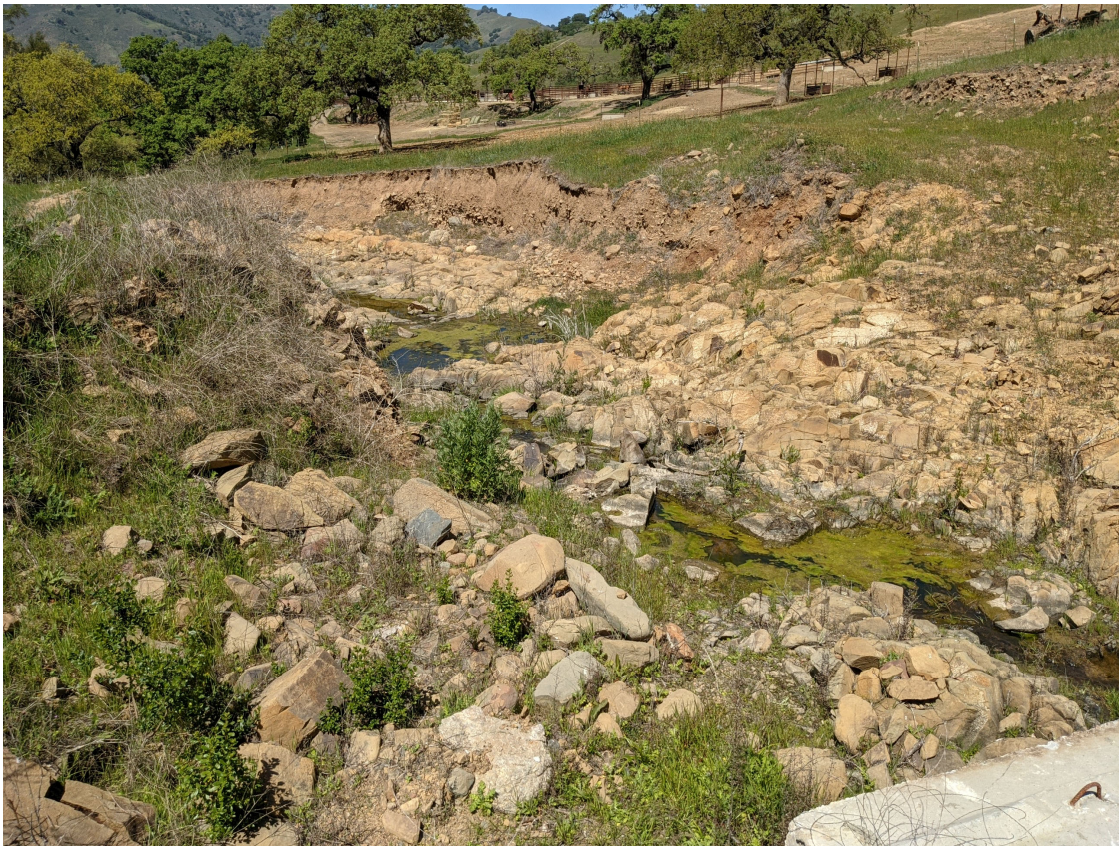
**Photo 2.** Looking downstream to the reservoir spillway channel from the left bank at the concrete barrier block weir. The over-widened channel has primarily bedrock banks on the right bank with the loose upper alluvium forming steep slopes above the 100-year water surface elevation in background of view (April 6, 2021).

The lower older consolidated colluvium exhibits substantial erosion resistance and soil strength. However, recent creek flows eroded the material to produce an oversized channel, and continuing bank erosion should be anticipated in this material where it is exposed on the channel banks within reach of future high flows. The upper looser material has lesser bank erosion resistance and strength (Photos 2-3).

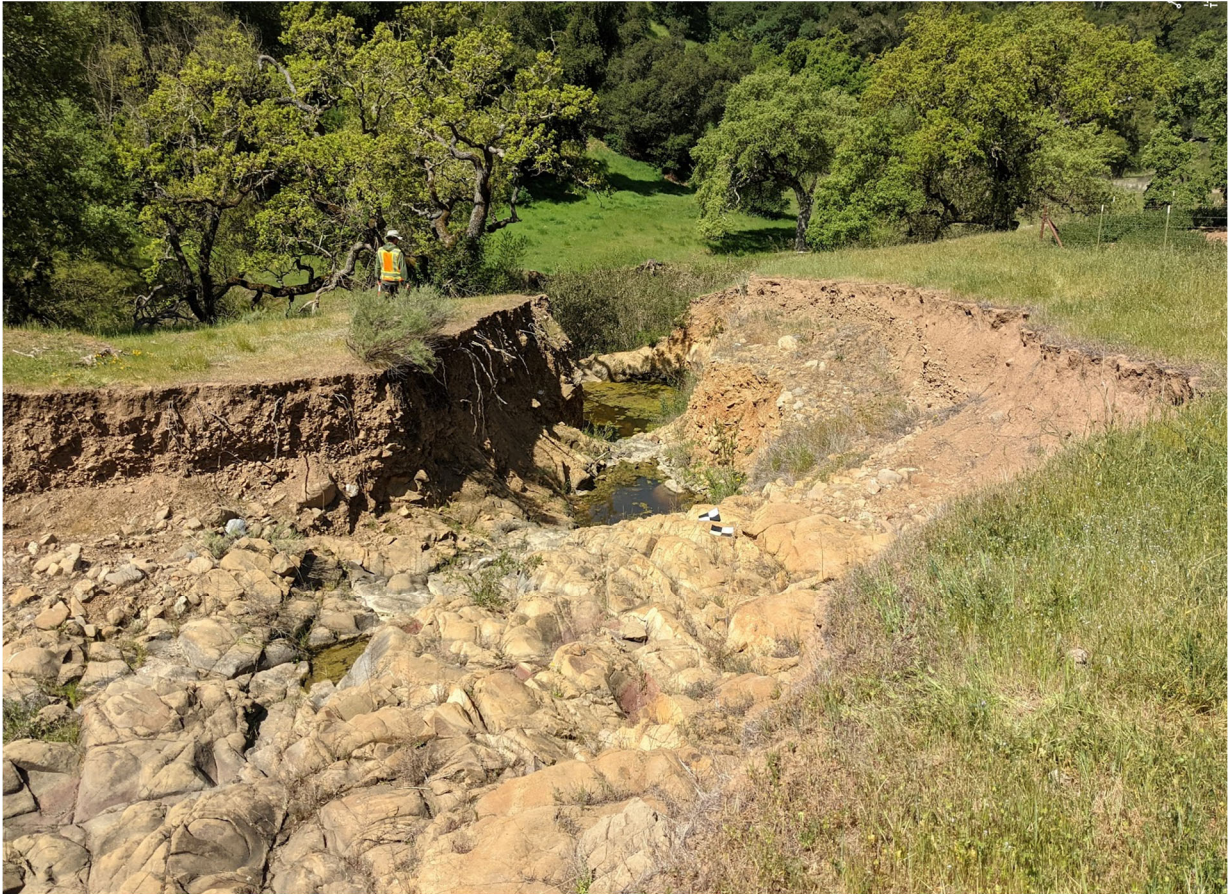
**Photo 3.** Looking downstream from the right bank showing the exposed bedrock and steep erodible soil layers to be laid back (April 14, 2021).

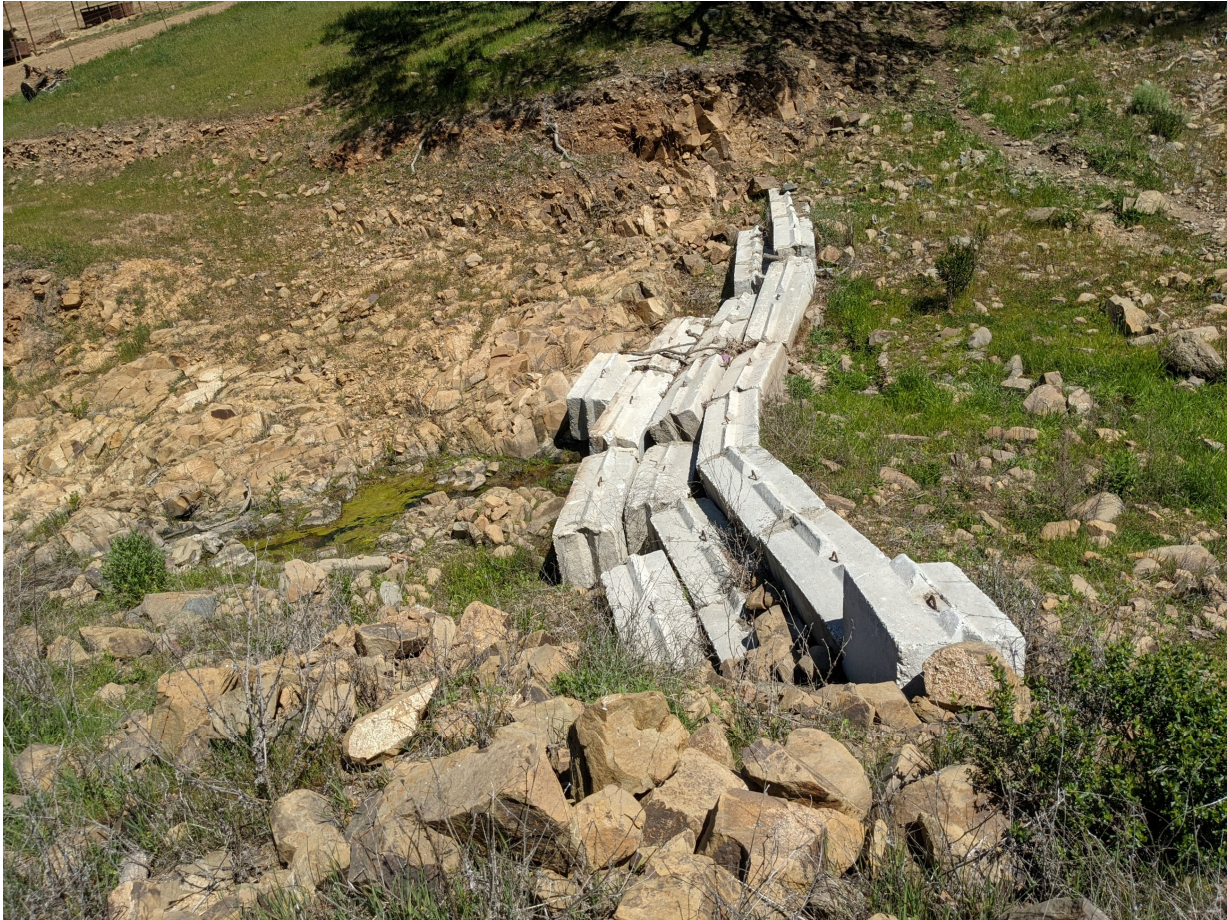
**Photo 4.** Looking from left bank to right bank at concrete barrier block weir at upstream end of the reservoir spillway channel. A shallow layer of coarse alluvium covers part of the bedrock spillway channel upstream from the weir (to the right of view) (April 6, 2021)

Close to the reservoir spillway, there is a 50-foot-wide channel-spanning weir constructed from 18 large (approximate unit dimensions 2'x4'x3') concrete barrier blocks, weighing about 2 tons each (Photo 3). The concrete barrier block weir was apparently installed after winter 2017 to plunge reservoir spillway channel flows into the center of the channel, and/or to prevent potential headcut advance into the spillway channel segment immediately downstream from the reservoir spillway.

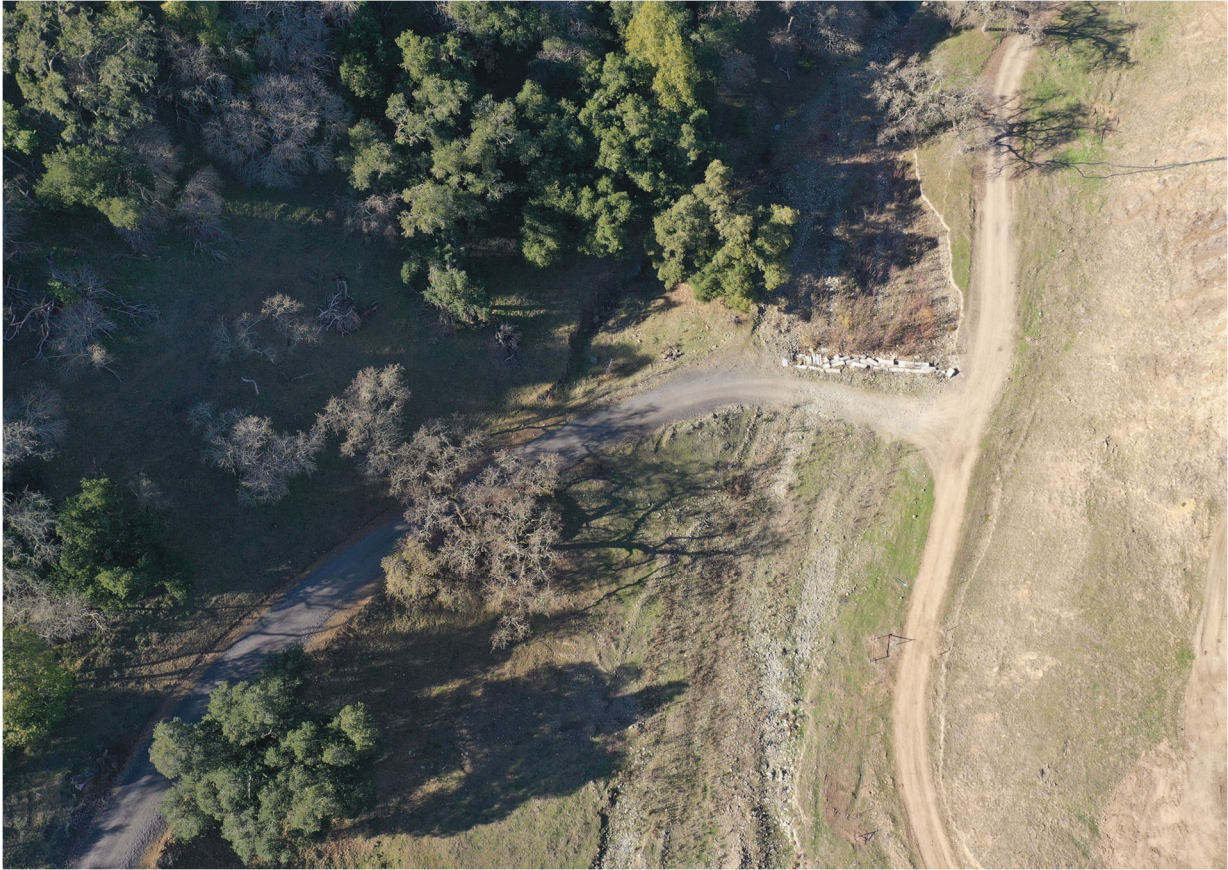
**Photo 5.** Drone photo looking downstream at ford crossing site (January 14, 2021)

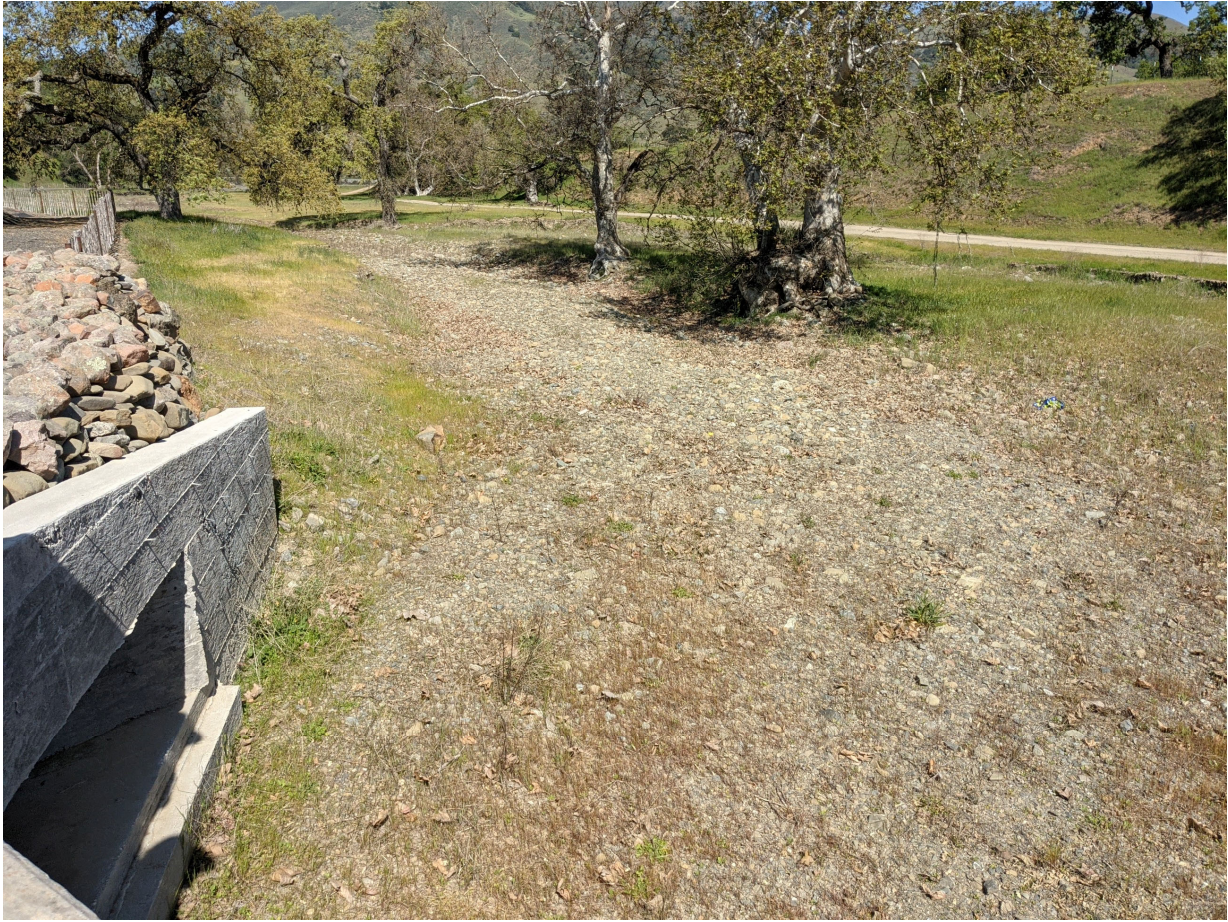
**Photo 7.** Looking downstream to Harper Canyon Creek channel downstream from the existing roadway bridge crossing to be removed. The sycamore trees on the right bank are rooted on a floodplain with a surface only 1.5-2 feet above the adjacent channel bed (April 6, 2021)

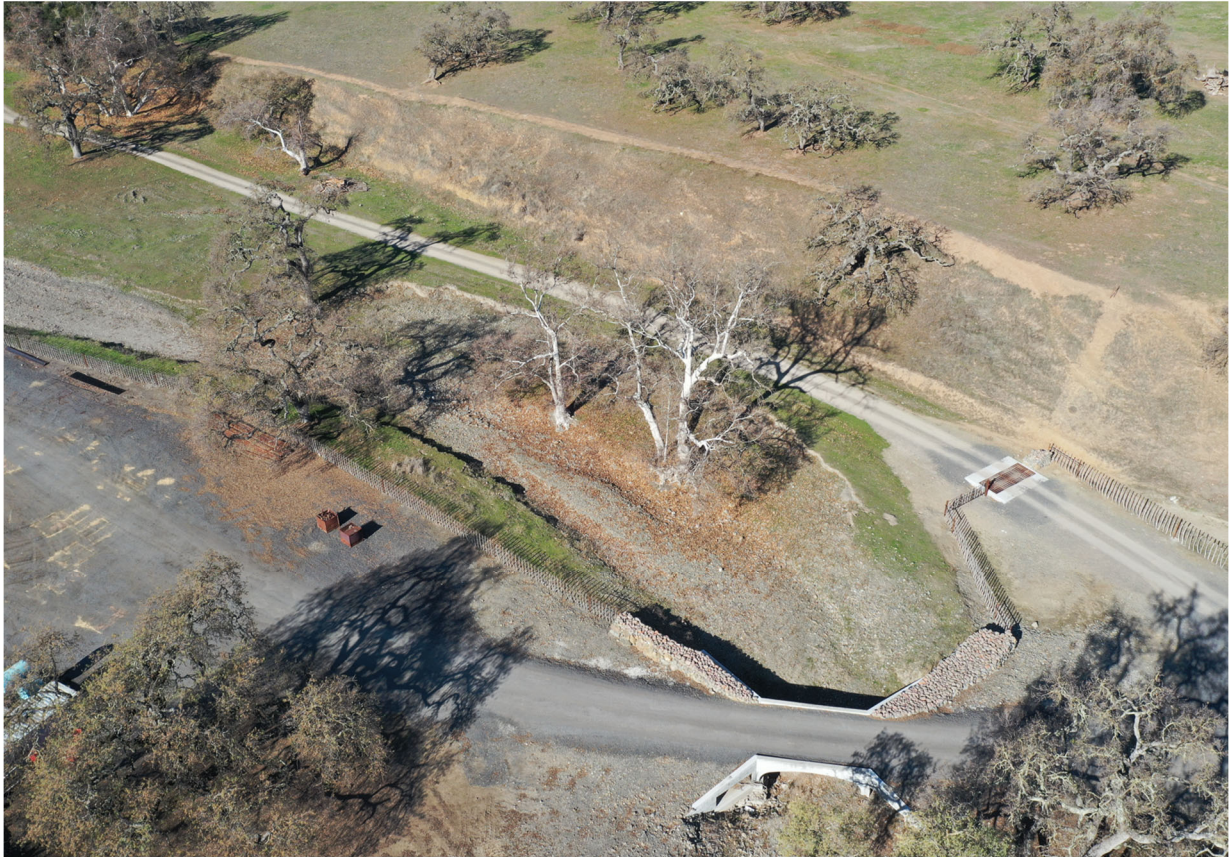
**Photo 8.** Drone photo looking downstream to Harper Canyon Creek channel downstream and the sycamore trees on the right bank are rooted on a floodplain (January 14, 2021)

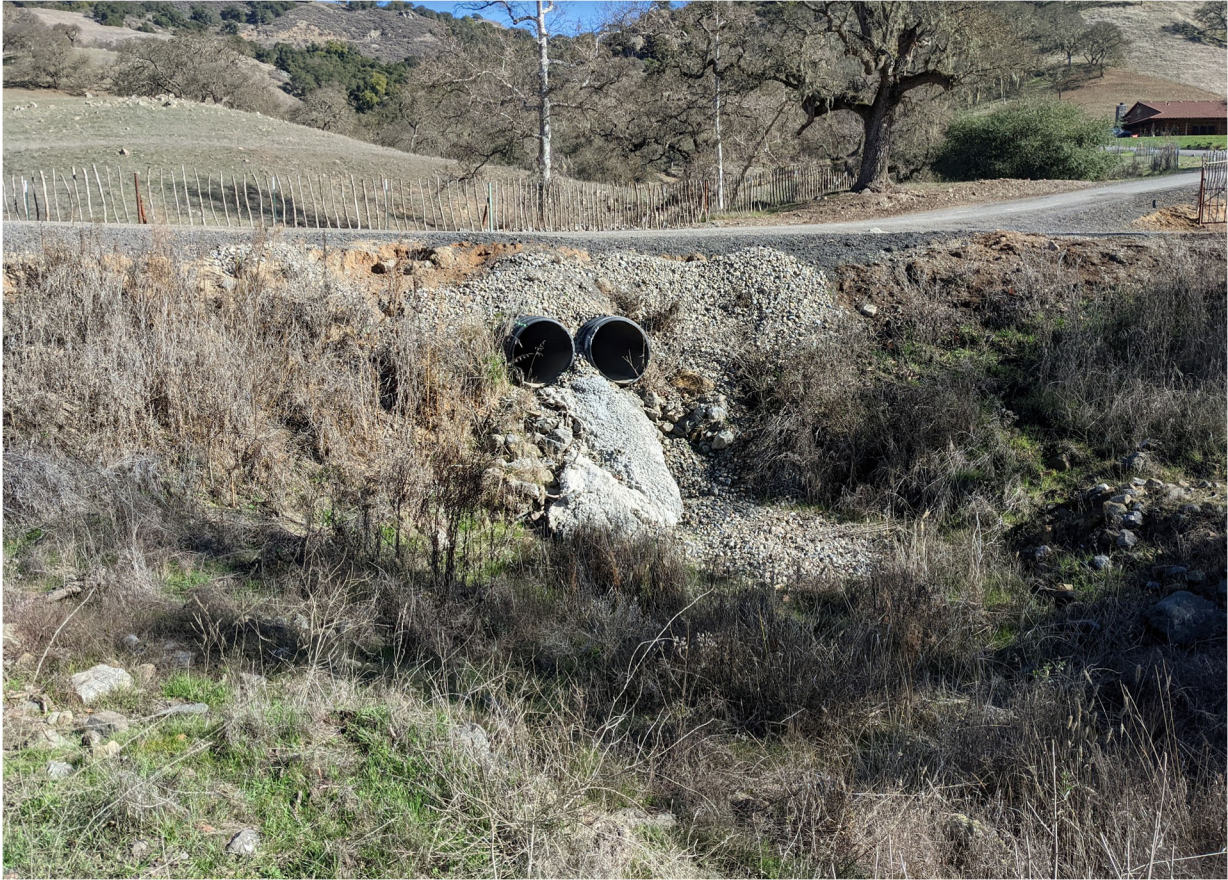
**Photo 9.** Photo of downstream end of culvert 6 and concrete tailwall (January 14, 2021)

The HEC-HMS computed peak flows were determined for the inlet of each of the seven roadway culverts (Table 2). Under existing conditions, culverts #3 and #6 do not pass the 10-year design flow under free outfall conditions when the headwater surface is at the top of the culvert inlet ( $H/W=1$ ) (Table 3). Culverts #3, #5, and #6 do not pass the 25-year design flow under free outfall conditions when  $H/W=1$ .

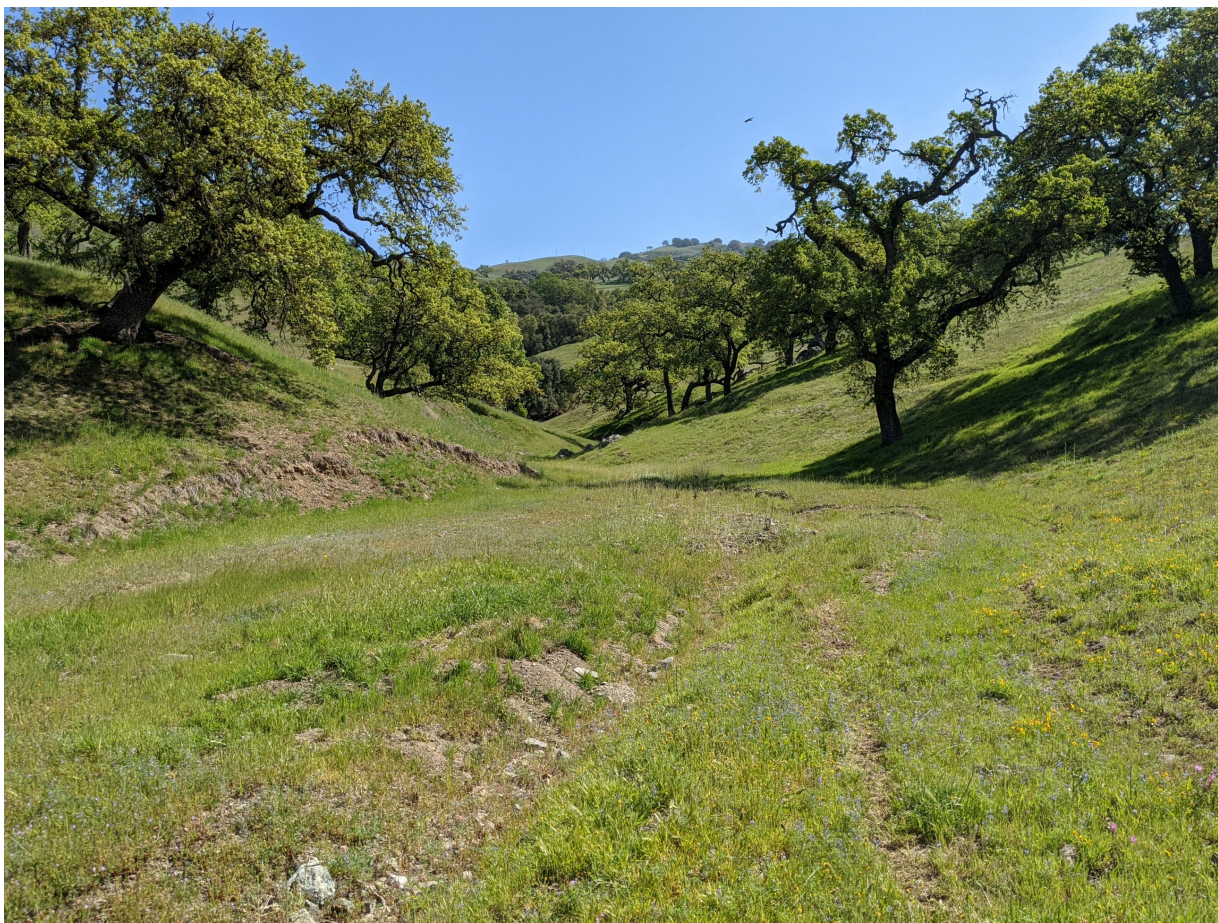
**Photo 10.** Looking upstream to the subwatershed and poorly formed channel tributary to Culvert #3 (April 6, 2021)

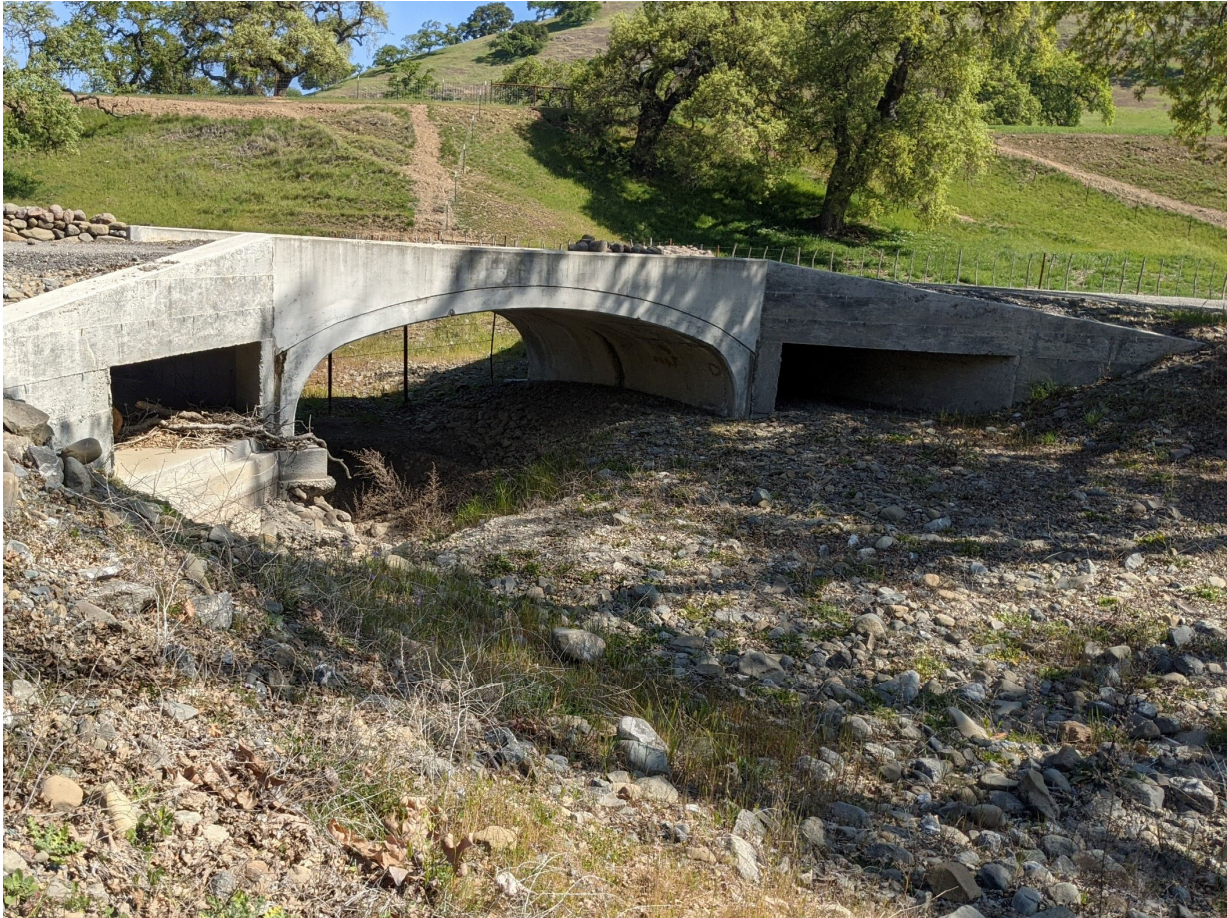
**Photo 11.** Looking downstream from the left bank to the existing roadway bridge to be removed and replaced with a new bridge conforming with restored pre-violation creek bank slopes and meeting hydraulic design criteria (April 6, 2021)

The existing roadway bridge crossing (Photo 10) will be removed and replaced by a new bridge engineered to meet Santa Clara County hydraulic design standards and support findings substantiating a Federal Emergency Management Agency (FEMA) “No Net Rise Certificate”.

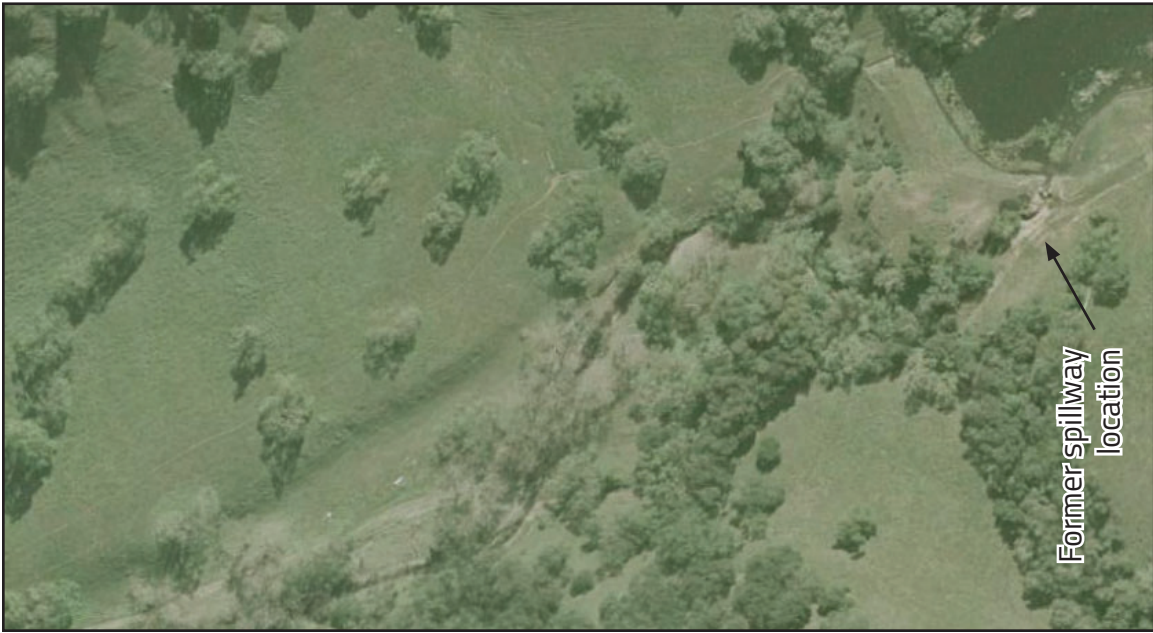
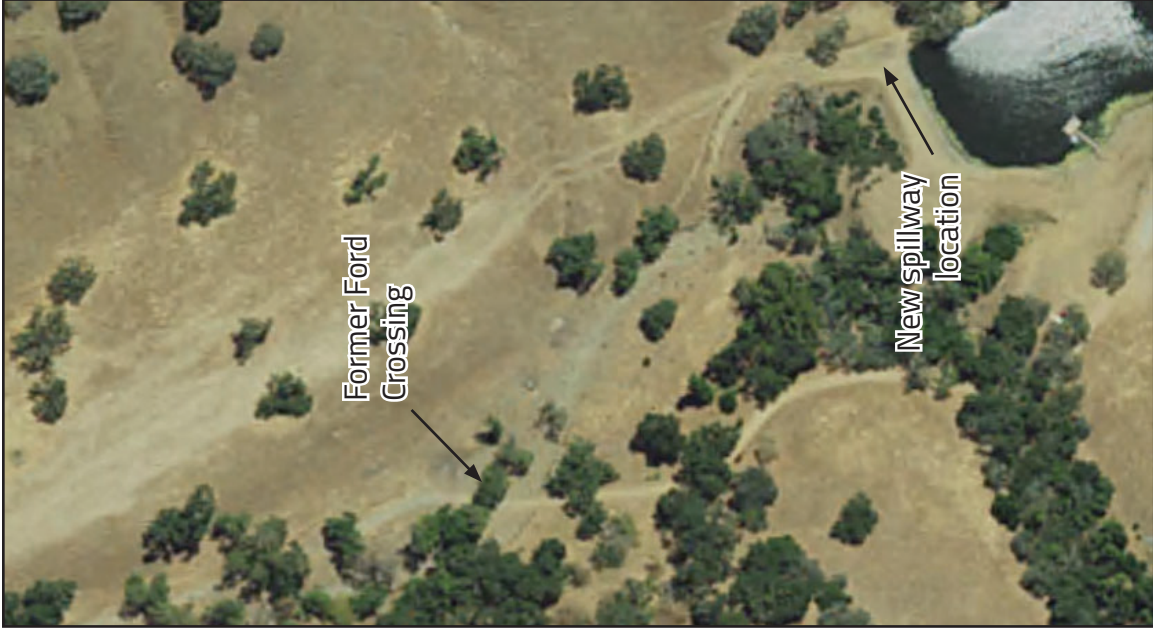
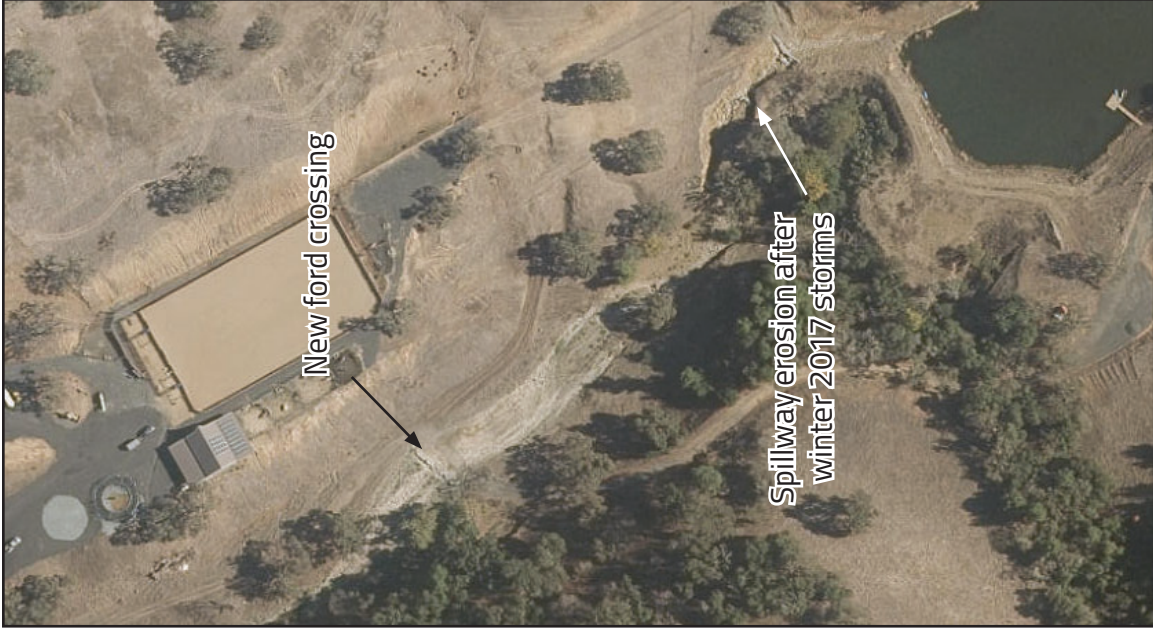
FIGURE 7. 2014-2018 Time Series of Spillway Channel and Ford Crossing Sites

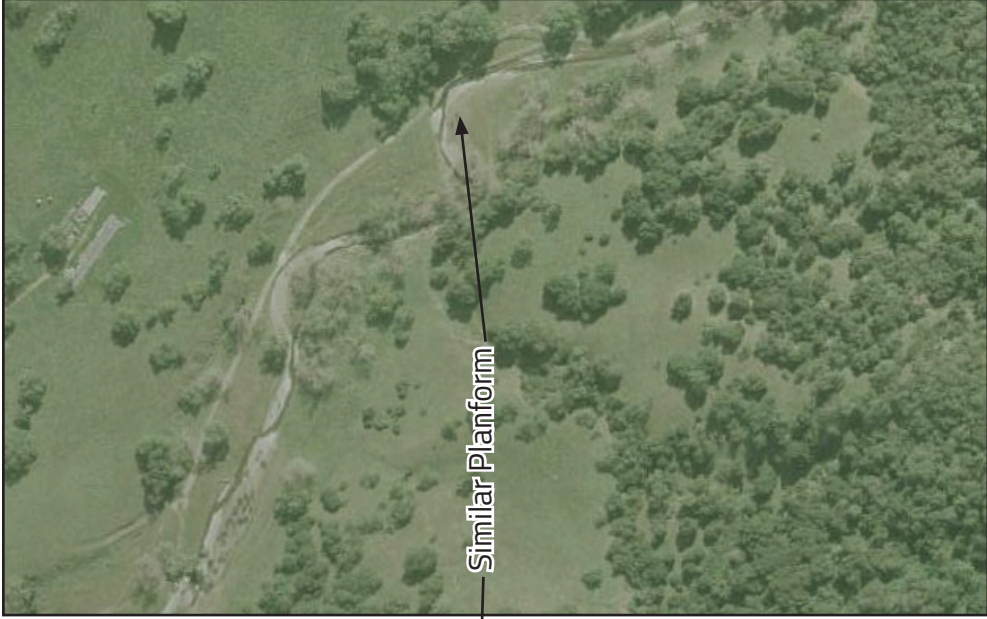
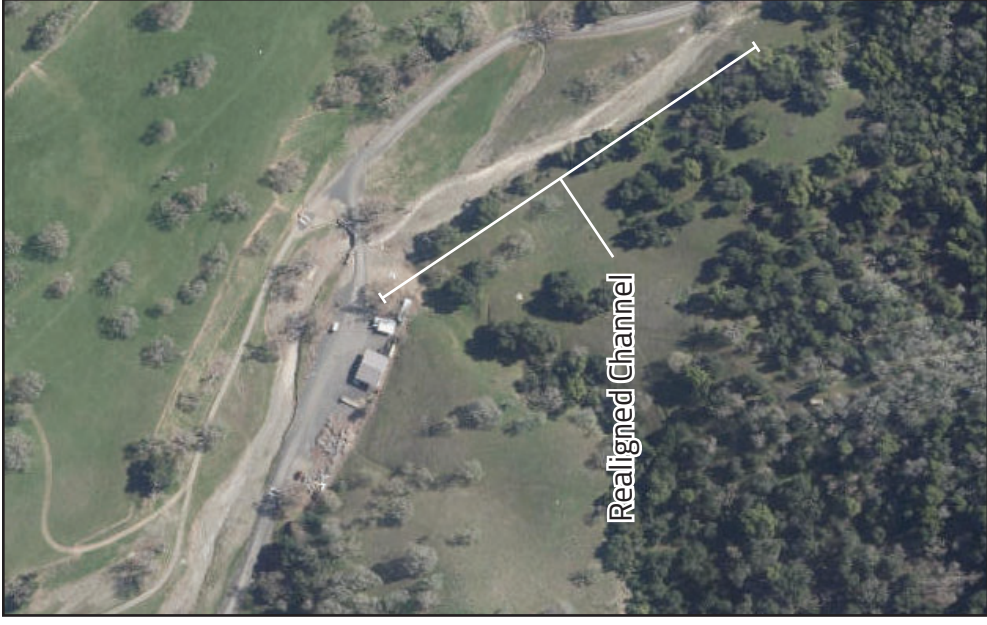
FIGURE 9. 1956-2020 Time Series of Creek Restoration and Bridge Replacement Reach

Prior to the grading violations, Harper Canyon Creek was in a relatively stable planform configuration since at least 1956 (Figure 9). This is likely due in part to the earthen dam construction in the 1970s that disrupts most of the coarse sediment supply and decreases lateral channel dynamism, as discussed in Chapter 2. There was an unimproved ford crossing at the existing bridge location.

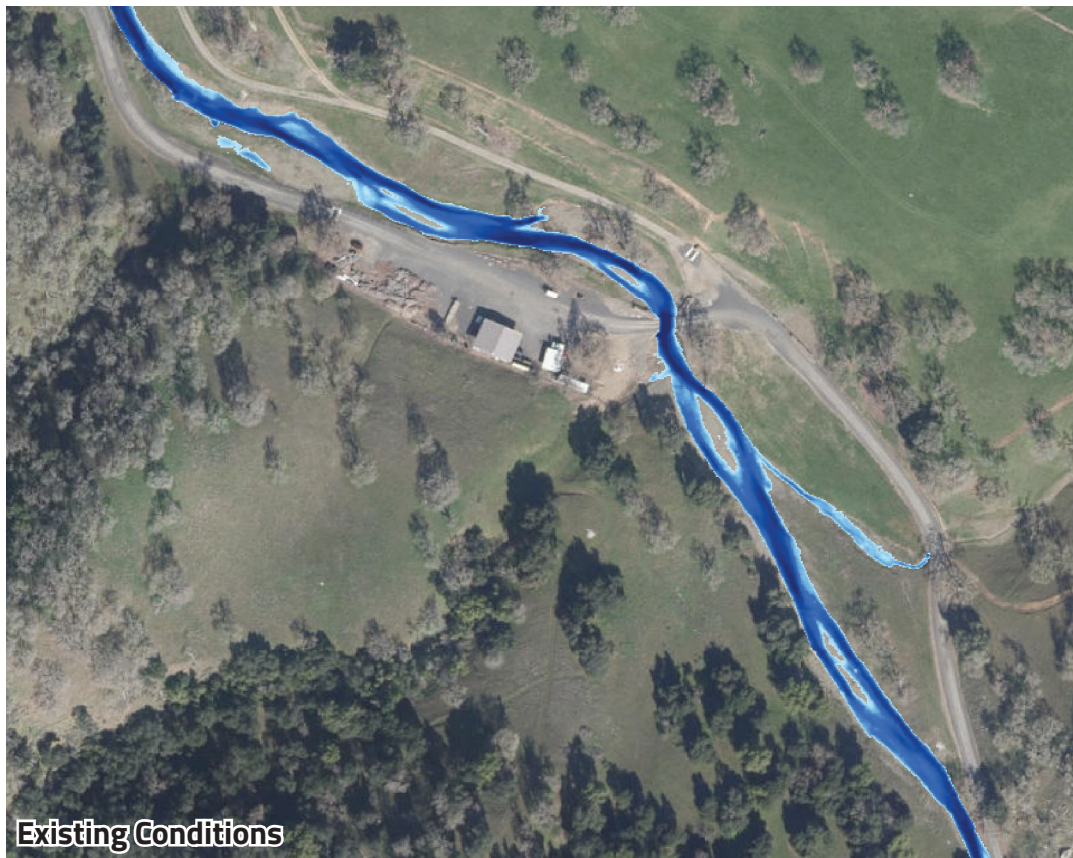
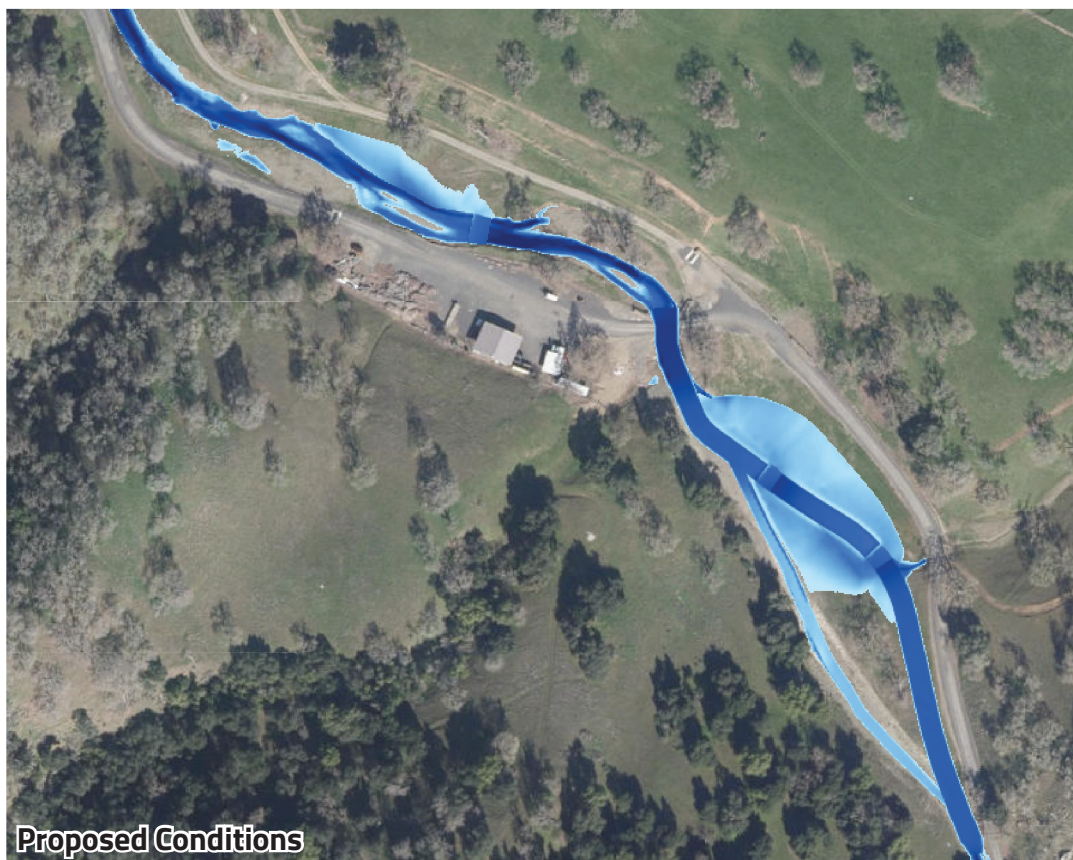
**2-year flow (117 cfs)**

FIGURE 11a. 2D Hydraulic Model Flow Depths in the Creek Restoration & Bridge Replacement Reach during 2-year flow

The 2D hydraulic model was then used to test the proposed restored stream channel with various iterations of floodplain elevations. Results demonstrate that a flood elevation of 1.5 ft corresponded to greater than a 2-year flood. The target floodplain elevation that would be inundated by the 2-year flood was determined to be approximately 1 ft above the thalweg elevation. Therefore, the design floodplains were set at 1 ft above the thalweg elevation for each floodplain restoration site. Even at 1 ft height, the typical threshold of accuracy for construction in stream channel work, floodplain inundation was not complete according to the hydraulic model. Thus, constructed riffles are proposed at key locations for promoting floodplain inundation for immediate post-construction conditions. Hydraulic modeling shows the 2-year flood produces an average depth of 0.2 ft across the restored floodplain surfaces (Figure 11a).

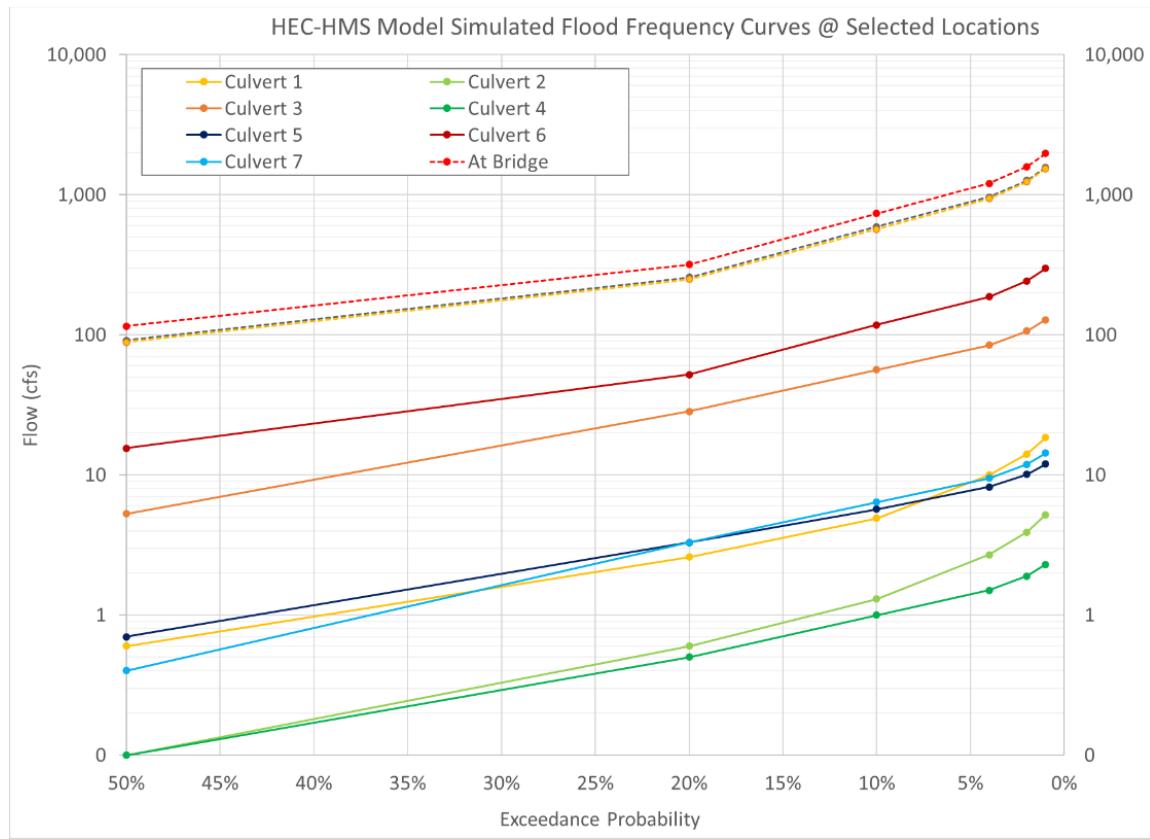
Figure 6 HEC-HMS model simulated flood frequency curves at selected locations

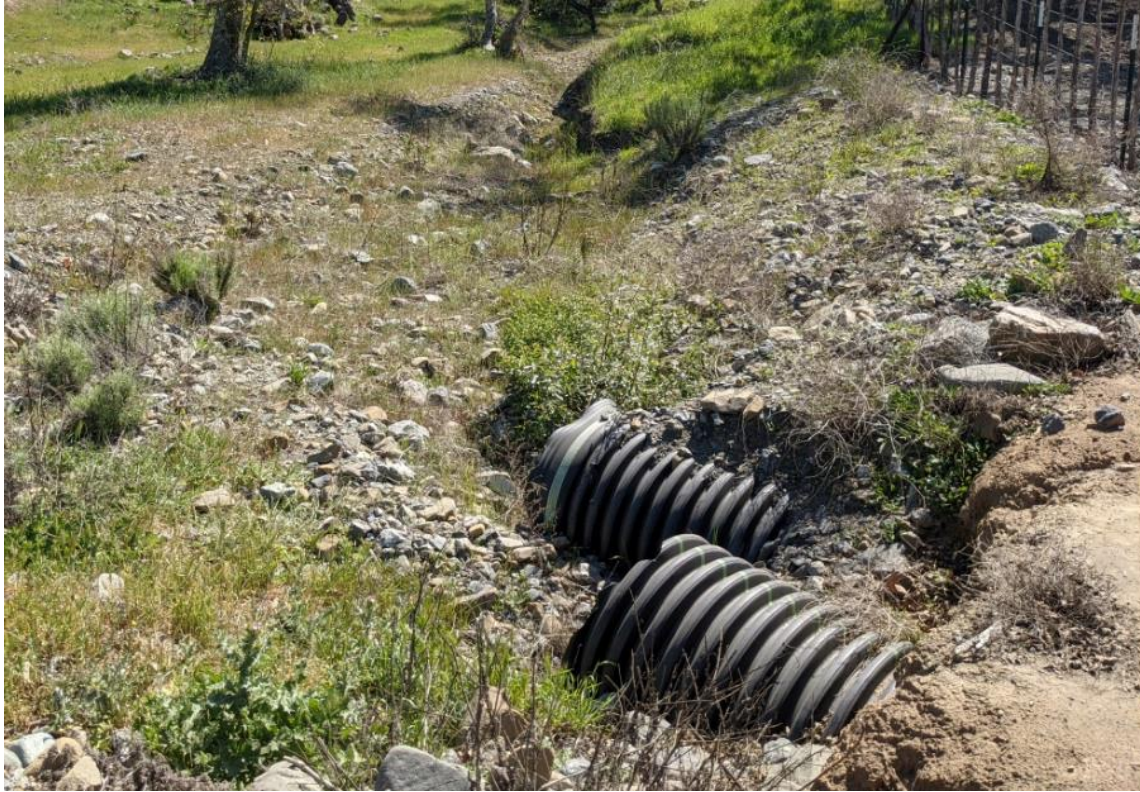
Figure 2 Upstream view of Culvert 6 (CPP, Projecting, Double-Barrel)

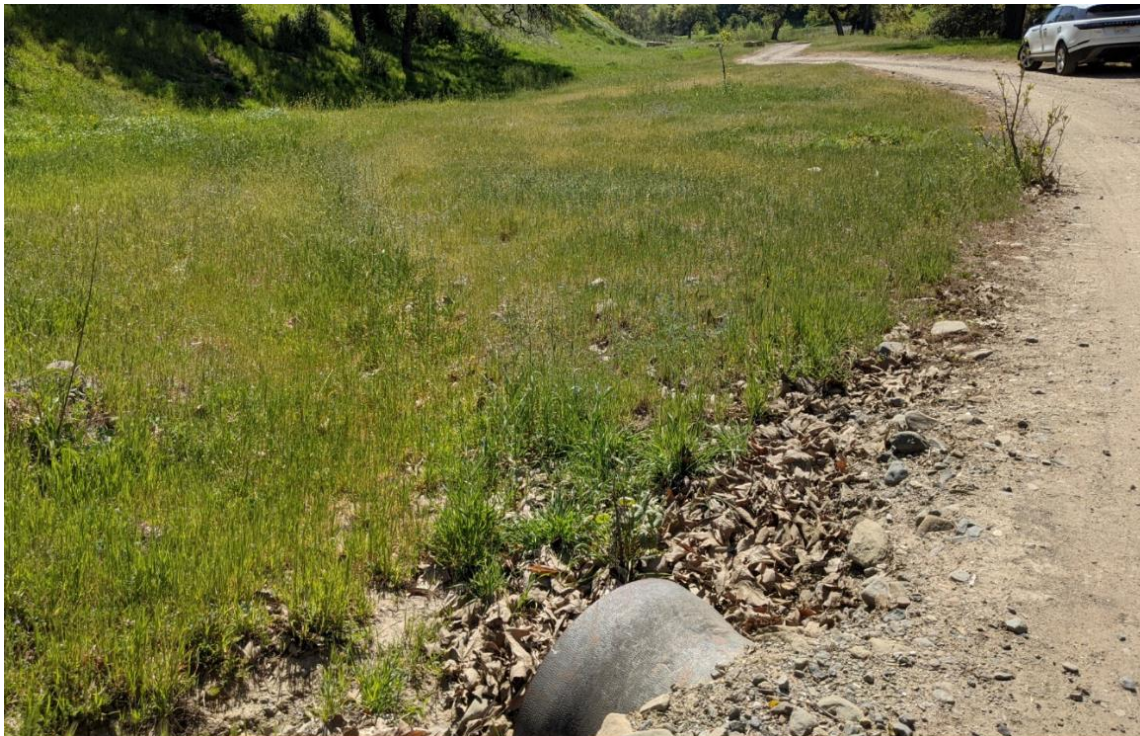
Figure 3 Upstream view of Culvert 7 (CIP, Projecting, Single-Barrel)
