DRAFT
ENVIRONMENTAL IMPACT REPORT

LION'S GATE RESERVE

VOLUME III: TECHNICAL APPENDICES F through N

**HAYES VALLEY
BIOLOGICAL RESOURCES REPORT**

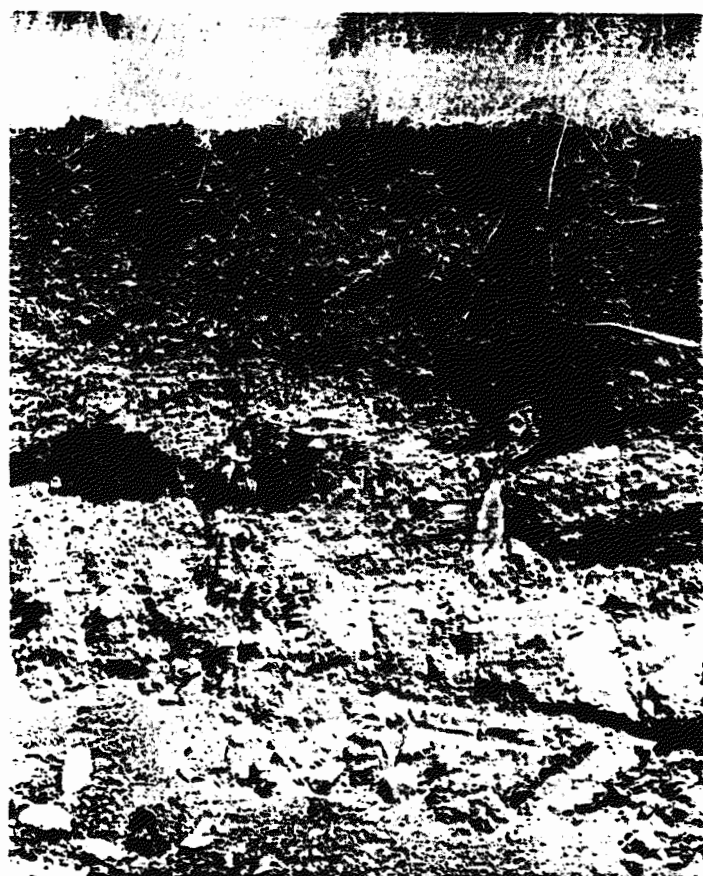
Figure 3.—Profile of Diablo clay, 9 to 15 percent slopes.

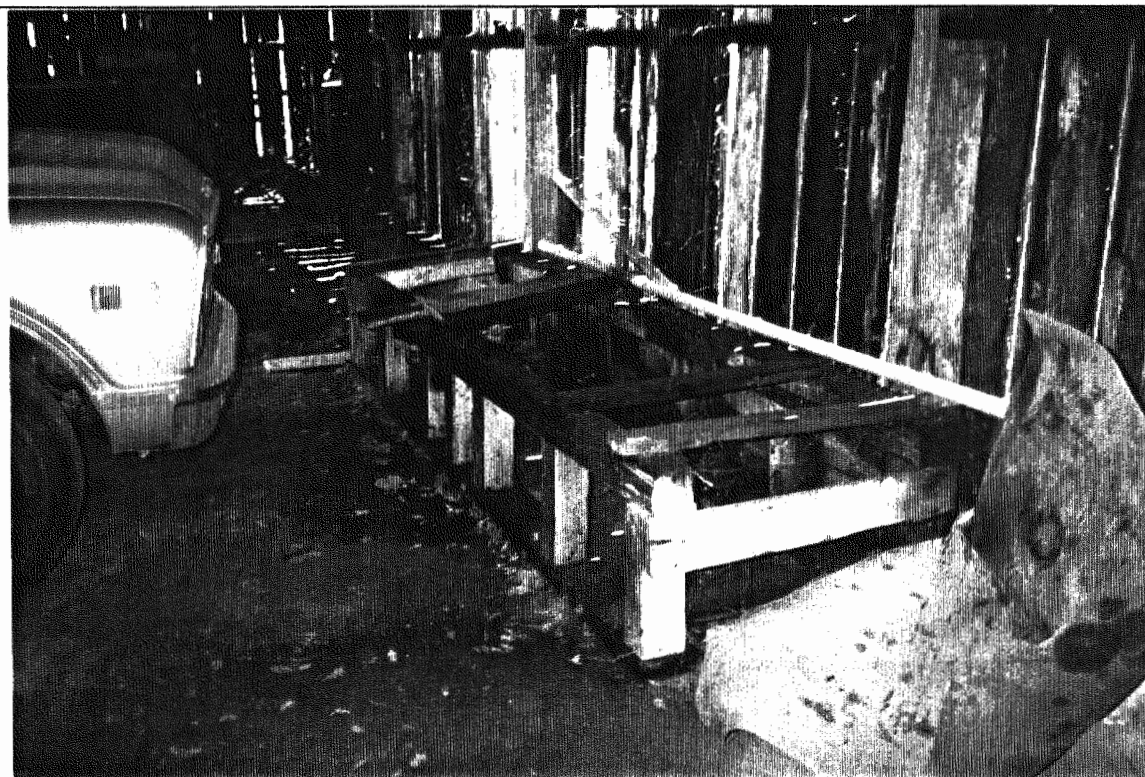
FIGURE 4B. VIEW OF DARK STAINS ON CONCRETE BENEATH A WOODEN
FRAME IN THE REPAIR SHED.

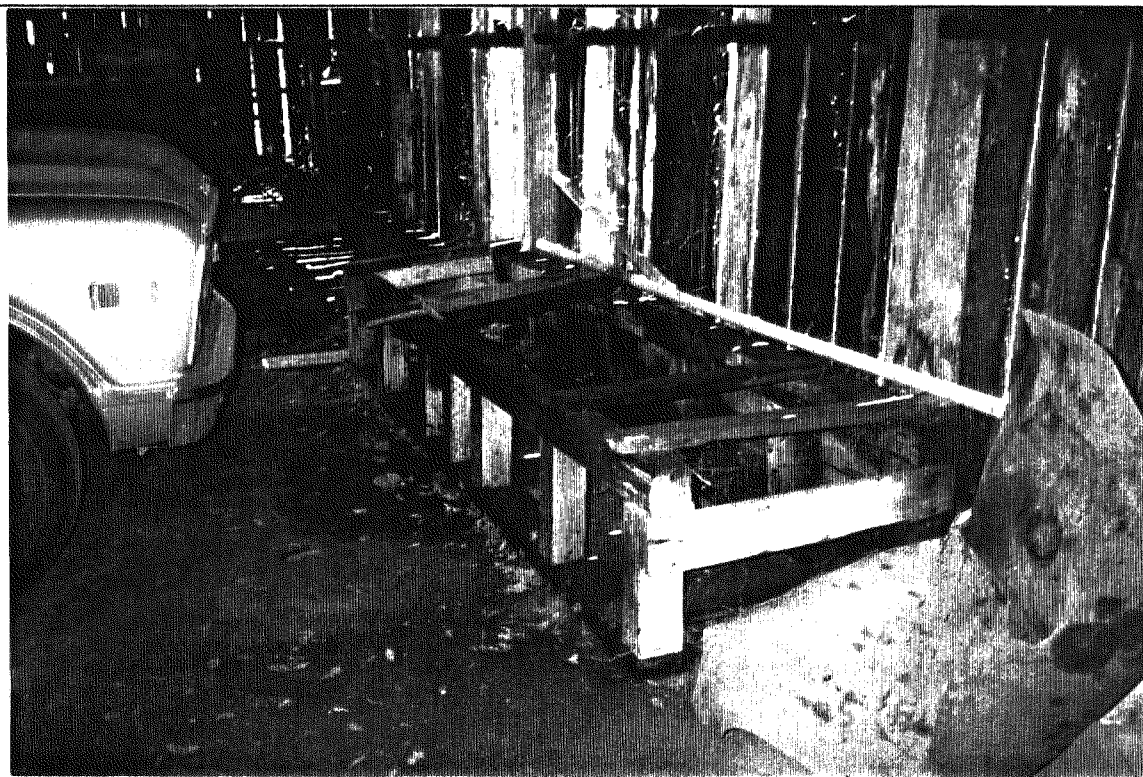
FIGURE 4B. VIEW OF DARK STAINS ON CONCRETE BENEATH A WOODEN
FRAME IN THE REPAIR SHED.
