RE: Lehigh Southwest Cement Company (Mine Operator) – Lehigh Permanente Quarry 2022-2023 COA Annual Report Information Package September 2023

2022-2023 ANNUAL REPORT INFORMATION PACKAGE

Lehigh Permanente Quarry Reclamation Plan Conditions of Approval Compliance

BMP Status Report 2022-2023

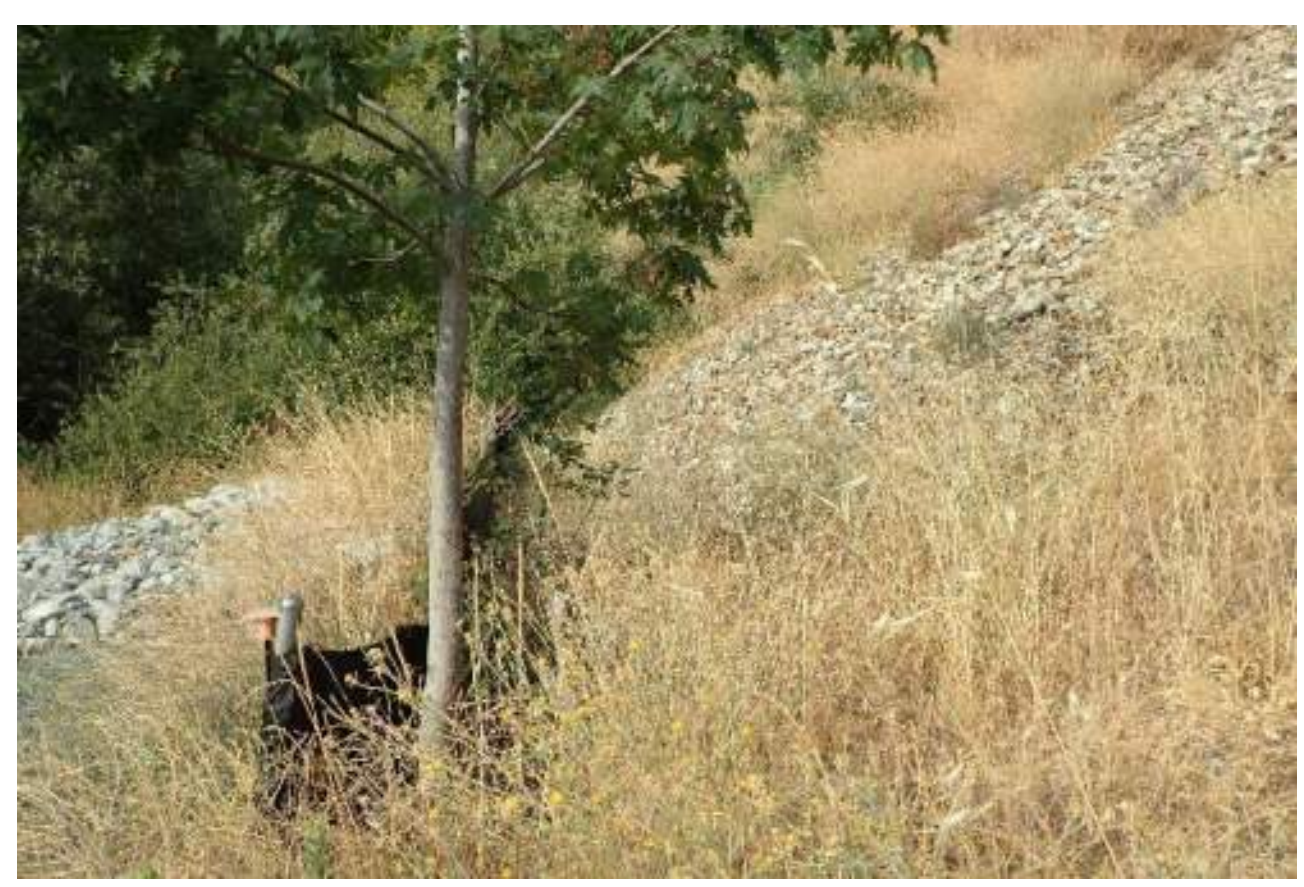
PHOTO ID	DESCRIPTION	PHOTO
0729_07	**Status:** **GOOD** **Location**: Yeager Yard – Upper Slopes **PCRA:** 2 and 3 **Observations:** Silt fences are in good condition and remain functional. Vegetative cover has established over the upper slopes of the Yeager Yard. **Recommendations:** Routine monitoring of the vegetative cover on the slopes. Monitor the sediment accumulation on vegetated benches and silt fence condition routinely.	
0729_08	**Status:** **MONITOR FOR CHANGES** **Location**: Yeager Yard – Sediment Basin **PCRA:** 2 and 3 **Observations:** Vegetation has established on the hydroseeded slope. Sediment accumulation was cleared from the sediment capture basin. **Recommendations:** Routine monitoring of the vegetative cover and BMPs conditions.	
0729_09	**Status:** **GOOD** **Location**: Yeager Yard – Sediment Basin **PCRA:** 2 and 3 **Observations:** Super silt fence remains in place and in good condition with low levels of sedimentation and debris accumulation. **Recommendations:** Frequent monitoring of the sedimentation in the sediment capture basin and above the super silt fence; clear debris regularly.
