Lehigh Permanente Quarry Reclamation Plan Amendment Conditions of Approval Compliance

2019-2020 Annual Report Information Package

SANTA CLARA COUNTY, CALIFORNIA

Date: October 1, 2020

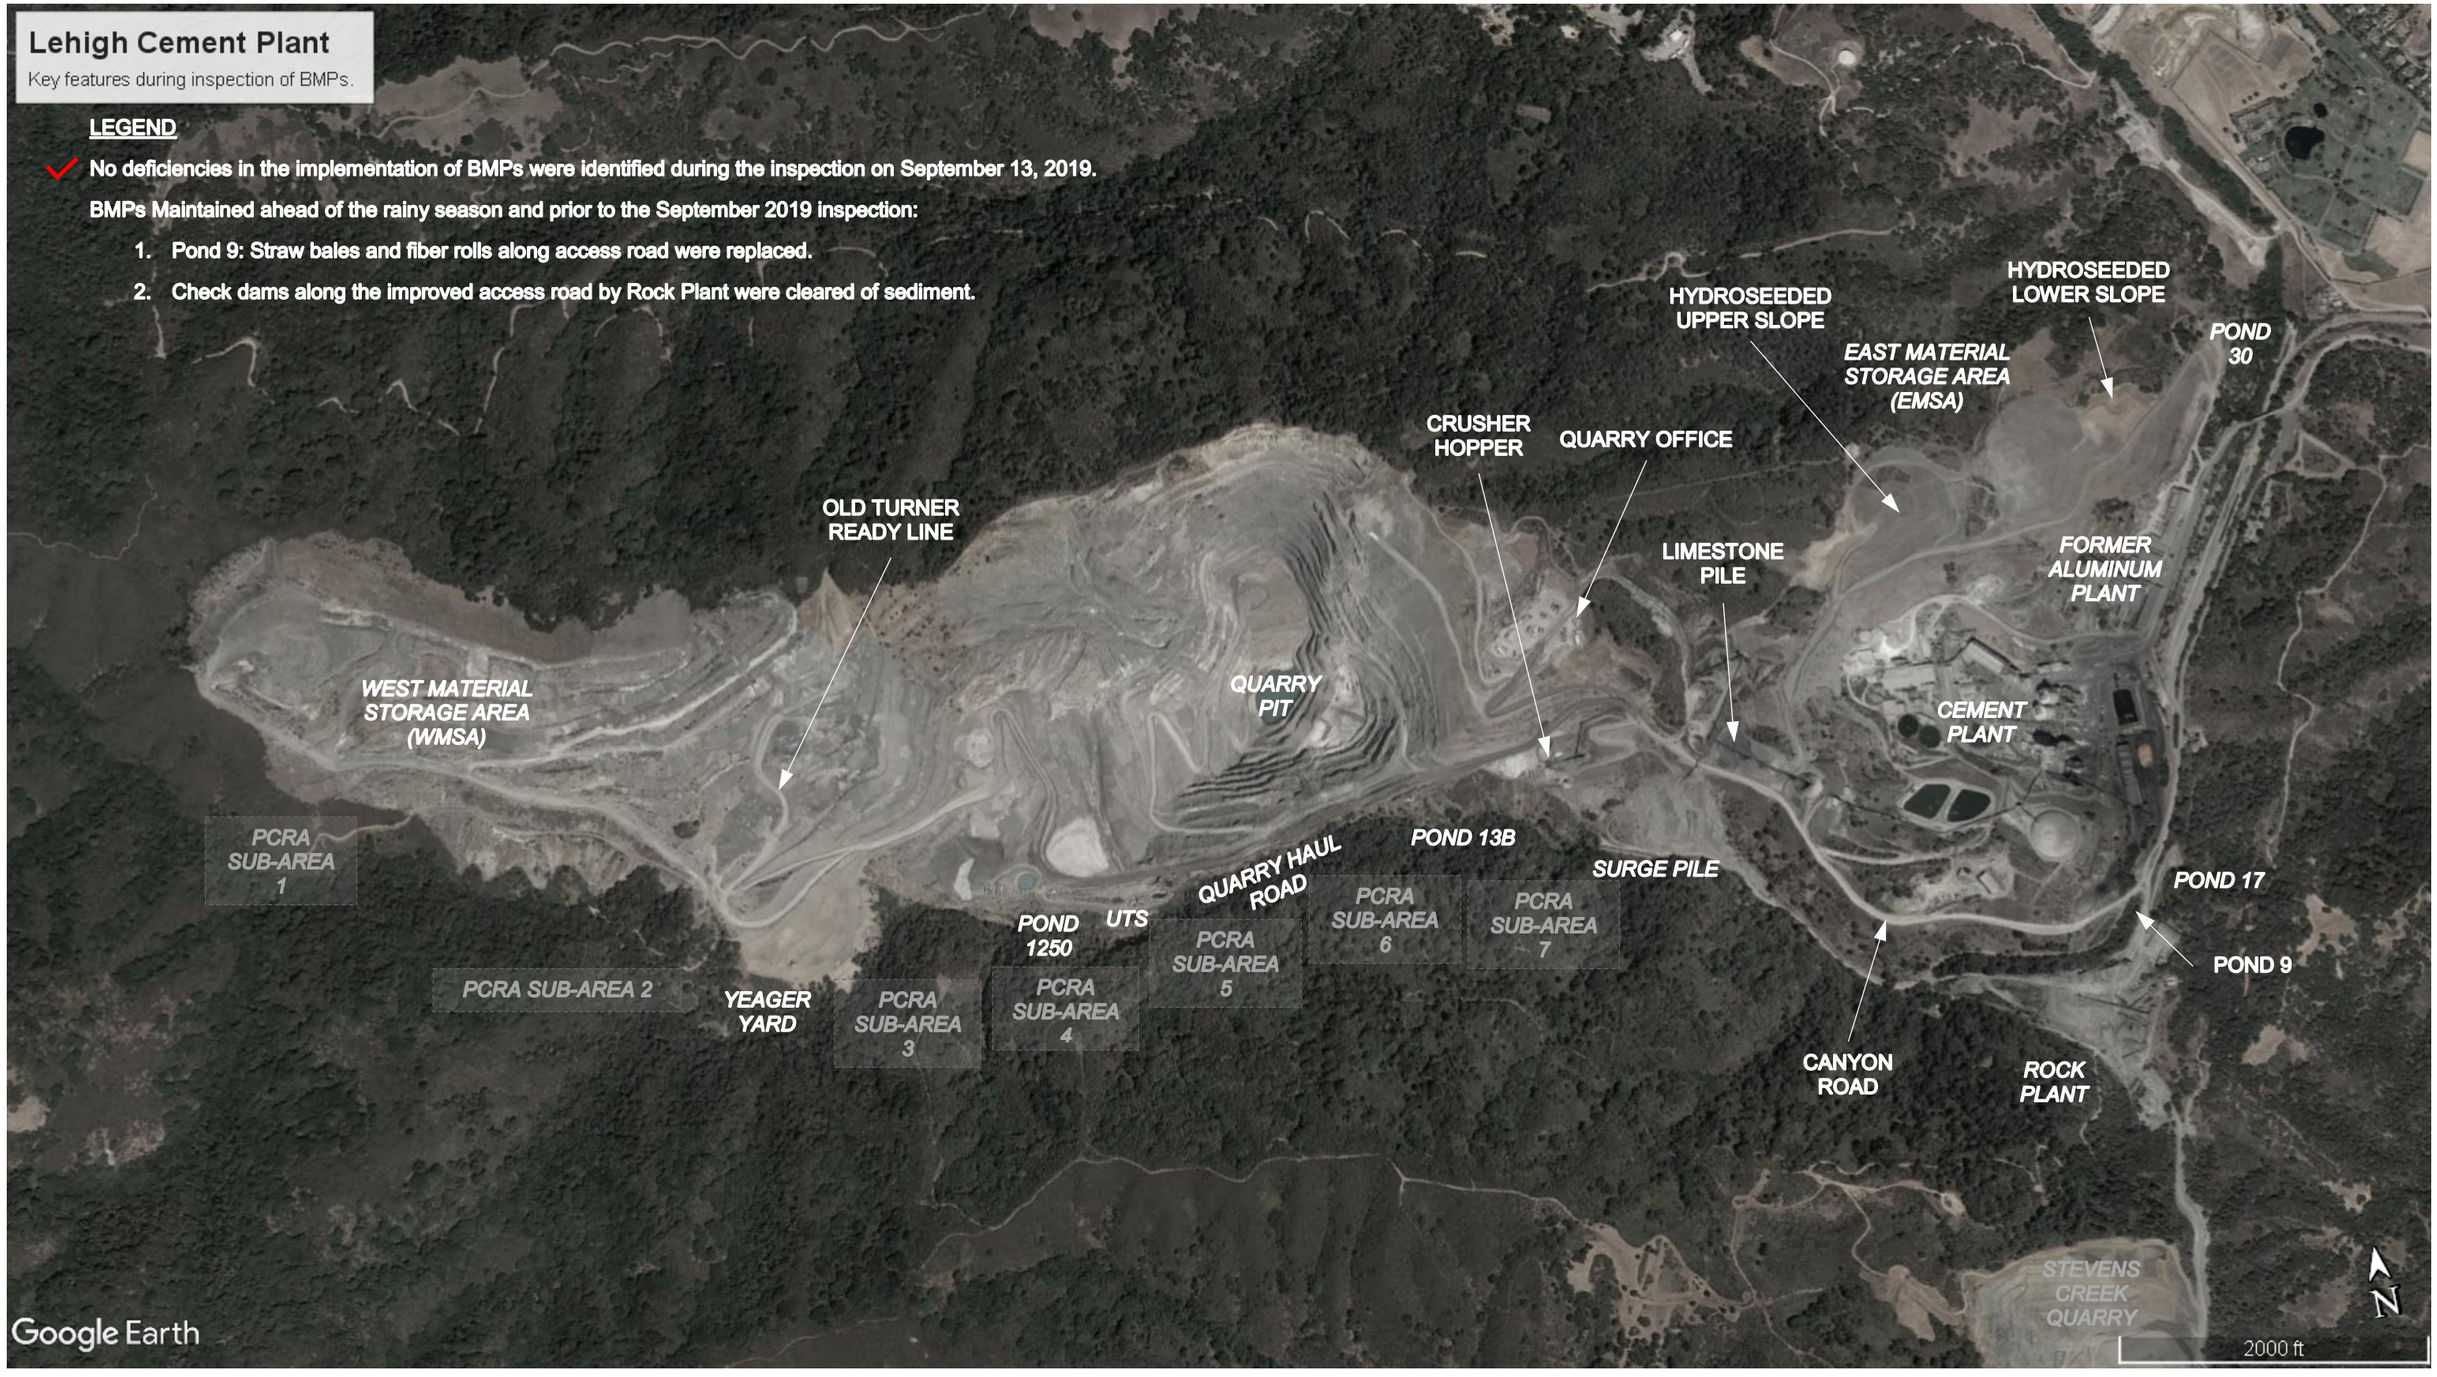
SITE MAP

- Vegetative cover is present over the upper slopes of the Yeager Yard. Silt fences at the Yeager Yard remain in good condition in areas where the vegetative cover is established.

- The drop inlet sediment basin and discharge pipe by the improved existing access road at the Rock Plant remain clear of sediment after repairs were completed.

- Fiber rolls and straw wattles were replaced at Pond 9 by the access road.
- Other BMPs are to be maintained following the rainy season: (1) check dams and rock-lined drainage ditches are to be cleared of sediment regularly; or replaced if necessary before the beginning of the next rainy season (2) accumulation of sediment behind silt fences is to be monitored and silt fences maintained for containment of sediment year-round. (3) water bars should be monitored and re–established when they wash away.

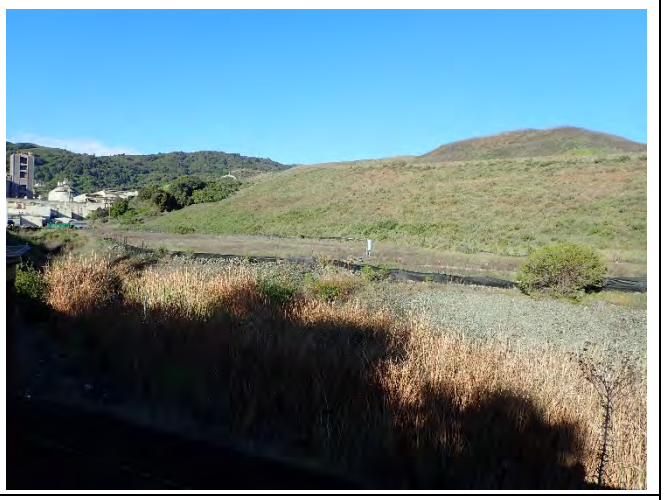
PHOTO ID	DESCRIPTION	PHOTO
0407_01	**Status:** **GOOD** **Location**: Lower EMSA Access Road **Observations:** Silt fences near Pond 30 and French drain conveyance are in good condition and were maintained and re-established ahead of the rain season. **Recommendations:** Routine monitoring of the condition of the silt fences and vegetative cover; maintain as needed.

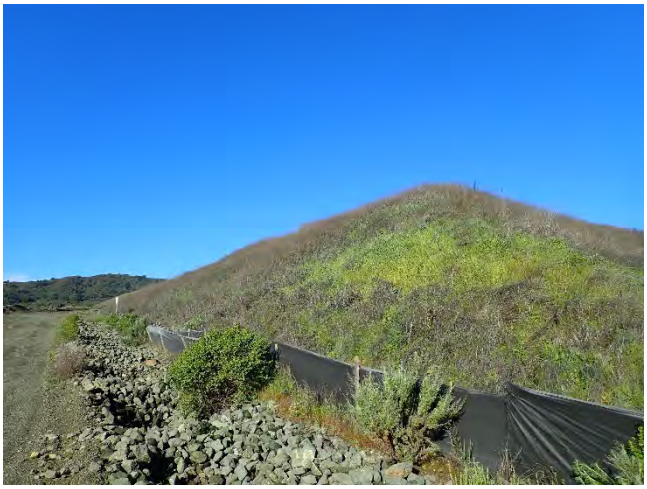
0407_02	**Status:** **GOOD** **Location**: Lower EMSA Slopes, Access Road at EMSA **Observations:** Lower slopes at the EMSA are vegetated, and perimeter silt fences and roadside ditches and check boxes remain in place and in good condition. **Recommendations:** Routine monitoring of the condition of the silt fences, rock-lines features for sediment, and vegetative cover during the rain season.

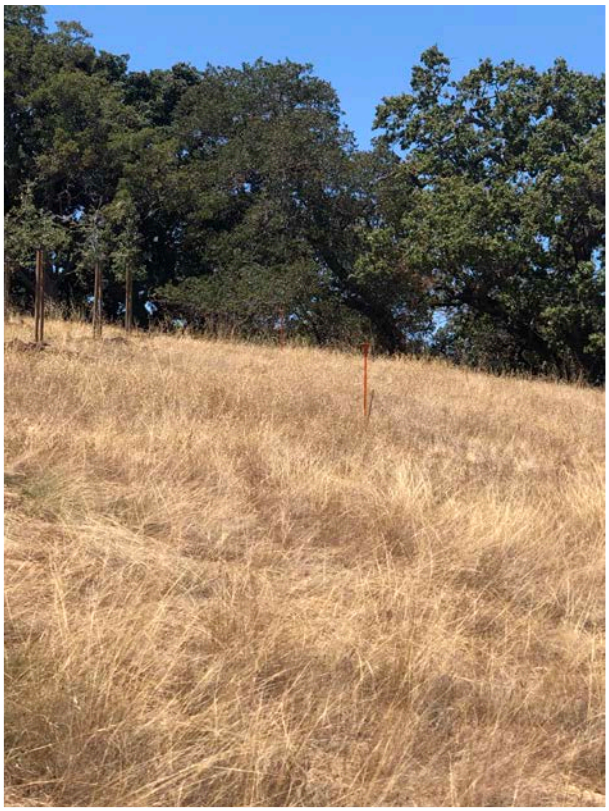
Figure 1. Location of RPA Boundary Demarcation in the EMSA.
