Lehigh Permanente Quarry Reclamation Plan Amendment Conditions of Approval Compliance

2020-2021 Annual Report Information Package

SANTA CLARA COUNTY, CALIFORNIA

Date: October 1, 2021

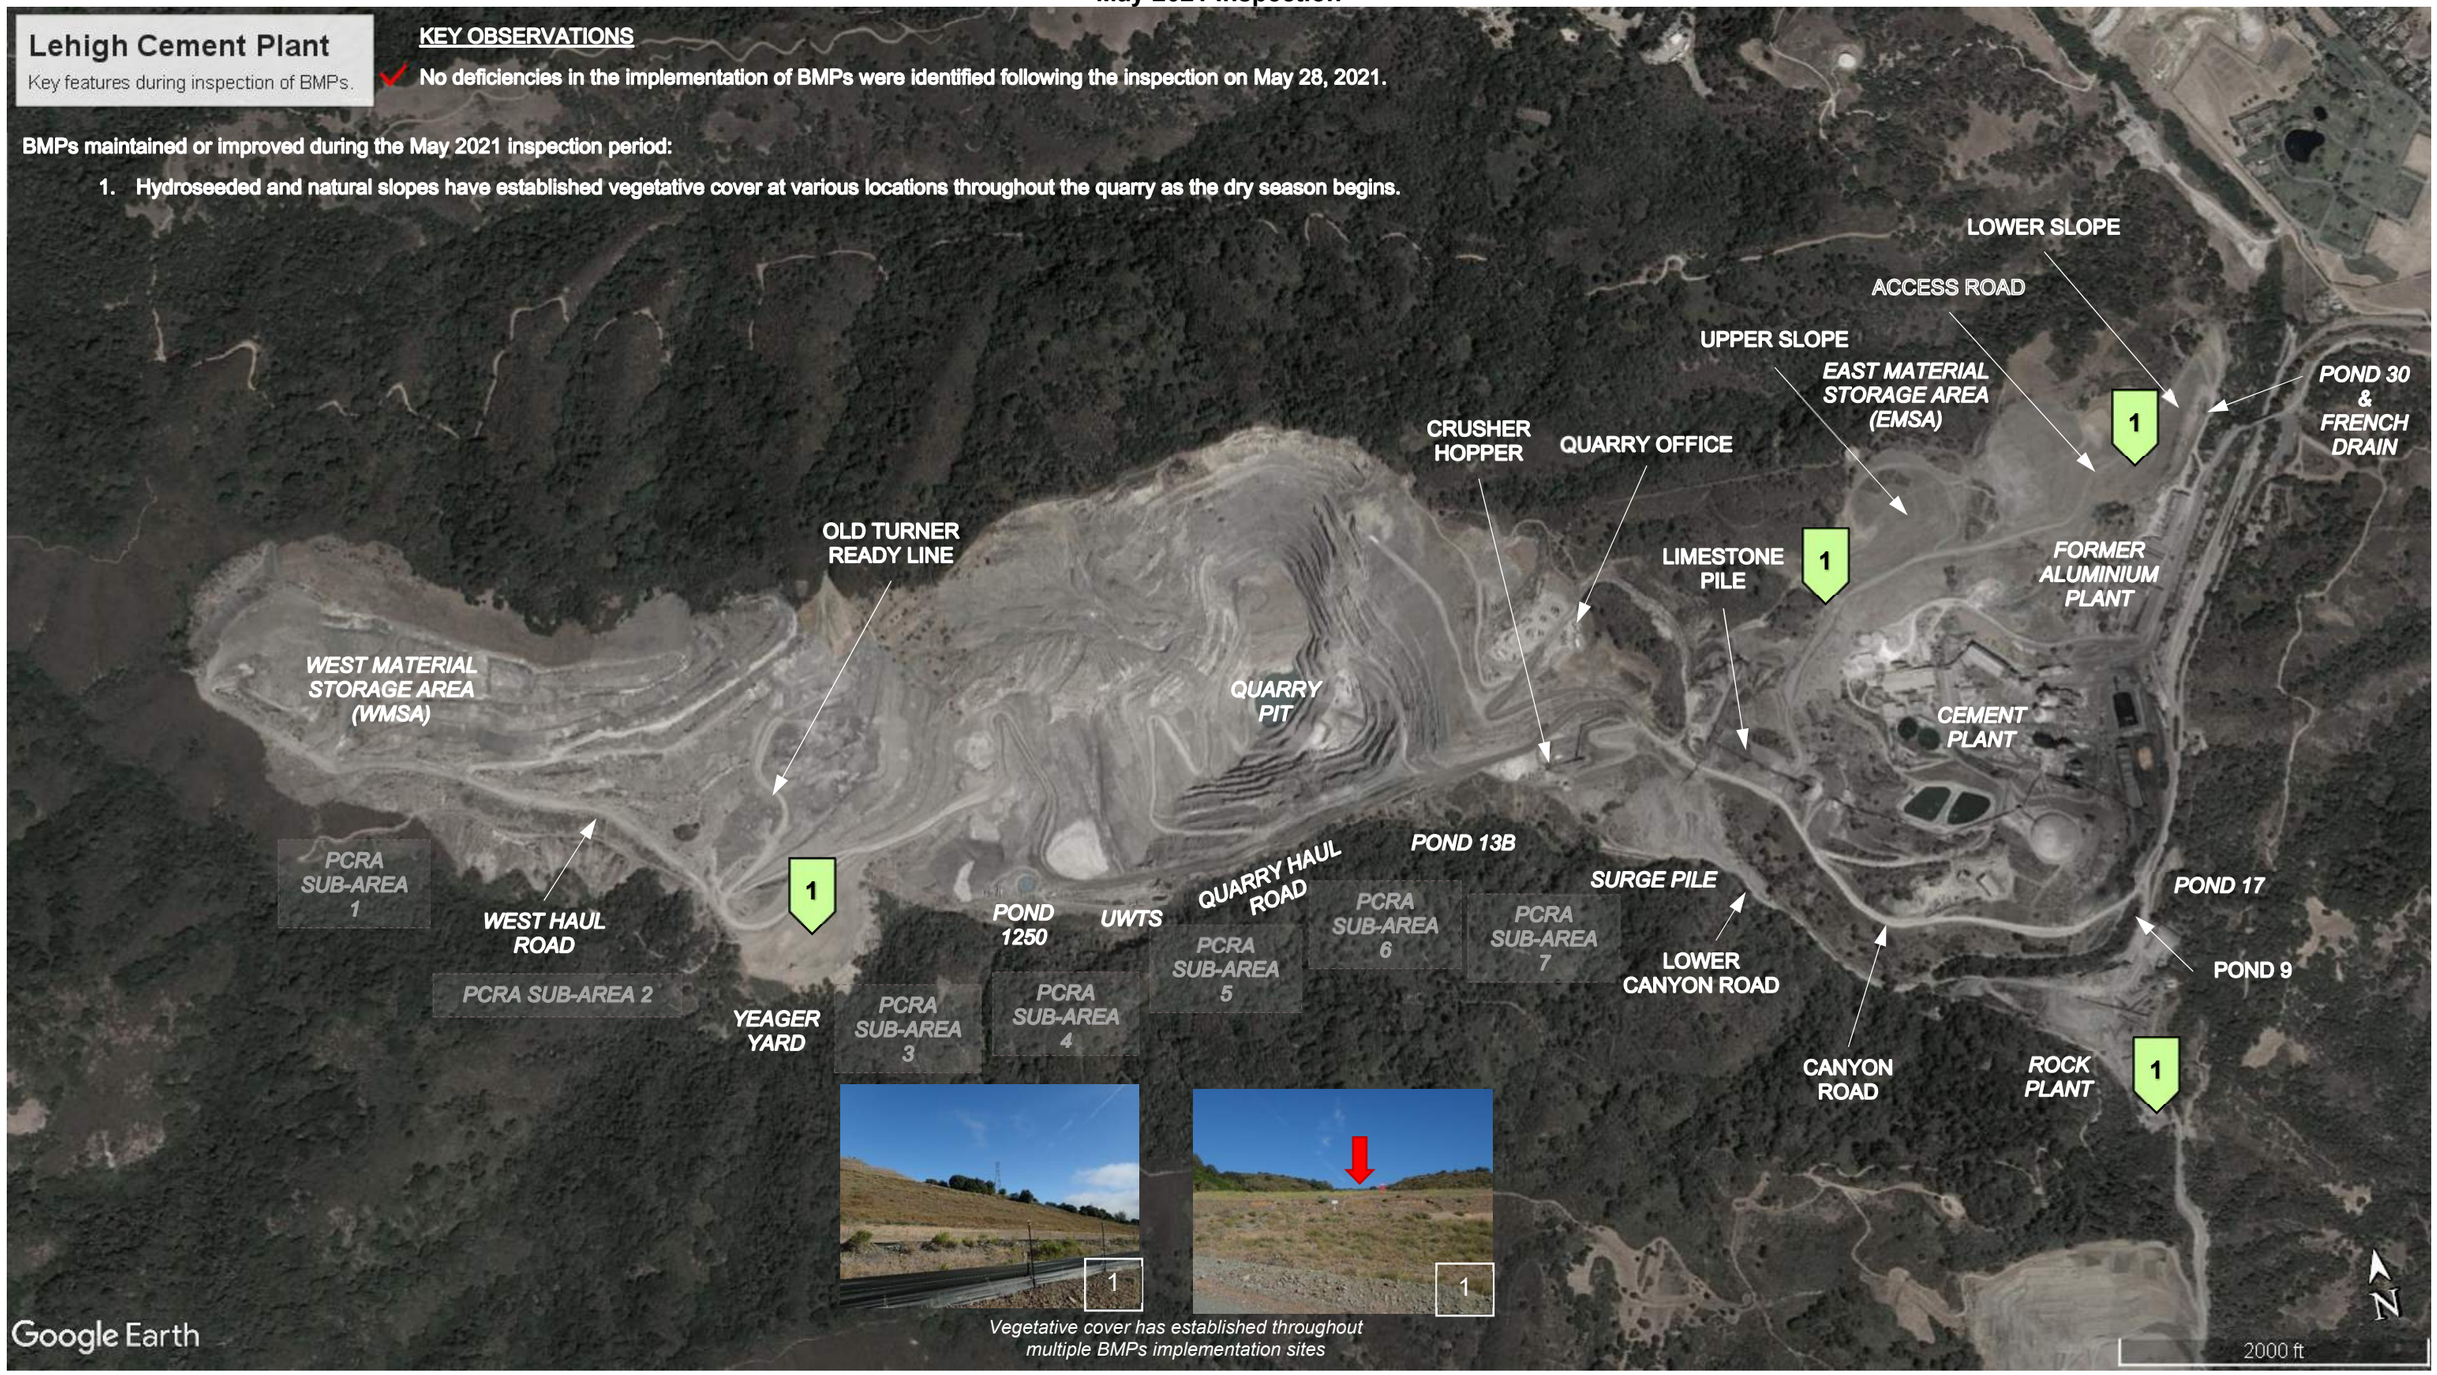
May 2021 Inspection

Vegetative cover has established throughout multiple BMPs implementation sites
