## SURFACE MINING INSPECTION REPORT

## **SITE CONDITIONS**

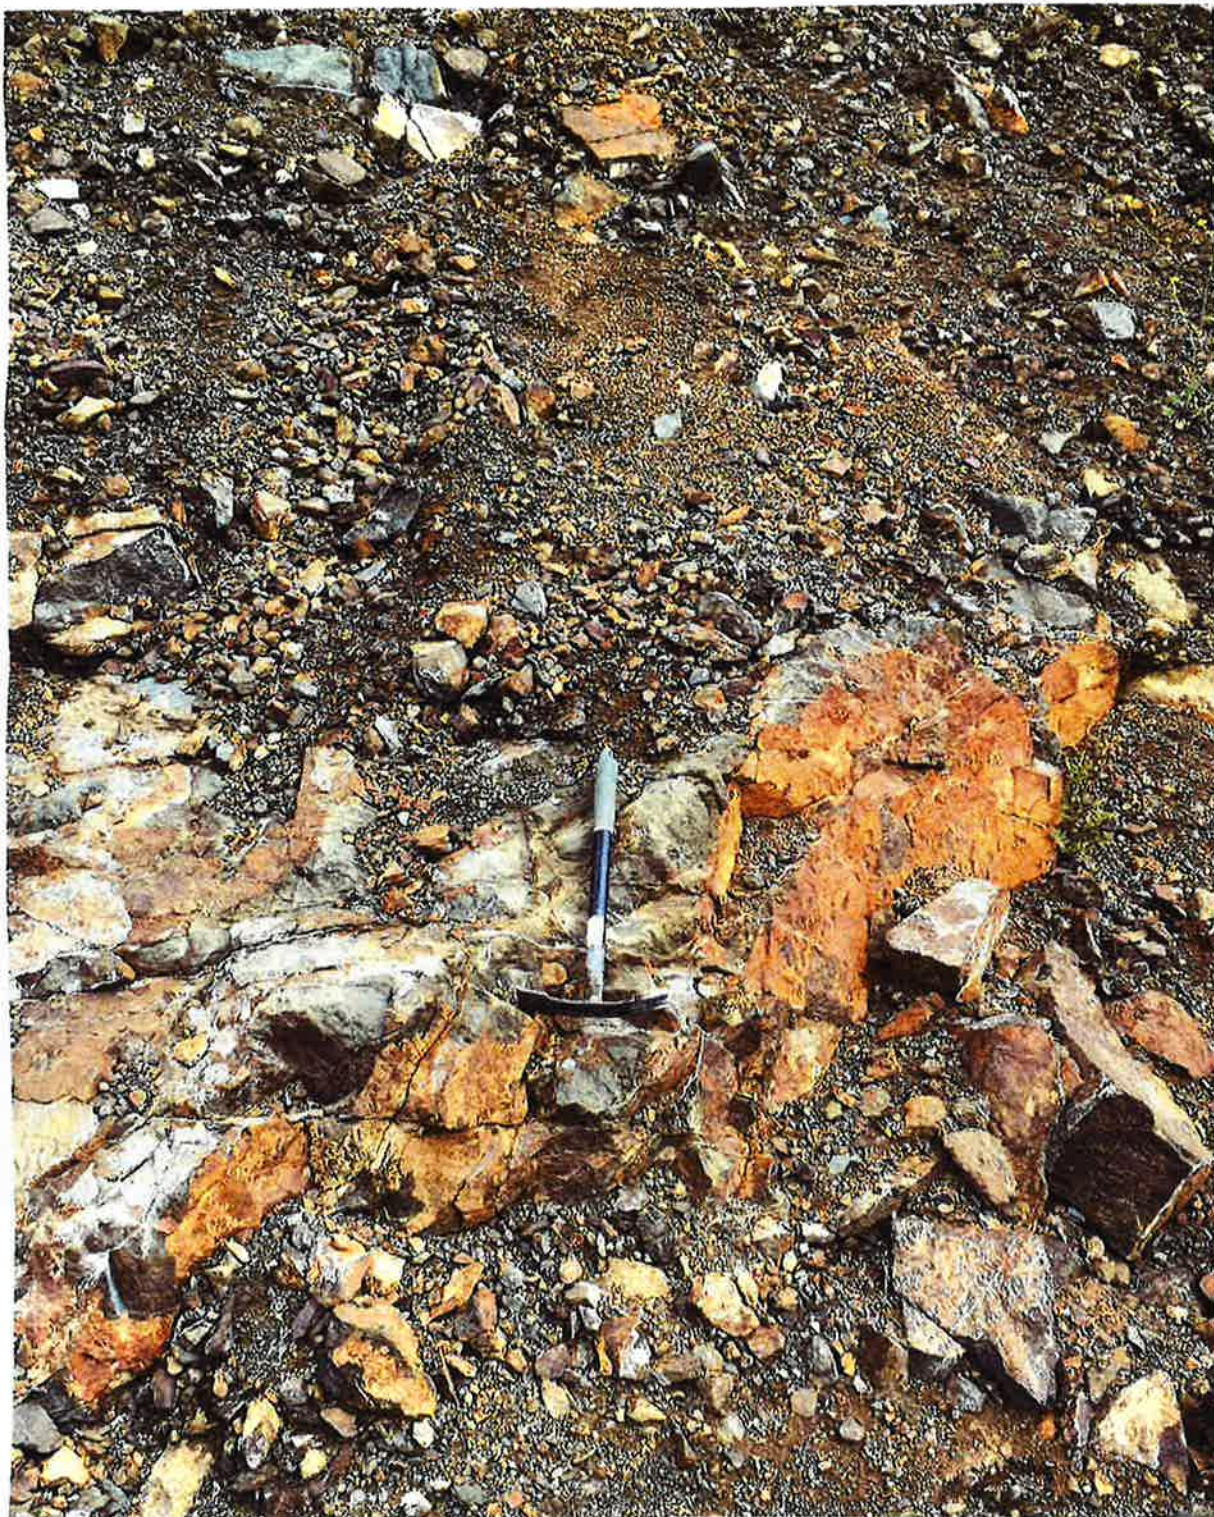
WESTERN PORTION OF NORTHERN SLOPE	Project Number:	SCQ-1	BLOCKY GREENSTONE	Plate  3
	Date:	MAY '16	BEDROCK	
	Entry By:	SD	STEVEN'S CREEK QUARRY	
	Checked By:		CUPERTINO, CALIFORNIA	
	Date:

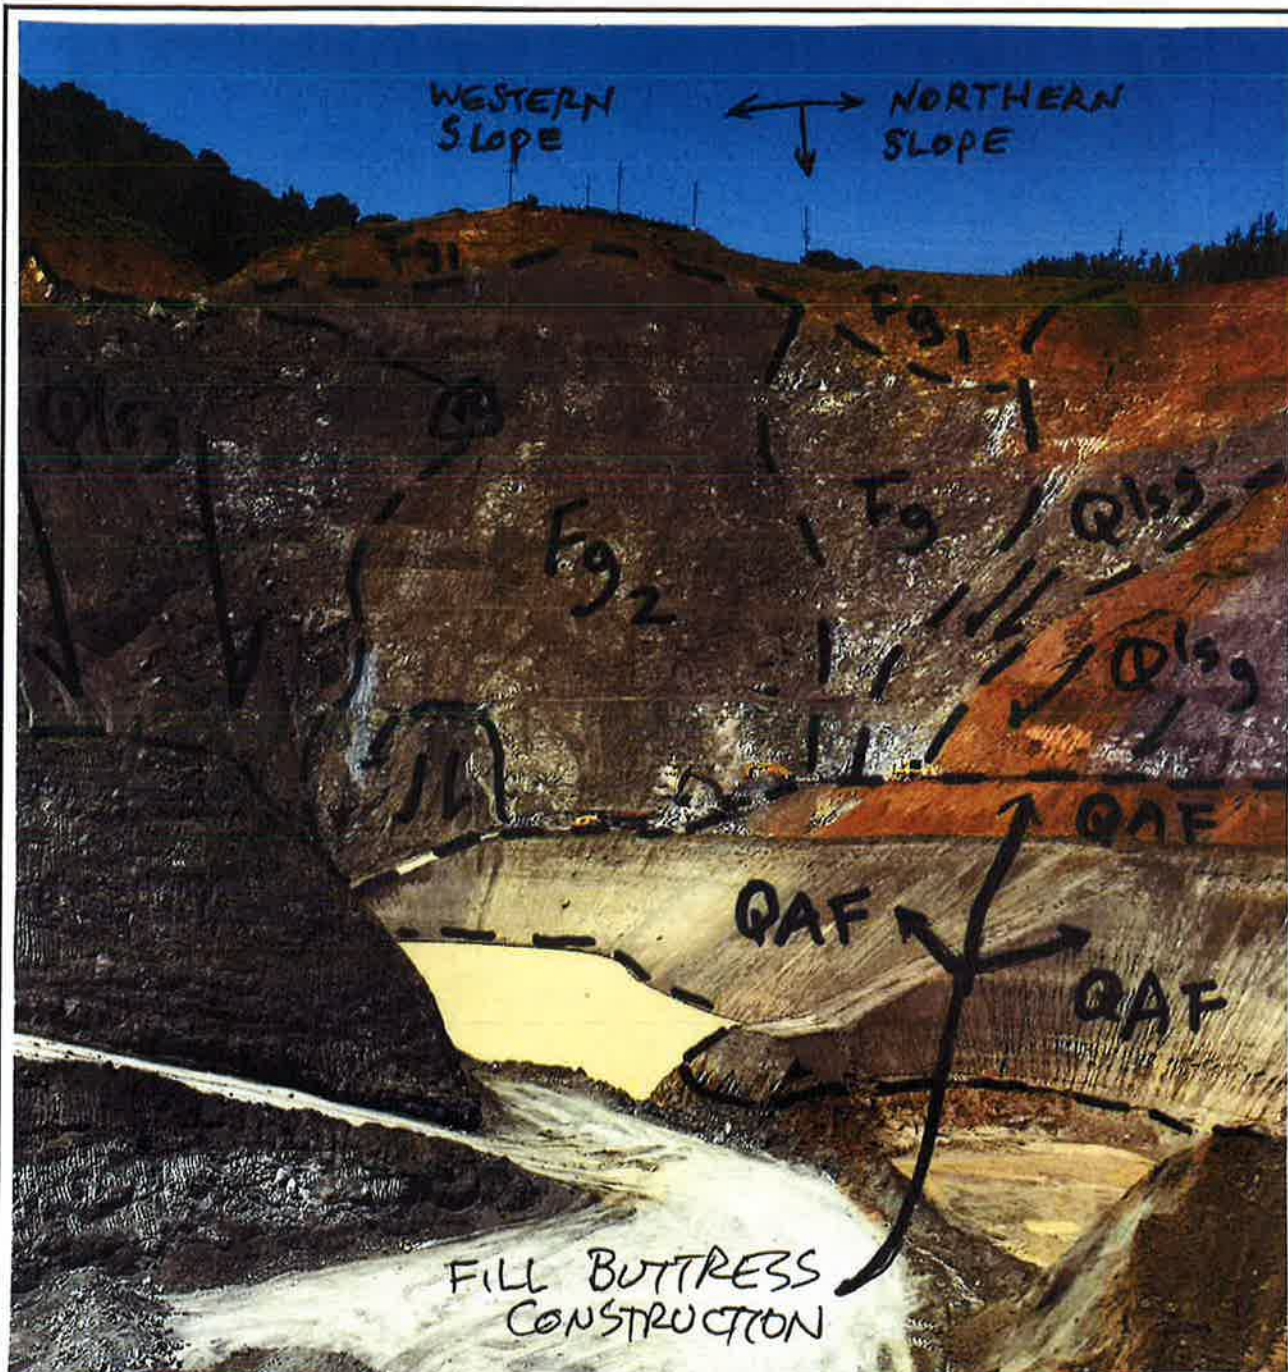
6

QAF: ENGINEERED FILL BUTTRESS

Qlsg: LANDSLIDE IN GREENSTONE

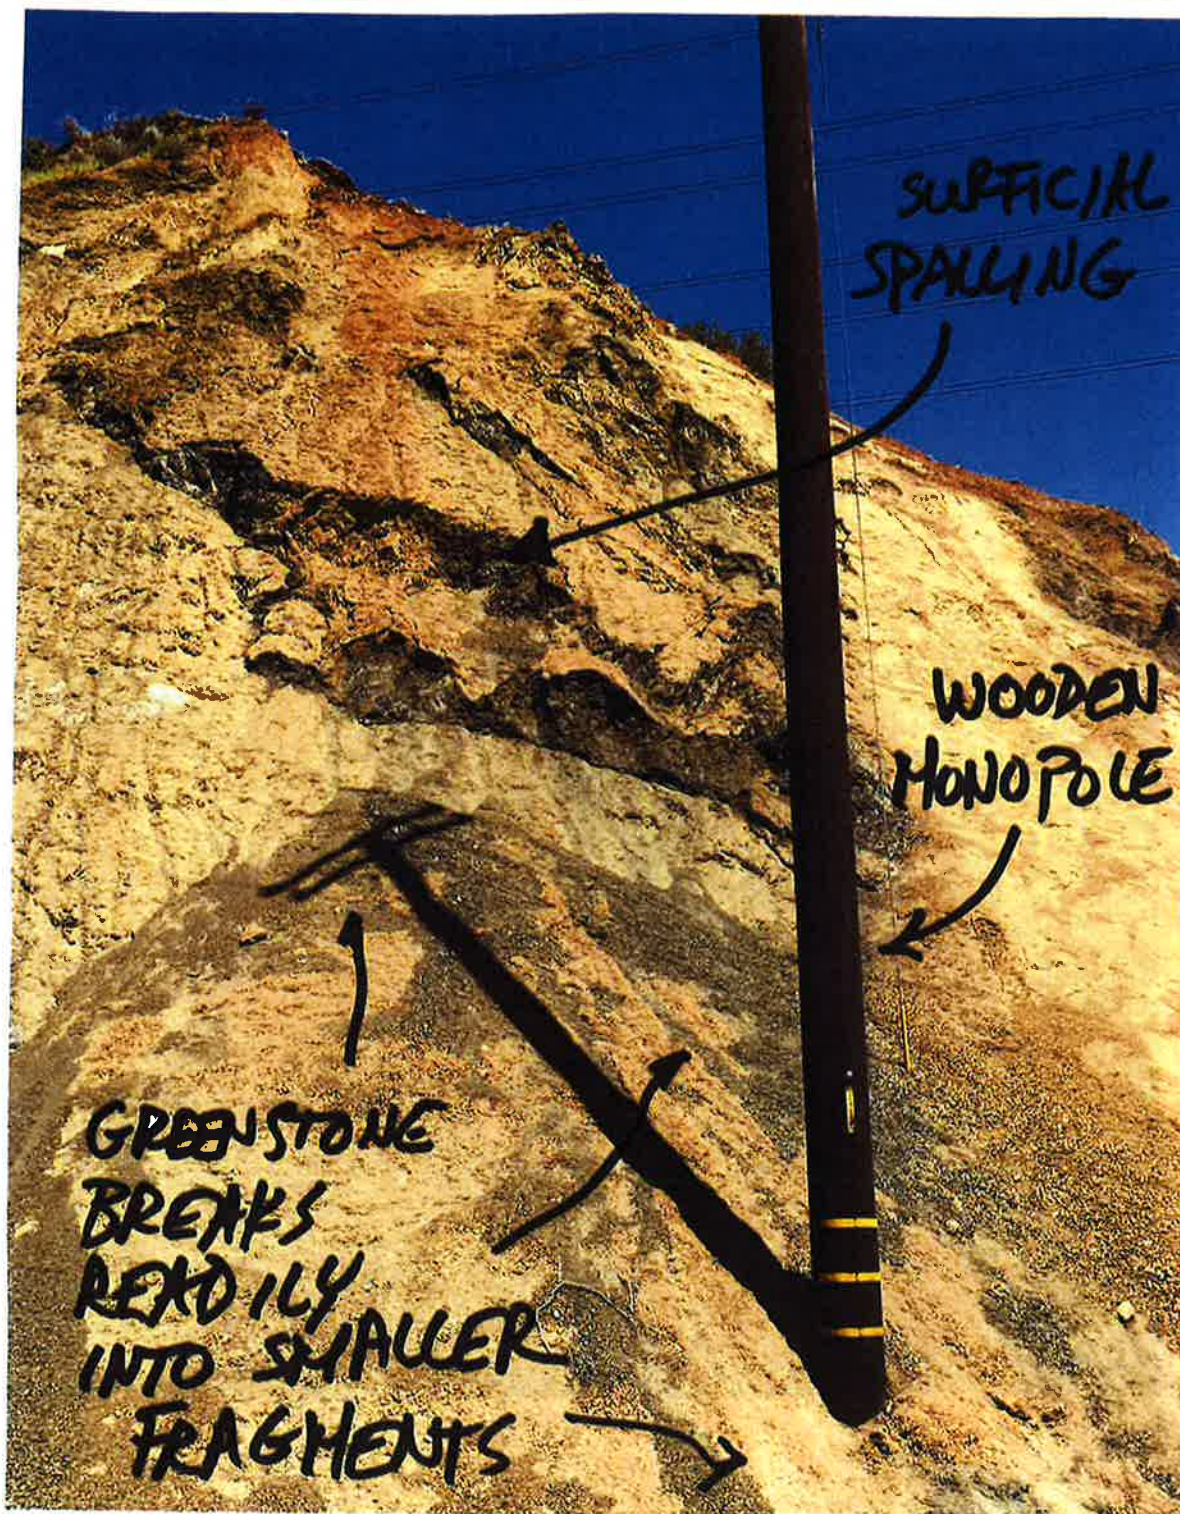
9

Surficial slumping was also observed in the area of the PG&E wooden monopole where the cut slope forms a south-facing section. The slumping is ongoing as portions of sheared greenstone bedrock that is highly and closely fractured detach and crumble as they fail. See Figure 9, Surficial Spalling Southeastern Corner.

SURFICIAL SPALLING  
SOUTHEASTERN CORNER  
CUPERTINO,  
CALIFORNIA

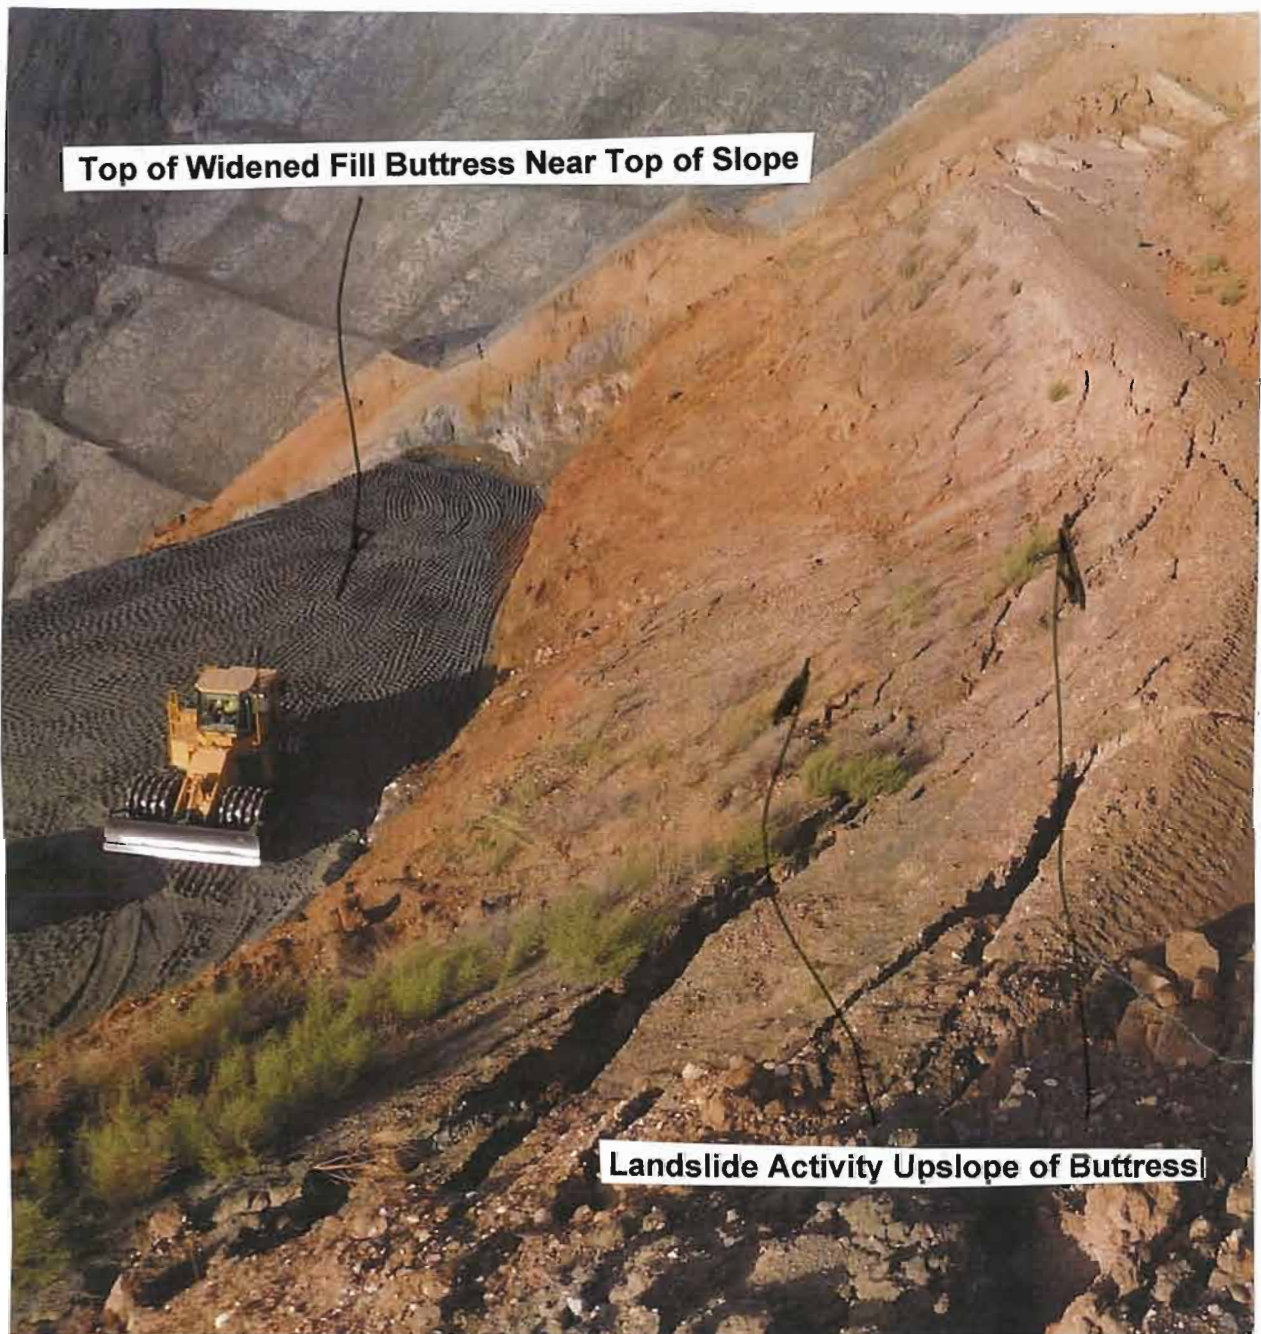
**Plate 4**

**Fill Buttress Construction during October 2016**

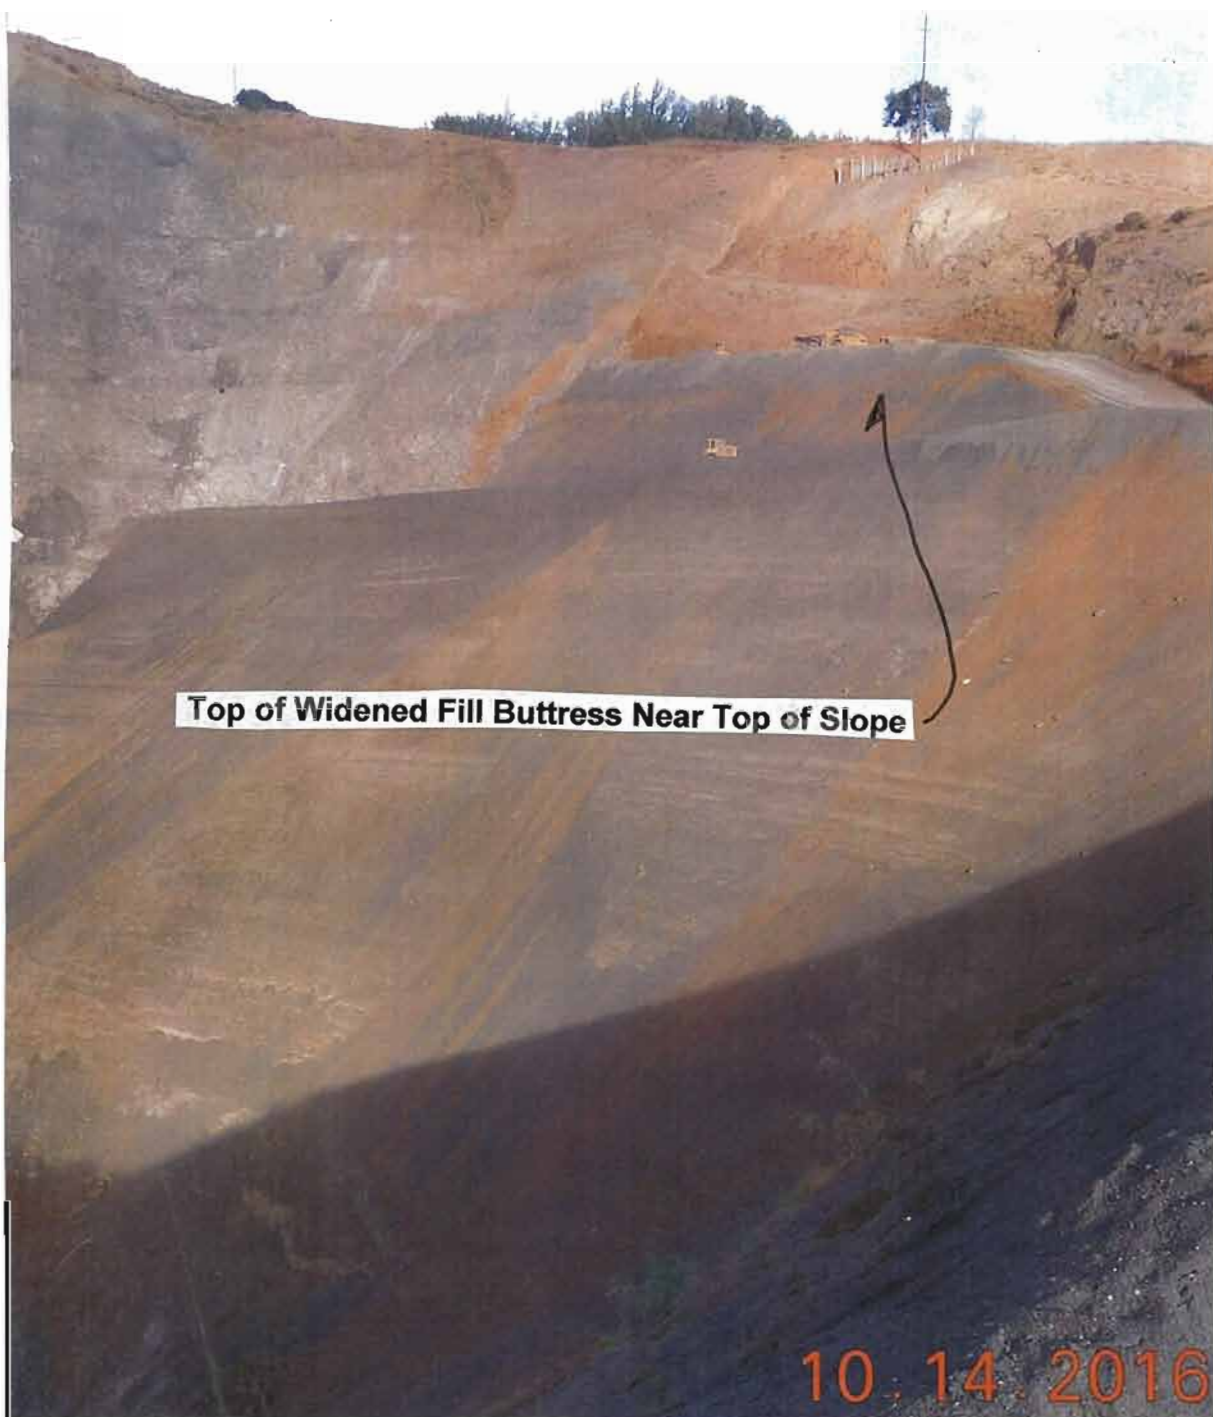
**Plate 5**

- The Fill Buttress under construction against the entire Northern Slope continued as it approached the top of the slope. The upper portion appeared to be widened as the benching and keying continued upslope. See Site Photographs, Plates 5 and 6.

**Top of Widened Fill Buttress Near Top of Slope**

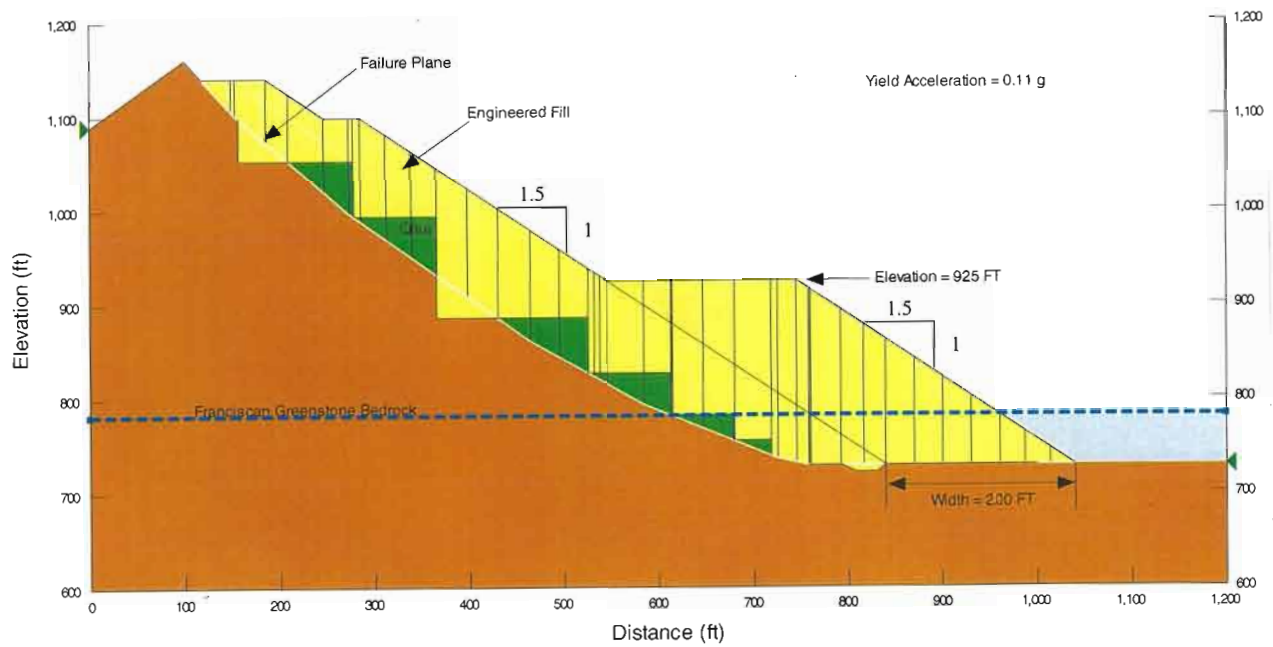
Name: Failure Plane Model: Mohr-Coulomb Unit Weight: 130 pcf Cohesion: 0 psf Phi: 14 °  
 Name: Franciscan Greenstone Bedrock Model: Mohr-Coulomb Unit Weight: 140 pcf Cohesion: 680 psf Phi: 28 °  
 Name: Engineered Fill Model: Mohr-Coulomb Unit Weight: 130 pcf Cohesion: 500 psf Phi: 35 °  
 Name: Q15a Model: Mohr-Coulomb Unit Weight: 130 pcf Cohesion: 200 psf Phi: 28 °

1.01

Note: Buttress width and Geometry  
 Was Not Observed by the CEG

**Yield Acceleration**
