County of Santa Clara

**Subject: MRRC-1 Winter Inspection Report for the Stevens Creek Quarry
County Planning Office File 1253-15PAM
State Mine ID #91-43-0007
Violation**

SURFACE MINING INSPECTION REPORT

I. Mine Name (As Shown on Approved Reclamation Plan) Stevens Creek Quarry	Inspection Date: 12-22-15 and 01-28-16	CA MINE ID# 91- 43-0007
---	--	-----------------------------------

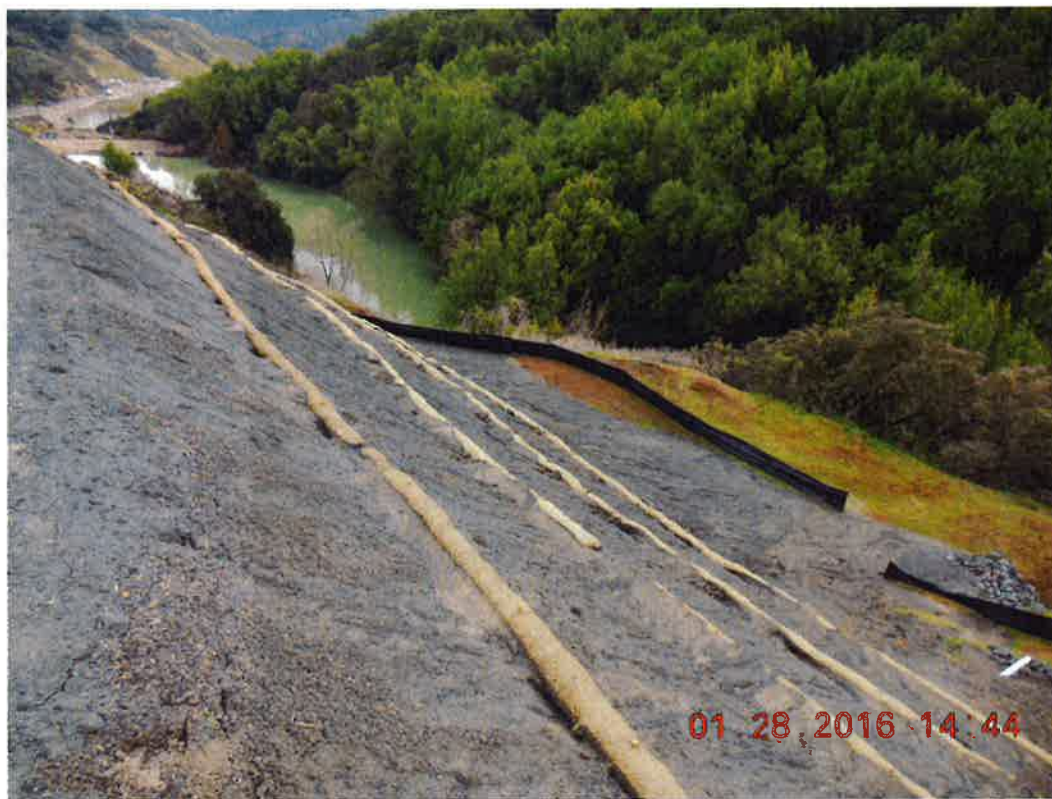
(Pic 3)

No Change in Condition(s), Conditions worsened. Additional disturbed closer activity to the creek / access road, with equipment activity disturbing additional soil material (Pic 1, 2, 3). The minimum amount of fill slope BMP's that were installed post the 10/29/15 Inspection failed due to the straw wattle incorrectly installed. Furthermore, allowing sediment to erode under and around the incorrectly placed wattles, (maintenance / housekeeping needed (Pic 4, 5). An additional upper inboard access road bench with fillslope was recently graded and no BMPS's were place, observed, nor installed, etc, (Pic 6, 7). Note: After a lengthy field discussion, SCQ then agreed to have their stormwater consultant address the BMP's. A post inspection 1/29/16 email was sent by Jason Voss with minor BMP installation to the lower access road and recently graded upper access road.

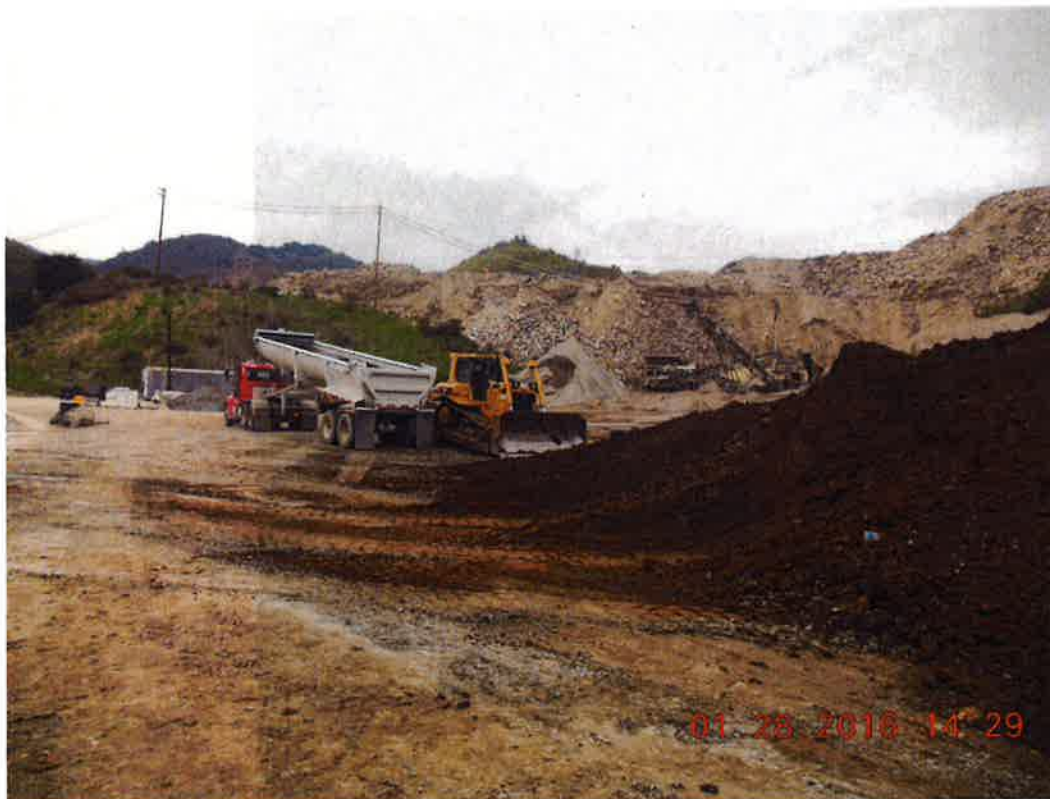
(Pic 12)

No Change in Condition(s). Continued sediment buildup observed on fill bench above basin. No change in conditions with lack of fill slope BMP's. Further erosion observed to basin inlets with basin at capacity (Pic 11). It was noted that since a "polymer" was added to the basin to assist with stormwater de-sedimentation, extra basin maintenance will be required with activity. Both fill slopes above basin now have erosion rills and new slope slumping combined with sediment onto fill bench (Pic 12). No BMP's onsite or placed since last inspection 12/22/15.

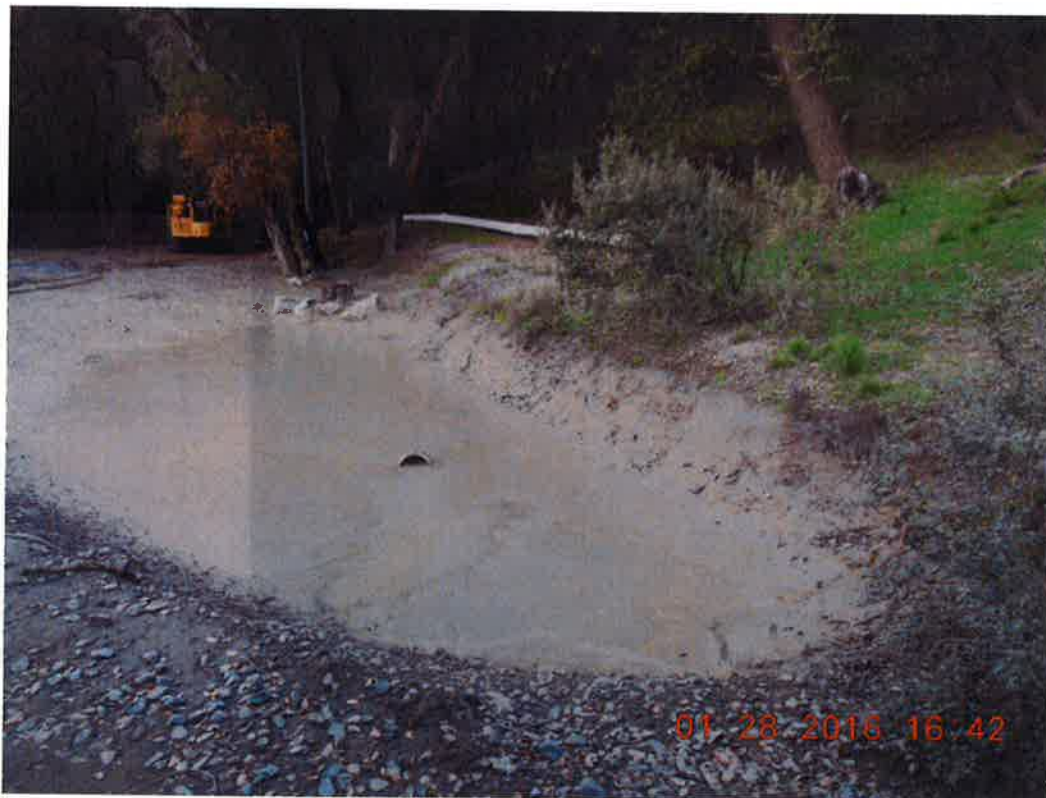
(Pic 14)

- j) **Upper Easternly PG&E Tower Easement.** Lack of BMP's on hillside Erosion Rills to cut slopes. Existing slopes to the lower Tower Easement need to be addressed / evaluated. The now harvesting of an existing stockpile is currently undermining existing hillside vegetative slopes below the PG&E Tower easement (Pic 14).

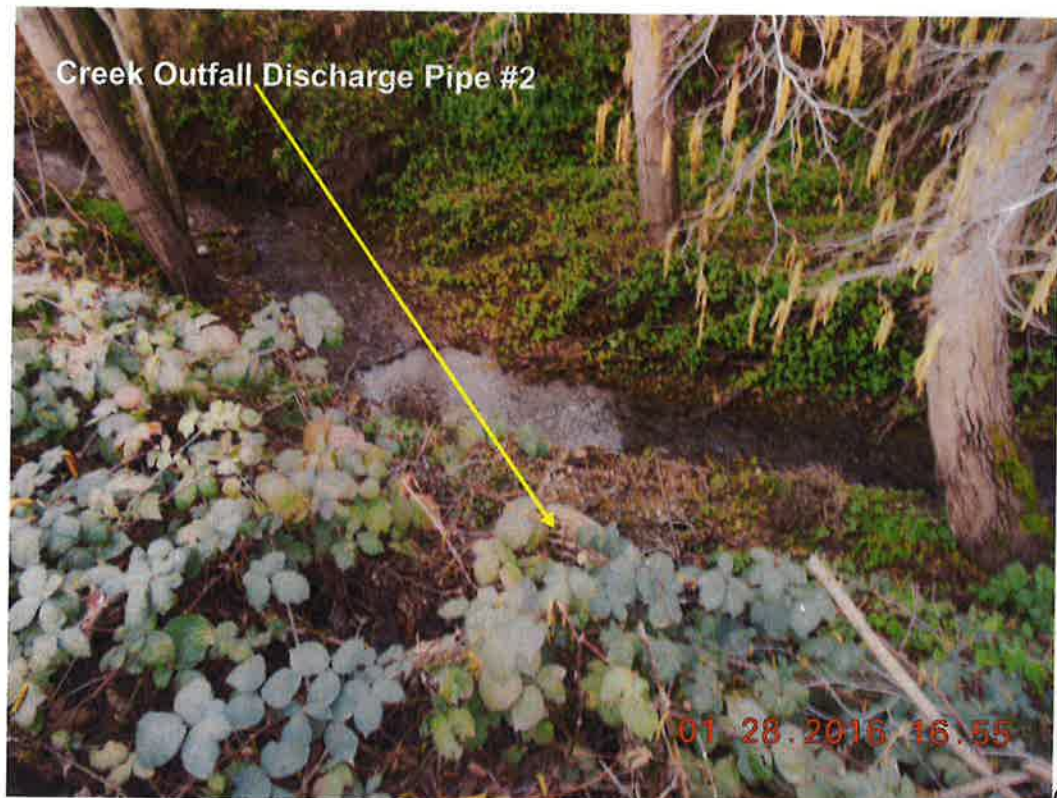
(Pic 17)

- m) **Upper Rattlesnake Creek Pump Equipment** was observed to be operational with an electric sump pump placed into the lower creek. An existing metal tank used for a nonoperational spring 10-12 years ago, (stated by Jason Voss), was now used with the placed equipment into the creek for related pumping activity (Pic 17). A follow up

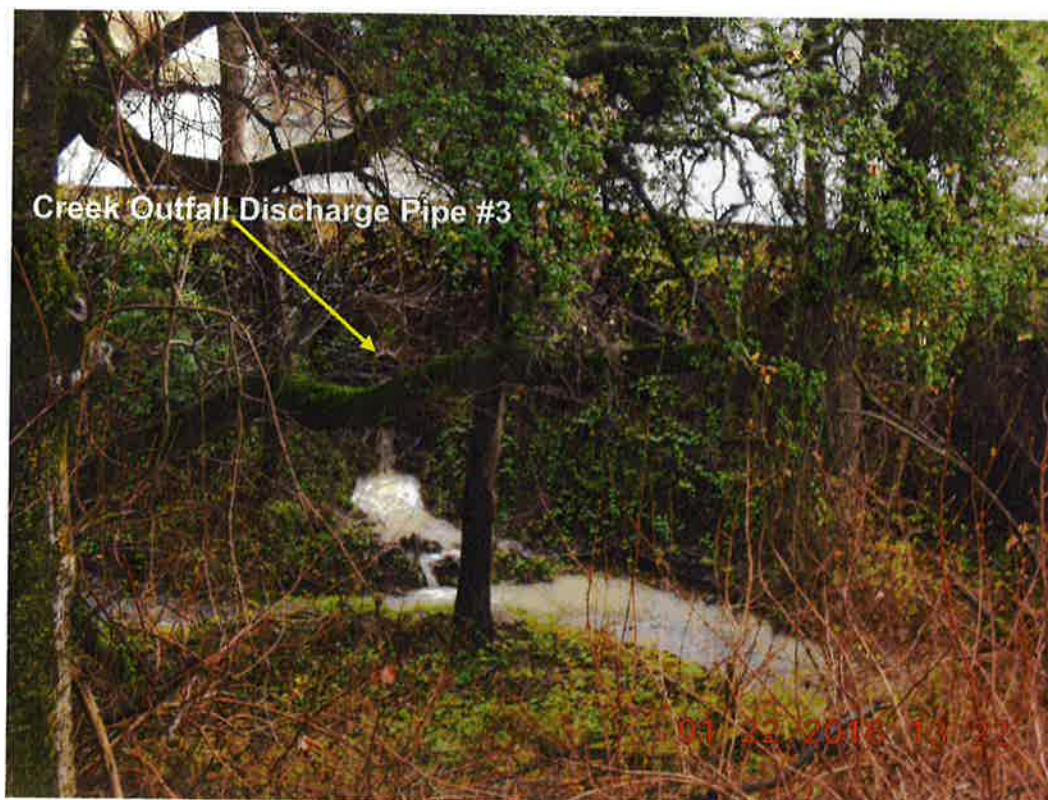
(Pic 18)

- n) **Lower Shop Area Stock Pile** near creek needs to be covered and or Winterized.
- o) **Lower inline creek outfall discharge pipes #2 and #3** lack outlet rock energy dissipators. Discharge outfall pipe #2 was observed discharging 1/22/16 (Pic 18, 19).
- p) **Lower Office Area / Weigh Scale / Sediment Basin Area.** Stormwater runoff that is collected before the creek outfall #1 should be free of truck parking activity, construction activity, etc. to prevent more erosion / material into the sediment basin / creek. It was observed during a site visit that transfer trucks would park in this area, then clean off their dump rails and rear tail gate free of soil material, etc. The cleaned off soil, fuels, etc. freely drops onto the ground with no BMP's, sediment controls, quarry observation before running into the lower sediment basin / outfall / creek / reservoir (Pic 20, 21).
