County of Santa Clara

Department of Planning and Development
Planning Office

SUBJECT: NOTICE OF VIOLATION – STEVENS CREEK QUARRY

Stevens Creek Quarry
Map of Violations
September 5, 2017

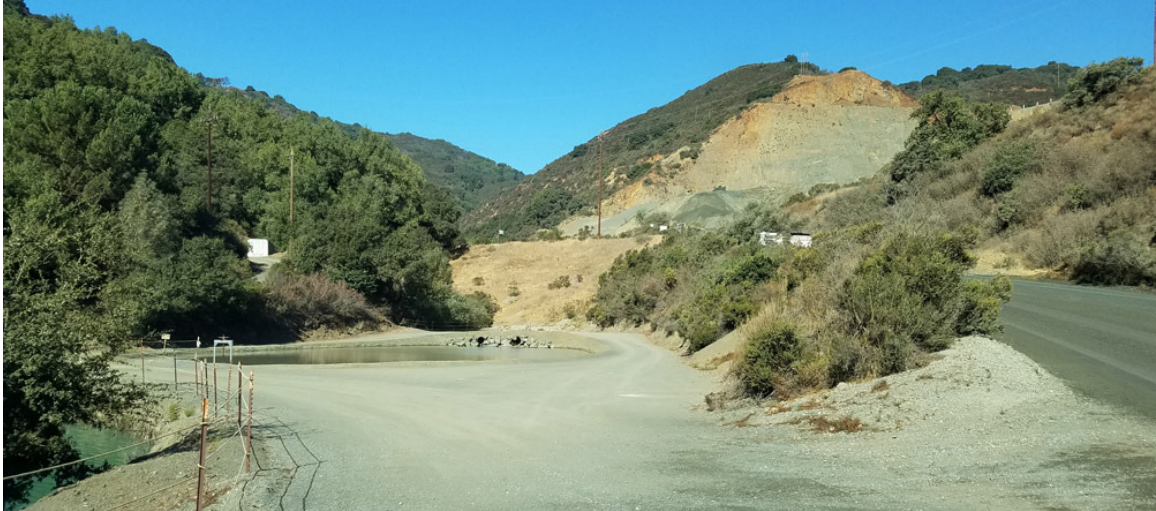
Photo 5 (taken 9-15-2016): Face of dam between upper and middle settling basins.

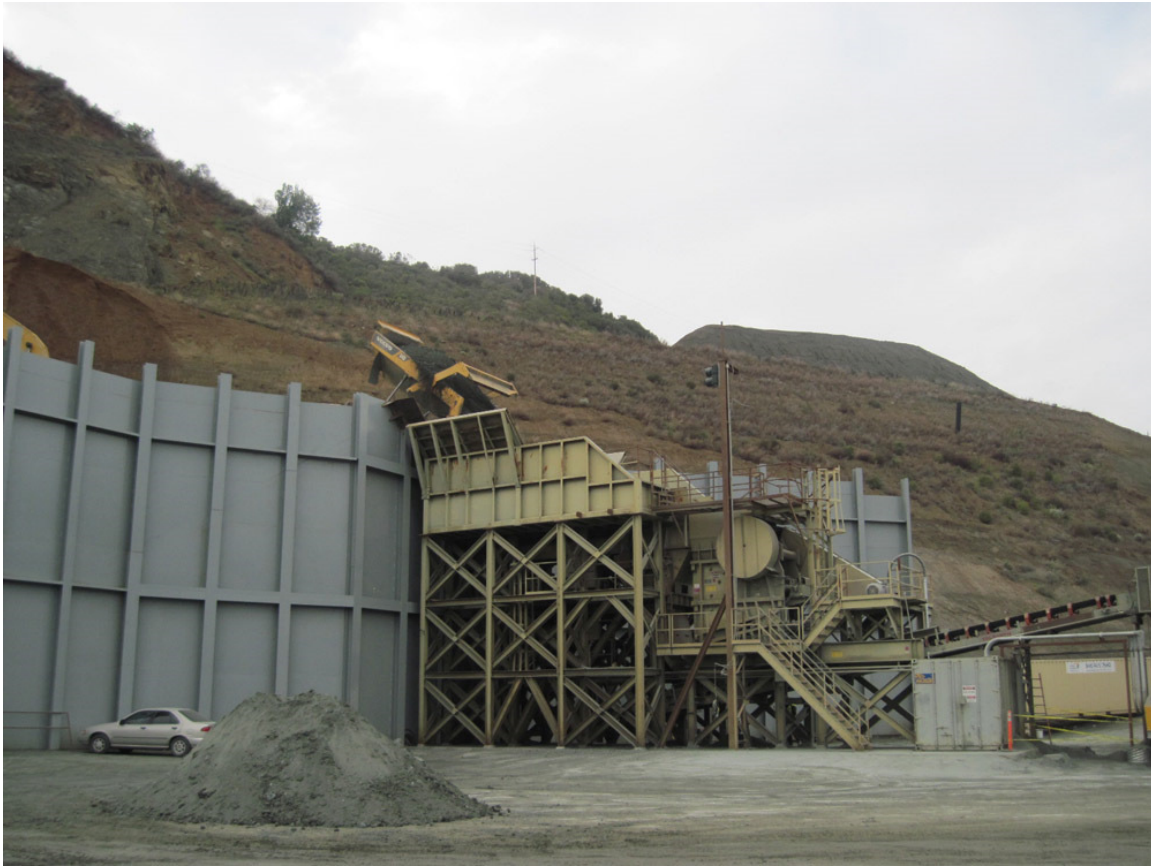
Photo 7 (taken 1-28-2016 by Regional Water Quality Control Board): Relocated rock crusher.

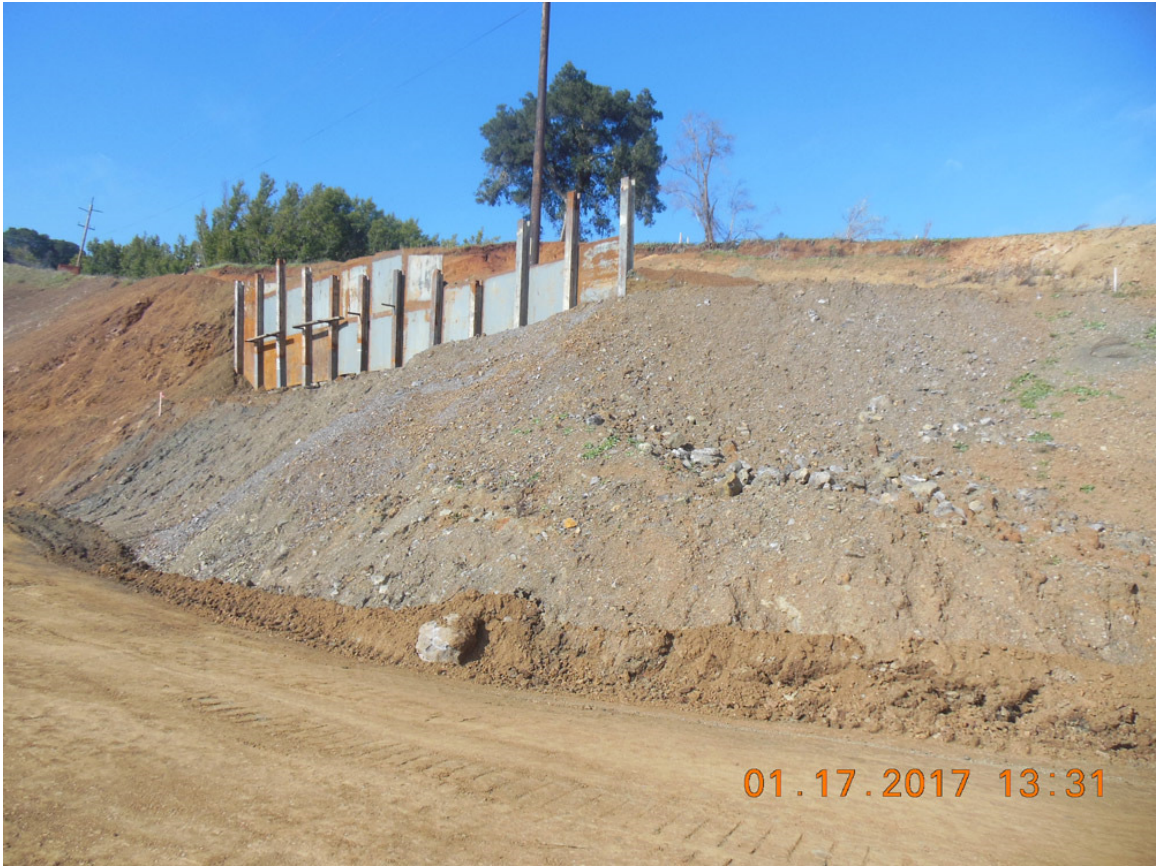
Photo 12 (taken 1-17-2017): Retaining wall on north high wall.

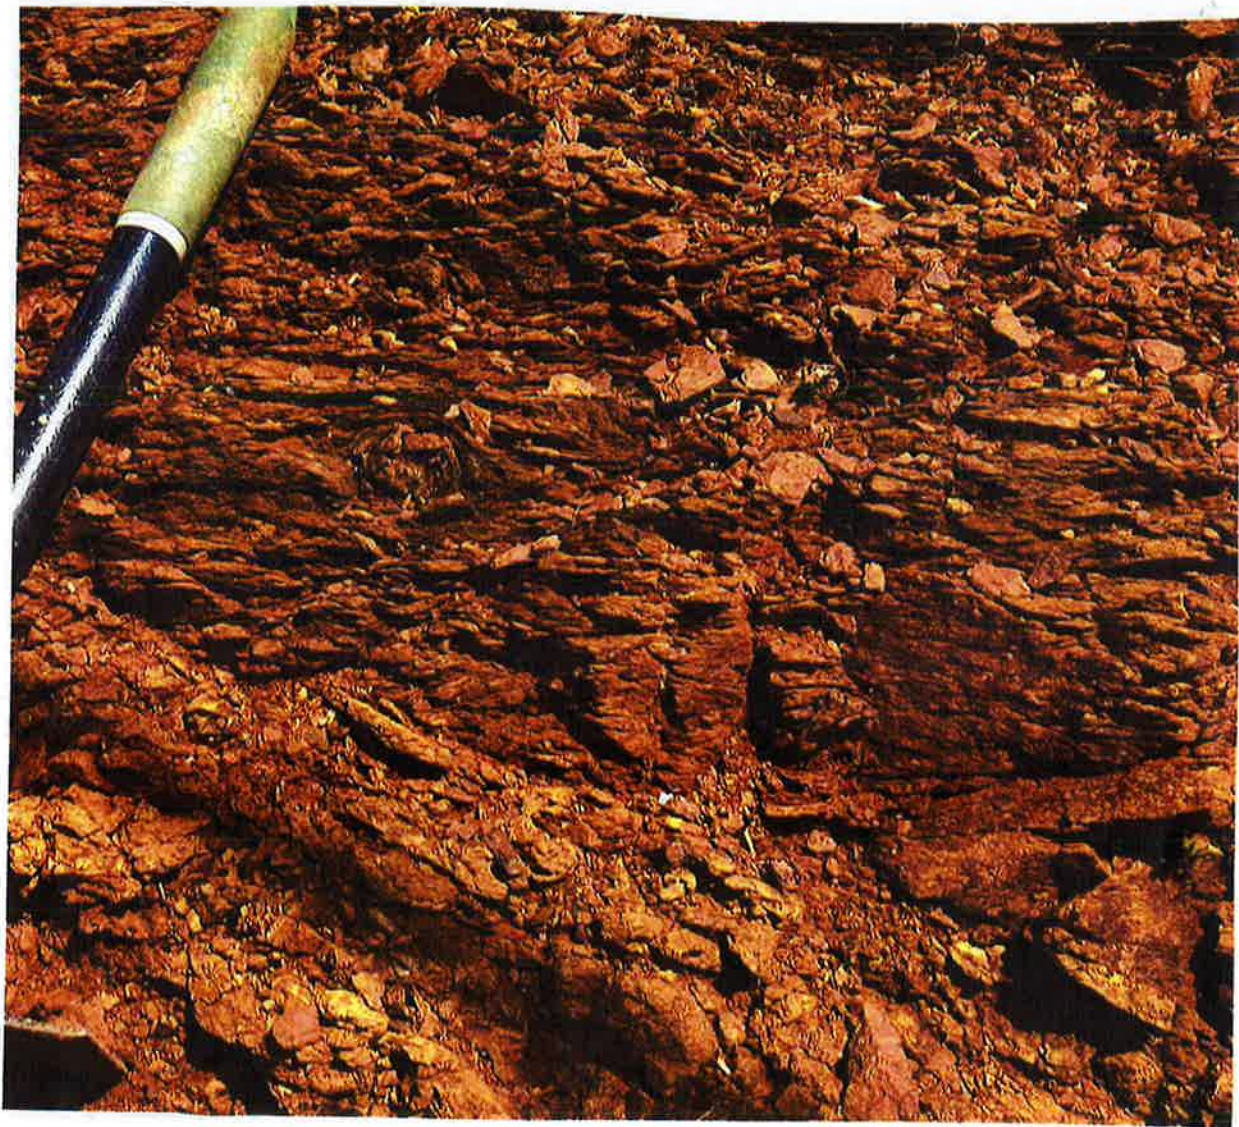
STEVENS CREEK QUARRY	Project Number:	SCP-1	FOLIATED GREENSTONE BEDROCK CUPERTINO, CALIFORNIA	Plate 2
	Date:	MAY '16		
	Entry By:	SD		
	Checked By:			
	Date:

FOLIATED & OXIDIZED GREENSTONE (IN-PLACE).
NOTE TIGHT FOLIATIONS.

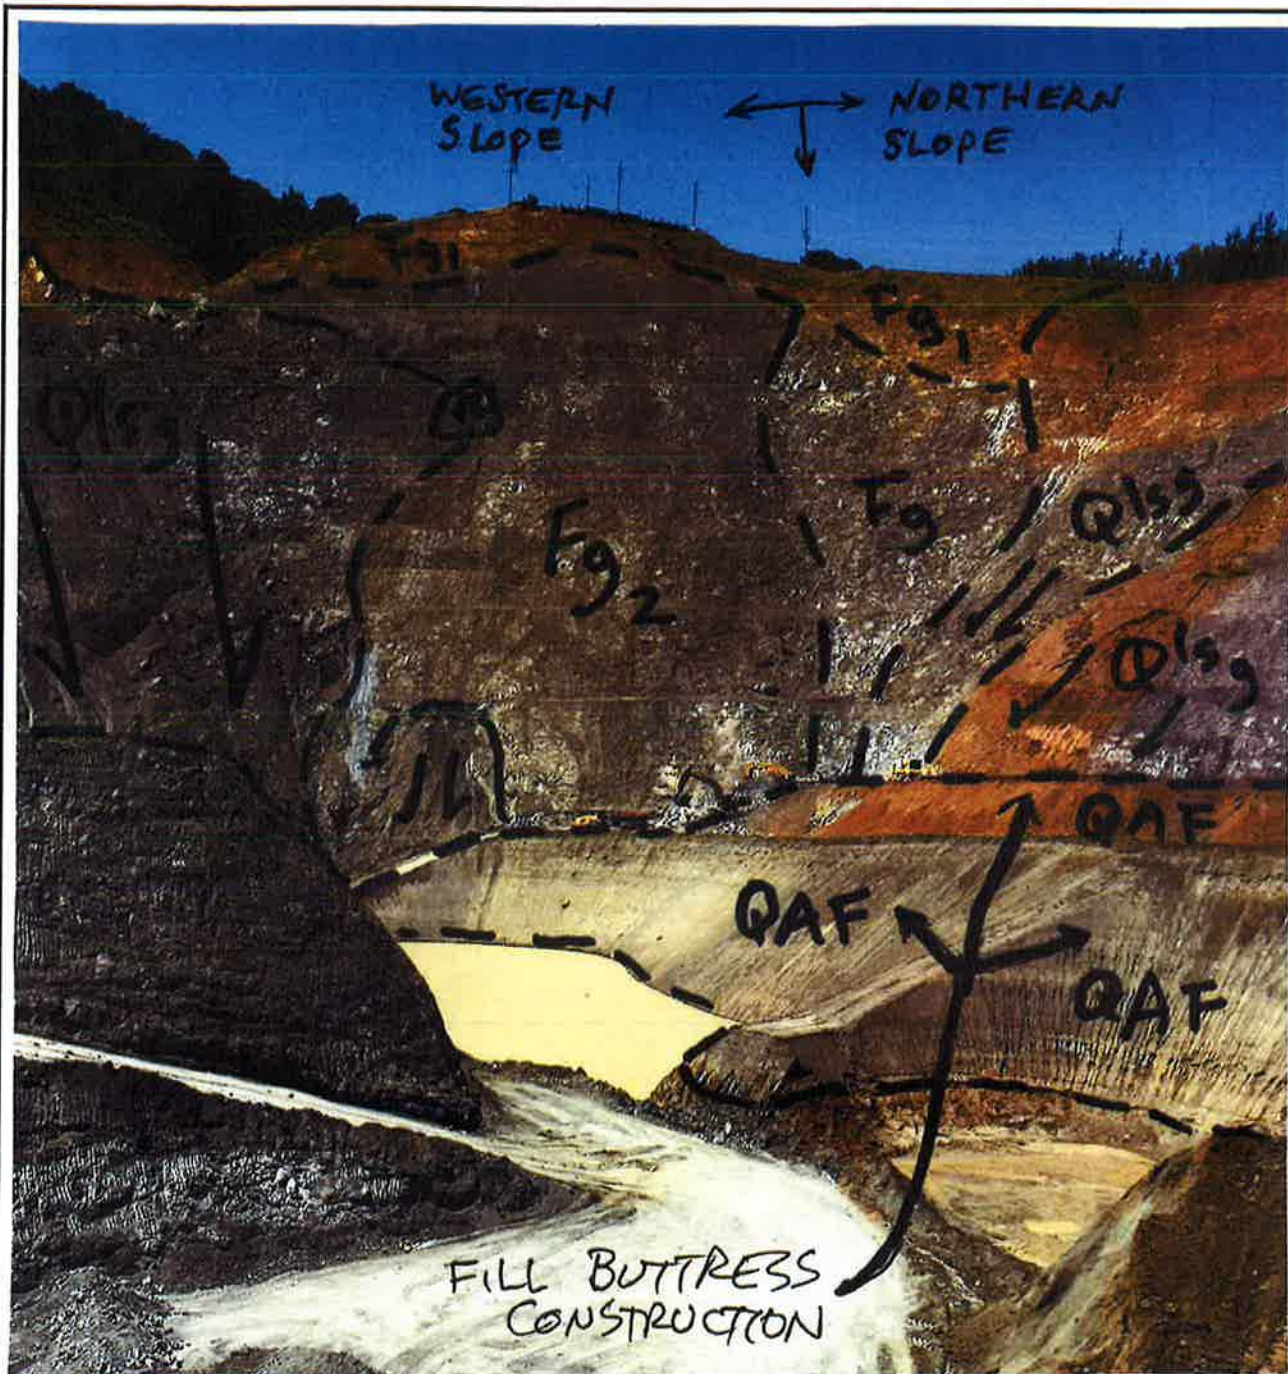
Project Number:	SCQ-1	NORTHWEST CORNER OF NORTHERN SLOPE CUPERTINO, CALIFORNIA	Plate 6
Date:	MAY 76		
Entry By:	SD		
Checked By:			
Date:

QAF: ENGINEERED FILL BUTTRESS

Qlsg: LANDSLIDE IN GREENSTONE

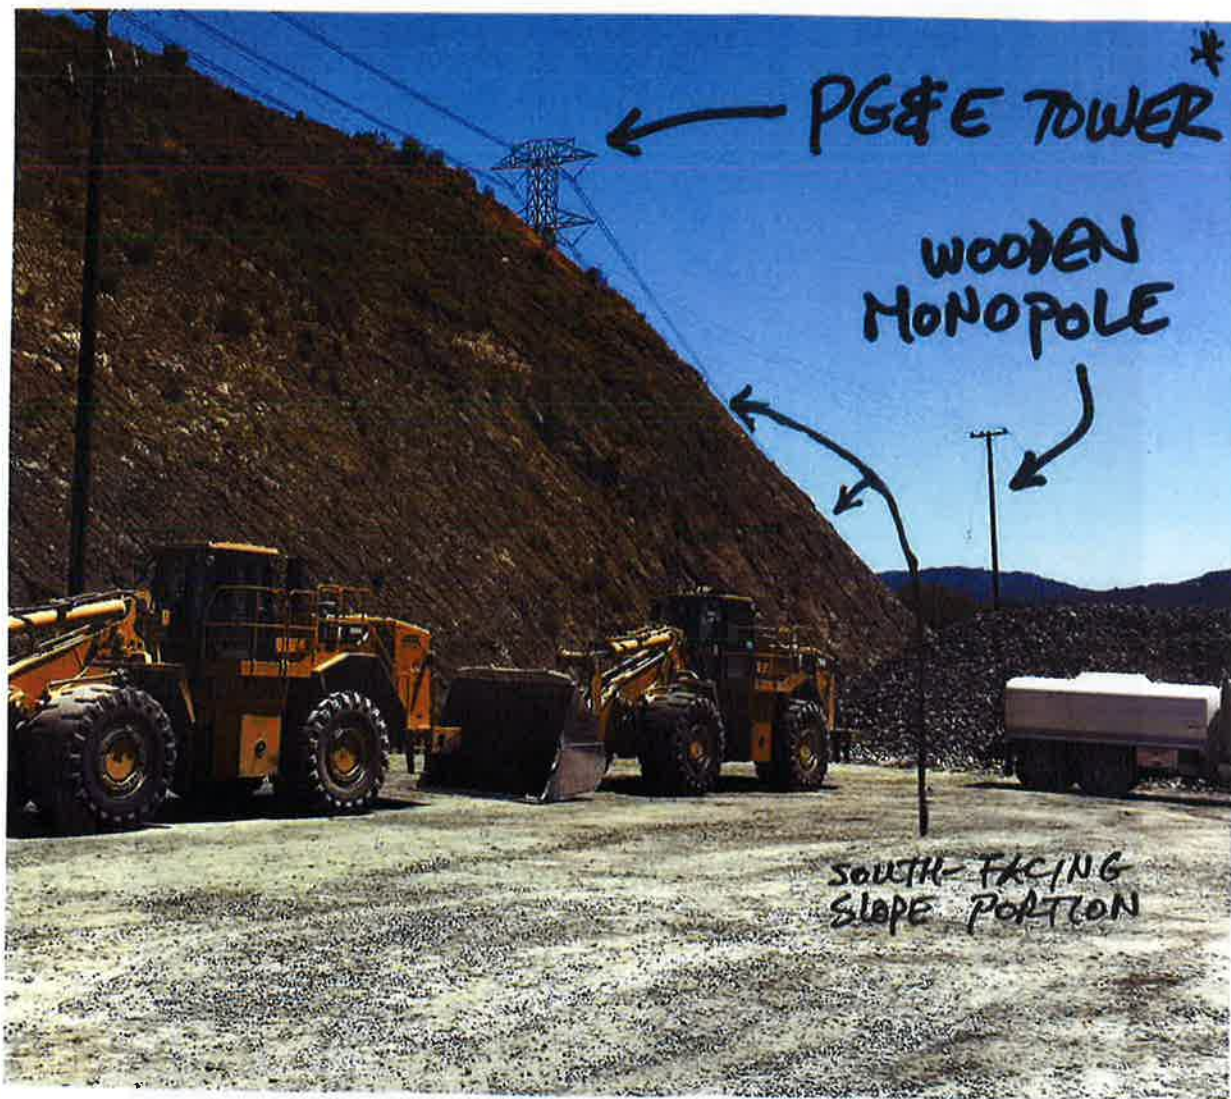
STEVENS CREEK QUARRY	Project Number:	SCQ-1	SOUTHEASTERN CORNER SLOPE CUPERTINO, CALIFORNIA	Plate 8
	Date:	MAY '16		
	Entry By:	SD		
	Checked By:			
	Date:

* THE PG&E STEEL LATTICE TOWER IS SETBACK BEYOND THE TOP OF SLOPE.

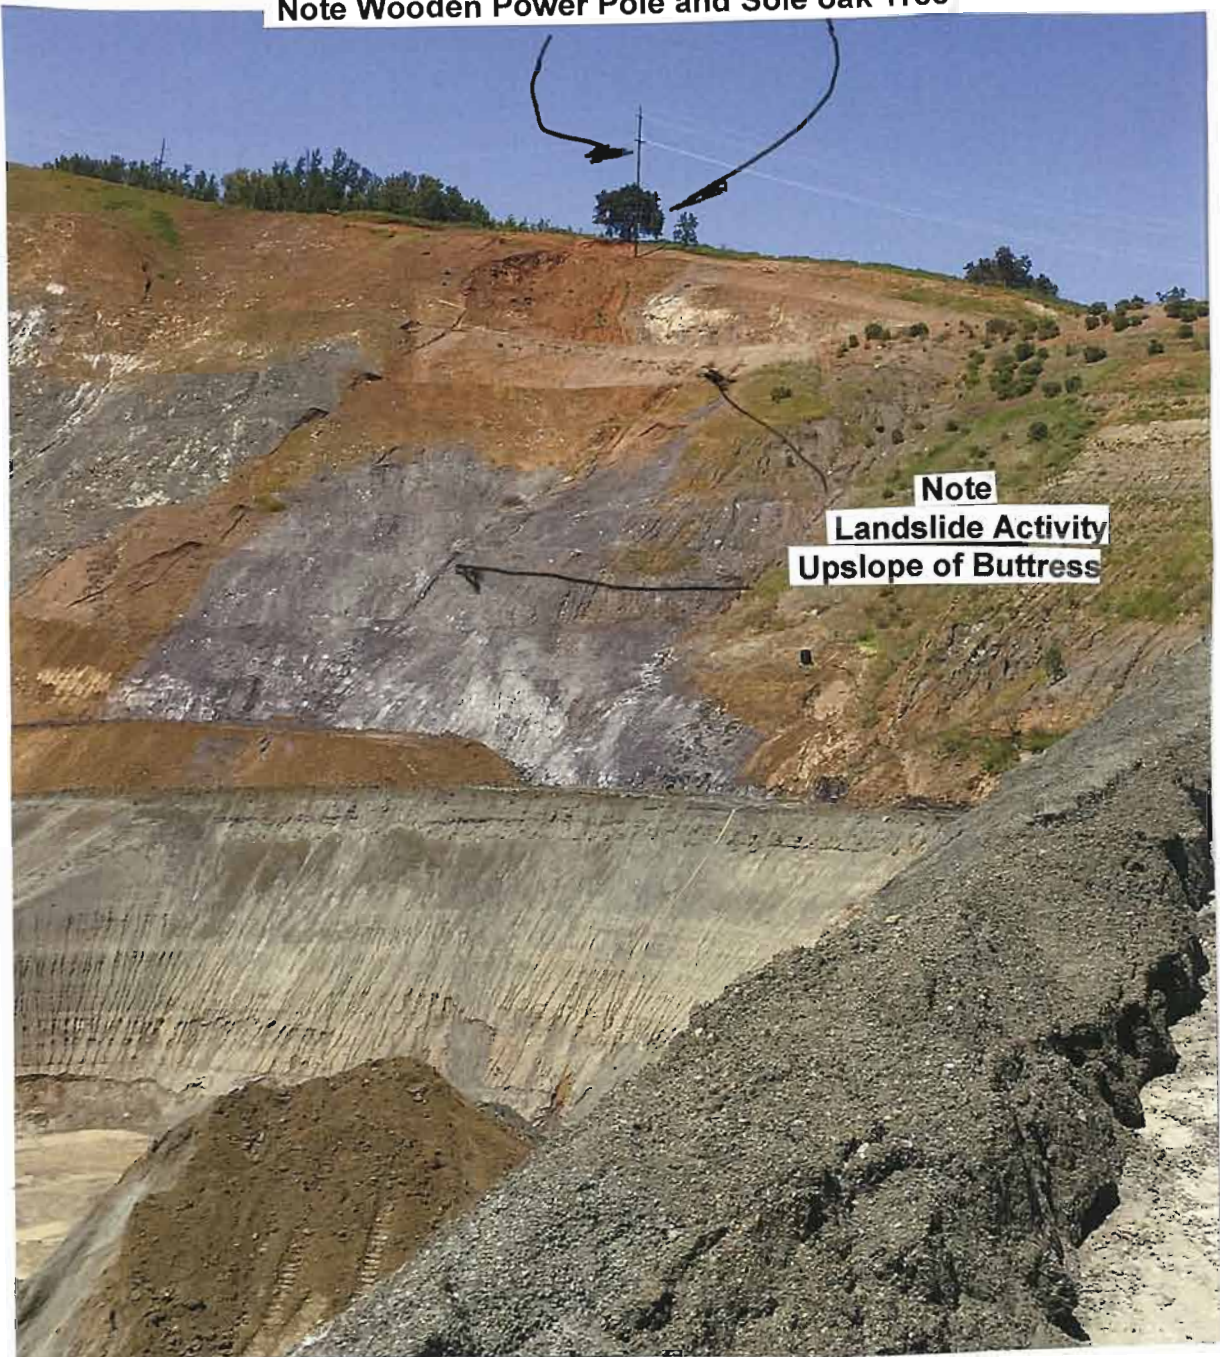
Plate 3

The central portion of the Northern Slope has been experiencing slope movement but the initiation and construction of a compacted fill buttress along the toe of the entire length of the Northern Slope has stabilized the noted movement along the lower part of the slope, which has been buttressed. During the time of our April 2016 site reconnaissance, the fill buttress construction continued as it was benched and keyed heavily to raise the fill prism and widen it. See Site Photographs, Plates 2, 3 and 4.

**Note
Landslide Activity
Upslope of Buttress**

Fill Buttress Construction during April 2016

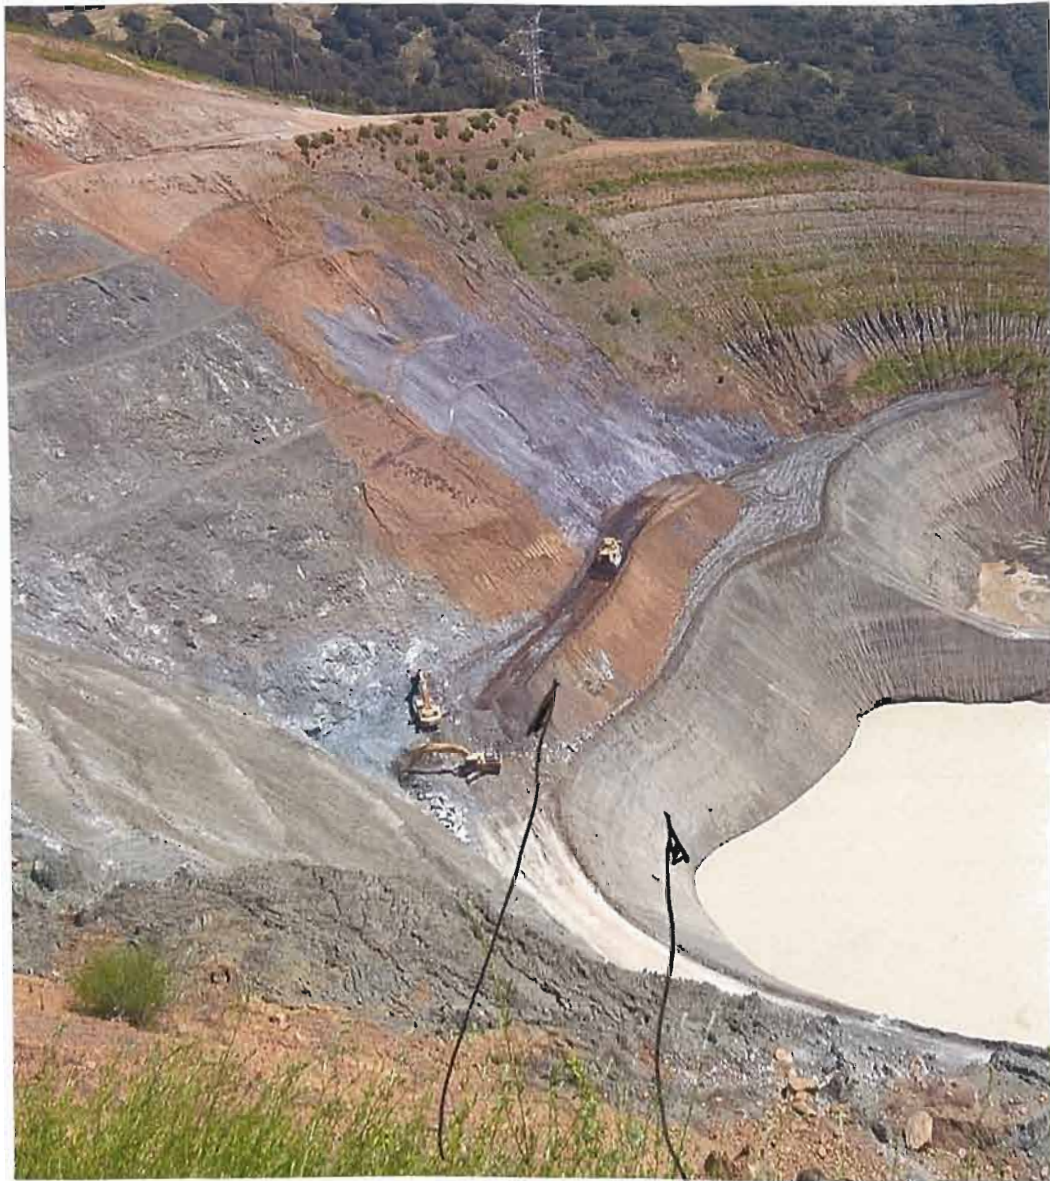
Plate 4

Fill Buttress Construction during April 2016

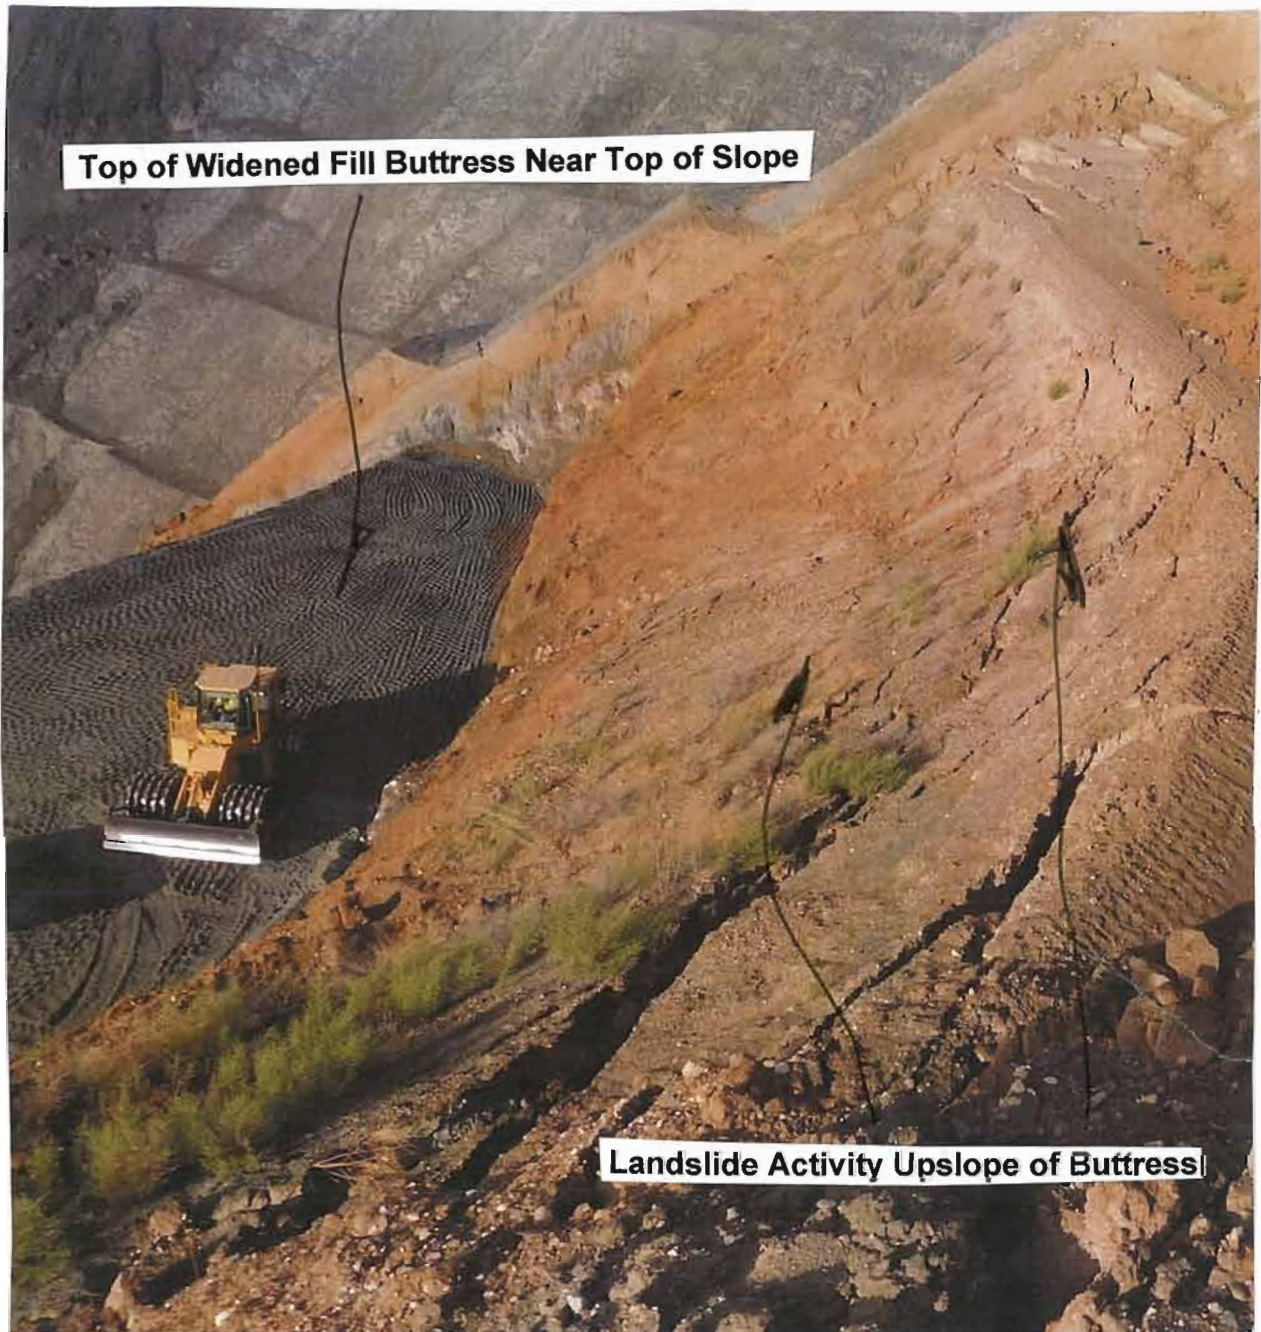
Plate 5

- The Fill Buttress under construction against the entire Northern Slope continued as it approached the top of the slope. The upper portion appeared to be widened as the benching and keying continued upslope. See Site Photographs, Plates 5 and 6.

Fill Buttress Construction during October 2016

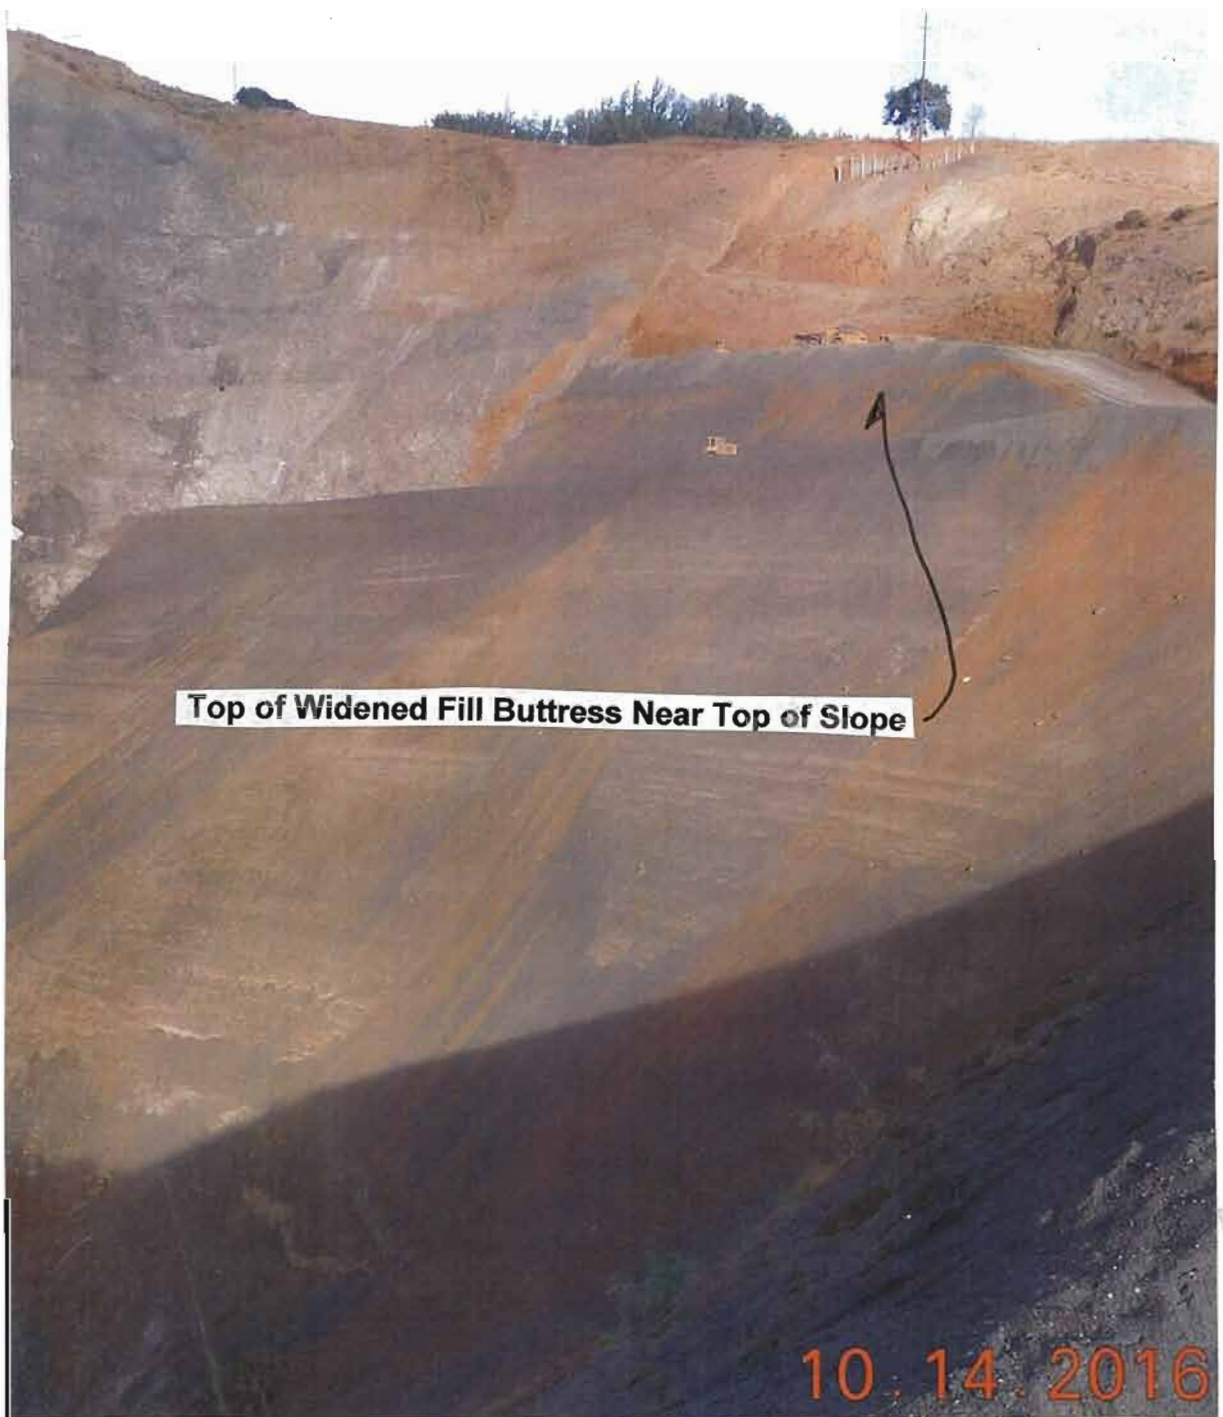
Plate 6

- No signs of slope movement were observed on the completed and compacted buttress slope face and the only signs of active slope movement were noted upslope beyond the buttress. See Site Photographs, Plate 6.

Top of Widened Fill Buttress Near Top of Slope

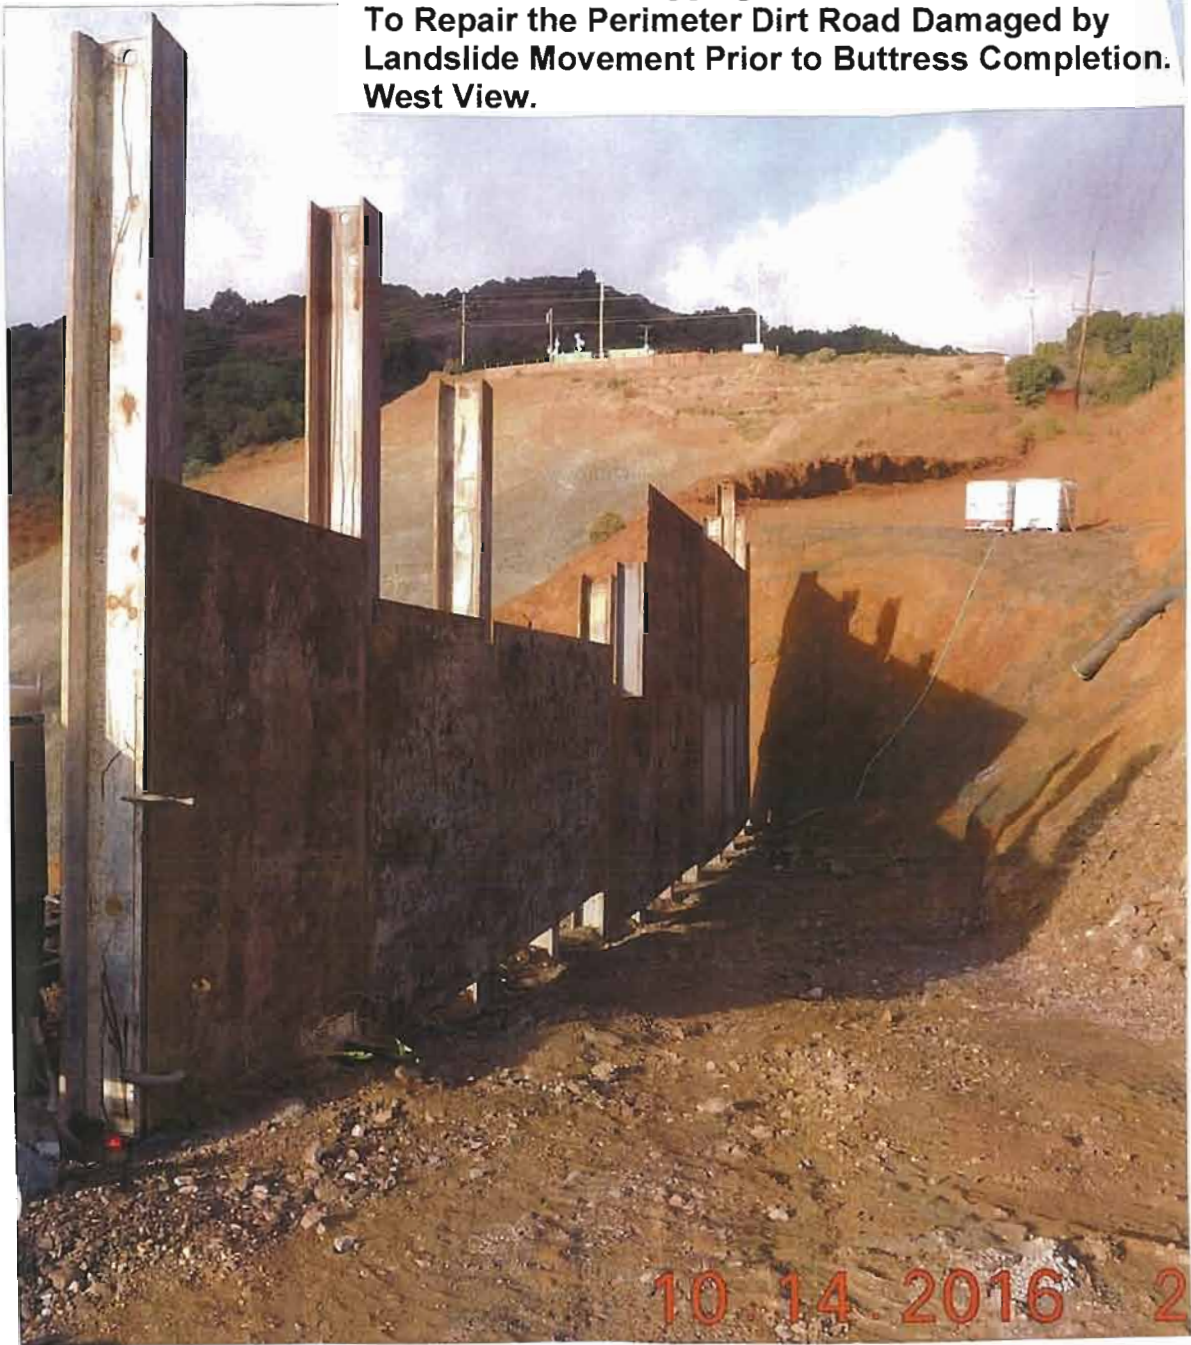
Plate 10

- The upper portion of the landslide along the central section of the Northern Slope has mobilized significantly, encroached onto the perimeter dirt road and damaged it preventing westward access. A soldier pile wall with steel sheet metal welded onto steel I-beams had been constructed along the downslope side of the perimeter dirt roadway so that fill can be placed upslope of the wall to reestablish the road level. Recent soil cracking was observed on the downslope side of the concrete piers supporting the wall. No recent cracks appear to have occurred upslope of the soldier pile retaining wall pier line. Open soil cracks marking the top of the slide had formed before the installation of the wall. See Site Photographs, Plates 10 and 11.

**Soldier Pile and Lagging Wall Constructed
To Repair the Perimeter Dirt Road Damaged by
Landslide Movement Prior to Buttress Completion.
West View.**

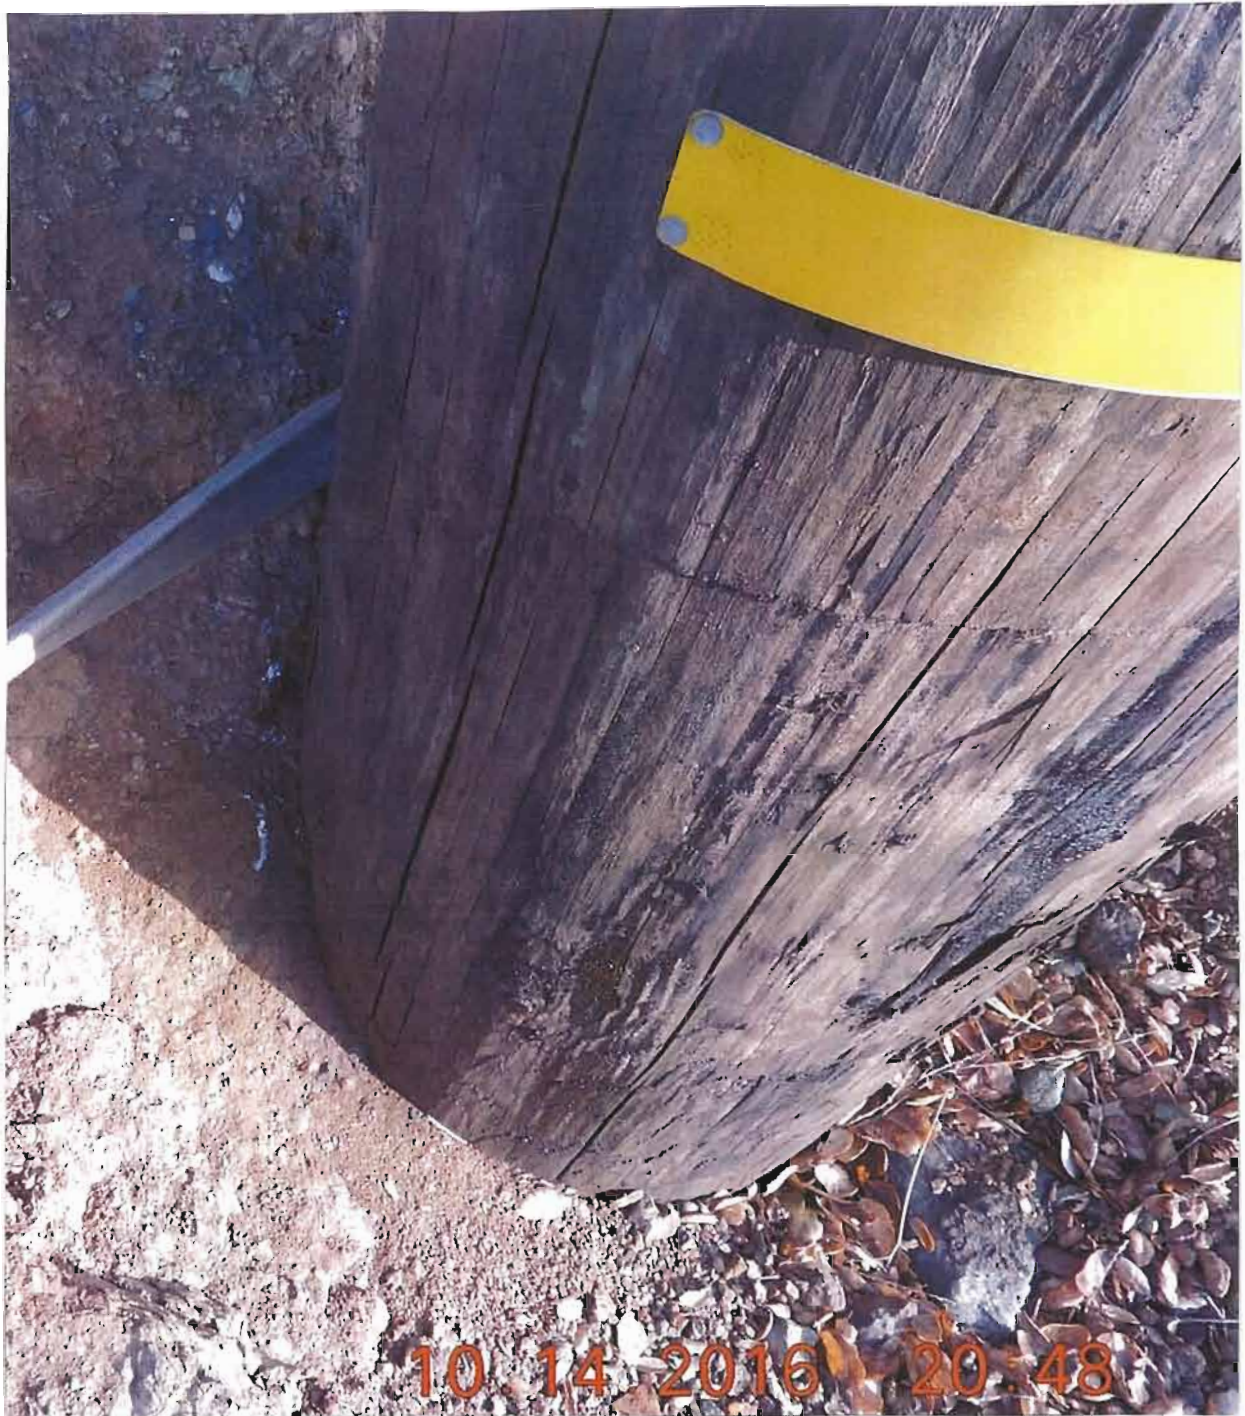
PG&E wooden pole present along the top of the slope on the north side of the access dirt road. See Site Photographs, Plate 12.

No Annular Void around Power Pole
And No significant Tilt

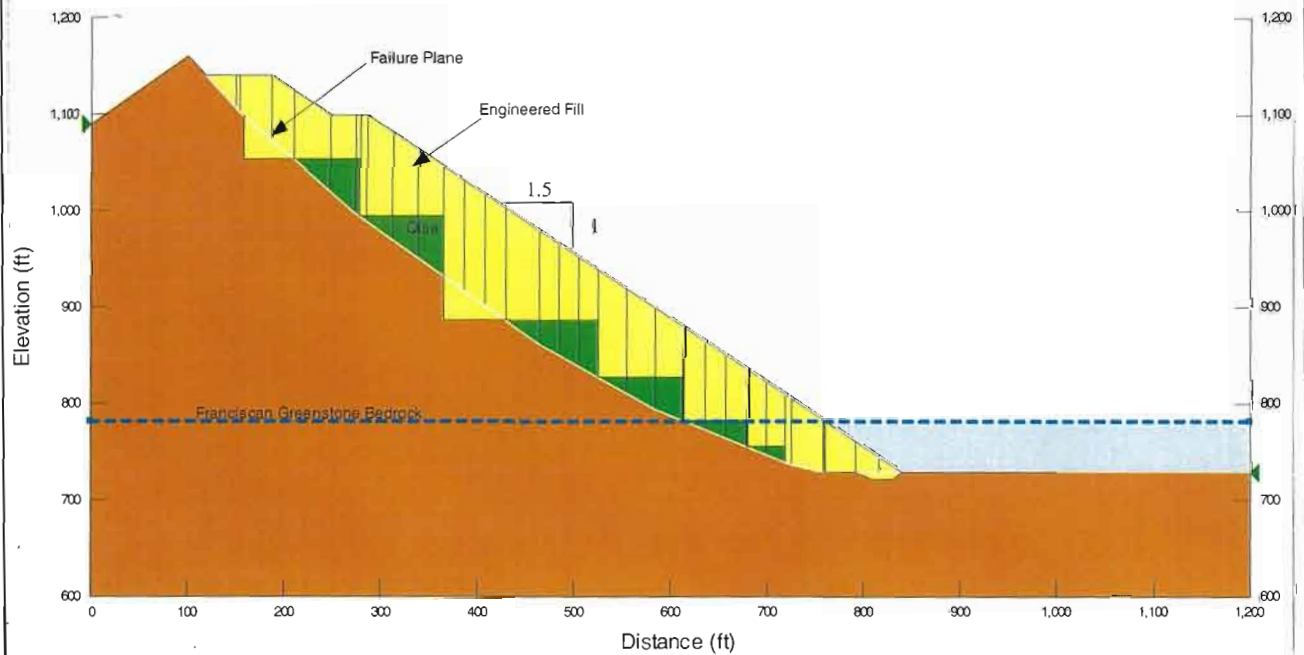
To assess the stability of the temporary 1.5H:1V fill buttress placed against the actively failing mined Northern Slope, we performed our analysis utilizing the slope topographic configuration obtained from the Kespry plan and the field measurements performed by others during construction of the buttress. A groundwater elevation of 781.5 feet was utilized in our slope stability analyses based on the level of groundwater shown on the Kespry plan. The computed FOS for the completed buttress configuration under static conditions was analyzed to be 0.69, indicating the 1.5H: 1V constructed fill slope is not stable under static conditions. The graphic output from SLOPE/W is presented on Plate 14.

0.69

Note: Buttress width and Geometry
Was Not Observed by the CEG

Under Static Conditions

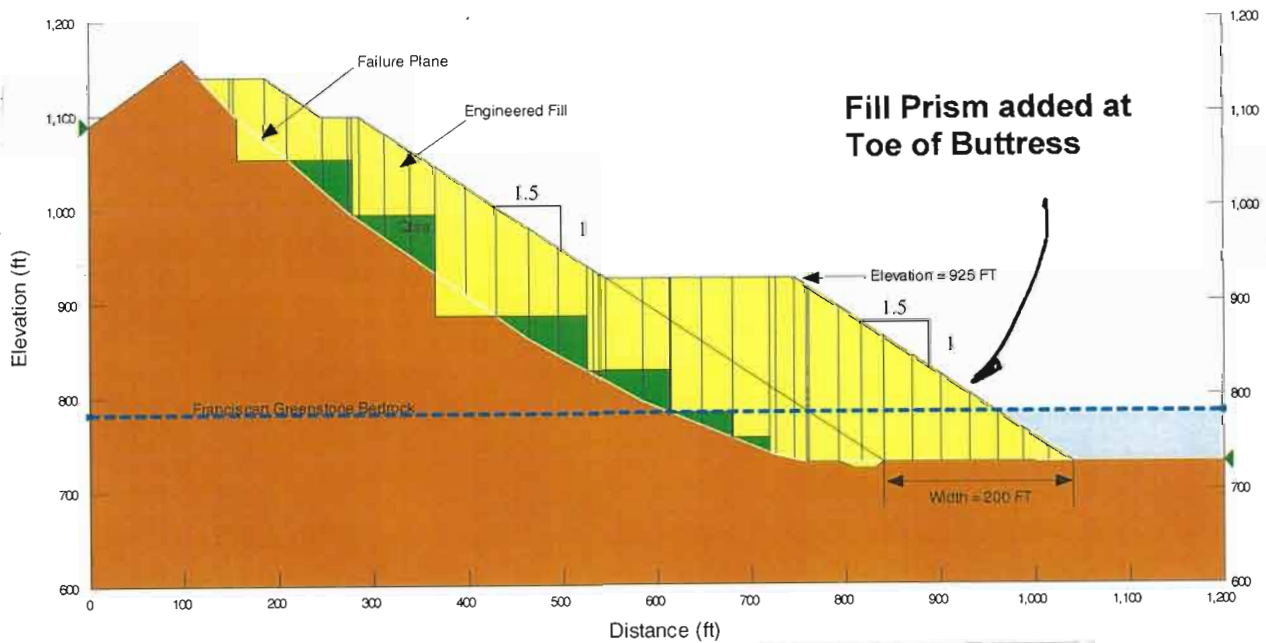
1.30

Note: Buttress width and Geometry
Was Not Observed by the CEG

Under Static Conditions

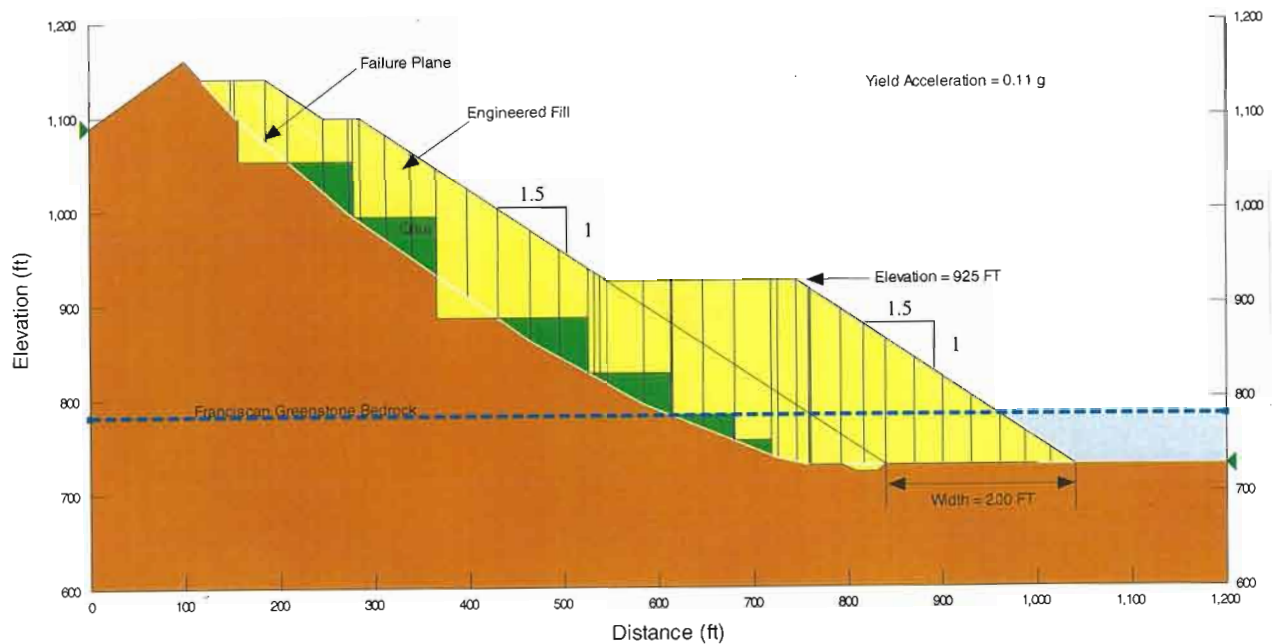
1.01

Note: Buttress width and Geometry
Was Not Observed by the CEG

Yield Acceleration
