PERMANENTE CREEK LONG-TERM RESTORATION PLAN

Prepared for
Lehigh Southwest Cement Company
24001 Stevens Creek Boulevard
Cupertino, CA 95014

March 11, 2011

URS Corporation
1333 Broadway, Suite 800
Oakland, CA 94612
510-893-3600
26817215.20000

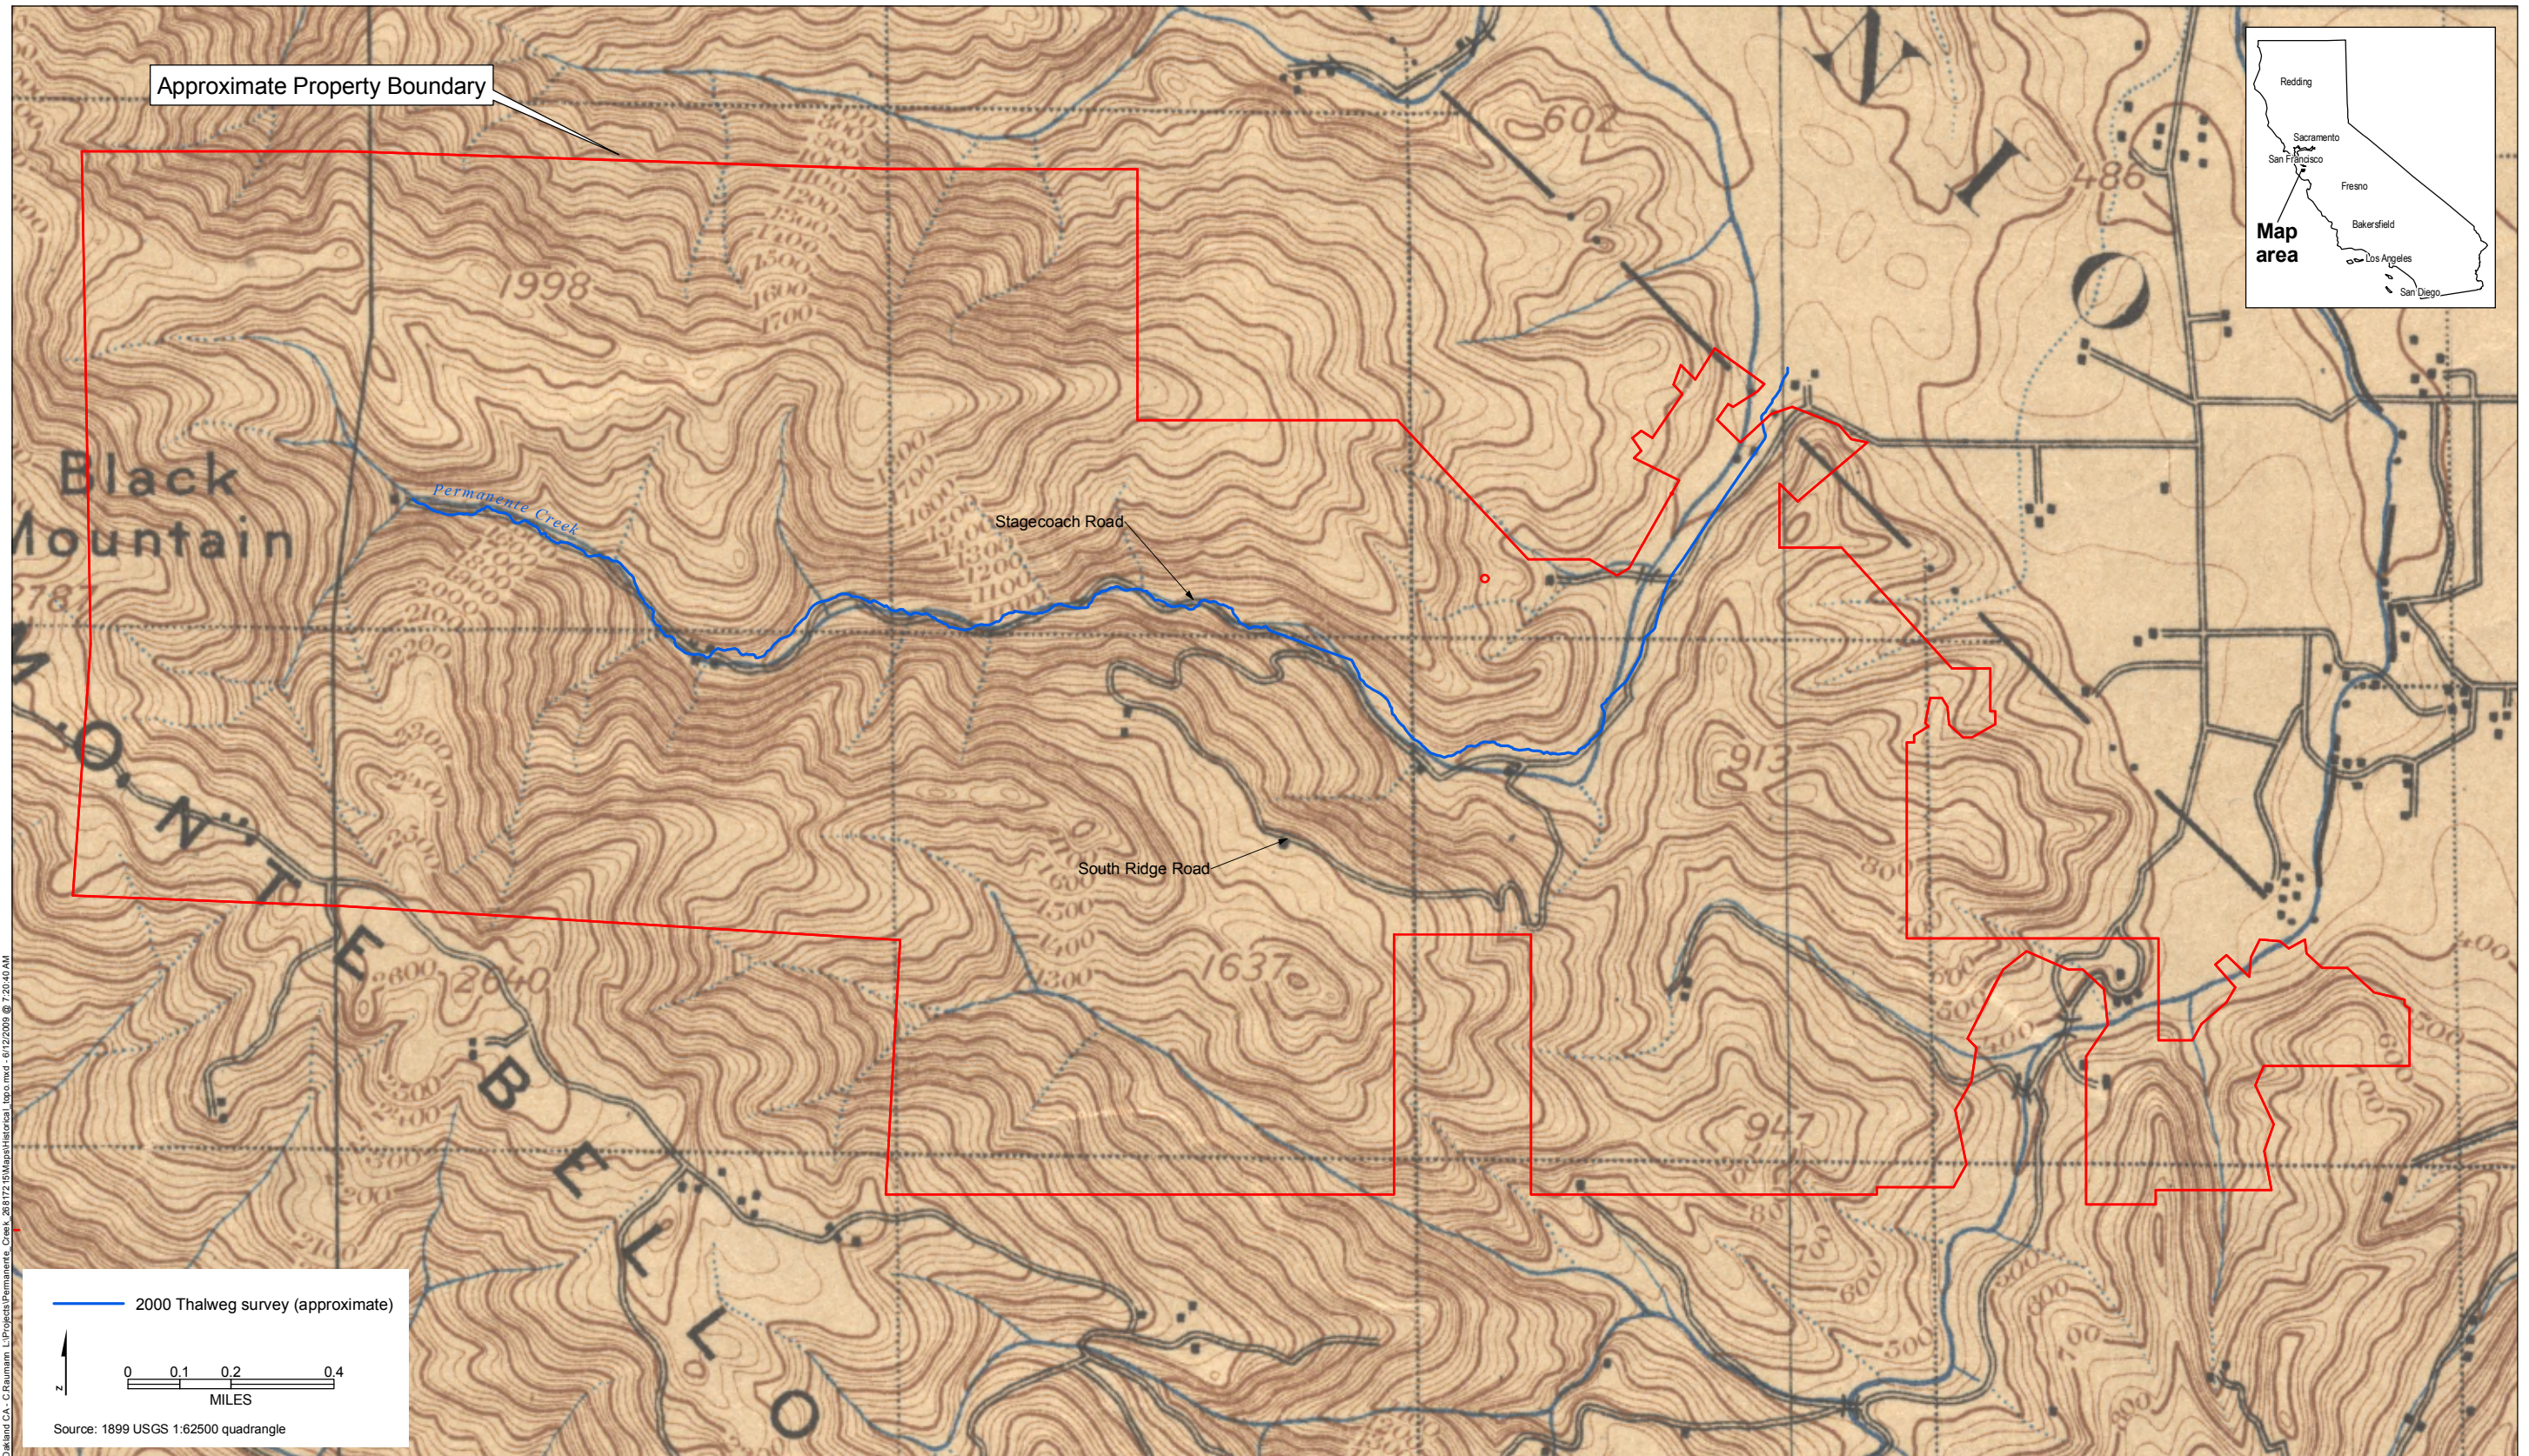
The 1899 Palo Alto United States Geological Survey (USGS) 15-minute topographic quadrangle (see Figure 2-3) provides the earliest topographic record of the area before the Quarry operations had a profound effect on the stream. In an effort to draw a comparison between the 1899 and 2000 plan view, the 1899 map was geo-rectified using three identifiable landscape features. While the maps did not overlay exactly, a relative comparison can be drawn between the stream alignments in 1899 and 2000. The overlay was used to compare the stream's position in the valley along the current railroad track alignment and near the full culvert. Both locations suggest that in 1899 the creek channel may have been positioned more to the center of the valley rather than against one side of the valley as the stream is currently.

The earliest maps are not of a sufficient scale to indicate signs of meandering planform geometry in the lower reaches of the Creek before they were affected by land use practices. The 1899 Palo Alto USGS 15-minute topographic quadrangle (Figure 2-3) indicates that the Creek was located in the middle of the valley where the railroad tracks currently reside and that it was located on the northern side of the valley where the rock pile is currently located. The reference reach search found a B-type reference stream for the upper reaches of the project area, however no streams were identified in the vicinity with an unaltered C-type channel in a low gradient wide bottomed valley such as occurs along the railroad tracks.

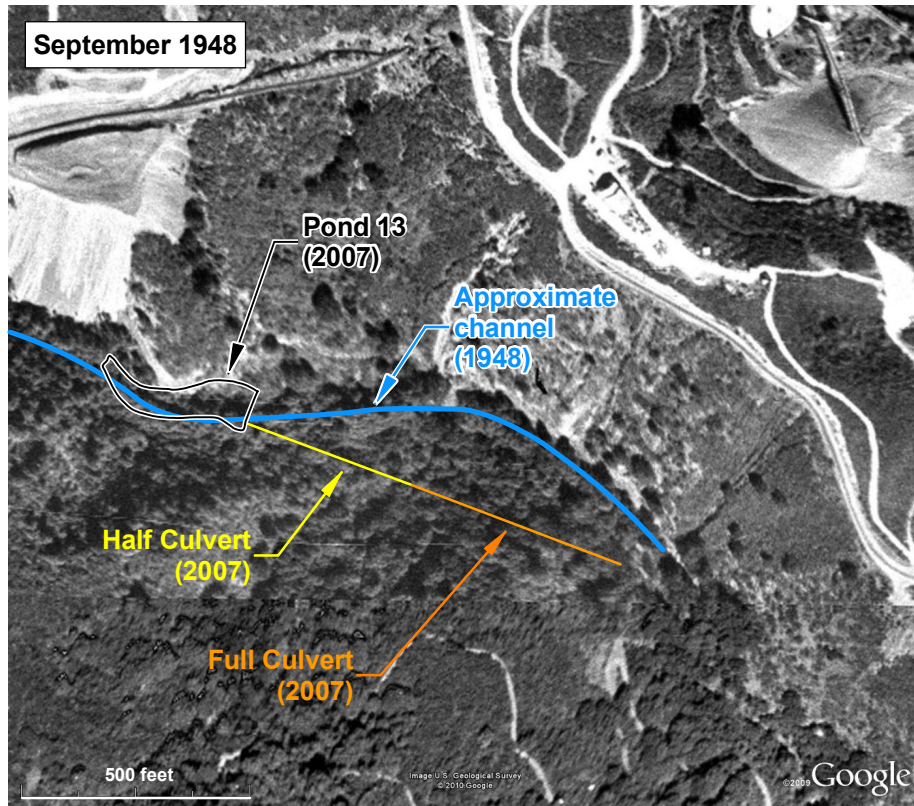
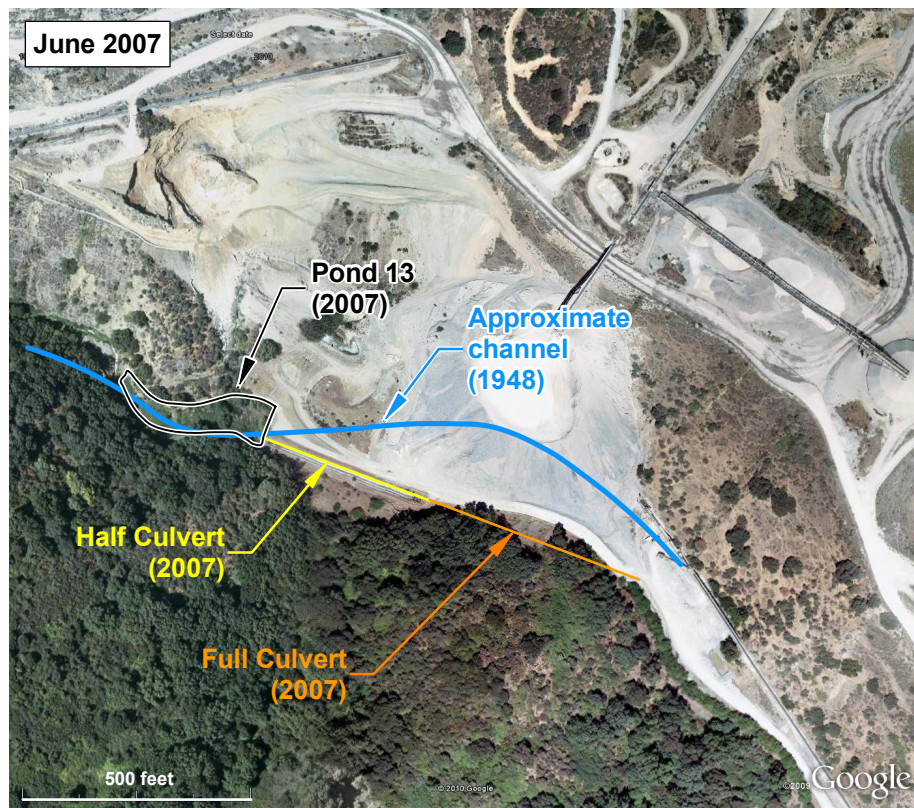
A 1948 historical aerial photo comparison in Figure 2-4 confirms the shift in the channel alignment at the location of the full and half culvert (75+00 – 84+00). A similar shift in the channel alignment was observed in Reaches 17 – 19 (131+00 – 140+00) where debris slides and overburden material placed in and adjacent to the stream has pushed the stream to the south side of the valley likely at a higher elevation. No pre-development aerial imagery is available for the lower reaches of the Creek because by the time of the 1948 photo, the creek had already been realigned to accommodate the rail lines.

The configuration of this reach prior to the installation of the culverts is not known. Based on the historic topographic map (Figure 2-3) and aerial imagery (Figure 2-4), it is likely that this reach always had a high gradient and may have been a natural fish passage barrier.

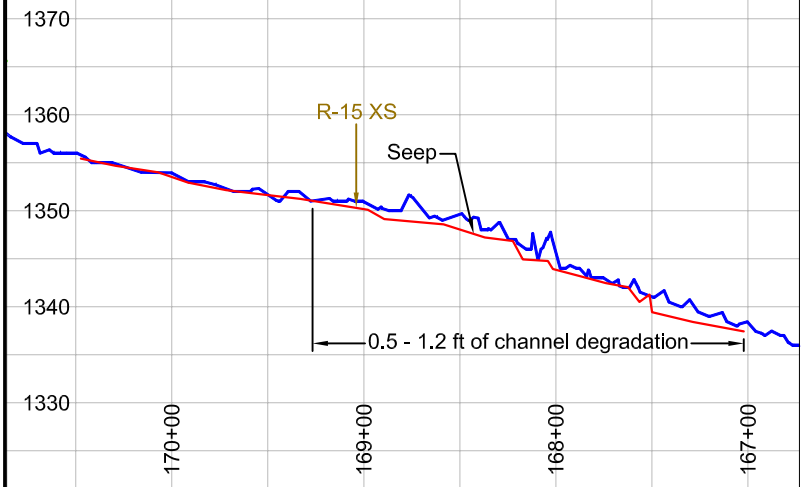
2000/2009 Longitudinal Survey Comparison (Station 167+12 - 170+52)
 Horizontal Scale: 1" = 100'
 Vertical Scale: 1" = 20'

Figure 2-5 presents a comparative longitudinal profile of the stream thalweg showing 2000 and 2009 surveys. Predominantly, the resurveyed reaches experienced thalweg degradation of approximately 0.5 foot. In the reach from Stations 135+50 to 138+40, the 5 feet of degradation cited in the table occurs in two localized areas near Stations 135+63 and 136+00; the degradation does not occur over a long distance. The 4.5 feet (Stations 186+79 to 187+31) of degradation through Q_s 1 deposits can be seen in Figure 2-6. Based on the profile and field observations, it appears that the material eroded from this area has deposited in the reach from Station 185+15 to 185+92.

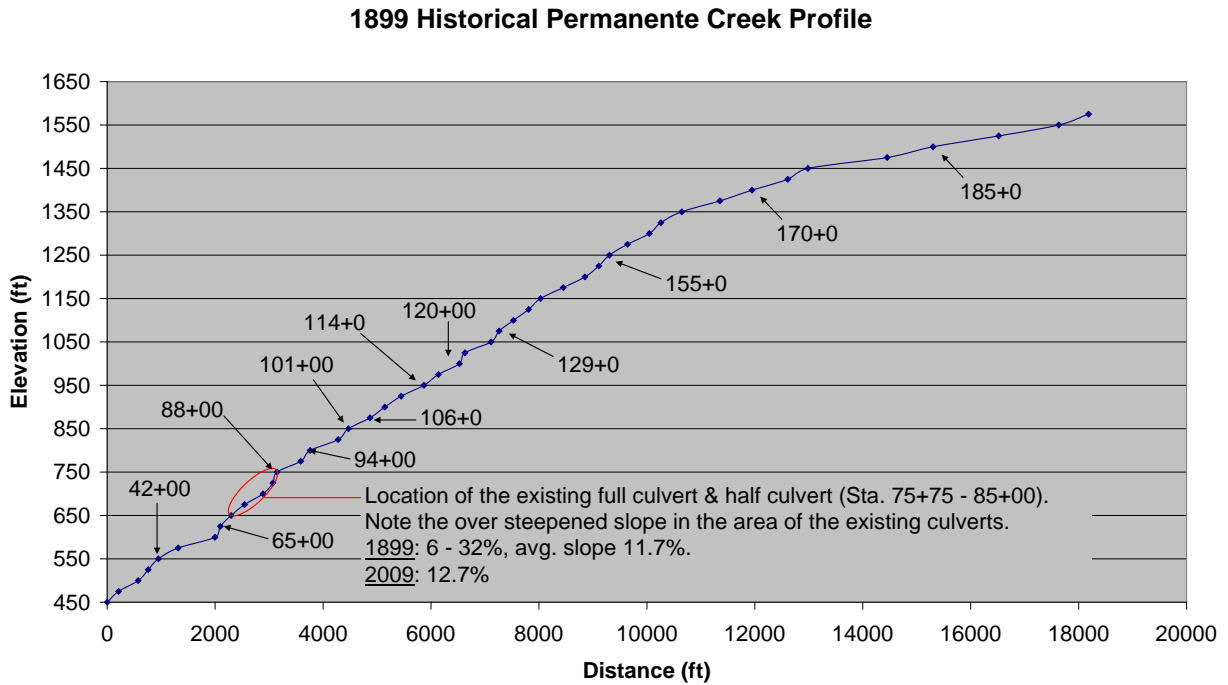
Figure 2-7 Historical Permanente Creek profile

The stream profile through reaches 11 and 12 (the full and half culvert between stations 75+75 to 85+00) is straight and steep at 12.7 percent. The creek profile was recreated from the 1899 topographic map to determine if the profile through the culverted area has always been steep or was steepened by the Quarry operations. The 1899 profile indicates that the profile ranged from 6 to 32 percent between reaches 11 and 12, with an average slope of 11.7 percent (Figure 2-6). Given that the stream length was longer at that time and had not been straightened or culverted, the results indicate the likely presence of bedrock in the streambed that created a series of step pools, chutes, or falls.

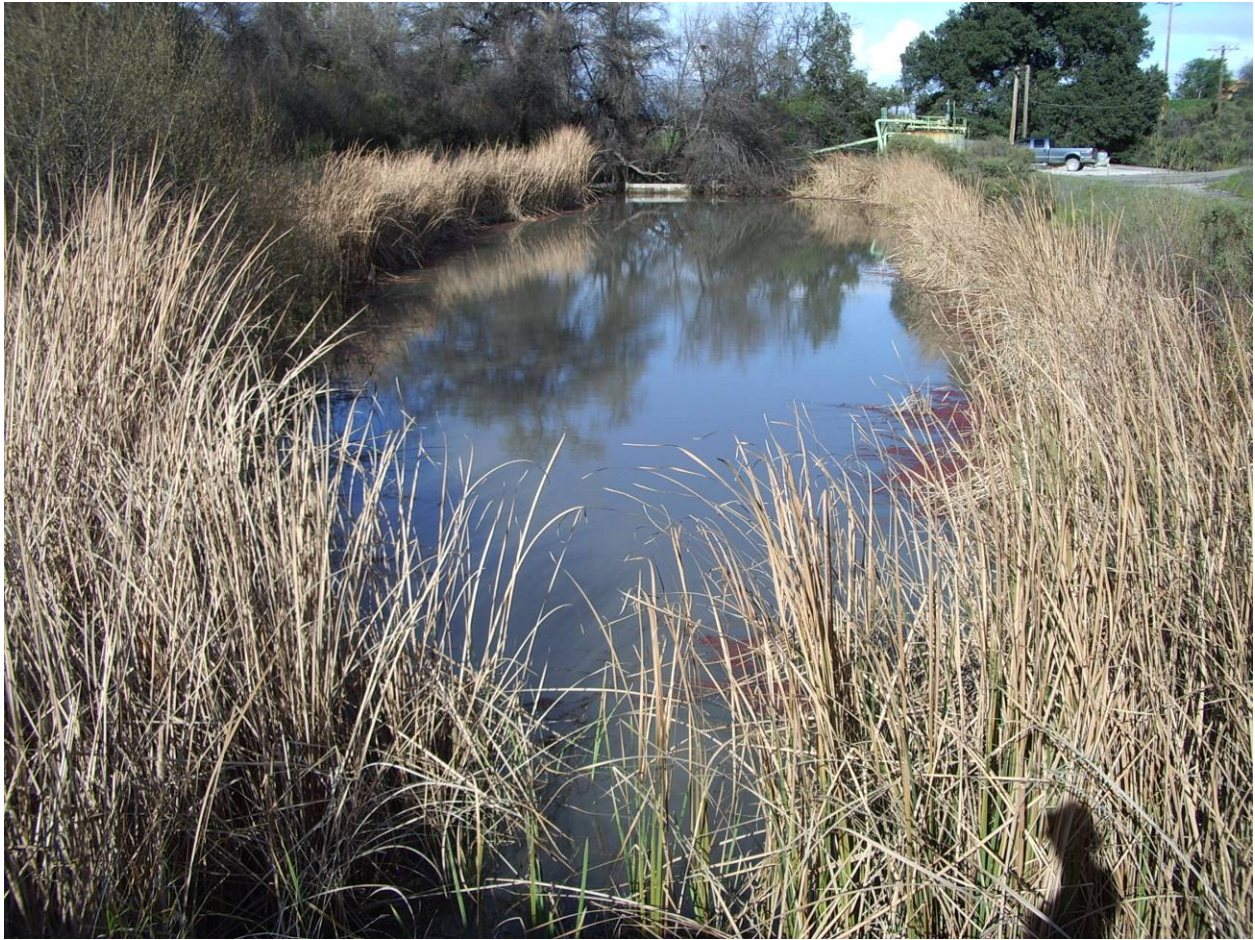
Figure 2-13 Looking downstream along Pond 14

This pond (see Figure 2-13) can be an offline pond or an online pond depending on how the overflow weir on Pond 22 is adjusted. During high flows, both Pond 14 and its bypass channel receive flow.

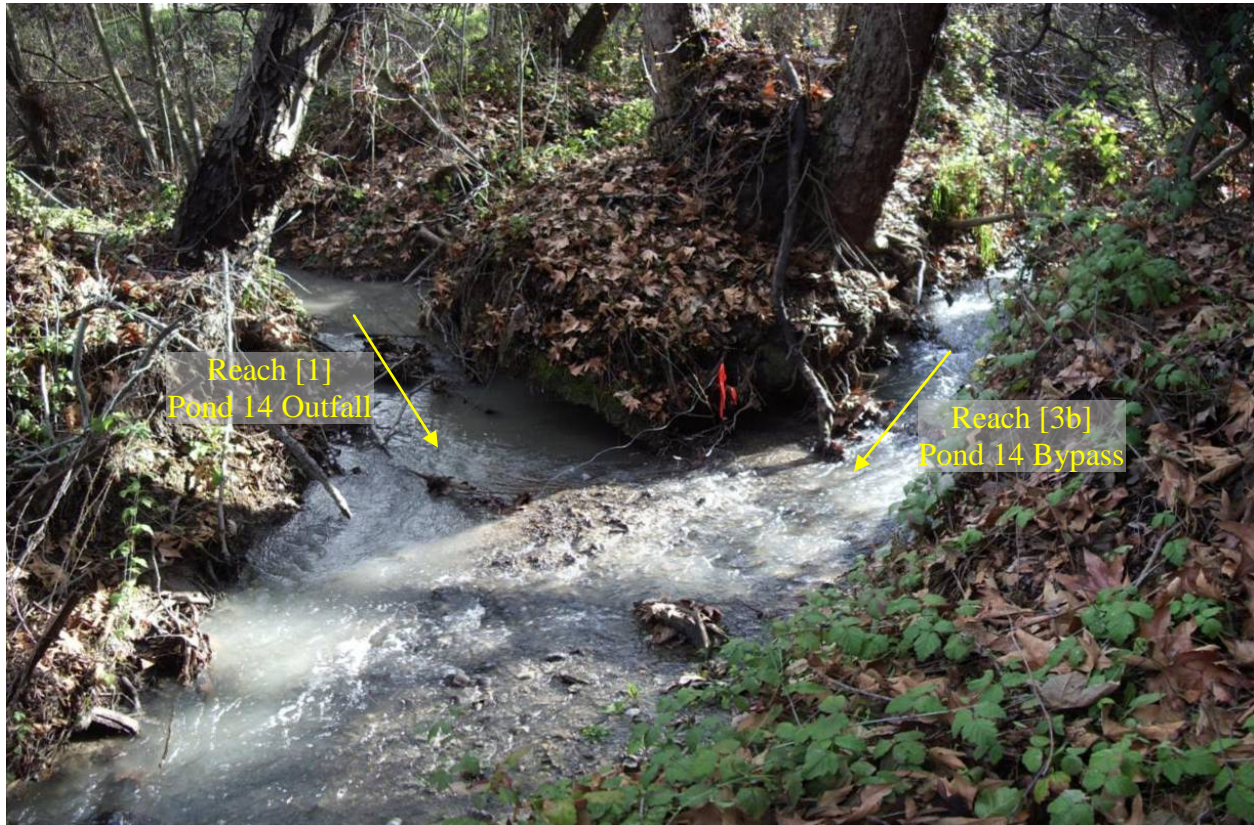
Figure 2-14 Looking upstream at the confluence of Reaches [1] and [3b]

This reach has been confined to a narrow space between the hillside to the north and Pond 14 to the south. The channel is separated from Pond 14 by a narrow earthen berm. The channel is deep and straight with steep to vertical banks (see Figure 2-14).

Length (ft)	Classification	Pfankuch Rating
300	G4	Good

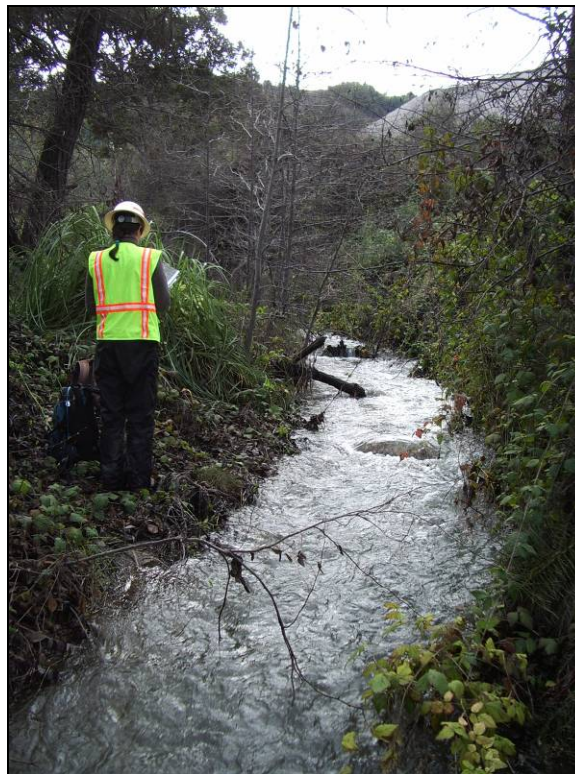
Figure 2-16 View of Reach [7] near Station 37+50

Due to its location at the Facility, directly adjacent to operations, this reach is channelized and does not have access to its original floodplain. This reach includes two culverted road crossings. However, the bed has stabilized in this position and the banks are stable and vegetated (see Figure 2-16). A short portion of this reach near the road crossing has widened and built a small, vegetated floodplain within the old channel.

Length (ft)	Classification	Pfankuch Rating
500	A4	Good

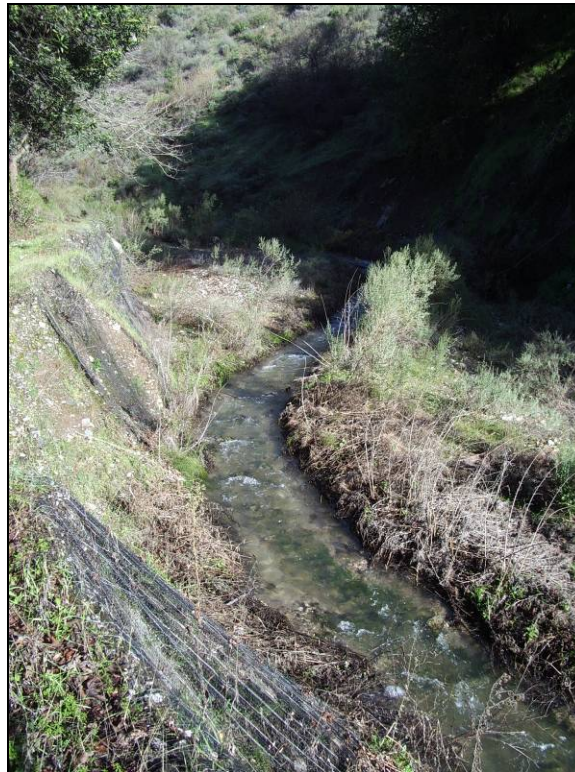
Figure 2-20 Looking upstream of Pond 13 near Station 90+00

These reaches are characterized by the full culvert, the half culvert, Pond 13, and the channel immediately upstream (a portion of which was once a part of Pond 13 prior to channel sedimentation). No geomorphic assessment was performed in this reach due to its manipulated nature. However, it should be noted that the Creek upstream of Pond 13 had been experienced a headcut initiated by excavation of the pond during sediment clearing (URS 2000), has built a stable, meandering channel with a floodplain (see Figure 2-20). Excavated side slopes along the access road (former stagecoach road) on the southern side of the creek remain steep and mostly unvegetated, but the Creek appears to be mostly unaffected by these side slopes. The relatively short slope (less than 15 feet long) and rocky soil contribute little sediment to the creek, **thus are no longer a significant sediment source to the creek.** The rock pile extends over the full culvert and lies adjacent to the half culvert.

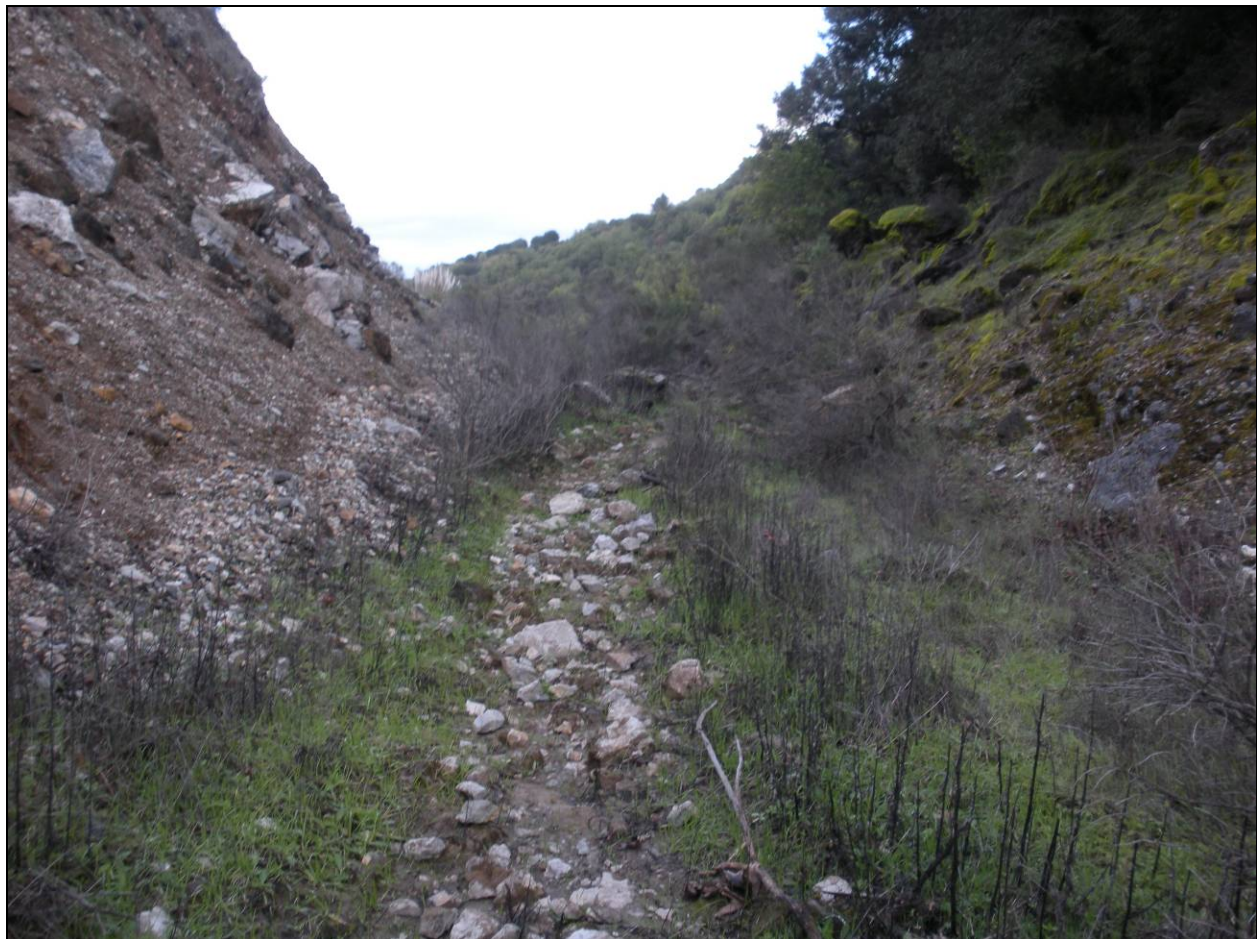
Figure 2-23 Looking downstream through Reach [18] near Station 135+00

This reach is characterized by the overburden slope, which has narrowed the valley sufficiently to straighten the channel (see Figure 2-23). The valley fill acts as a sediment plug and grade control for upstream areas. The channel has low, vegetated bankfull benches on both sides. The overburden slope is unvegetated and a potential sediment source for the Creek. Portions of the slope near station 135+00 consist of small gravel mixed with a smaller fraction of fine sediment that sloughs down towards the creek or is mobilized when rainfall is intense enough to generate surface flow (Figure 2-23). The coarse bed material is embedded with finer materials from upstream. The old debris slides at Stations 135+00 (Q_s6) and 138+00 (Q_s5) are no longer significant sources of sediment because runoff from the Quarry operation no longer drains to the gullies or the slope. Vegetation has also become established in the gully and on the banks at Q_s5, helping stabilize remaining overburden material.

Length (ft)	Classification	Pfankuch Rating
400	B4c	Fair

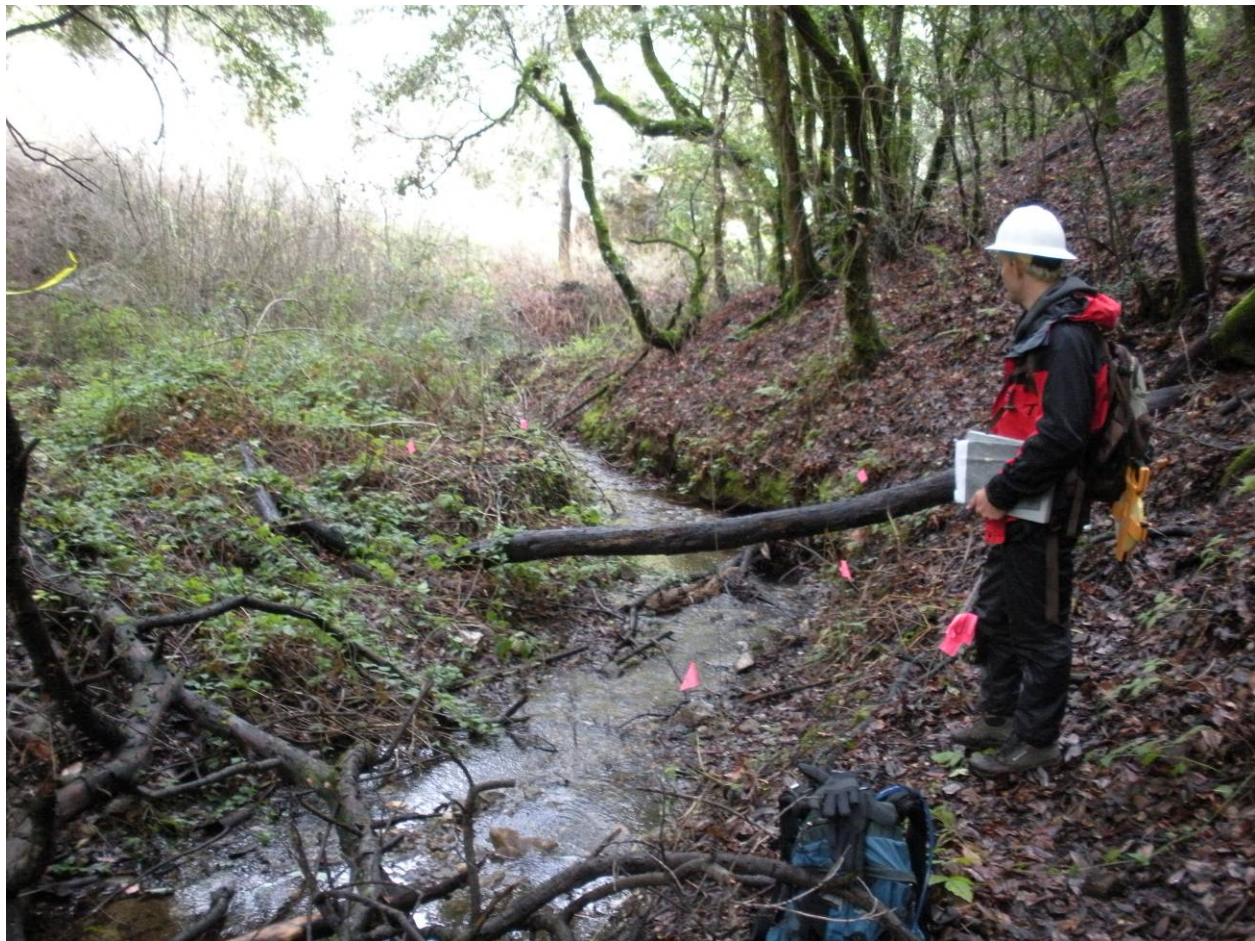
Figure 2-26 View near Station 169+00 on Reach [20]

This reach is building bankfull benches within its floodplain. The reach appears to have been previously affected by sediment from upstream debris slides, and terraces of this material as well as an old stagecoach road. The channel is stabilizing (see Figure 2-26). A gully that starts below the upper portion of the Kaiser house road drains to a sediment basin at the base of the Kaiser house road. This gully was eroded by runoff diverted from the upper Quarry Road, however, it no longer conveys sediment or runoff from the Facility to the creek. The sediment basin was lined with grass and contained no sediment or water after a 2-year storm event. The pond discharges to the inside of the road near a turnaround where any flow would spread over the turnaround and filter through the floodplain before entering the creek. This gully was not identified in 2000.

Length (ft)	Classification	Pfankuch Rating
1,400	A4	Fair

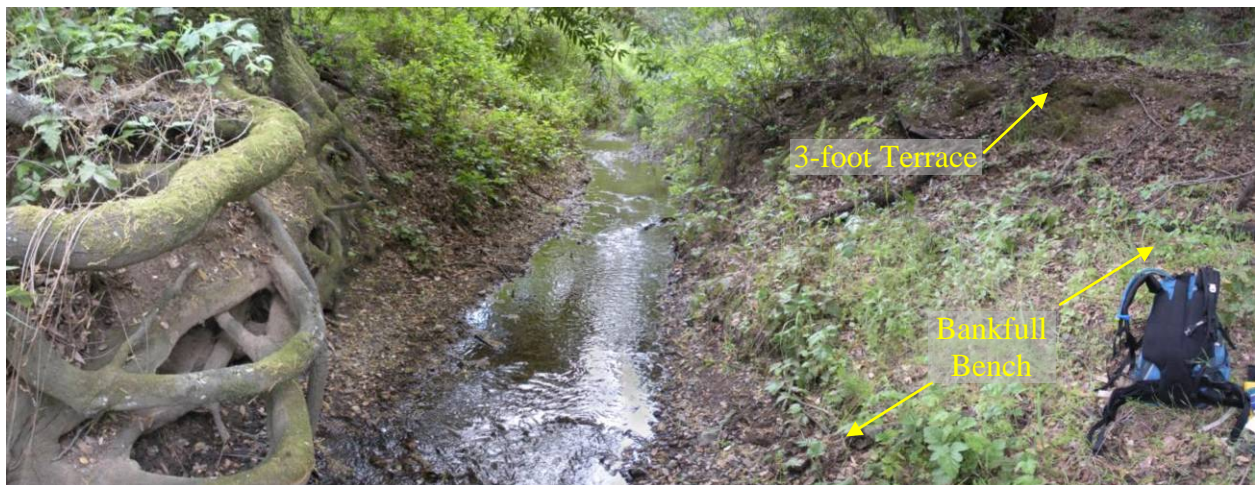
Figure 3-1 Looking upstream along West Fork Permanente Creek

During the observations, West Fork Permanente Creek appeared to be intermittent because it contained flow throughout the observed reach, yet no precipitation had occurred in the 2 weeks prior to the assessment. In comparison to Permanente Creek, West Fork Permanente Creek does not exhibit the calcium carbonate conglomerate, the gravel substrate is a much smaller size, it has a lower gradient and wider valley, and it has an abandoned floodplain terrace approximately 3 feet above bankfull (see Figure 3-1). The reach exhibited small and partially formed bankfull benches within the channel. Due to the variation from the nature of Permanente Creek, this reach is not recommended for use as a reference.

Length (ft)	Classification	Pfankuch Rating
N/A	G4	Good

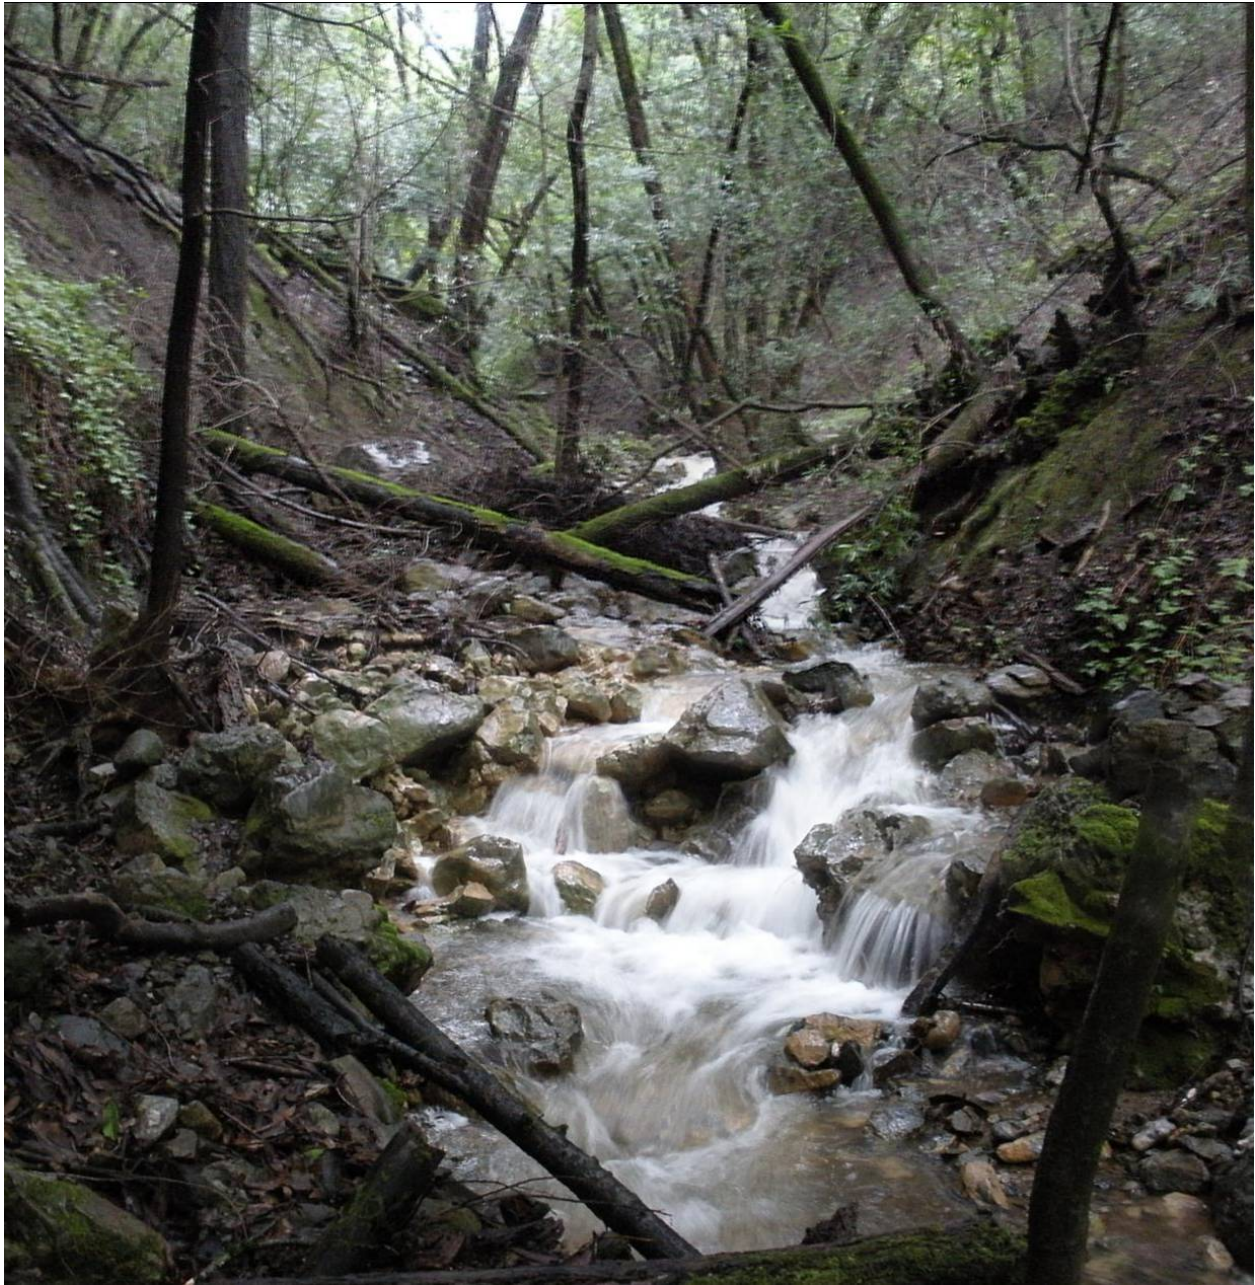
Figure 3-2 Looking upstream along Swiss Creek above Peacock Court

Swiss Creek was observed approximately 500 feet above the Peacock Court crossing because the channel was downcut at the crossing. In comparison to Permanente Creek, Swiss Creek also exhibited the calcium carbonate conglomerate, the channel was also shaped by debris flows and landslides from natural hillside processes, and the valley was similarly narrow and steep, but the sediment composition is somewhat coarser than that of Permanente Creek (see Figure 3-2). Due to the landslides and debris flows, this location of Swiss Creek is not in reference condition. However, it does demonstrate that landslides are characteristic of the area.

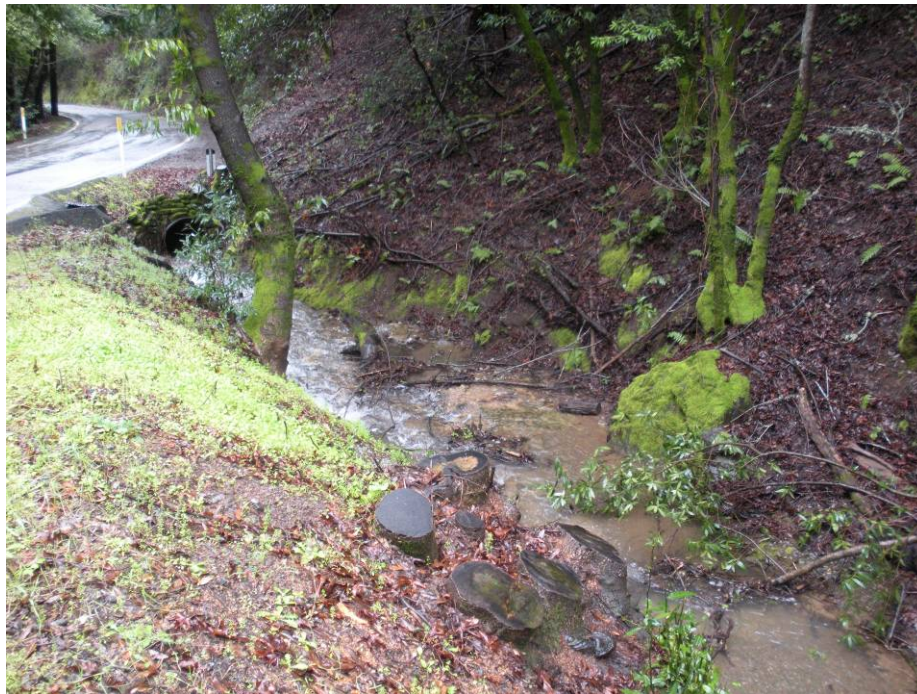
Figure 3-3 Looking downstream along Swiss Creek near Stevens Creek Road

Swiss Creek was also observed above and along Stevens Creek Road where the channel was found to be incised, have eroded banks and low bank vegetation, and be impacted by the close proximity of the road (see Figure 3-3).

Neither observed reach is recommended for use as a reference reach.

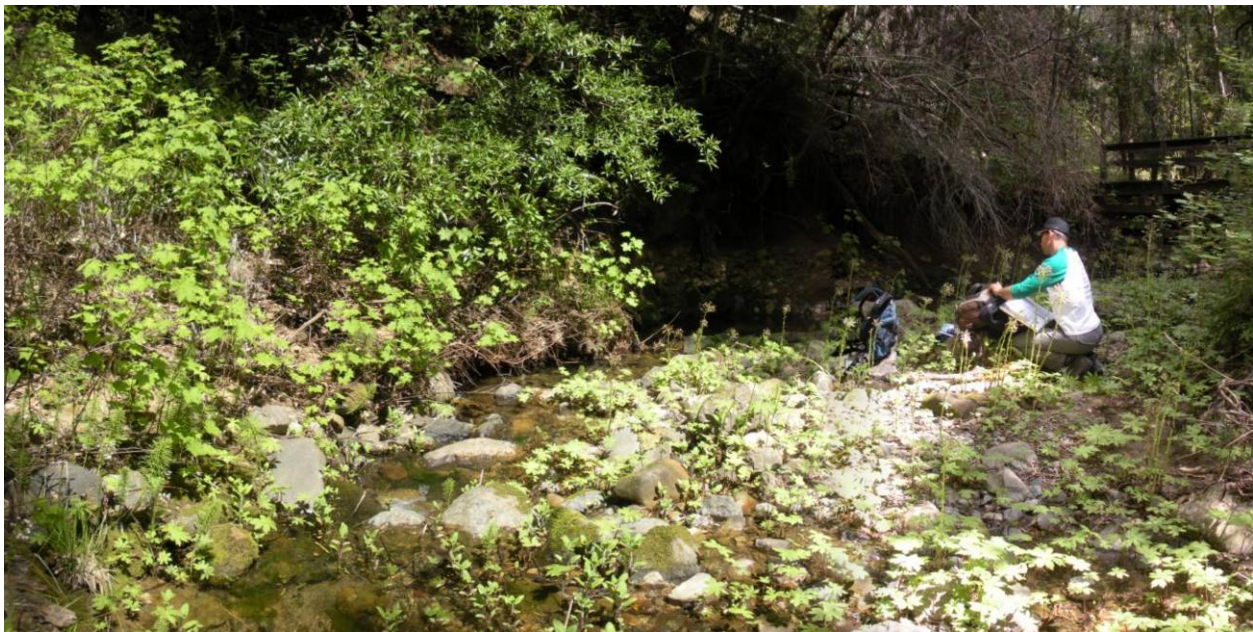
Figure 3-4 Looking downstream along Upper Stevens Creek

location was desired. Upper Stevens Creek, west of Permanente Creek, was observed in the Monte Bello Open Space Preserve near the junction of the Stevens Creek Nature Trail and the White Oak Trail. The assessed portion of Upper Stevens Creek, upstream of a bridge trail crossing, was in excellent condition with significant newt and aquatic vegetation populations in the channel. In comparison to Permanente Creek, Upper Stevens Creek exhibits similar hillslope and landslide processes, has similar bed material of cobbles and boulders interspersed with some small amounts of sand and silt, has similar riparian vegetation communities, and has steep canyon walls like Permanente Creek, but it does not contain the calcium carbonate conglomerate (see Figure 3-4 and Figure 3-5). Upper Stevens Creek, while being affected by landslides and debris flows, remains in dynamic equilibrium and has been able to accommodate or adjust to the sediment inputs quickly. The trail bridge limits lateral channel adjustment, which has caused some bank scouring both upstream and downstream of the crossing, but the erosion is localized.

The channel scores a 'fair' stability rating due to its steep upper slopes and landslide potential, but these features are necessary for a reference reach to be applicable to Permanente Creek.

If the channel exhibited the calcium carbonate conglomerate, it would be an ideal reference for Permanente Creek. Despite the absence of the conglomerate, the Upper Stevens Creek provides the most appropriate reference reaches because of its exceptional condition and its similarities to Permanente Creek.
