**APPENDIX G**  
**GEOTECHNICAL EVALUATIONS**

***APPENDIX G-1***  
***WMSA GEOTECHNICAL EVALUATION***

## West Materials Storage Area Geotechnical Evaluation

Permanente Quarry

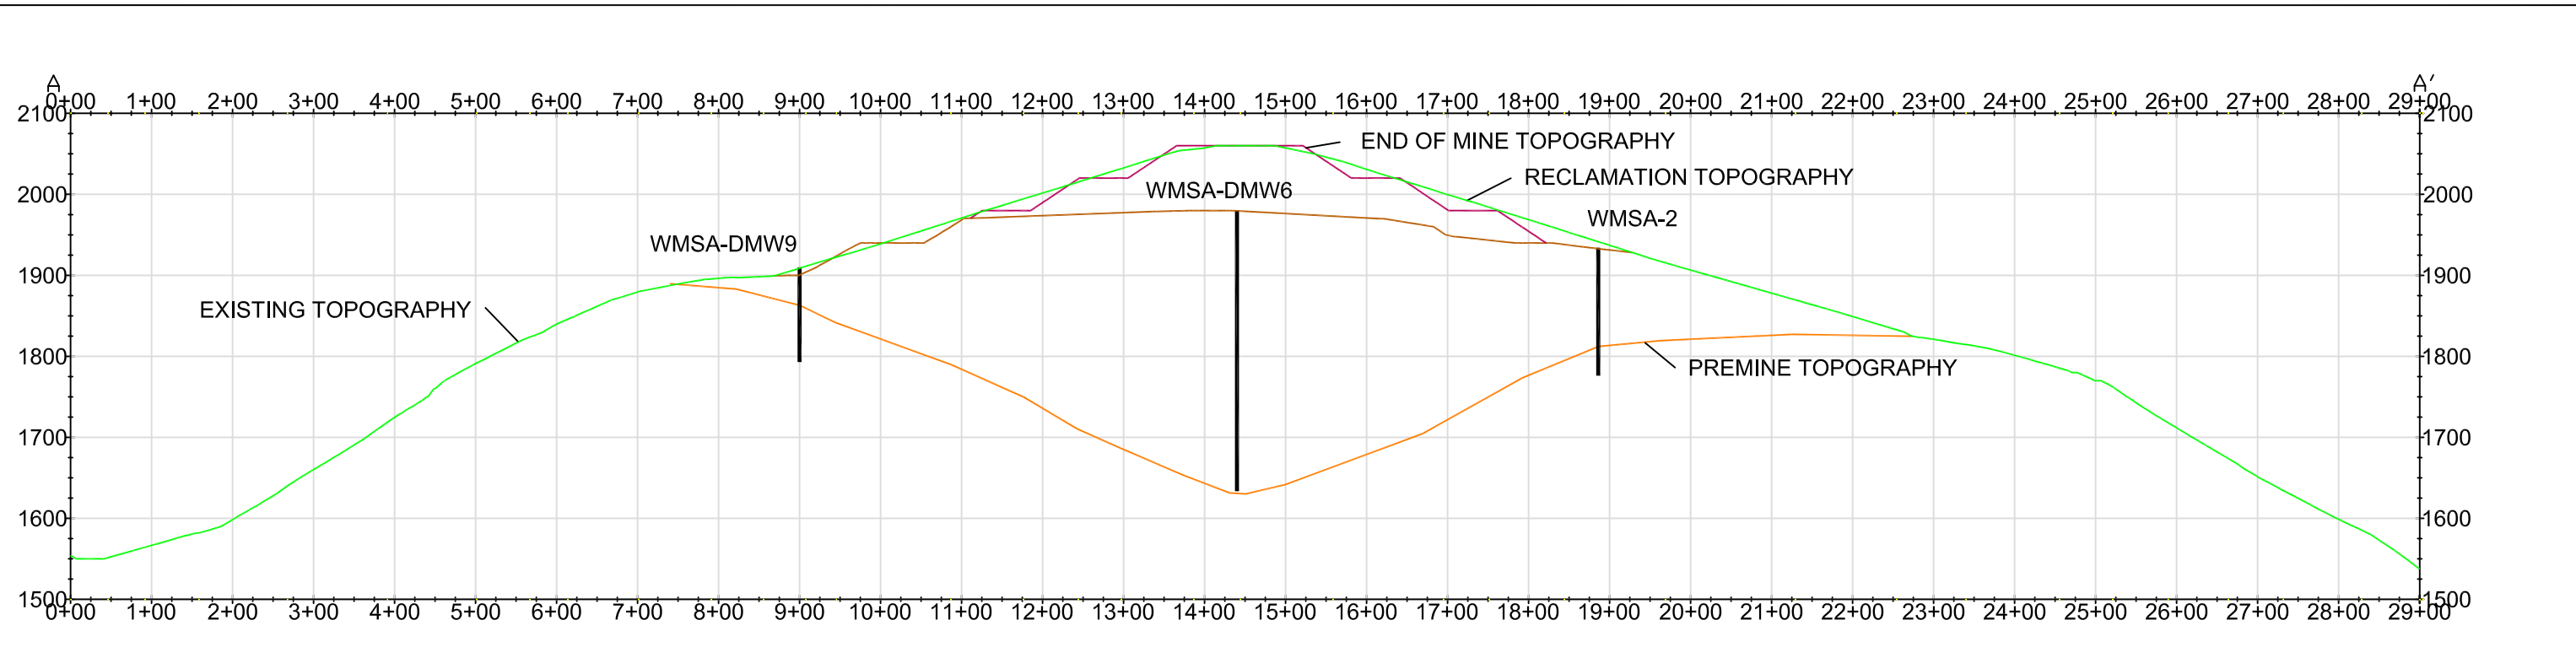
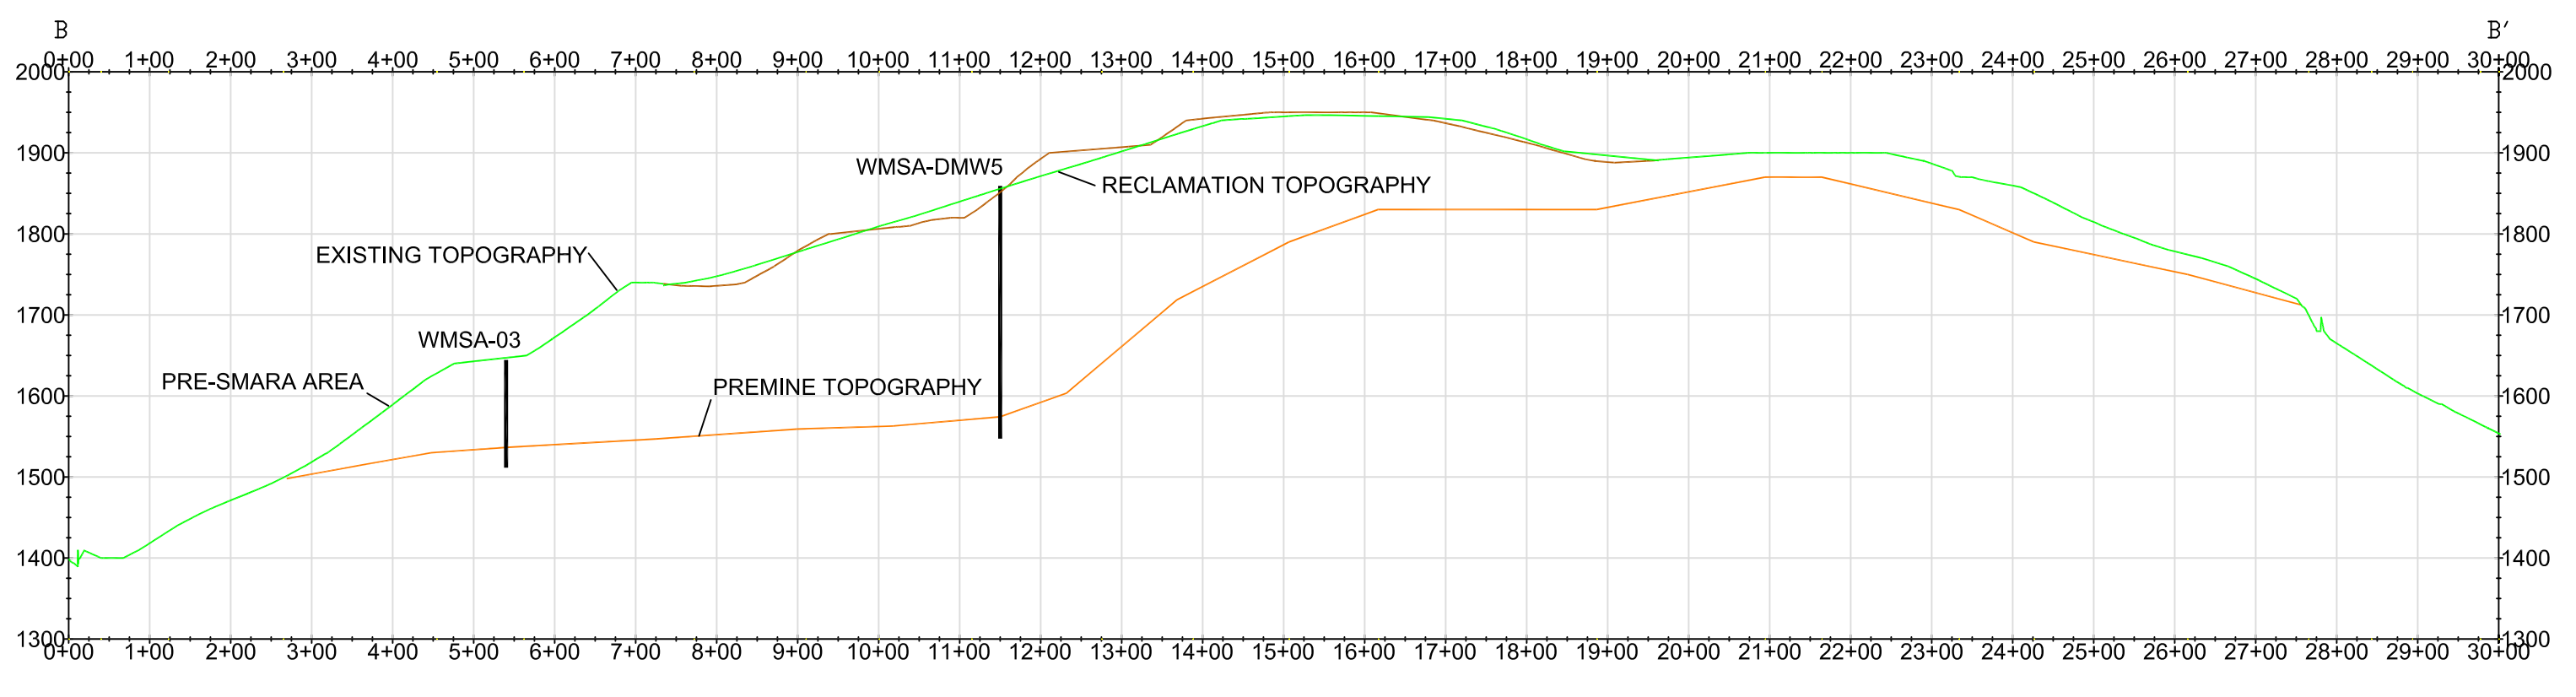
**Figure 2.5 Permanente Quarry WMSA Cross-Sections**

Two cross-sections of the WMSA were modeled to ensure that an appropriate factor of safety against slope failure is achieved. These sections include the greatest fill depths and the native ridge beneath WMSA. These cross-sections represent the worst-case scenarios for WMSA, and all other cross-sections are a subset of these sections. The steep portions of the sections present the pre-SMARA areas of WMSA. Figures 2.1 through 2.4 show the locations of the two cross-sections which were analyzed, and the cross-sections are included as Figure 2.5.

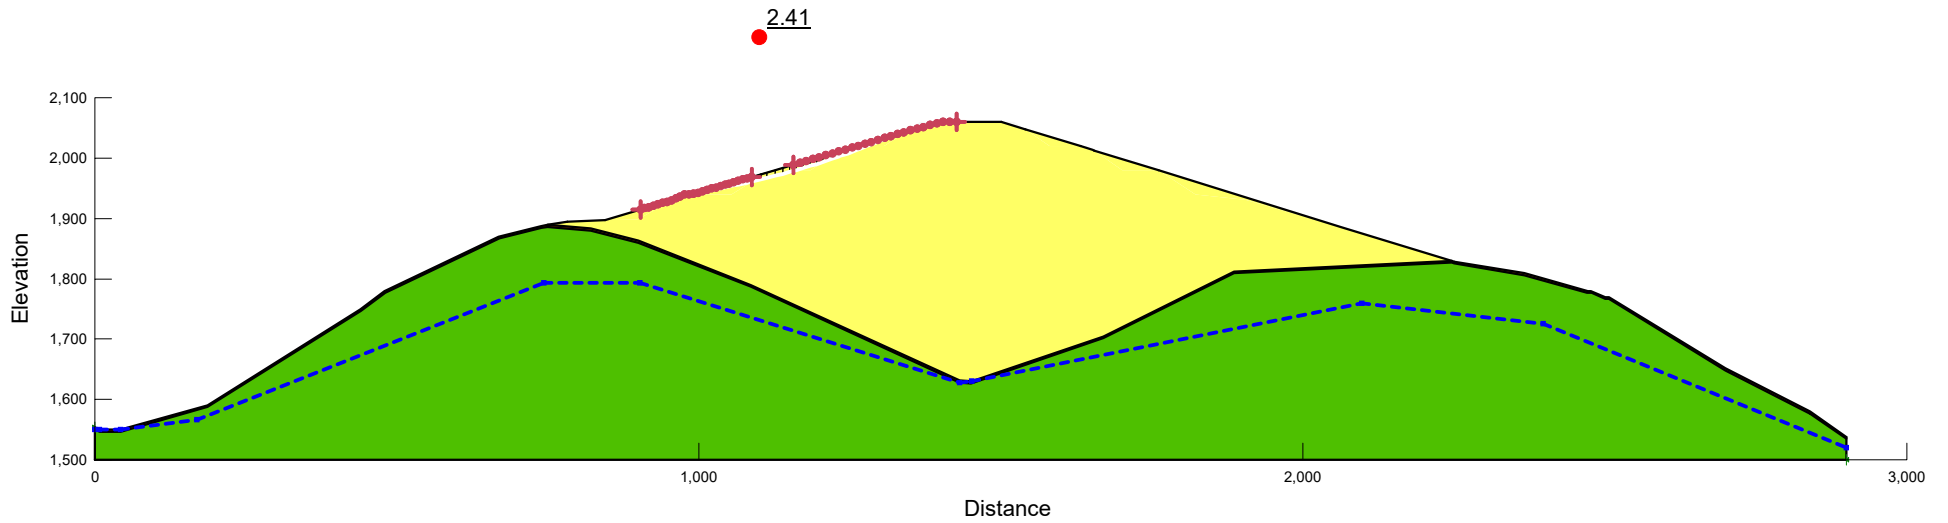
Title: WMSA - Section A  
 Parent: 01. South Slope - Static  
 Name: 01b. Reclamation Surface  
 Method: Spencer  
 Factor of Safety: 2.41  
 Horz Seismic Coef.:

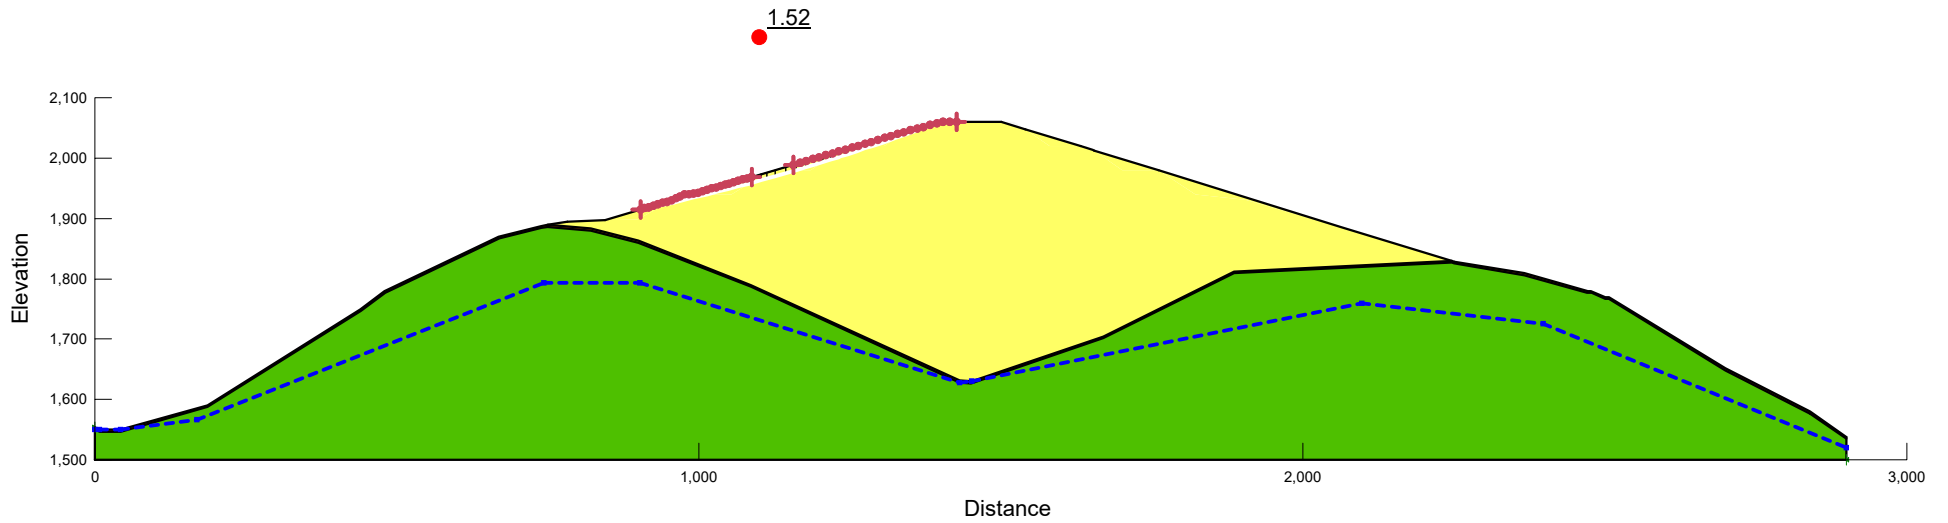
Title: WMSA - Section A  
 Parent: 02. South Slope - Pseudostatic  
 Name: 02b. Reclamation Surface  
 Method: Spencer  
 Factor of Safety: 1.52  
 Horz Seismic Coef.: 0.15

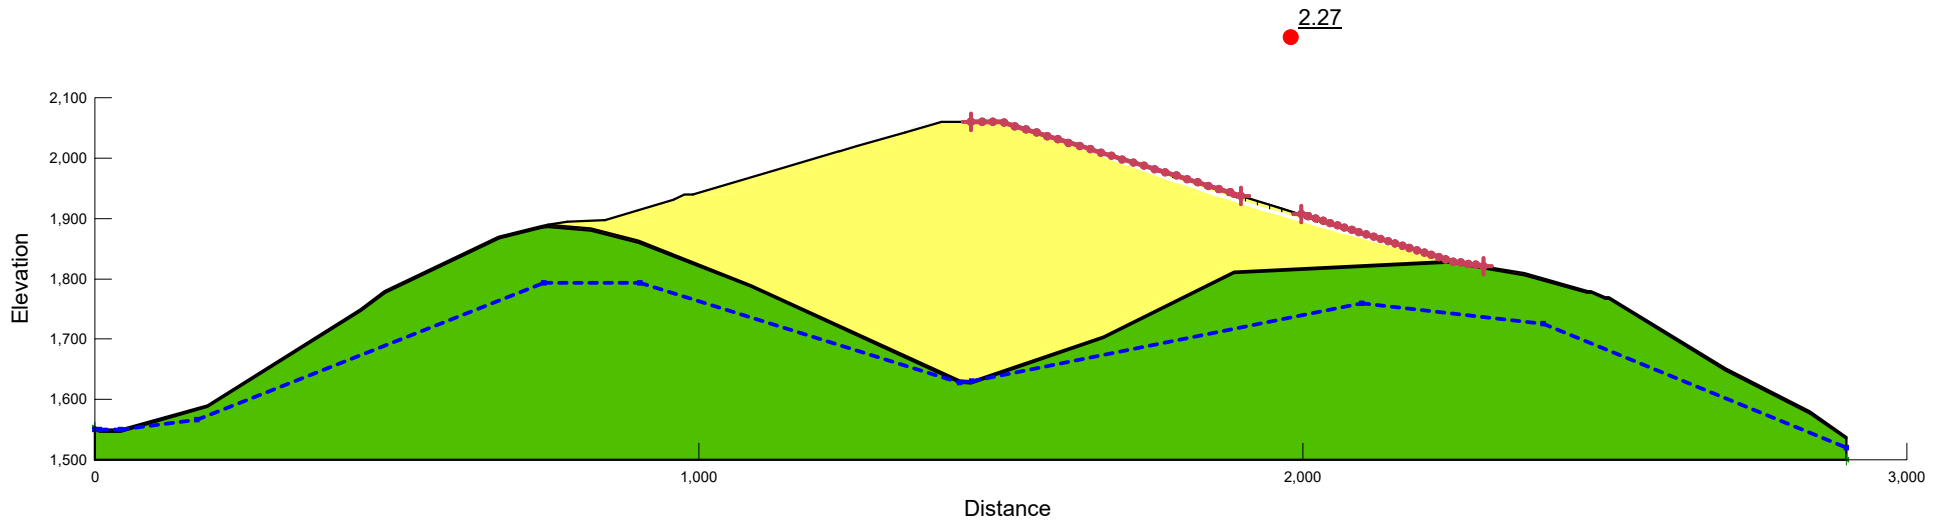
Title: WMSA - Section A  
 Parent: 03. North Slope - Static  
 Name: 03b. Reclamation Surface  
 Method: Spencer  
 Factor of Safety: 2.27  
 Horz Seismic Coef.:

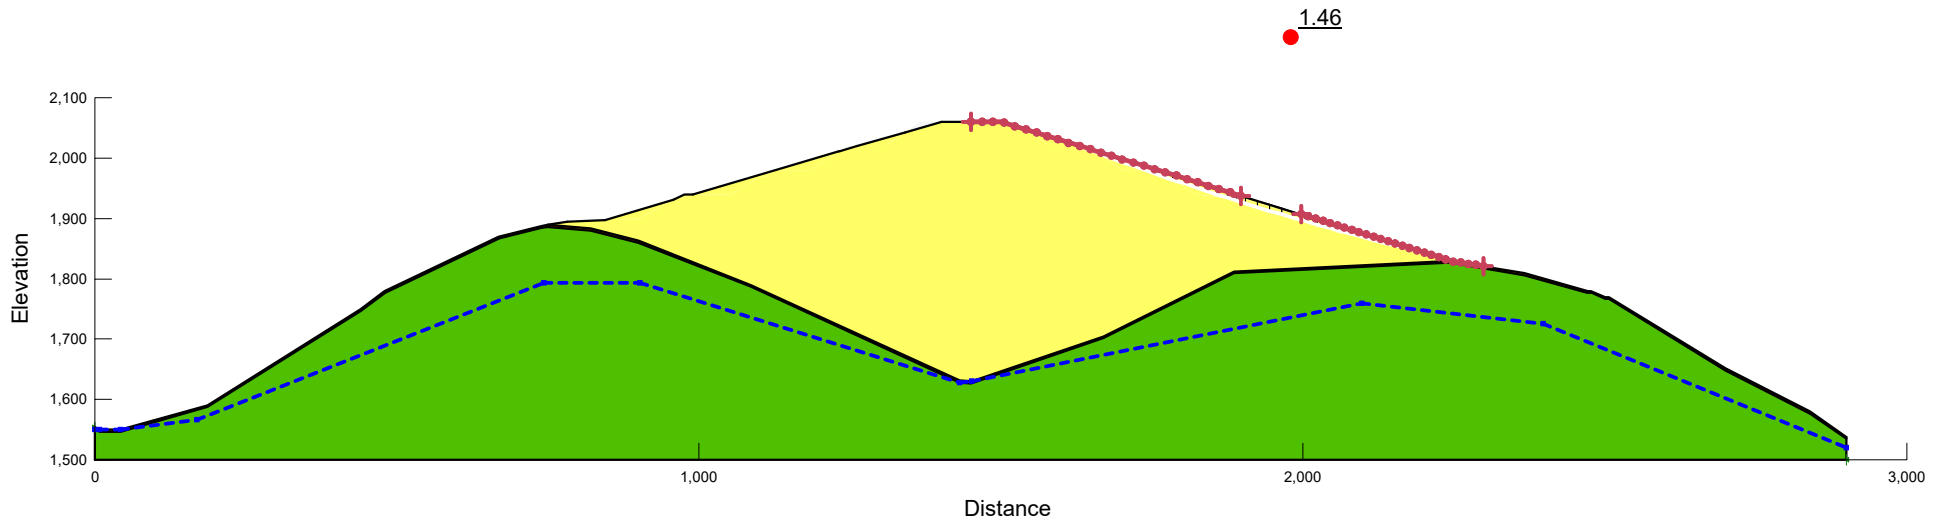
Title: WMSA - Section A  
 Parent: 04. North Slope - Pseudostatic  
 Name: 04b. Reclamation Surface  
 Method: Spencer  
 Factor of Safety: 1.46  
 Horz Seismic Coef.: 0.15

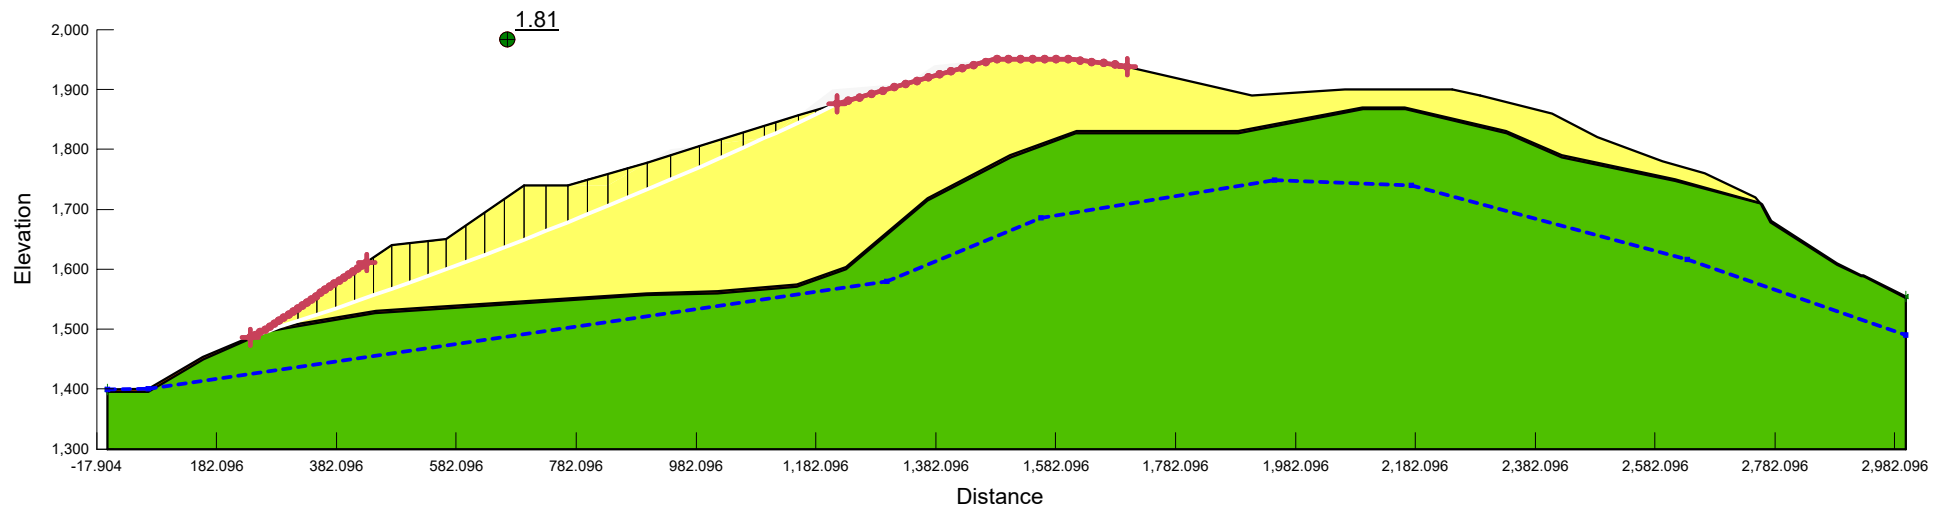
Title: WMSA - Section B  
 Parent: 01. South Slope - Static  
 Name: 01f. Reclaimed Surface (Global)  
 Method: Spencer  
 Factor of Safety: 1.81  
 Horz Seismic Coef.:

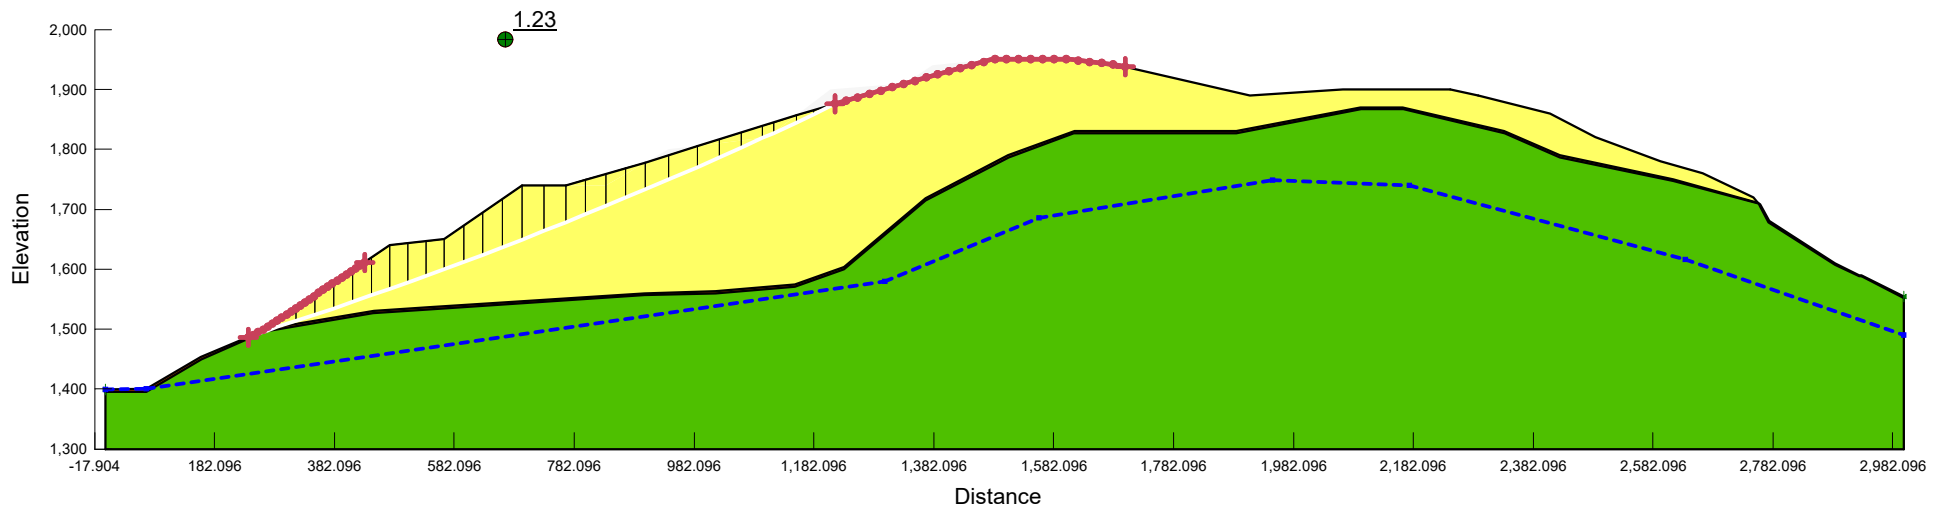
Title: WMSA - Section B  
 Parent: 02. South Slope - Pseudostatic  
 Name: 02f. Reclaimed Surface (Global)  
 Method: Spencer  
 Factor of Safety: 1.23  
 Horz Seismic Coef.: 0.15

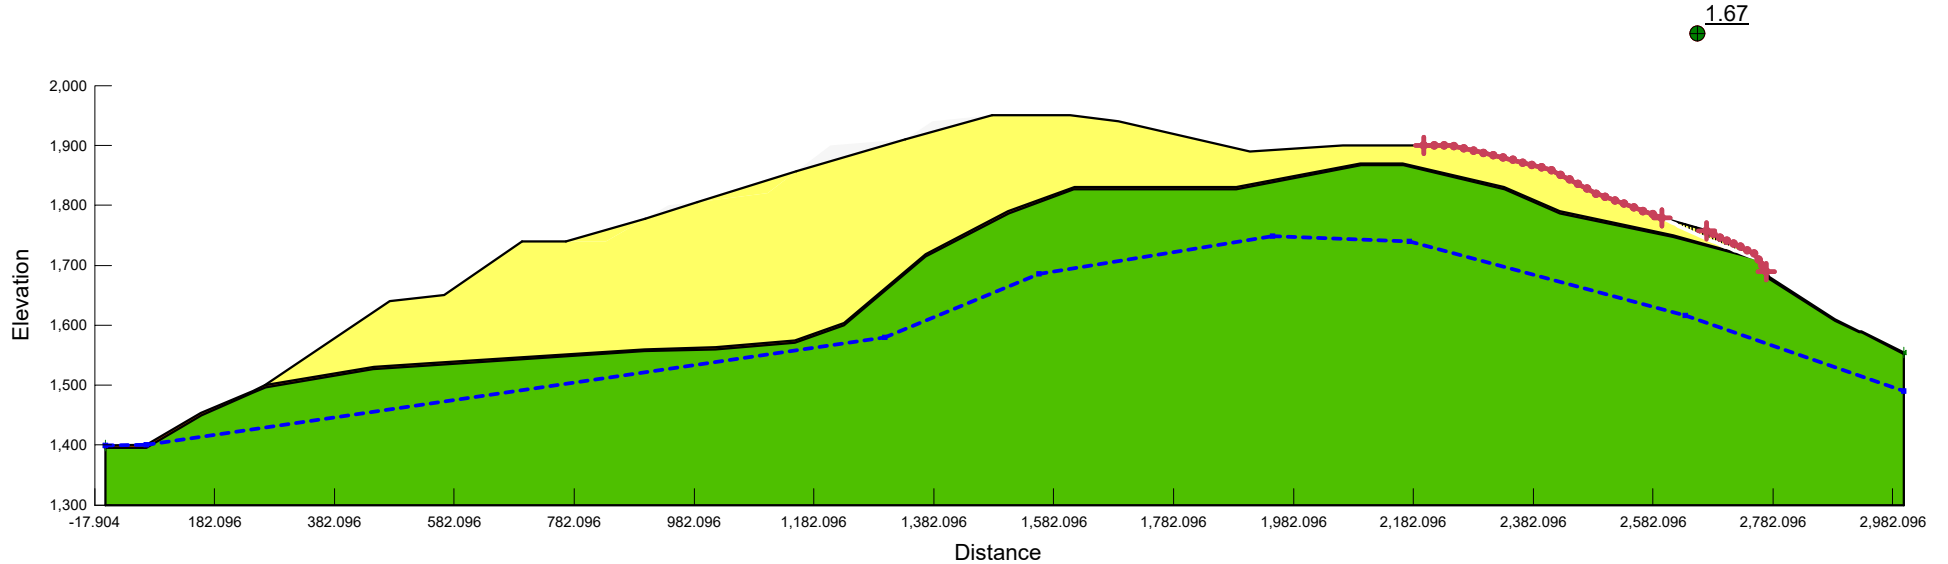
Title: WMSA - Section B  
 Parent: 03. North Slope - Static  
 Name: 03b. Reclaimed Surface  
 Method: Spencer  
 Factor of Safety: 1.67  
 Horz Seismic Coef.:

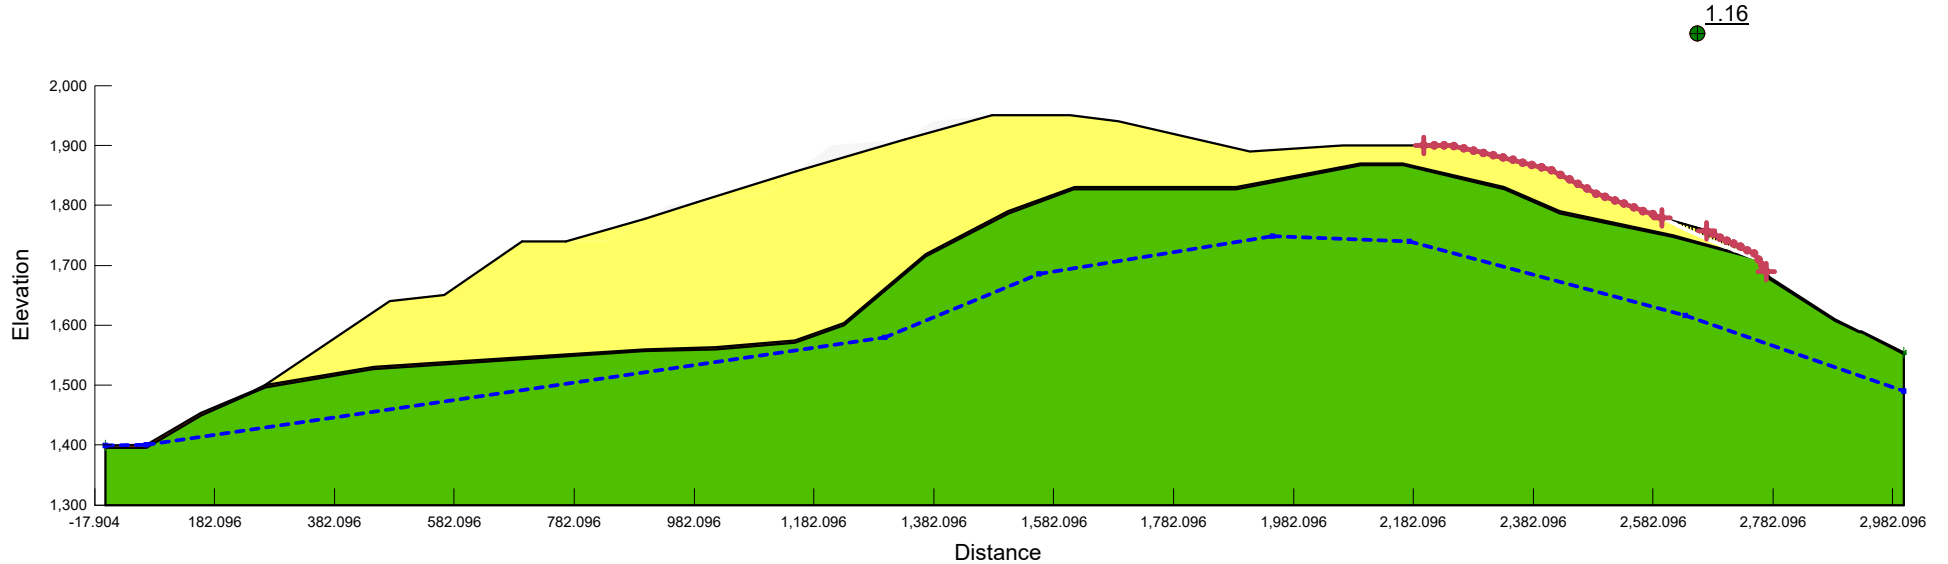
Title: WMSA - Section B  
 Parent: 04. North Slope - Pseudostatic  
 Name: 04b. Reclaimed Surface  
 Method: Spencer  
 Factor of Safety: 1.16  
 Horz Seismic Coef.: 0.15

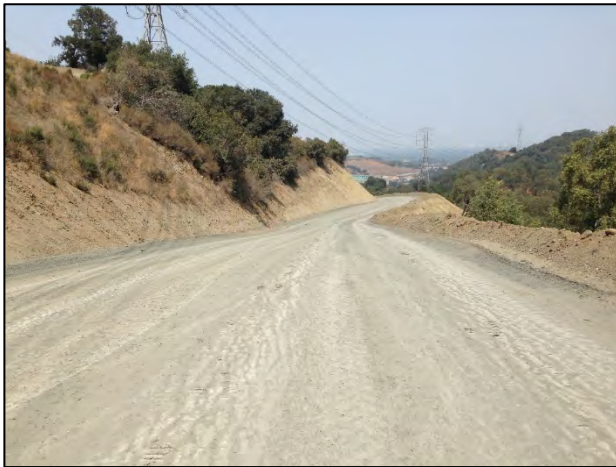
**Figure 2 Utility Road Cross-Section**

The utility road was improved along its preexisting alignment. While the road contains steep slopes and grades, it is within typical mining industry standards for grading, slopes, and drainage controls. A key consideration of this road is that it is an internal road that cannot be accessed by the public. It must remain serviceable as it serves the primary access to the southern property and as an easement for PG&E utility lines. Roads such as this are typically constructed following existing site practices that have been proven to work at the site. Photographs of the improved road are included below. **Figure 2** shows the road cross-section and presents the range of excavation heights. **Figure 3** shows the fill profile. It should be noted that the slopes pictured have been revegetated since these photographs were taken.

Stantec recommends grading the road to reduce fill slope gradients to comply with local rules and regulations. City and County grading regulations require slope gradients be 2h:1v, or the design be certified by a Certified Engineering Geologist. The grading design is based on a minimum 20-foot road width, which includes sufficient space for one-way travel, a ditch, and a berm. Road widths for retained roads, in the currently approved Reclamation Plan Amendment for the Permanente Quarry, vary and are as narrow as 12 feet. Wherever practical, the road will be wider than 20 feet to provide turn-off locations. The grading plan has an overall road gradient of approximately 12%, with short sections that exceed 20% gradient. These grades are consistent with the original utility road and other roads that will be retained during reclamation per the currently approved Reclamation Plan Amendment for the Permanente Quarry.

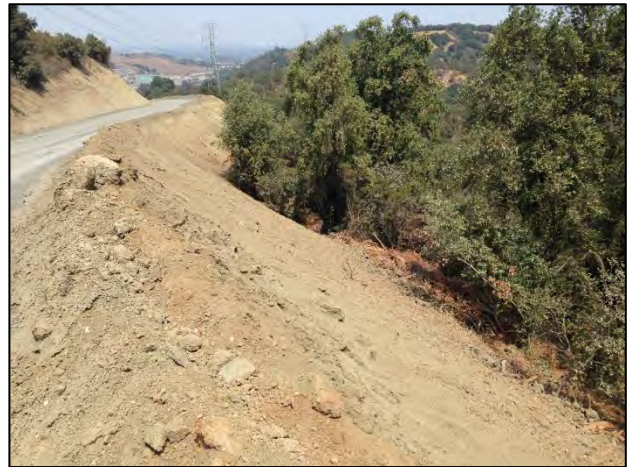
**Figure 3 Utility Road Fill Profile**

The utility road was constructed by placing a key at the toe of the fill slope. The key included excavating material from the toe of the fill area and backfilling it with compacted fill. Water was added to the fill to achieve optimal moisture content, and it was compacted with a vibratory sheep's foot roller. Once the key was constructed, the utility road was improved by cutting material from the uphill slope and placing compacted fill on the downhill slope above the key. The fill slope was cleared and grubbed, but the surface soil was not removed, except where the key was placed. The cut slopes vary, but they are generally steep at approximately 1:1 (45°), with cut heights are up to 30 feet. The fill slopes are also steep at approximately 1.2:1 (39°), with fill slopes up to 50 feet high. Internal mine roads are often constructed with cut and fill slopes in this range, and any erosion that occurs is managed by the site maintenance crews. A safety berm was

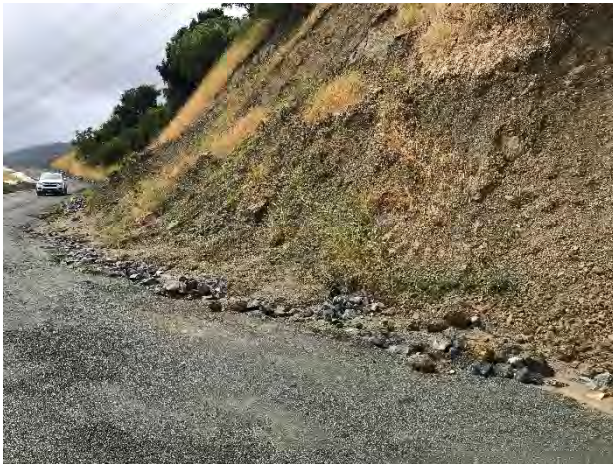
**Figure 4 Road Cut at Cross-Section B-B'**

A Stantec Certified Engineering Geologist (CEG) inspected the utility road in May 2019 to evaluate the lithology along the road cut. The inspection confirmed the road was constructed primarily in the Santa Clara Formation; however, the southern section (including C-C') was constructed in Franciscan Limestone and Greenstone. The limestone is not present at the two areas where a geotechnical assessment is required (see below). **Figures 4** and **5** show the Santa Clara Formation at the road cut at cross-section B-B' and Greenstone at the road cut at cross-section C-C', respectively. **Drawing 1** includes the cross-section locations, and the cross-sections are included as **Drawing 2**.
