## SURFACE MINING INSPECTION REPORT

Photos from 2020 Annual SMARA Inspection Conducted on 8-06-2020

by  
Robert Salisbury, Senior Planner  
James Baker, CEG#1021, County Geologist  
Steve Beams, Senior Construction Inspector  
Glen Jia, Assistant Planner

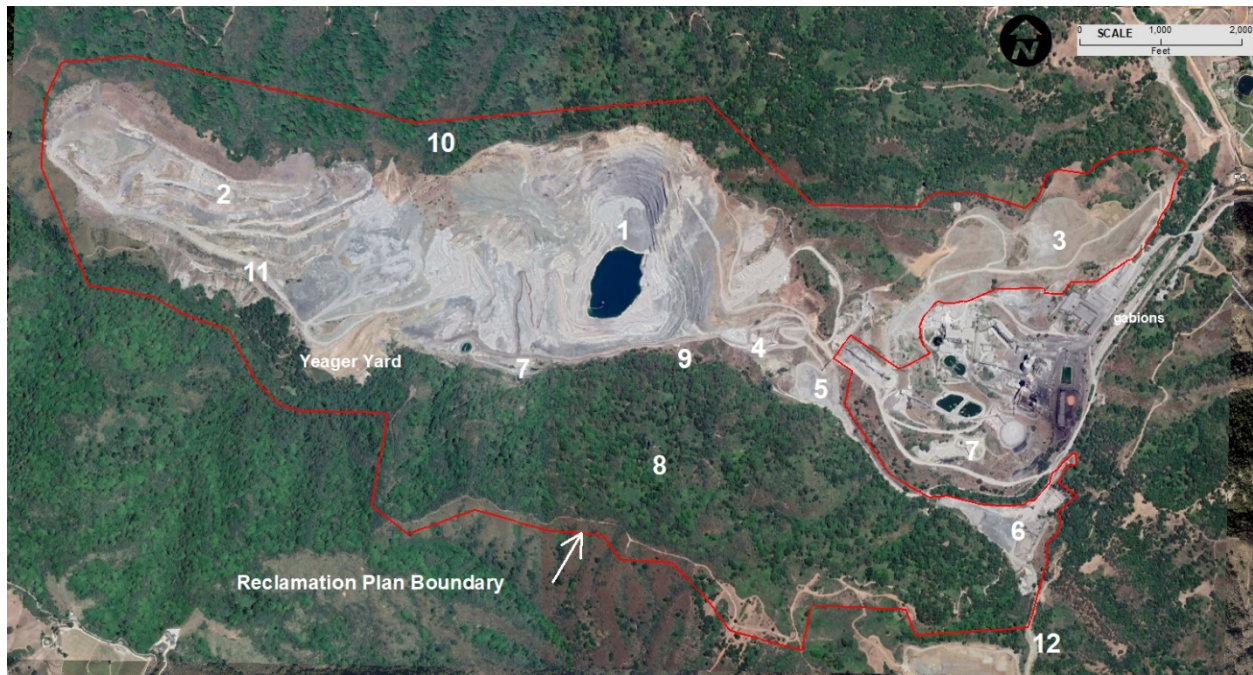
The numbers on the map above correspond with the following twelve areas within the mining boundary of the 2012 approved Reclamation Plan Amendment:

1. North Quarry (main pit)
2. West Materials Storage Area (WMSA)
3. East Materials Storage Area (EMSA)
4. Crusher/conveyor
5. Surge Pile
6. Rock Plant
7. Water Treatment Facilities
8. South Quarry Exploration Area
9. Permanente Creek Restoration Area (PCRA)
10. Buffer Areas that surround active mining areas.
11. Drainage Facilities
12. Stevens Creek Quarry Haul Road Violation

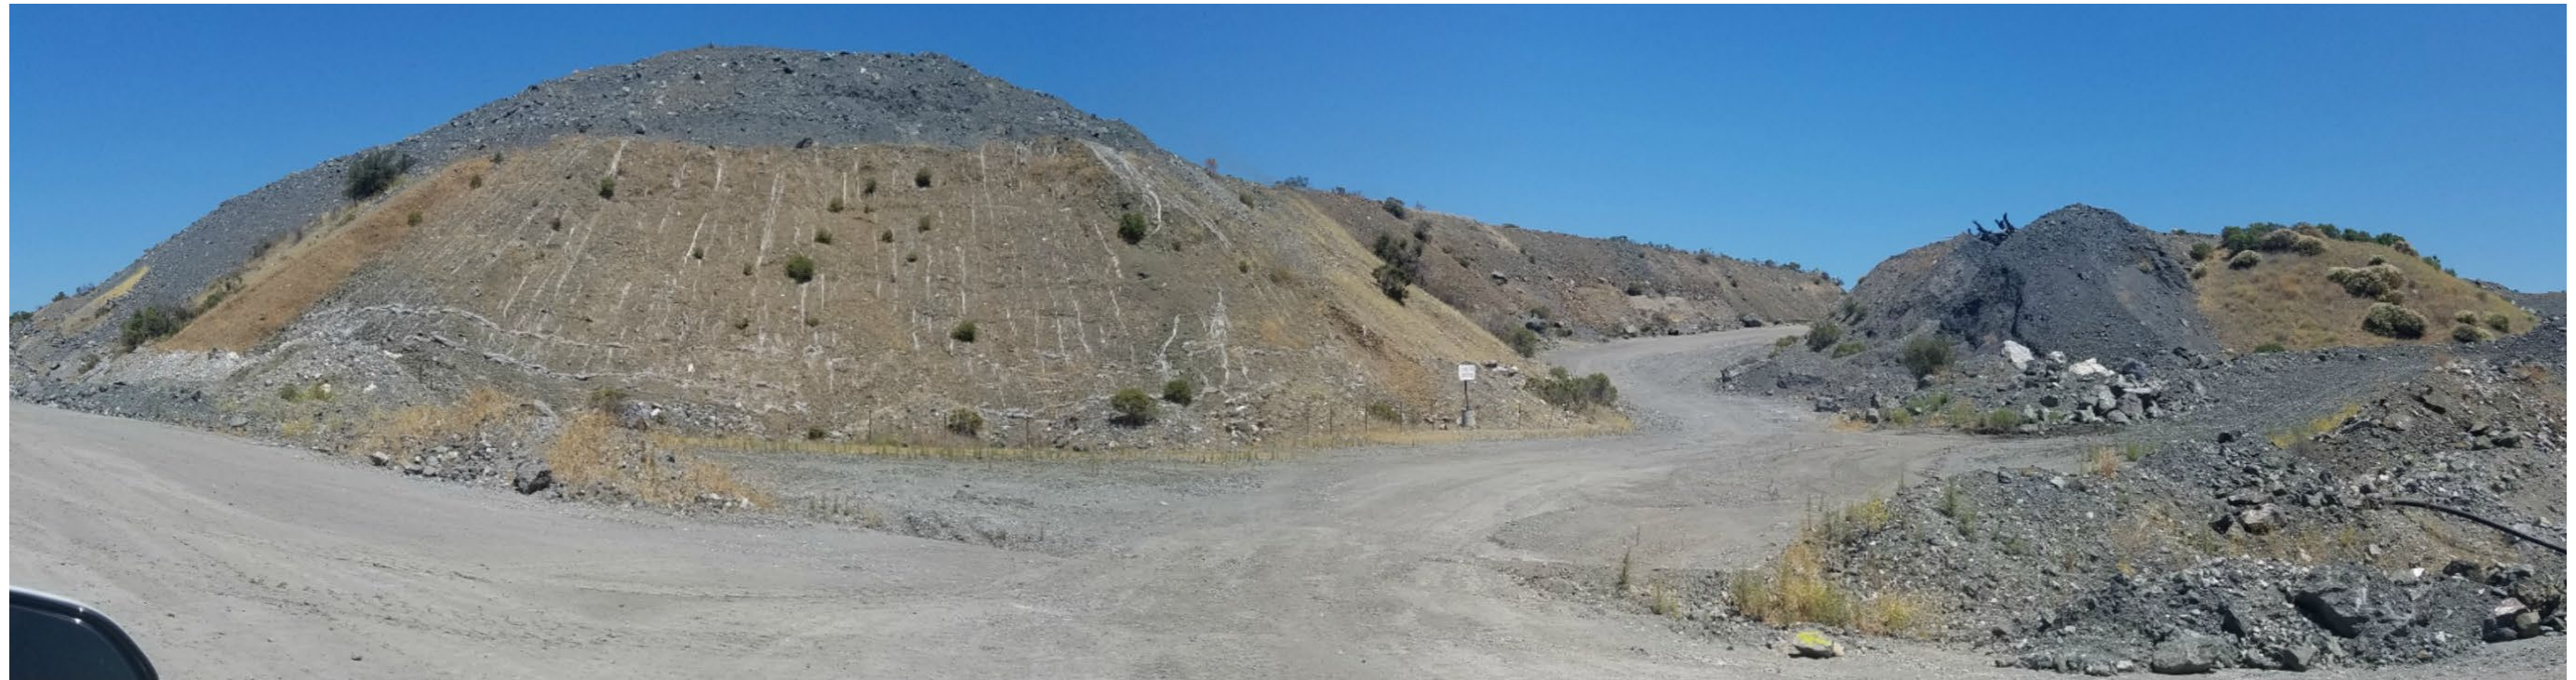
**PHOTO #5A – Topsoil Stockpiles**

Topsoil and organics are stored and covered in the central portion of the WMSA. County staff observed deterioration of previously installed jute netting and minimal growth on the hydroseeded stockpile slopes. [See **PHOTOS #5A and #5B.**] Although no evidence of erosion was observed, County inspectors suggested that the operator monitor the stockpiles and replace erosion control measures as needed to prevent loss of stockpile material through erosion.

- 1) (See map location 2.) County inspectors suggested that the operator monitor the topsoil stockpiles WMSA south slope and replace erosion control measures as needed to prevent loss of material through erosion.
- 2) (See map location 12.) Localized erosion on the haul road cut slopes needs to be managed by installation of erosion control BMPs. Operator has been directed to install these BMPs. Installation will be verified during forthcoming winterization inspection.
- 3) (See area between map locations 6 and 12.) Area of recent grading needs to be hydroseeded in order to minimize the potential for erosion during approaching rainy season.
- 4) (See map location 3.) Shallow slumps need to be regraded in order to minimized the potential for ongoing slope failure.

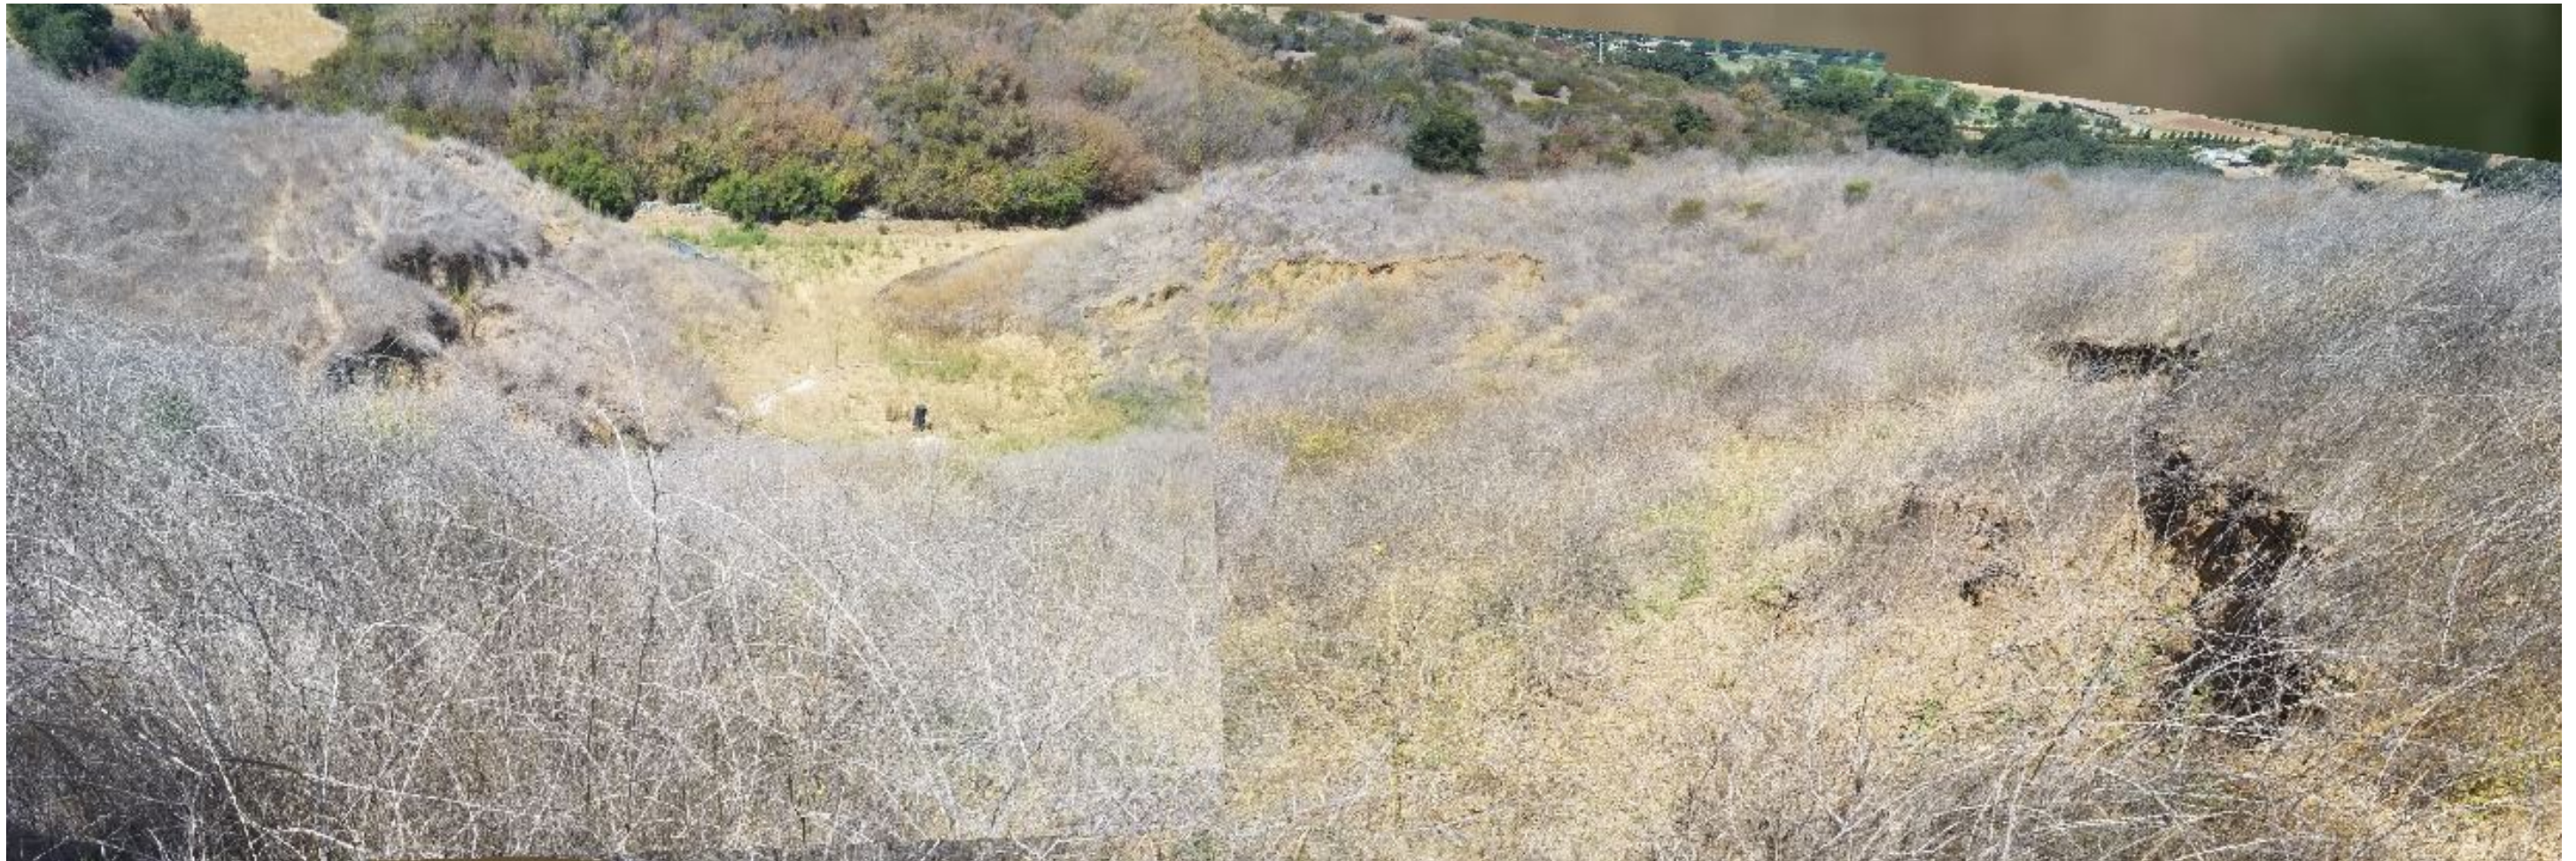
During the annual inspection, County inspectors observed an area in which recent grading had created a level pad adjacent to the modified utility road south of the Rock Plant. The fill slopes were covered with jute netting which had not yet been hydroseeded. [See **Photos 28a and 28b.**] In addition, County inspectors saw a localized area of shallow slumping of slopes on the northern side of fill placed in 2017 on top of the EMSA. [See **Photo 29.**]

**Photo #29 – Shallow slumps in fill material added to EMSA beginning in September or October of 2017**
