SURFACE MINING INSPECTION REPORT

BACKGROUND

Lehigh Quarry is a vested hard rock quarry which has been in operation since approximately 1903. The operation primarily harvests limestone for the production of cement but has also produced greenstone aggregate in the past. Over time the quarrying operation has expanded, and now encompasses 546 acres of disturbed area. The site also includes a cement plant operating under a Use Permit and located outside of the Reclamation Plan area. The current Reclamation Plan was approved in 2012 as an amendment to the 1985 Reclamation Plan.

Photos from 2022 Annual SMARA Inspection Conducted on 9-20-2022

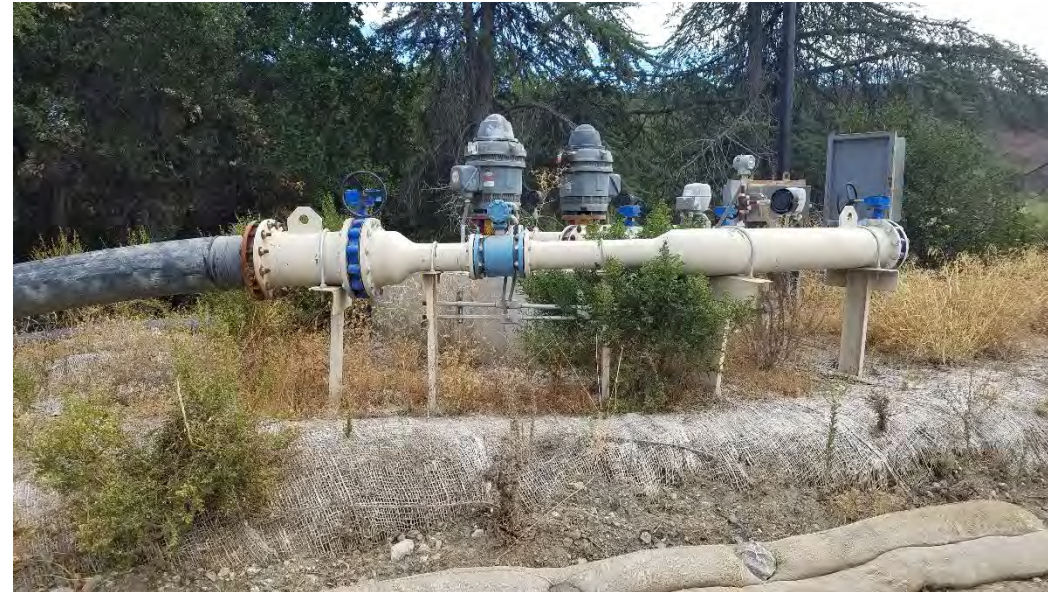
BMPs were previously placed on the slopes (wattles) and along the benches (rock check dams and silt fences). [See **PHOTO 7** for a view of the southern slopes of the EMSA.] Previously established vegetation on the EMSA slopes appears healthy and relatively free of invasive weeds. [See **PHOTO #8**.] Surface drainage from EMSA is directed into Pond 30 which is rock-lined with non-limestone rock. [See **PHOTO #9B**.] Water from Pond 30 is then directed to a vault and pumped to the upper treatment system. [See **PHOTO #9A**.]

Surface drainage from EMSA is directed into Pond 30 which is rock-lined with non-limestone rock. Water from Pond 30 is then directed to a vault and pumped to the upper treatment system.

PHOTO #9A– Vault and pump at Pond 30

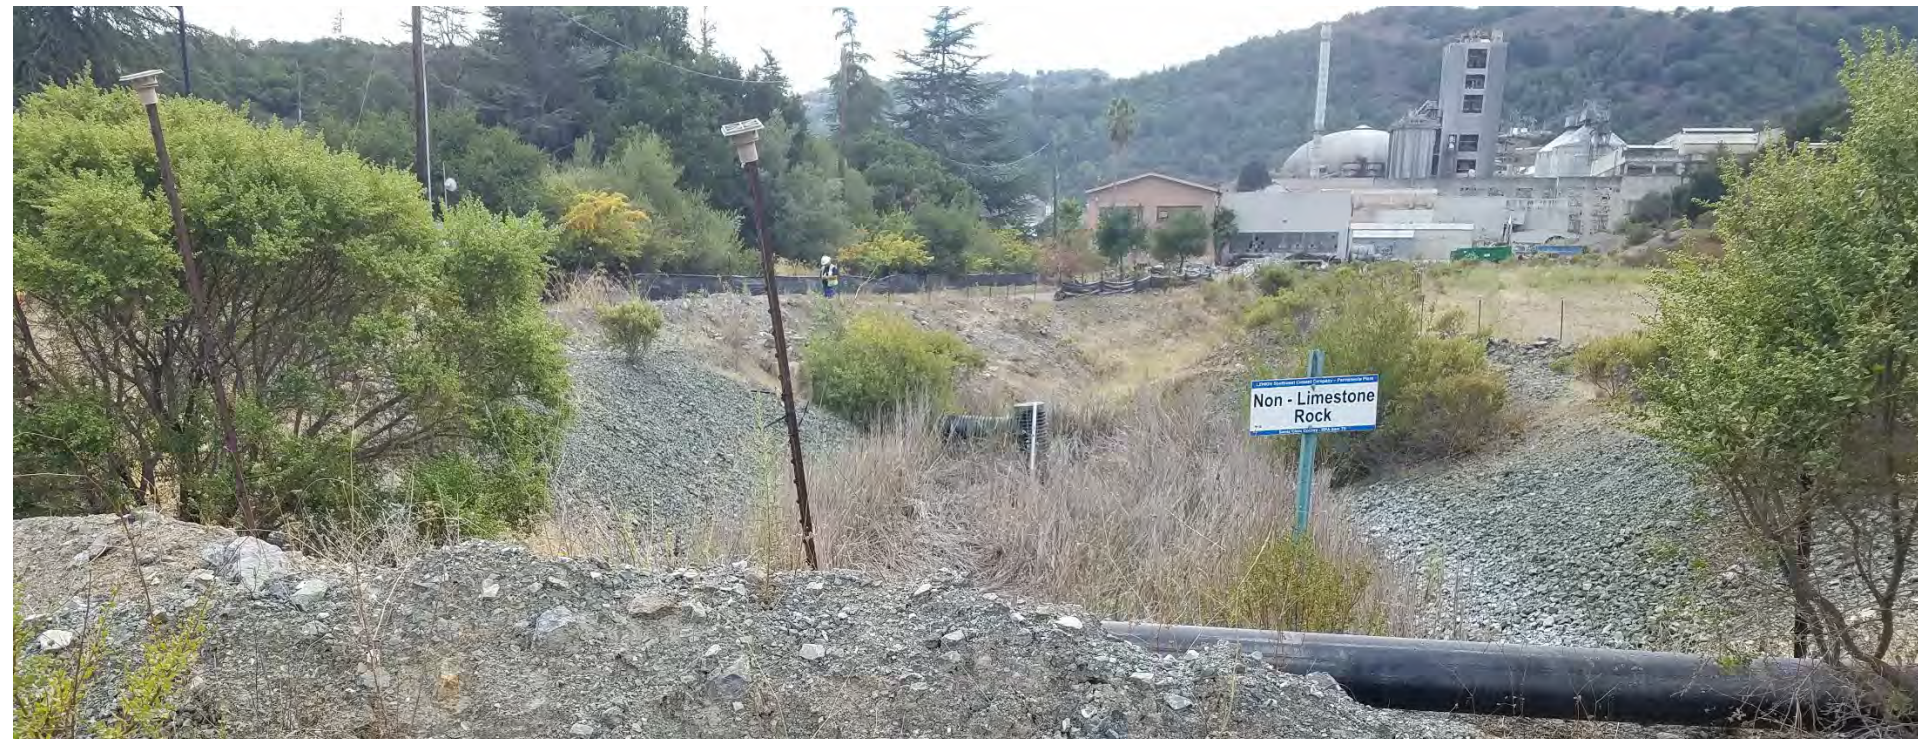
PHOTO #9B – Pond 30 (looking southwest)

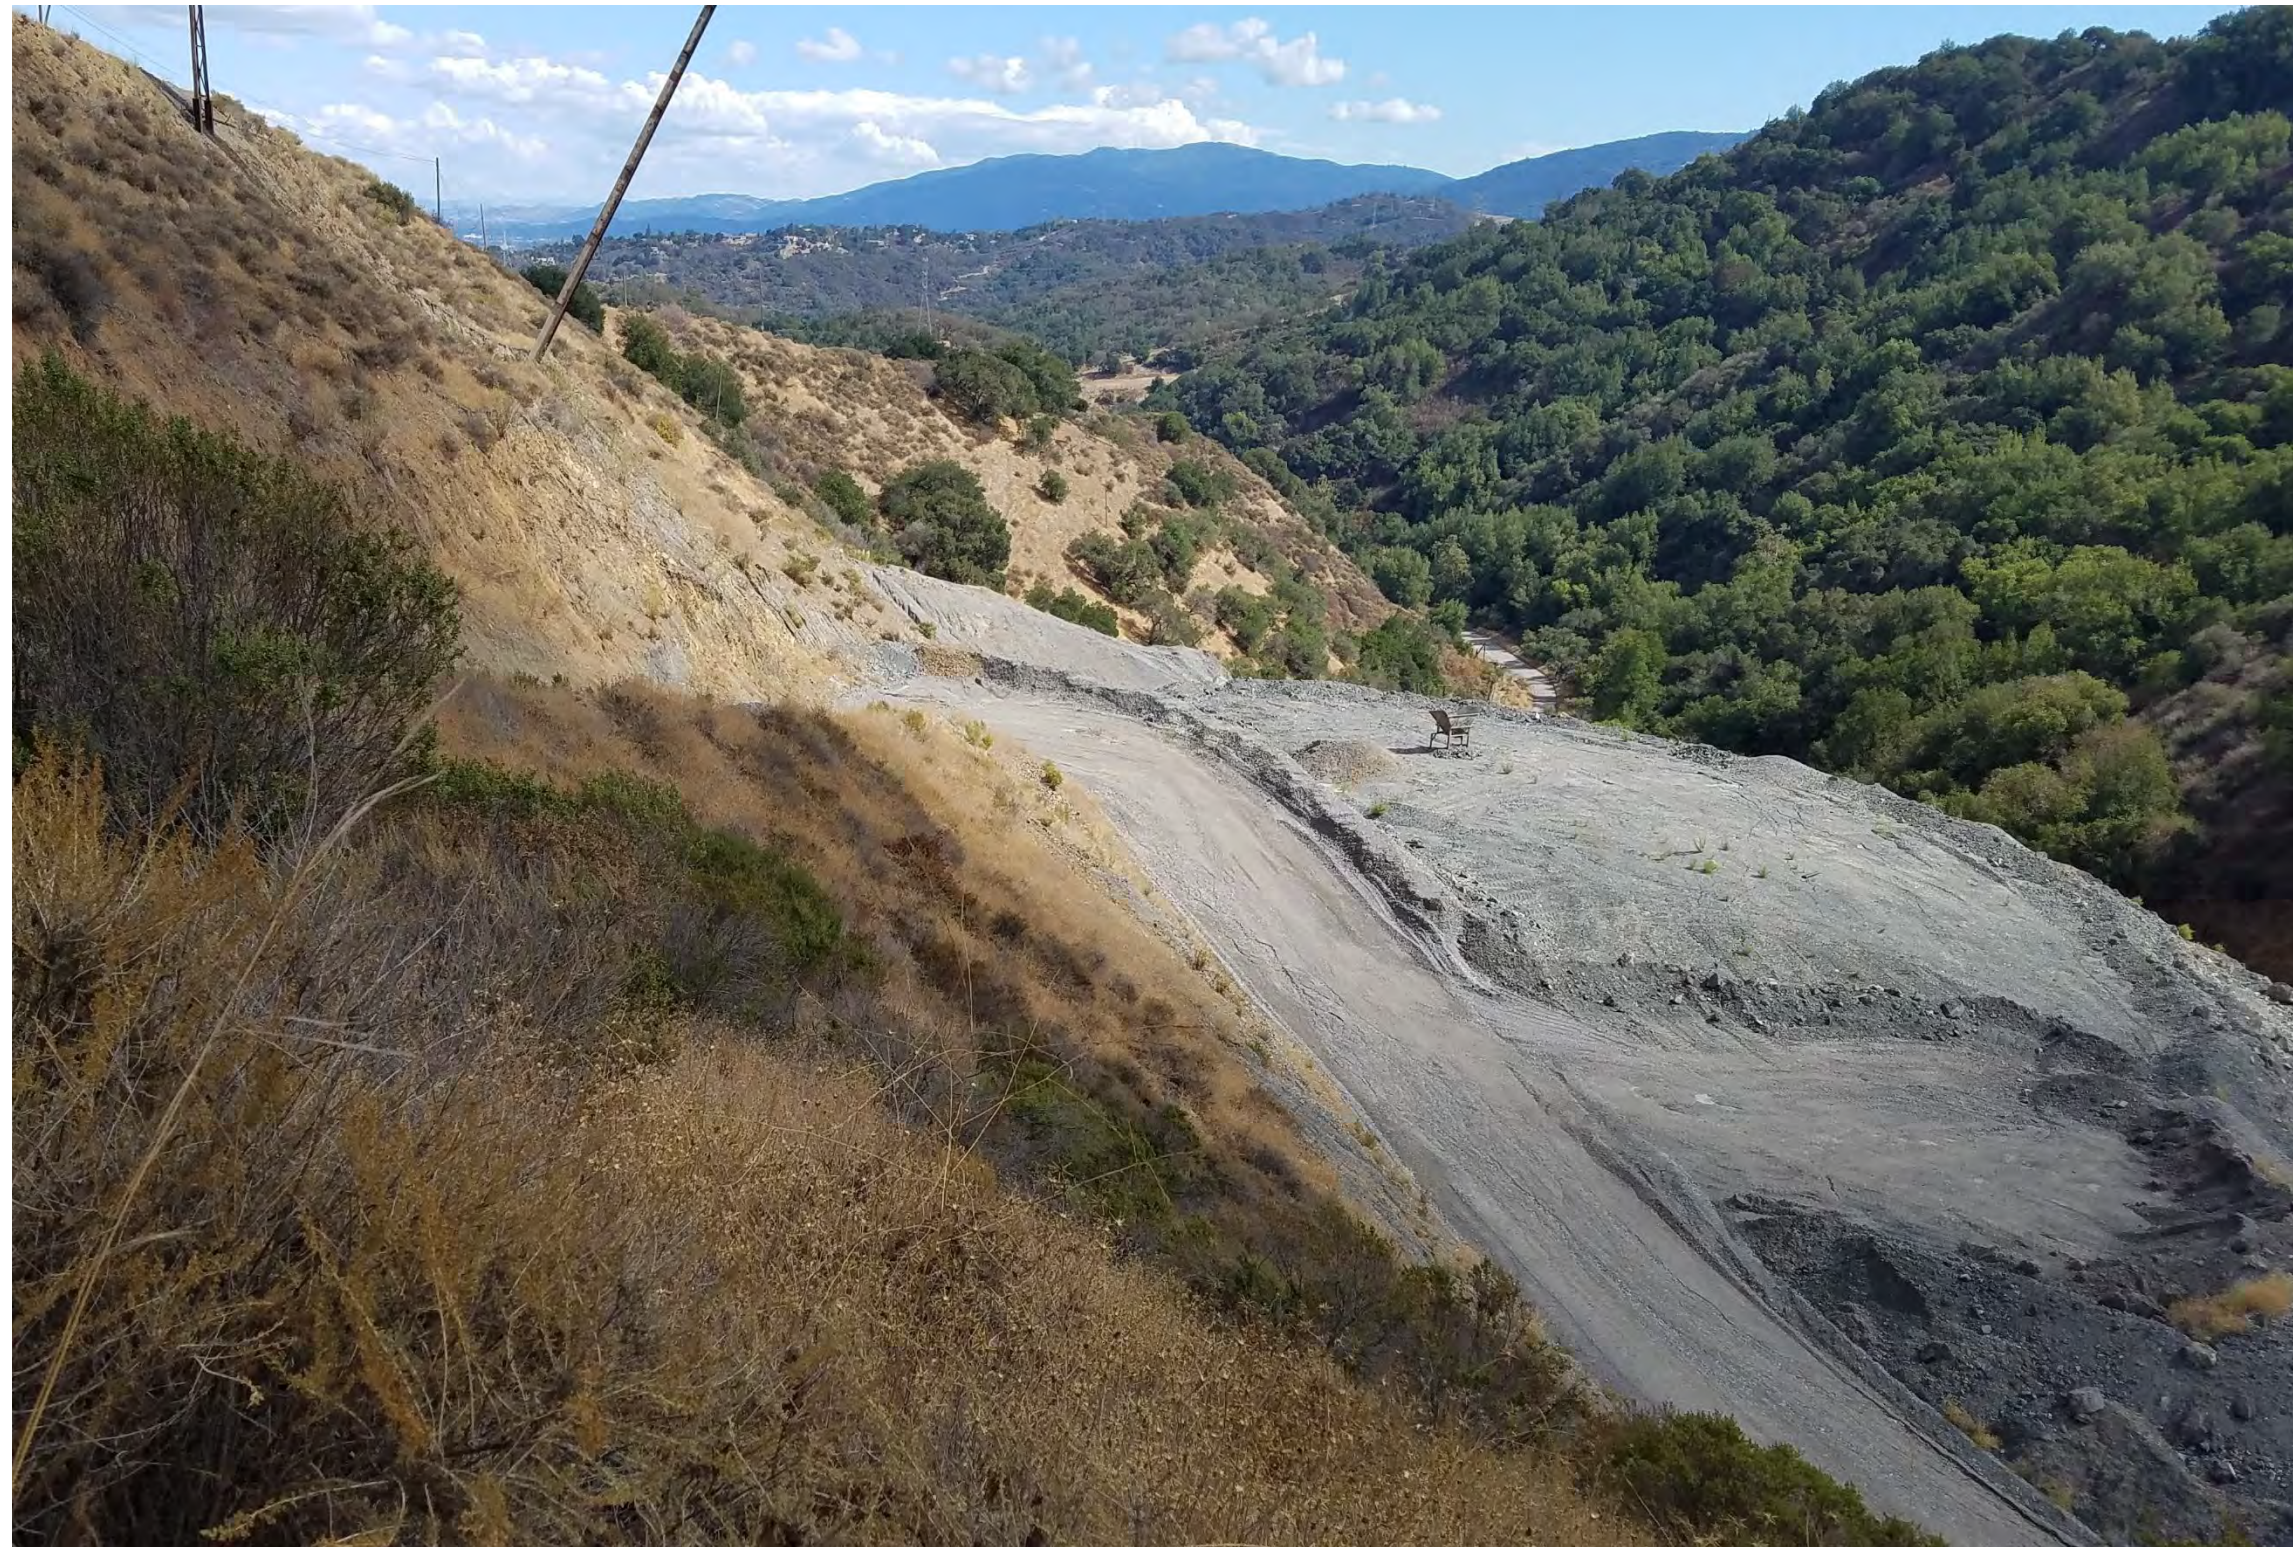
Additional material was added to the surge pile during the last year. [See **PHOTO #13.**] Sediment that erodes from the surge pile is detained in ponds. Next to the surge pile are slopes above Pond 13. [See **PHOTO #14.**]

PHOTO #13 – Surge Pile looking southeast

Map Location 5: Surge Pile
Material was removed from the surge pile during the last year.

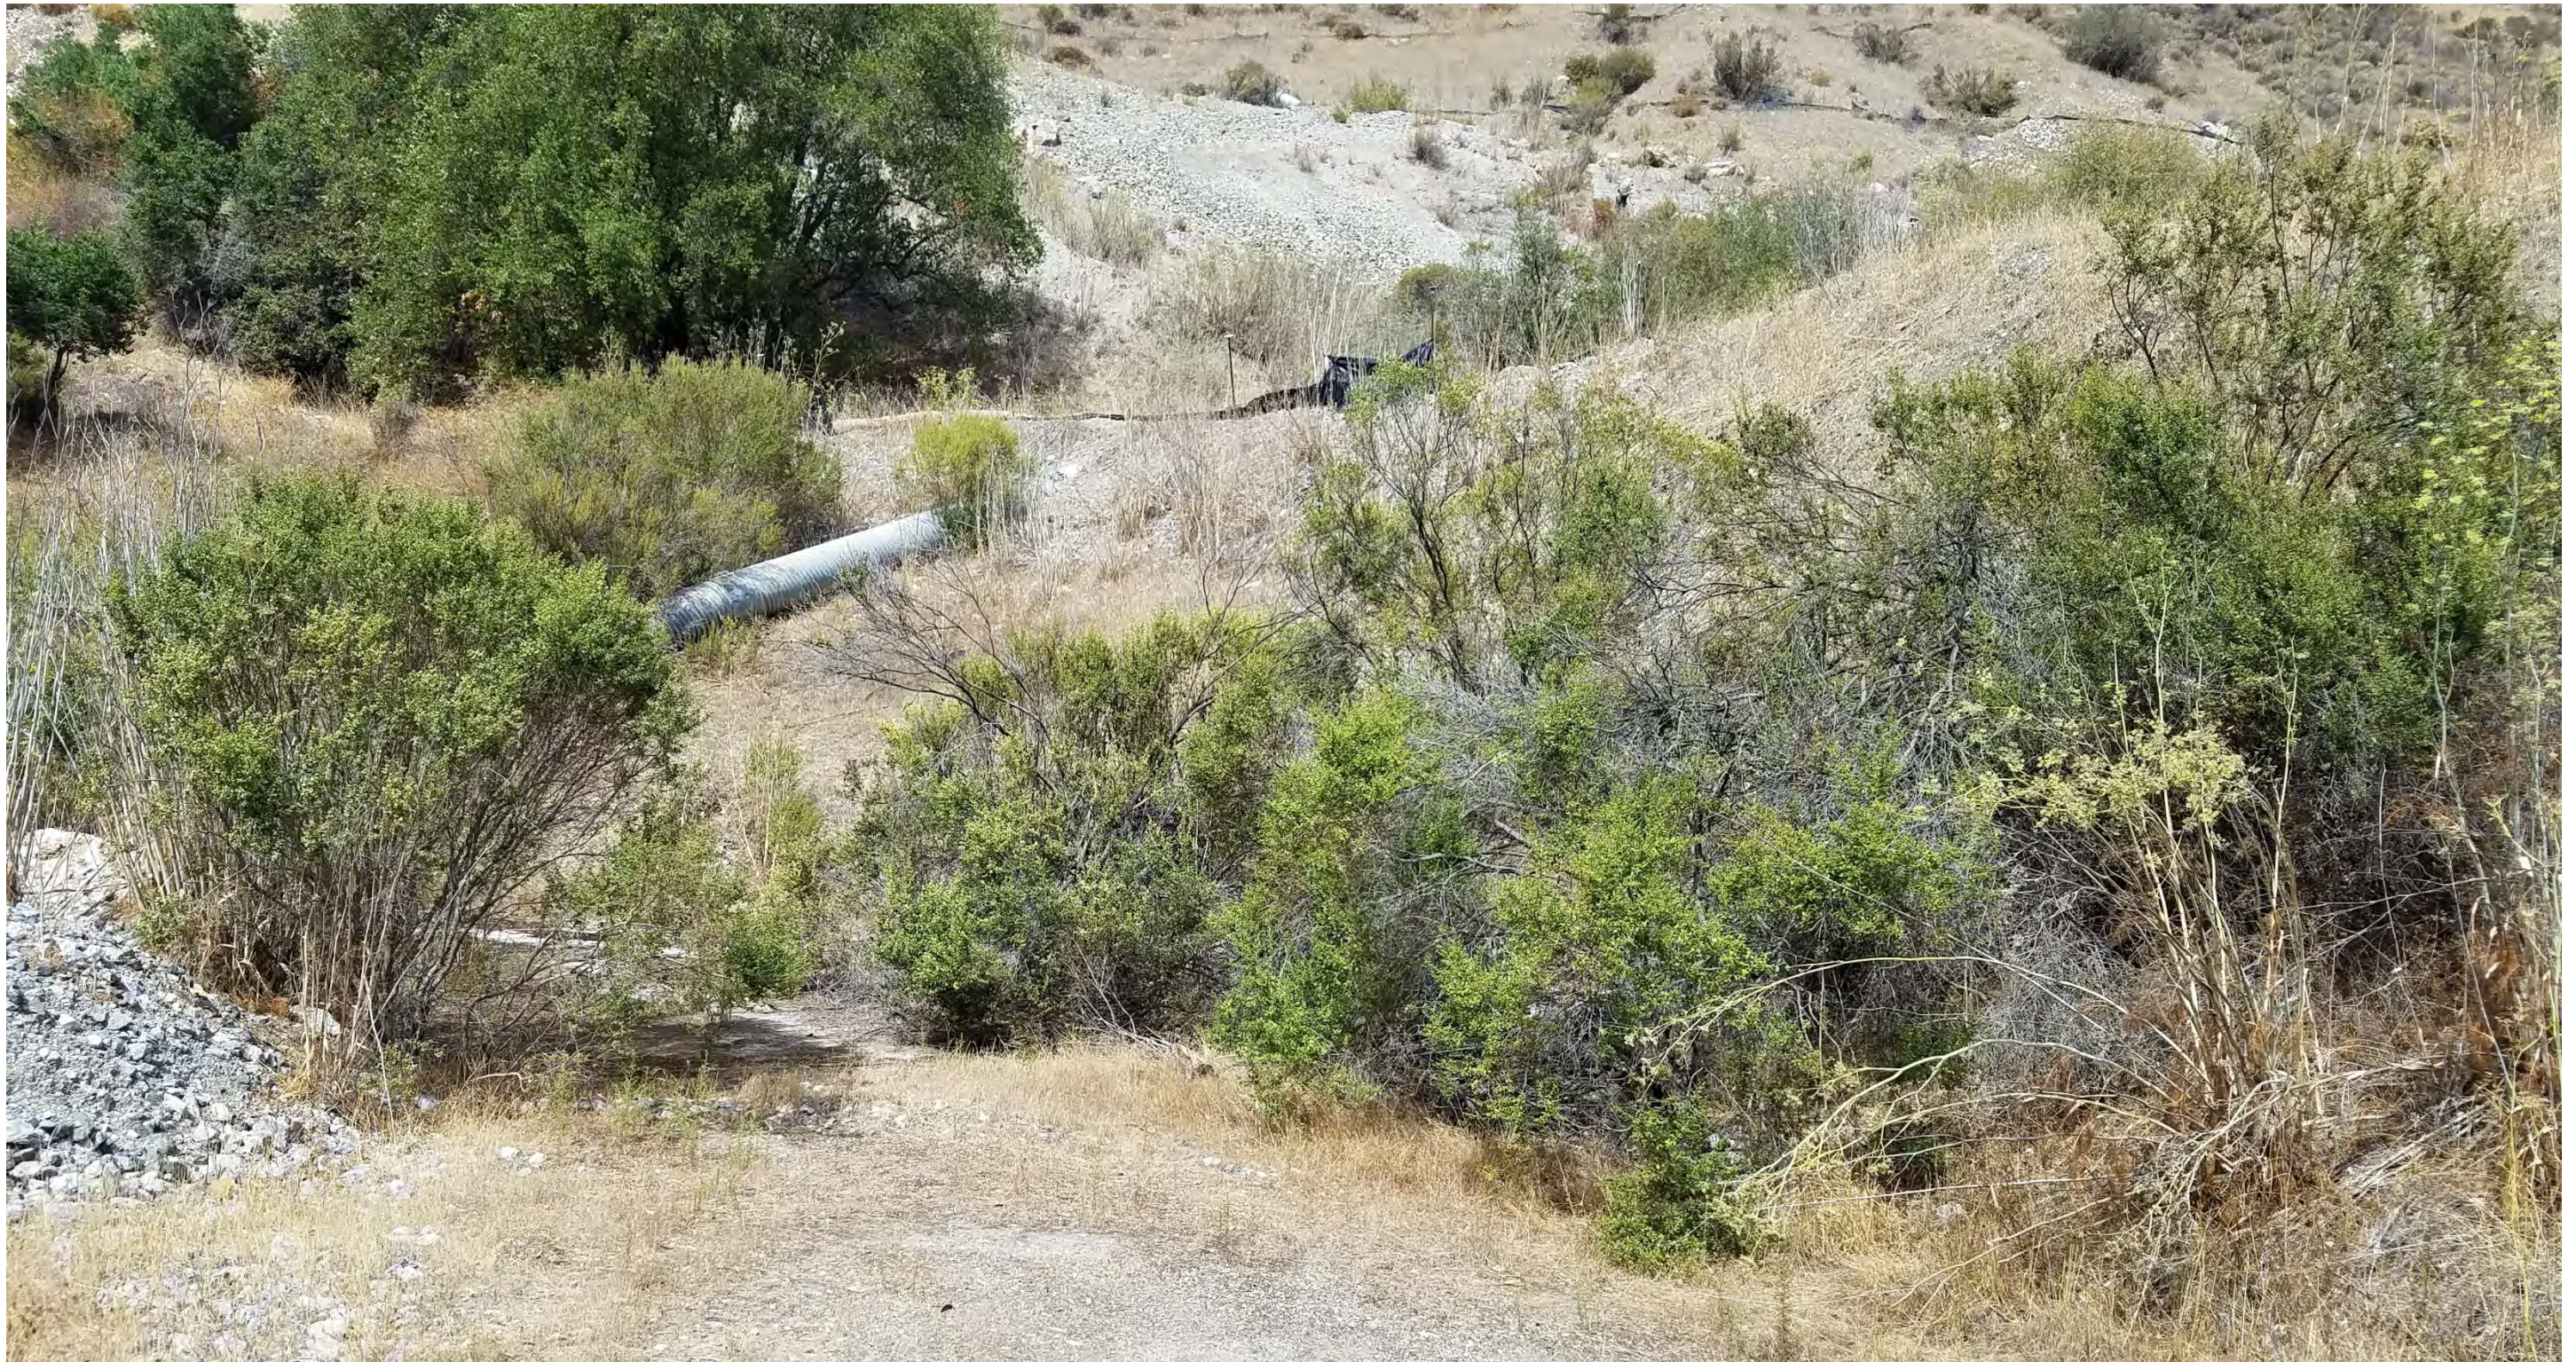
PHOTO #14 – Slopes above Pond 13

Sediment that erodes from the surge pile is detained in ponds. Next to the surge pile are slopes above Pond 13.

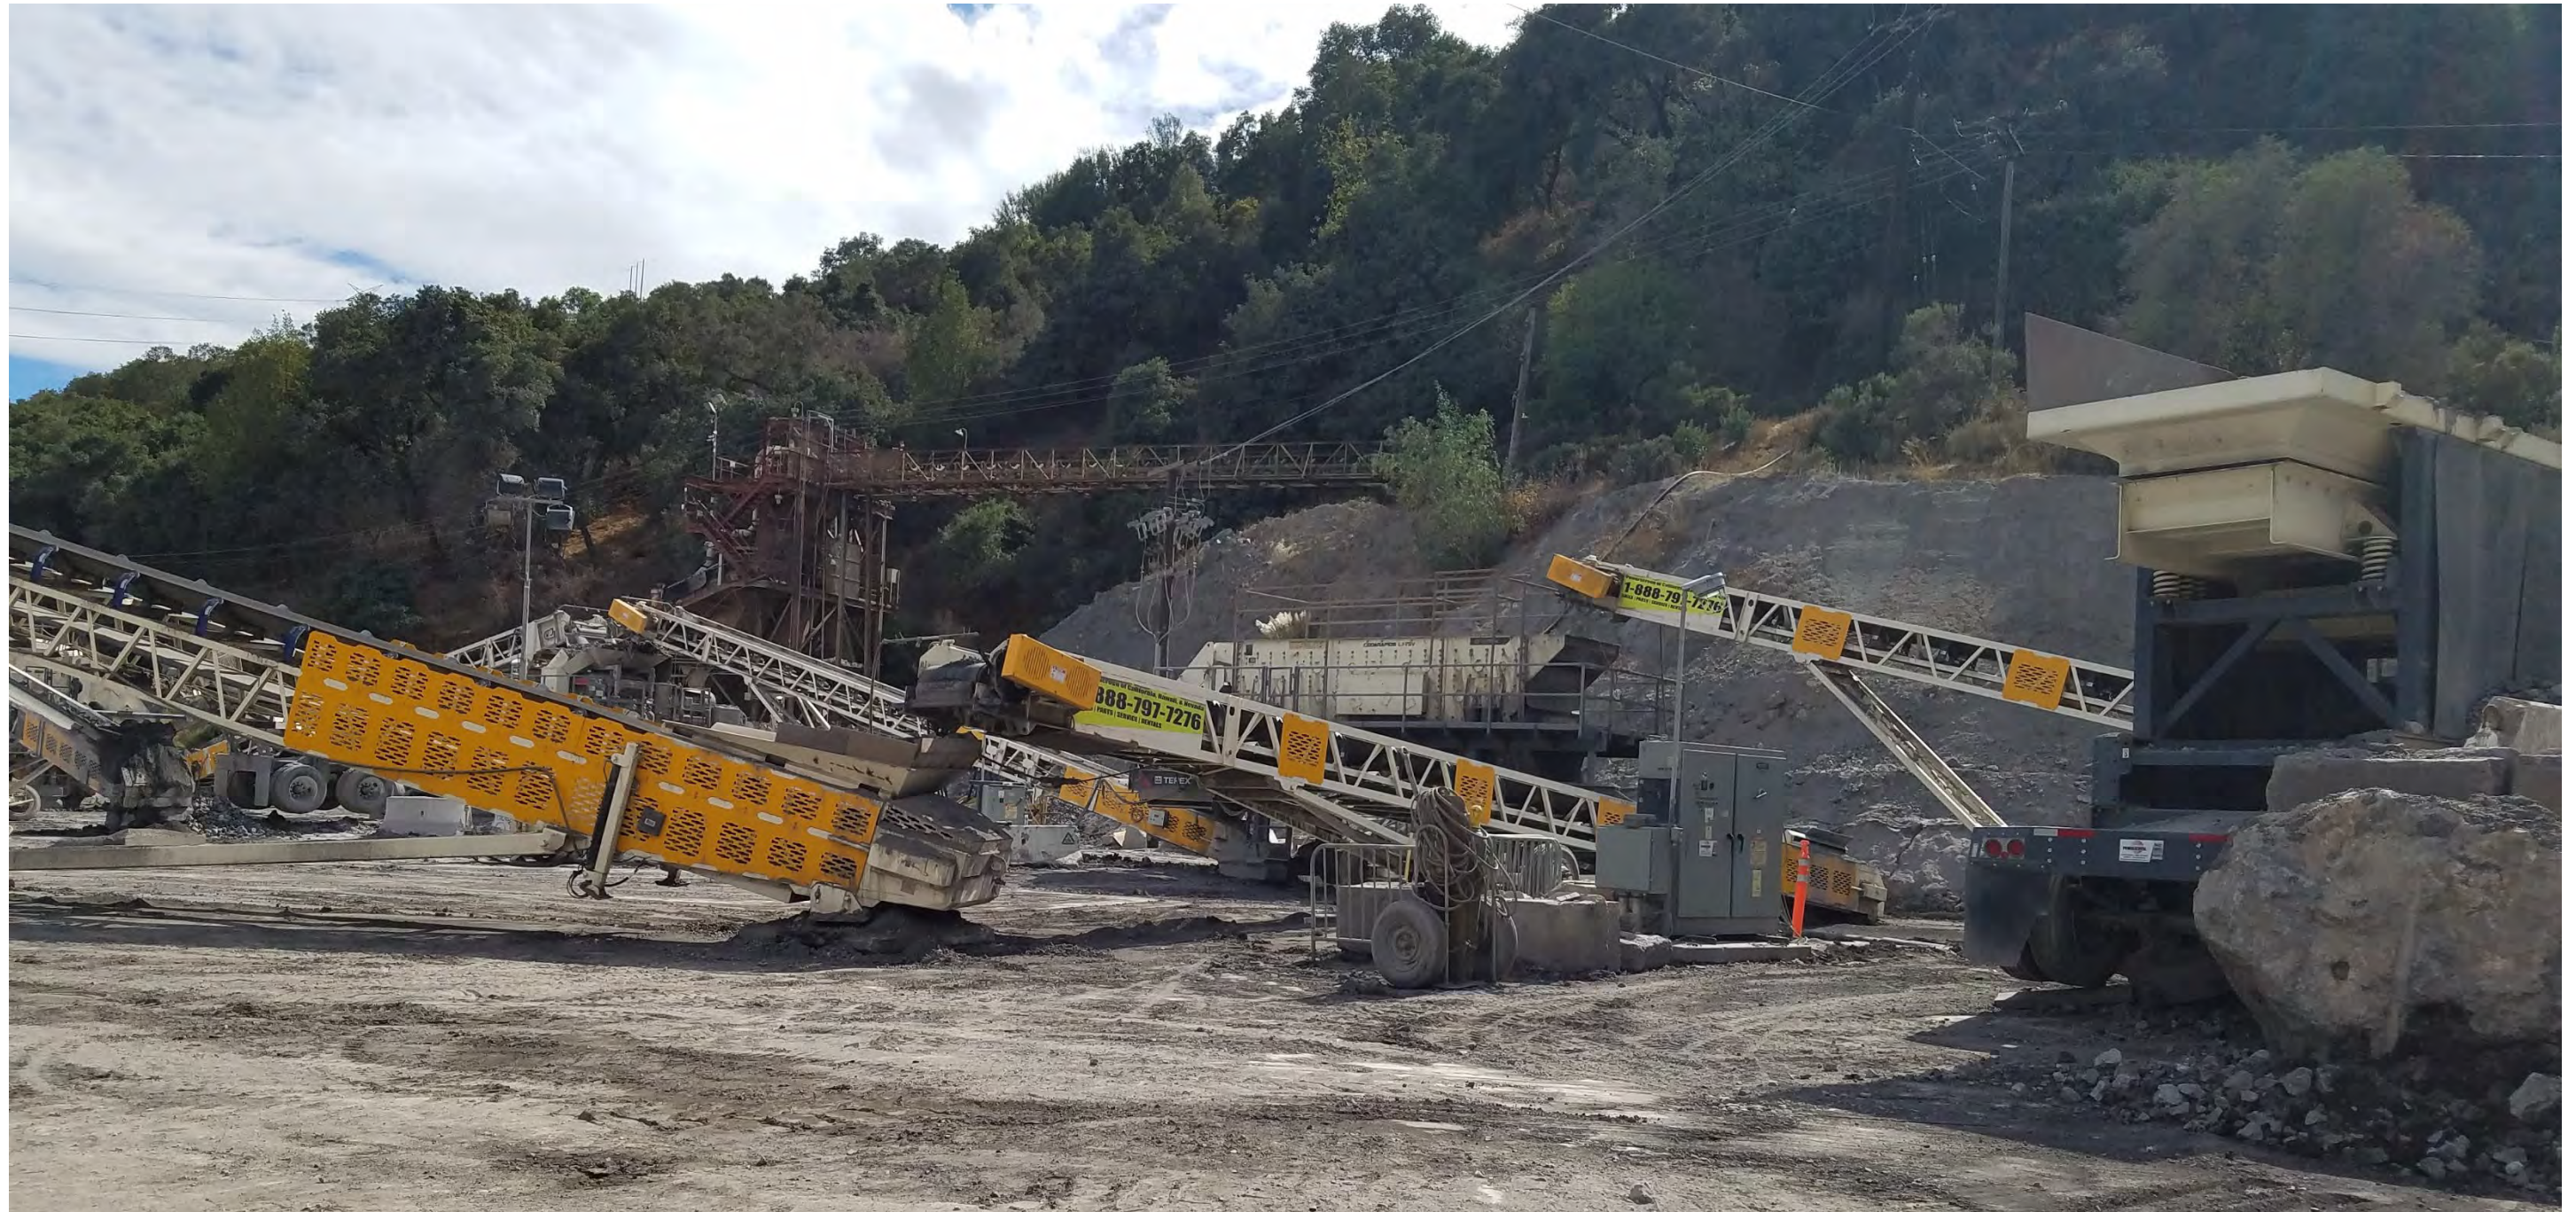
In the Rock Plant area Lehigh has setup portable equipment to process aggregate. [See **PHOTO #15.**] Runoff from the rock plant area was previously being directed into Pond 17. [See **PHOTO #16.**] Pond 17 has been decommissioned and the runoff which was previously routed to Pond 17 now flows into a new basin in Permanente Creek installed at the direction of the San Francisco Bay Regional Water Quality Control Board, which is located outside of the Reclamation Plan boundary.

PHOTO #15 – New aggregate processing equipment.

The rock plant did not appear to be operating during the inspection; however, it was active during portions of 2022. Runoff from the rock plant was previously being directed into Pond 17.

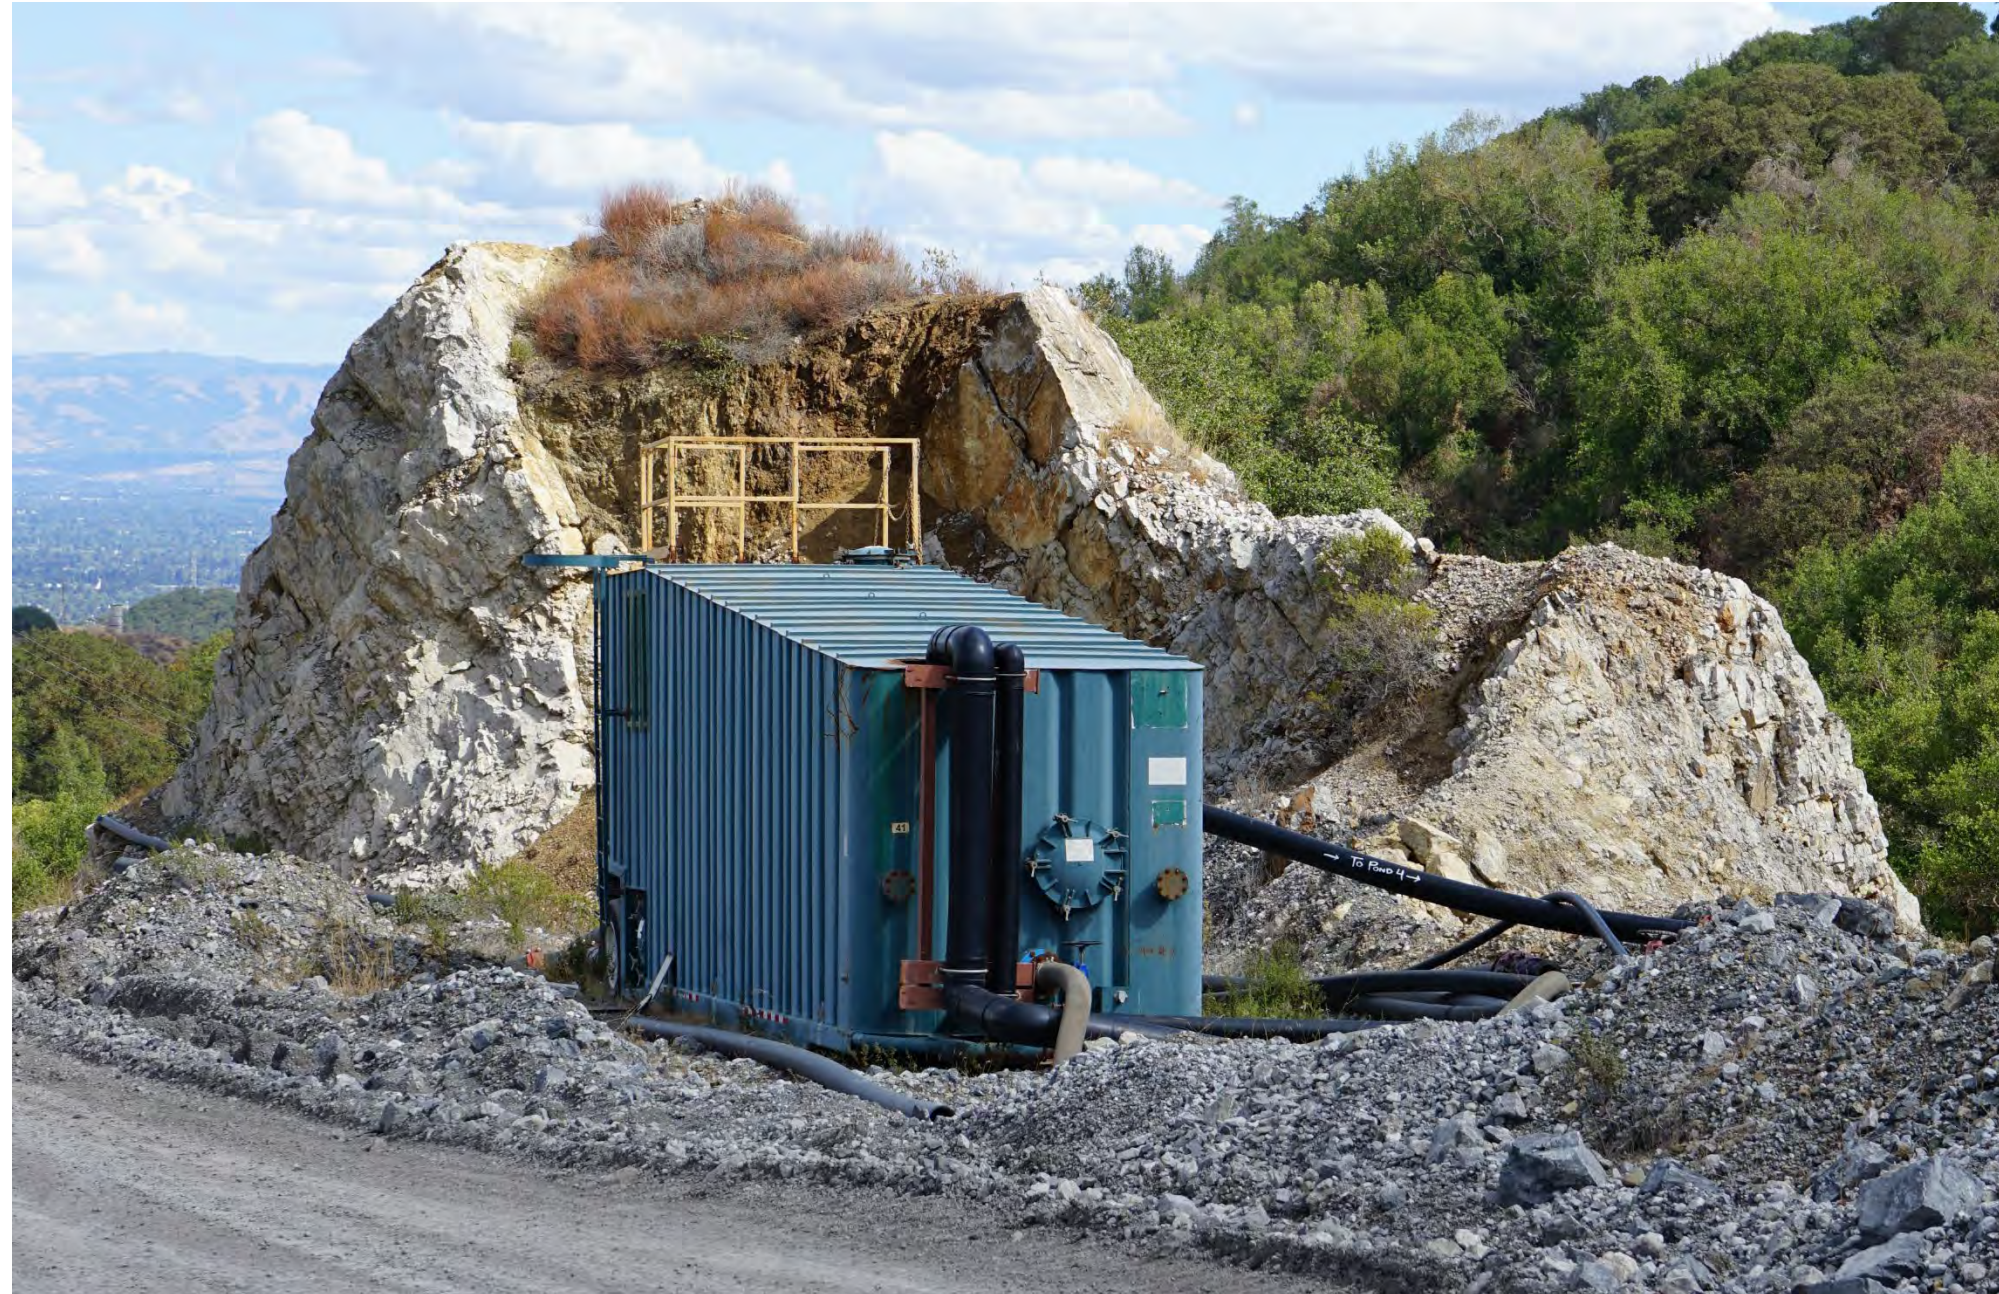
Adjacent to former Pond 4A is water treatment and filtration equipment used to remove selenium from quarry water prior to discharge into Permanente Creek. [See **PHOTOS #17 and #18.**] Associated tanks are located adjacent to Pond 1250. [See **PHOTO #19.**]

PHOTO #17 Blending tank above former Pond 4A

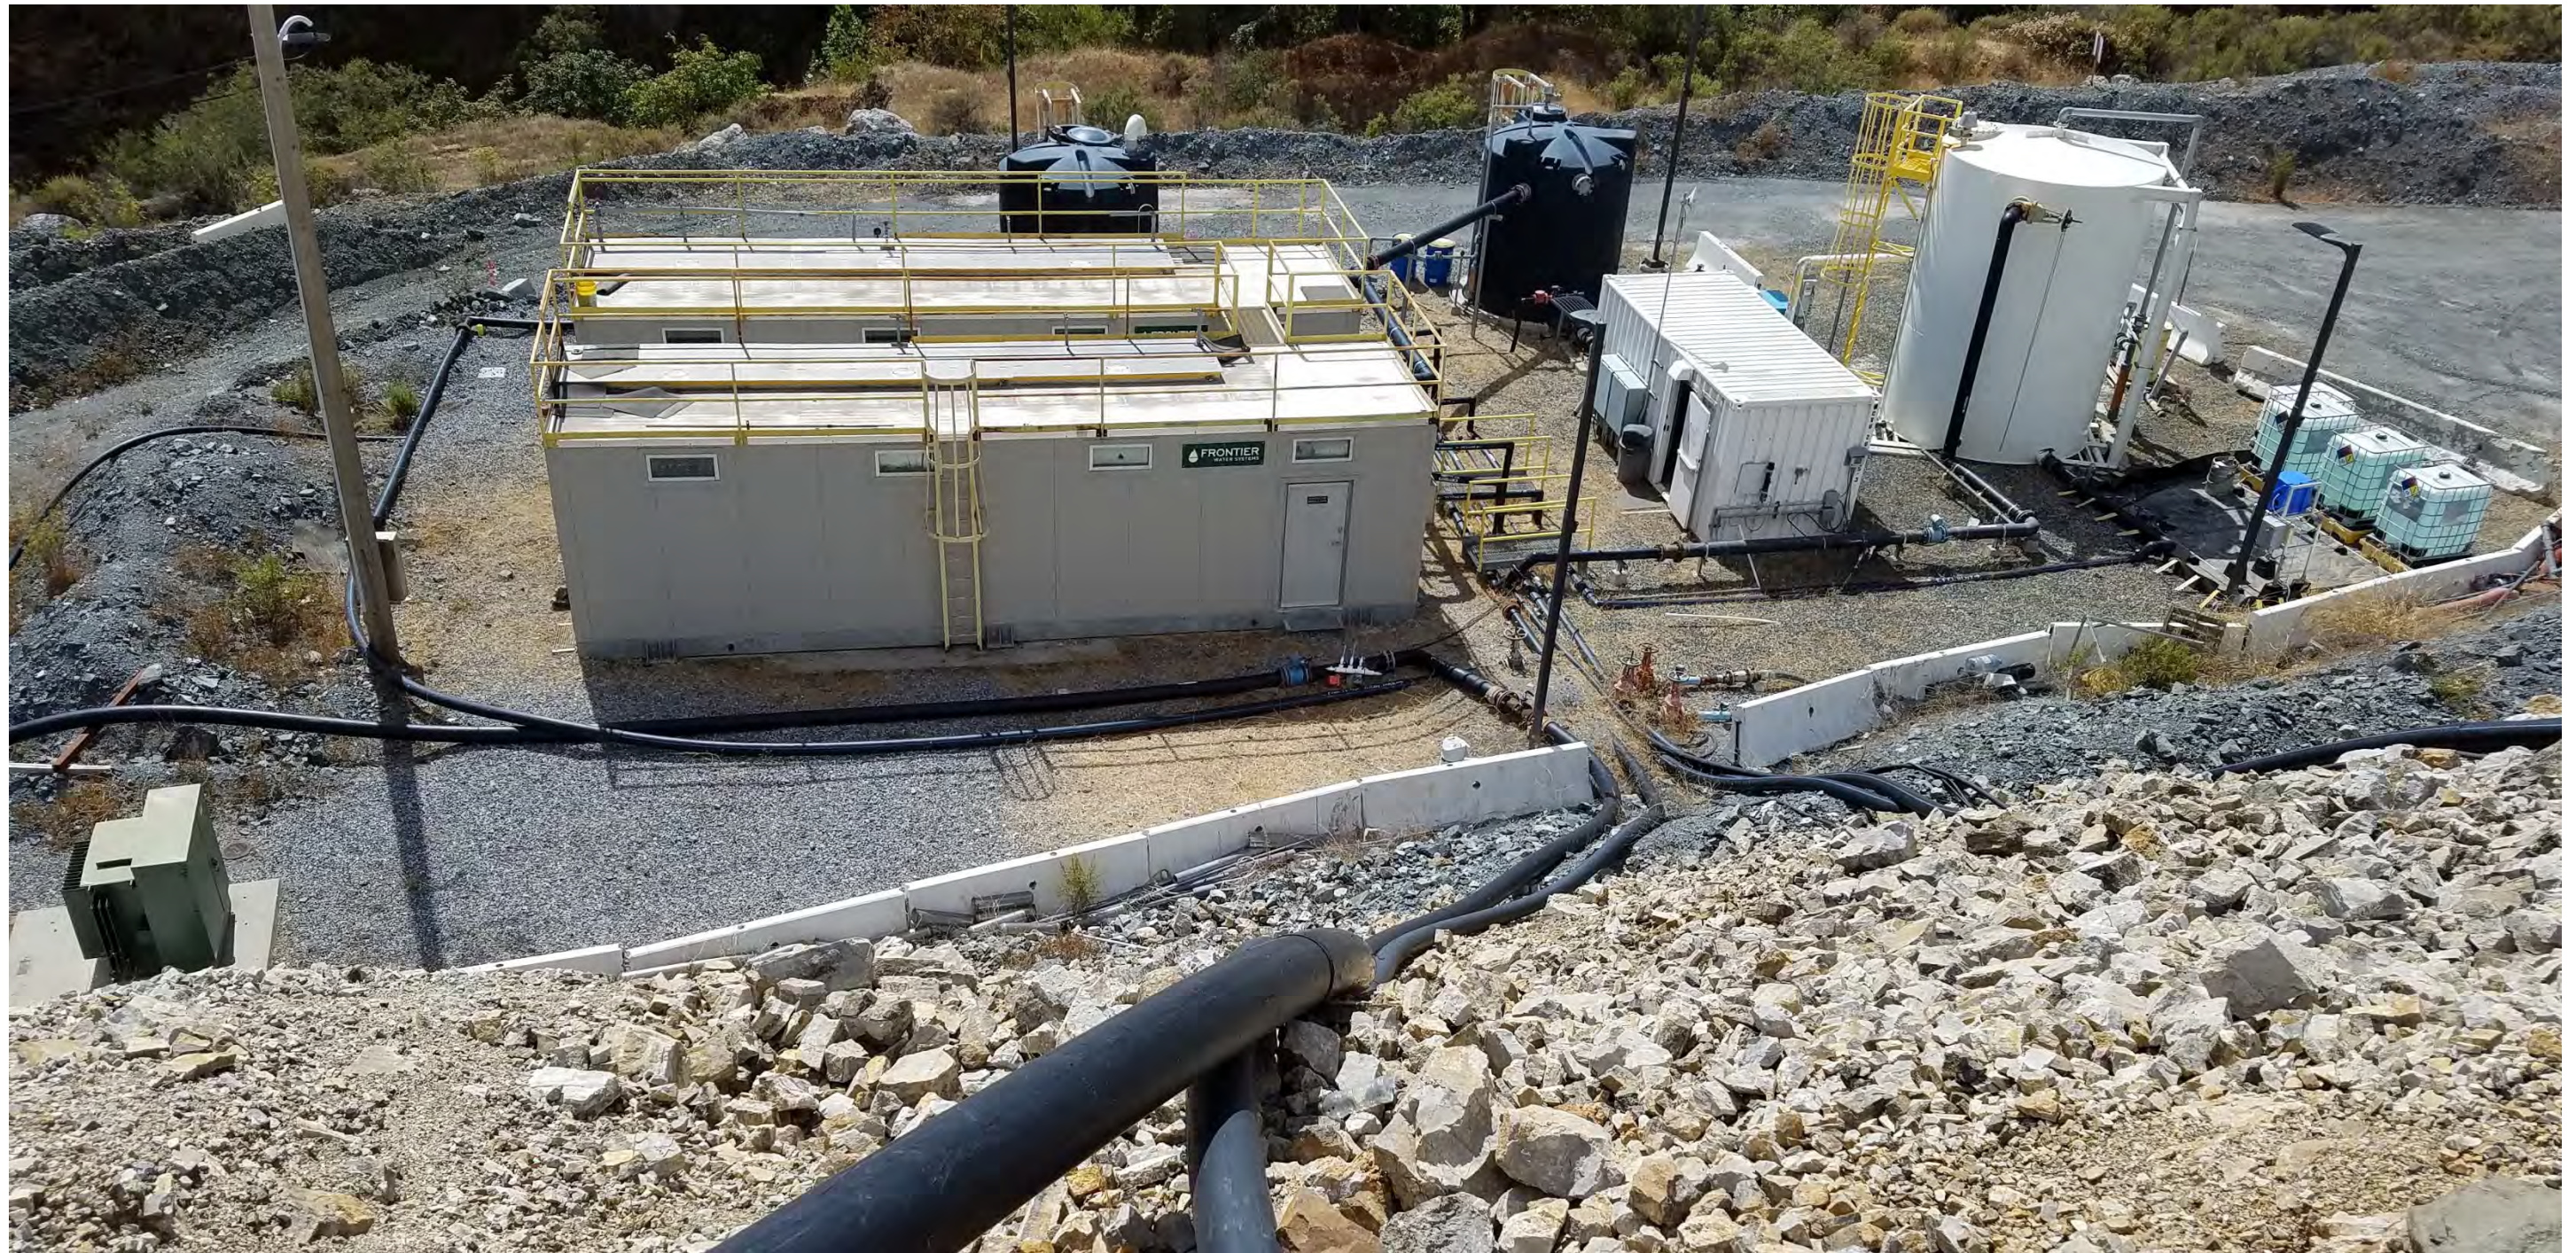
PHOTO #18 – Treatment System near former Pond 4A

Adjacent to former Pond 4A is water treatment and filtration equipment used to remove selenium from quarry water prior to discharge into Permanente Creek.

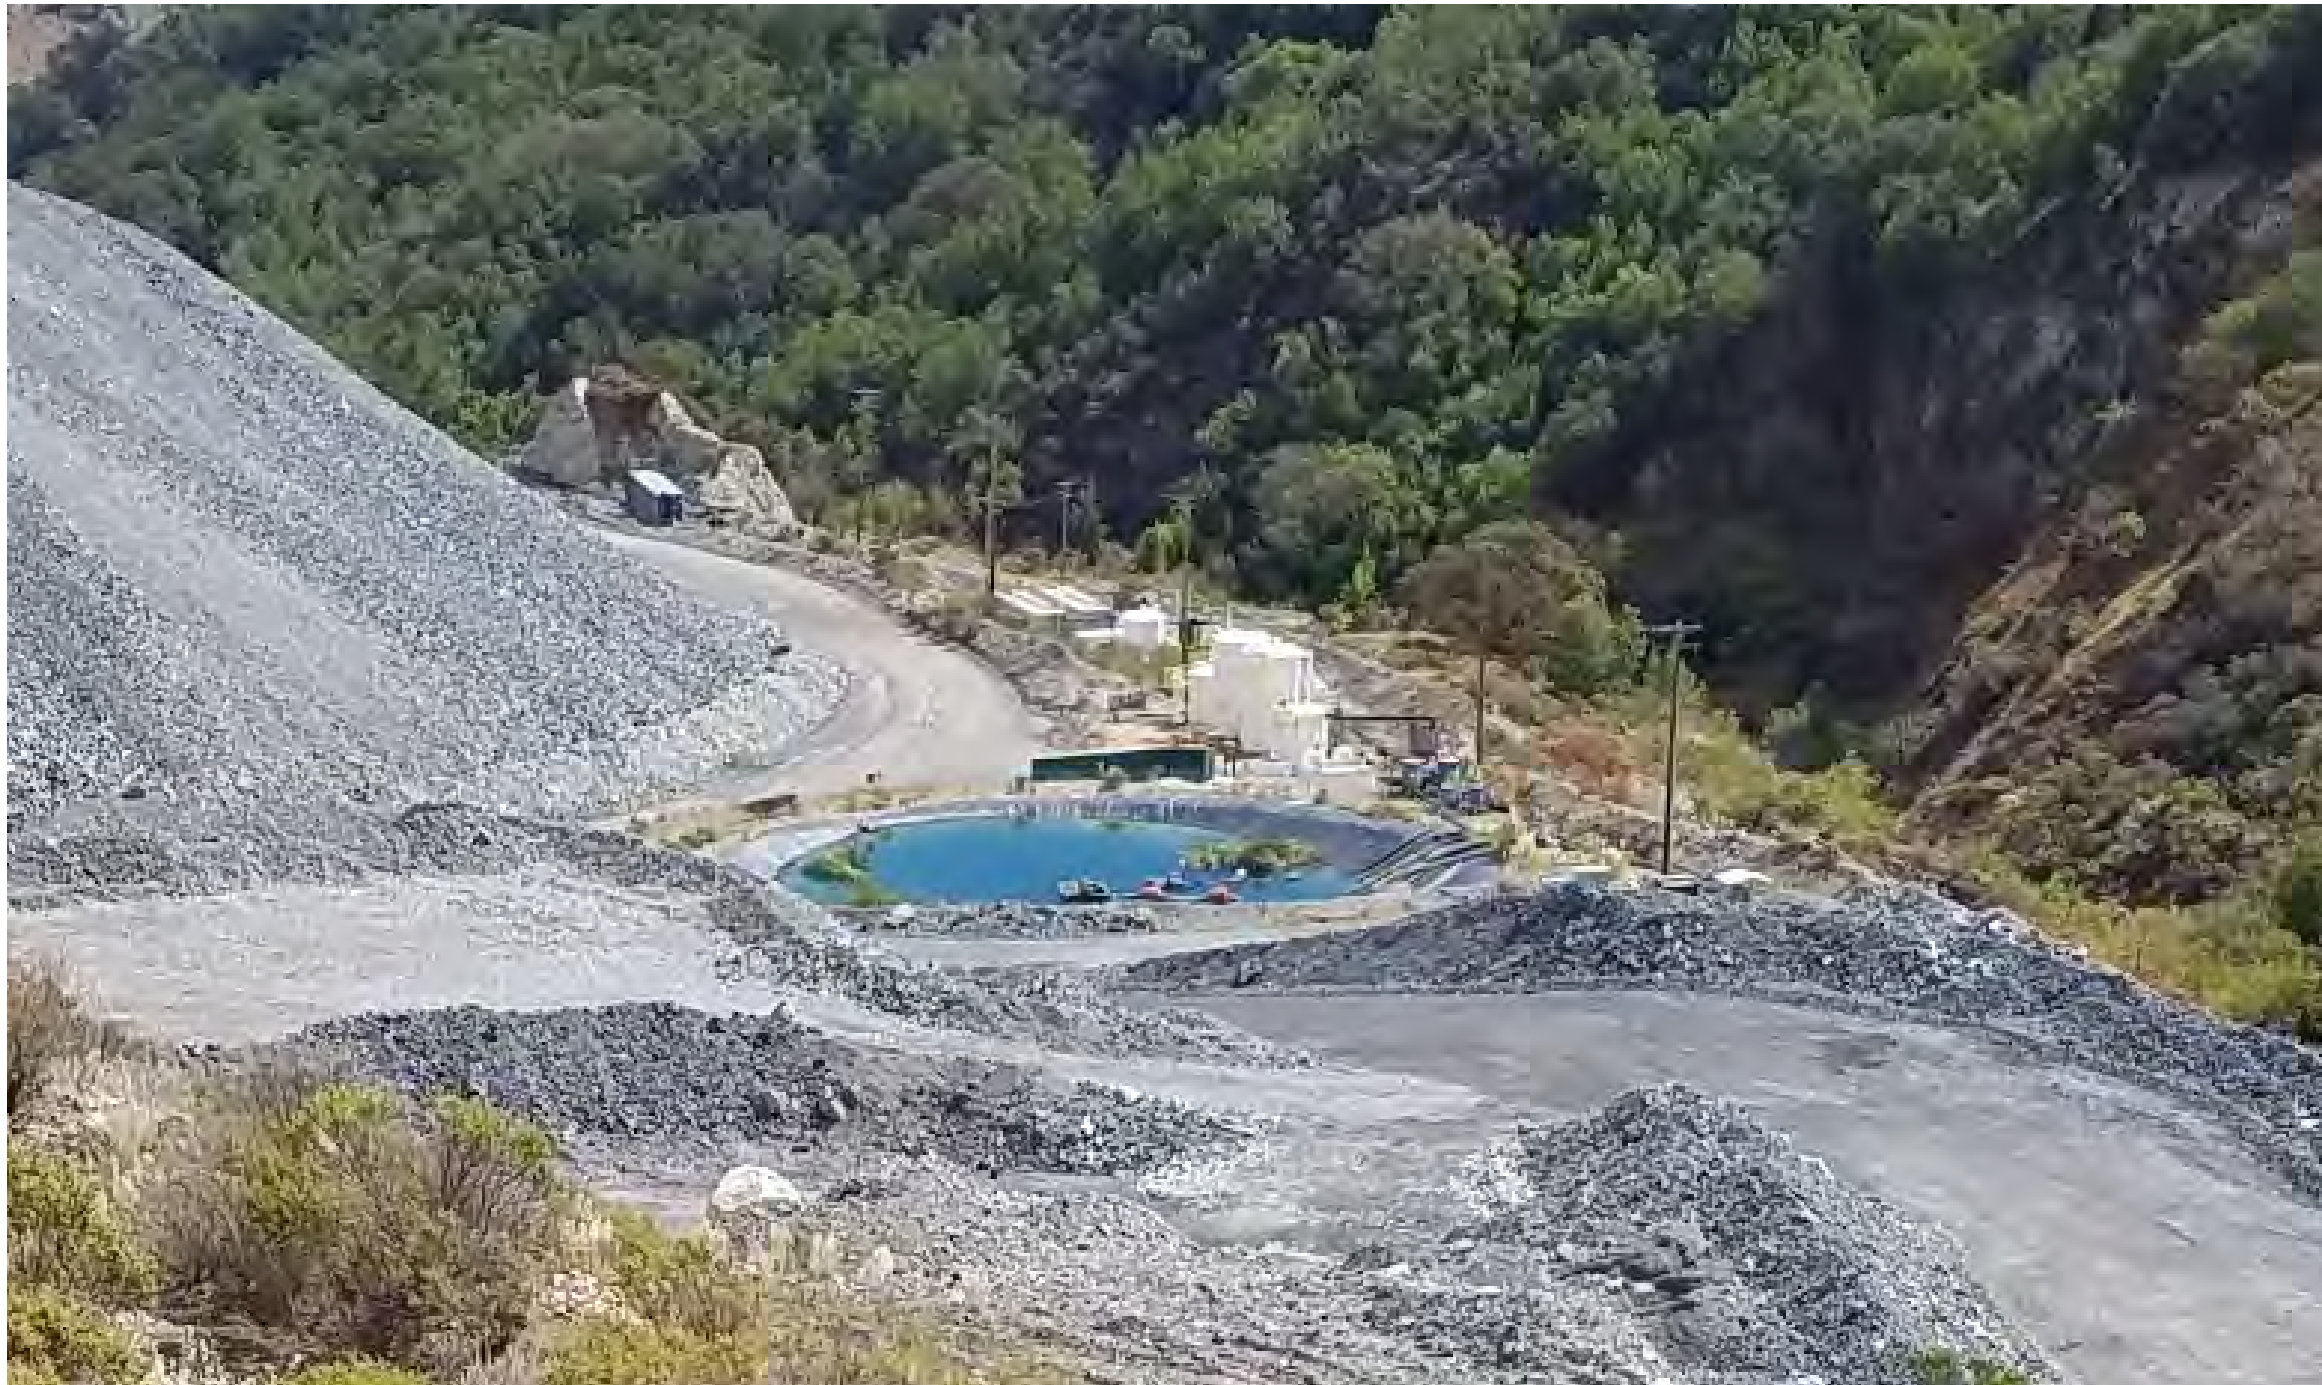
PHOTO #19 – Treatment tanks near Pond 1250

Associated tanks are located adjacent to Pond 1250.
