SURFACE MINING INSPECTION REPORT

BACKGROUND

Lehigh Quarry is a vested hard rock quarry which has been in operation since approximately 1903. The operation primarily harvests limestone for the production of cement but has also produced greenstone aggregate in the past. Over time the quarrying operation has expanded, and now encompasses 546 acres of disturbed area. The site also includes a cement plant operating under a Use Permit and located outside of the Reclamation Plan area. The current Reclamation Plan was approved in 2012 as an amendment to the 1985 Reclamation Plan.

Photos from 2022 Annual SMARA Inspection Conducted on 9-20-2022

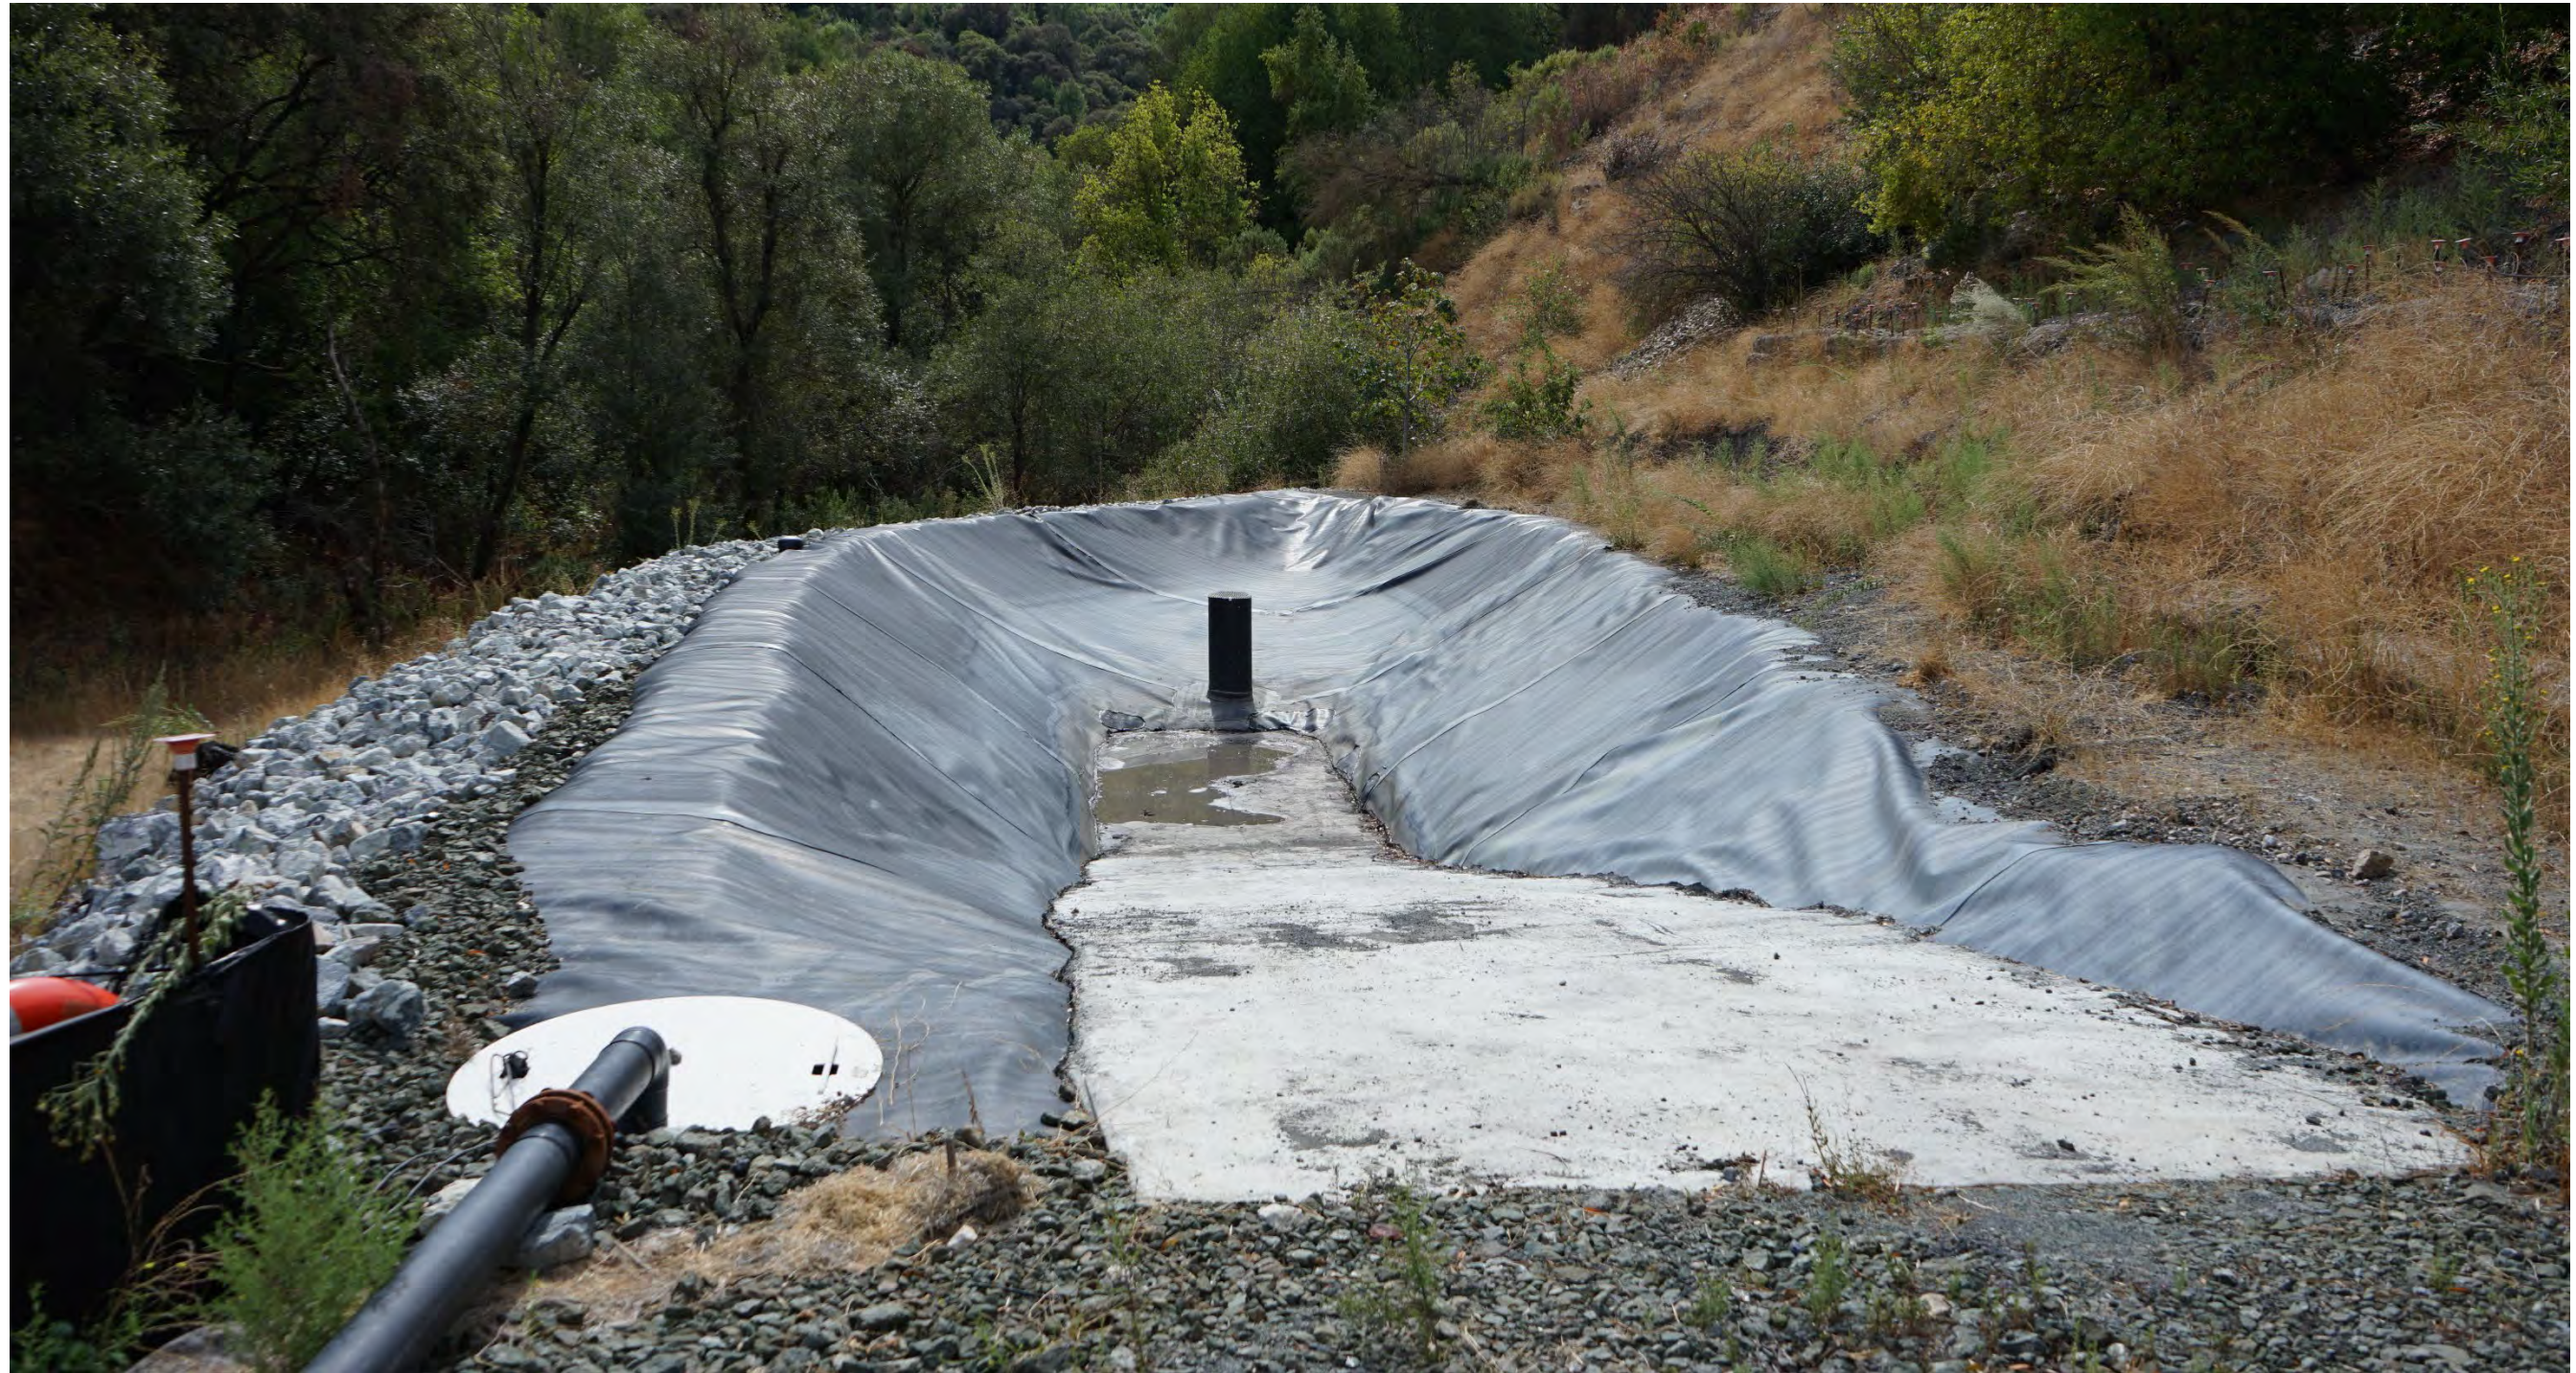
No new SMARA violations were noted during the annual inspection. As previously reported, on June 13, 2019 the County issued a Notice of Violation (Attachment C) for sediment discharge into Permanente Creek in the vicinity of the Yeager Yard [See **Photo 25**]. As required by the June 13, 2019 NOV, the operator created a lined sediment basin to prevent any more sediment or loose rock from entering the Permanente Creek channel [See **Photo 26**], replaced old silt fences upslope of the discharge area [See **Photo 22**], placed straw bales which have since been removed above the lined sediment basin [See **Photo 27**]. On April 27, 2020, the County informed Lehigh that they had abated the violation

Photo #26 – Debris basin
