NORFLEET CONSULTANTS

December 7, 202
NC Proj. No. 201881.61

RE: Stevens Creek Quarry Use Permit and
Reclamation Plan Application
12100 Stevens Canyon Road
Cupertino, CA 95014

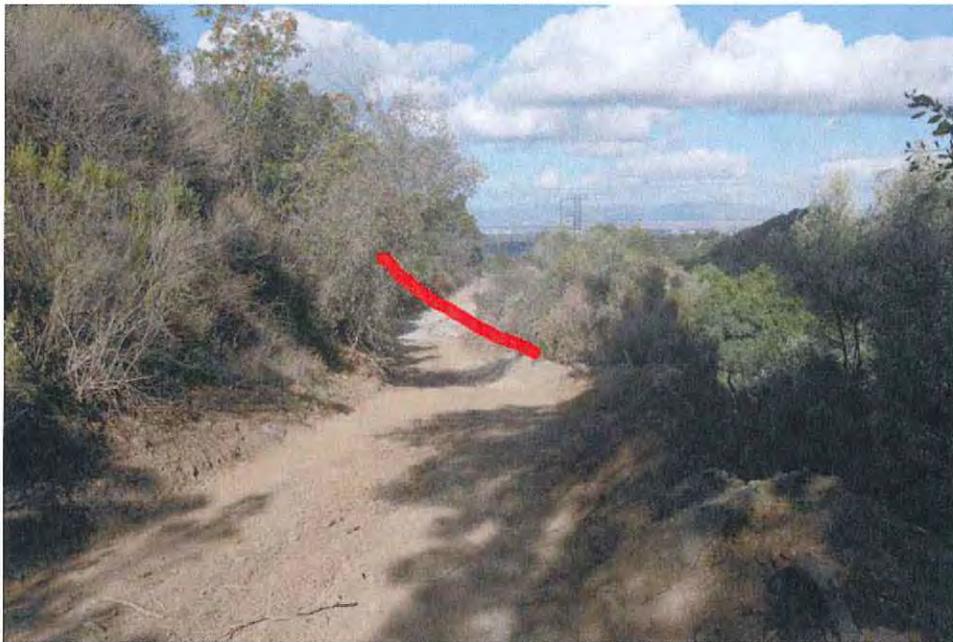
Photo 2: A dirt road northeast of the quarry, looking north. The red line indicates the approximate location of the Berrocal fault northeast of the Quarry. See Figure 6 for the location. Santa Clara units crop out on the far side of the red line. Franciscan limestones crop out in the road on the near side of the red line. Also see photograph 16.

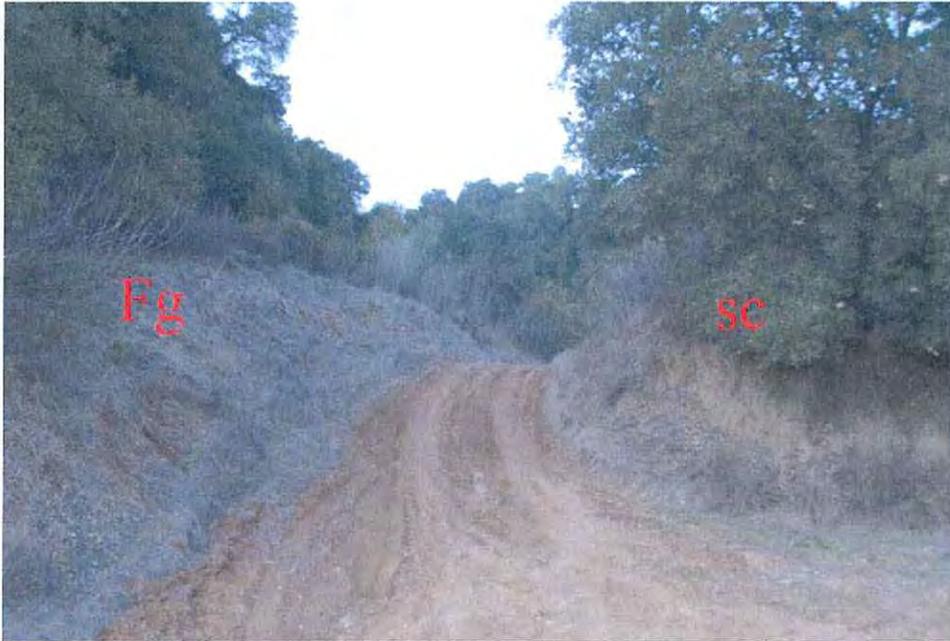
At the southern two locations (Locations 2 and 3 -Figures 5 and 12 and Photos 3 and 26), readily identifiable Santa Clara units crop out, but the Franciscan is covered with float. The fault zone is west of these locations. These locations are at approximately the same elevation (650 to 675 feet) and provide an approximate fault trace of N 5° to 7° W.

Photo 3: Looking north along a dirt road at the southeast corner of the quarry. See Figure 6 for the location. Santa Clara units (labeled sc, dipping more than 40 degrees to the east) are on the right side of the road. The Berrocal fault trends semi-parallel to and left (west) of the road. Franciscan float (Fg) is on the left side of the road. See Photograph 25 for location.

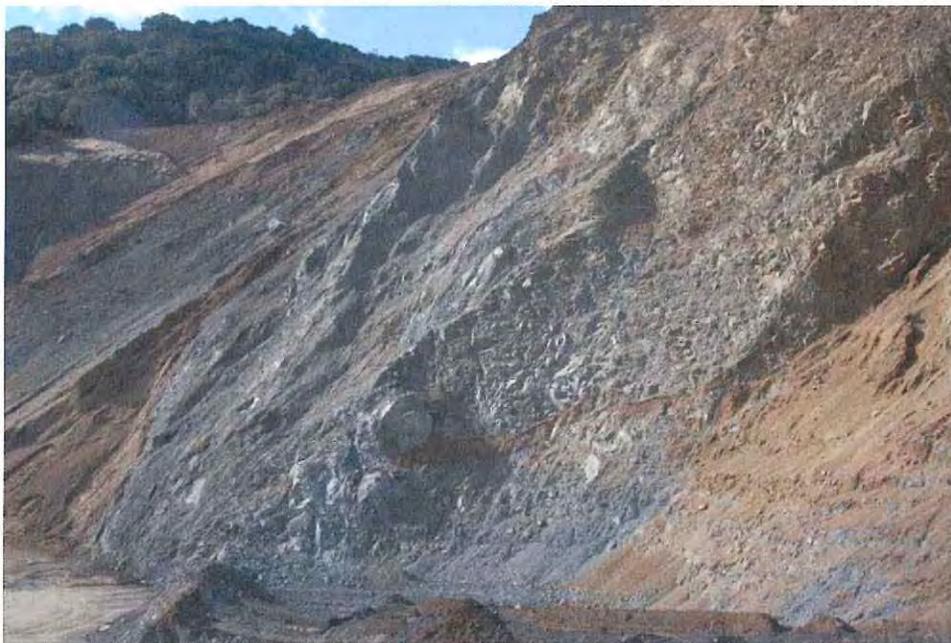
Fracturing within the greenstone cores is relatively widely spaced, and the unfractured greenstone is quite hard (Photo 4). When the cores are mined, the larger greenstone blocks are broken up with a concrete breaker (these rocks were blasted in the past). Fracture spacing, block size, and global rock competence all decrease away from the core to the degree that the rock can be ripped. The shear between the two greenstone zones appears to be combination of serpentine, clay, and highly sheared greenstone (Photos 5 and 6). It can be easily broken apart with a geologist's hammer. Surface topography mimics rock competence. The high ridges overlie the competent cores, while a valley is

Photo 4: Hard (less jointed) greenstone in the core of the north face.

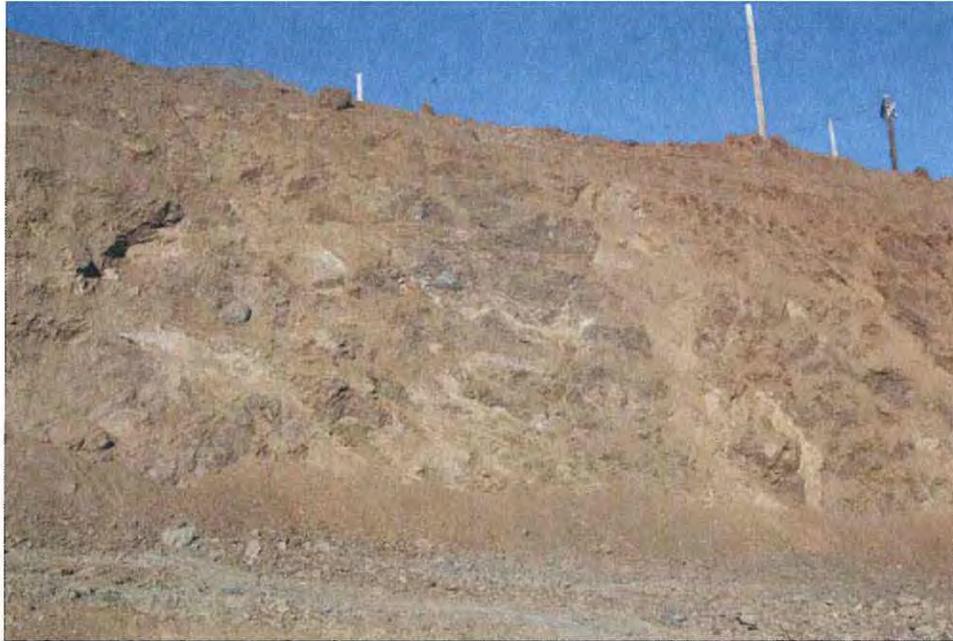
Superimposed on these relationships is the effect of weathering. The upper 2 to 20 feet consists of a reddish brown residual soil (Photos 7 and 8). This overlies moderately to highly weathered bedrock (a 50 to 90 percent rock/soil mixture) that can extend another 5 to 20 feet. Below this is slightly weathered bedrock. This has weathered brown but contains no observable soil. It is more fractured than the underlying unweathered bedrock. Overall weathering and fracturing (with respect to gross rock competence) decreases with depth. Based on color changes and failure mechanisms, the weathered zone extends 80 to 100 feet below the ground surface. We will refer to the rocks below the visibly weathered units (about 100 feet below the ground surface) as unweathered rocks even though weathering on the microscopic level likely extends hundreds of feet below the ground surface. It appears that as weathering increases, joint persistence is reduced. This change increases the surface unraveling of rocks in the weathered zone, but, at the same time, reduces the potential for large-scale wedge failure.

Photo 7: In-place residual soils at the top of the north face. In this area, the residual soils are more that 40 feet thick.

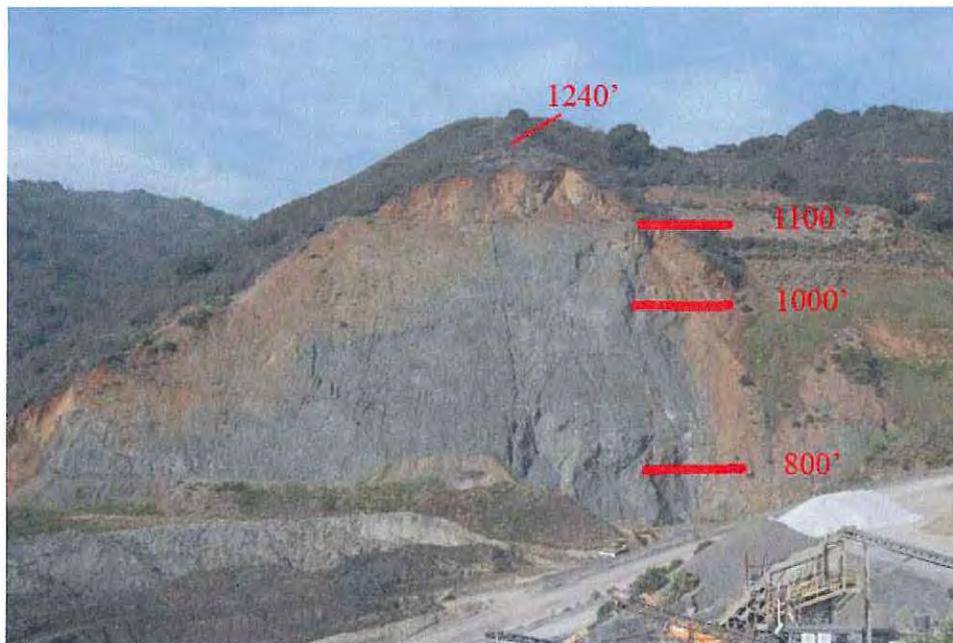
The current western and northern quarry faces are 250 to 300 feet high and slope steeply. The western face is about 12 years old (slopes 40 to 50 degrees east; Photos 8 and 17). The upper bench was cut 6 to 7 years ago. The northern face is 2 to 3 years old (slopes 45 to 70 degrees south; (Photo 13). Various sized wedge failures occur in the lower, unweathered material in the western face (Photo 14). These failures range in size from a few cubic yards to hundreds of cubic yards. We did not observe similar wedge failures in the northern face. It is likely that the observed failure differences between the two faces is a function of joint patterns and the trend of each face.

Photo 8: The west face. Note the change in color marking the irregular boundary between weathered and unweathered greenstone. The slope on the right side cast fill. The elevations are approximate.

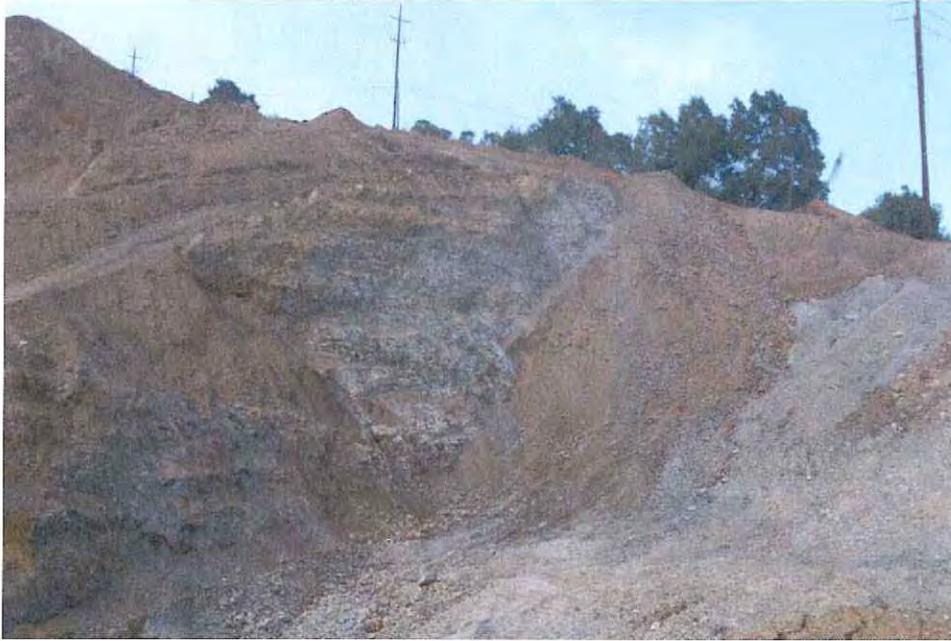
A small area of Franciscan limestones and sedimentary units is located at the northeast corner of the pit (Photo 9). This unit appears to be the southern continuation of a limestone trend on the Kaiser-Permanente quarry. A shear zone separates greenstone from limestone units. The shear zone is 50 to 80 feet wide. Shear indicators were not visible. The Berrocal fault marks the eastern boundary of this area. Like the greenstones, the limestones and sedimentary units are strongly fractured, and it appears that fracturing increases adjacent to the Berrocal fault. Sandstone units at the northeast corner of the quarry (adjacent to the Berrocal fault) showed indications of mineralization while adjacent clays (not the shear zone clays) were moist. No free groundwater was encountered. The moist zone was about 100 feet in diameter and confined to the clays along the eastern border of the pit.

Photo 9: Franciscan limestones at the northeast corner of the quarry. This outcrop has been mined.

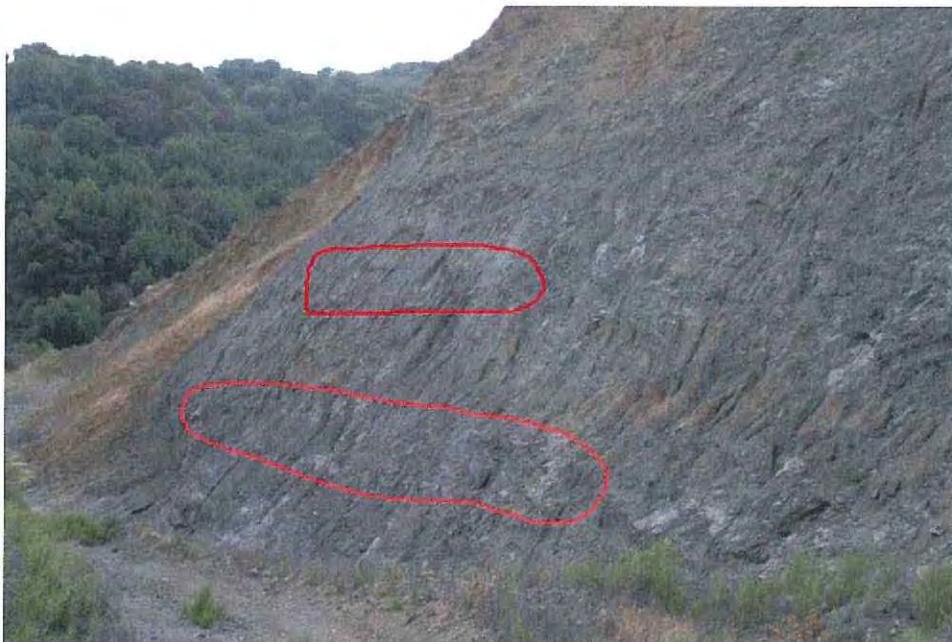
We observed two seepage areas in the quarry walls (Figure 8). One is located in the west face near the south end of the quarry, and the second is located in the middle of the north face. The western seepage area (Photo 10) consists of a series of sub-horizontal seeps that extend 100 to 150 feet at about the 800 foot elevation. At the time of our site visit (in the fall, the driest time of year), only the southernmost seep was active, producing in the range of 5 to 10 gallons of water per hour. The remainder of the seeps were marked by rinds of efflorescent salts. There was no obvious alteration/weathering of the bedrock in the vicinity of the seeps. This area is at the base of weathered greenstone, and it appears that this zone is related to slope interflow through the weathered zone. It is likely that the flow increases during the winter.

Photo 10: The lower circled area marks a sub-horizontal zone of seeps at the south end of the west face during the summer. The upper circled area marks seeps active during the winter. There were no seep to the right of these zones.

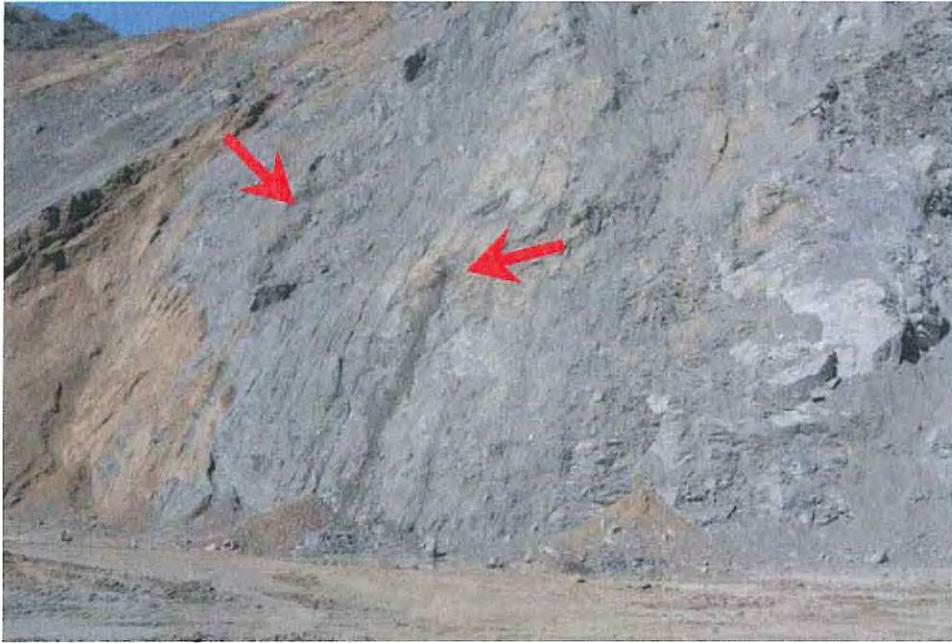
The second seep area is located in hard bedrock in the middle of the north face (Photos 11 and 12) at about elevation 925 feet (the top of the face is above 1200 feet elevation). This zone consists of two seeps, spaced 20 to 30 feet apart at about the same elevation. The flow is in the range of 10 to 20 gallons per hour. There is a 2 to 3 inch wide, vertical clay zone below the eastern seep. The flow from these seeps is currently directed into the existing gravity drainage system. There is no indication that drainage wells have been used in or around the quarry. The majority of the quarry walls are covered with fill, and no obvious indications of seepage were seen in those areas. It is likely that there is some seepage in the northeast corner of the quarry. A seasonally dry valley and dry stream above this part of the quarry trend towards the northwest corner of the quarry.

Photo 11: Seeps in the core of the north face (arrows).

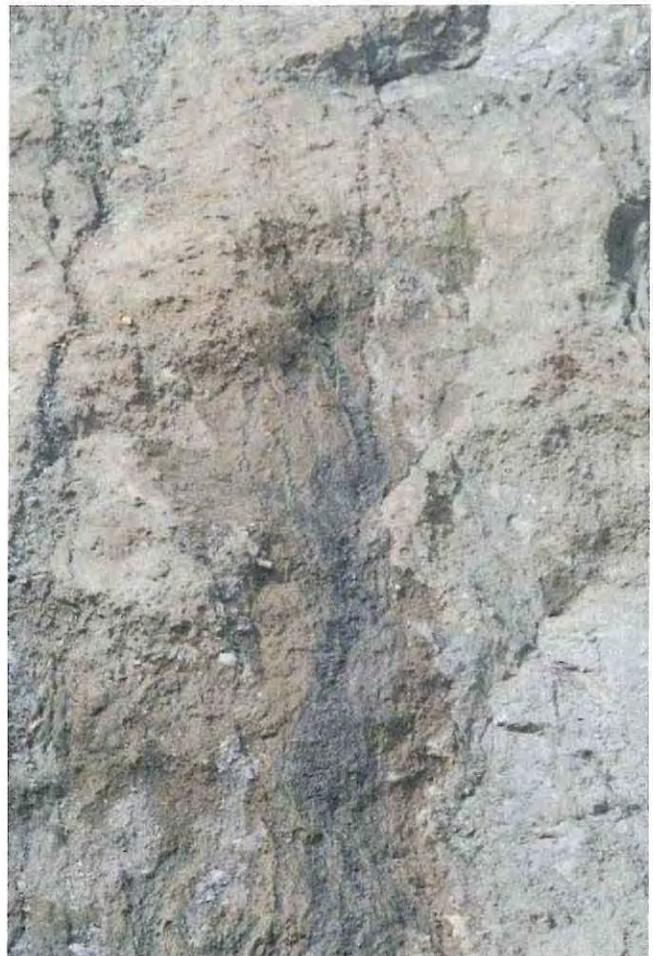
Photo 12: A close-up of the right seep shown in the previous photograph. Note the gray clay seam below the water entry point

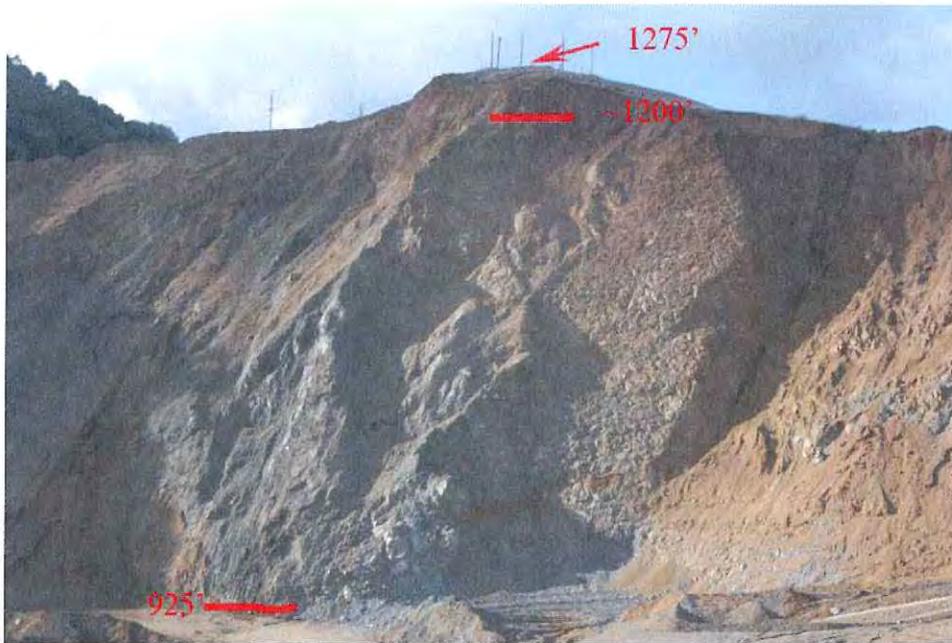
Photo 13: The north face. The reddish-brown slopes on either side of the center of the face are side-cast fills.

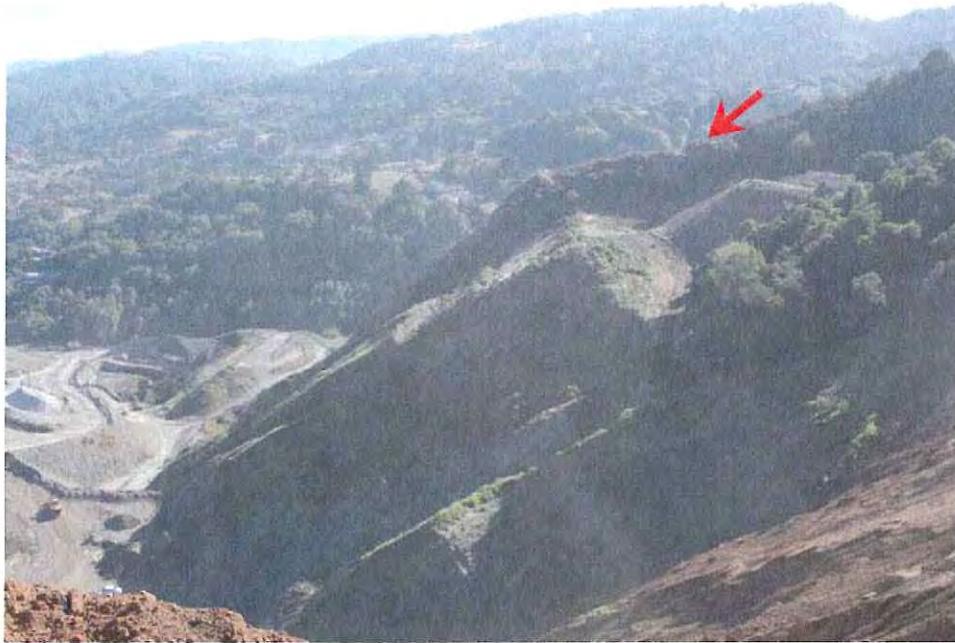
Photo 17: The west slope looking south. The arrow indicates the approximate location of the western property line.

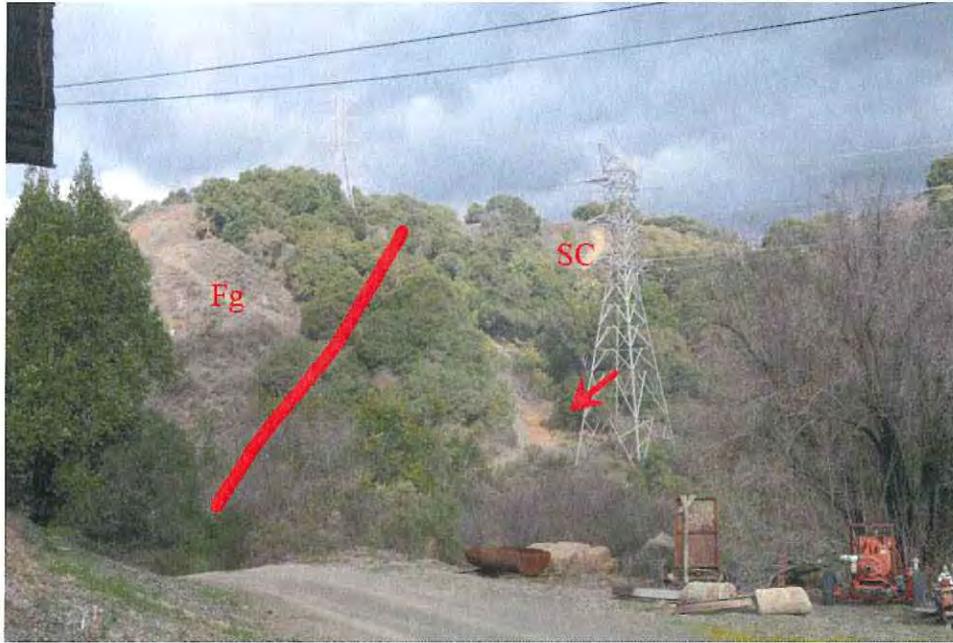
Photo 25: The approximate location of the Berrocal fault (red line). Looking north across the access road to Parcel B. The arrow indicates the location of Photograph 3. The southeast corner of the quarry is at the upper left side of the photograph.

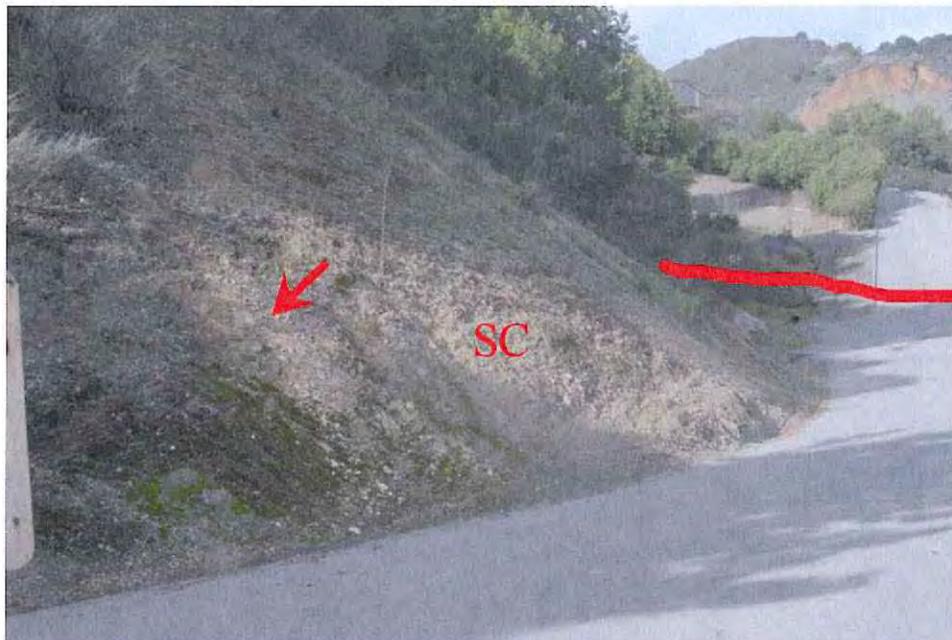
Photo 26: The red line indicates the approximate location of the Berrocal fault. View is to west on the south side of Rattlesnake canyon. The arrow marks the location of the basal Santa Clara fossil bed mapped by Sorg and McLaughlin (1974).

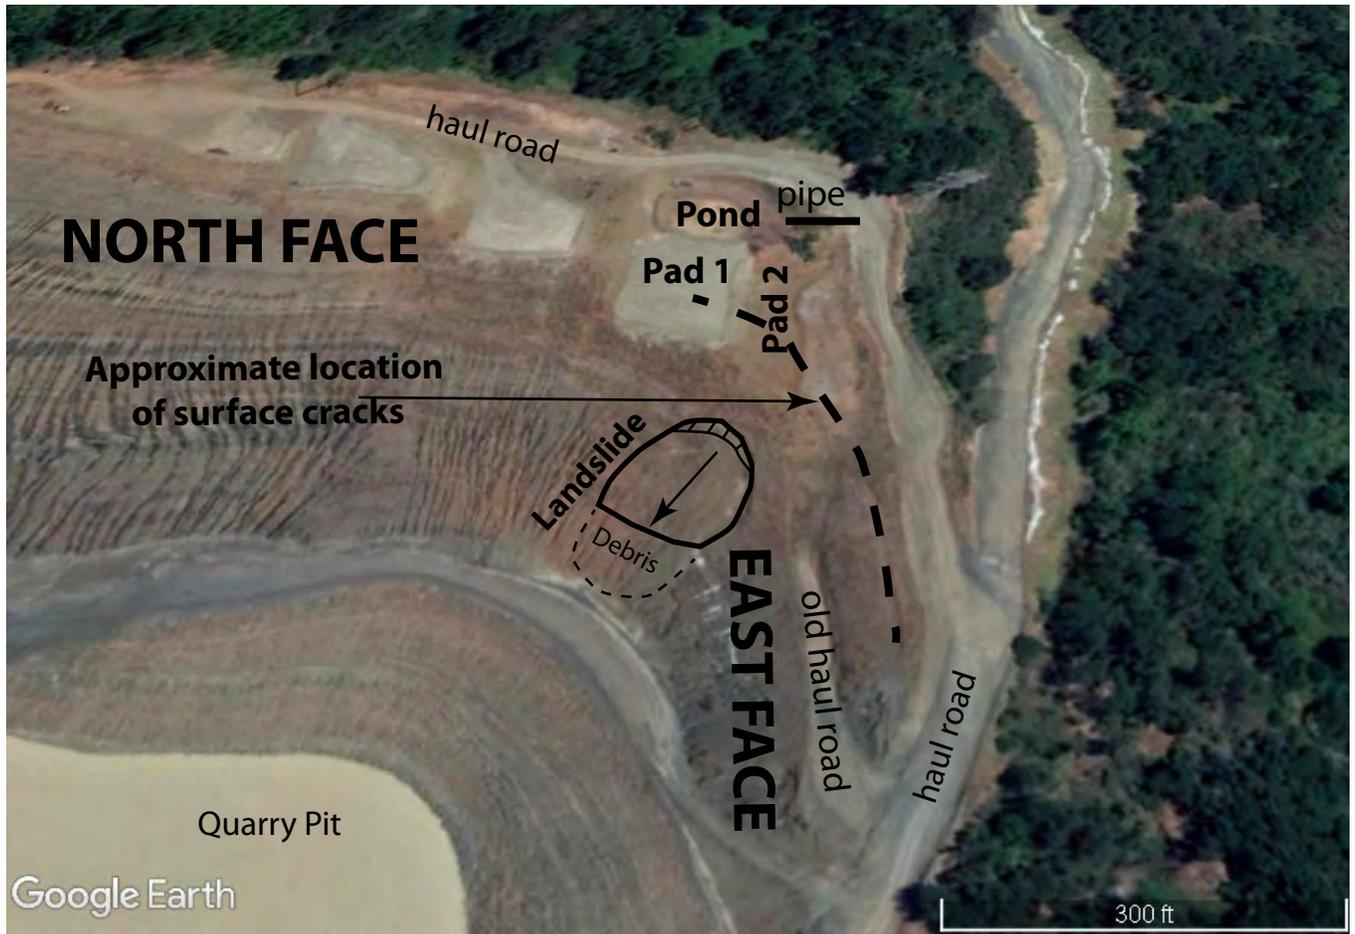
Index Map

This photo shows the approximate location of features that are the subject of this report. This is the most current photo of this area on Google Earth. The location of the landslide is approximate. That landslide likely occurred October-November, 2019, after this photograph was taken.

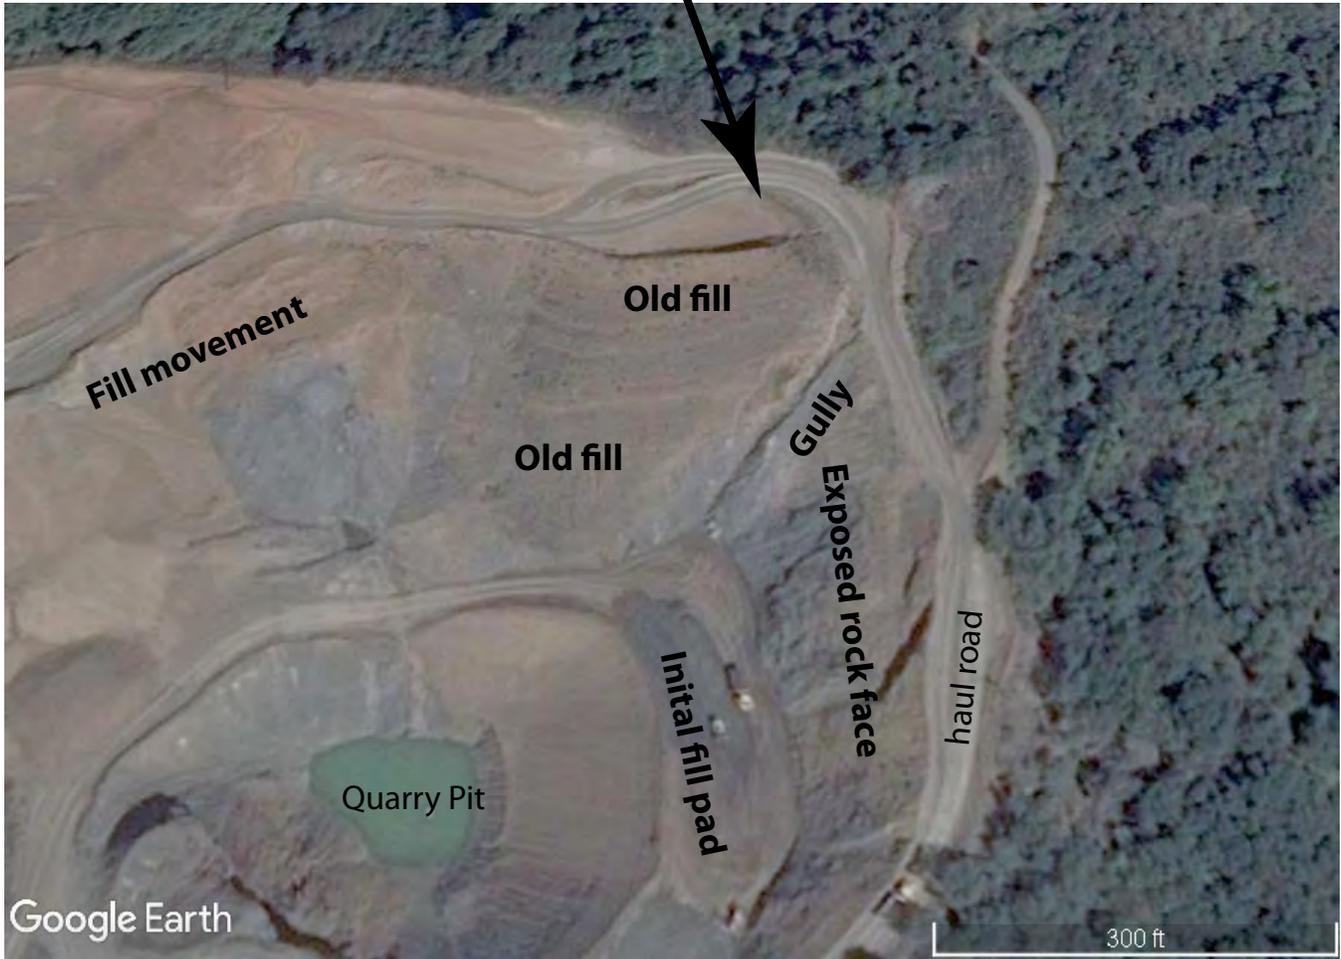
This photo shows the quarry soon after mining of the eastern face stopped (labeled - exposed rock). New fill is beginning to be placed along the base of the east face (initial fill pad). Note the gully that marks the junction between exposed rock and the old fill that had been placed on the north face. As fill was placed in this corner of the quarry, the gully formed a buried valley and a focus for groundwater.

Old fill is several years old and can be identified by bushes growing on it. At this time, new fill is also being placed/stored on the west side of the north face (fill movement). Note the shifting of pond at the bottom of the pit (quarry pit) as mining progresses.

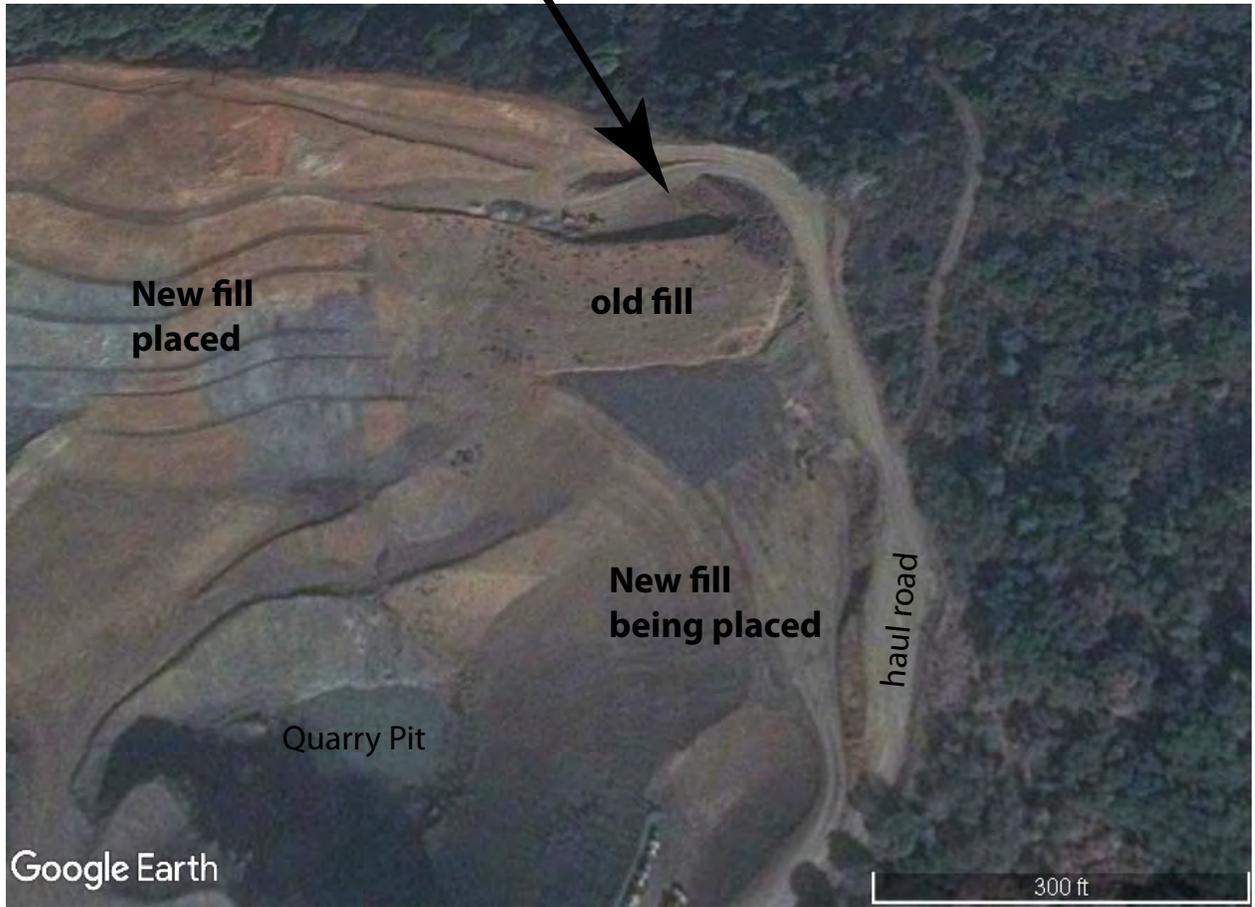
Fill continues to be placed on the east quarry face. New fill has also been placed on the north face. Just a small area of old fill remains unburied. The arrow indicates the approximate future location of pads 1 and 2 and the pond. Only the upper portion of the gully is visible.

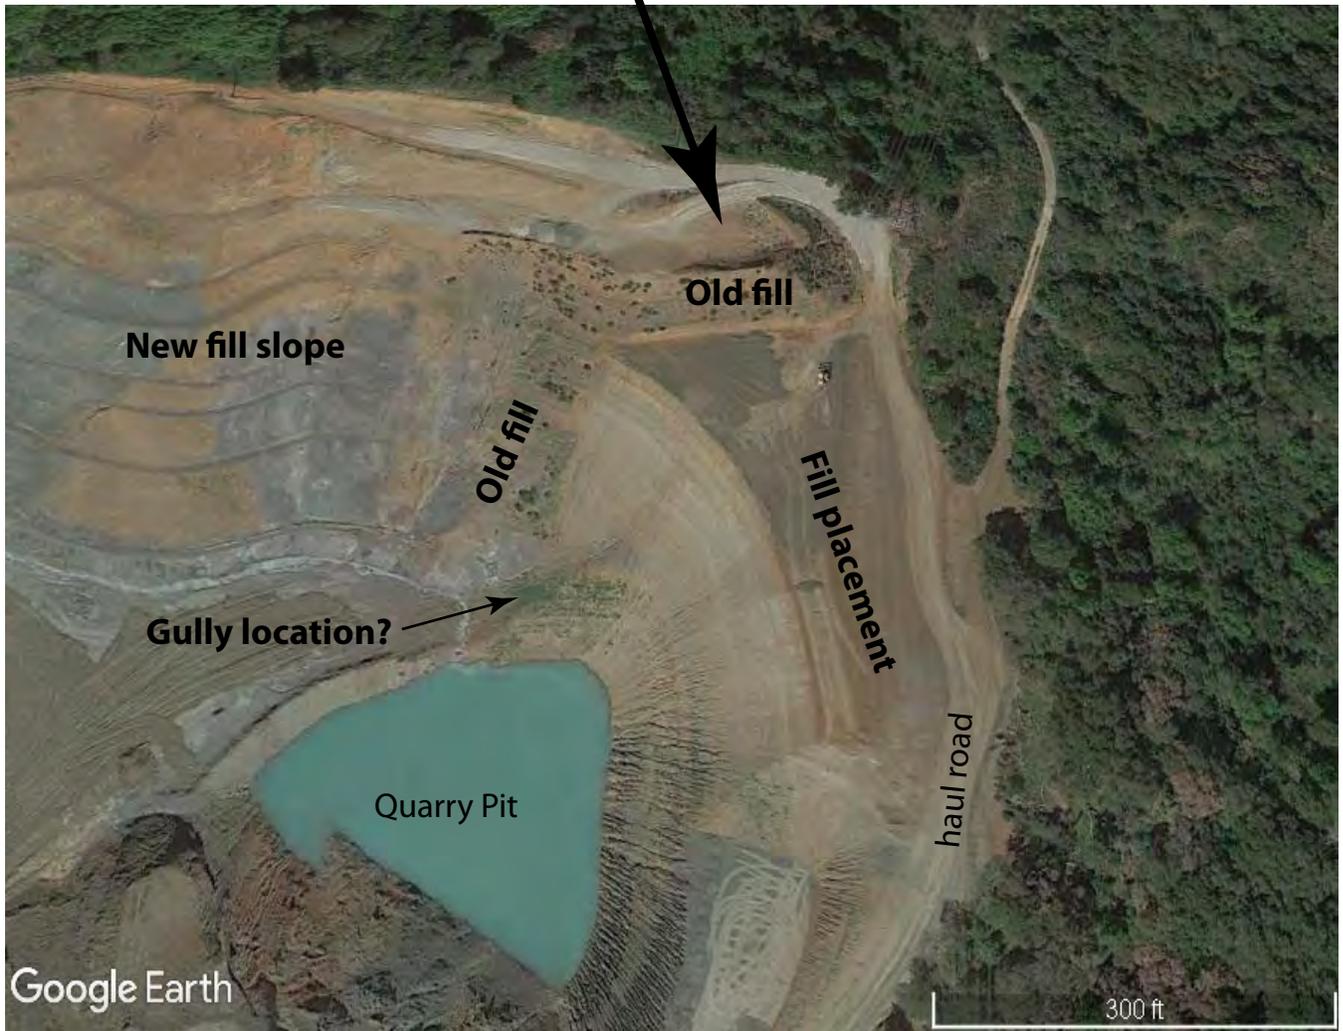
FIGURE: 3

The fill prism on the east face has continued to grow. Only small areas of old fill in the NE corner remain exposed. The gully is completely covered. It appears that a pond or pad had been constructed at the top of the NE quarry corner.

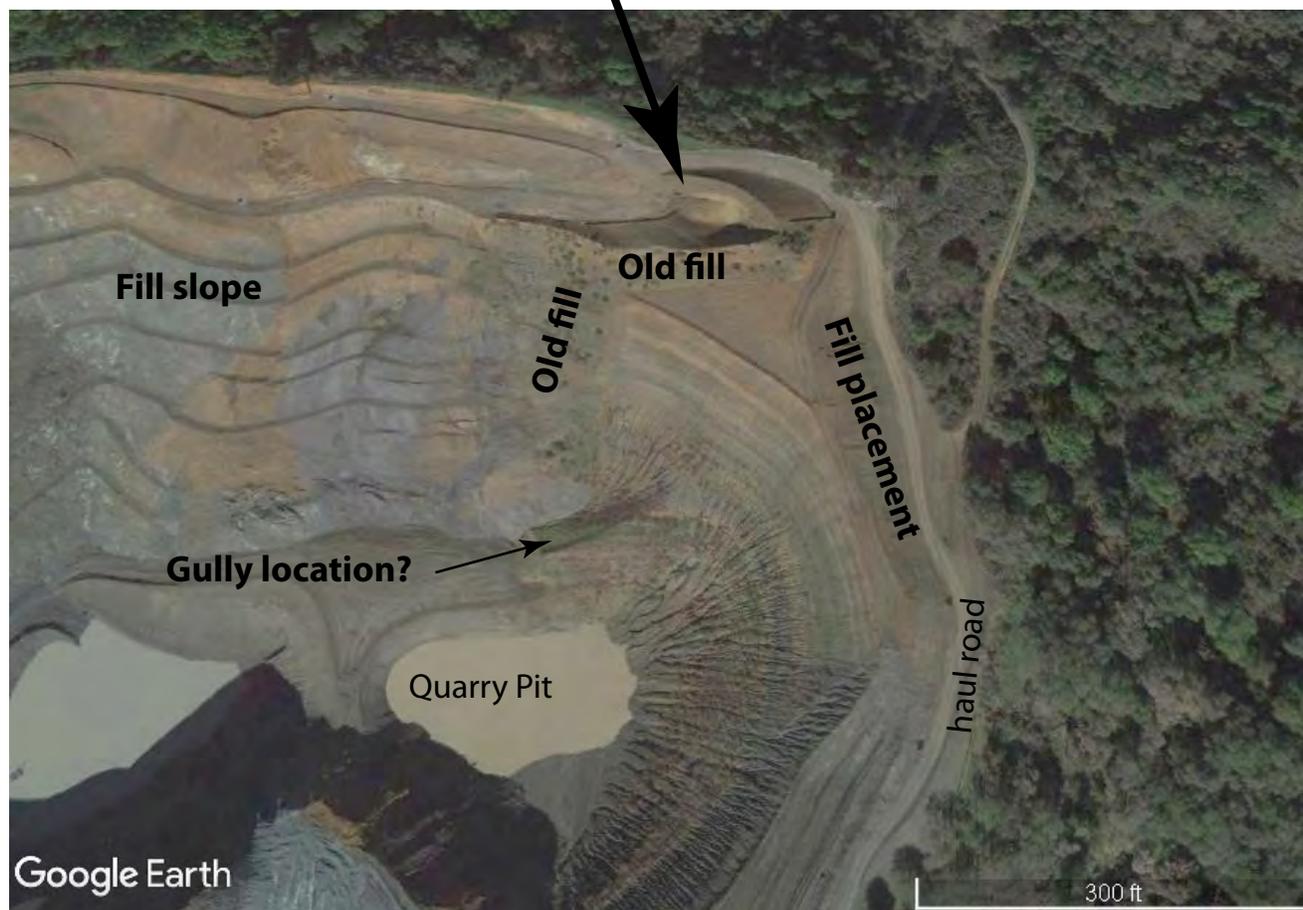
The eastern fill prism has grown higher. The face of the east fill prism is steep. A green area is visible at the toe of the slope where the east and north fills connect (the toe of the gully). The green area indicates that water is collecting in this area. The photo was taken in January and it is likely that surface water is concentrating in this area.

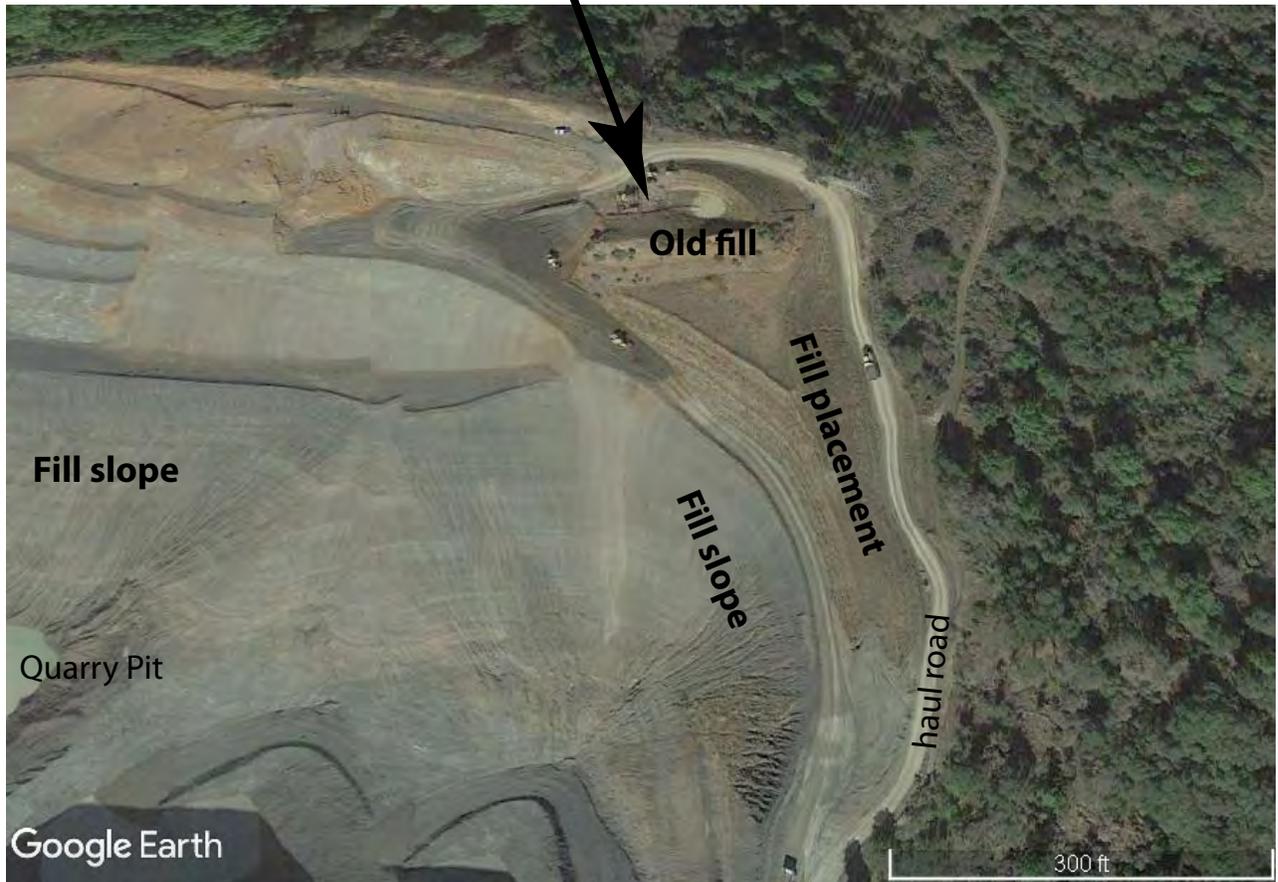
Fill continues to be placed on the north face and in the north-east corner. Fill is also being placed at the location of the current pond. Only a small sliver of old fill is visible. Note the shifting of the quarry pit.

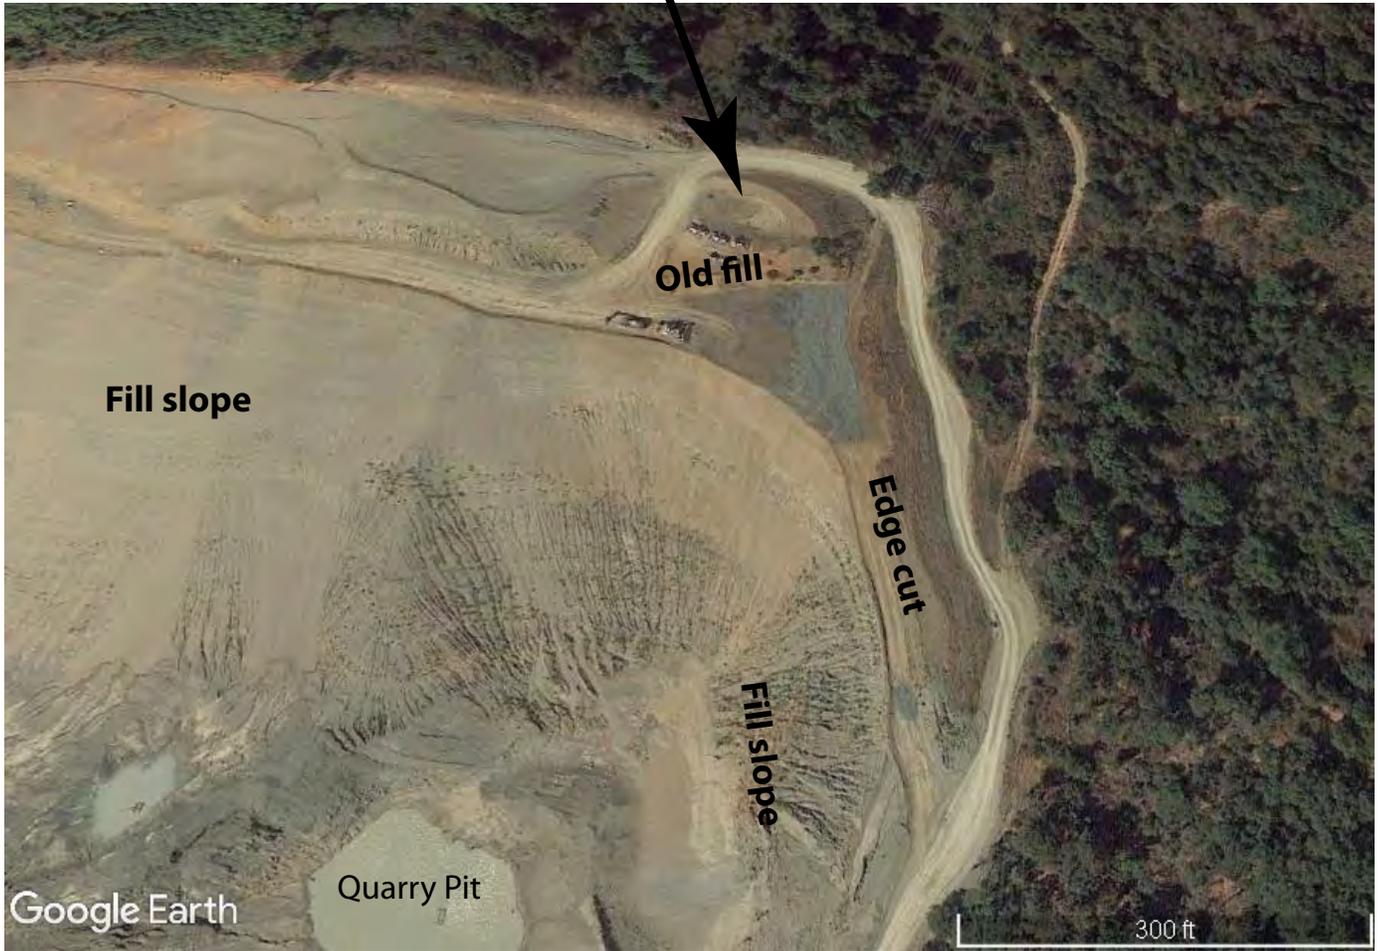
Fill continued to be placed on the north slope. Fill was removed from the base of the east slope (note the new quarry pit), and the top of the east face fill prism has narrowed slightly (see fill configuration on Figure 6).

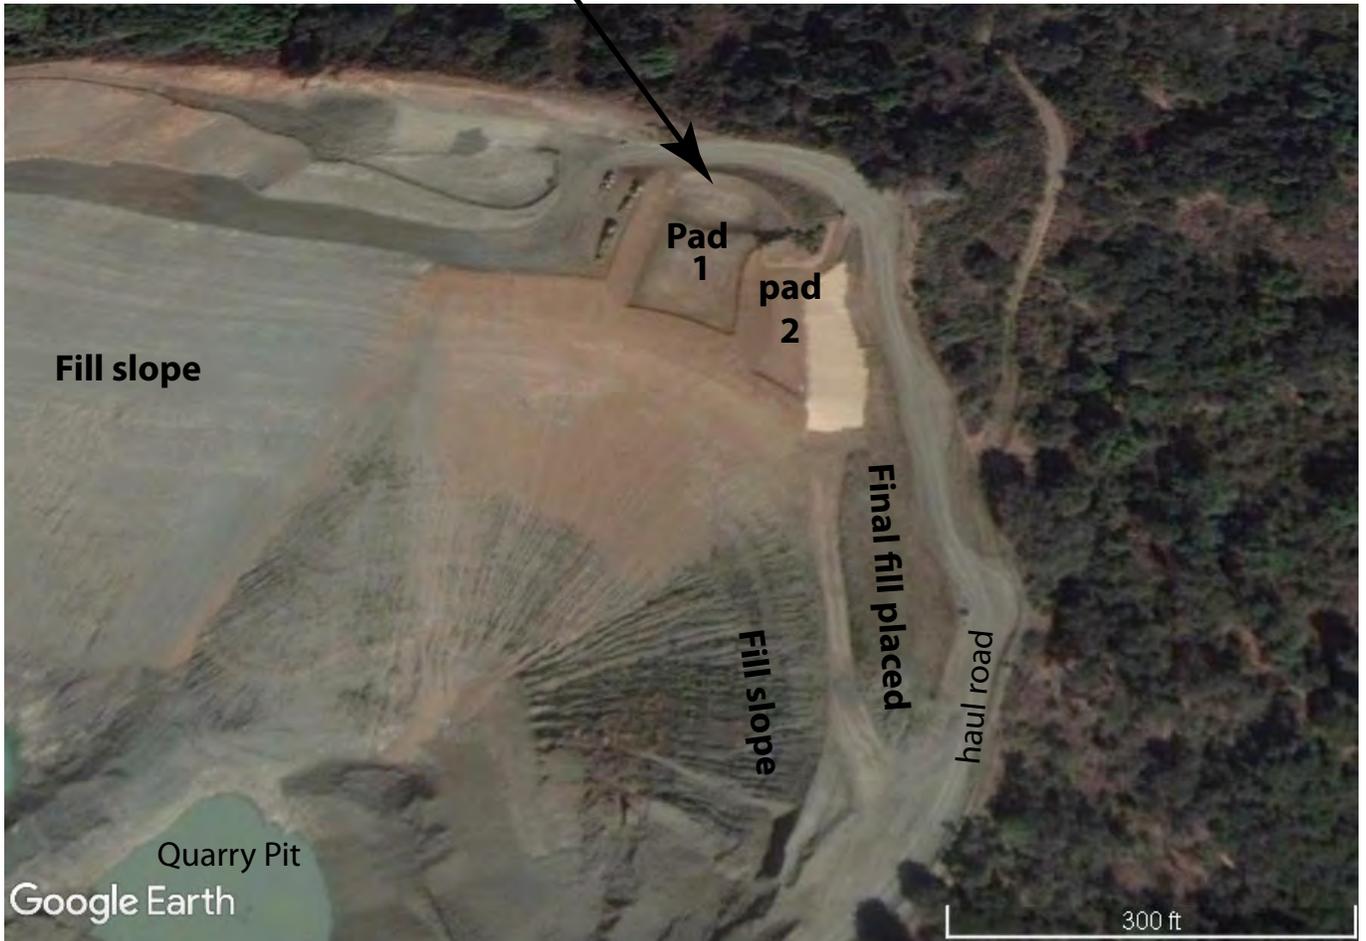
The current pads and settling pond are in place. No old fill is visible. Additional fill was placed at the top of the east face fill prism.

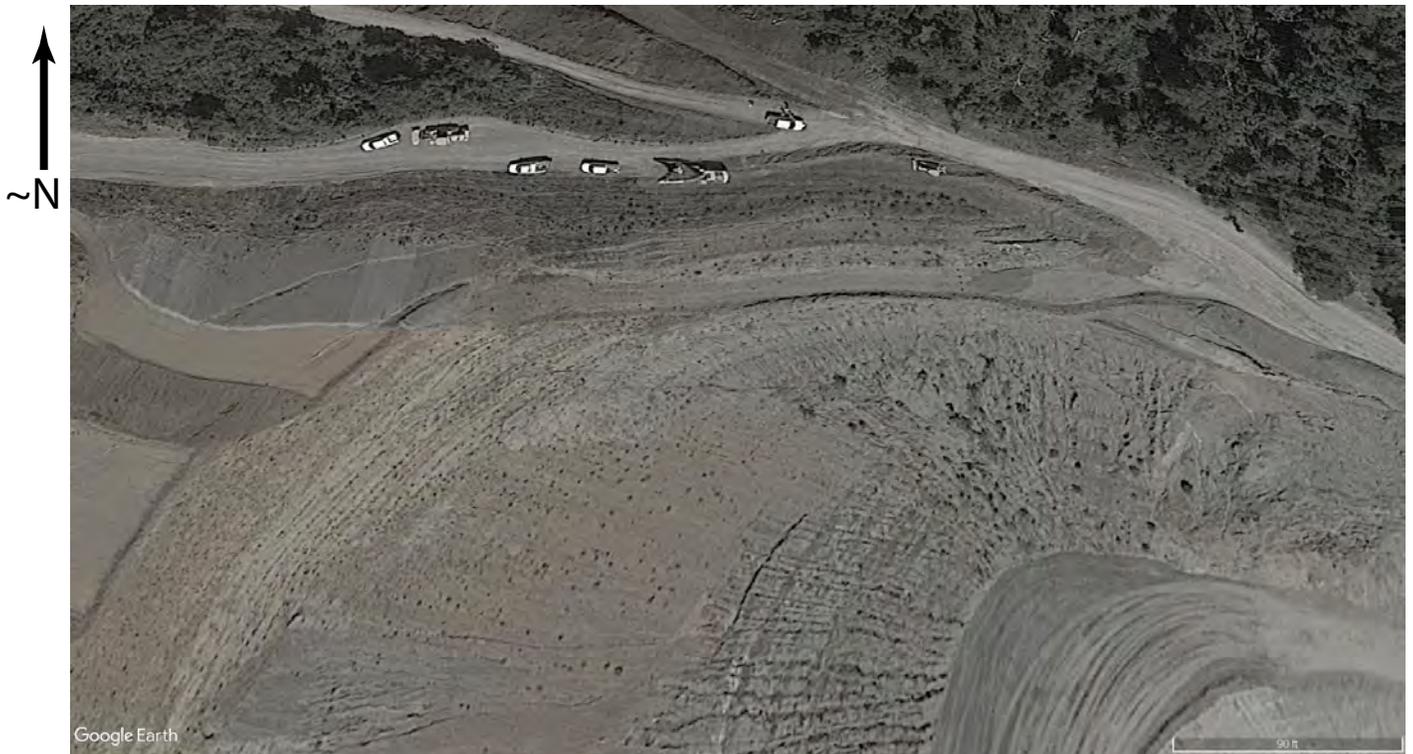
North East Corner of Stevens Creek Quarry Pit, Oblique View

This is an oblique view of the Figure 9a photograph. The fracture traces are shown (dashed where uncertain). There may be a fracture in the fill face at the approximate location of the future fill face landslide.

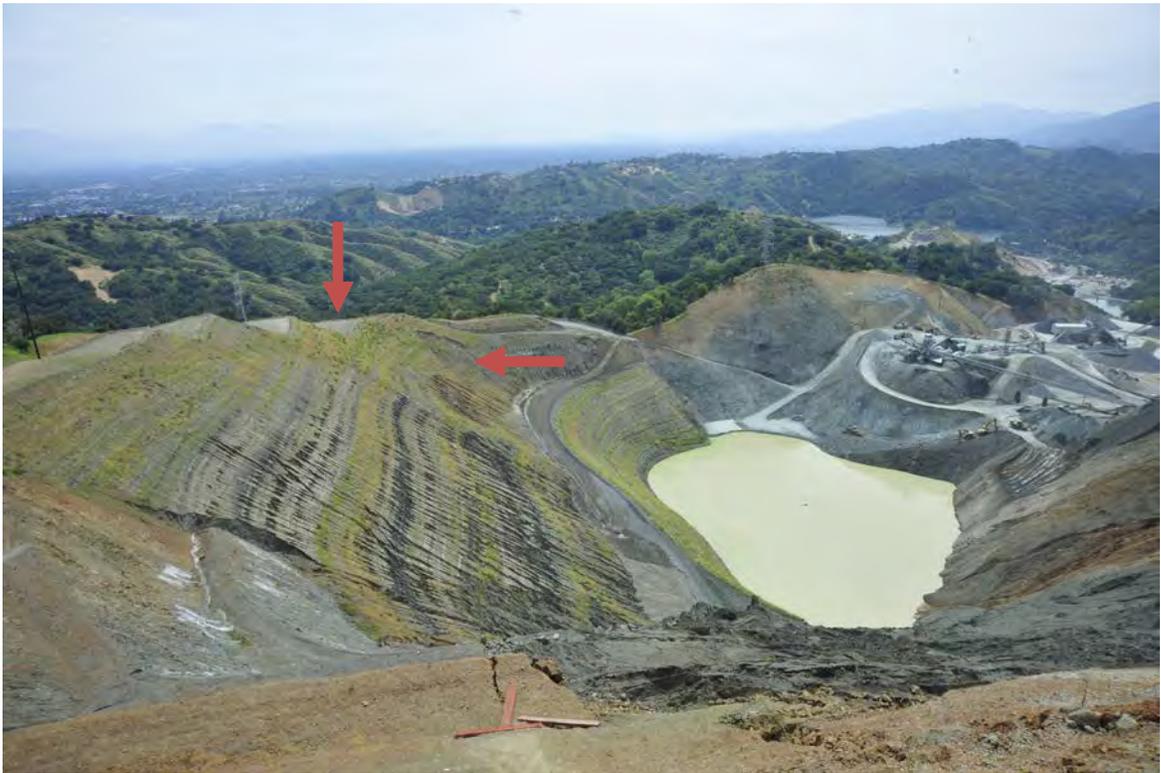
Photograph 1. An oblique view, looking east towards the NE corner of the quarry (from the NW corner). The horizontal arrow marks the 2019 landslide. The vertical arrow marks pad 1.
