NORFLEET CONSULTANTS

December 7, 202
NC Proj. No. 201881.61

RE: Stevens Creek Quarry Use Permit and
Reclamation Plan Application
12100 Stevens Canyon Road
Cupertino, CA 95014

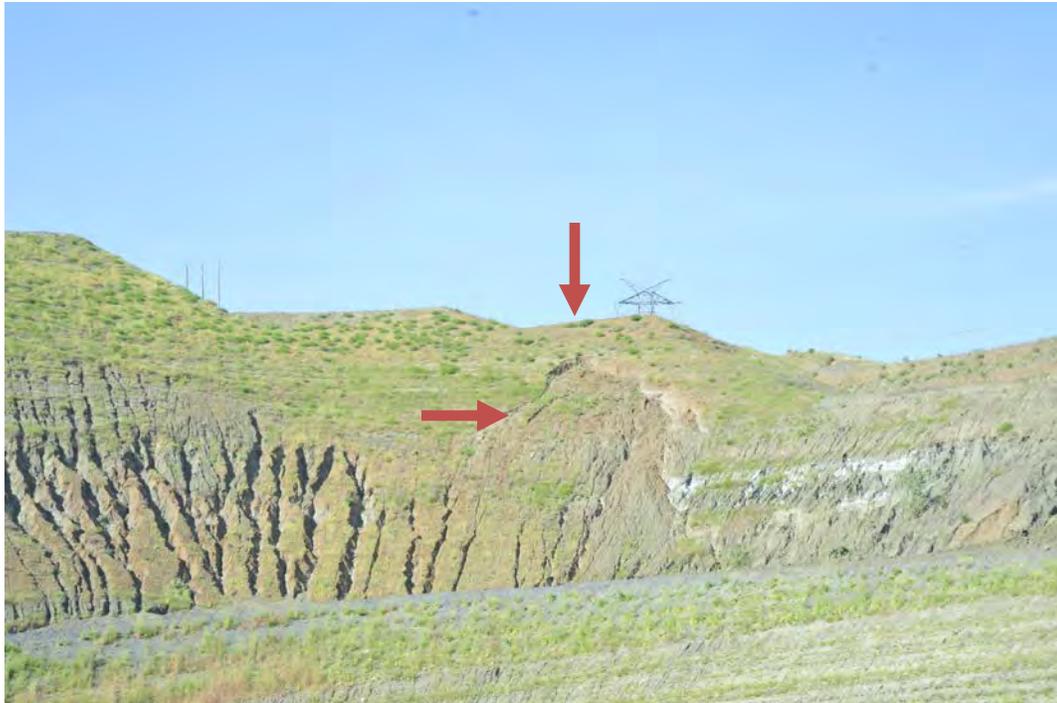
The recent surface landslide (Photos 2 and 3) was caused by the rains during the 2019-20 winter (likely in December, 2019). It is a surface feature and does not present a global slope stability problem. The white, horizontal bands visible on the slope face to the right of the lower part of the landside on Photo 3 are suggestive of groundwater evaporation from that zone. Water evaporates, leaving calcium minerals on the ground surface. On a smaller scale, the process is called efflorescent deposition. This is most likely unsaturated water flow. Because of the excavated geometry of this area (a curved valley), it appears that subsurface water concentrates in this area. There are no seeps/vegetation growth that would indicate saturated flow (current or historic) flowing out of the fill.

Photograph 2. The east end of the north face, looking north. The horizontal arrow marks the 2019 landslide. The vertical arrow marks pad 1. The white band marks are on the east quarry face and are a possible indication of water seepage.

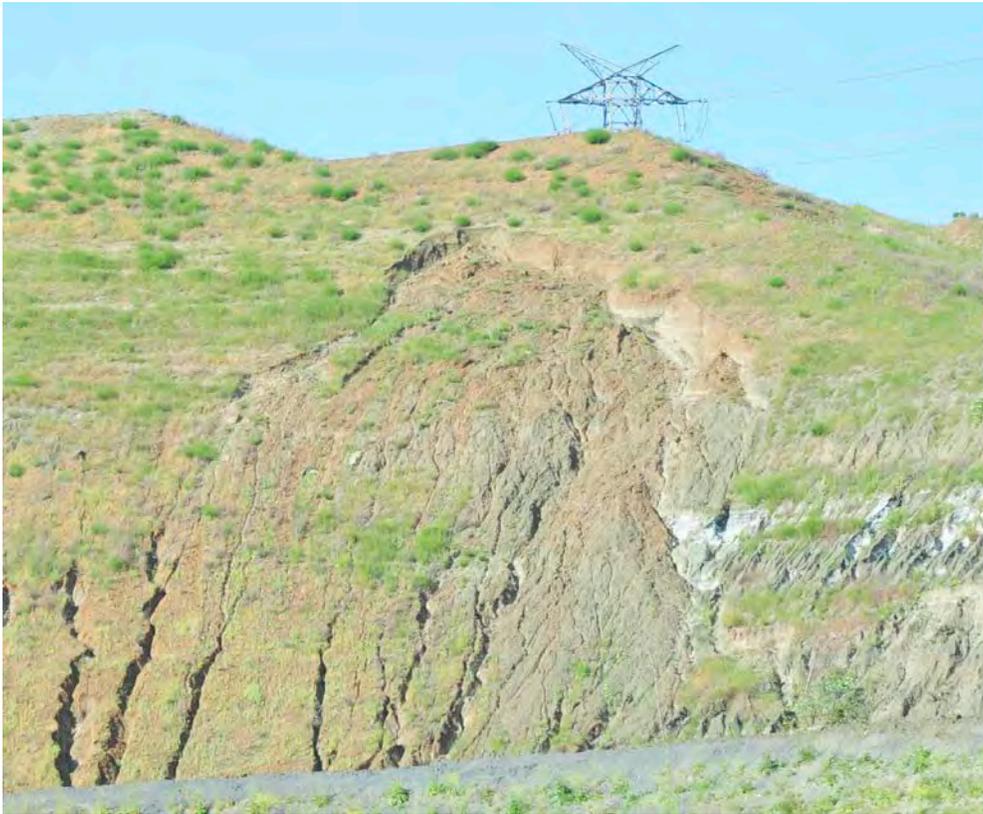
Photograph 3. An enlarged area from Photograph 2. The landslide is visible and Pad 1 is above the landslide. The landslide toe does not extend to the bottom of the slope.

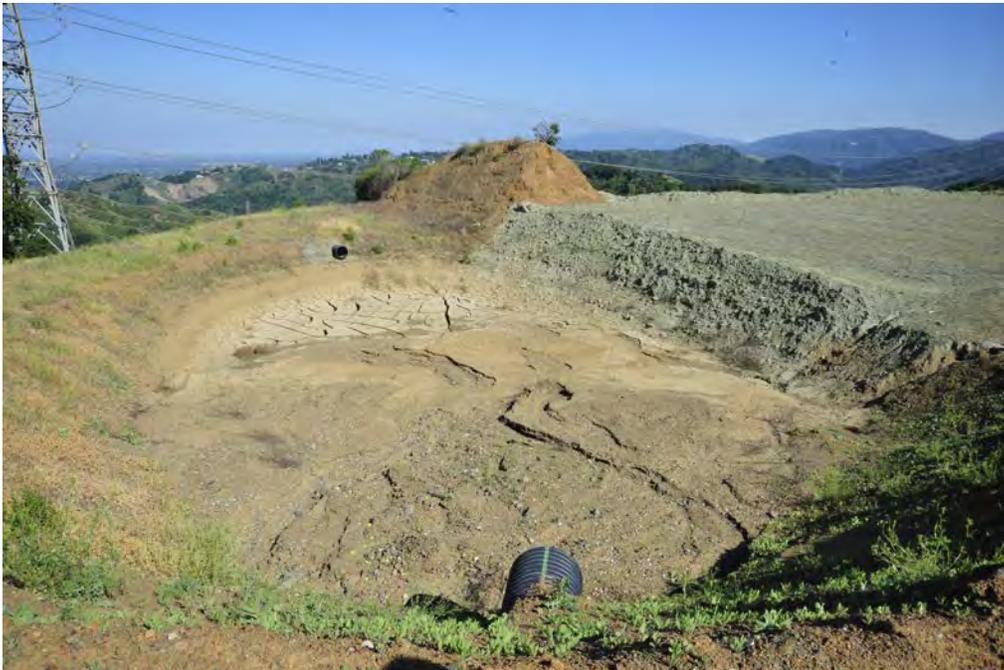
The settling pond does allow water to seep in the ground episodically during the winter (depending on rain events). I doubt it was a direct contributory factor to the 2017 failure, but it likely had some effect. The surficial slope surface failure during the 2018-19 winter suggests that this area has a higher fill soil moisture content during the winter than surrounding areas because of the geometry of this area.

Photograph 4. The settling pond at the north end of Pad 1, looking east. Water flows into the pond through the pipe in the foreground. It leaves the pond through the pipe opening (black dot) in the far bank. Pad 1 is on the right. Note the bathtub rings that mark water levels in the pond.

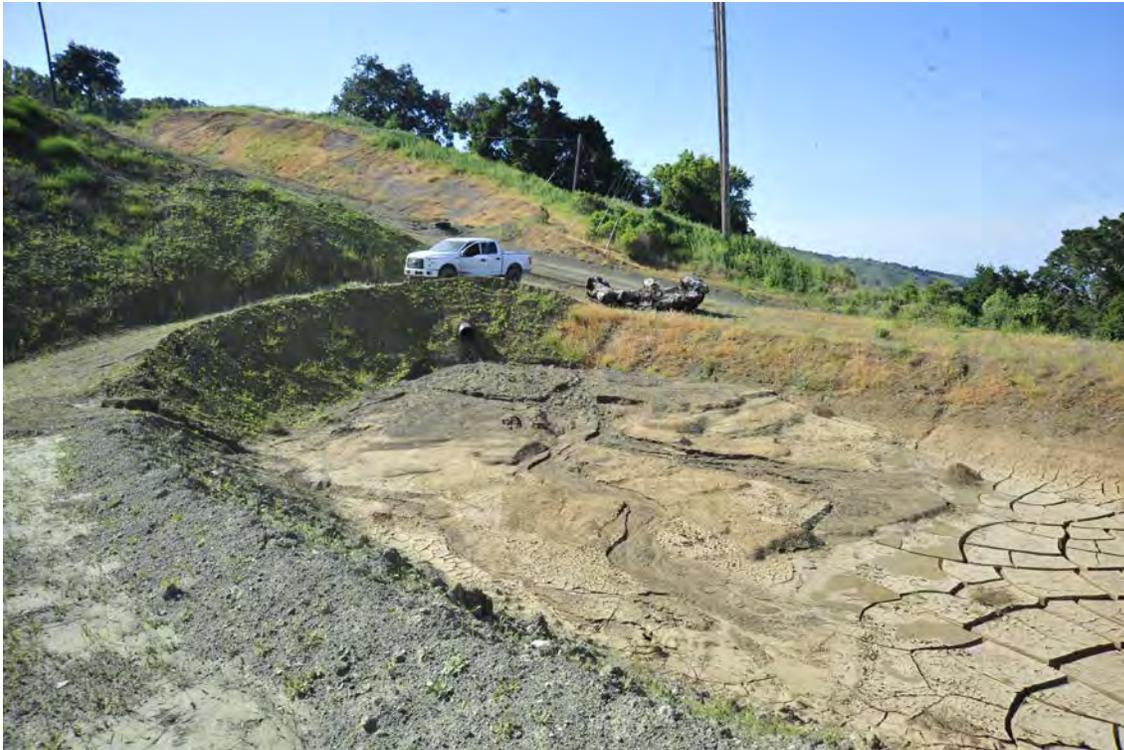
Photograph 5. The settling pond, looking NW. Water enters the pond through the pipe visible below the truck.

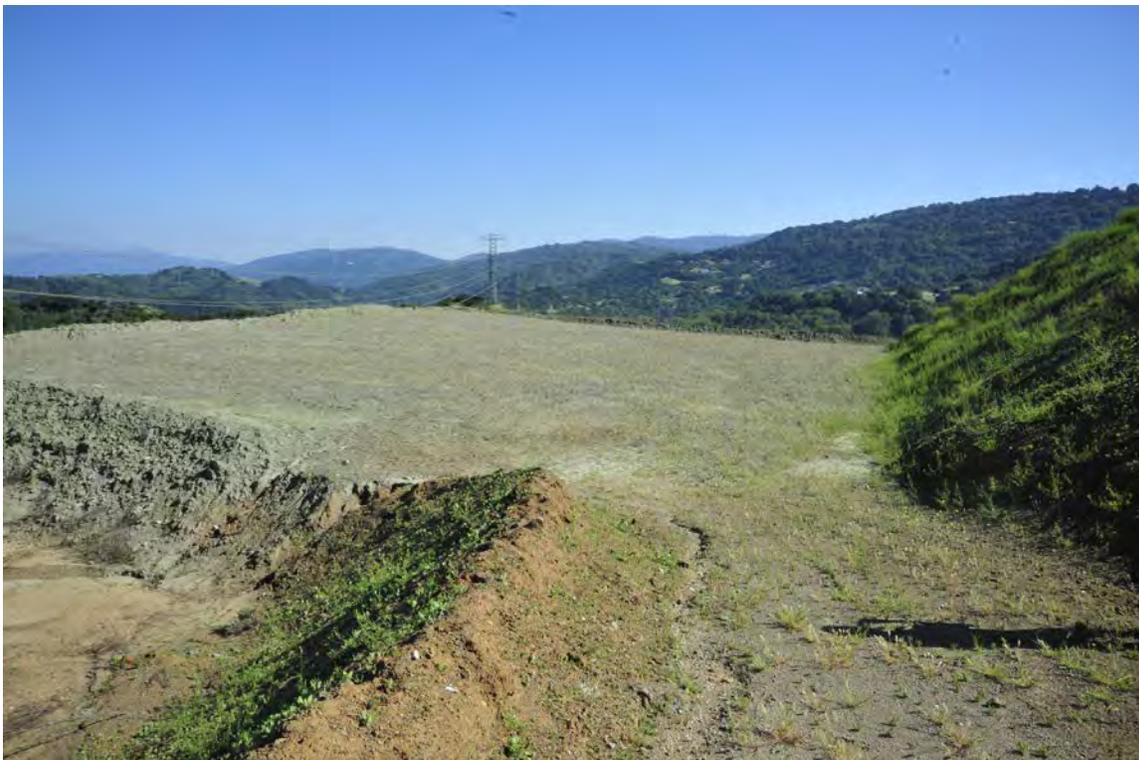
Photos 6 and 7 show Pads 1 and 2 (looking south). They are flat and have berms along their outside edges. Photos 7 and 8 show the ground cracks in the south end of Pad 2. The cracks exhibit both horizontal and vertical offset (south side down). The orientation of the northern crack in Pad 2 indicates that the crack dip is fairly steep. The cracks extend west into Pad 1, where they extend one-half to three-quarters of the way across Pad 1. The cracks narrow as they go into Pad 1. Cracking did not appear to extend to the west side of Pad 1.

Photograph 6. Pad 1, looking south towards the pit face.

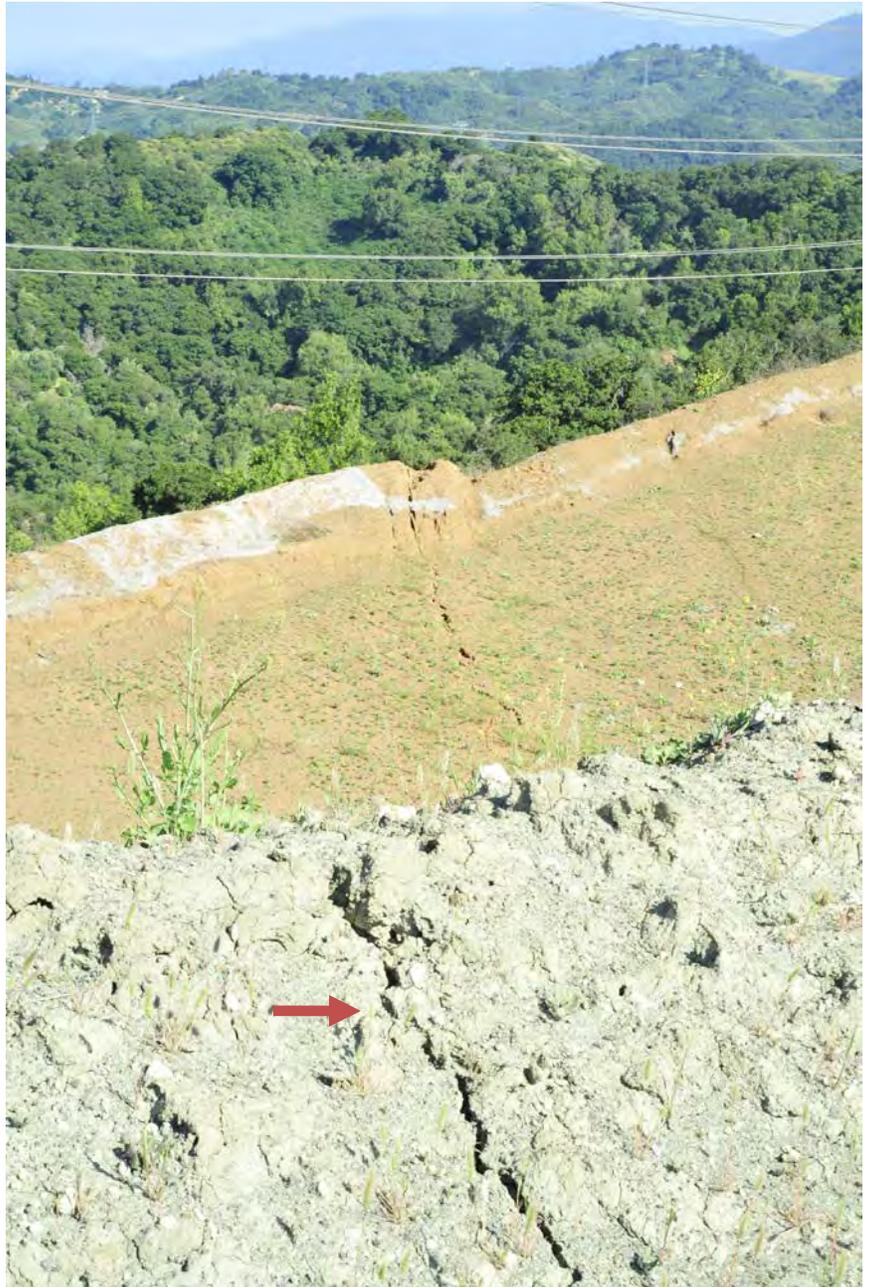
Photograph 9.

Extension of a crack in Pad 2 into Pad 1 (arrow). The crack extends about 3/4 of the width of Pad 1 (to the south). The orientation of the crack suggests that the failure plane dip is fairly steep.

The minor extension of the fractures into Pad 2 in 2018 (Figure 10) suggest that this slope is still marginally stable. Placing additional fill at the bottom of this slope would increase the Factor of Safety by further reducing the slope angle.

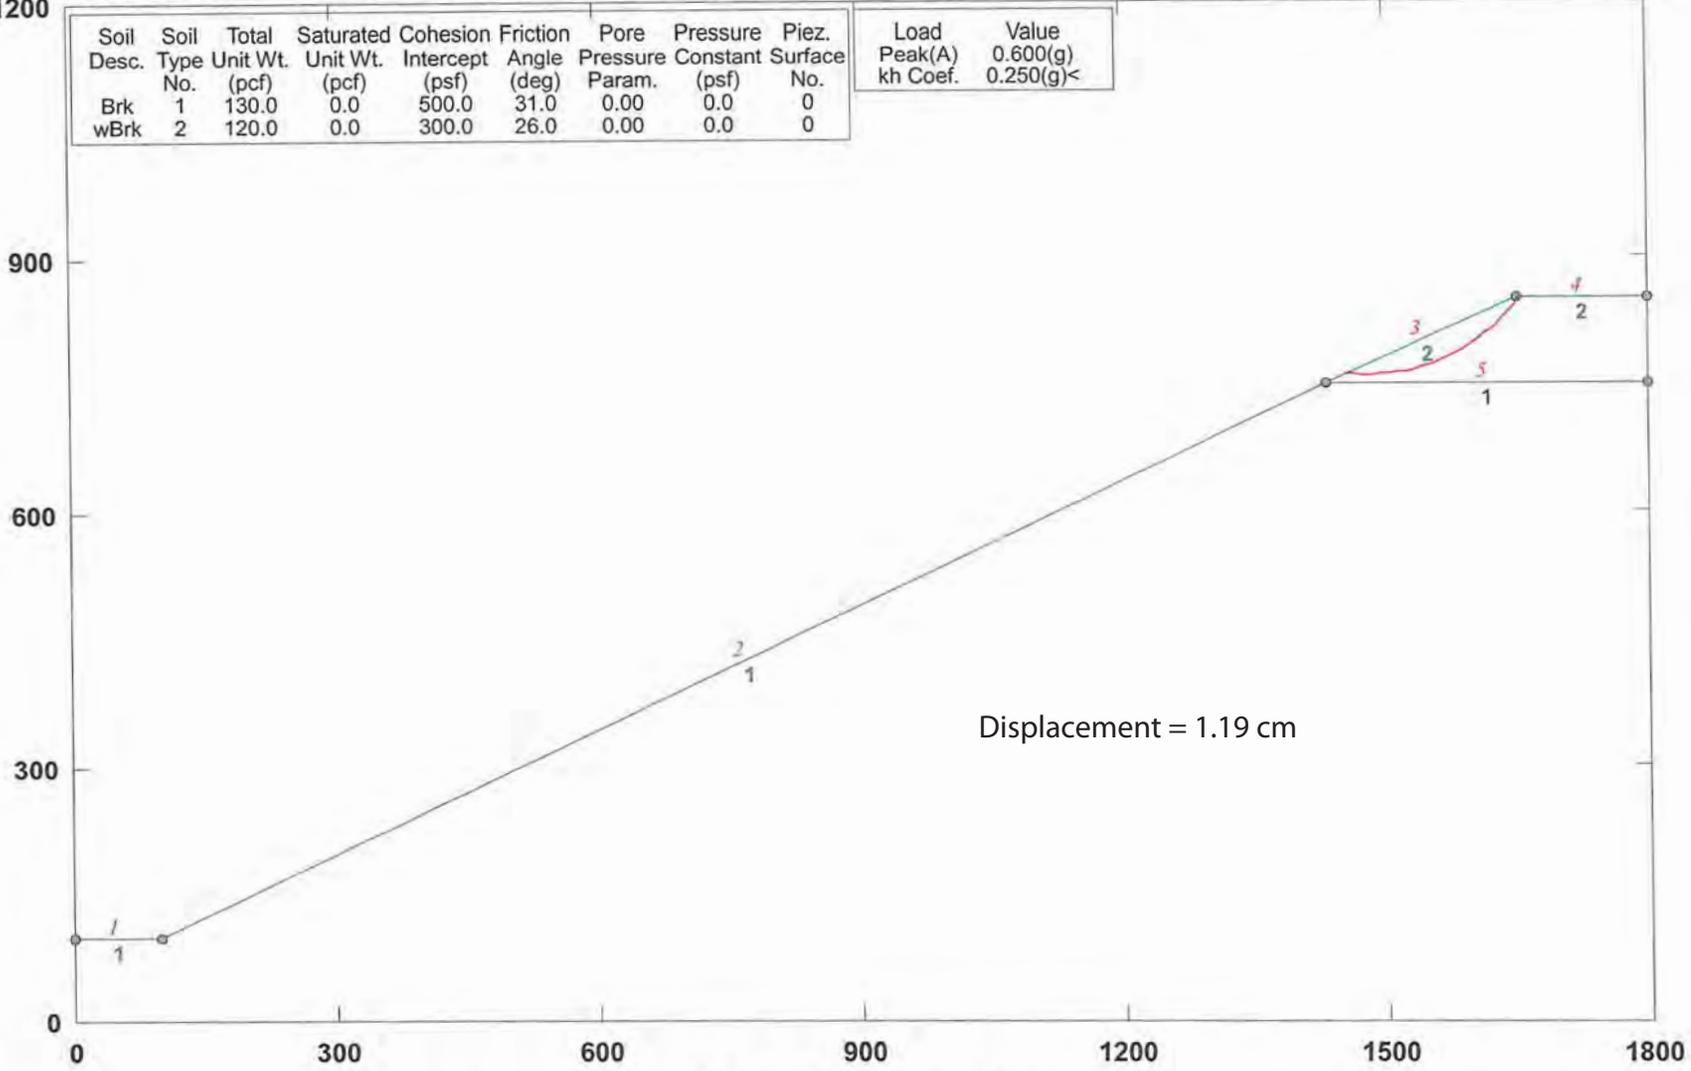
Norfleet Consultants	Stevens Creek Quarry		
	Seismic Analysis of Weathered Layer		
	PROJ NO: 191881.6	DATE: 9-17-2020	FIGURE: 4

GSTABL7 v.2 FSmin=0.935
Factor Of Safety Is Calculated By The Modified Bishop Method

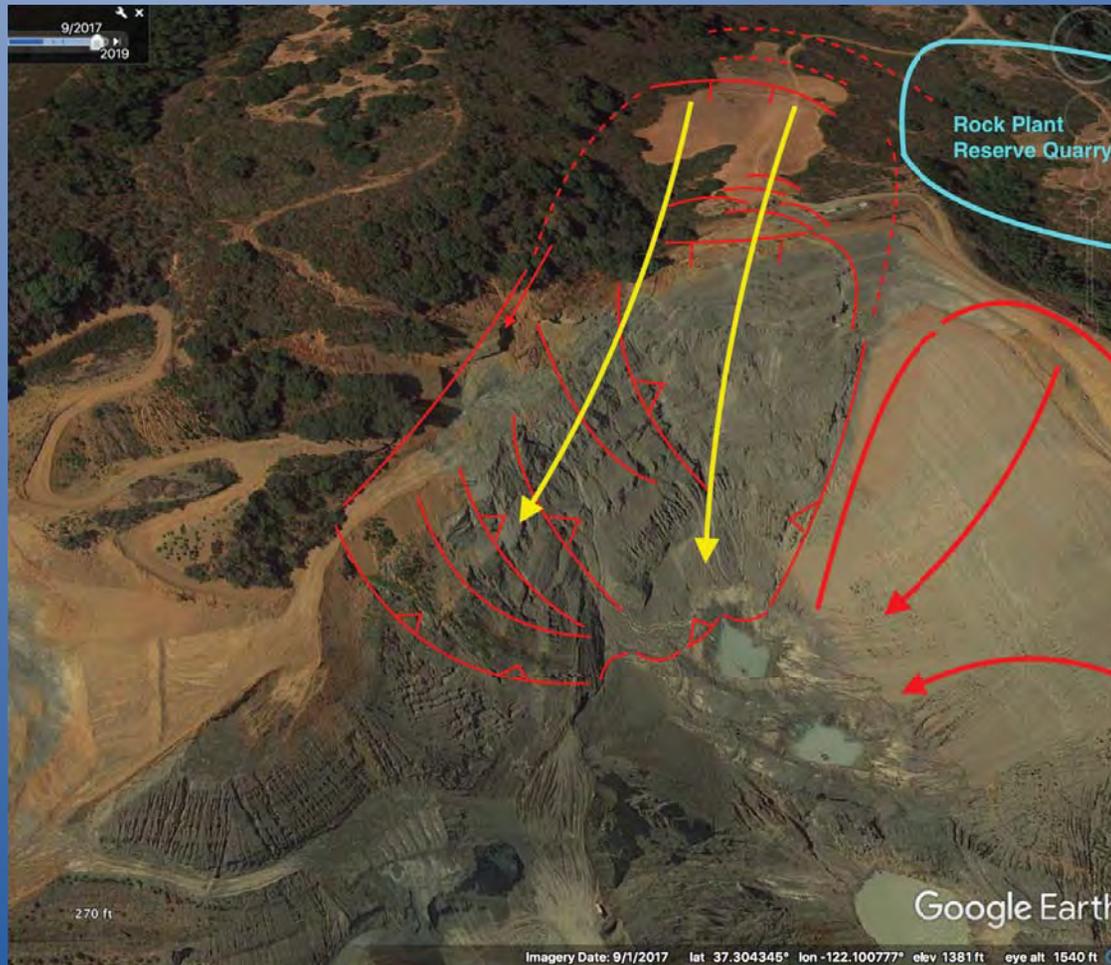
Stevens Creek NW Wall Landslide

- Activated in 2013
- 1,300 feet long
- 550 feet wide
- 250 to 350 feet deep
- Up to 10 mil cu. Yrds
- Approx 500 to 700 feet into Lehigh Property

- **Ground Cracks 740 feet from property line**
- **Not just a cut slope failure**
