July 29, 2022

File No.: 303659-001

PROJECT: LANDS OF BOURDET –STOCK PONDS
PACHECO PASS HIGHWAY, APN 898-19-005
SANTA CLARA COUNTY, CALIFORNIA

SUBJECT: Qualitative Evaluation of Past Performance of Stock Pond Stability

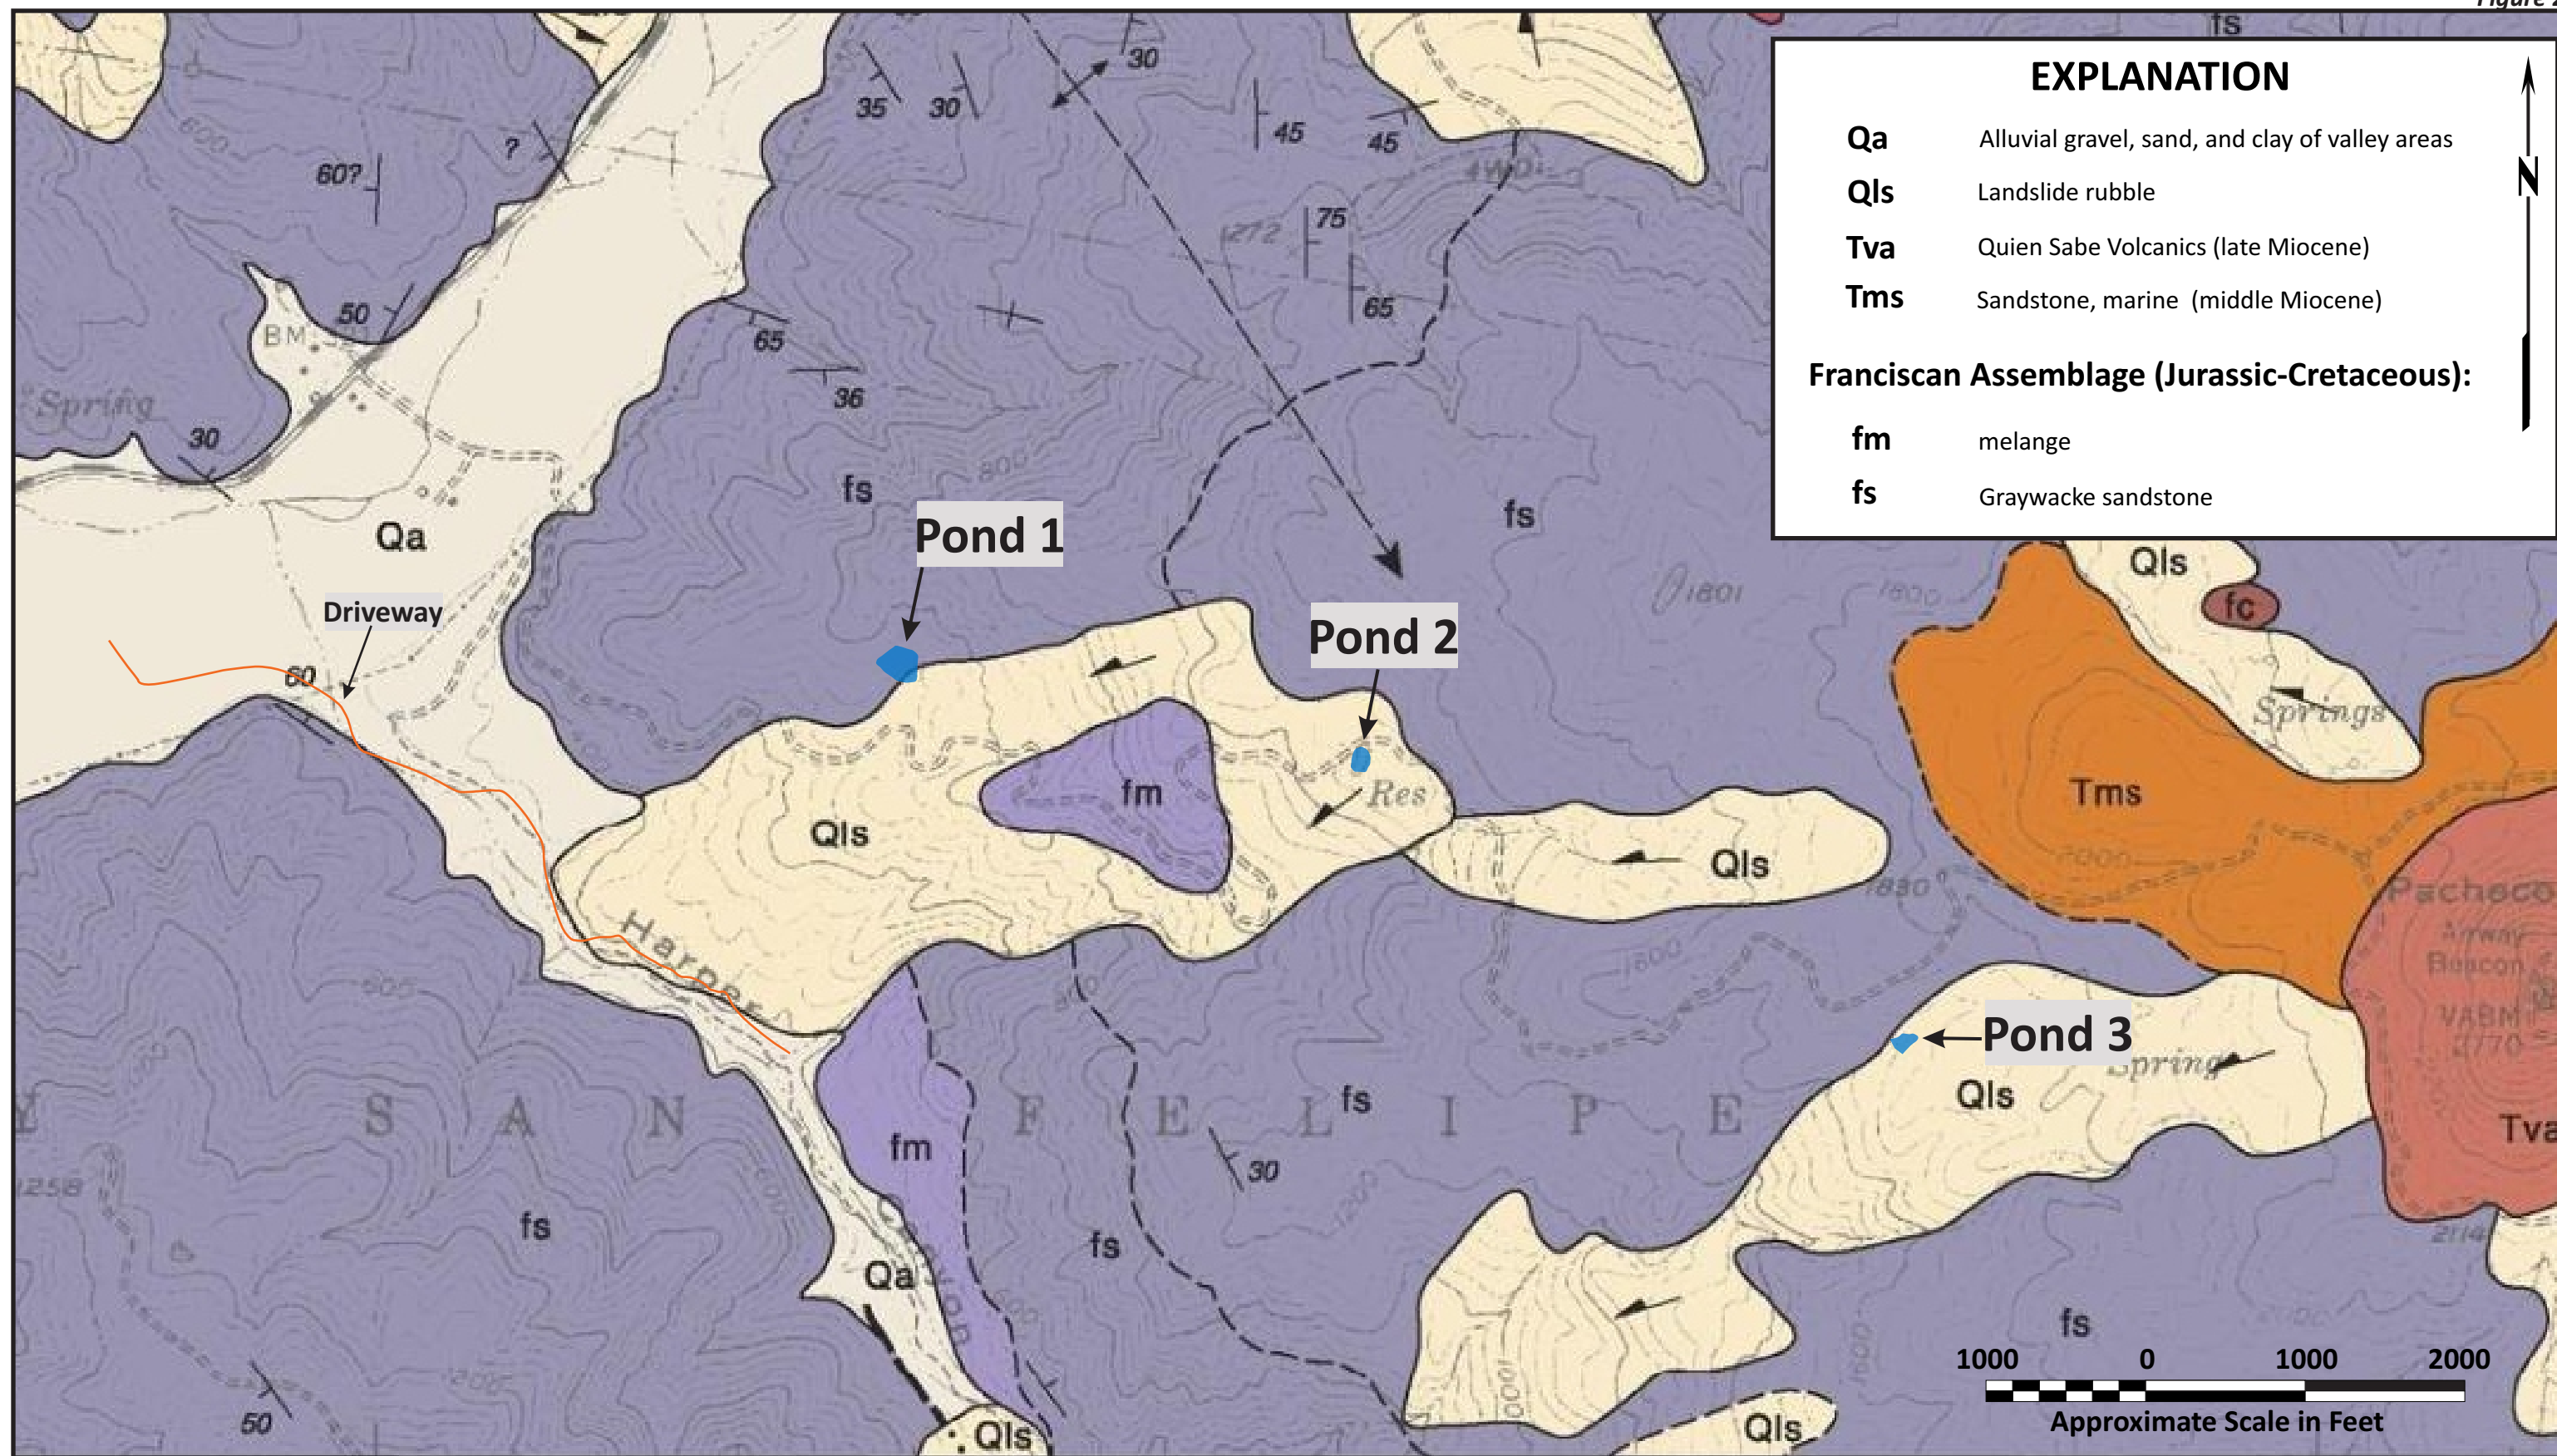
Figure 2

Based on Dibblee, et al (2007; Figure 2)¹, most of the site is underlain by graywacke sandstone (fs) of the Jurassic-Cretaceous Franciscan Assemblage. The graywacke sandstone is described as “gray, hard, massive to bedded, fine to medium grained, with thin layers of gray siltstone-claystone”. Two smaller areas of Franciscan Assemblage mélange (fm) are mapped on west-facing slopes above Harper Canyon. The mélange is described as “fragments of sandstone, chert, and greenstone in a pervasively sheared matrix of dark-gray gougy claystone and graywacke”. Tertiary marine sandstone (Tms) is mapped on the north and northwest flank of Pacheco Peak. Pacheco Peak is composed of Miocene andesite of the Quien Sabe Volcanics (Tva). Dibblee maps two large-scale Quaternary landslide complexes on west-facing slopes between Pacheco Peak and Harper Canyon. Ponds 1, 2, and 3 are located on these landslide complexes.

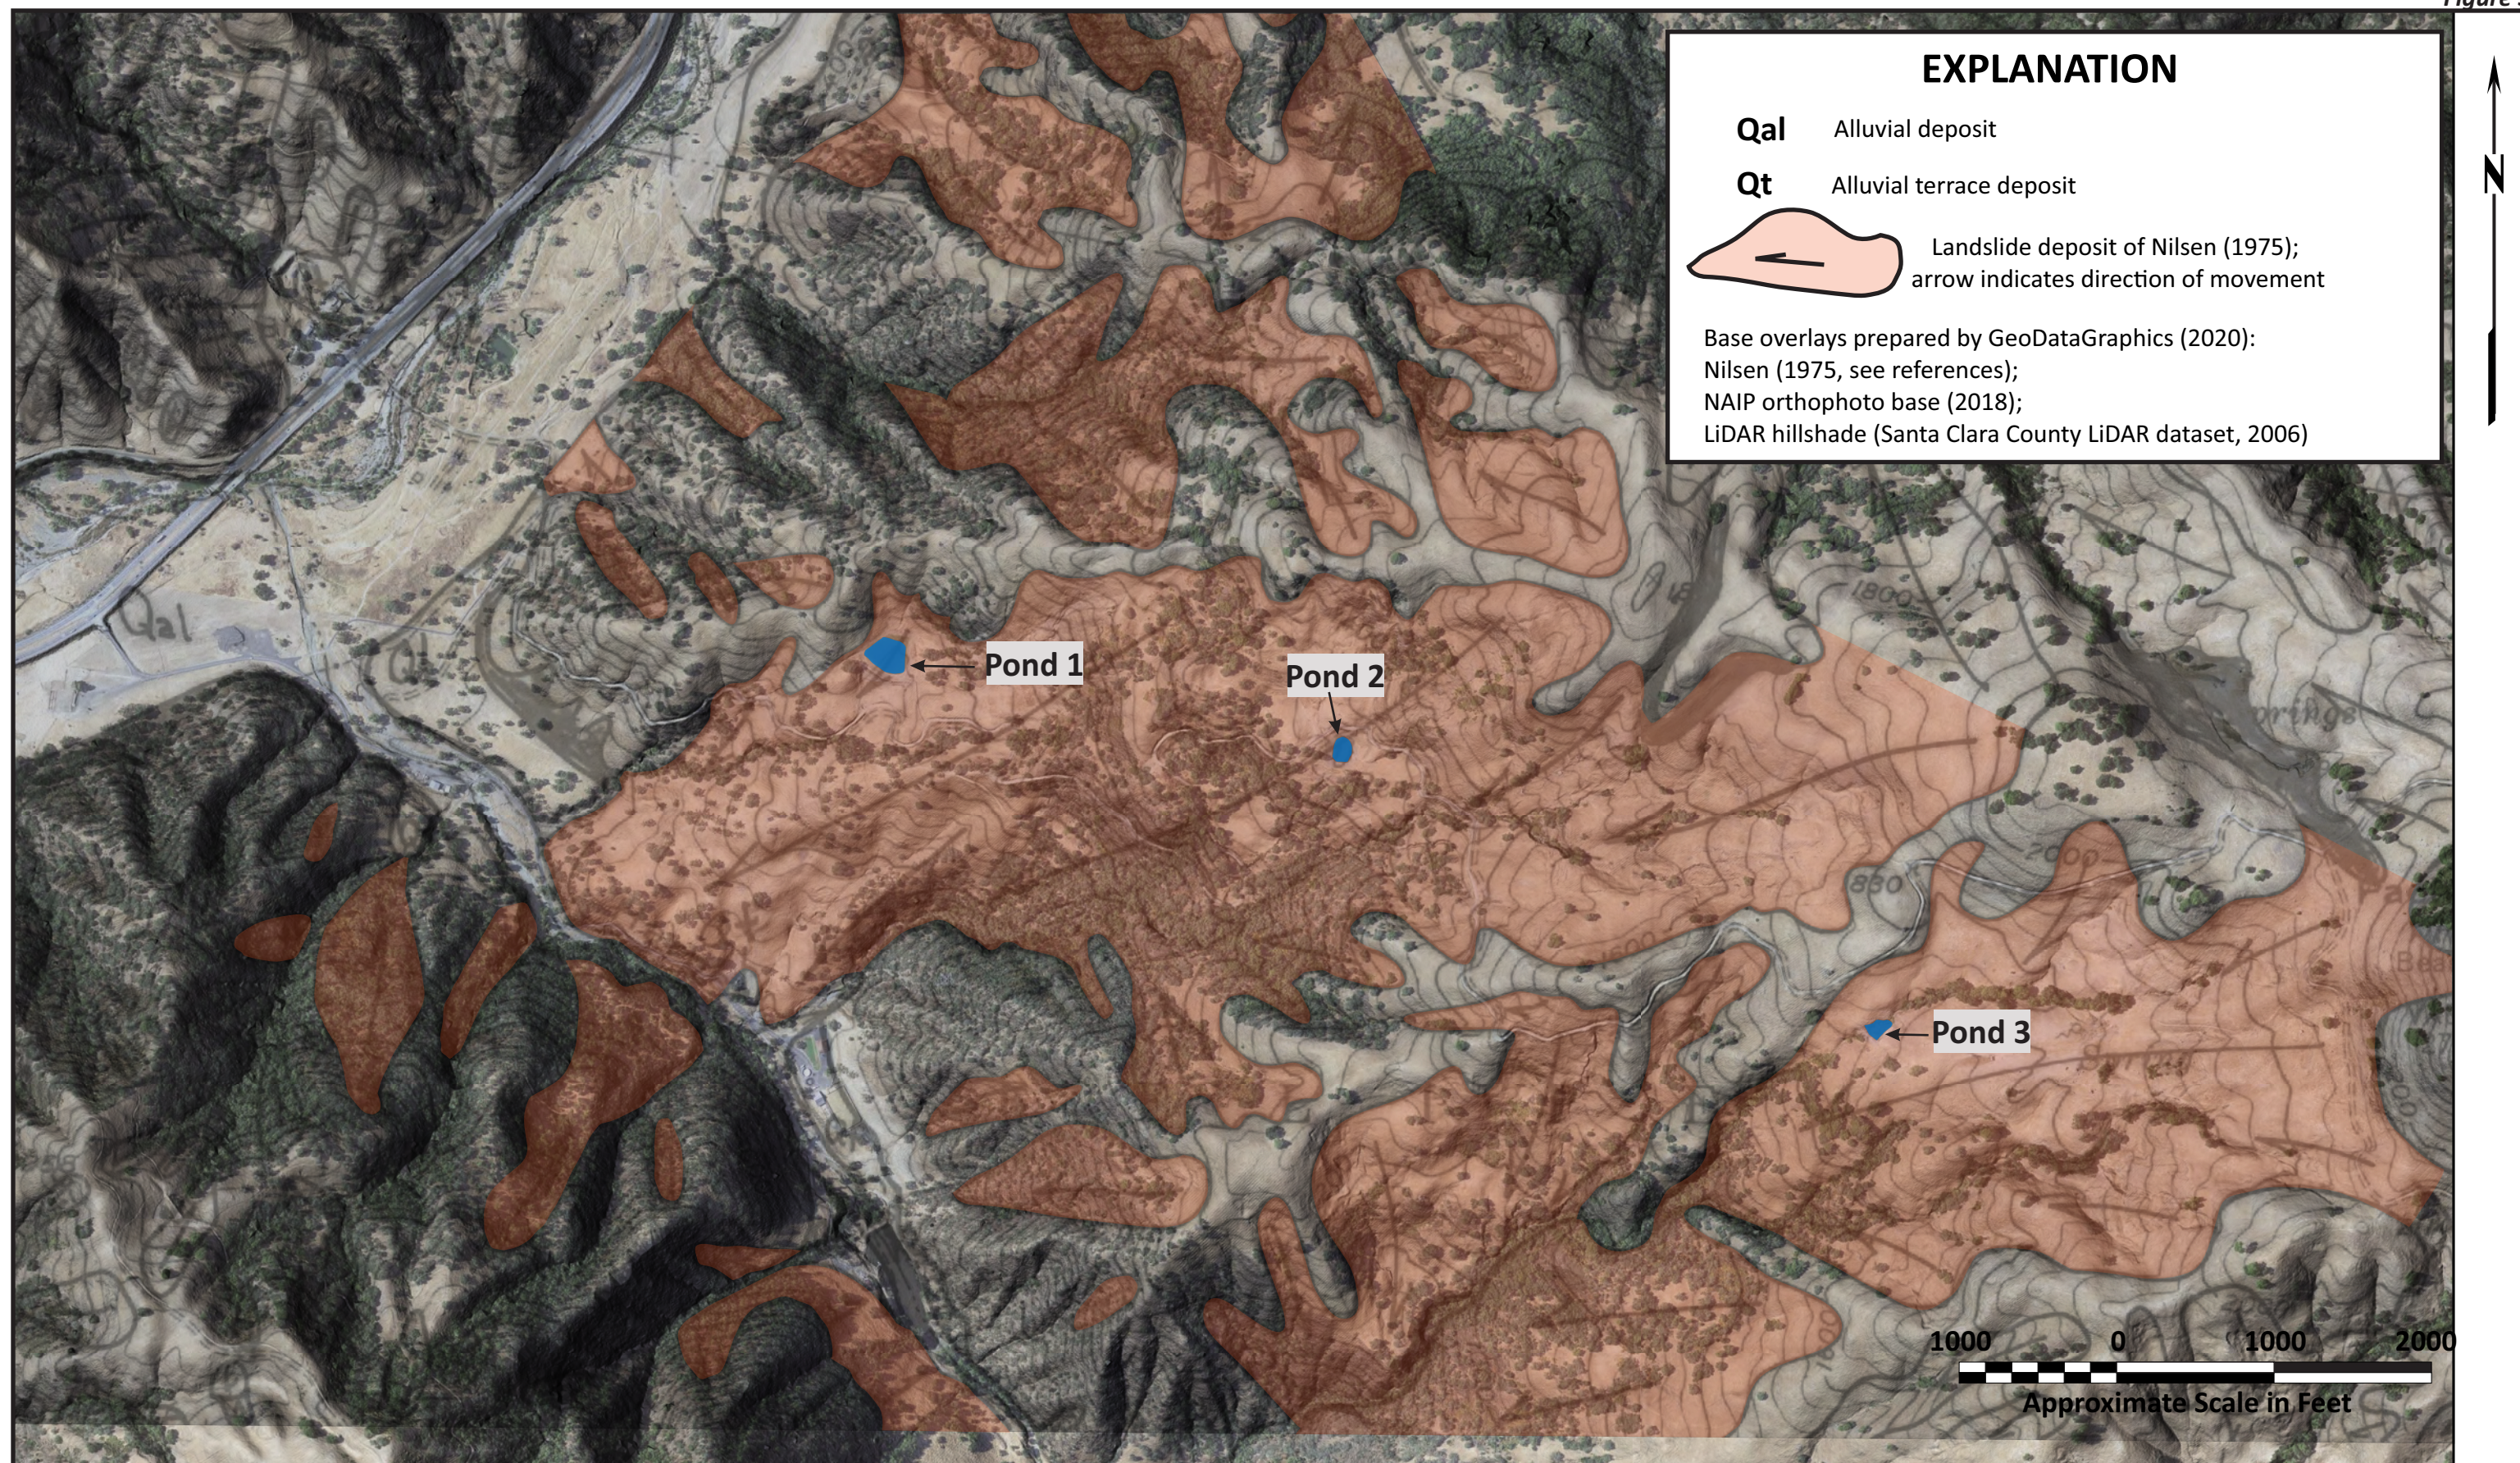
Figure 3

Nilsen² prepared a preliminary photointerpretation map of landslide deposits for the Pacheco Peak 7.5-minute map quadrangle covering the northern portion of the property, including the areas of the three ponds. The map was prepared by review and analysis of stereo-pairs of aerial photographs, which provides a 3-dimensional view of the ground surface via stereographic projection. Geomorphology associated with landslides, such as hummocky topography, arcuate scarps, and concave/convex landforms can be easily recognized using this method. The mapping by Nilsen shows large areas of mountain-scale, deep-seated landslides on west-facing slopes between Pacheco Peak and Harper Canyon (Figure 3). Ponds 1, 2, and 3 are located on these deep-seated landslide complexes. As noted in our landslide compilation report (ESP, 2020), the

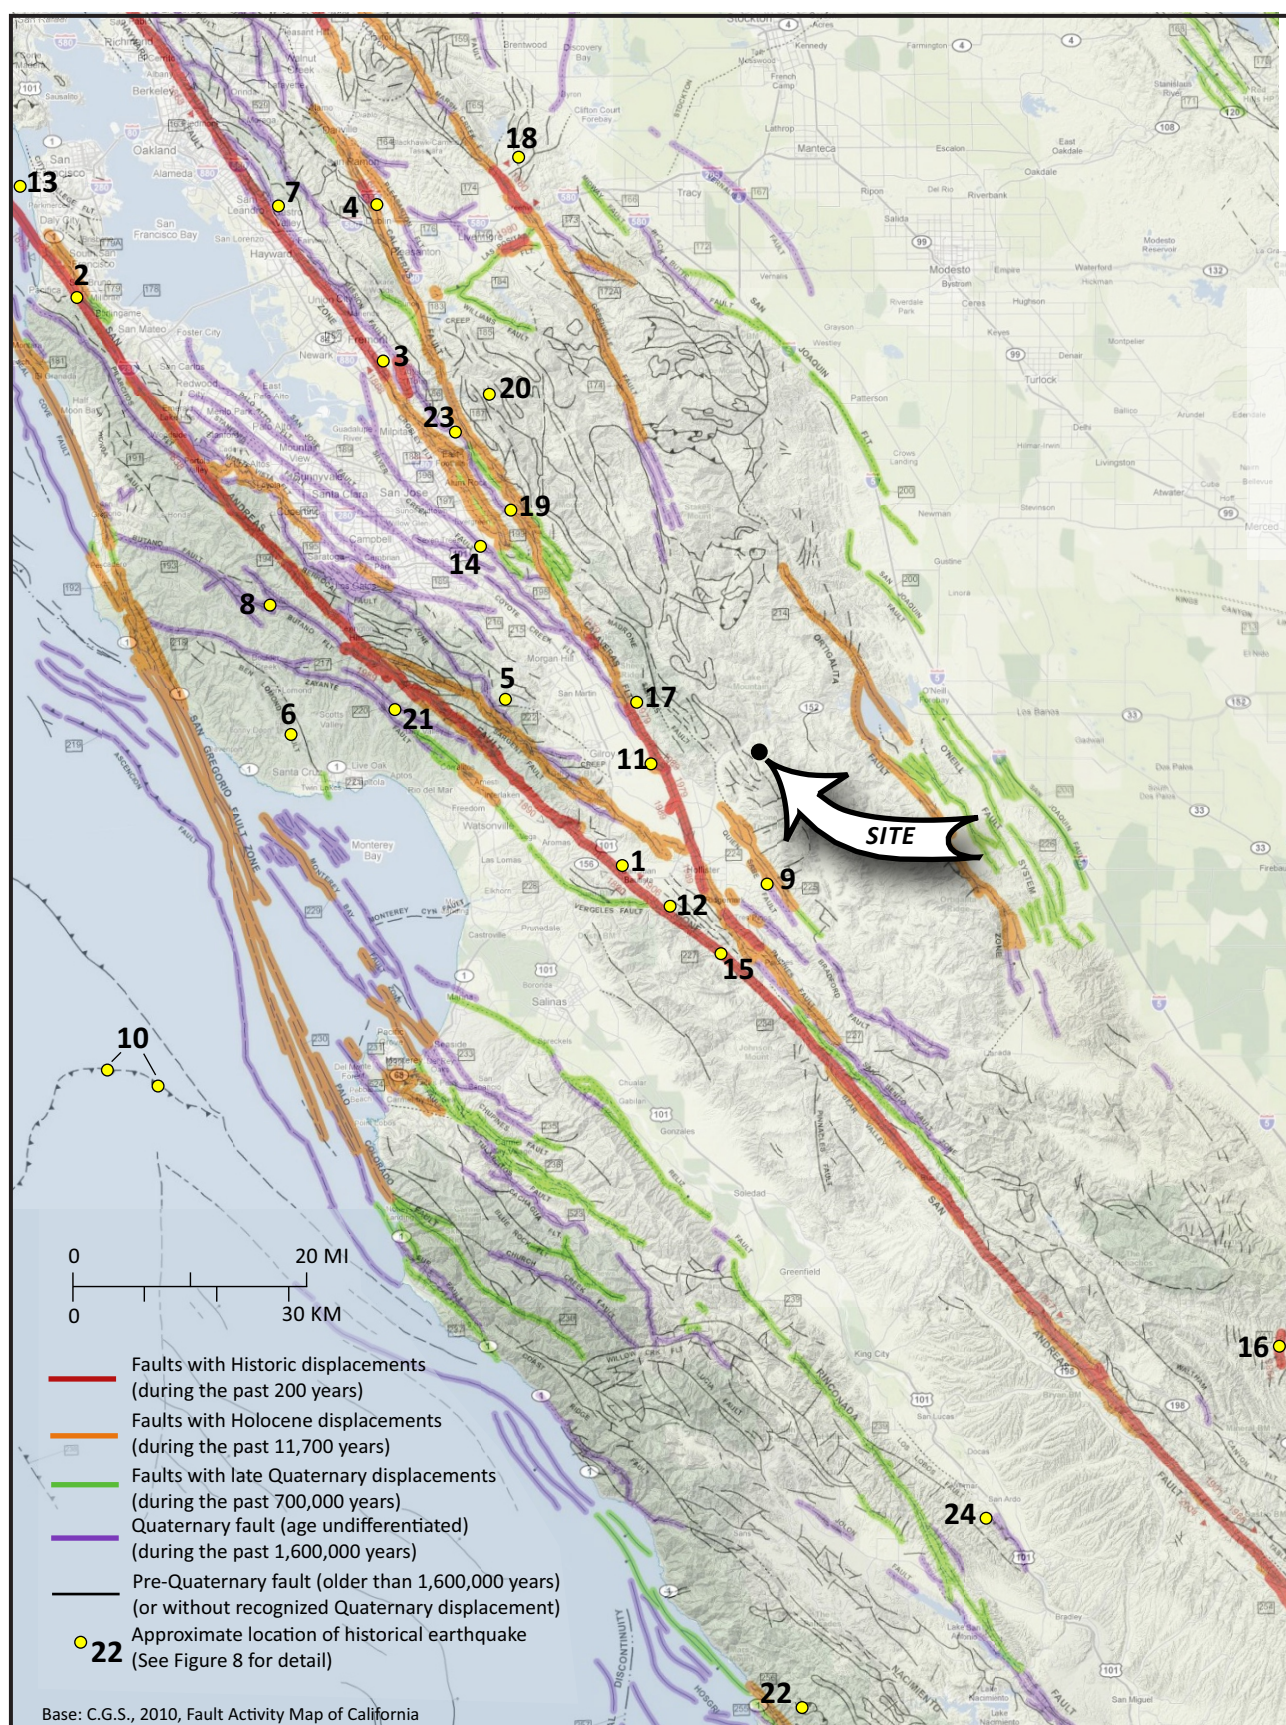
Figure 7

earthquake. The active San Andreas fault (Santa Cruz Mountains section) is located approximately 16.4 miles southwest of Pond 1 and is capable of generating a M7.6 earthquake. The locations of these and other faults of the San Andreas fault system relative to the site are shown on a Regional Faults and Earthquakes map (Figure 7). The earthquake locations are keyed to the Selected Earthquakes table (Figure 8).

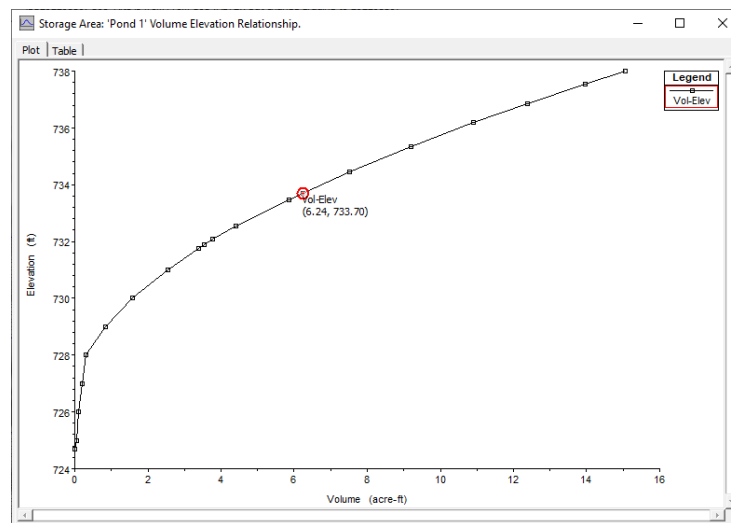
Figure 1
Estimated Pond 1 E-S Curve and Spillway Crest Elevation-Storage (red circle)

First, the sloped pond bottom elevation was estimated by drawing a straight line from the downstream toe of the dam to the pond water surface elevation at the upstream pond limit. The minimum pond bottom elevation occurs where the sloped pond bottom intersects the projected upstream toe of the dam. The water depth equals the LiDAR pond water surface elevation minus the estimated minimum pond bottom elevation.

Second, according to the estimated bathymetric geometry, the volume of water below the LiDAR pond water surface elevation was estimated to be between one-half ($\frac{1}{2}$) and one-third ($\frac{1}{3}$), or $\frac{5}{12}$ of the surface area times the water depth. Finally, the intermediate data points on the E-S curve from the pond bottom to the water surface were interpolated by fitting a polynomial line using the resulting volume and the upper portion of the E-S curve. The resulting E-S curves for both ponds are shown in Figures 1 and 2. The dam spillway crest elevation and corresponding storage are highlighted on each curve.

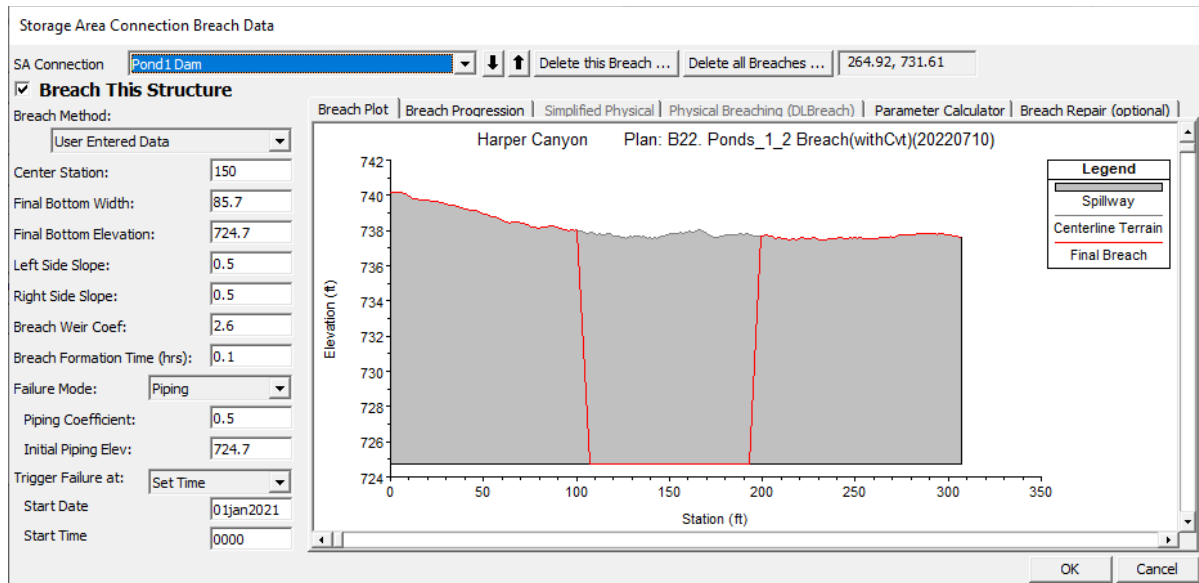
Figure 3
Pond 1 Dam Breach Parameters

Other dam breach parameters are: dam failure mode (piping vs overtopping); breach formation time; and, final breach dimensions (width, bottom elevation, and side slope).

The breach parameters selected for this analysis (Figures 3 & 4) were according to DSOD guidelines.

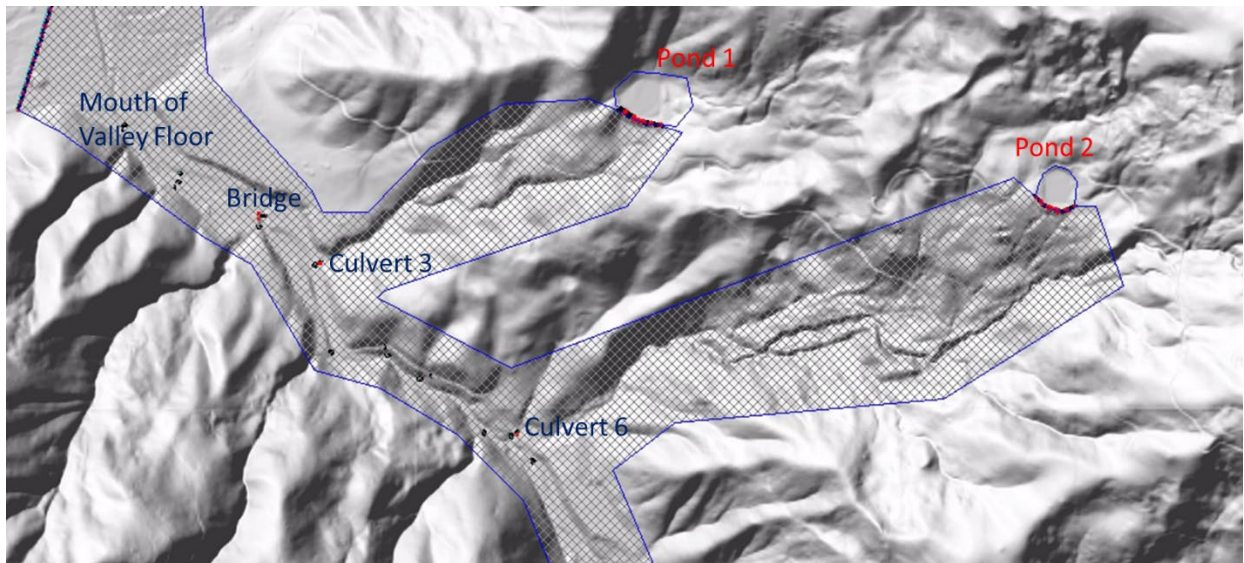
Figure 5
Model Configuration

represented in the model as storage areas. Connections were added between the ponds and the 2D flow area to represent the dams. The model configuration is shown in Figure 5.

Culverts 3 and 6 were added to the 2D model for more accurate representation of the flood wave flow path. Manning's n roughness coefficient for the flow paths below the two ponds was set to 0.045 based on HEC-RAS manual recommended literature values for watershed characteristics similar to Harper Canyon.

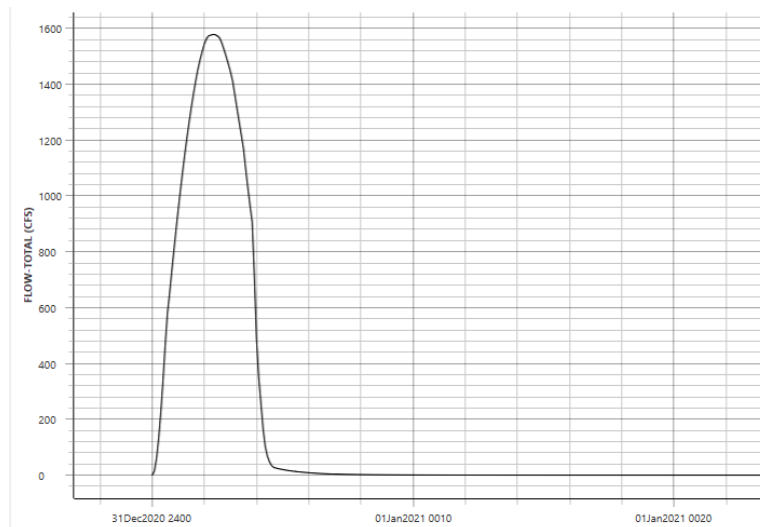
Three breach scenarios were modeled. The 1st scenario assumed only Pond #1 would breach. The 2nd scenario assumed only Pond #2 would breach. And the 3rd scenario assumed Pond #1 and #2 would breach simultaneously. The planned restored channel condition with replacement bridge was modeled as the likely future condition applicable for long-range risk forecasting.

Figure 6
Pond #1 Breach Flow Hydrograph at D/S of Pond 1 Dam
(Peak Discharge = 1,578 cfs)

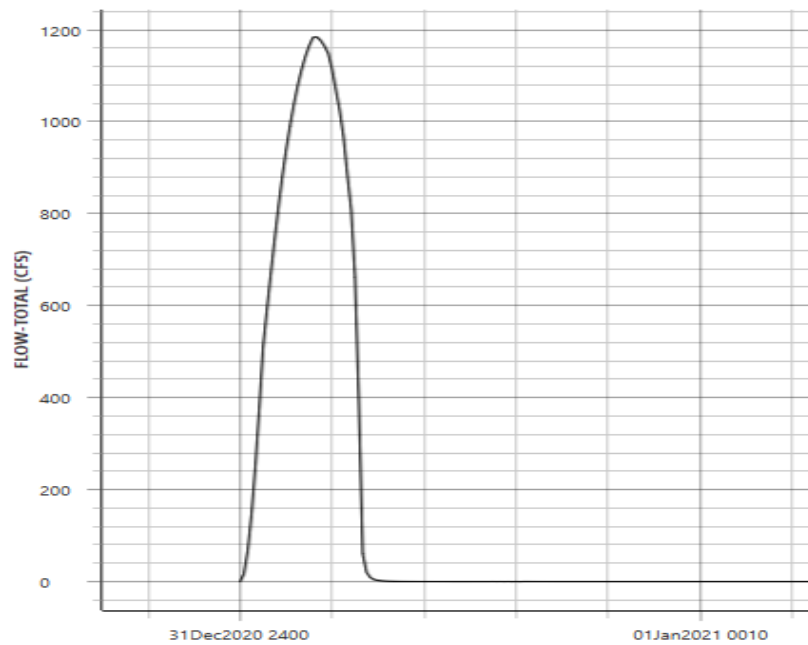
Figure 7
Pond #2 Breach Flow Hydrograph at D/S of Pond 2 Dam
(Peak Discharge = 1,184 cfs)

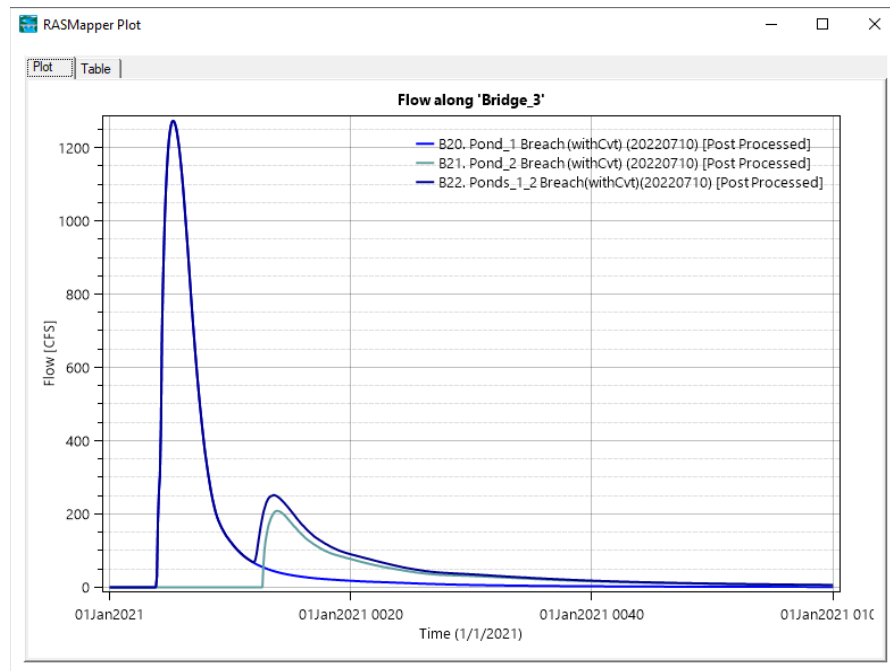
Figure 8
Ponds #1 & #2 Breach Flow Hydrographs at U/S of Bridge
(Peak Flow = 1,274 cfs)

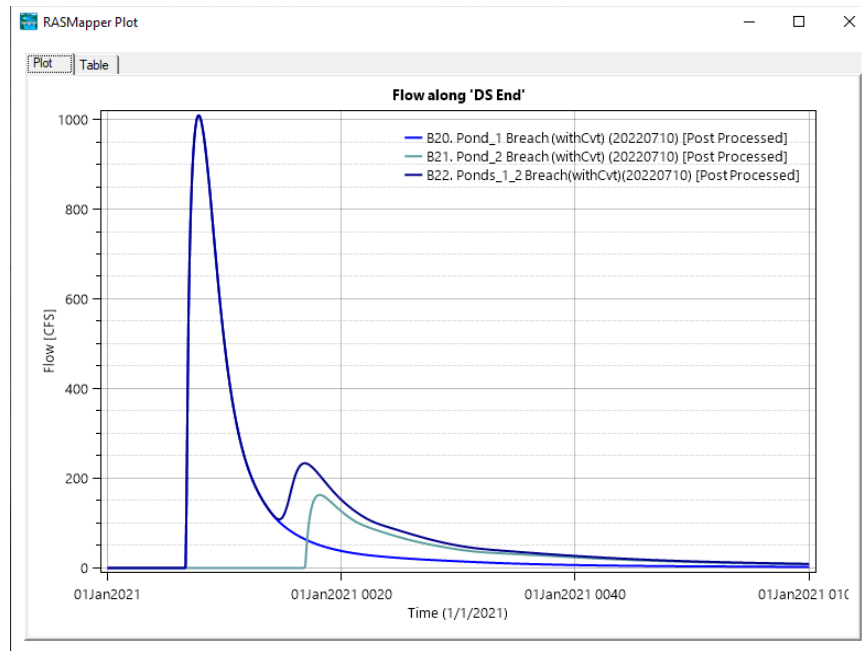
Figure 9
Ponds #1 & #2 Breach Flow Hydrographs at the D/S Mouth of Valley Floor
(Peak Flow = 1,010 cfs)
