APPLICATION FOR TREE REMOVAL PERMIT

Tree Risk Assessment Summary Report

377 Tully Rd., San Jose

February 2024

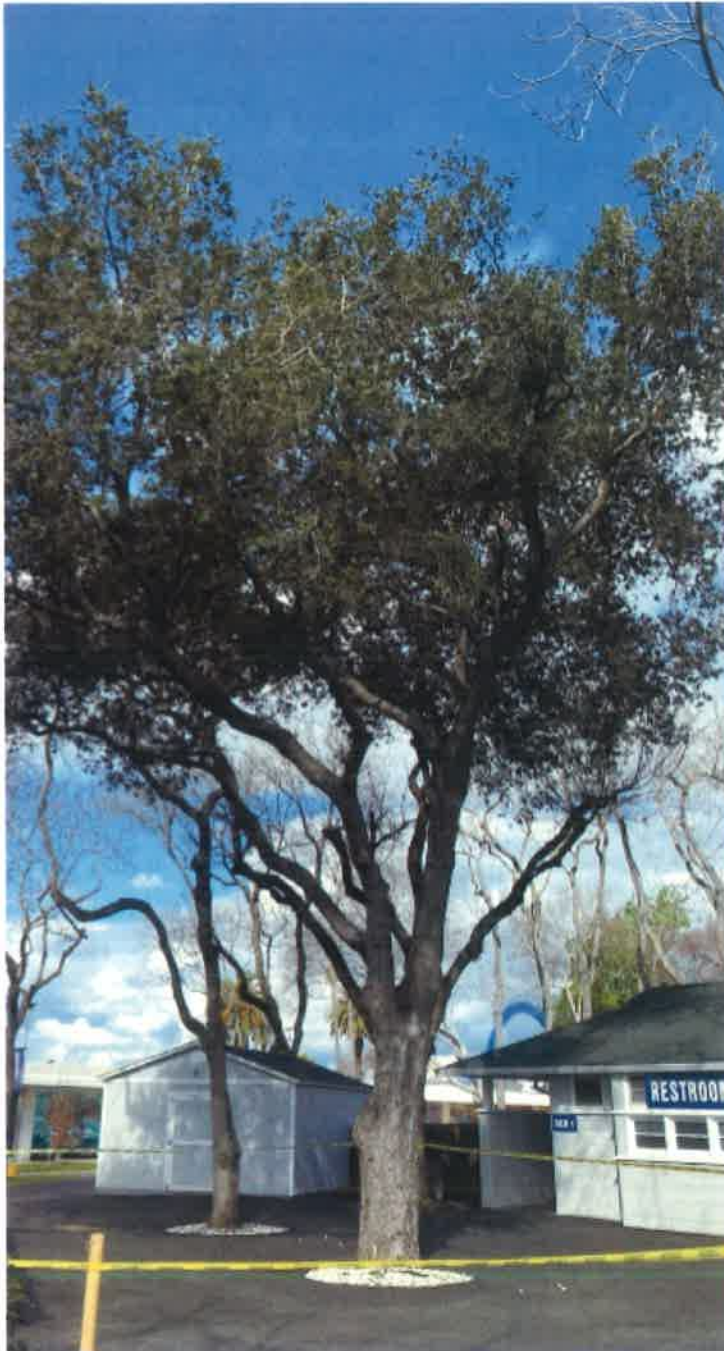
- Tree #1 had a risk rating of high for root plate failure. The whole tree is in the process of failing, the tree is currently being upheld by two other trees, and the whole tree should be removed for safety. This tree does fall under protected tree status. This tree qualifies for an exception falling under Santa Clara County Municipal Codes Division Sec. C16-4 section b. Once the tree is removed there will be no remaining risk.
- Target ratings (occupancy rate) were constant with a high or high likelihood of impacting the targets.
- Completely removing the tree is the only way to eliminate all risk. Ultimately, the acceptable tolerance of risk is set by the tree managers.

Tree Defect Observations
