SURFACE MINING INSPECTION REPORT

I. Mine Name (As Shown on Approved Reclamation Plan) Permanente Quarry	Inspection Date: 9/4 & 9/5, 2014	CA MINE ID# 91- 43-0004
--	--	-----------------------------------

This letter report summarizes the findings of PMC's annual Surface Mining and Reclamation Act (SMARA) site inspection of the Permanente Quarry in Cupertino, CA (Mine ID #91-43-0004) conducted on September 4 and 5, 2014. PMC was retained by Santa Clara County to assist County staff with the annual SMARA mine inspection and to provide written documentation of our observations, issues of concern and recommendations.

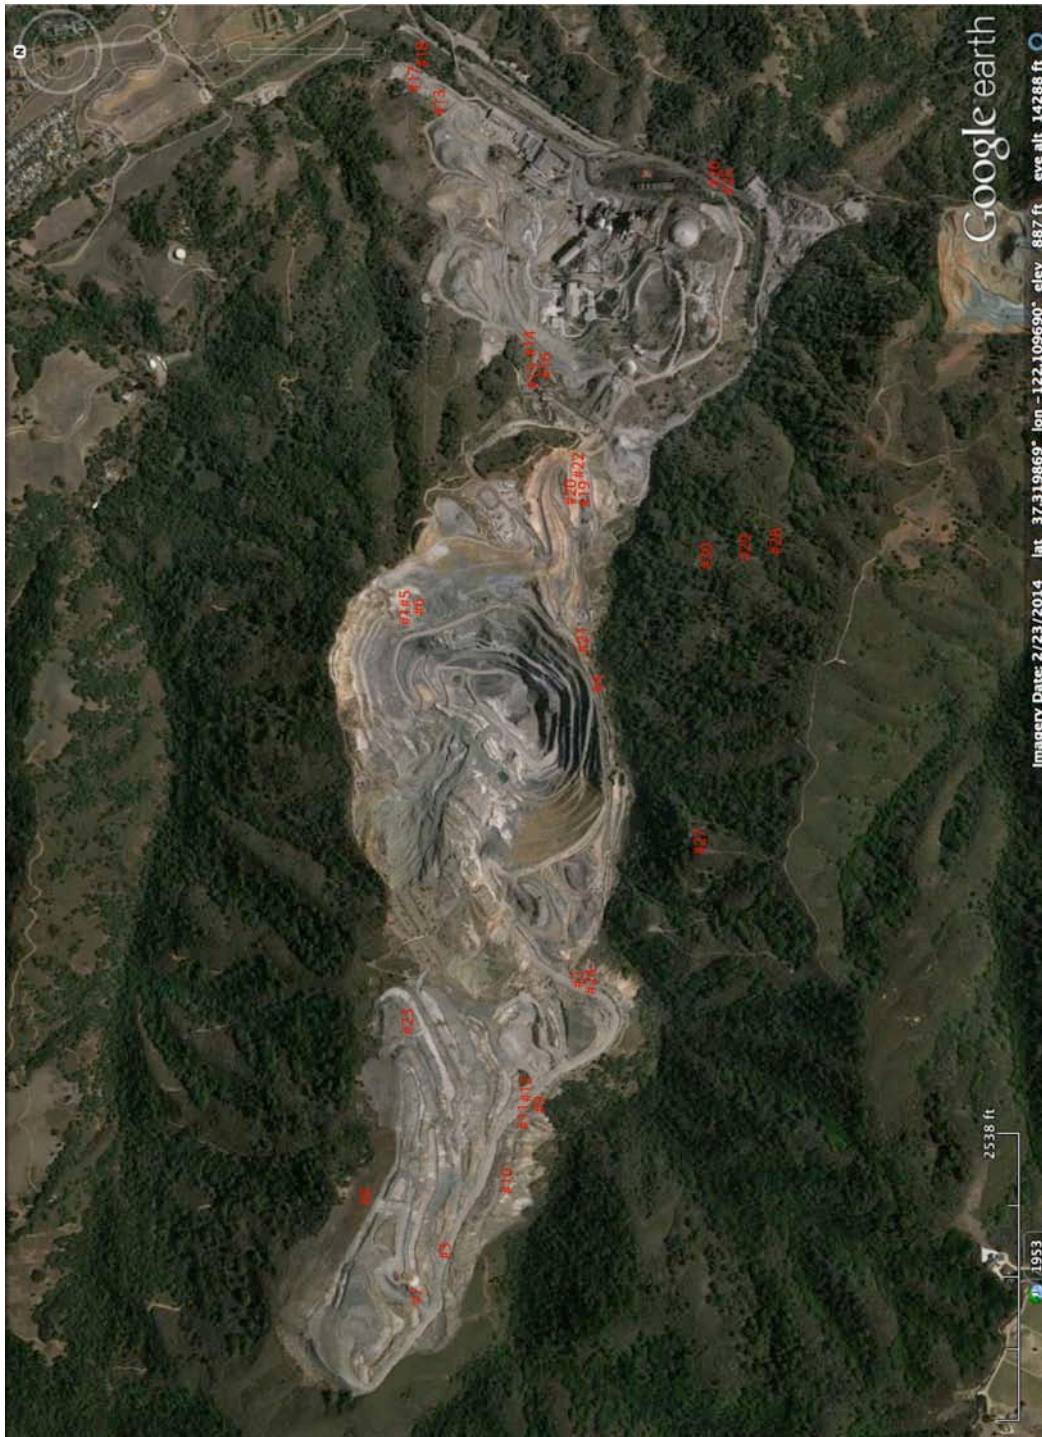
This discussion of the mine's existing conditions is broken into sections based on the nine mining areas defined in the RPA. In addition, issues that apply to all or several parts of the mine site will be discussed under separate topics. Photo 31 provides a February 23, 2014 mine overview image along with the locations of inspection report photo stops.

Photo 31: Photo stops photos #1 through #30. Image from Google Earth; aerial photo dated February 23, 2014.
