## GEOTECHNICAL EVALUATIONS AND DESIGN RECOMMENDATIONS (REVISED)

**Permanente Quarry Reclamation Plan Update  
Santa Clara County, California**

**Submitted By:** Golder Associates Inc.  
425 Lakeside Drive  
Sunnyvale, CA 94085

Project 063-7109

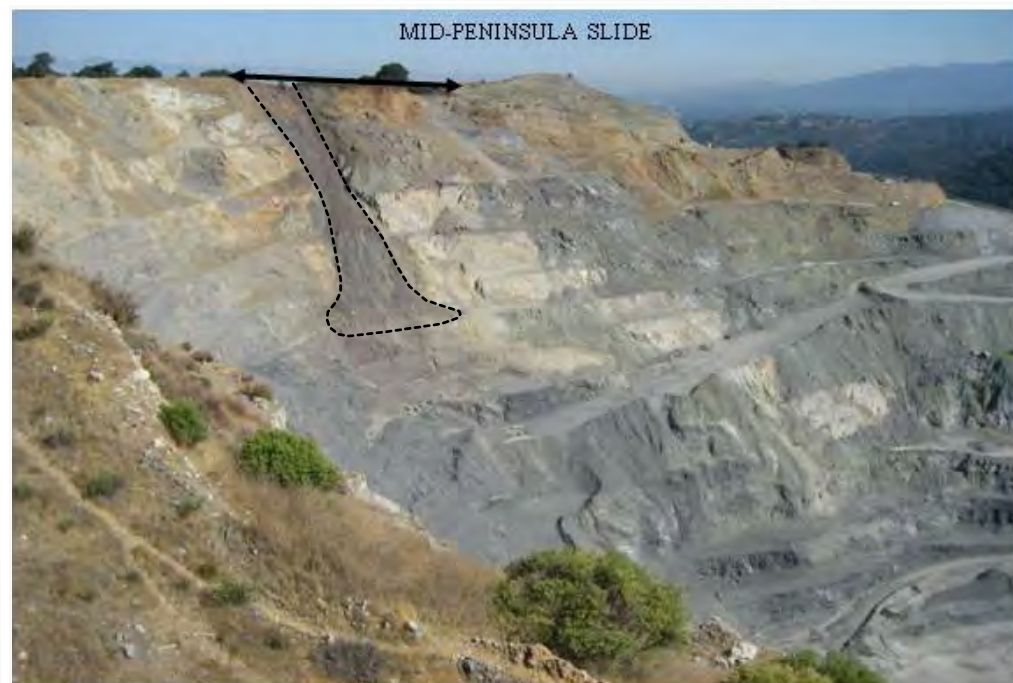
PROJECT No.	063-7109	800	FILE No.	Figure 4.2
DESIGN	--	01/22/10	SCALE	AS SHOWN
CADD	AJS	01/22/10	REV.	1
CHECK	GM	01/22/10	<b>FIGURE 4.2</b>	
REVIEW	BF	01/22/10

The condition of the Quarry slopes as of June 2007 is shown in Figure 4.2. The current North Quarry bottom at elevation 710 feet mean sea level (msl) was established during the previous phase of mining (Foruria, 2004). Historically, the North Quarry has filled with water to an approximate elevation of 775 feet msl except when the North Quarry is being actively dewatered.

LOOKING NORTH-NORTHWEST

EAST WALL

LOOKING SOUTHEAST

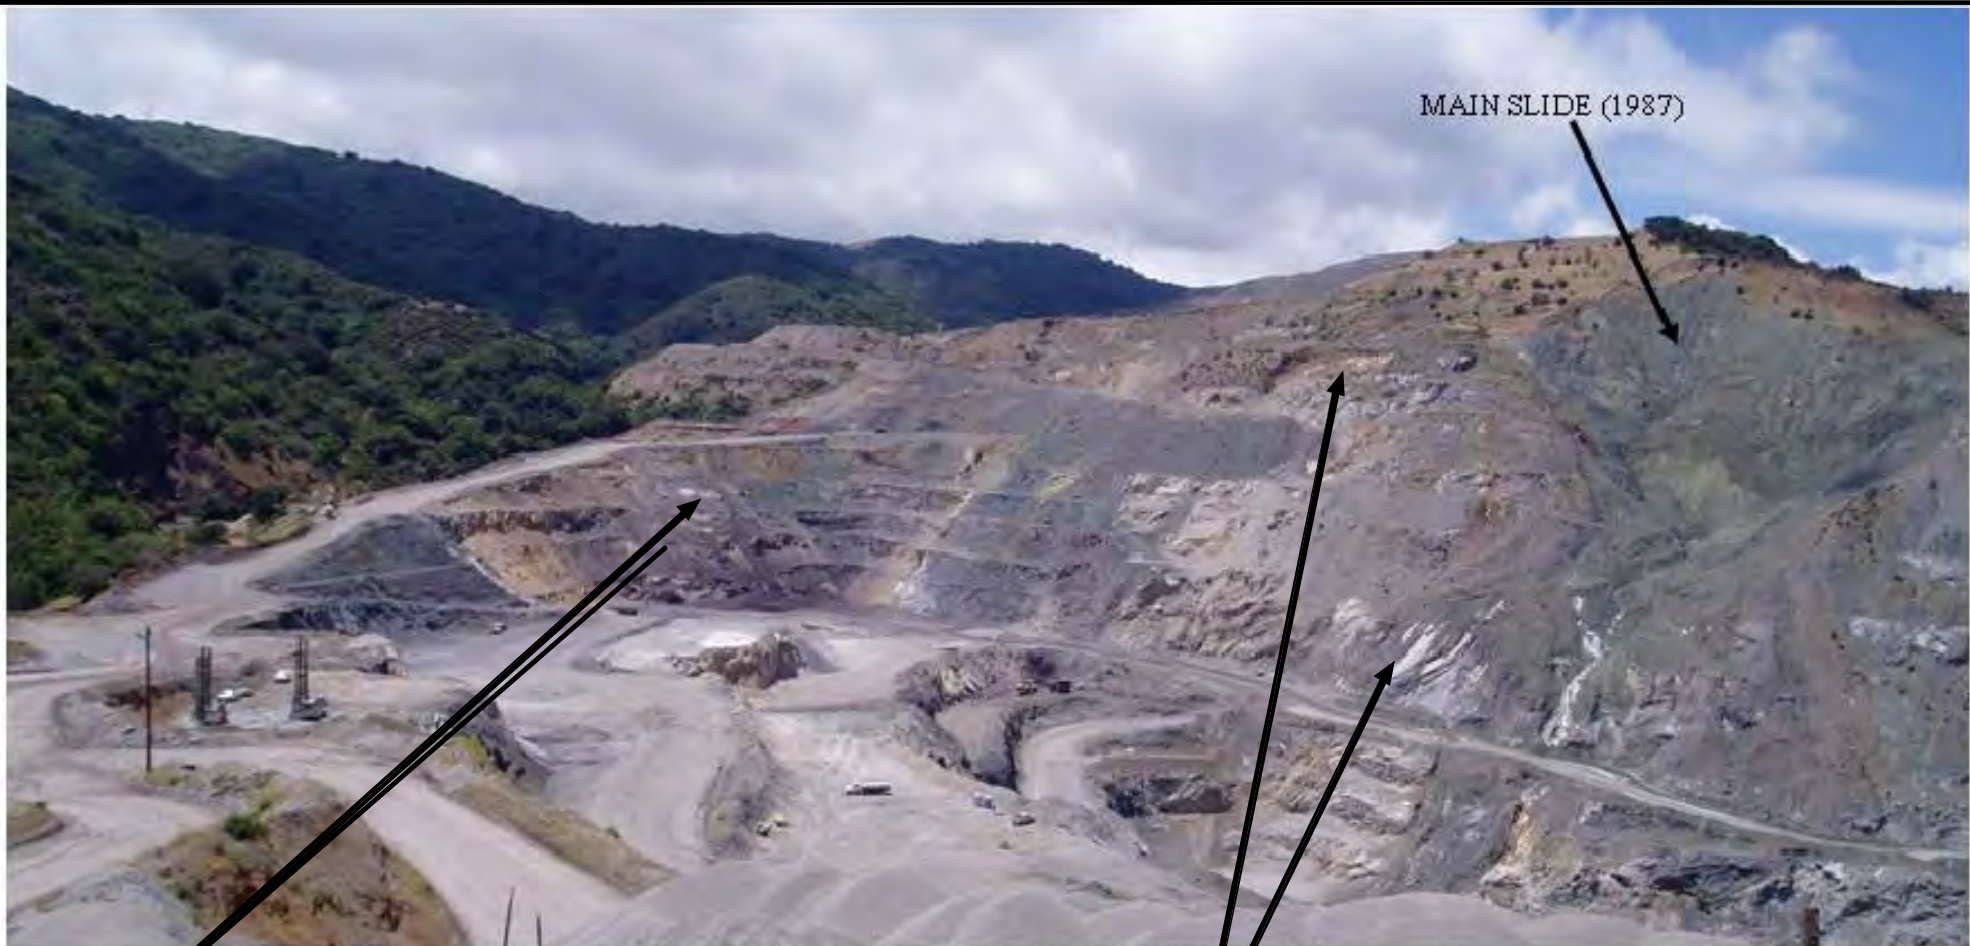
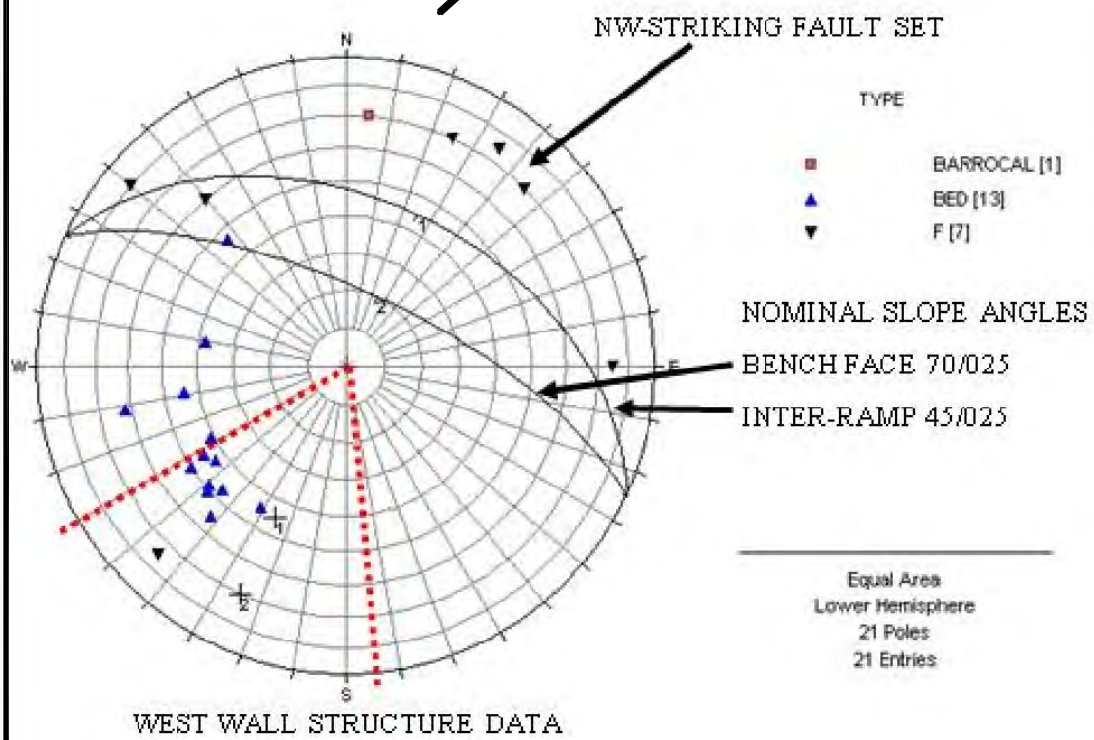
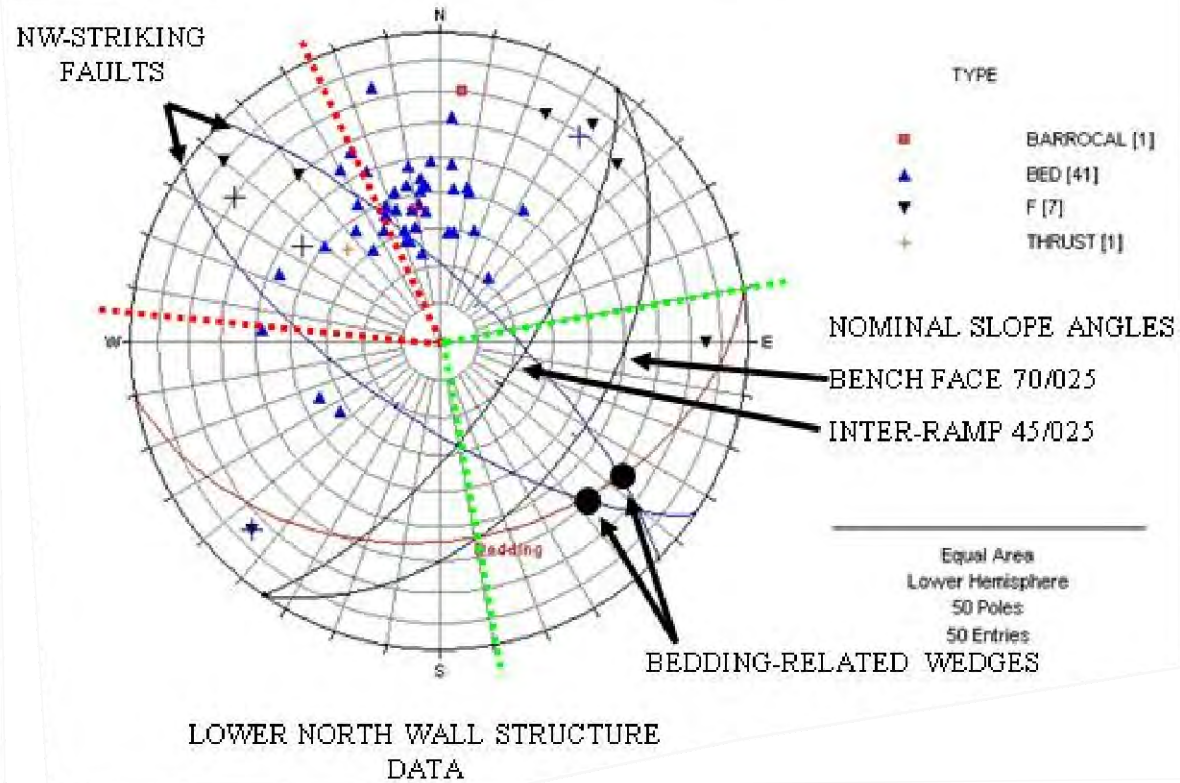
Limestone generally stands well at the design inter-ramp angle (IRA) of 45-50° across most of the North Quarry, with steep bench faces and functional catch benches. However, adversely-oriented structure within the limestone blocks has affected slope performance in the following areas (Figure 4.6):

PROJECT GEOTECHNICAL EVALUATIONS AND DESIGN RECOMMENDATIONS PERMANENTE QUARRY RECLAMATION PLAN UPDATE SANTA CLARA COUNTY, CALIFORNIA			
TITLE <b>NORTH QUARRY STRUCTURAL CONTROL IN LIMESTONE</b>			
PROJECT No. 063-7109 800		FILE No.	Figure 4.6
DESIGN	--	01/22/10	SCALE AS SHOWN REV. 1
CADD	AJS	01/22/10	
CHECK	GM	01/22/10	
REVIEW	BF	01/22/10

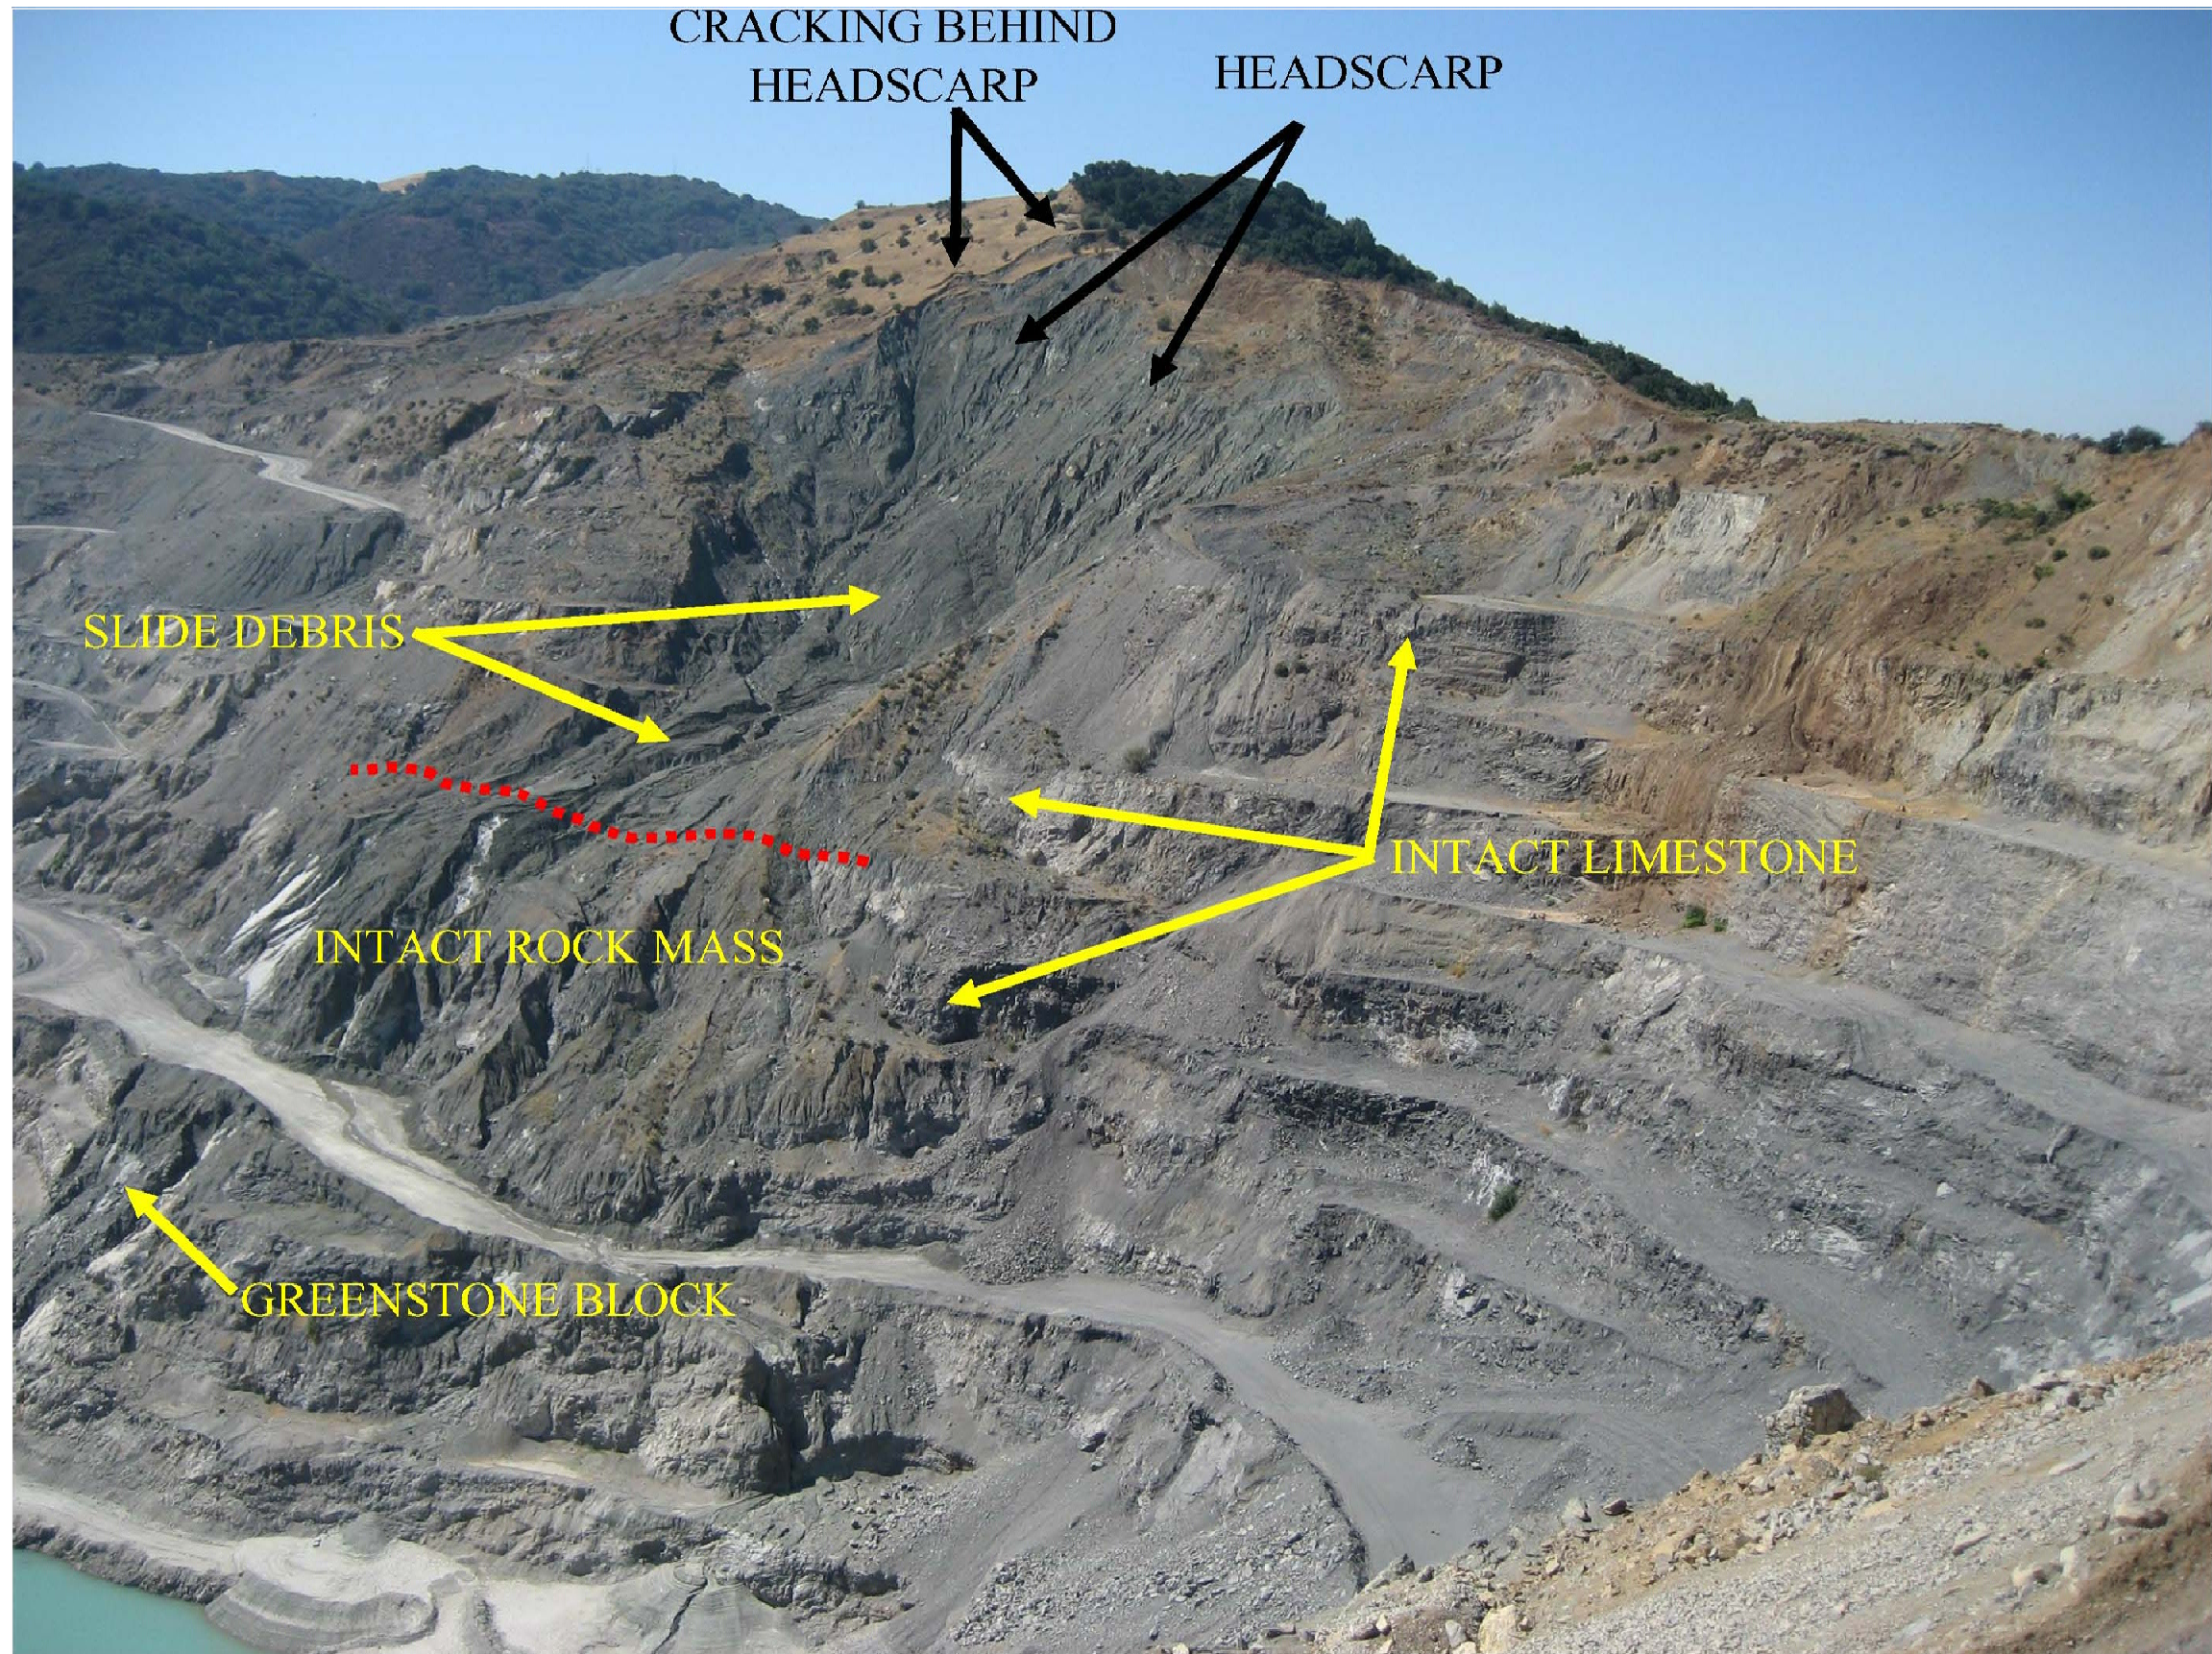
PROJECT No. 063-7109 800		FILE No. Figure 5.3		
	DESIGN	--	01/22/10	SCALE	AS SHOWN
	CADD	AJS	01/22/10	REV.	1
	CHECK	GM	01/22/10	<b>FIGURE 5.3</b>	
	REVIEW	BF	01/22/10

At present, the slope profile within the Main Slide (1987) features a headscarp in the upper slope that has progressed into the ridgecrest; slide debris accumulated in the lower elevations of the slide area, and steeper slopes developed in intact limestone at the toe of the slide (Figure 5.3). The headscarp exposure is greenstone along its full length and is typically inclined at slope angles between about 30° and 40°. Greenstone extends from the crest downward over the full height of the slide, more than 500 feet. Golder understands that instability has been limited to slumping and surficial movement since early 1999. However, instability during the winter of 2007-2008 included regression of the headscarp into the ridgecrest through failure of crack-bounded blocks; weather-related degradation of the headscarp; and generation of debris flows from the lower section of the slide that has been on-going through 2008 to the present. The debris flows were observed throughout the dry months of 2008.

PROJECT GEOTECHNICAL EVALUATIONS AND DESIGN RECOMMENDATIONS PERMANENTE QUARRY RECLAMATION PLAN UPDATE SANTA CLARA COUNTY, CALIFORNIA					
TITLE <b>MAIN SLIDE (1987)</b>

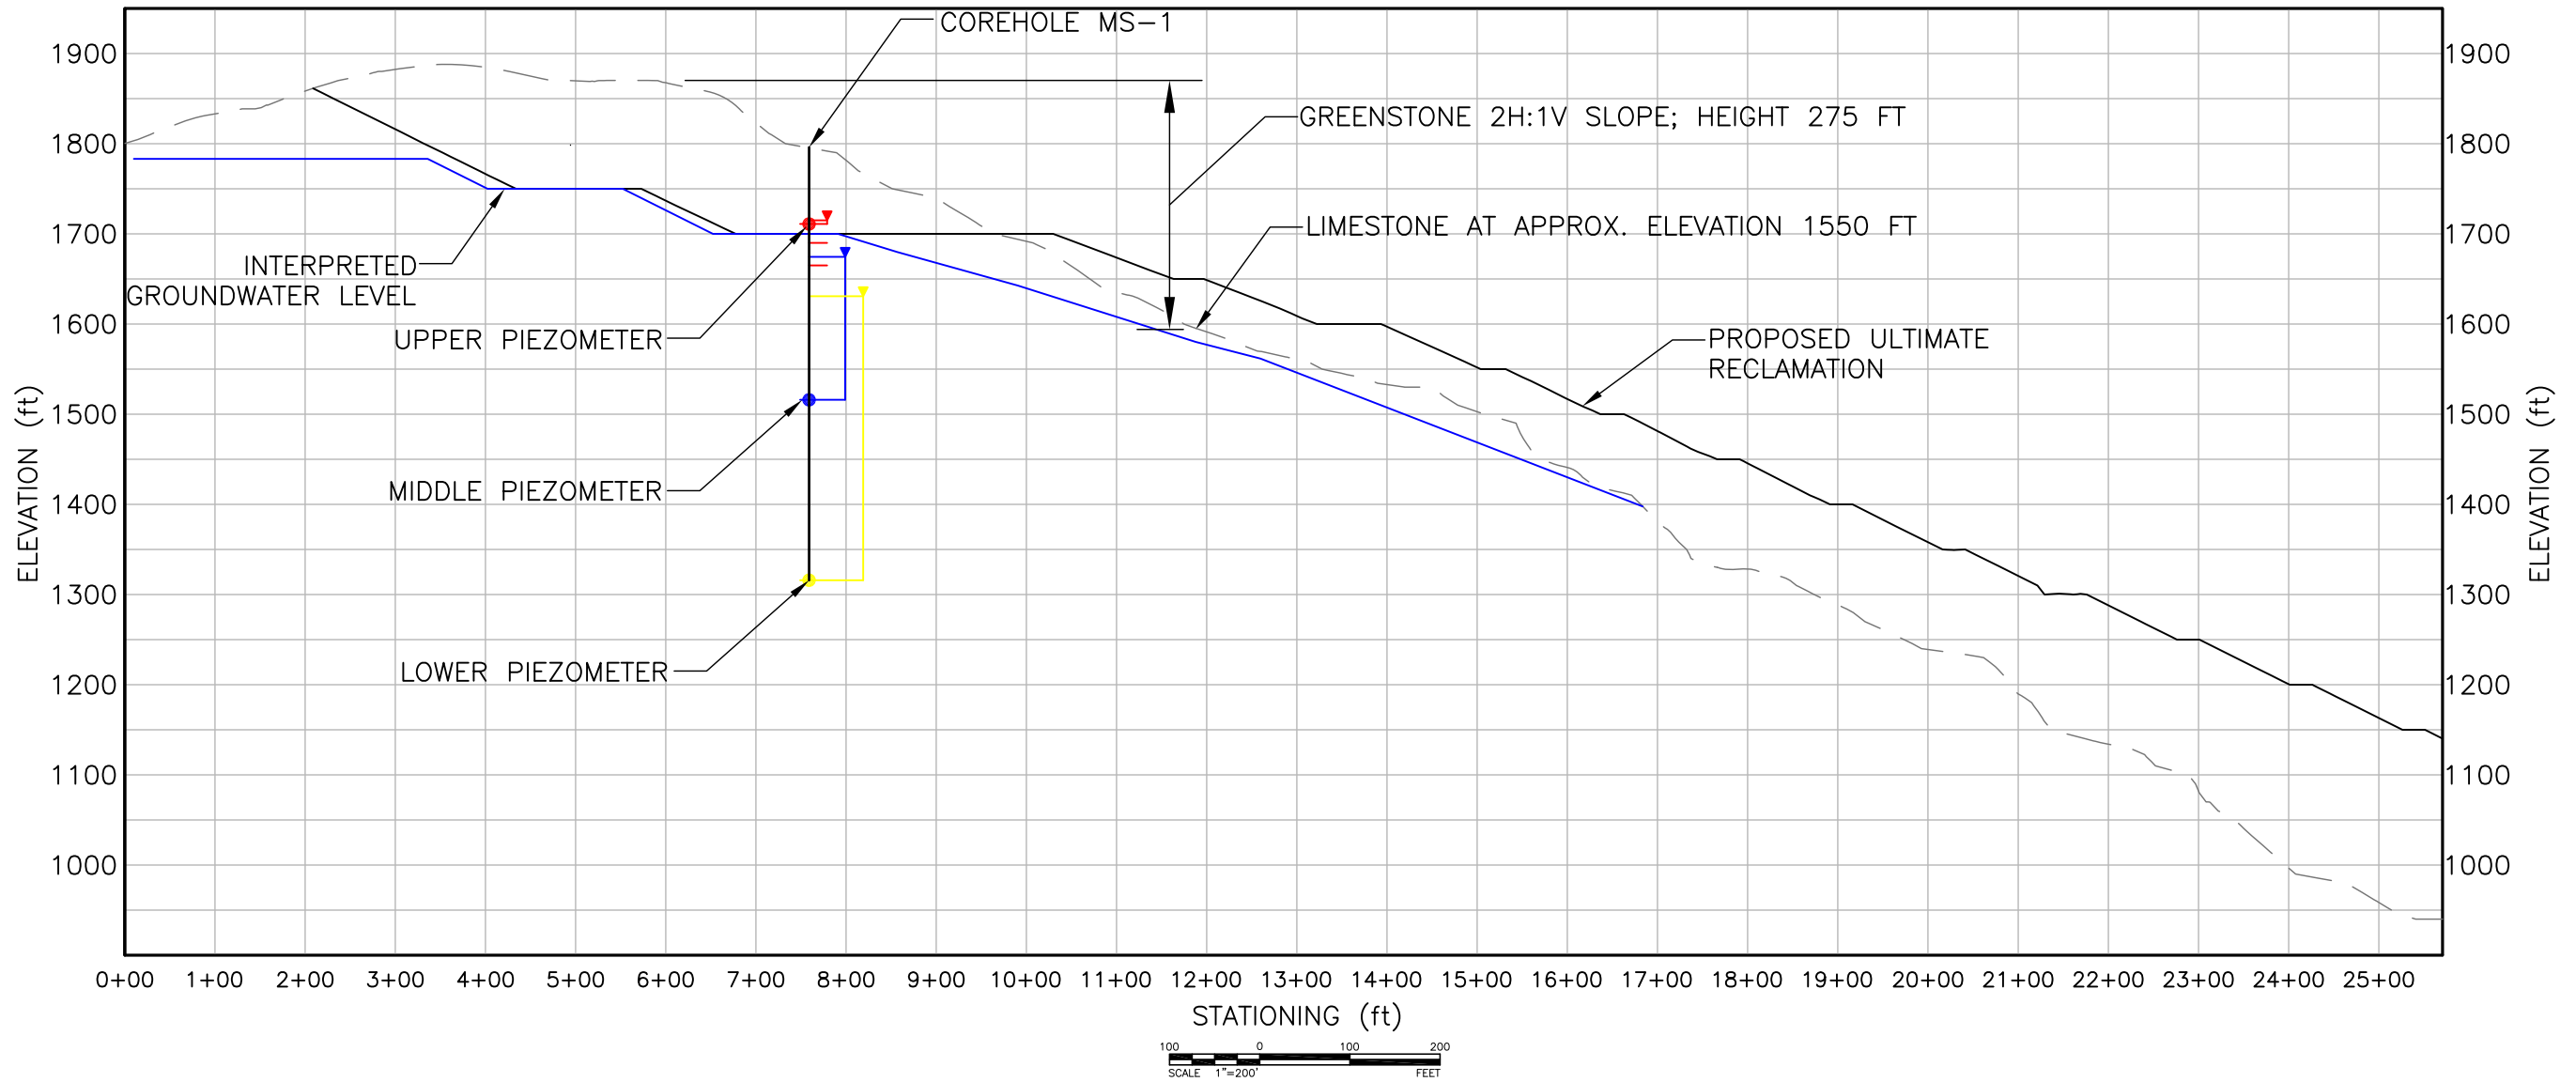
PROJECT No. 063-7109 904			FILE No. Figure 5.6
	DESIGN	RK	07/07/11	SCALE AS SHOWN REV. 2
	CADD	AJS	07/07/11	
	CHECK	BF	07/07/11	
	REVIEW	KH	07/07/11	<b>FIGURE 5.6</b>

Vibrating wire piezometers were installed in coreholes MS-01 and MS-02 in order to improve the understanding of hydrogeological conditions in the greenstone rock mass. Piezometer installations involved attaching transducers and their cables to a string of PVC pipe as it was inserted in a hole; and then fully-grouting the hole, using the PVC string as a tremmie pipe. Piezometers were installed at three depths in corehole MS-01, and a single piezometer was installed in corehole MS-02. Piezometer depths and recent groundwater levels are summarized in Table 5.3; groundwater levels in the piezometers installed in corehole MS-01 are illustrated in Figure 5.6.

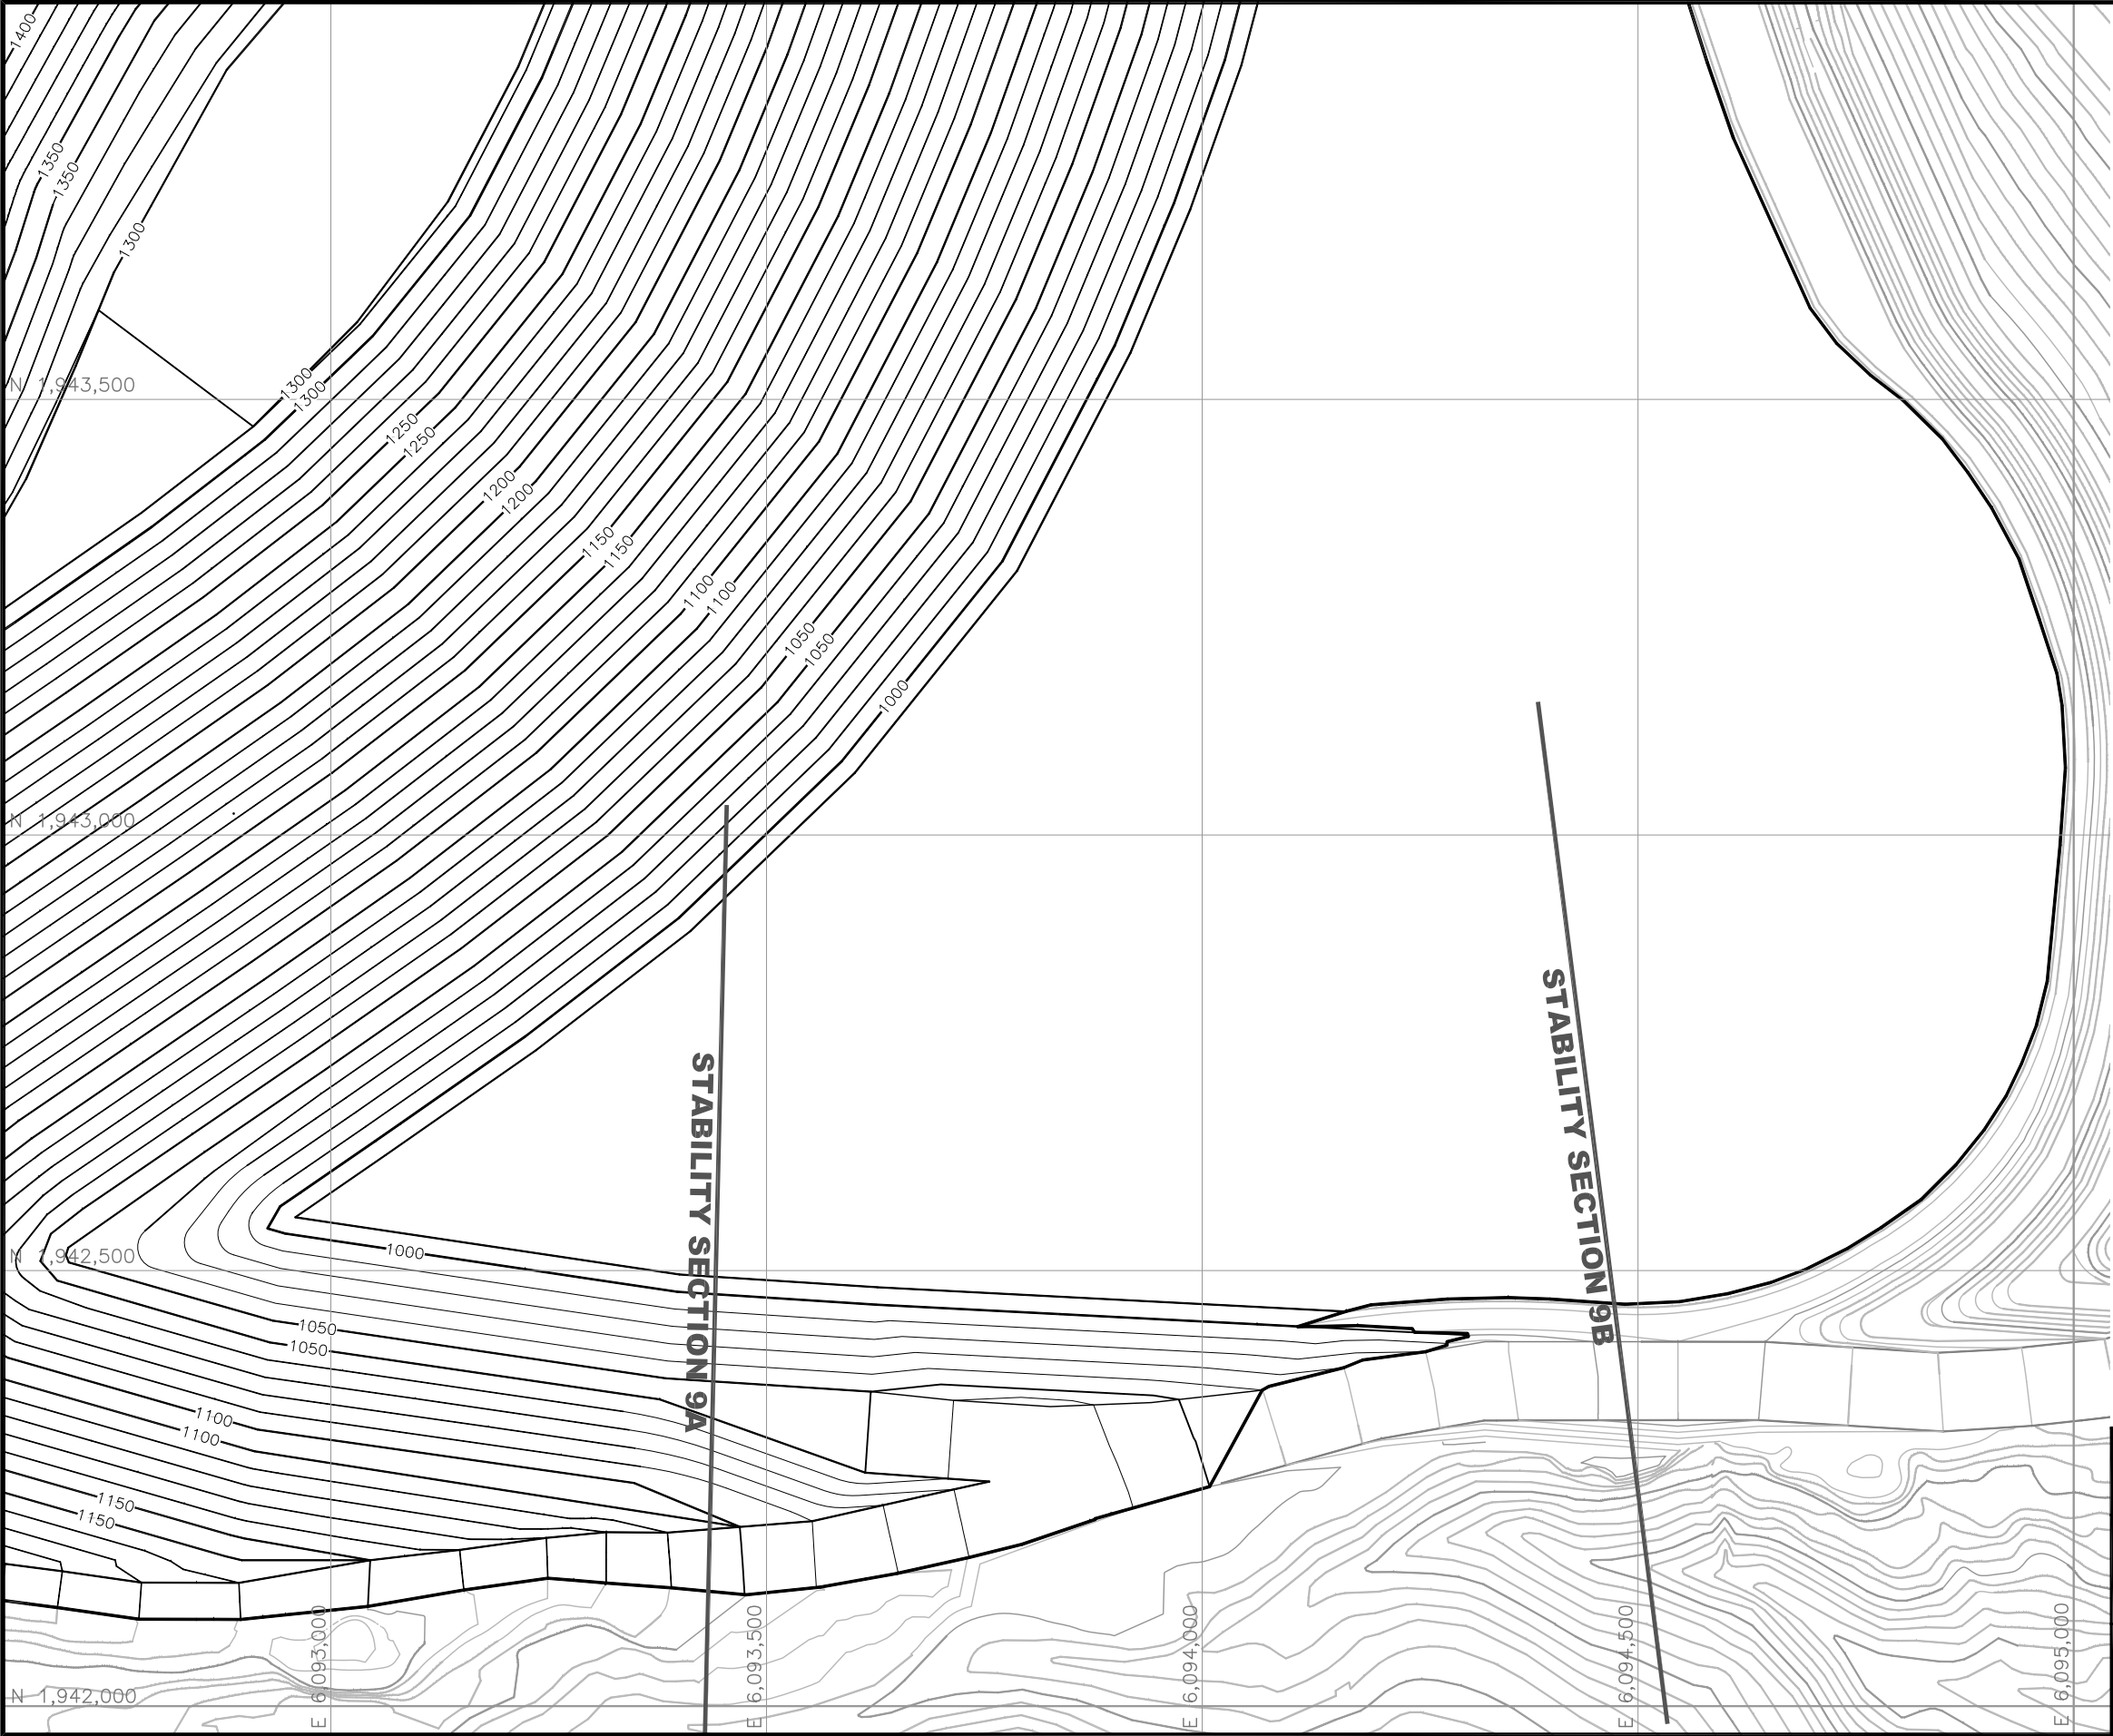
PROJECT No. 063-7109 904			FILE No. Figure 9.1-9.7
	DESIGN	RK	07/06/11	SCALE AS SHOWN
	CADD	AJS	07/06/11	REV. 2
	CHECK	BF	07/06/11	<b>FIGURE 9.3</b>
	REVIEW	KH	07/06/11

PROJECT GEOTECHNICAL EVALUATIONS AND DESIGN RECOMMENDATIONS PERMANENTE QUARRY RECLAMATION PLAN UPDATE SANTA CLARA COUNTY, CALIFORNIA				
TITLE <b>FINAL RECLAIMED TOPOGRAPHY OF SOUTH SLOPE</b>
