PROJECT: LANDS OF BOURDET
PACHECO PASS HIGHWAY, APN 898-19-005
SANTA CLARA COUNTY, CALIFORNIA

SUBJECT: Review of Proposed Septic Leach Field Conditions

SITE EVALUATION RESULTS MAP			
Project Location:	Pacheco Pass Hwy, Gilroy, California	[Santa Clara County]	
Property Owner:	Lacy Bourdett		
Mailing Address:	PO Box 1378, Hollister, CA 95024		
Owner Phone #:	(831) 801-3483		
Date:	07/22/22	By: David Quinn / Andrew Brownstone	Sheet:
REVISION:		Job No.: 19026	APN: 898-19-005
			1 OF 1

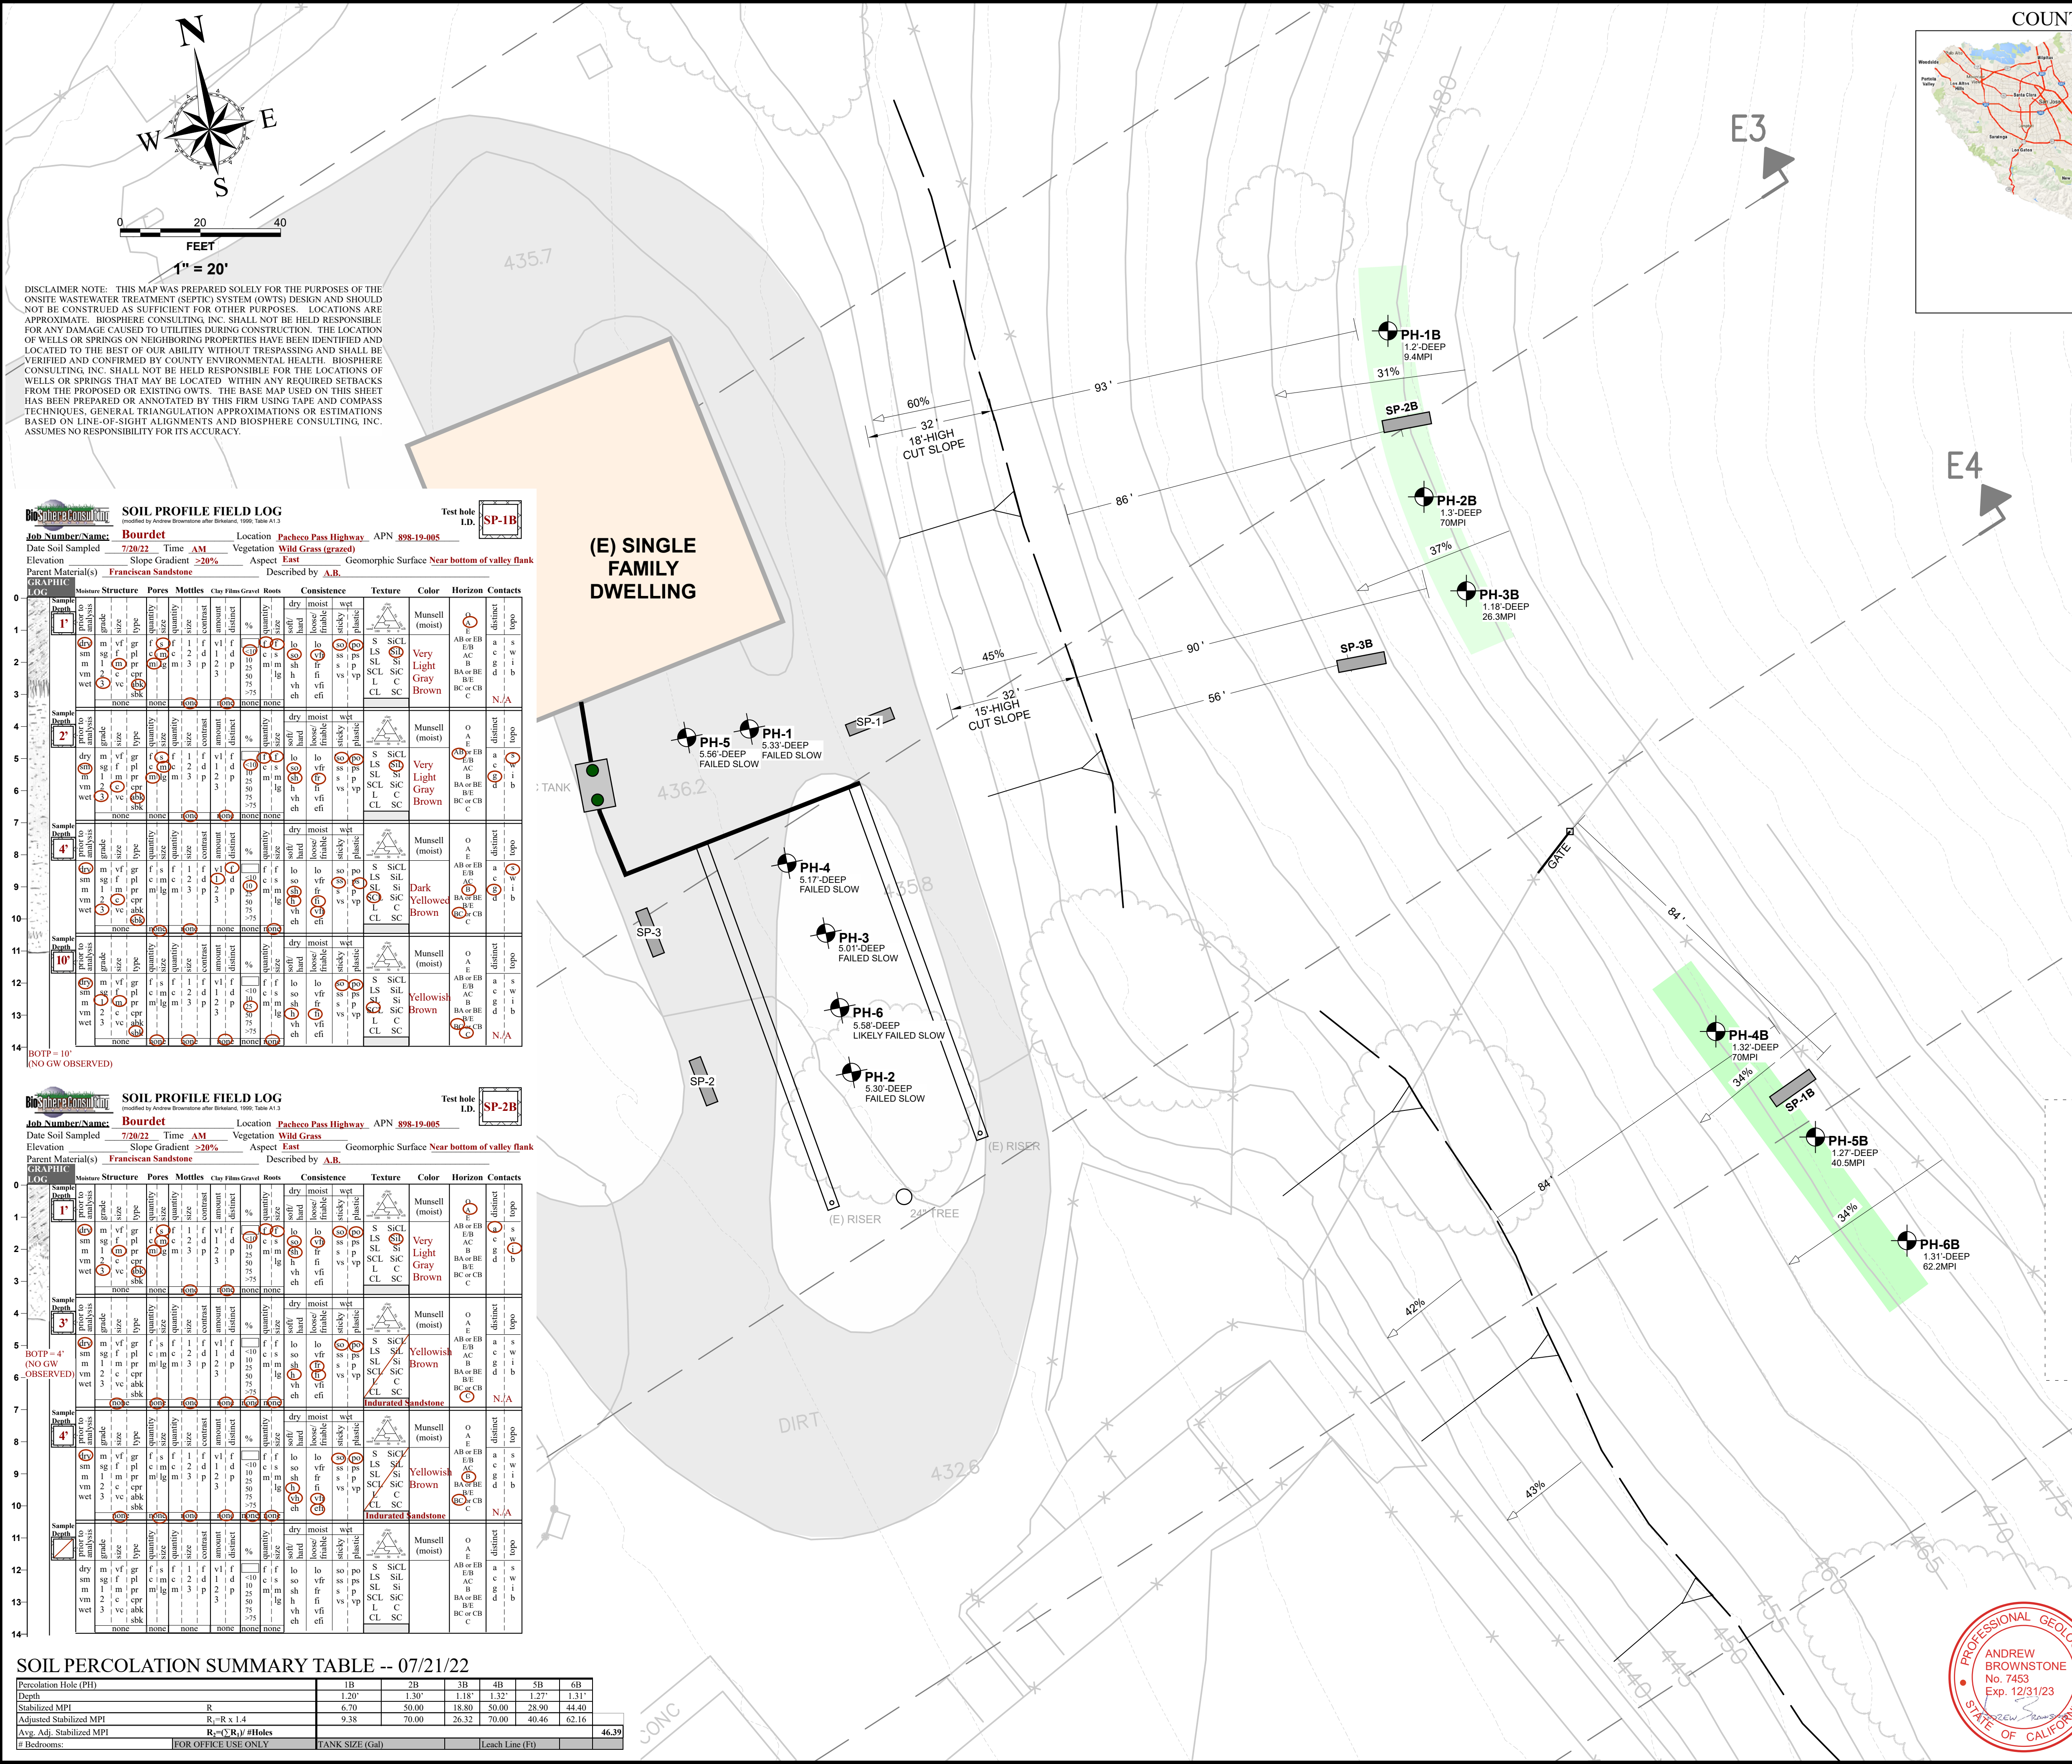
As shown on the map by BioSphere, the proposed leachfields will be located on west-facing slopes east of the existing residence in Harper Canyon. A northern and southern leachfield system are planned. Slopes are inclined between 31 and 37 percent in the area of the northern leachfield. The northern leachfield is located approximately 90 feet east of the top of a 15-18 foot-high cut slope inclined westward at 45-60 percent. The southern leachfield is located on slopes inclined approximately 34 percent to the southwest. The southern leachfield is located approximately 65 feet east of the top of a 18-20 foot-high cut slope inclined westward at approximately 42-43 percent. The cut slopes below the proposed leachfields are associated with the graded pad for the existing house and arena. We observed sandstone and shale bedrock in the lowermost sections of the cut slopes at the time of our visit on July 20, 2022. The few bedding exposures we observed dip obliquely into the slope. A small soil slump was observed in the cut beneath the oak tree downslope of the northern leachfield. No other signs of slope instability were observed in the area of the proposed leachfields.

REF.: Site Evaluation Results Map, by BioSphere Consulting, dated 07/22/22,
Provided to Earth Systems Pacific via email July 22, 2022.

Attachments: Site Evaluation Results Map, BioSphere Consulting
