### INFILTRATIVE AREA CALCULATIONS & SPECIFICATIONS

**TYPE OF SEPTIC SYSTEM:** Conventional Gravity Flow with Infiltration Chambers

## PROJECT SCOPE & RATIONALE:

This project is to construct a 3 BR house served by a conventional septic system. A conventional system design was selected due to sufficient area with slope < 30%, perc test results (8 MPI), and adequate separation (>8 ft) to potential high groundwater. Infiltration chambers are included to reduce the overall length of required drainfield. The proposed system is sized to serve an additional 5 BR residence in the future.

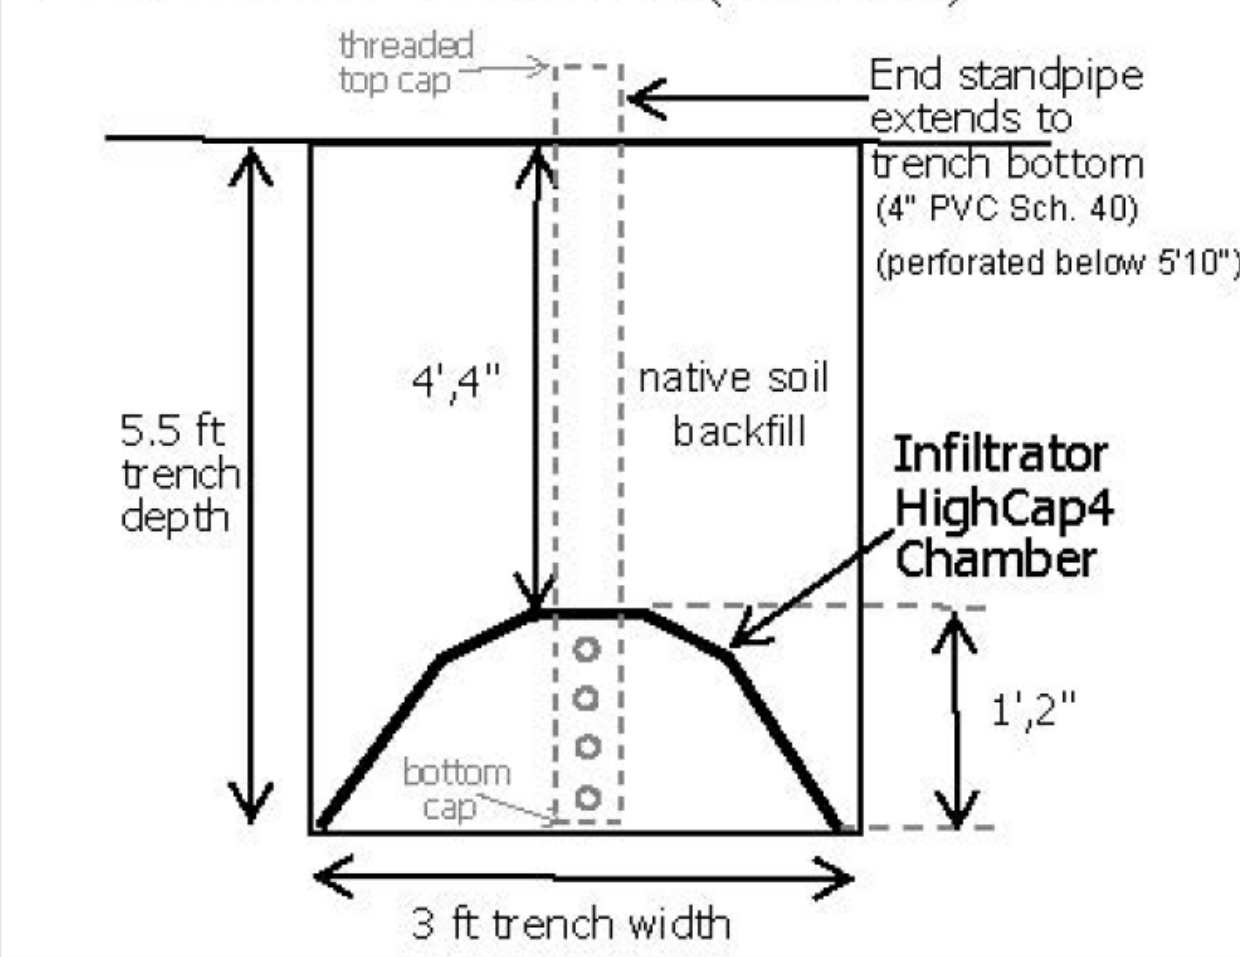
INFILTRATOR TRENCH DIAGRAM: (not to scale)

### **DRAINFIELD TRENCH:**

Drainfield Dimensions: **3 ft width x 5.5 ft depth**  
High Cap Chamber Height: **1.5 ft**  
Slope in Drainfield Area: **< 30%**  
Horizontal Drainfield Spacing: **7 ft o.c. (minimum)**  
Depth to GW Below Trenches: **> 8 1/2 ft (SP1&2)**

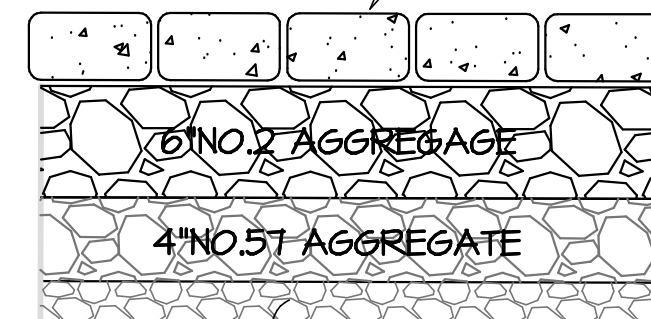
TYPICAL DETAIL  
PERVIOUS PAVERS  
PRIVATE DRIVEWAY  
NO SCALE

BELGARD PERVIOUS  
PAVERS (OR EQUAL)
