GEOTECHNICAL REPORT FOR THE EXPANSION OF POND 30

Permanente Quarry, Lehigh Hanson Southwest Cement

February 2015

Project No. 1417878

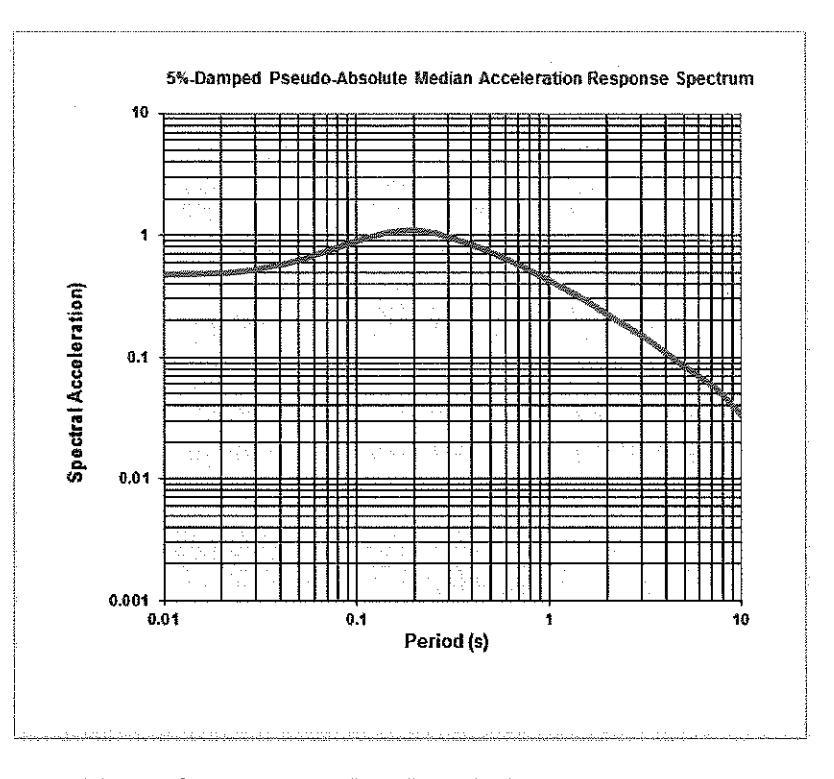
Golder estimated the peak ground acceleration (PGA) and the acceleration spectra for the MCE usina the Next Generation (NGA) Attenuation relationships developed by Abrahamson and Silva (2008), Boore and Atkinson (2008), Chiou and Youngs (2008), and Campbell and Bozorgnia (2008). The computed values from the four relationships were equally weighted (0.25 each) to estimate spectral accelerations as a function of magnitude, source-to-site distance, and fault geometry and for an average shear wave velocity in the upper 30 meters (100 feet) of the soil

column (V_{s30}) equal to 760 meters per second (2,500 feet per second). The calculations are presented in Appendix A. Golder estimates that the design PGA is 0.48g for the site. The median acceleration spectrum is included here for reference.

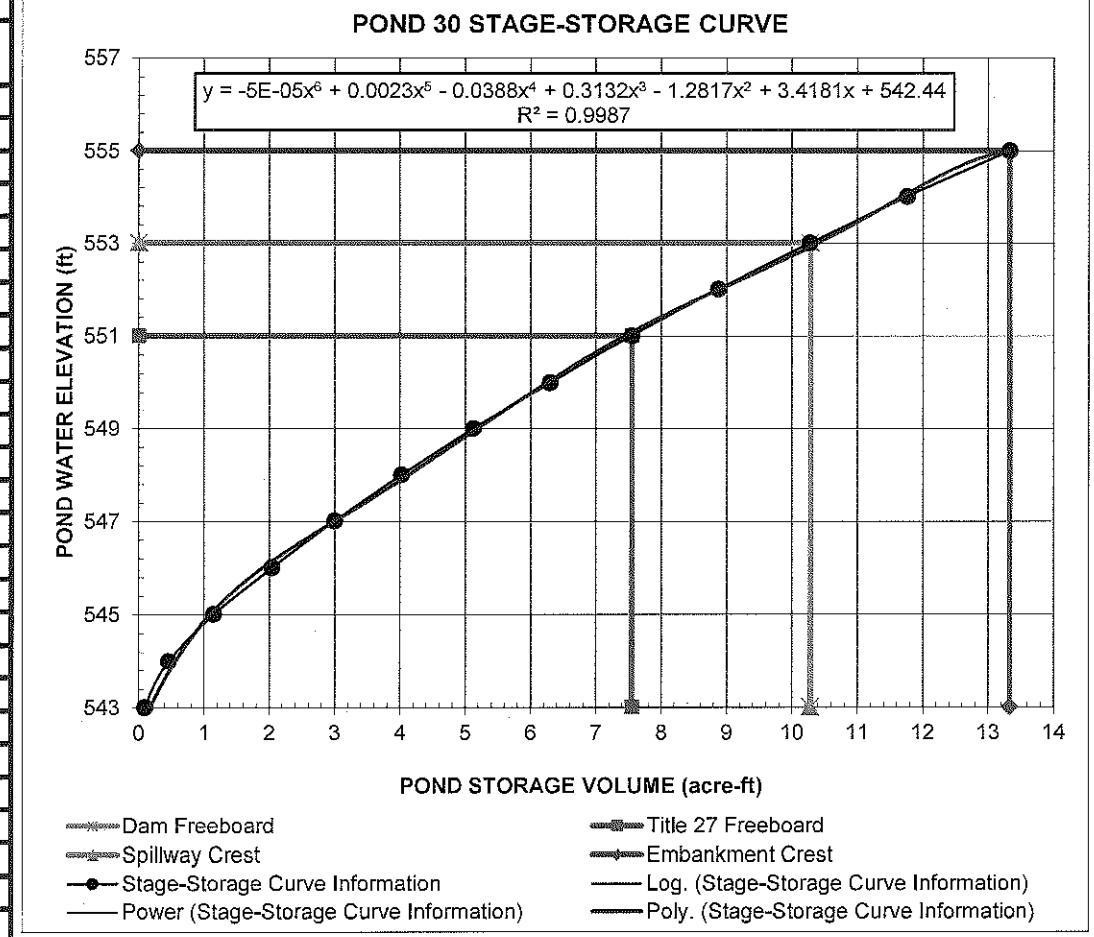
Stage-Storage Curve Information				
Elevation	Pond Surfa	ce Area	Capacity	
(ft)	(square-ft)	(acres)	(acre-ft)	
542.10	328	0.01	0.00	
543.00	8,814	0.20	0.09	
544.00	22,784	0.52	0.46	
545.00	37,258	0.86	1.15	
546.00	40,220	0.92	2.04	
547.00	43,252	0.99	2.99	
548.00	46,351	1.06	4.02	
549.00	49,520	1.14	5.12	
550.00	52,757	1.21	6.30	
551.00	56,063	1.29	7.55	
552.00	59,438	1.36	8.87	
553.00	62,881	1.44	10.28	
554.00	66,393	1.52	11.76	
555.00	69,974	1.61	13.32	
			·

Pond 30 Informa	tion
Pond Floor Elevation	542.10 ft amsl
Downstream Toe Elevation	550.03 ft amsl
Spillway Invert Elevation	553.00 ft amsl
Embankment Crest Elevation	555.00 ft amsl

Pond	30 Capa	city Infori	mation		
Title 27 Freeboard	0.00	7.55	7.55	551.00	551.00	543.00
Dam Freeboard	0.00	10.28	10.28	553.00	553.00	543.00
Spillway Crest	0.00	10.28	10.28	553.00	553.00	543.00
Embankment Crest	0.00	13.32	13.32	555.00	555.00	543.00

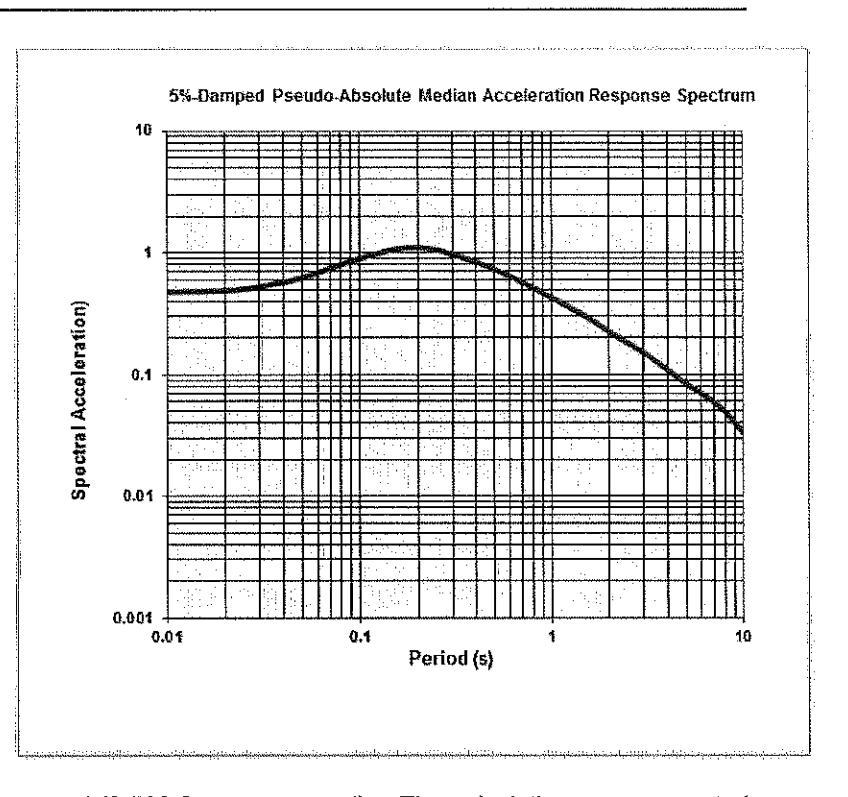
Golder estimated the peak ground acceleration (PGA) and the acceleration spectra for the MCE using the Next Generation Attenuation (NGA) relationships developed by Abrahamson and Silva (2008), Boore and Atkinson (2008), Chiou and Youngs (2008), and Campbell and Bozorgnia (2008). The computed values from the four relationships were equally weighted (0.25 each) to estimate spectral accelerations as a function of magnitude, source-to-site distance, and fault geometry and for an average shear wave velocity in the upper 30 meters (100 feet) of the soil

column (V_{s30}) equal to 760 meters per second (2,500 feet per second). The calculations are presented in Appendix A. Golder estimates that the design PGA is 0.48g for the site. The median acceleration spectrum is included here for reference.

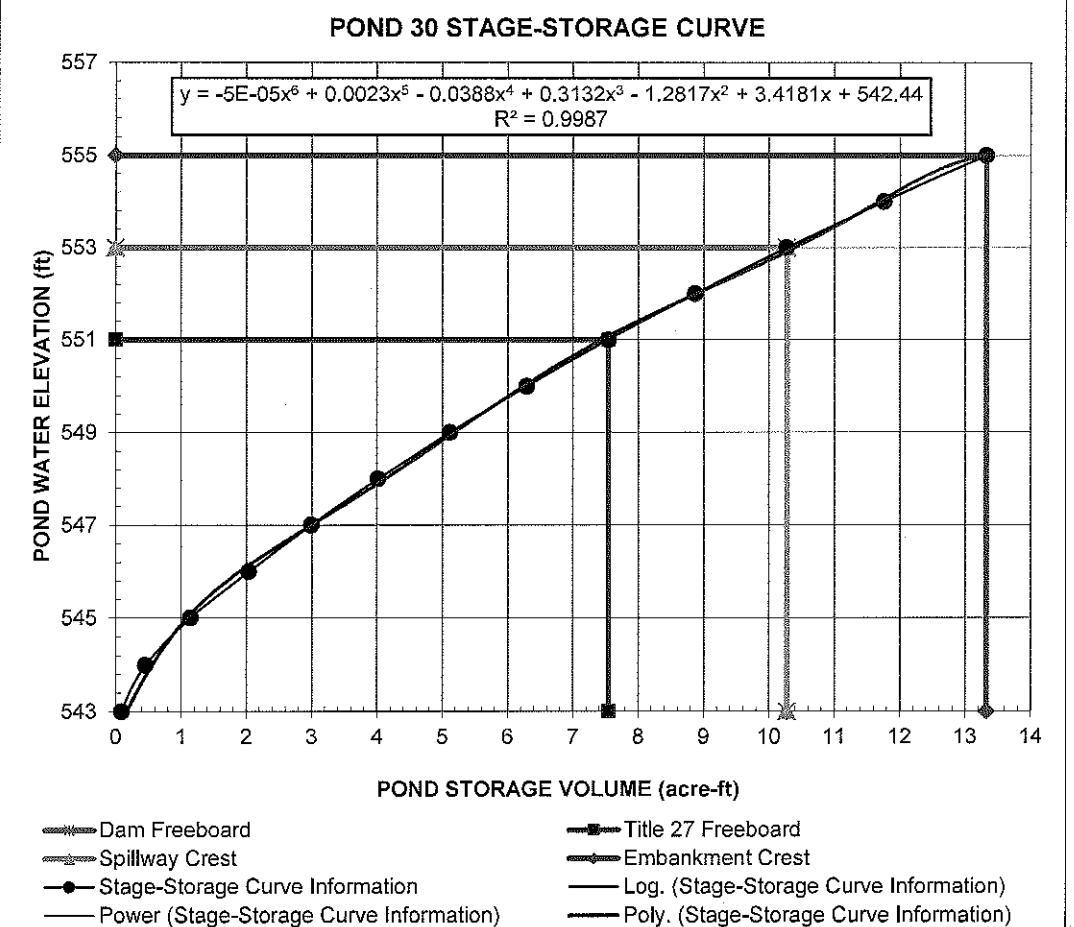
Stag	Stage-Storage Curve Information				
Elevation	Pond Surface Area		Capacity		
(ft)	(square-ft)	(acres)	(acre-ft)		
542.10	328	0.01	0.00		
543.00	8,814	0.20	0.09		
544.00	22,784	0.52	0.46		
545.00	37,258	0.86	1.15		
546.00	40,220	0.92	2.04		
547.00	43,252	0.99	2.99		
548.00	46,351	1.06	4.02		
549.00	49,520	1.14	5.12		
550.00	52,757	1.21	6.30		
551.00	56,063	1.29	7.55		
552.00	59,438	1.36	8.87		
553.00	62,881	1.44	10.28		
554.00	66,393	1.52	11.76		
555.00	69,974	1.61	13.32		
,,,,,,,,,,,,,,,,,,,,,,,,,,,,,,,,,,,,,,					
		<u> </u>			
······					
5112000720000000000000000000000000000000

Pond 30 Information					
Pond Floor Elevation	542.10 ft amsl				
Downstream Toe Elevation	550.03 ft amsl				
Spillway Invert Elevation	553.00 ft amsl				
Embankment Crest Elevation	555.00 ft amsl

Pond 30 Capacity Information						
Title 27 Freeboard	0.00	7.55	7.55	551.00	551.00	543.00
Dam Freeboard	0.00	10.28	10.28	553.00	553.00	543.00
Spillway Crest	0.00	10.28	10.28	553.00	553.00	543.00
Embankment Crest	0.00	13.32	13.32	555.00	555,00	543.00
