STANFORD UNIVERSITY UNIVERSITY ARCHITECT / CAMPUS PLANNING AND DESIGN

CASBS Evaluation – 2018 GUP application

PRIMARY RECORD	Trinomial
	NRHP Status Code 3CS
Other Listings	
Review Code	Reviewer
Date	
Page_1_ of _8 *Resource Name or #: (Assigned	I by recorder) Center for Advanced Study in the Behavioral Sciences
P1. Other Identifier: Stanford University Building 12-200) (main building), 12-210 (studios 1-6), 12-220 (studios 7-12), 12-230
(studios 13-16), 12-240 (studios 17-20), 12-250 (studios 2	1-25), 12-270 (studios 30-37), 12-280 (studios 38-54)
*P2. Location: 🗆 Not for Publication Unrestr	ricted
* a. County<u>Santa Clara</u>a a	nd (P2c, P2e, and P2b or P2d. Attach a Location Map as necessary.)
*h USGS 7.5' Quad Palo Alto Date

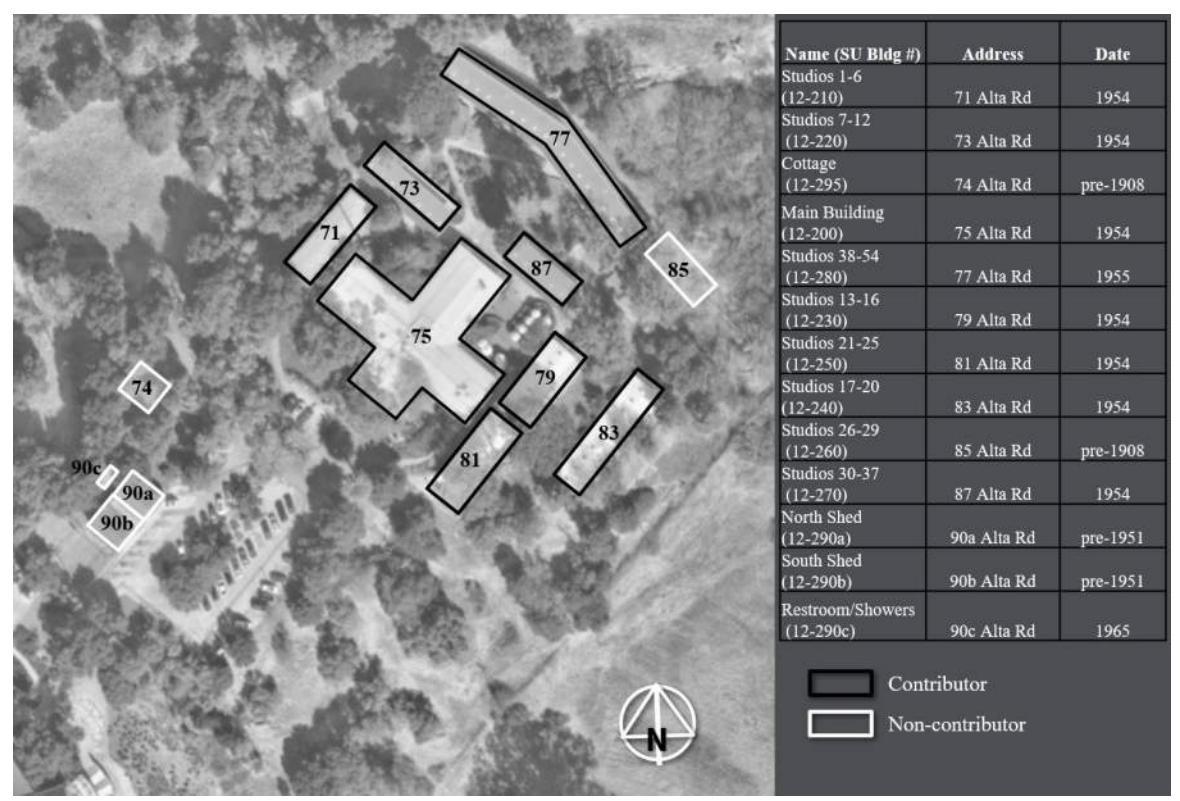
Site map numbered for entire document. Source: Nearmap edited by Author

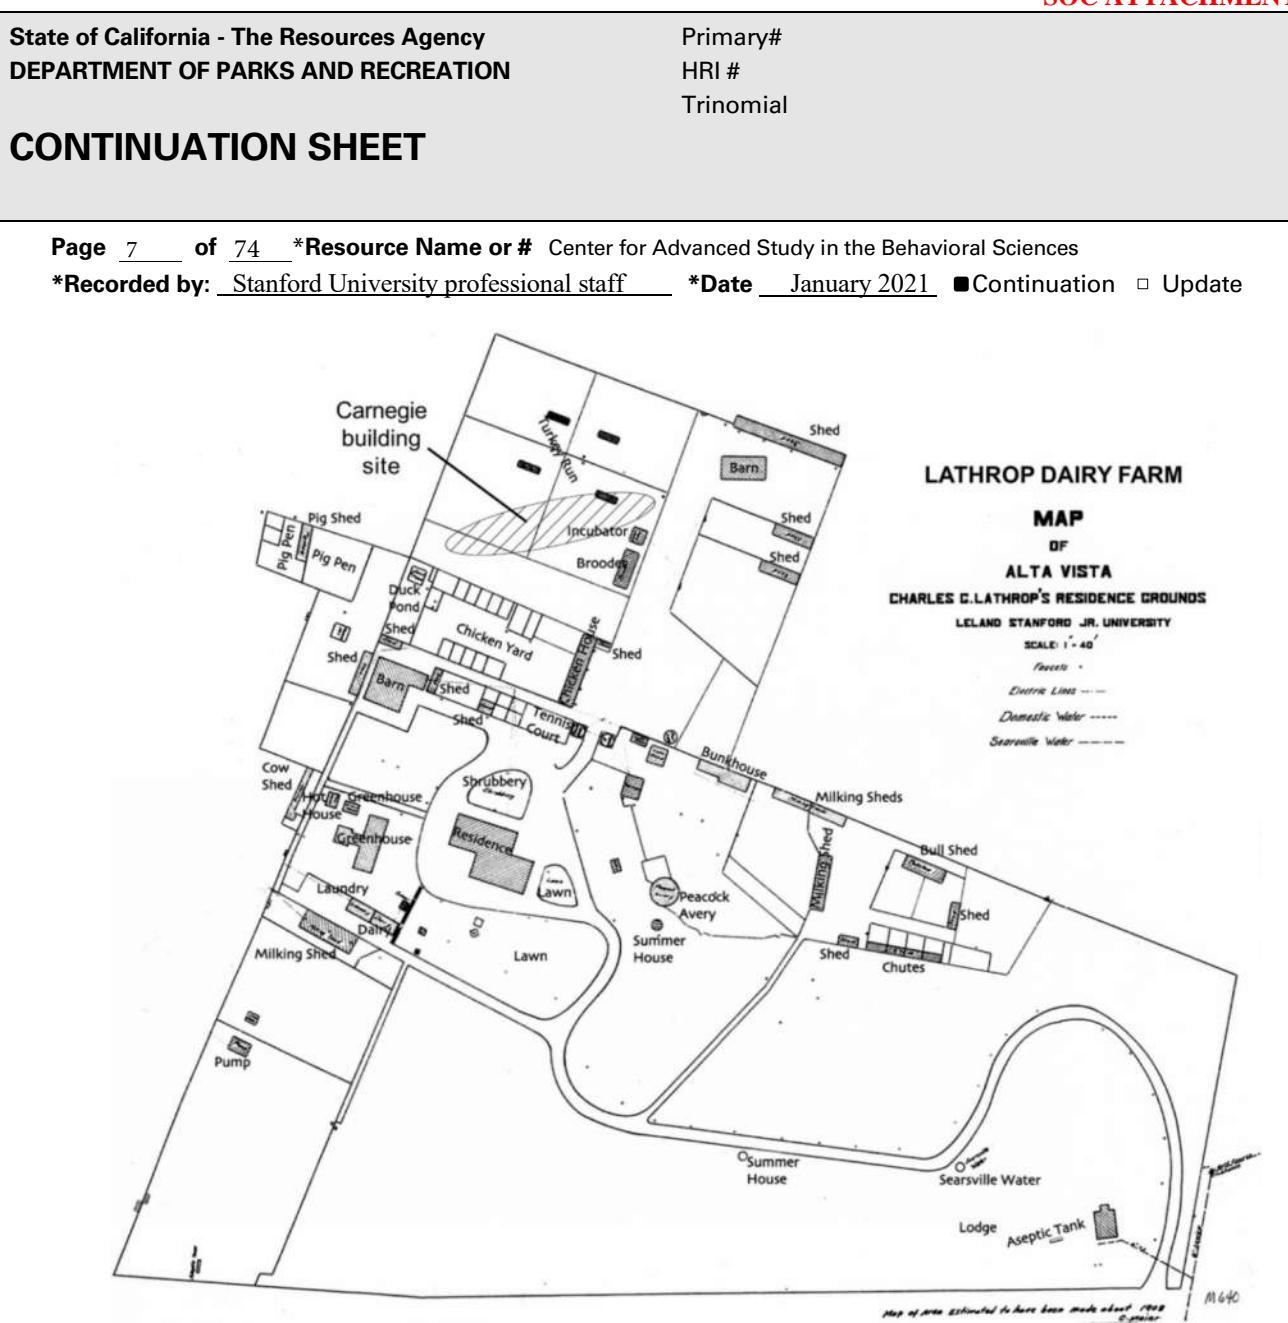
Map of Alta Vista, Charles G. Lathrop's residence and grounds, 1908. Source: Stanford University Archives.

A survey map (1908) presents a detailed view of the Alta Vista Estate, a residence and small farm established by Charles Lathrop in 1899 on land leased from his sister, Jane Lathrop Stanford. Charles Gardner Lathrop, the university business manager, built the main house in 1900. Charles Hodges, the university's resident architect, designed a large Victorian house sited on the crest of a hill.¹ The *San Francisco Chronicle* noted that the house "will command a magnificent view of the Santa Clara valley."² Located in the vicinity of the house was a peacock aviary and tennis court.

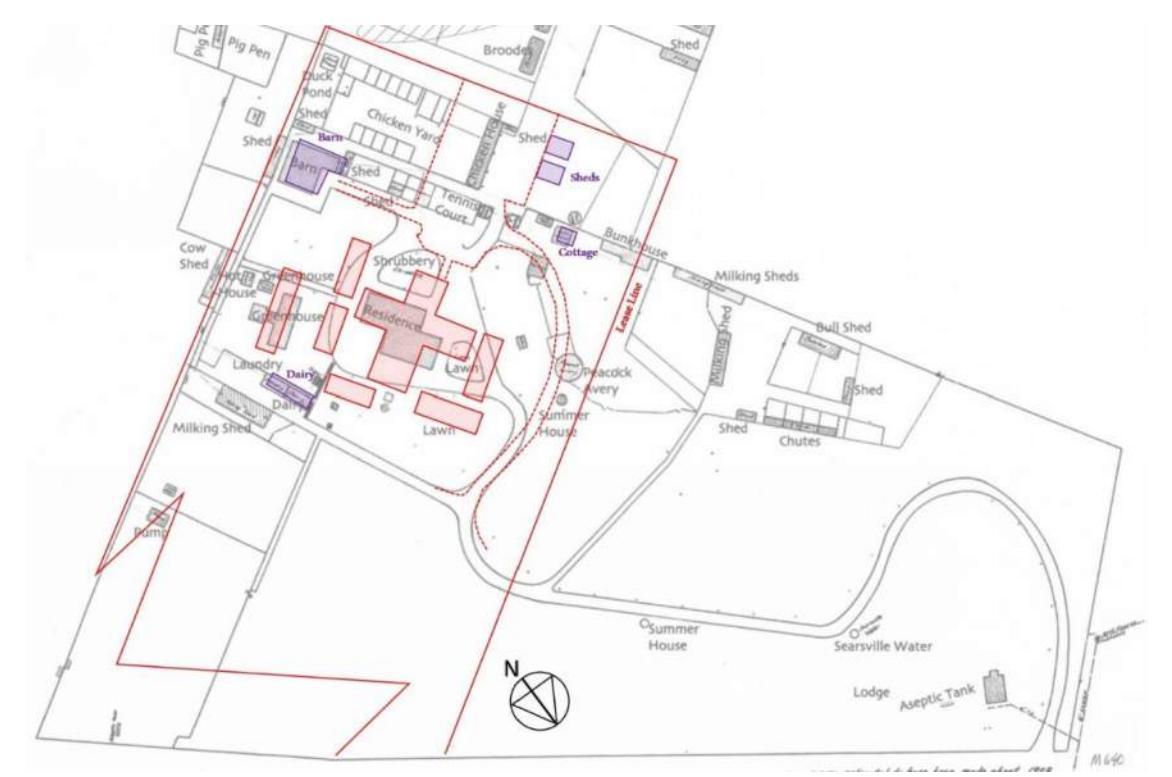
CASBS (red) 1954 Phase 1 Overlay on Lathrop Residence & Grounds, 1908. Structures from Lathrop Estate within CASBS Lease Line (sheds, dairy, cottage, barn) marked in purple. Source: Stanford University Archives, edited by Author

While the main house and many ancillary farm structures were demolished in 1954, a few buildings from the original estate remained on site and were incorporated into the new design and marked in purple in the map on page 9. The "lodge" chicken house lies outside the CASBS boundary and therefore will not be discussed further. Two sheds (90 Alta Rd) were relocated slightly south of their original location within the CASBS boundary and used by CASBS for storage.⁷⁸ The cottage (74 Alta Rd) and the dairy building (85 Alta Rd), were retained in their original locations.⁹ The dairy was converted to researcher studies.

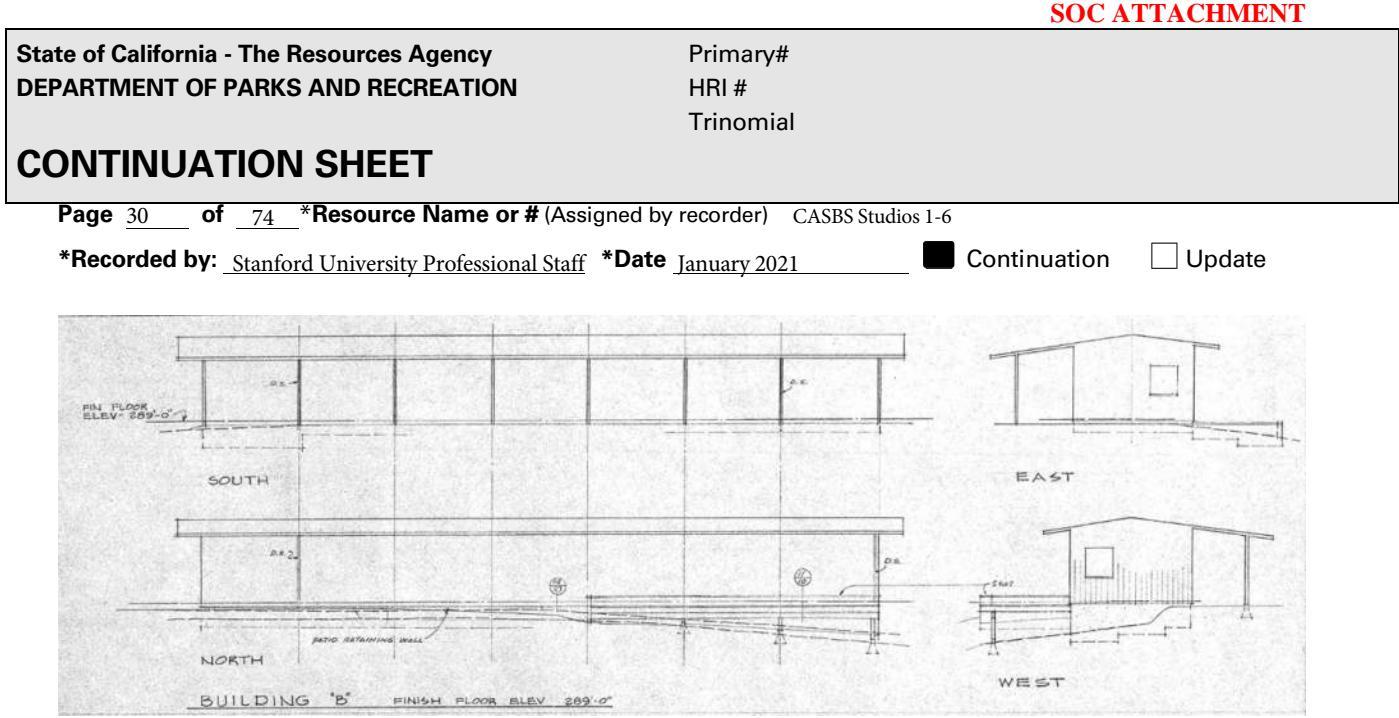
Study building elevations. Source: WBE 1954.

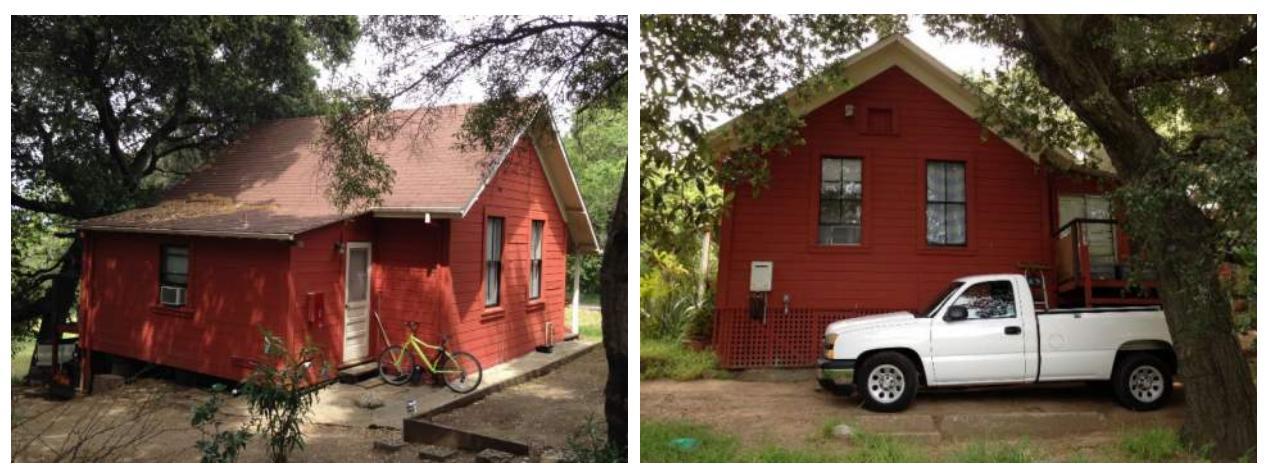
The cottage has a modest rear-addition attached to the south elevation. The addition has a single opening in the south elevation fitted with a wood double-hang one-over-one sash window. The east elevation of the addition has a single door and is setback from the east elevation of the main building. The west elevation of the addition has a sliding aluminum door opening directly onto a small deck with metal railing. The aluminum door and metal railing are modern replacement materials.

East elevation with addition. Source: UA/CPD March 2015. DPR 523L (9/2013

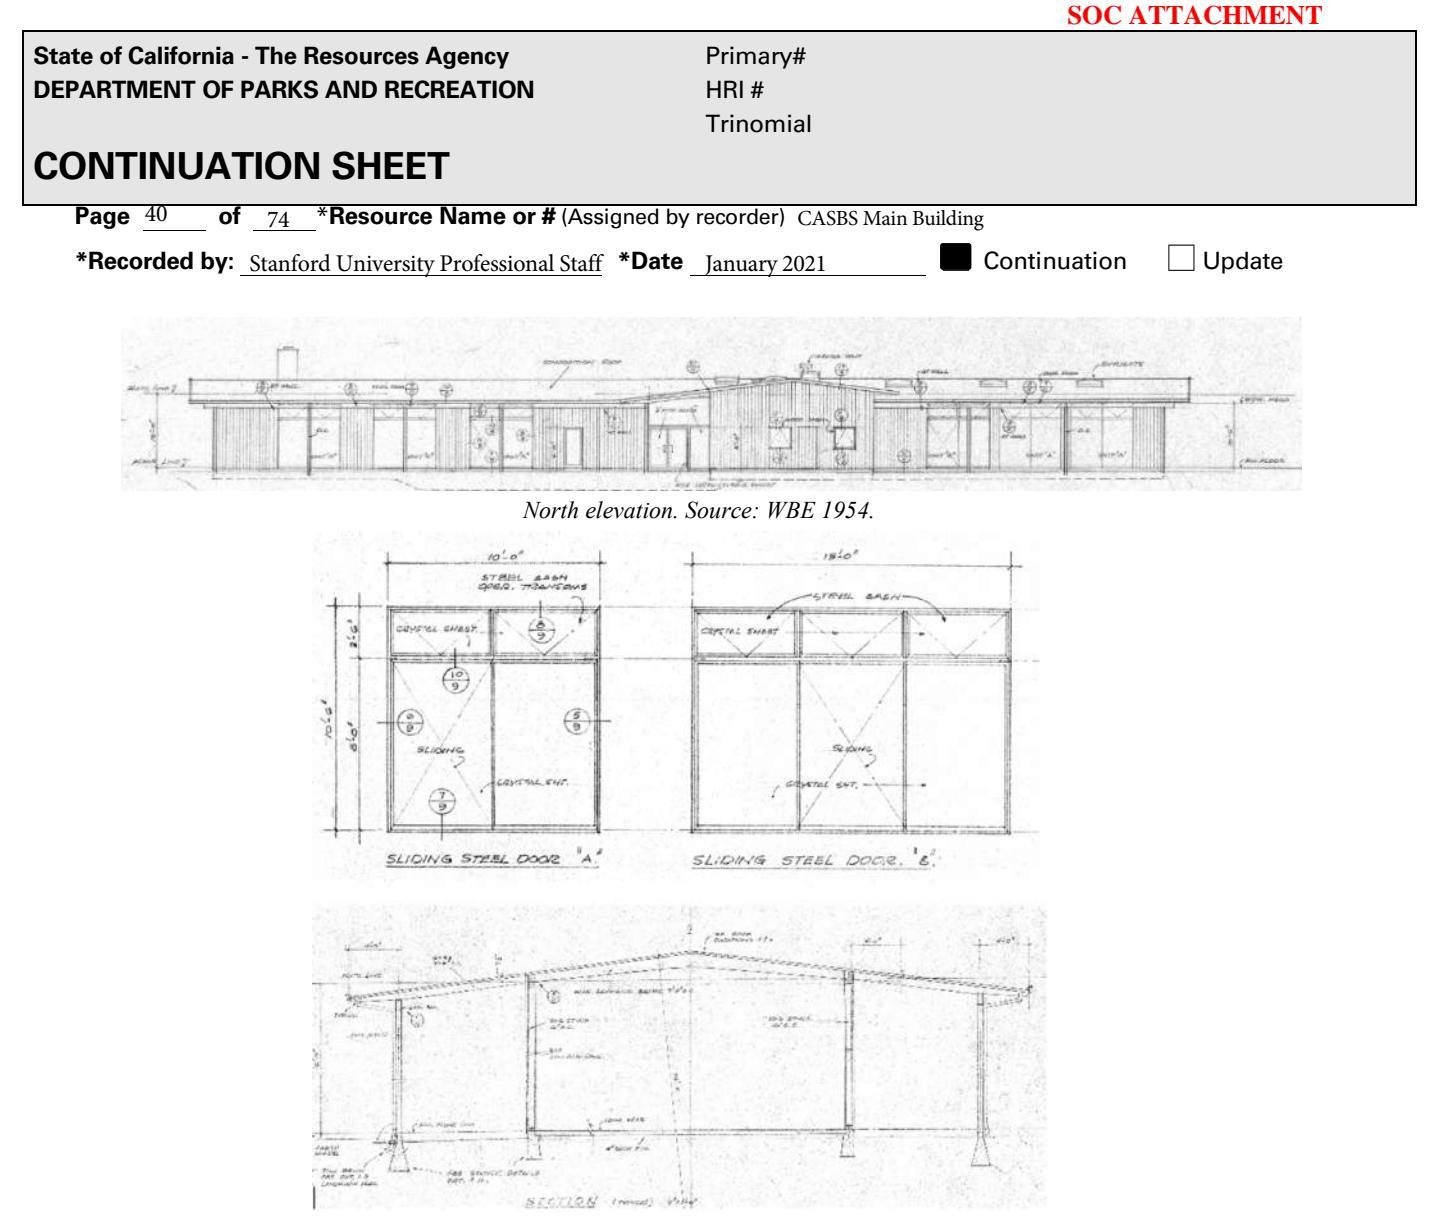
1954 Section Building A, Sliding Doors details. Source: WBE 1954.

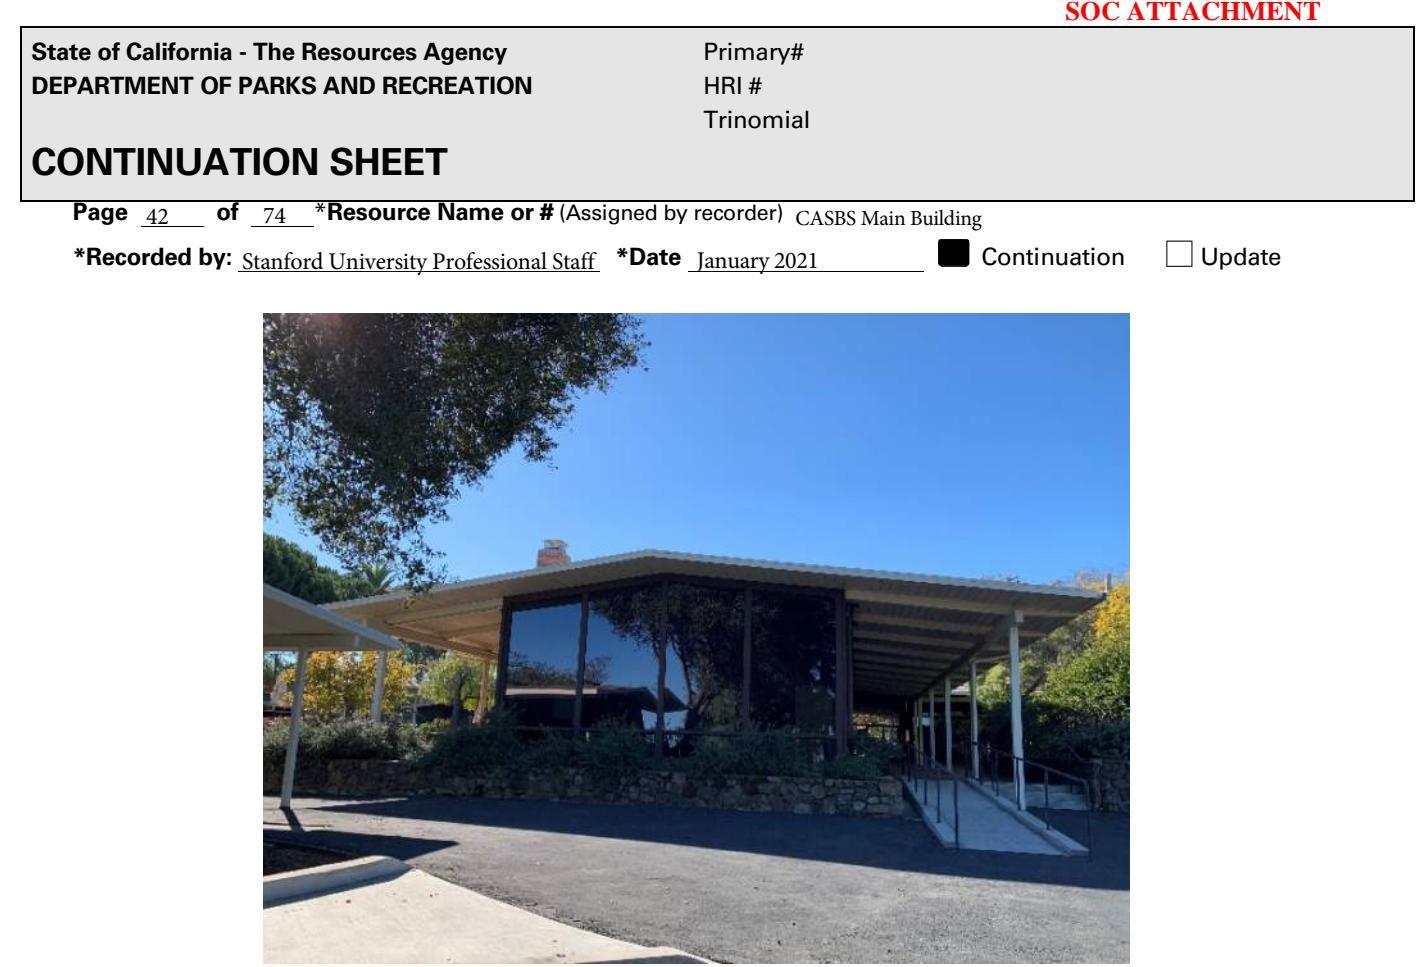
East elevation of the Main Building contains five black metal sliding doors, one solid wood door, one redwood and glass door and one window.

East elevation of Main Building. Source: UA/CPD November 2020.

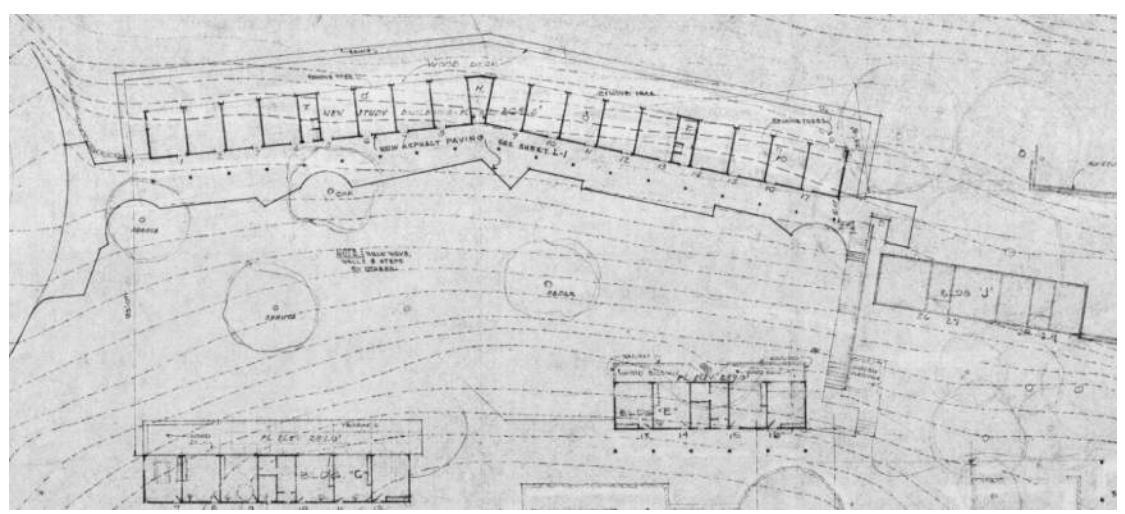
Studios 38-54 (77 Alta Rd)

Phase 2 addition. Source: WBE 1955.

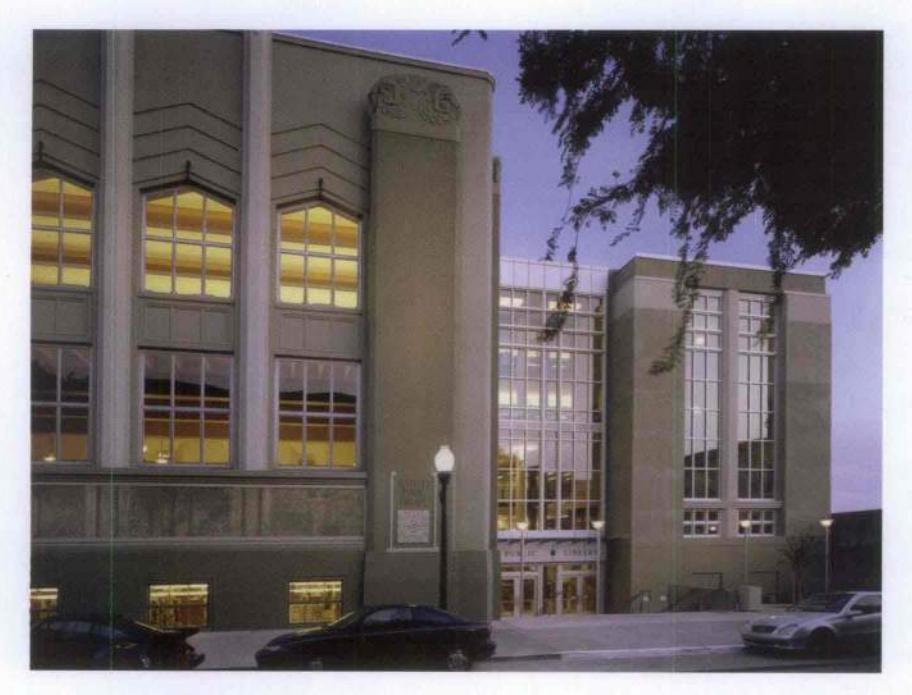
Figure 1. The addition to the right with its connecting hyphen is compatible with the Collegiate Gothic-style library. The addition is set back from the front of the library and uses the same materials and a simplified design that references, but does not copy, the historic building. Photo: David Wakely Photography.

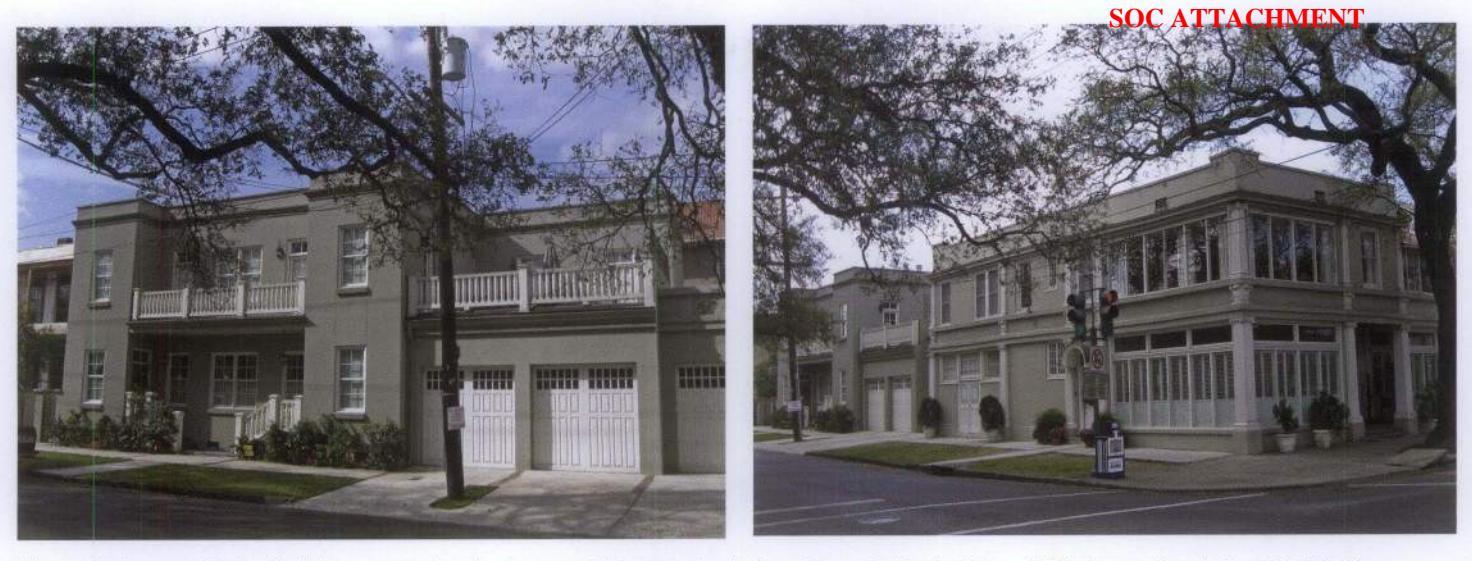
Figure 6. A new addition (left) is connected to the garage which separates it from the main block of the c. 1910 former florist shop (right). The addition is traditional in style, yet sufficiently restrained in design to distinguish it from the historic building.

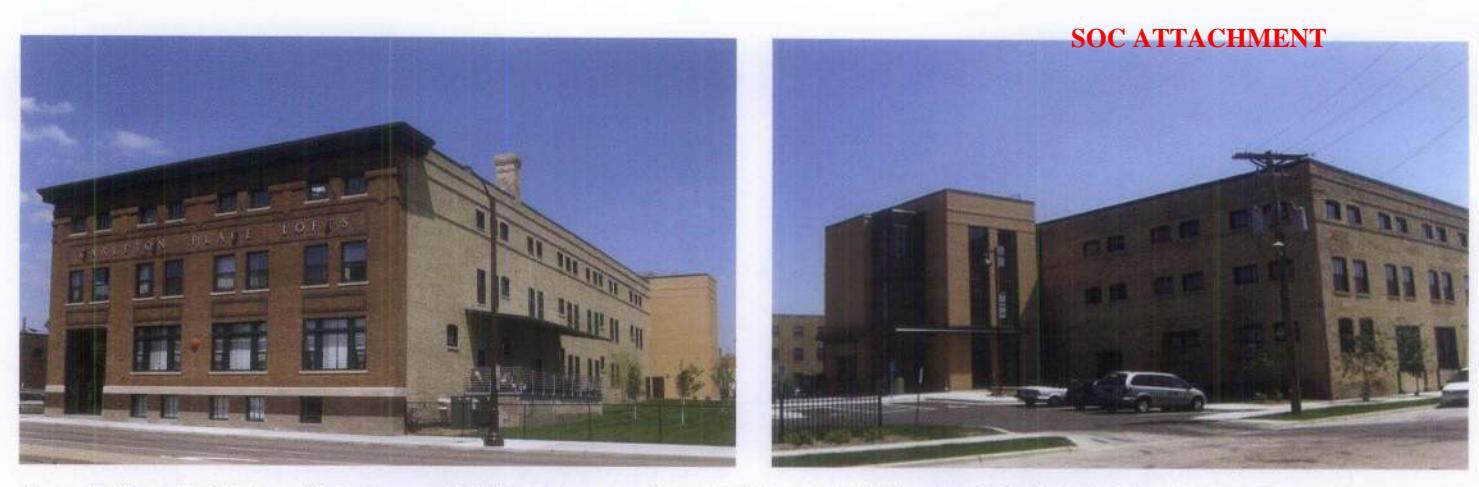
Figure 8. The rehabilitation of this large, early-20th century warehouse (left) into affordable artists' lofts included the addition of a compatible glass and brick elevator/stair tower at the back (right).

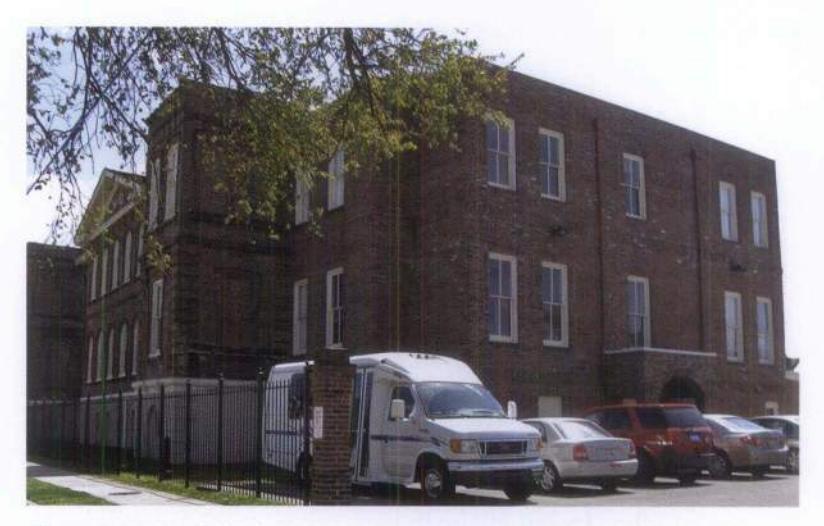
Figure 9. A simple, brick stair tower replaced two non-historic additions at the rear of this 1879 school building when it was rehabilitated as a women's and children's shelter. The addition is set back and it is not visible from the front of the school.

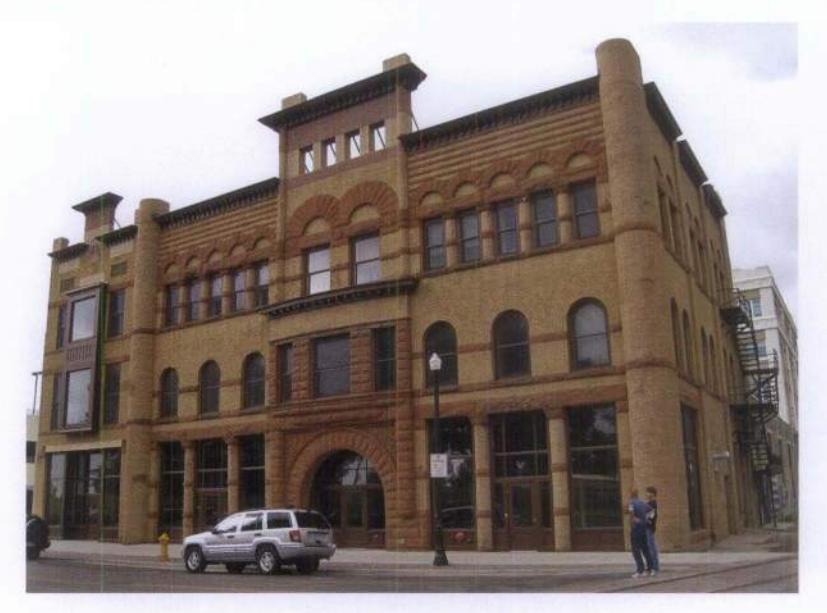
Figure 10. The small size and the use of matching materials ensures that the new addition on the left is compatible with the historic Romanesque Revival-style building.

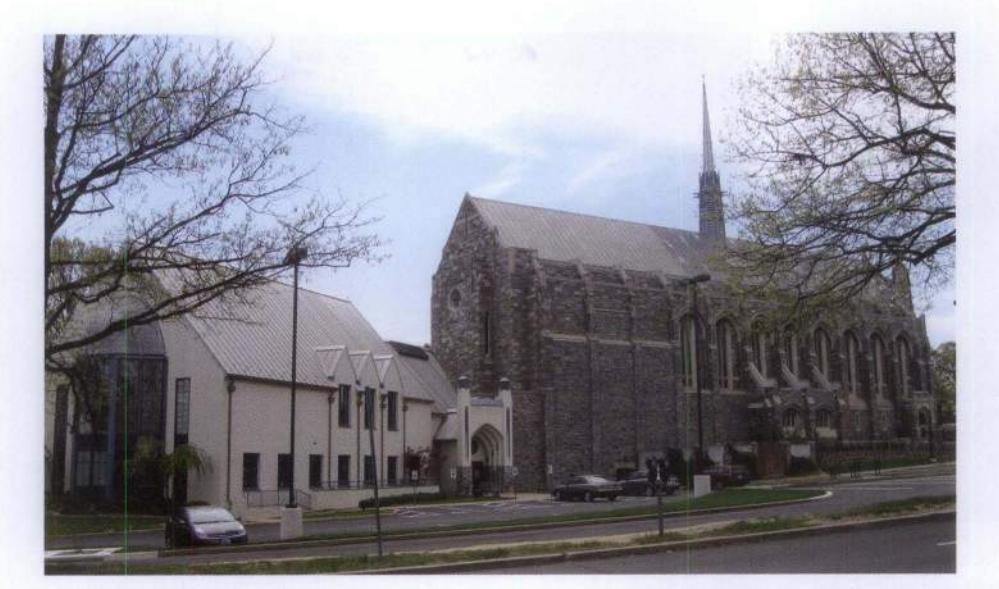
Figure 11. The addition to this early-20th century Gothic Revival-style church provides space for offices, a great hall for gatherings and an accessible entrance (left). The stucco finish, metal roof, narrow gables and the Gothic-arched entrance complement the architecture of the historic church. Placing the addition in back where the ground slopes away ensures that it is subordinate and minimizes its impact on the church (below).

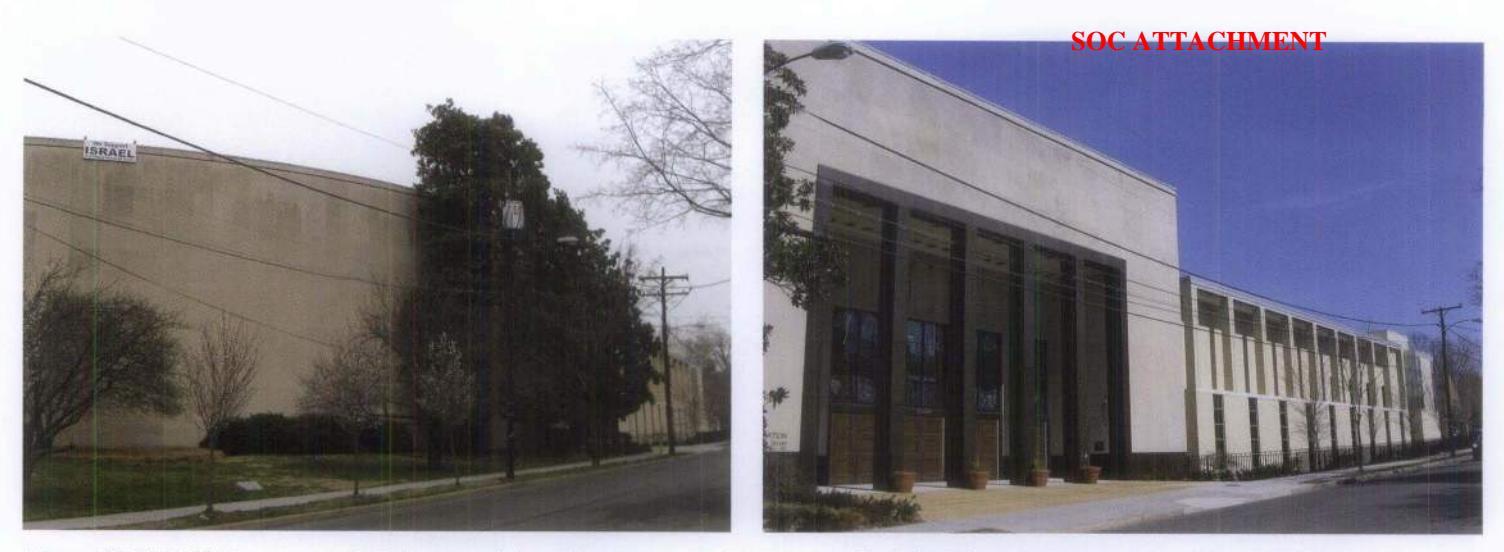
Figure 12. This 1954 synagogue (left) is accessed through a monumental entrance to the right. The new education wing (far right) added to it features the same vertical elements and color and, even though it is quite large, its smaller scale and height ensure that it is secondary to the historic resource.

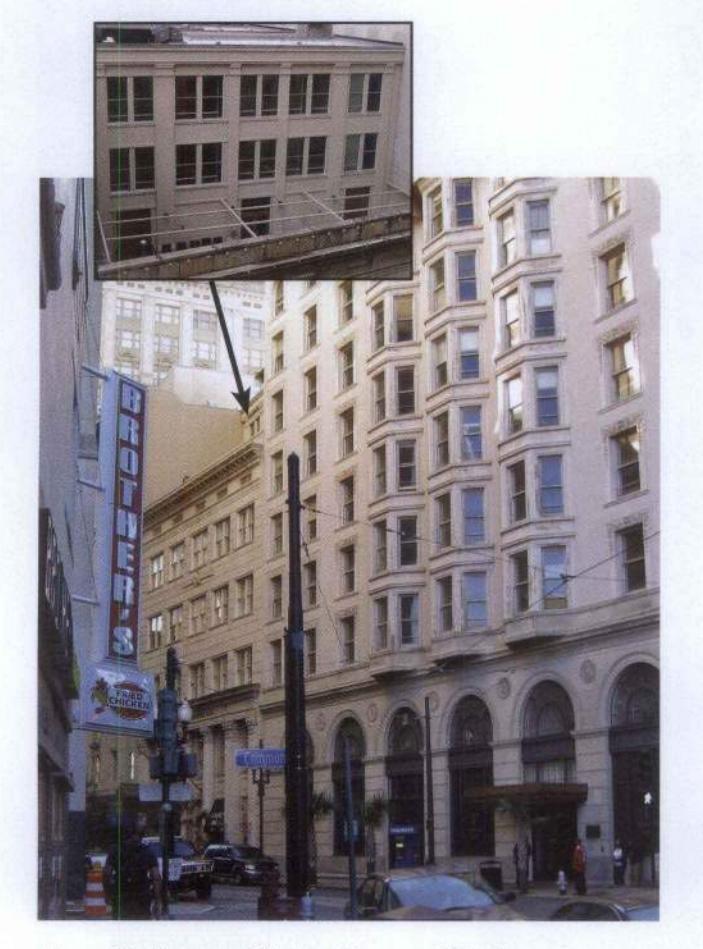
Figure 25. It was possible to add a compatible, three-story, penthouse addition to the roof of this five-story, historic bank building because the addition is set far back, it is surrounded by taller buildings and a deep parapet conceals almost all of the addition from below.

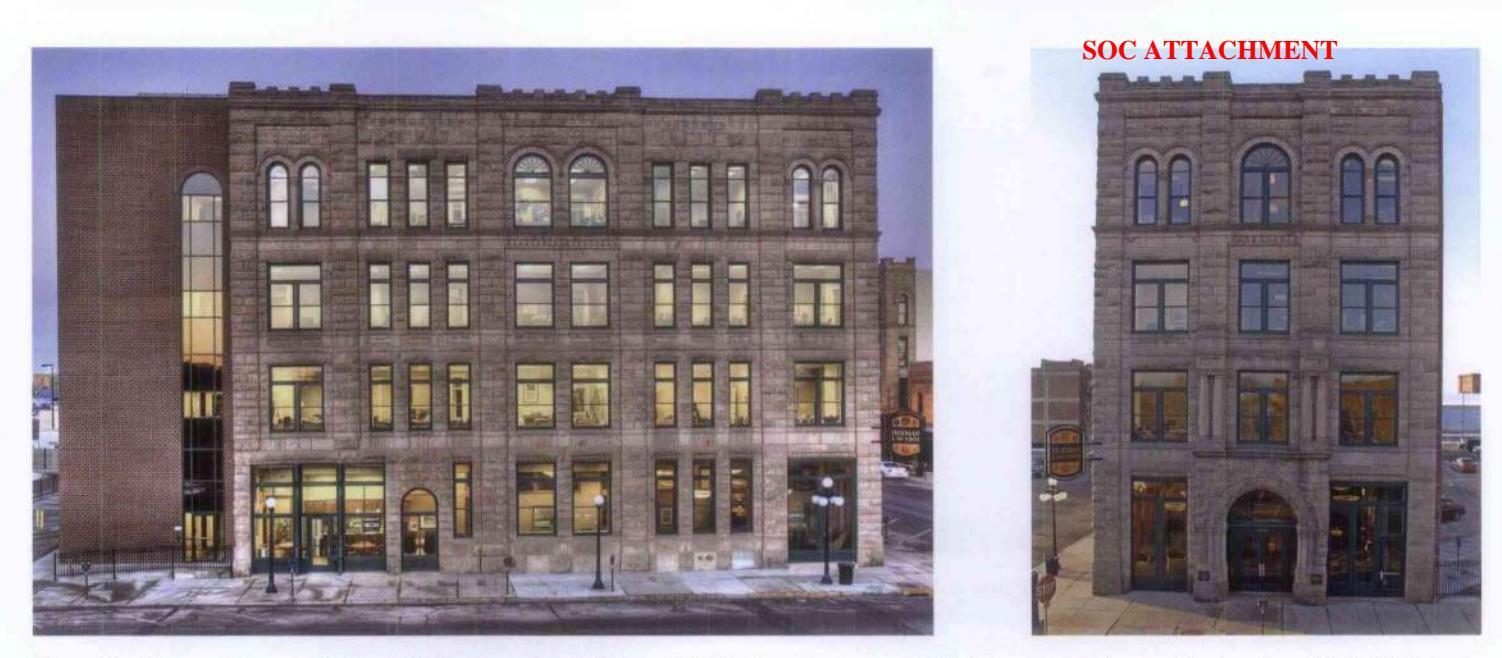
Figure 27. Although the new brick stair/elevator tower (left) is not visible from the front (right), it is on a prominent side elevation of this 1890 stone bank. The compatible addition is set back and does not compete with the historic building. Photos: Chadd Gossmann, Aurora Photography, LLC.

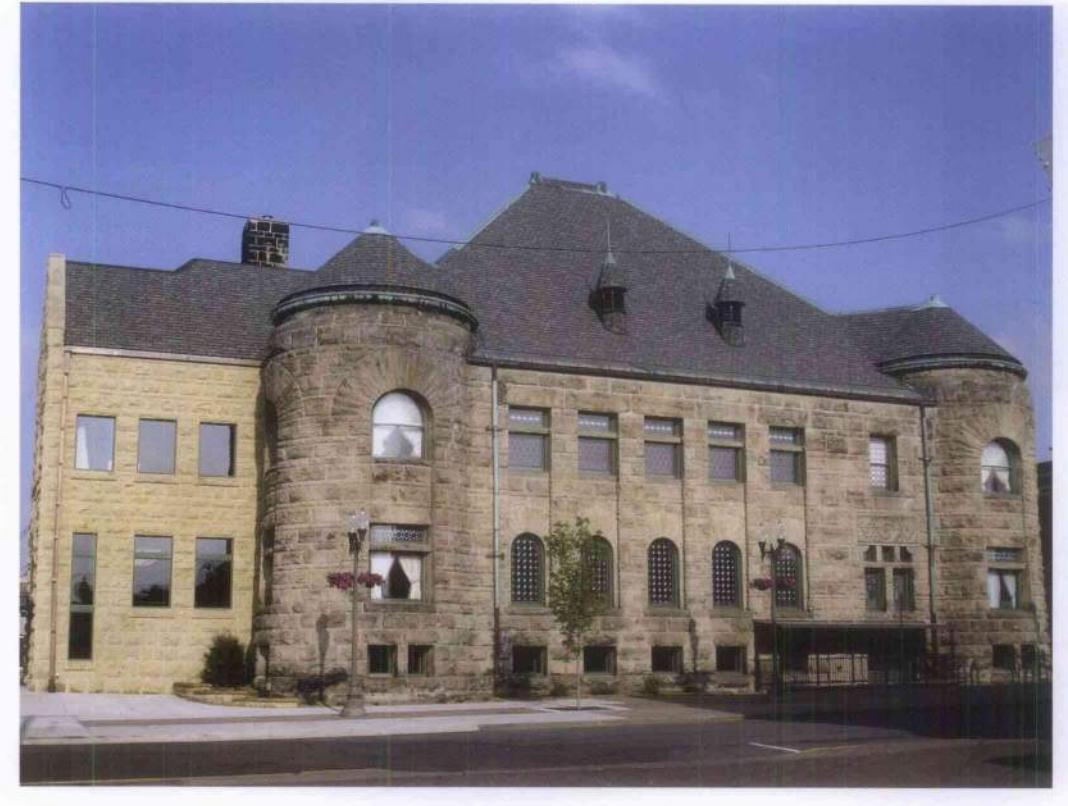
Figure 31. An elevator/stair tower was added at the back of this Richardsonian Romanesque-style theater when it was rehabilitated. Rough-cut stone and simple cut-out openings ensure that the addition is compatible and subordinate to the historic building. Photo: Chuck Liddy, AIA.
