# Revegetation Plan Permanente Quarry

SANTA CLARA COUNTY  
CALIFORNIA

December 2011

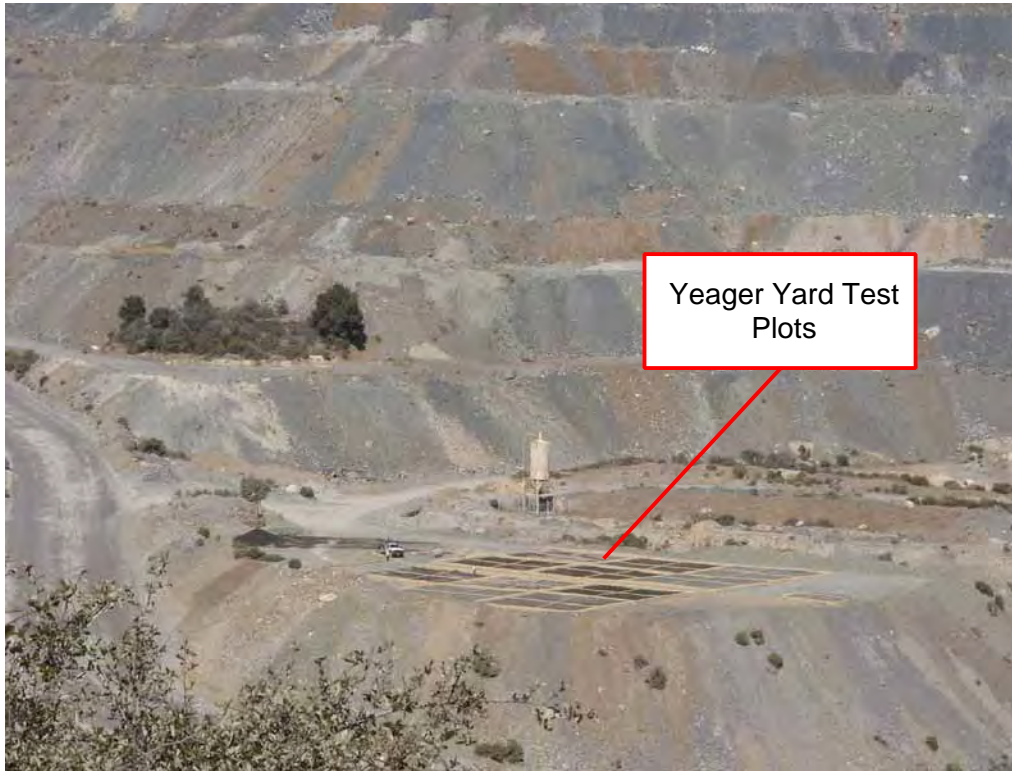
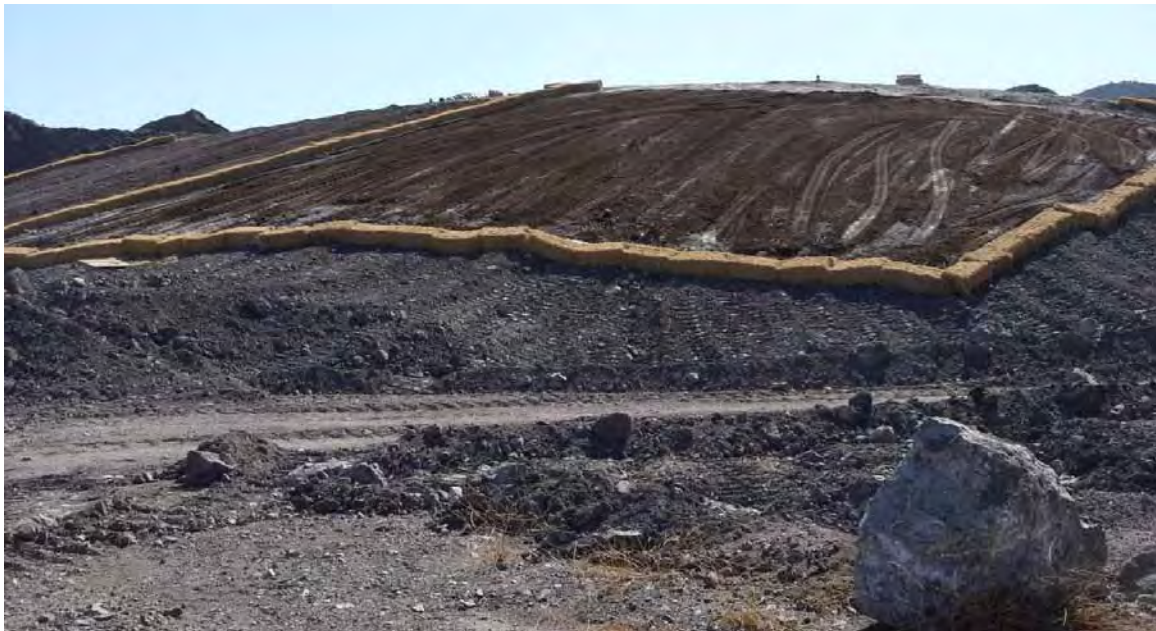
*Top:* Yeager Yard Test Plots (October 21, 2008)

*Bottom:* EMSA Test Plots (October 21, 2008)

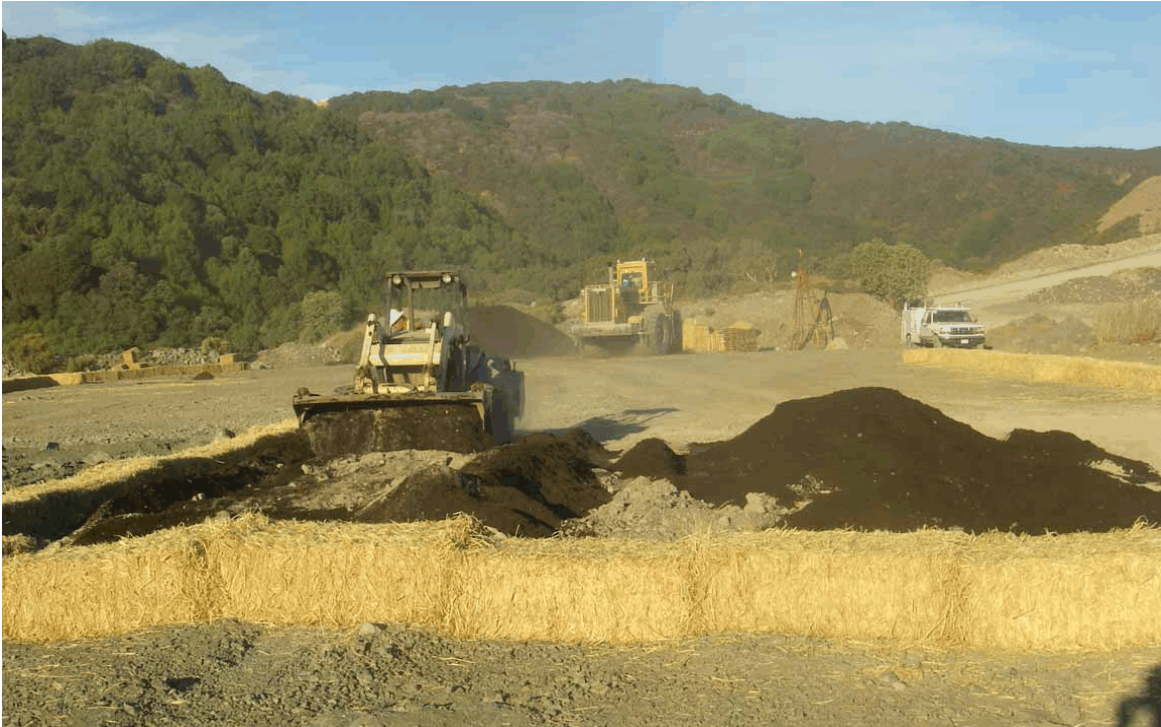
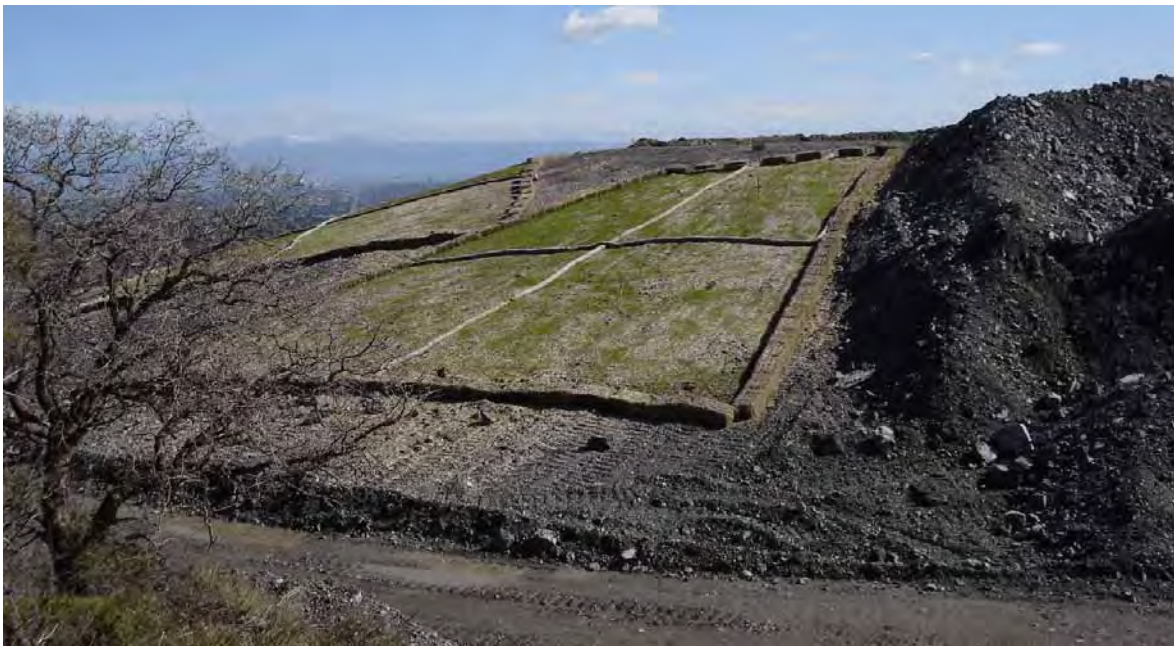
*Top:* Test plot construction at Yeager Yard:  
Blending soil materials (October 17, 2008)

*Bottom:* Early spring growth of hydroseed in  
the EMSA test plots (February 2, 2009)

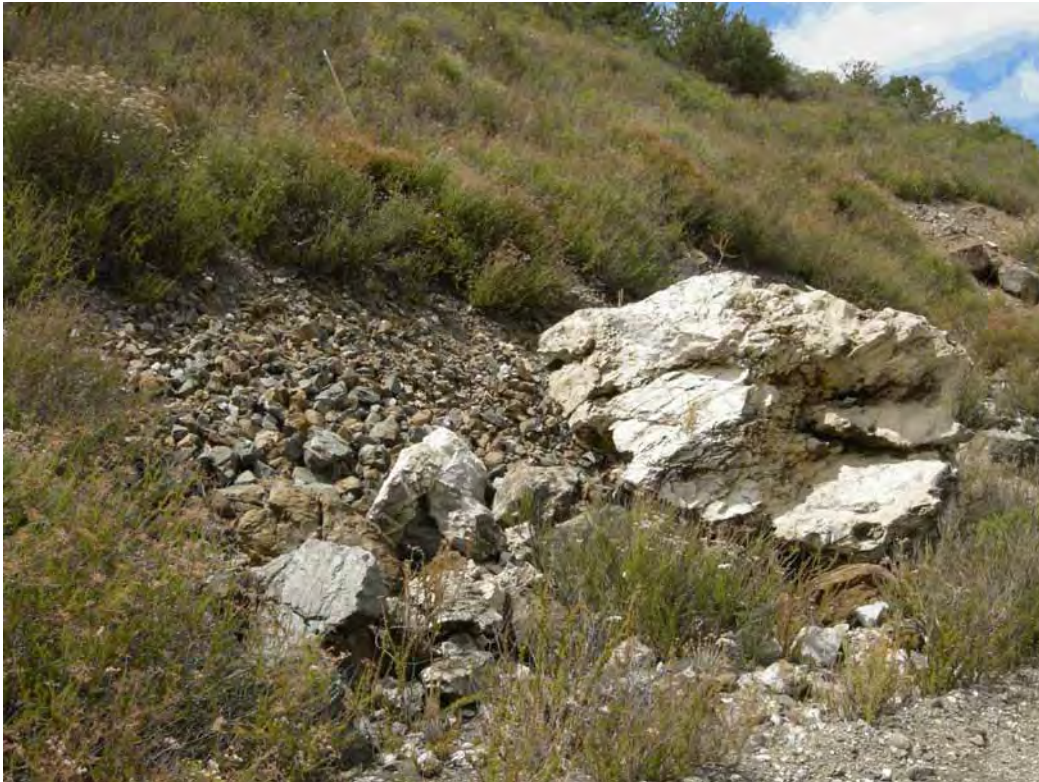
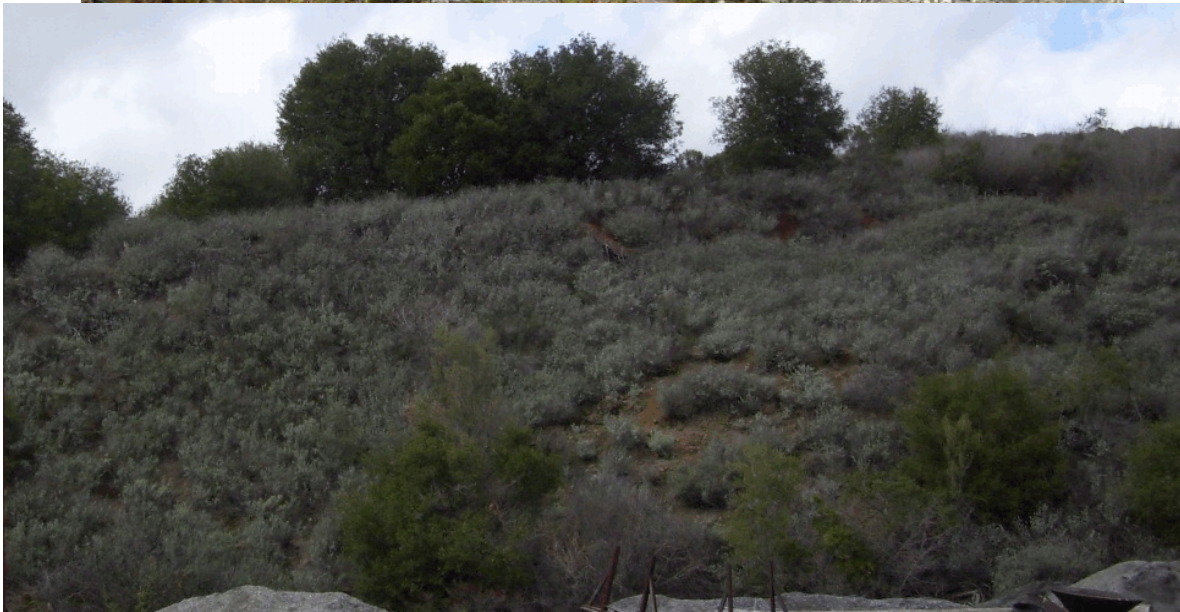
Previous successful revegetation areas supporting dense cover of native shrubs.

*Top:* East Quarry Revegetation area (photo May 27, 2008).

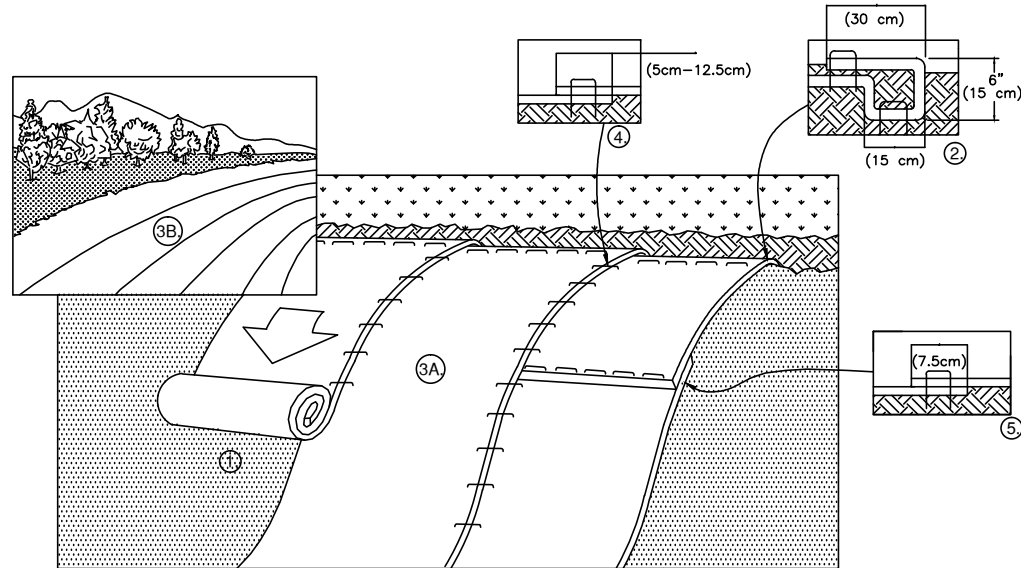
1. PREPARE SOIL BEFORE INSTALLING ROLLED EROSION CONTROL PRODUCTS (RECP's), INCLUDING ANY NECESSARY APPLICATION OF LIME, FERTILIZER, AND SEED.  
NOTE: WHEN USING CELL-O-SEED DO NOT SEED PREPARED AREA. CELL-O-SEED MUST BE INSTALLED WITH PAPER SIDE DOWN.

2. BEGIN AT THE TOP OF THE SLOPE BY ANCHORING THE RECP's IN A 6" (15 CM) DEEP X 6" (15 CM) WIDE TRENCH WITH APPROXIMATELY 12" (30cm) OF RECP's EXTENDED BEYOND THE UP-SLOPE PORTION OF THE TRENCH. ANCHOR THE RECP's WITH A ROW OF STAPLES/STAKES APPROXIMATELY 12" (30 CM) APART IN THE BOTTOM OF THE TRENCH. BACKFILL AND COMPACT THE TRENCH AFTER STAPLING. APPLY SEED TO COMPACTED SOIL AND FOLD REMAINING 12" (30 CM) PORTION OF RECP's BACK OVER SEED AND COMPACTED SOIL. SECURE RECP's OVER COMPACTED SOIL WITH A ROW OF STAPLES/STAKES SPACED APPROXIMATELY 12" (30 CM) APART ACROSS THE WIDTH OF THE RECP's.

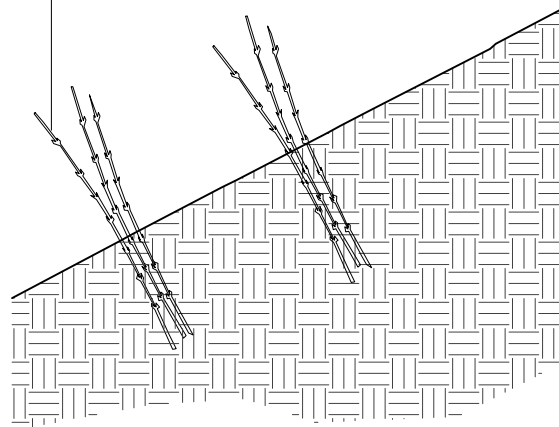
SECTION

WILLOW POLE CUTTINGS - SEE  
PLANTING SPECIFICATIONS.  
PLANT WILLOWS SUCH THAT BASE  
OF CUTTING EXTENDS A  
MINIMUM OF 24" BELOW THE  
FINISH GRADE.

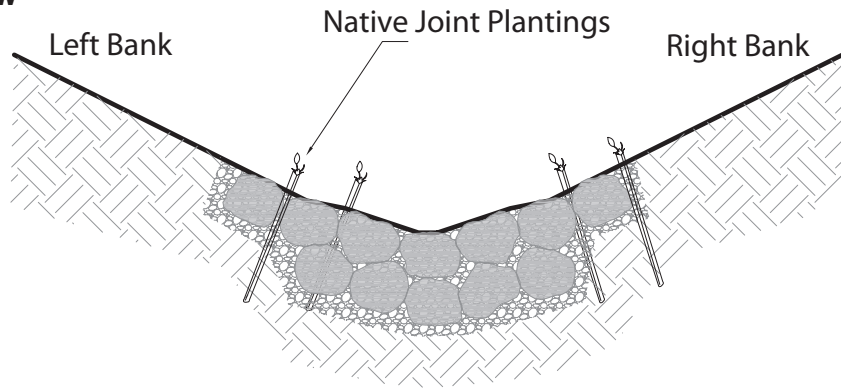
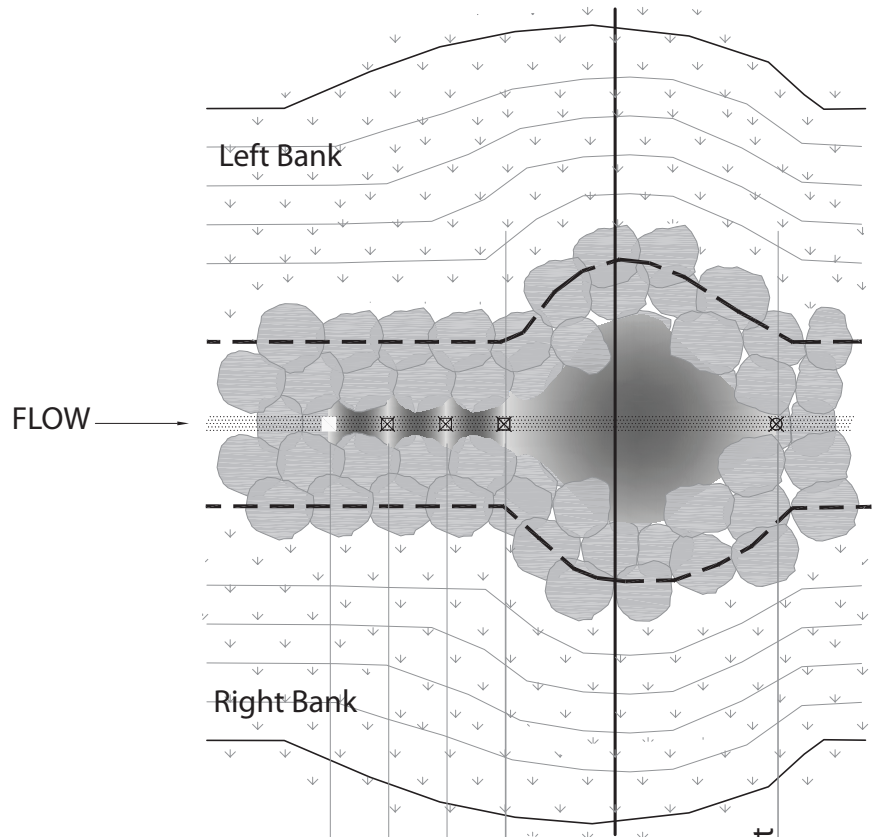
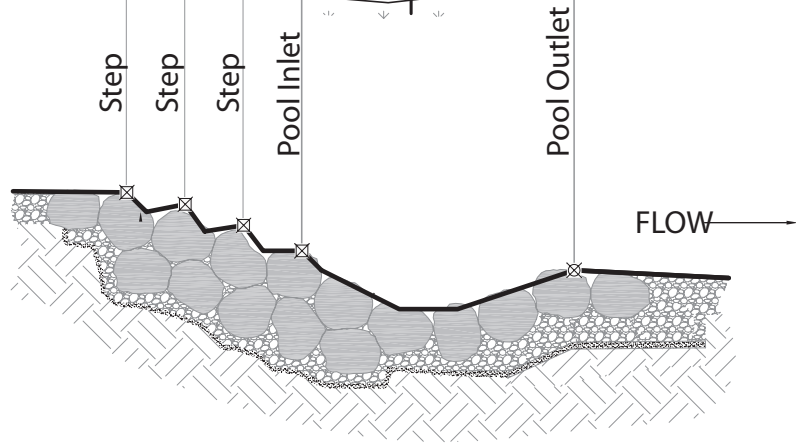
Figure 2. General schematic design of step pools.
