Revegetation Plan Permanente Quarry

SANTA CLARA COUNTY
CALIFORNIA

Lehigh Southwest Cement Company
24001 Stevens Creek Blvd.
Cupertino, CA 95014

December 2011

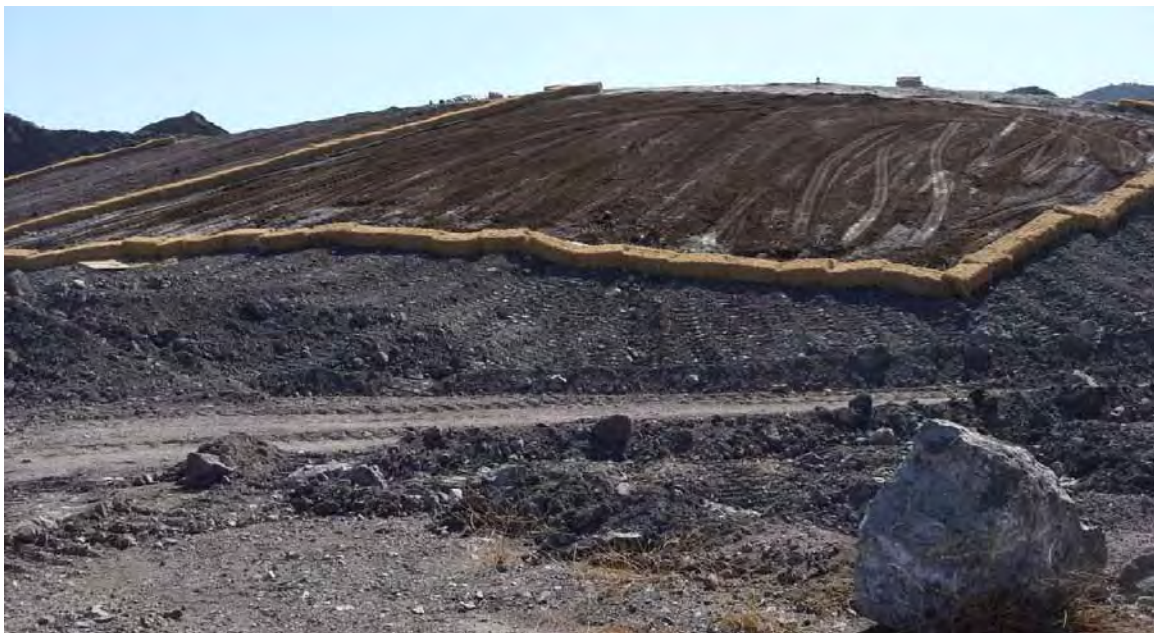
Appendix A - Revegetation and Test Plot Photographs

Top: Yeager Yard Test Plots (October 21, 2008)

Bottom: EMSA Test Plots (October 21, 2008)

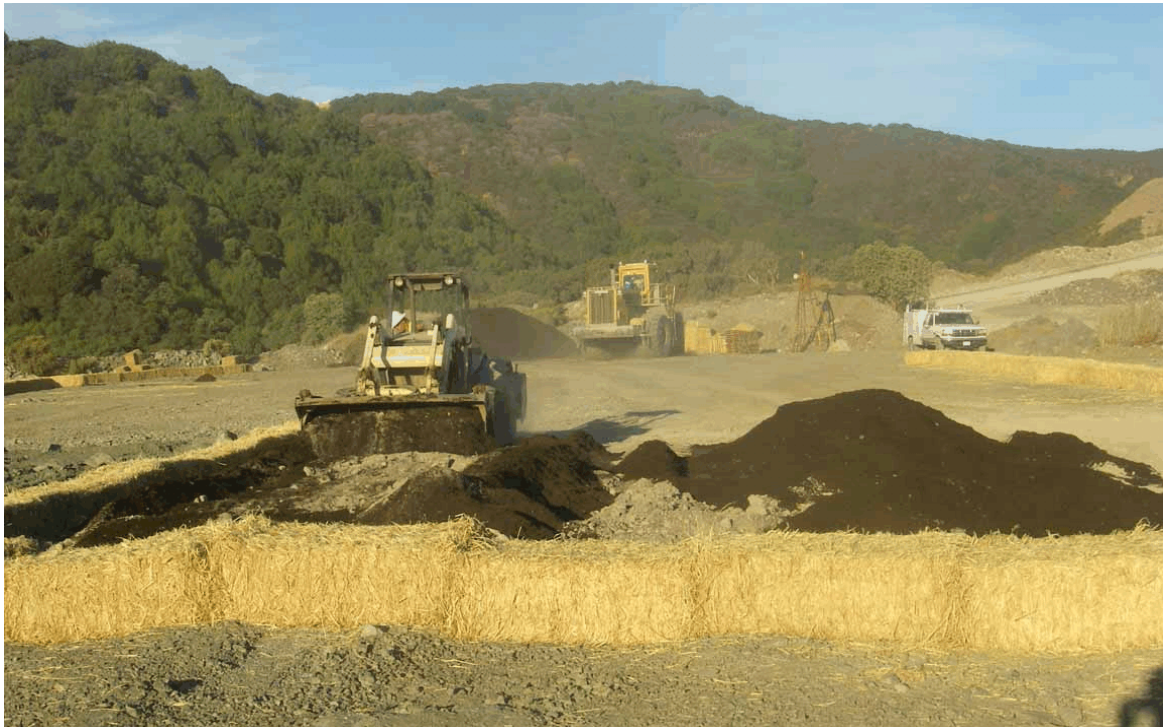
Top: Test plot construction at Yeager Yard:
Blending soil materials (October 17, 2008)

Bottom: Early spring growth of hydroseed in
the EMSA test plots (February 2, 2009)

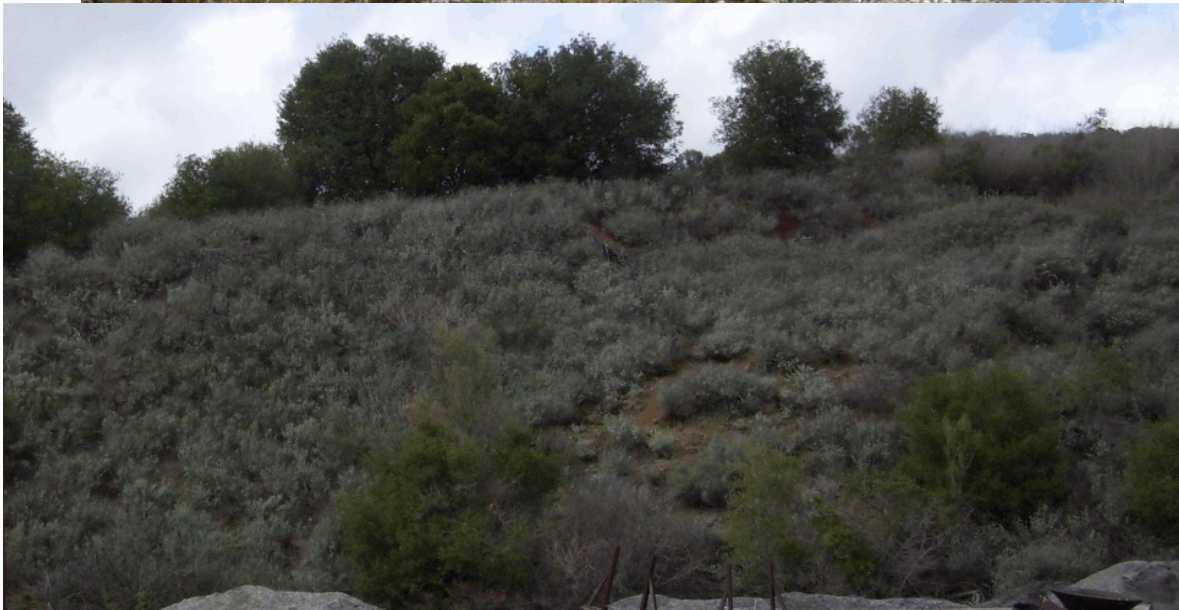
Previous successful revegetation areas supporting dense cover of native shrubs.

Top: East Quarry Revegetation area (photo May 27, 2008).
